APPENDIX C REPORT OF MANUFACTURING AND TEST PANEL

TASK ASSIGNMENT AND IMPLEMENTATION

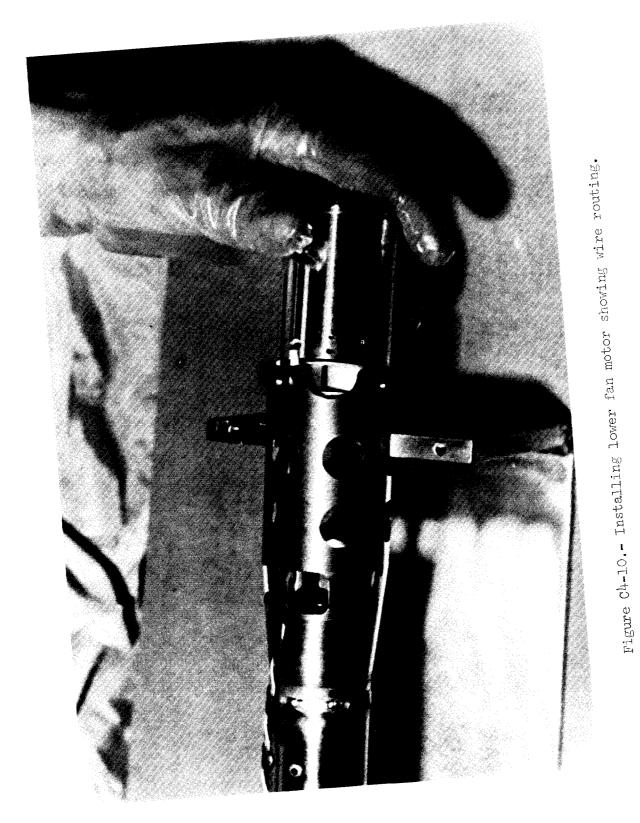
Figure $C^{4}-9$. Installing lower fan motor.
