# **A Survey of Crane Operating Experience at U.S. Nuclear Power Plants from 1968 through 2002**

**U.S. Nuclear Regulatory Commission  
Office of Nuclear Regulatory Research  
Washington, DC 20555-0001**

Manuscript Completed: June 2003  
Date Published: July 2003

Prepared by  
R.L. Lloyd

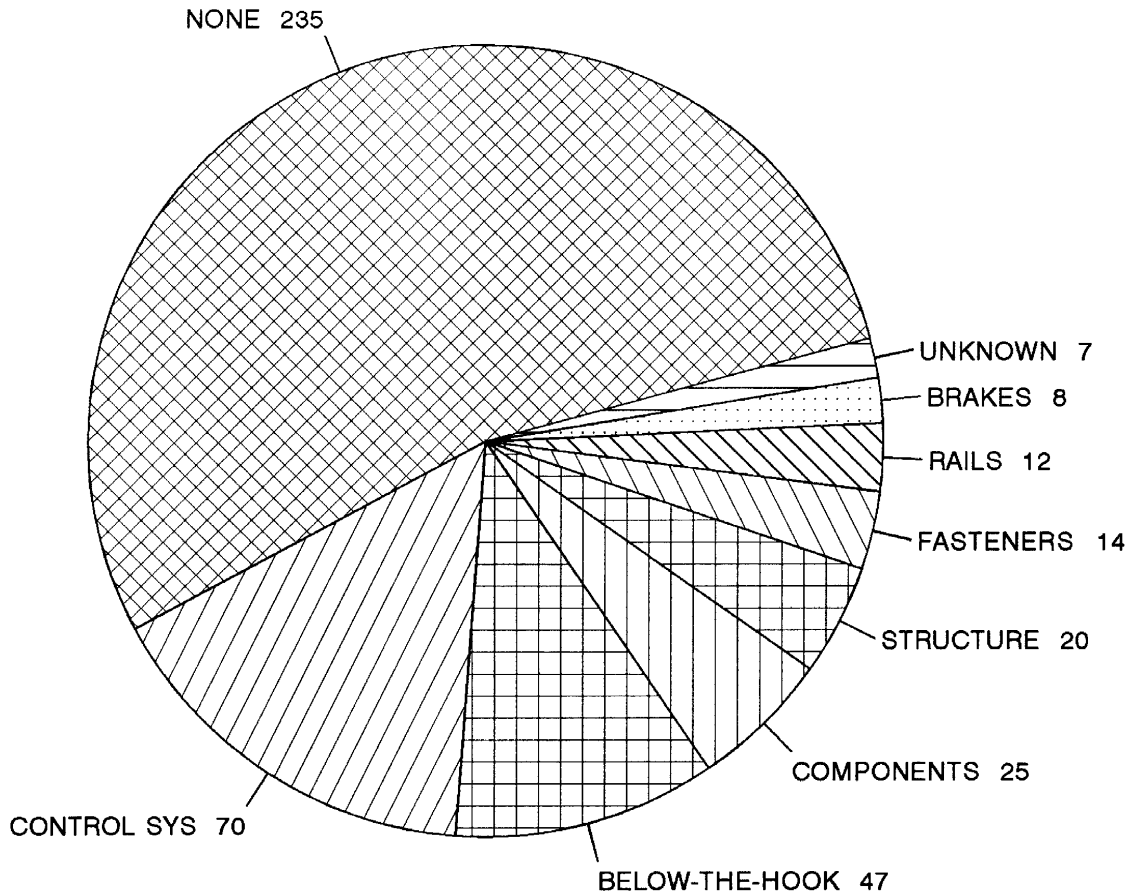
As shown in Figure 5, “Crane events due to hardware deficiencies,” of the 430 crane issues, 156 (approximately 36 percent) involved crane equipment or hardware problems. The crane issue was assigned to the category “Unknown” if a malfunction had clearly occurred, but the document did not indicate what component had failed. The crane issue was assigned to the category “Components” if the component that failed did not specifically fit into the remaining hardware categories. In addition to the 156 crane issues, there were 47 “Below-the-Hook” events involving mostly rigging failures or deficiencies not associated with the crane itself. The most prevalent hardware issue involved control system issues. Control system issues resulted in four load slips and 12 load drops, none of which involved single-failure proof cranes. In addition, there were many other control system issues involving load cells, limit switches. As can be seen from the figure, 236 of 430 reported crane issues did not involve any crane hardware deficiency, but were largely administrative or testing related.

Figure 5: Crane events due to hardware deficiencies

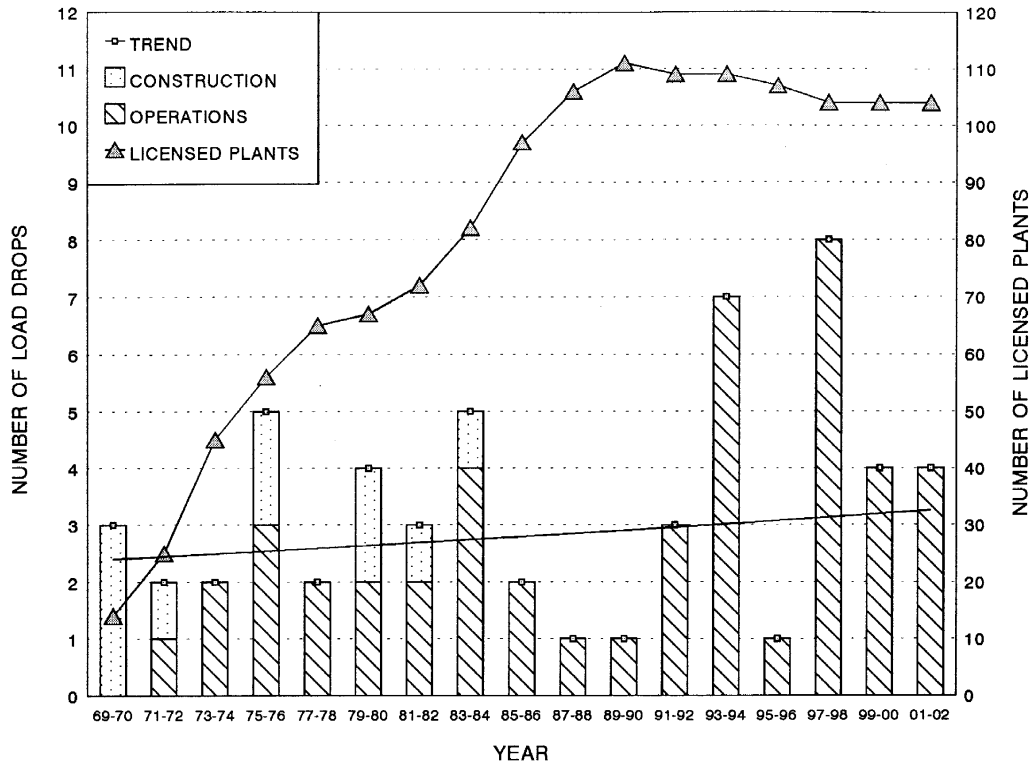
During the period 1968-2002, there were 57 reported events involving load drops. Figure 9, "Load drop distribution," shows the event distribution, a straight line representing the best fit curve for the 34 year period, and the number of operating nuclear plants. Table 2 provides a brief description of each event. Load drops while operating the spent fuel pool crane (representing over half of the load drop events) were largely because of fuel assembly drops caused by grapple operation or human errors which posed no safety issue. Load drops while operating mobile and other cranes (representing almost half of the events) have occurred outside of safety related areas. However, several load drops have involved overhead cranes similar to those used in safety-related areas of the power plant. A comparison of approximately three decades (i.e., 1969 to 1980, 1981 to 1992, and 1993 through 2002) of operating experience involving load drops provides the following observations.

Decade 2. There were 15 events, of which 2 occurred during plant construction. This decade is characterized by a significant increase in the number of operating power plants accompanied by a slight decrease in the number of load drop events.

Decade 3. There were 24 events, of which none involved construction facilities. This decade is characterized by a leveling off of the number of operating facilities, but an increase in the number of load drop events. When compared to Decade 2, Decade 3 experienced a 60 percent increase in the number of load drop events, given a nine percent increase in the average number of operating units.

**Figure 9: Load drop distribution**

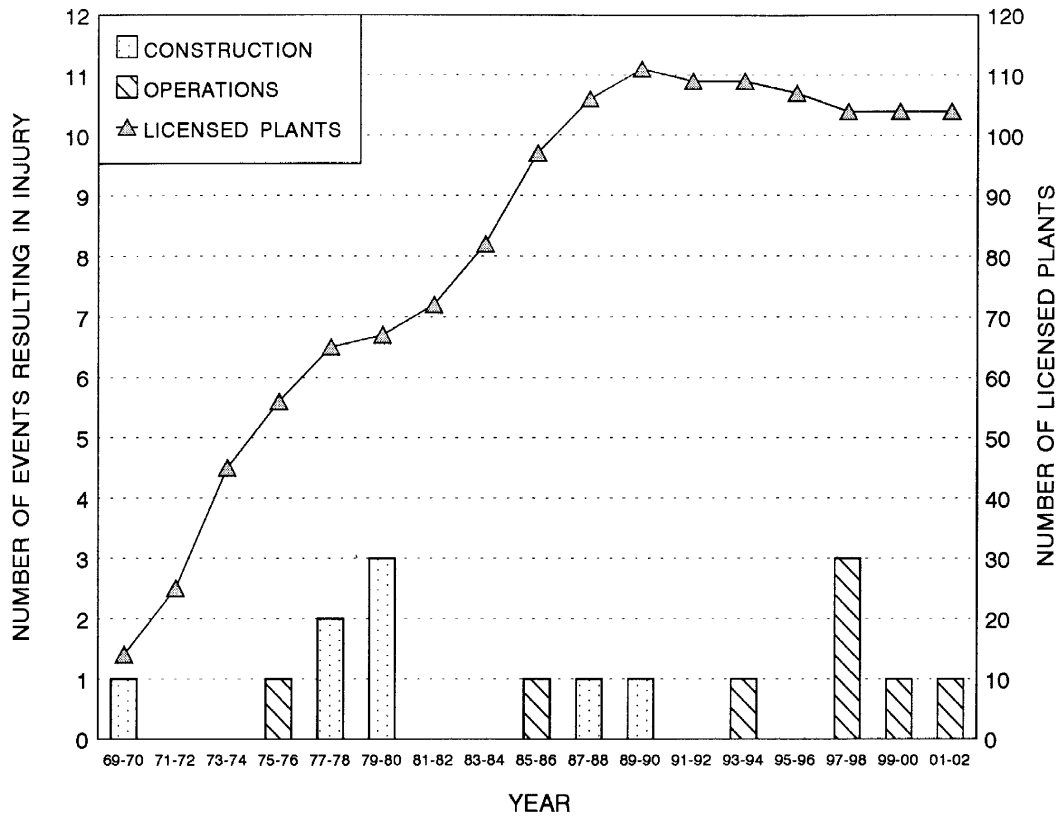
Figure 13, "Distribution of crane related injuries," shows the number of crane related events leading to at least one injury. In some instances, one crane event resulted in multiple injuries. There have been 16 reported crane events that have led to injuries in the nuclear industry for the period 1968 through 2002.

Decade 3. Six injuries, all occurring at operating plants. When comparing Decade 2 crane injuries with Decade 3 injuries, a 100 percent increase in the number of injuries occurred with a 9 percent increase in the number of operating power plants.

Figure 13 also shows the cumulative number of nuclear power plants that had an operating license during the period from 1968 through 2002. When considering the number of operating facilities during each of the three decades, the injury rate has significantly decreased.

Figure 13: Distribution of crane related injuries

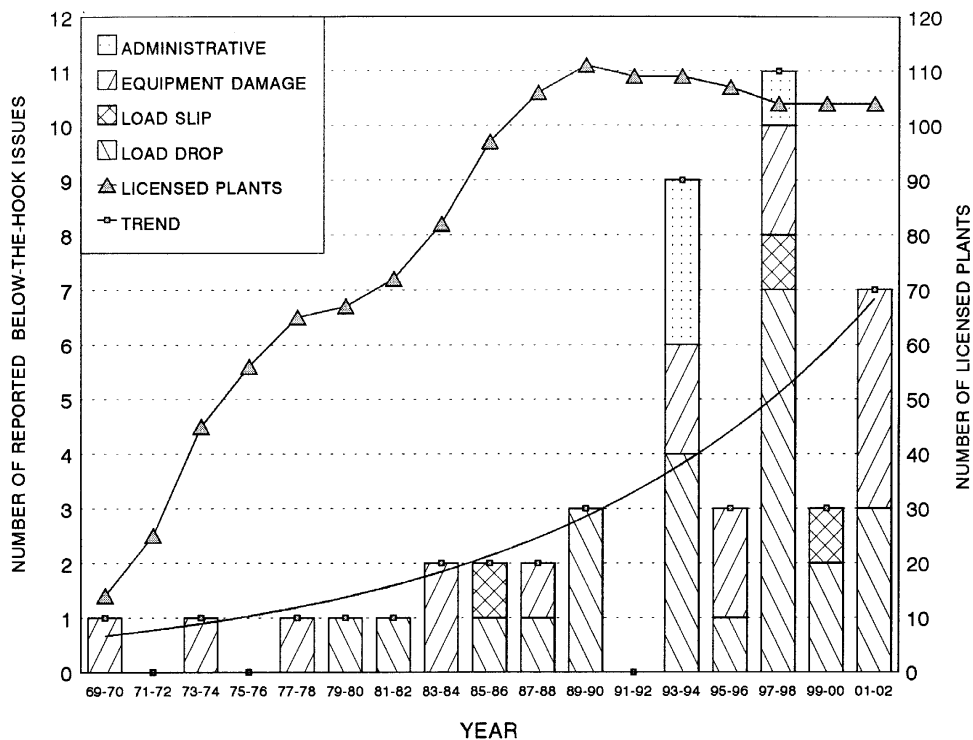
For the period 1968 through 2002, there have been 47 below-the-hook events that have been reported. A below-the-hook event is classified as an event where rigging or handling errors resulted in an event. Figure 17, “Below-the-hook crane events,” shows a significant overall increase in the number of events. Figure 17 also categorizes below-the-hook events into “administrative,” “equipment damage,” “load slip,” and “load drop.” Many of these events have resulted in load drops and damaged equipment. A comparison of the three decades presents the following observations:

Decade 2. There were 10 below-the-hook events. Six involved a load drop, three involved equipment damage, and one involved a load slip. During Decade 2, the number of events increased by 150 percent, concurrent with an increase in the number of operating units by 113 percent when compared to Decade 1.

Decade 3. There were 33 below-the-hook events, of which 17 involved load drops, 10 involved equipment damage, four involved administrative issues, and two involved load slips. During Decade 3, the number of events increased by 230 percent, concurrent with an increase in the number of operating units by 9 percent when compared to Decade 2.

Figure 17: Below-the-hook crane events

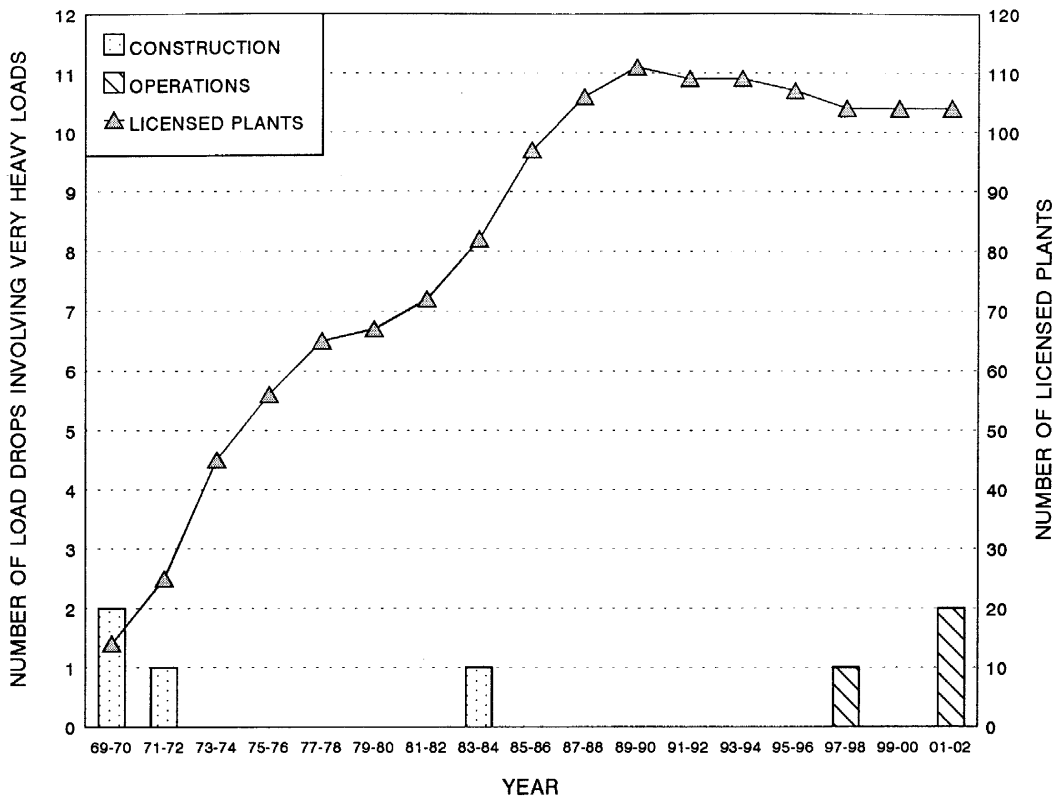
Of the estimated 54000 very heavy load lifts, there were three load drops. Figure 20, "Very heavy load drop distribution," shows the distribution of very heavy load drops from 1969 through 2002. A load drop is defined as an uncontrolled lowering of a load to the point where contact with the floor or some object stops any further decent. The figure shows seven very heavy load drops, four of which occurred during plant construction. The three very heavy load drop events that occurred after NUREG-0612 was issued and when the plant had an operating license, occurred because of human error, and ultimately because of rigging deficiencies and not because of crane deficiencies. The three events also did not occur near any safety related areas, and none resulted in radiation releases, risks to licensee personnel, or the public. Table 10, "Load drops involving very heavy loads at operating nuclear plants (1980-2002)," provides a brief summary of the three events. The Byron very heavy load drop event occurred while operating a mobile crane, while the San Onofre 3 and Turkey Point 4 very heavy load drop events occurred while operating turbine building overhead cranes.

Figure 20: Very heavy load drop distribution
