# NATIONAL TRANSPORTATION SAFETY BOARD

## AIRCRAFT ACCIDENT REPORT

UNCONTROLLED IMPACT WITH TERRAIN  
FINE AIRLINES FLIGHT 101  
DOUGLAS DC-8-61, N27UA  
MIAMI, FLORIDA  
AUGUST 7, 1997

**Abstract:** This report explains the accident involving Fine Airlines flight 101, a Douglas DC-8-61, which crashed after takeoff from runway 27R at Miami International Airport, Miami, Florida, on August 7, 1997. Safety issues in the report include the effects of improper cargo loading on airplane performance and handling, operator oversight of cargo loading and training of cargo loading personnel, the loss of critical flight data recorder information, and FAA surveillance of cargo carrier operations.

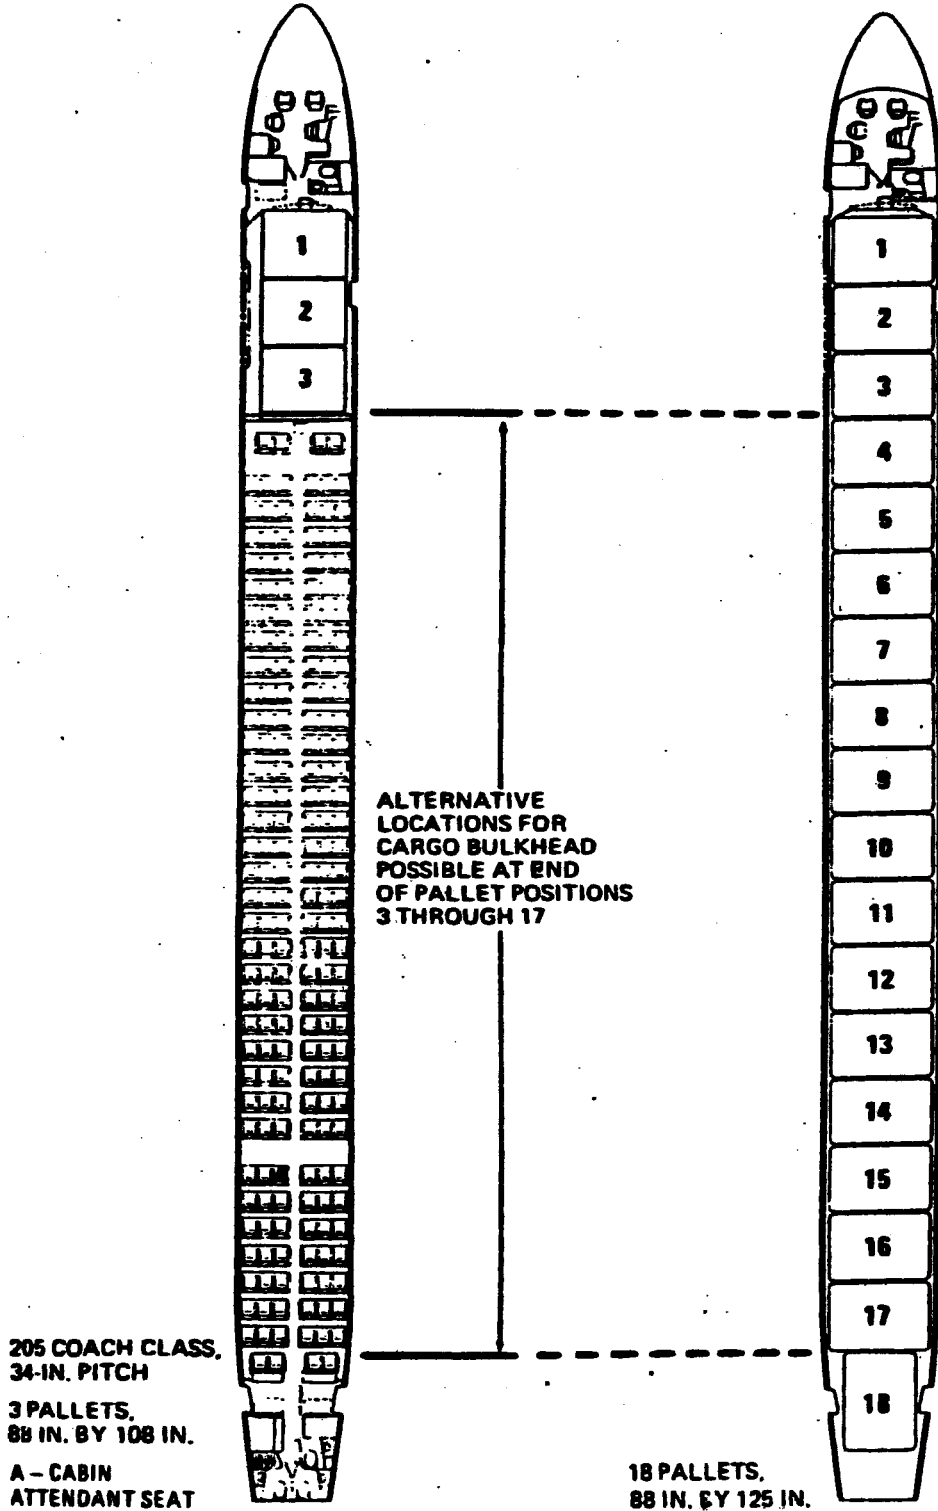
**MIXED PASSENGER AND CARGO MODE  
205 PASSENGERS**

**ALL FREIGHTER**

Figure 1.—DC-8-61 18-pallet cargo configuration diagram.

The airplane was equipped with a cargo handling system designed to accommodate and restrain 18, 88-inch x 125-inch pallets. Five guide floor tracks with encased ball rollers were installed in the cabin floor to move cargo pallets forward or aft of the main cargo door. Retractable pallet locks (Pemco 50044-1 pallet lock assemblies), or "bear traps," were installed in the cabin floor along the five guide tracks (aligned in a row) at 89-inch intervals (see figure 2). Each of the 85 pallet locks included a folding lock mechanism (to allow pallets to move over them during loading) comprising a forward and aft facing pawl. When raised, the pawls engage the edges of adjoining cargo pallets and prevent forward, aft, or vertical pallet movement (see section 1.16.3 on load testing). Rails were attached along the cabin walls to prevent cargo from striking the fuselage. According to the loading system design, pallet positions 1 through 17 are loaded in the 125-inch (lateral) x 88-inch (longitudinal) position. Pallet position 18, located in the tapering end of the aft fuselage was reversed, loaded in the 125-inch (longitudinal) x 88-inch (lateral) position.
