NATIONAL TRANSPORTATION SAFETY BOARD

PIPELINE SPECIAL INVESTIGATION REPORT

EVALUATION OF ACCIDENT DATA AND FEDERAL
OVERSIGHT OF PETROLEUM PRODUCT PIPELINES

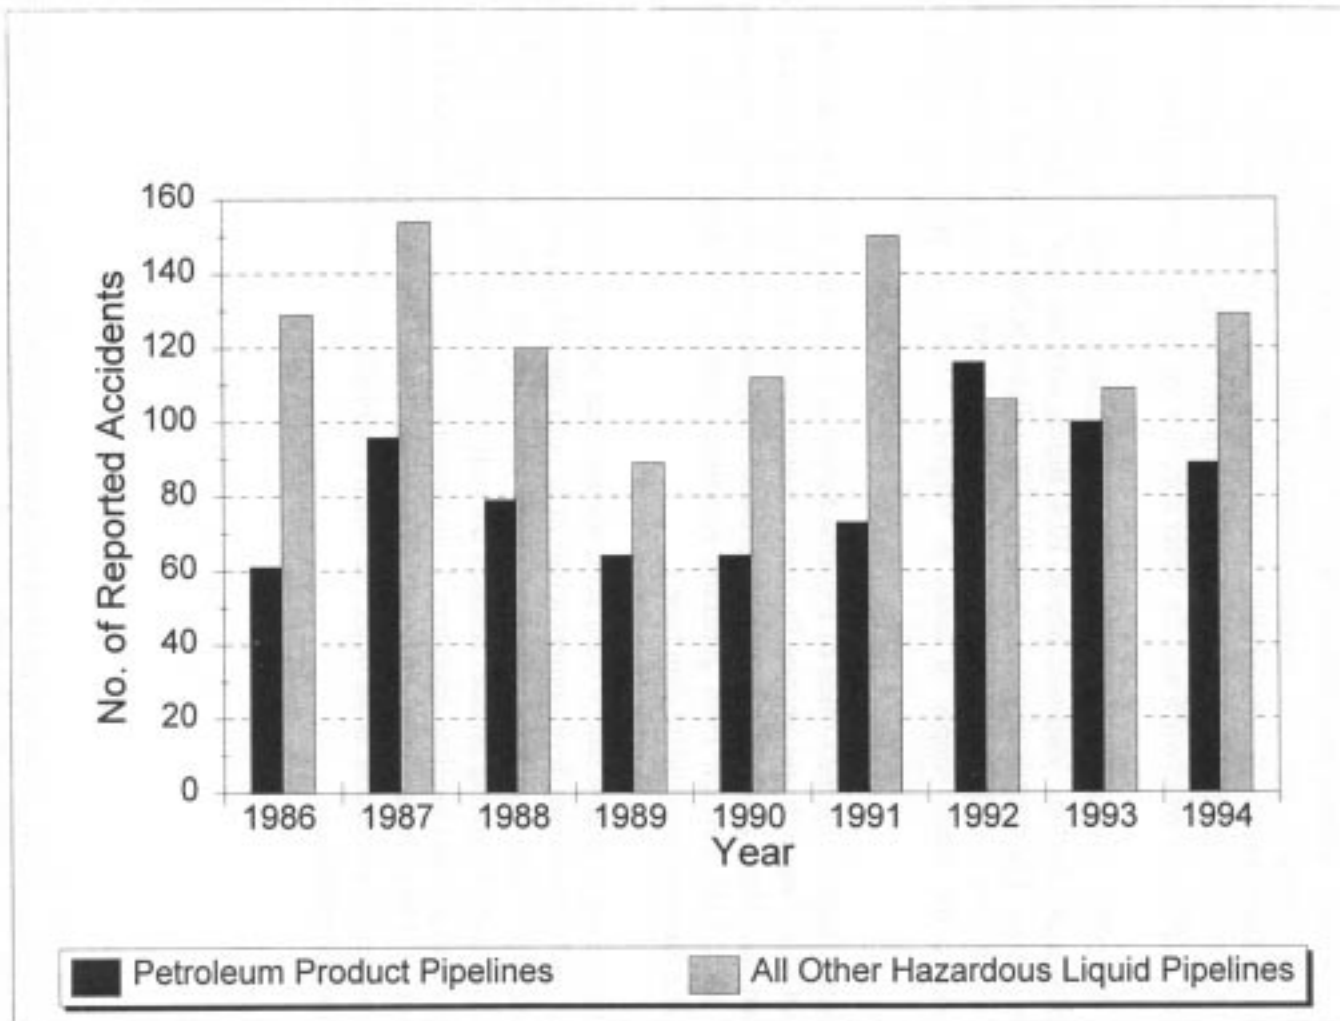
Figure 1. -- Petroleum product accidents versus other liquid pipeline accidents, for 1986-1994

Accident data compiled by the Office of Pipeline Safety (OPS) in the U.S. Department of Transportation's (DOT's) Research and Special Programs Administration (RSPA) indicate that the number of reported accidents involving petroleum product pipelines and all other hazardous liquids³ pipelines from 1986 through 1994 generally remained stable. (See figure 1.) (Accident rates are not available through the accident data base.)

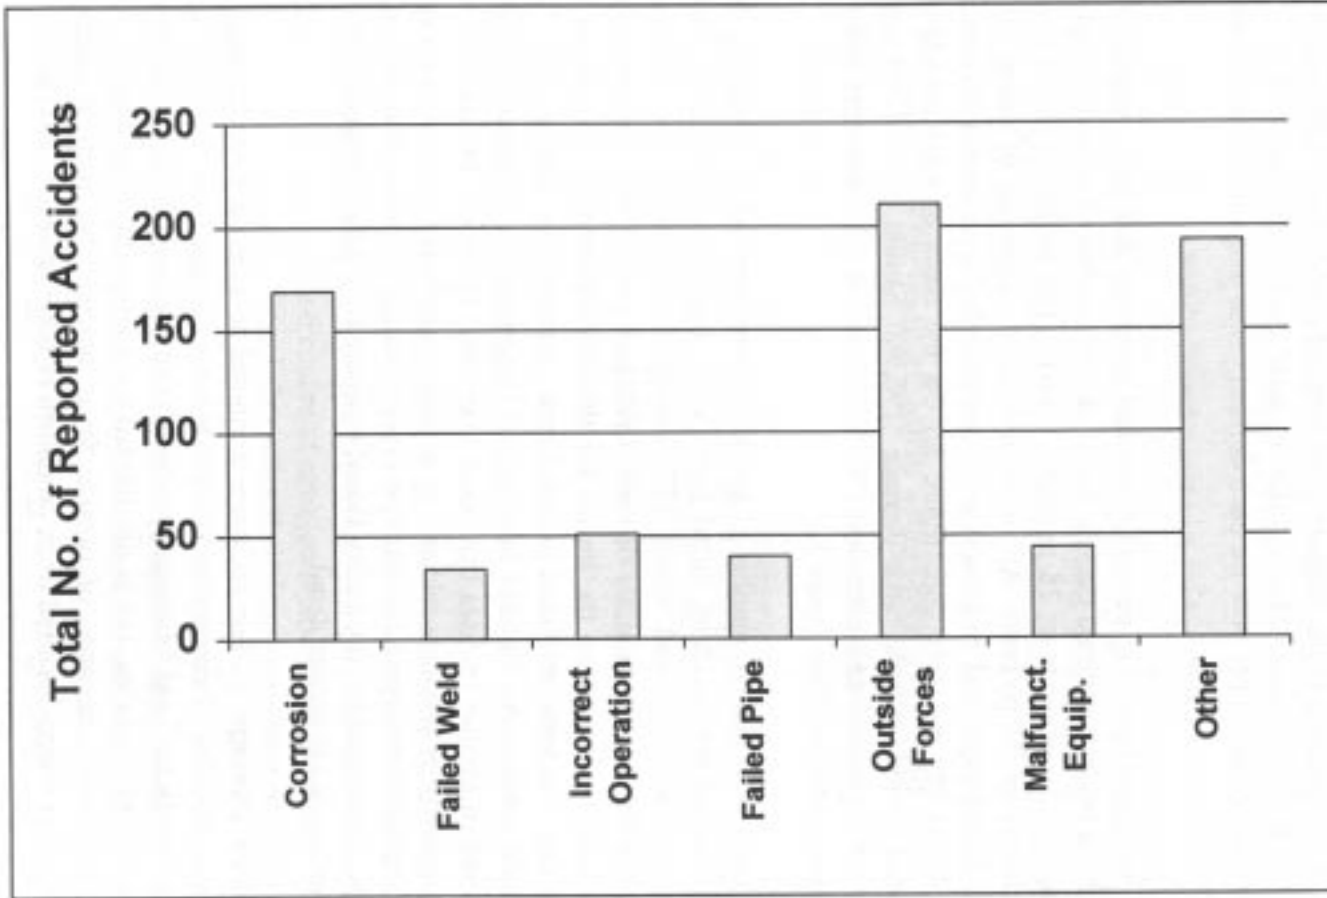
Figure 2. -- Petroleum product pipeline accidents by cause reported on form 7000-1, for 1986-1994

Of the 742 accidents involving petroleum product pipelines that were reported from 1986 through 1994, the three leading reported causes, based on the number of accidents reported, were outside force damage (211 accidents or 28 percent), "other" (193 accidents or 26 percent), and corrosion (169 accidents or 23 percent). All other designated categories of cause (failed weld, incorrect operation, failed pipe, and malfunction of control/relief equipment) accounted for the remaining 169 accidents (23 percent). (See figure 2.) On the basis of total barrels of product released for the same period, outside force damage (196,960 barrels or 37.4 percent), "other" (148,624 barrels or 28.2 percent) and corrosion (70,975 barrels or 13.5 percent) again were the leading reported causes of failure. (See figure 3.)

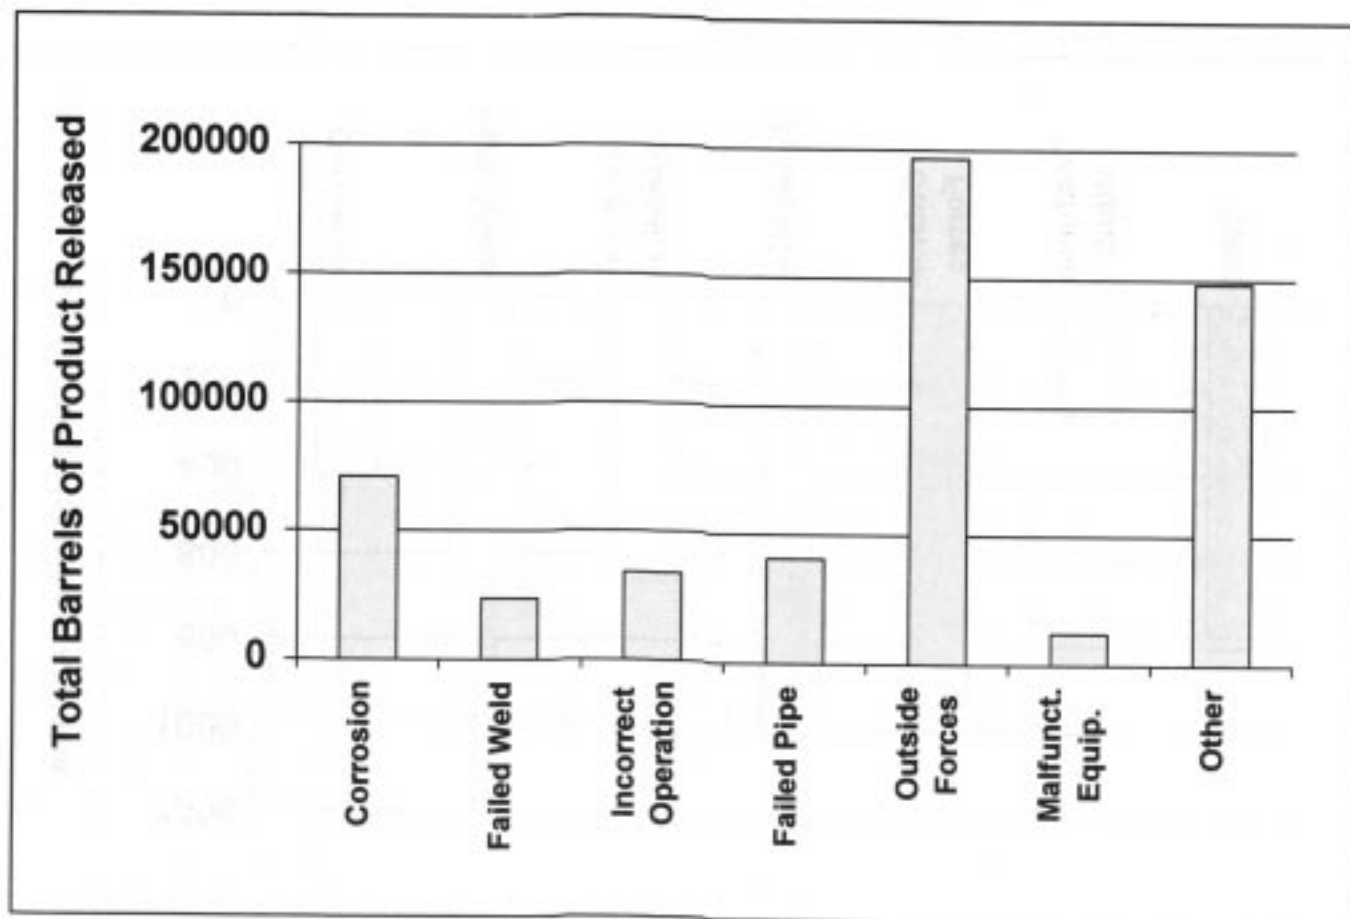
Figure 3. -- Petroleum product volume released by cause reported on form 7000-1, for 1986-1994

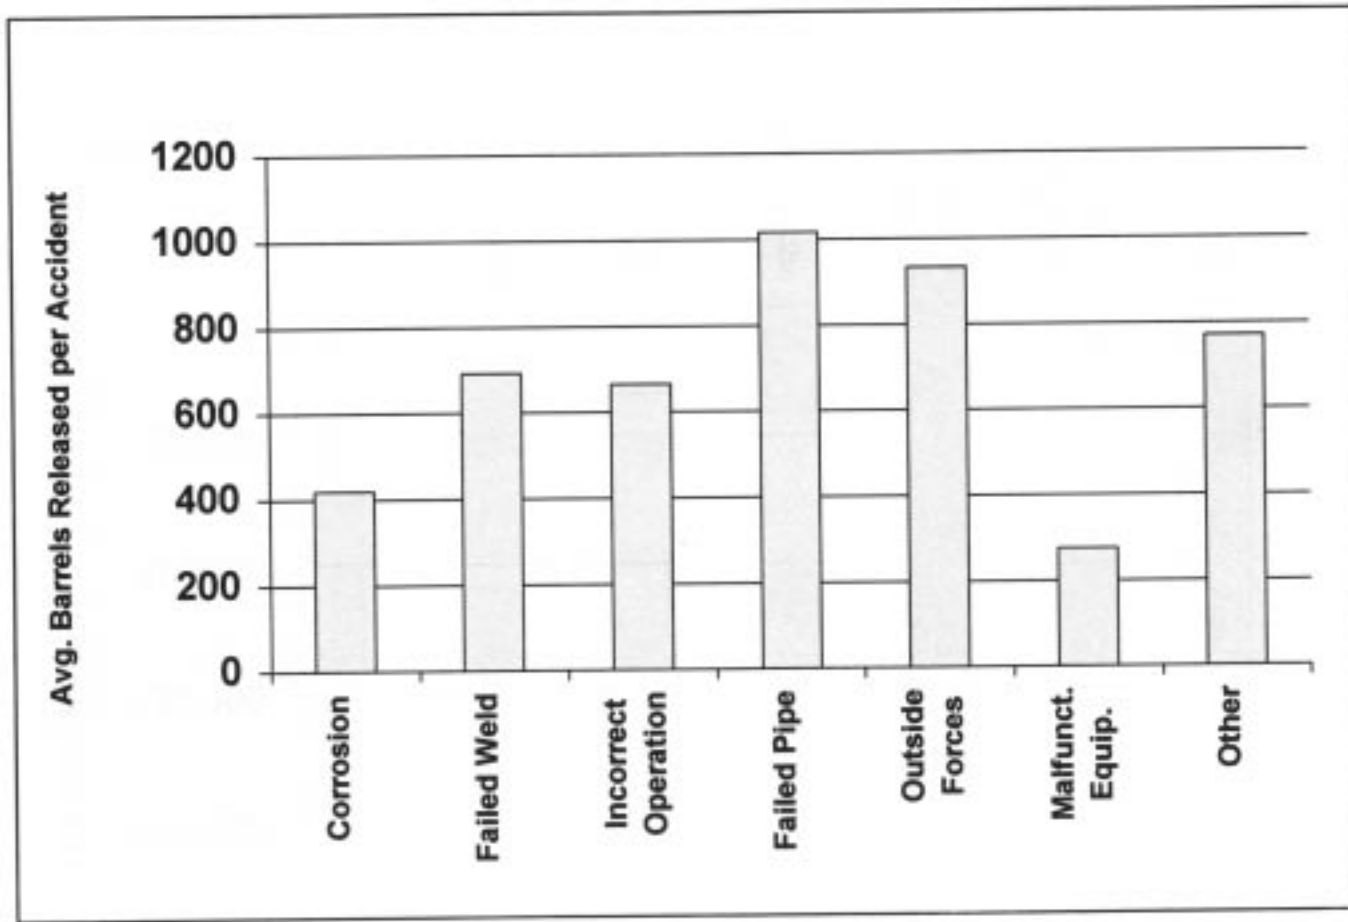
Figure 4. -- Average volume of petroleum products released per accident by cause reported on form 7000-1, for 1986-1994

When the total barrels and the number of accidents were combined to calculate the average number of barrels released per accident, failed pipe (1,017 barrels per accident), outside force damage (933 barrels per accident), and "other" (770 barrels per accident) were the three leading causes. (See figure 4.) The average number of barrels released per accident for corrosion failures (420 barrels per accident) was next to the lowest for the seven designated categories for cause. These data indicate that accidents attributed to failed pipe, outside force damage, and "other" are more likely to include catastrophic failures resulting in large releases, whereas corrosion-caused accidents tend to result in smaller releases that occur over time. However, because the number of accidents and total quantity of products released in accidents attributed to corrosion exceed those for failed pipe, the impact of corrosion accidents on pipeline safety is greater than that of accidents caused by failed pipe. Consequently, the Safety Board examined the data for outside force damage, corrosion, and "other" causes in greater detail.
