# Energy Code Compliance Study

## Honolulu and Hawaii Counties

January 15, 1999

State of Hawaii  
Department of Business, Economic Development, and Tourism  
Energy, Resources, and Technology Division

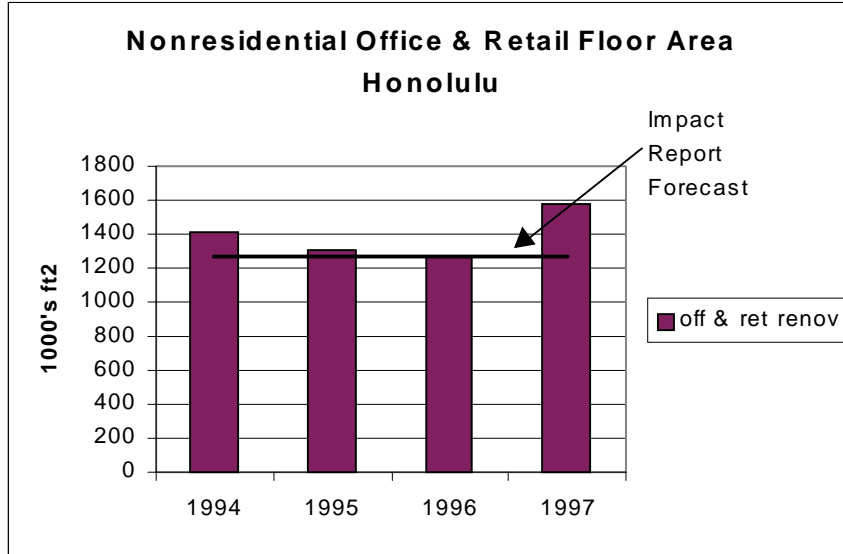
**Figure 3**  
**Comparison of**  
**Predicted to Actual**  
**Additions and**  
**Alterations**

Source: calculations of floor area based on permit value reported in *Construction in Hawaii 1998*, Bank of Hawaii.

The construction levels are close to those predicted in the Impact Report for the Hawaii Model Energy Code (December 1993). For example, new construction was predicted to be 2,210,000 ft<sup>2</sup> per year for nonresidential buildings. Corresponding Bank of Hawaii data for the period is shown in Figure 2. The same information for additions and alterations is in Figure 3.

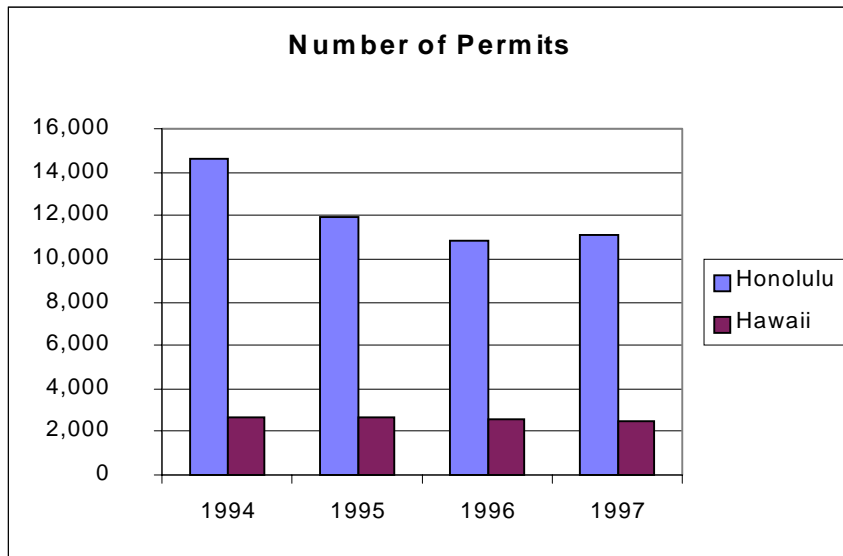
**Figure 4**  
**Number of Total**  
**Building Permits, Both**  
**Residential and**  
**Nonresidential**

Source: Hawaii State Department of Business, Economic Development & Tourism.

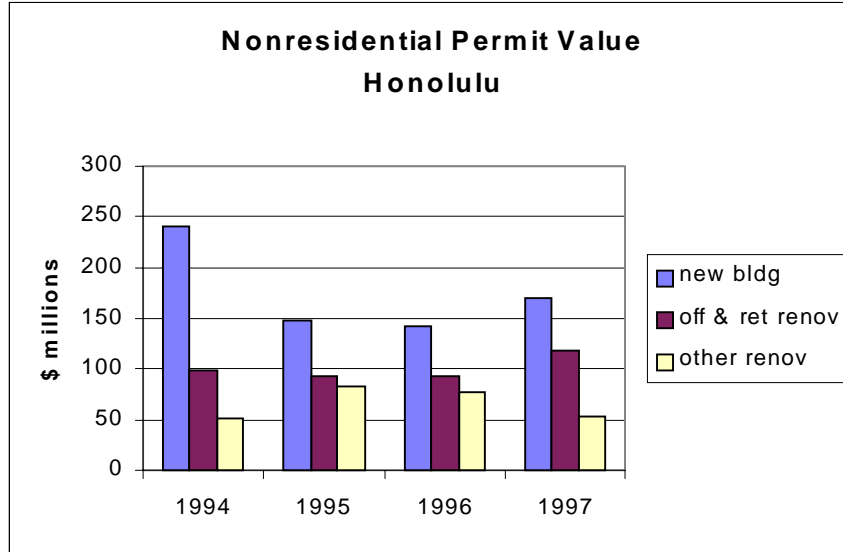
**Figure 5**  
Permit Value, Honolulu

Source: permit value reported in *Construction in Hawaii 1998*, Bank of Hawaii.

Floor area estimates are shown in the following two charts. These are approximate estimates based on the permit value illustrated in the previous graphs. Construction cost is assumed to be about \$150/ft<sup>2</sup> for new buildings and \$75/ft<sup>2</sup> for renovations.
