**NATIONAL TRANSPORTATION SAFETY BOARD  
OFFICE OF AVIATION SAFETY  
WASHINGTON, D.C.**

**SURVIVAL FACTORS GROUP CHAIRMAN'S FACTUAL REPORT**

A. ACCIDENT : DCA99MA060  
LOCATION : Little Rock, Arkansas  
DATE : June 1, 1999  
OPERATOR : American Airlines  
TIME : 2351 Central Daylight Time (CDT)  
AIRCRAFT : McDonnell Douglas MD-82, N215AA

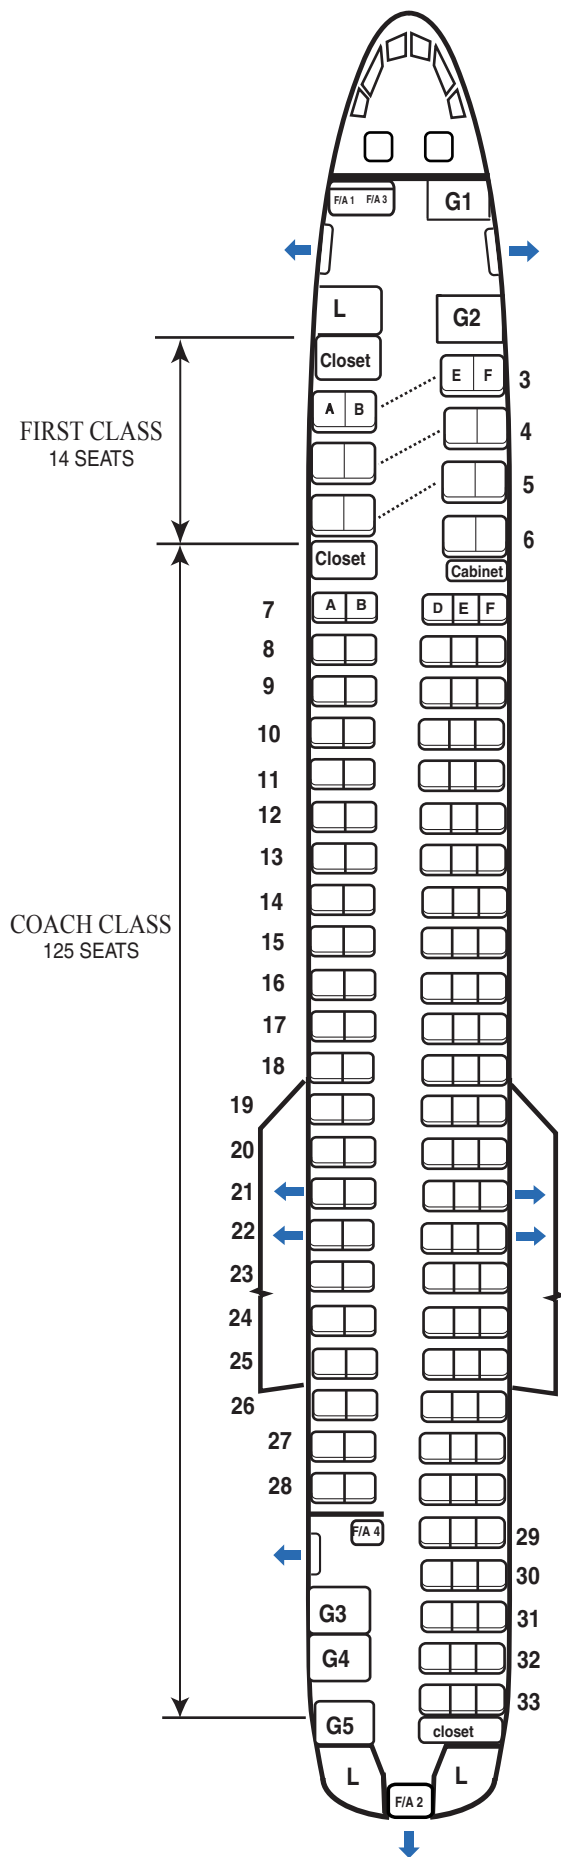
Legend

G = Galley  
 L = Lavatory  
 F/A = Flight Attendant Jump Seat
