Water Operation and Maintenance Bulletin

No. 213

The New Materials Engineering and Research Laboratory

Early Warning System Phase I Design – Prairie Dam No. 1 and
Standing Rock Dam No. 1

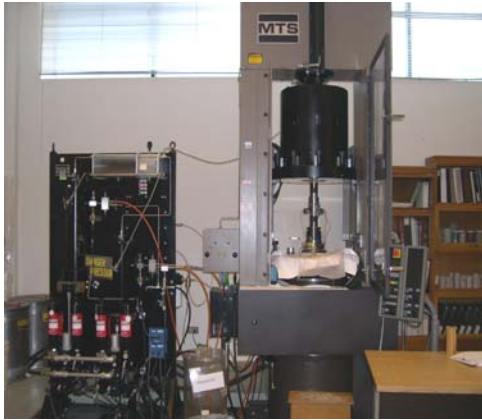
Geotechnical testing and analysis are being facilitated by the use of a half-million-pound stiff testing frame capable of testing rock in triaxial compression with pore pressure measurements at elevated temperatures. We also use a large triaxial shear facility for soils capable of testing up to 9- by 22-inch specimens, large direct-shear machines for testing up to 10-inch-diameter rock and concrete specimens, 12- by 12-inch soil direct shear, various permeability and filter testing apparatus, along with most soil and rock testing services.

Stiff testing frame.

Cover photograph –Stiff testing frame.

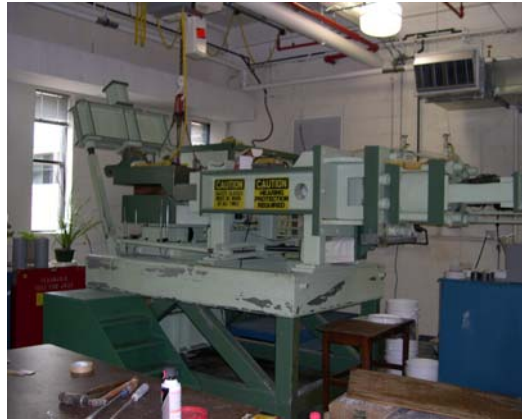
Large direct shear machine.

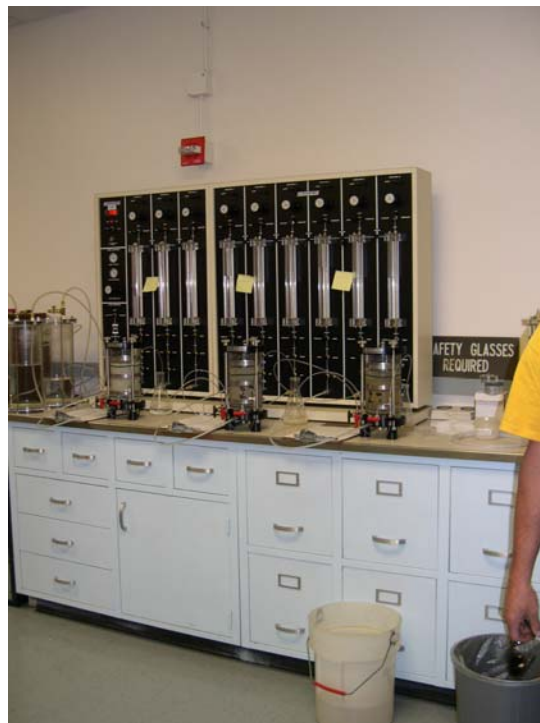
Flexible wall permeameter.

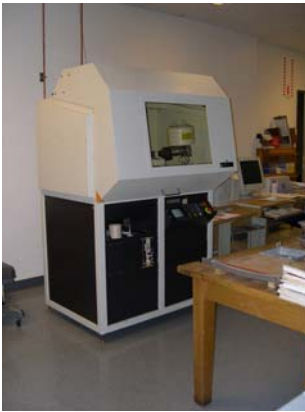
Other services include specialized petrographic analysis utilizing stereo-microscopes, an X-ray diffractometer, and a scanning electronic microscope.

X-ray diffractometer.

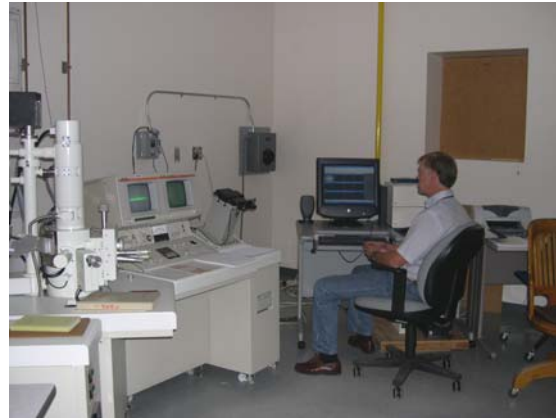
Scanning electron microscope.

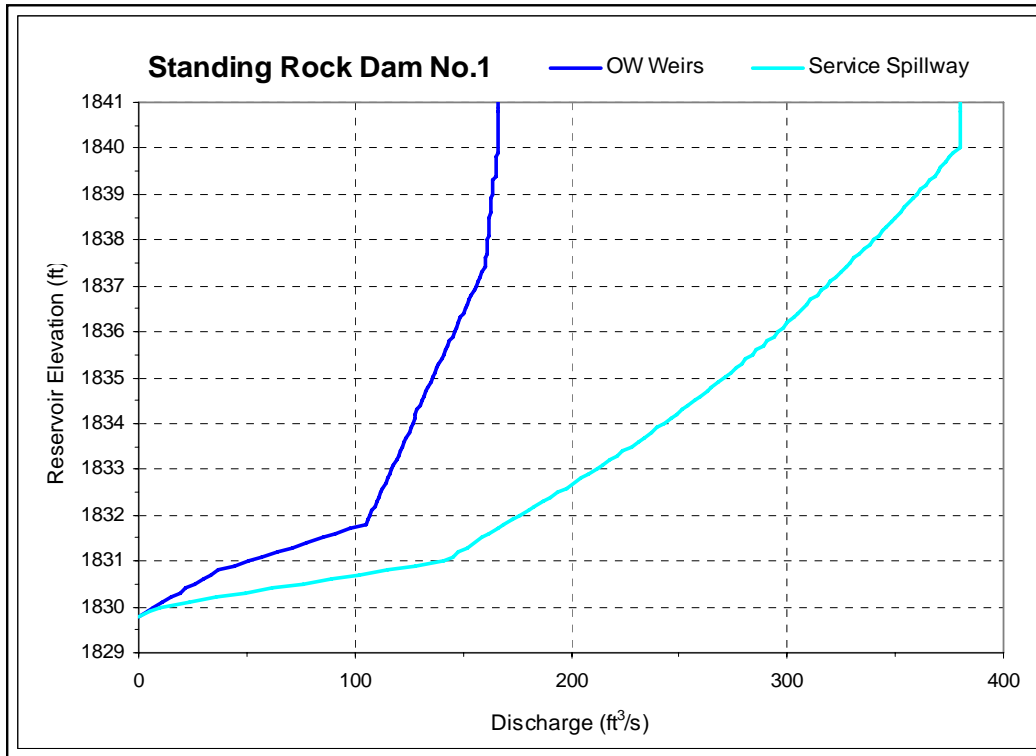
Figure 4.—Standing Rock Dam No. 1 principal spillway rating curves.

There are three spillways at Standing Rock Dam No. 1. The principal spillway has two features: (1) an ungated overflow concrete box located near the left abutment that serves as the service spillway and (2) three overflow weir slots in the exterior walls of the outlet works control tower that discharge into the outlet works conduit. The service spillway concrete box connects with a 120-foot-long, 5- x 4-foot concrete culvert that extends through the embankment and discharges into the downstream stilling basin and seepage pond. The three overflow weirs discharge into the downstream-most concrete box chamber in the base of the control tower, then through the outlet works conduit, and into the downstream stilling basin and seepage pond. The rated discharge capacity of the principal

spillway is 244 ft³/s at the auxiliary spillway crest elevation (1831.5 feet) and 546 ft³/s with the reservoir elevation 1 foot below the dam crest, or at 1840.0 feet (reference 4 and figure 4).

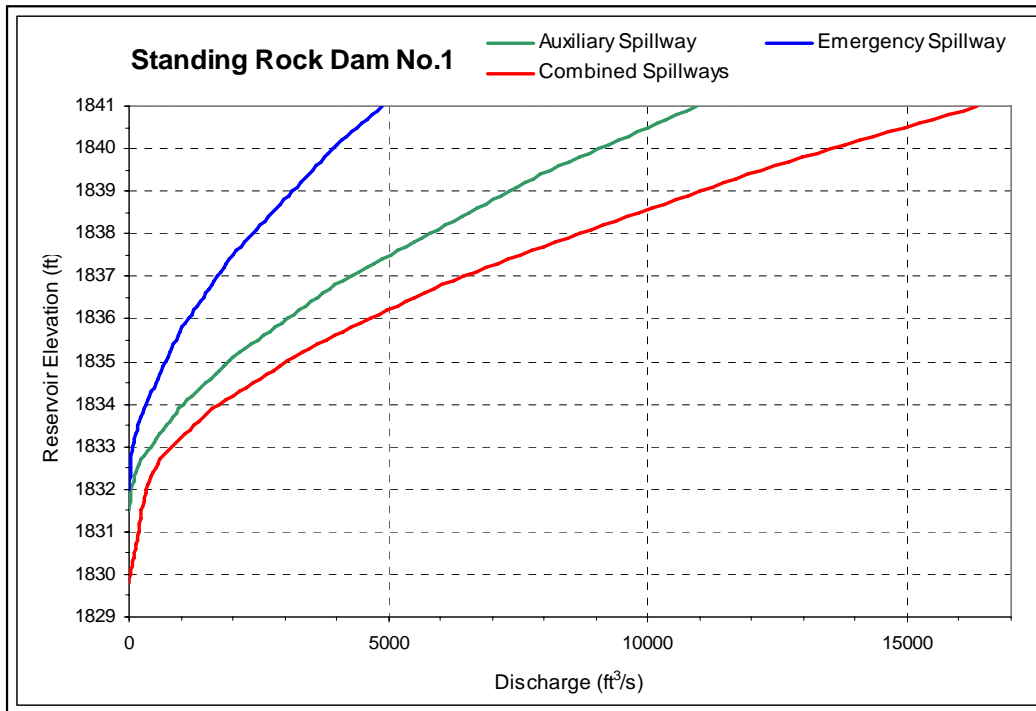
Figure 5.—Standing Rock Dam No. 1 spillway rating curves.

The auxiliary spillway is an uncontrolled, unlined, open-cut channel that extends around the left end of the dam. The channel has a bottom width of 165 feet, is 650 feet long, and has a crest elevation is 1831.5 feet. The rated discharge capacity is 9,052 ft³/s, with the reservoir water surface at 1840.0 feet (figure 5).

A secondary or emergency spillway channel is similarly cut around the right abutment of the dam. The unlined channel's floor is 60 feet wide and 700 feet long with an uncontrolled crest elevation of 1832.0 feet. The rated discharge capacity is 3,923 ft³/s, with the reservoir elevation at 1840.0 feet (figure 5).

The auxiliary and emergency spillway channels are separated from the dam embankment by training dikes with crest elevations of 1841.0 feet that direct any outflows several hundred feet downstream from the toe of the dam. The rated capacity of all the spillways with the reservoir at the dam crest (1841 feet) is 16,358 ft³/s (figure 5).
