Department of the Interior, Bureau of Reclamation

### **IRRIGATION OPERATION AND MAINTENANCE**

**BULLETIN NO. 53**

July, August, September 1965

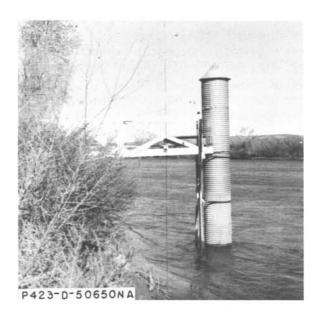
Figure 1 below is a view of the river stage recording gage at Taylor's Ferry. Figure 2 also is a view of the Taylor Ferry installation show-

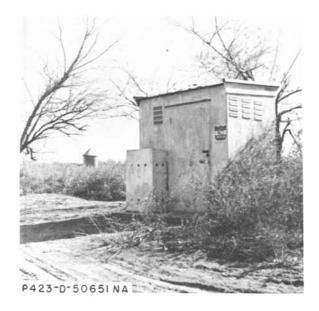
Figure 2

ing the radio building, and the small enclosure outside the building which protects the butane tanks supplying fuel to the butane burning engine which drives the generator to supply power to the radio unit as discussed later.

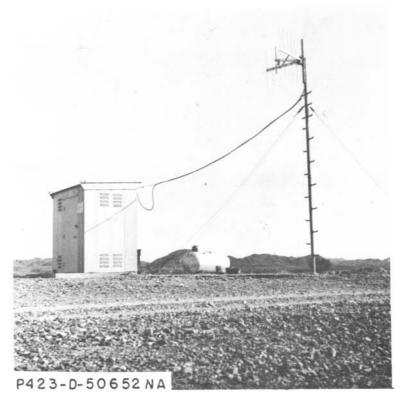
Figure 3 on the following page is a view of the radio building and antenna at the Adobe Ruin's river stage recording gage of the Cibola Field Division.

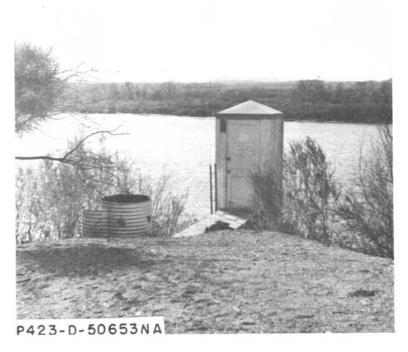
Figure 4

Figure 4, also on the following page, shows the river stage recording gage at the Adobe Ruin's.

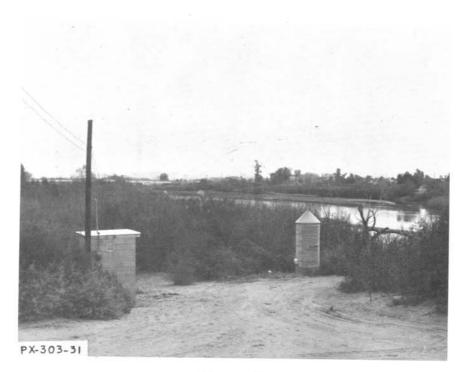
Figure 5

Figure 5, on page 4, is a view of the Yuma gaging station of the California side of the Colorado River, downstream from Yuma, Arizona. Commercial power as discussed below made this installation a more conventional type.

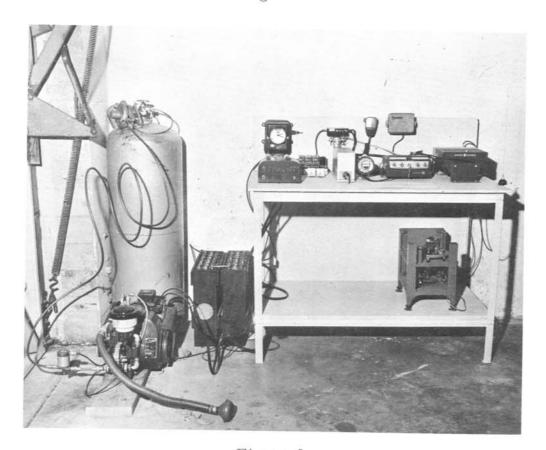
The Taylor Ferry on-call radio reporting gage was developed first. At that time, the gas-fueled thermoelectric generator, which has been developed as a static low-power source of electrical energy, was not commercially available. The cost of a suitable solar cell was about equal to the total cost of all of the other equipment needed for one installation. Thus, a small one-cylinder propane-fueled engine generator set with automatic starting control was used. The equipment for the Taylor Ferry installation is shown on the cover and in Figure 6 on the preceding page.

Each gage is equipped with a 12-volt, 30-watt, transistorized, FM, mobile radio, as shown in Figure 6 and on the cover page. These radios work into existing river control voice radio network repeaters. Vacuum tubes are used in the final stages of the transmitter. To keep the battery drain low, the transmitter tubes are heated only during reporting. A twenty-second time delay between the call and the report allows the tubes to warm up. This undesirable time lag can be eliminated now through the use of new all-transistorized radio or quick heat transmit tubes, without increasing battery drain.

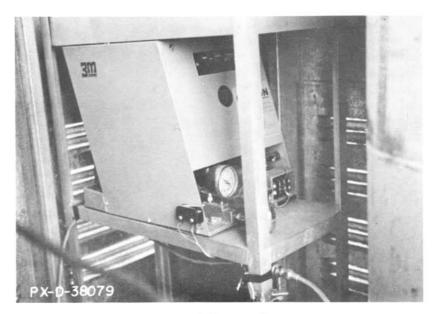
Figure 7

The second on-call gage at Cibola was designed with a thermoelectric generator consisting of a thermopile (series of thermocouples, a gas burner, cooling fins for the cold junction, and a transistorized converter and rectifier. A view of a thermal electric generator as installed is shown in Figure 7. It produces up to one ampere of direct current for charging a nickel-cadmium battery, has no moving parts,

is simple, trouble- and maintenance-free, and holds almost constant battery voltage.

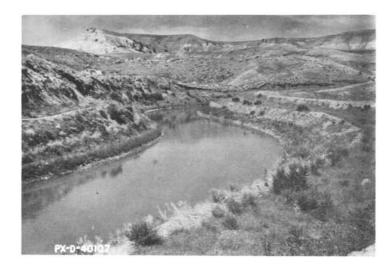
Figure 1 shows the Casper Main Canal, on the Kendrick Project. This is a reach lined with a buried asphalt membrane in 1954 that is providing excellent seepage control and has required no maintenance.

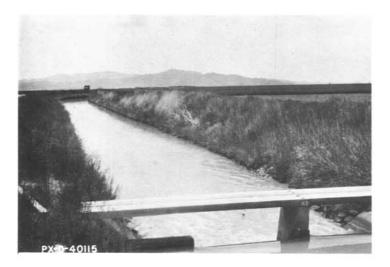
Figure 2 shows Lateral R4-S on the Shoshone Project. This reach was lined with a buried asphalt membrane in 1953.

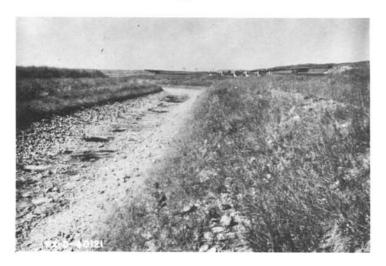
Figure 3 is a view of the Main lateral of the Angostura Unit of the Missouri River Basin Project; the lateral was lined with a buried asphalt membrane in 1952, and is effectively controlling seepage and has required no maintenance although the membrane has slipped and folded at the top of the slope.

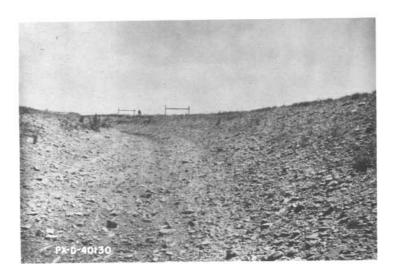
Figure 4 on the following page, shows the Casper Main Canal. Very stable gravel protective covers are used in some buried asphalt membrane lining installations.

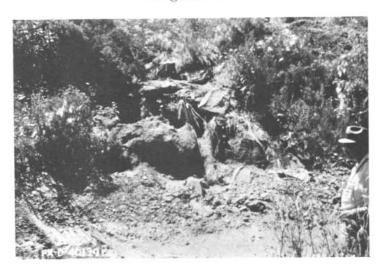
Figure 5 on the preceding page is a view of the Shirley Canal. The surface runoff has damaged buried asphalt membrane lining on the side slope.

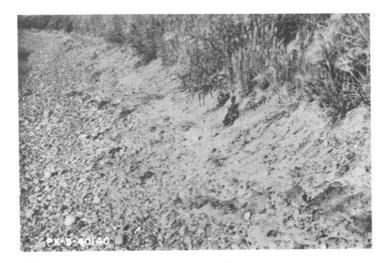
Figure 6 also on the preceding page, shows the Glendive Canal on the Buffalo Rapids Project. Membrane damage shown is attributed to scour and erosion on the outside of the curve and in part to cleaning with a dragline and sloper. Some membrane slippage also is apparent.

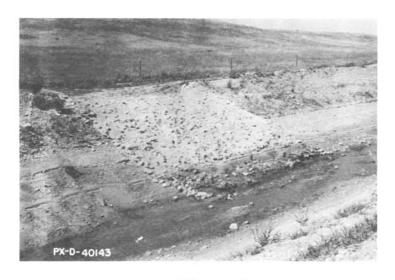
Figure 7 above is a view of the Main Canal, Angostura Unit, Missouri River Basin Project. Grouted rock over buried asphalt membrane lining serves as a satisfactory surface water inlet.

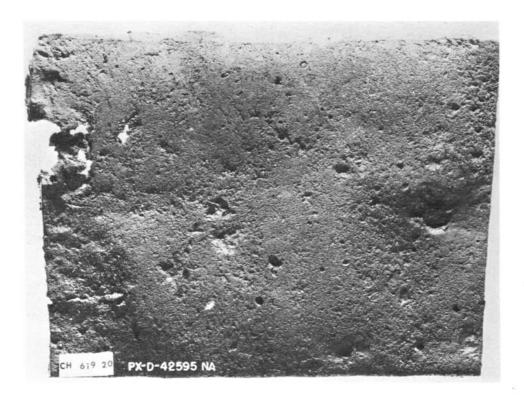
Figure 9

- (a) Nonuniform thickness of membrane.
- (b) Large rocks or clods contained in the membrane indicating improper subgrade preparation, Figure 9, above.
- (c) Sand, gravel, and silt mixed in the membrane as a result of use of excessive spray-bar pressures or use of the spray bar too close to the subgrade, or both.
- (d) Accumulation of excessive silt, sand, and gravel on the membrane before the second pass of spray application was completed. This results in two thin membranes separated by a layer of soil, as shown in Figure 10 on the following page.

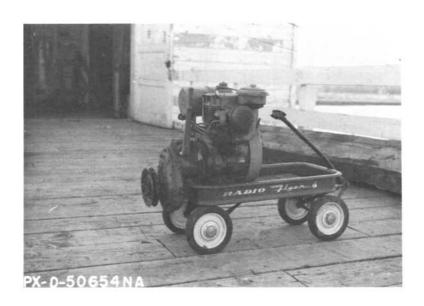
additional \$7.50. To make this motor movable, it was mounted on a small wagon which cost \$11.50. The work which formerly required 24 man-days is now accomplished in less than 8 man-days for an investment of only \$157.00. The motor is also used to operate a concrete mixer, weed sprayer and water pump as needed.

Photograph No. 1 above shows the unit mounted in a wagon.

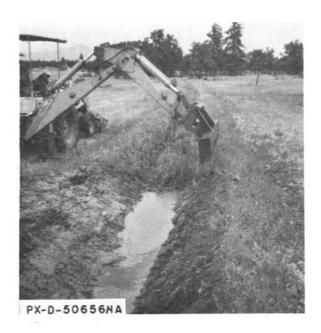
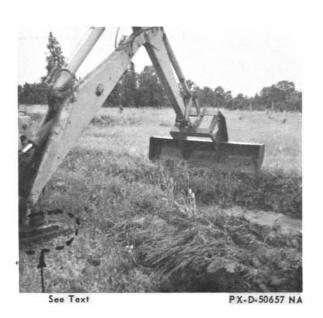
The photographs show the new blade (bucket) rehabilitating a small lateral. The lateral runs through varied soil conditions, as well as numerous fenced areas, which makes use of conventional ditchers only partially successful. Note the oversize pad used on the stabilizer to prevent tipping of the tractor. This is necessary with the use of the large blades.

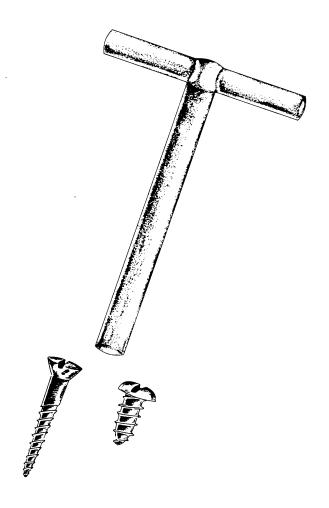
FIGURE 6.

This suggestion was submitted by Raymond J. Michels, Plant Mechanic, Region 1. He states that in replacing the 1-inch packing in the expansion joints of penstock and outlet tubes, it was found that a corkscrew type of packing puller would straighten out and would not pull out the packing. By welding a self-tapping metal or wood screw to a quarter-inch rod, as shown in the sketch below, the job was done very well, and although some of the packing came out exceptionally hard, there was no damage to material, and it could be used again.

The screw should be butt welded to the end of the quarter-inch rod, using a slight excess of acetylene when there is a gas weld.

PACKING PULLER

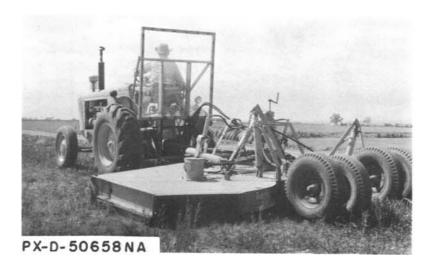
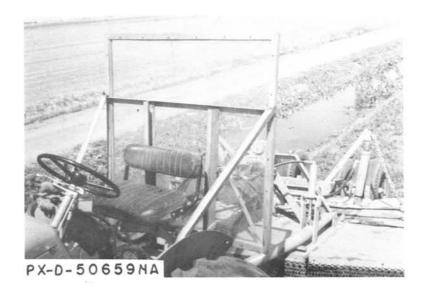
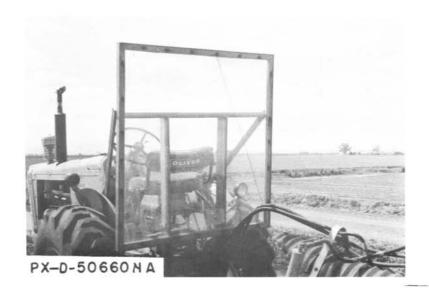
Figure 1 below and Figures 2 and 3 on the following page are views of the 3/16-inch by 4-foot by 4-foot plexiglass shield installed behind the tractor operator to prevent him from being struck by objects thrown from the mower blades.

With the plexiglass shield the operator may observe the mower in complete safety at any and all times. The shield should be braced to the tractor because of heavy vibration caused by the mower blades, however, metal braces can be easily adapted to any make or model tractor. Also a special coating applied to the plexiglass will prevent excess dust accumulation on the plexiglass caused by static electricity. The plexiglass shield should be edged with light angle iron for extra strength and rigidity.

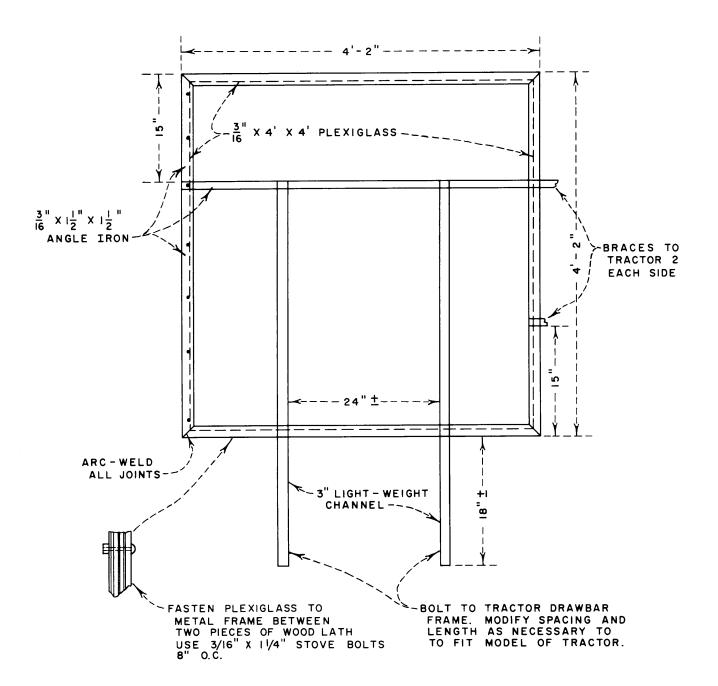
Figure 4 on page 24 is a sketch of the shield.

#### PLEXIGLASS SHIELD FOR MOWER TRACTOR

BACK VIEW
