WATER OPERATION
AND MAINTENANCE

BULLETIN NO. 176

June 1996

Selective Withdrawal for Hungry Horse Dam to Improve Fishery Habitat
Access to Formerly Inaccessible Features
Understanding Seepage and Piping Failures - the No. 1 Dam Safety
Problem in the West
New Standard Specifications Available for Repair of Concrete

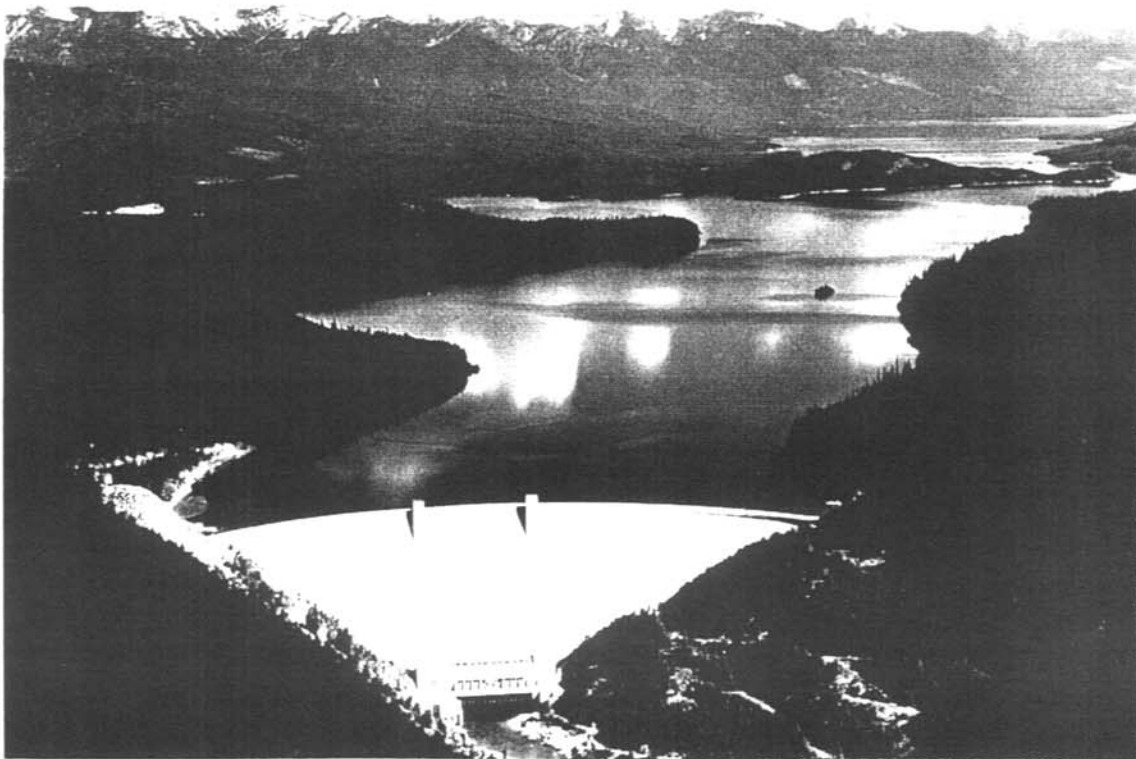
Hungry Horse Dam—564-foot-high thin arch dam located on the South Fork of the Flathead River system.

Hungry Horse Dam, built in the early 1950's, is located about 15 miles south of the western entrance to Glacier National Park, Montana. The multifunctional dam, owned and operated by the Bureau of Reclamation (Reclamation), provides hydroelectric power, flood control, and water storage. The structure is a 564-foot-high thin arch dam, having a total storage capacity of 3,468,000 acre-feet. The powerplant has four hydroelectric units, with a total generating capacity of 428 megawatts. Releases through the plant range from 145 to 13,000 cubic feet per second.

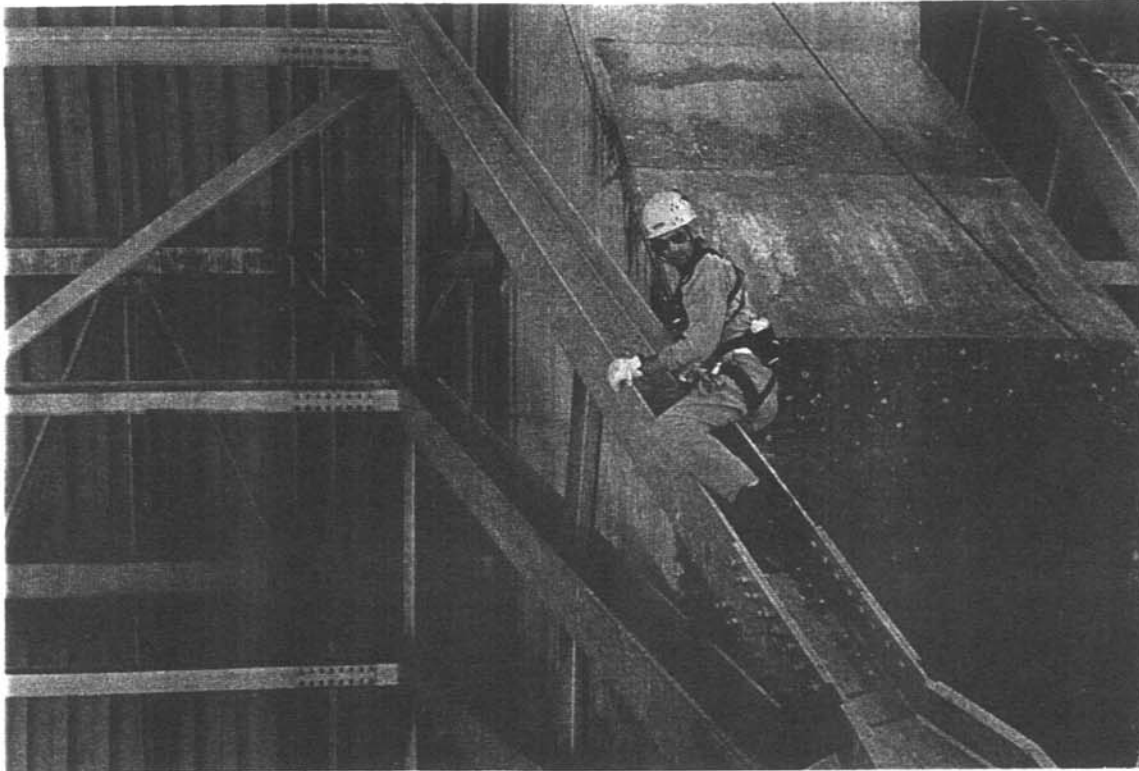
Examination of radial gate at Folsom Dam.

The failure of a 50-foot-high spillway gate at Folsom Dam, outside Sacramento, California, in July 1995 has led to new ideas about the examination of normally inaccessible features. Following the failure, Corps of Engineers, Bureau of Reclamation, and California Department of Transportation (Caltrans) engineers mounted an effort to access and inspect the other seven spillway gates at Folsom. Based on the Caltrans model of using alpine mountaineering techniques to safely access the gate structures, which hang over the top of the 300 foot high spillway, engineers from the three agencies donned climbing harnesses and rigged belay lines to inspect every joint on the remaining seven gate structures.

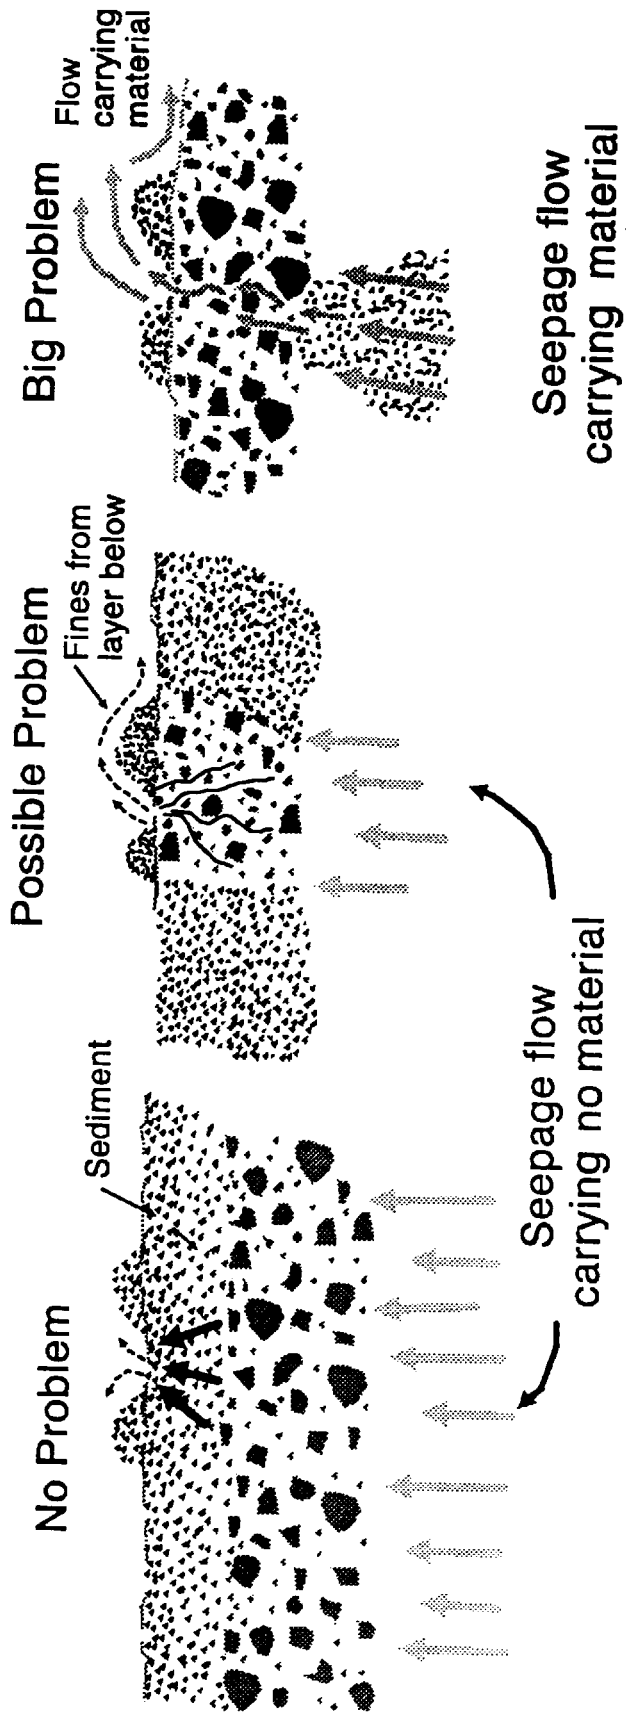
Figure 1

Sand Boils

Sand Boils—Three basic types of sand boils are shown on figure 1. The fundamental appearance and causative mechanism of all three types is the same—that is, a subsurface to surface gradient producing a flow that leaves a deposit of material at the ground surface. The difference in the types is the source of the material deposited.

In the third case, seepage is carrying material from either the dam or the foundation and, due to the coarseness of the surface deposit, this material being carried is able to escape. Since material from the flow path source is being carried away, the threat of tapping into the reservoir source is great.
