## **APPENDIX E**

***Appearance and Microstructure of E110 Standard As-received Tubes  
after a Single-sided Oxidation at 1100 C and F/F Combination  
of Heating and Cooling Rates***

EXPERIMENTAL STUDY OF EMBRITTLEMENT OF  
ZR-1% NB VVER CLADDING UNDER LOCA RELEVANT  
CONDITIONS

During 2001-2004, research was performed to develop test data on the embrittlement of niobium-bearing (Zr-1%Nb) cladding of the VVER type under loss-of-coolant accident (LOCA) conditions. Procedures were developed and validated to determine the zero ductility threshold. Pre-test and post-test examinations included weight gain and hydrogen content measurements, preparation of metallographic samples, and examination of samples using optical microscopy, scanning electron microscopy and transmission electron microscopy. Sensitivity of the zero ductility threshold to heating and cooling rates was determined. Oxidation kinetics and ductility threshold were measured for the standard E110 alloy, six variants with different impurities, Zircaloy, and irradiated E110. Oxidation temperatures were varied from 800-1200 C, and mechanical (ring compression) testing temperatures were varied from 20-300 C. It was conclude

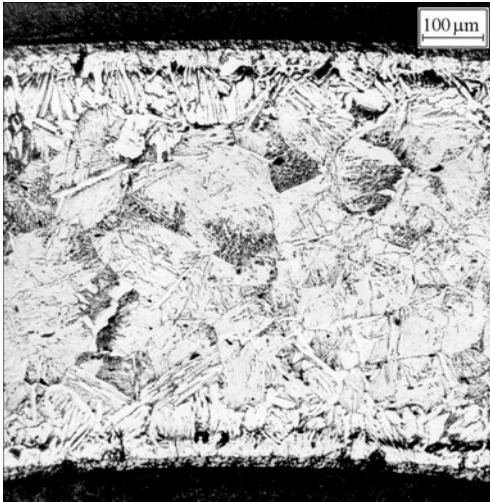
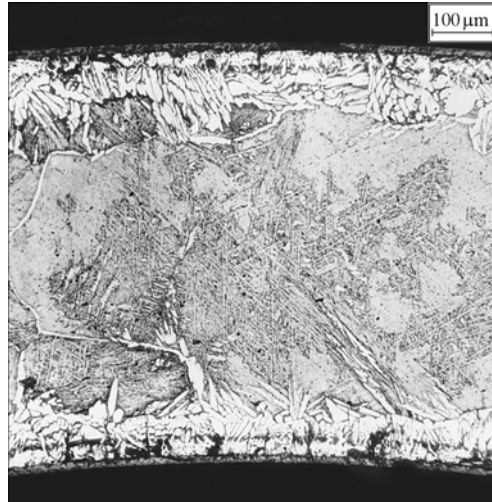
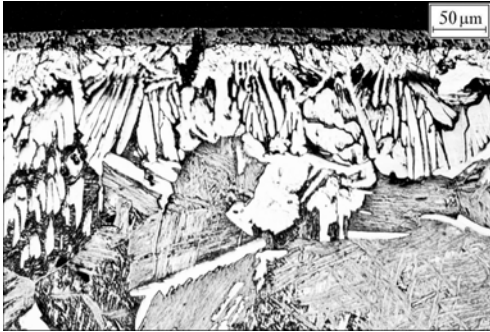
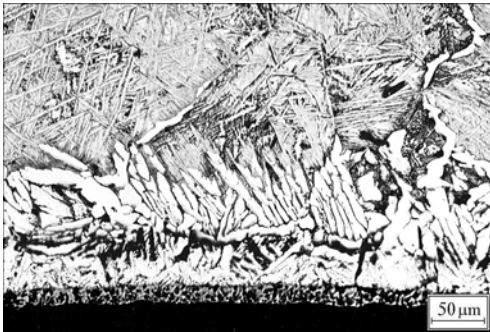
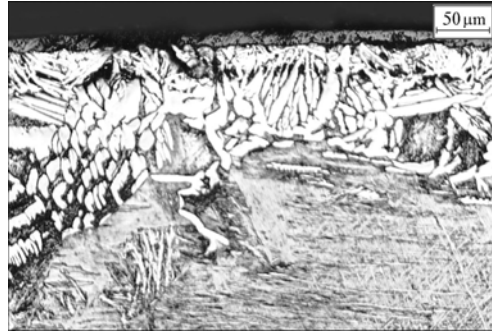
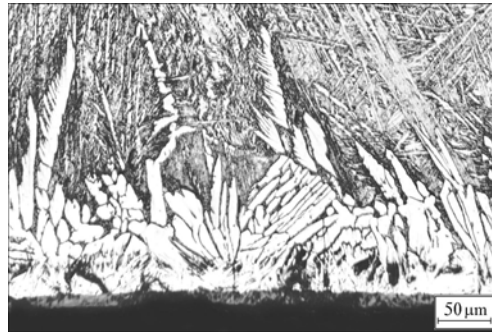
#98-4 ECR=6.9 %	E110 <sub>G(3ru)</sub>	#91-4 ECR=6.5 %	E110 <sub>G(fr)</sub>
<p><i>Etched</i></p>

**Fig. H-5. Microstructure of E110<sub>G(3ru)</sub> and E110<sub>G(fr)</sub> as-received tubes after a double-sided oxidation at 1000°C and ECR=6.5–6.9 % (F/F combination of heating and cooling rates)**

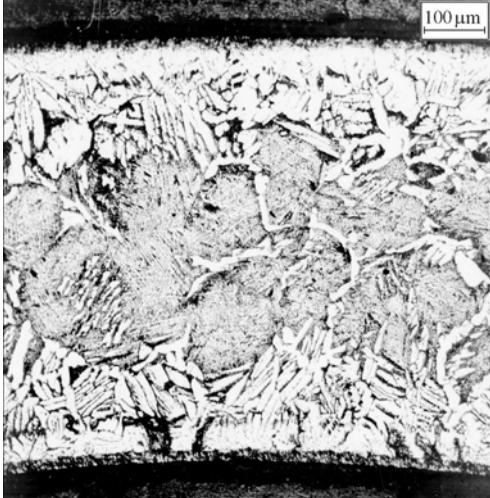
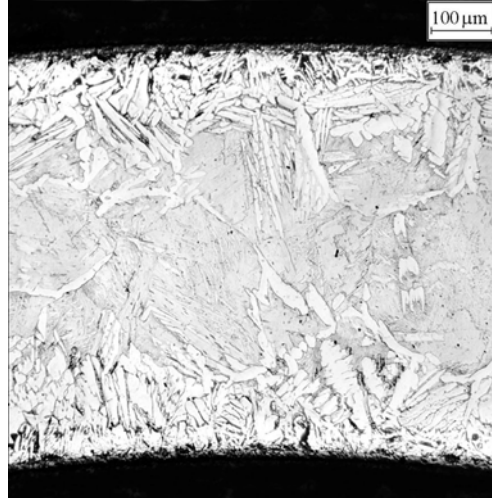
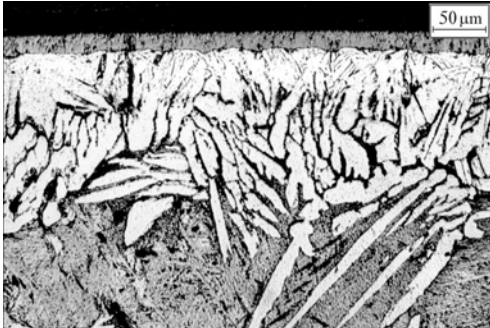
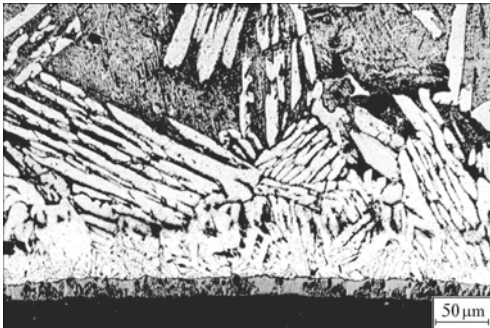
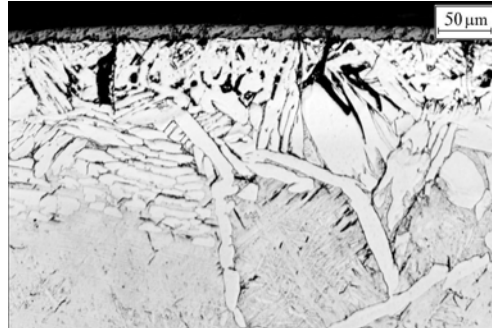
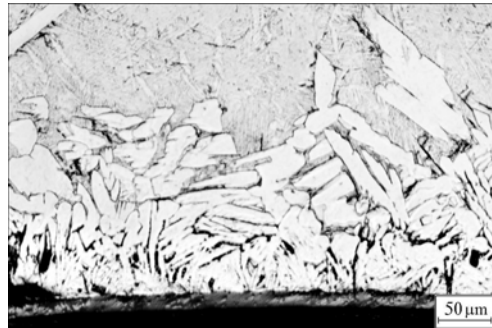
#101-4 ECR=8.9 %	E110 <sub>G(3ru)</sub>	#93-4 ECR=8.5 %	E110 <sub>G(fr)</sub>
<i>Etched</i>

**Fig. H-6. Microstructure of E110<sub>G(3ru)</sub> and E110<sub>G(fr)</sub> as-received tubes after a double-sided oxidation at 1000°C and ECR=8.5–8.9 % (F/F combination of heating and cooling rates)**

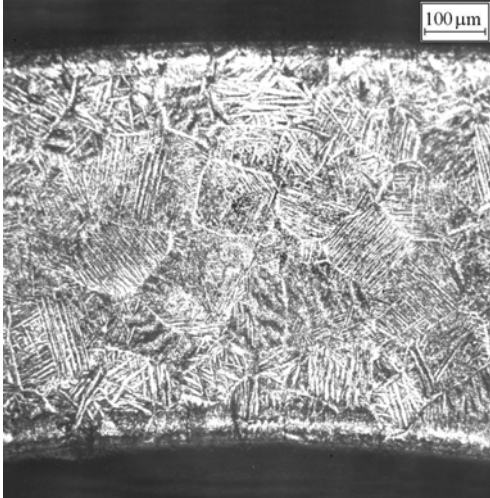
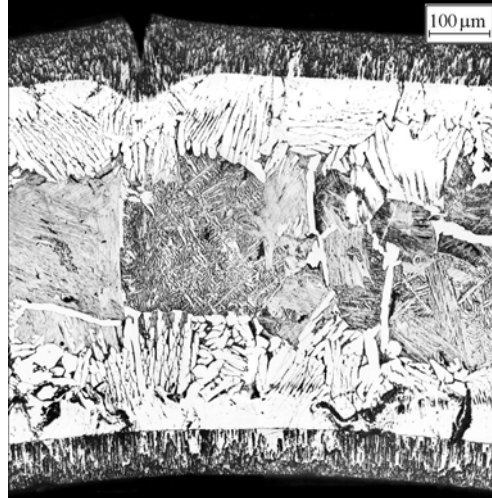
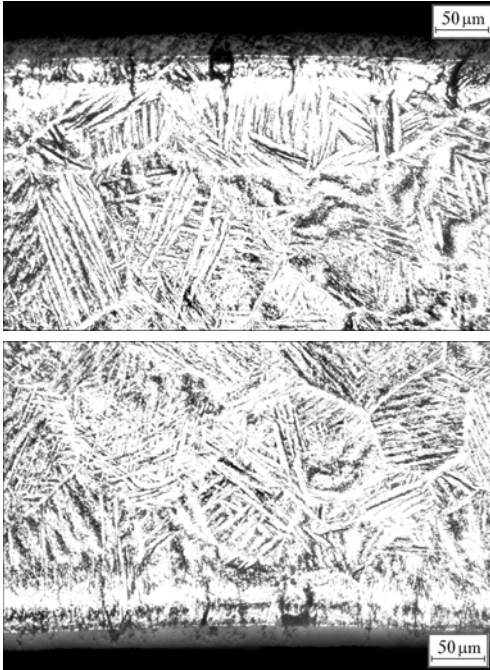
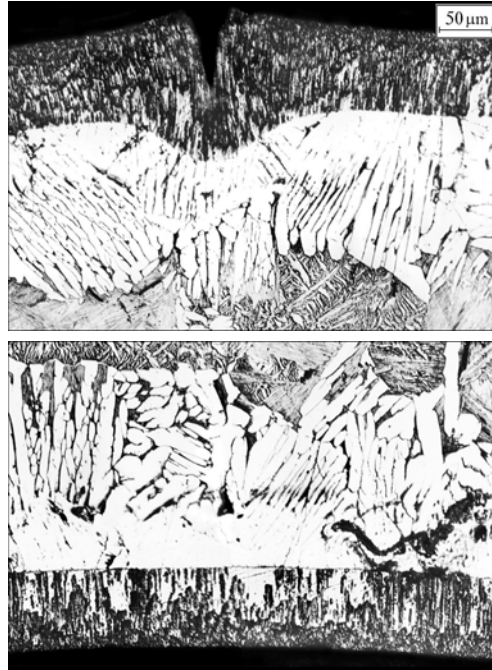
#120-5 ECR=7.8 %		#112-2 ECR=23.5 %	
Etched

**Fig. H-12. Microstructure of E110<sub>G(3ru)</sub> as-received tubes after a double-sided oxidation at 1200°C and F/F combination of heating and cooling rates**

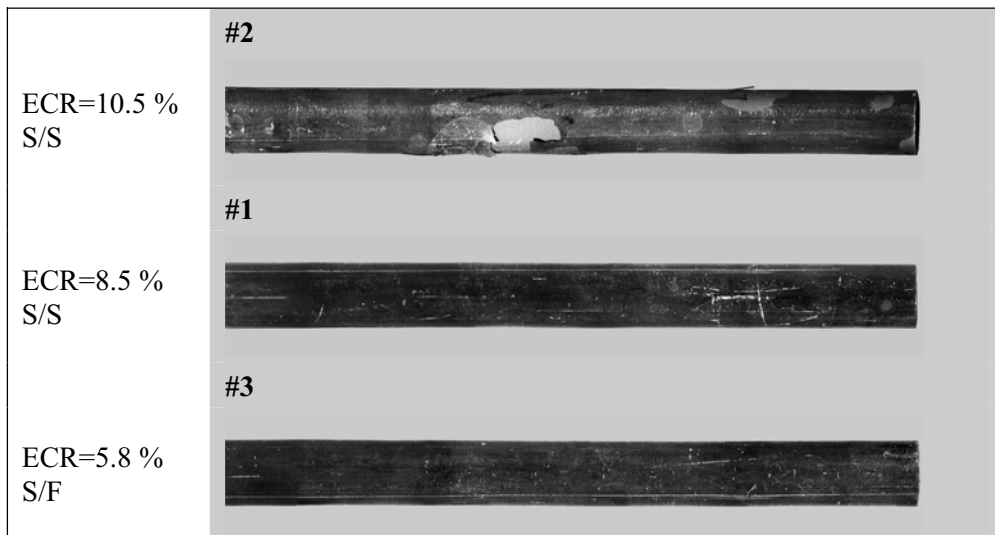
**Fig. I-2. Appearance of E110 commercial irradiated claddings after a double-sided oxidation at 1100 C and S/S, S/F combinations of heating and cooling rates**

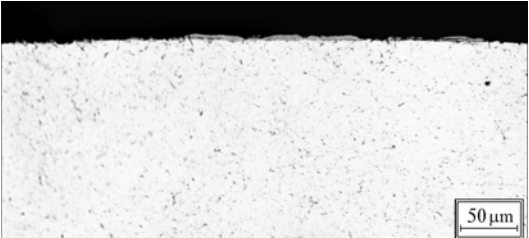
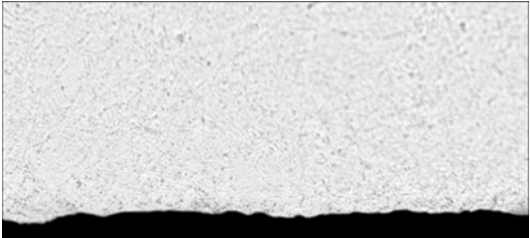
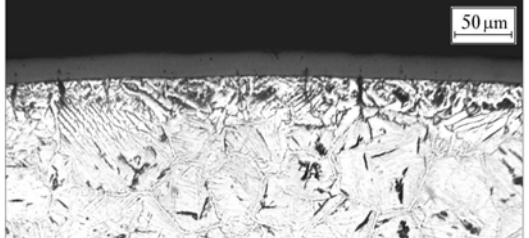
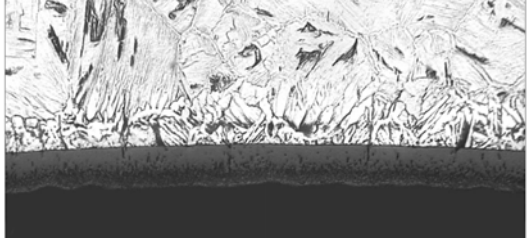
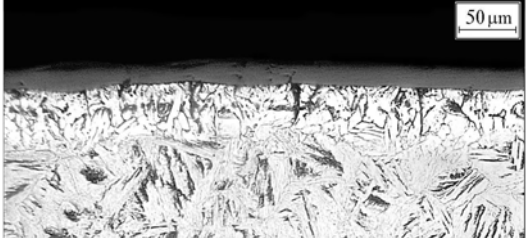
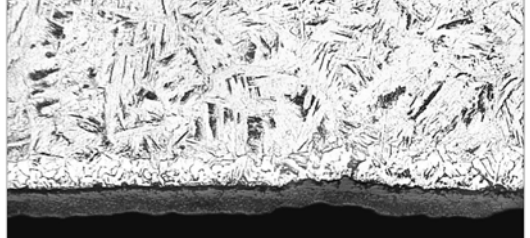
Sample	External surface	Internal surface
Before oxidation tests (Polished)

#20-4 ECR=6.3 % (Etched)

#21-4 ECR=7.0 % (Etched)

#10-4 ECR=7.7 % (Polished)

#15-4 ECR=8.1 % (Polished)

#14-4 ECR=8.3 % (Polished)

**Fig. I-6. Microstructure of  $ZrO_2$  and  $\alpha$ -Zr(O) layers in E110 commercial irradiated cladding before and after a double-sided oxidation at 1100 C and F/F combination of heating and cooling rates**
