MANNED  
SPACE  
FLIGHT  
NETWORK

# POSTMISSION REPORT ON THE AS-506 (APOLLO 11) MISSION

FEBRUARY 1970

GODDARD  
SPACE  
FLIGHT  
CENTER

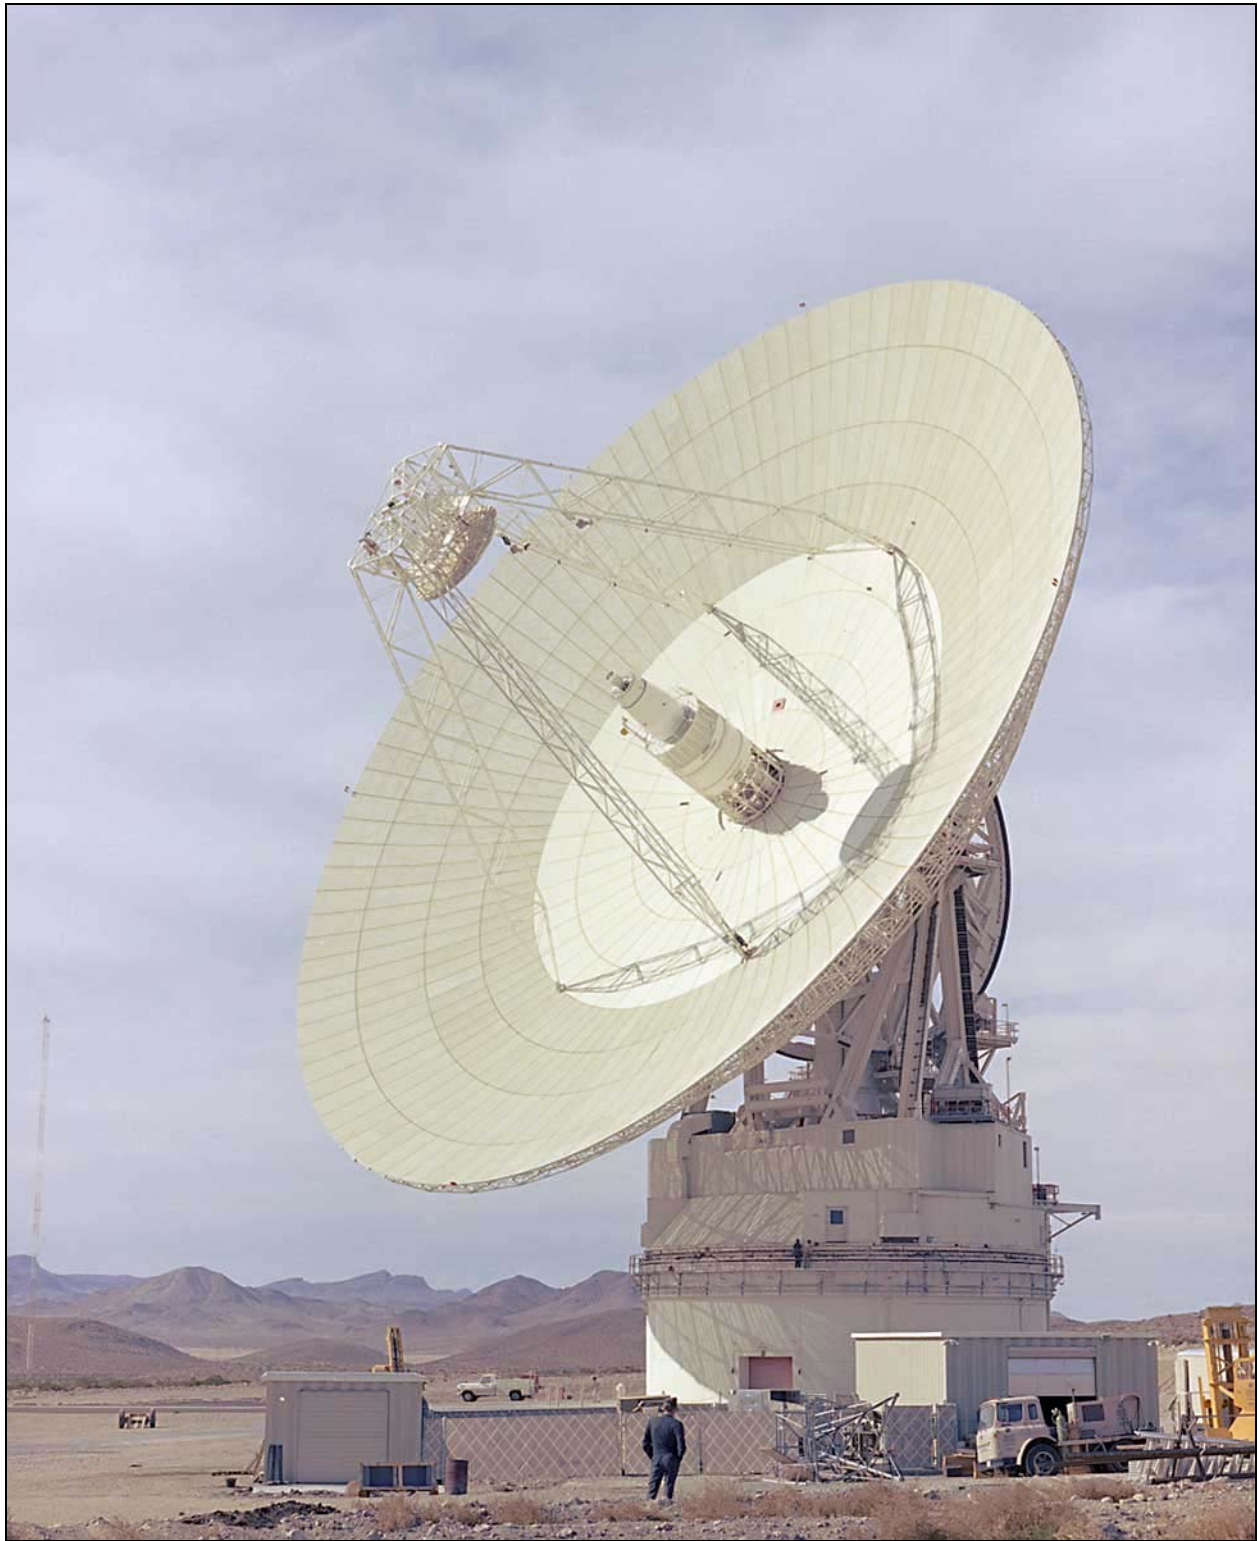
**Frontispiece. MARS 210-foot Antenna at Goldstone, California**

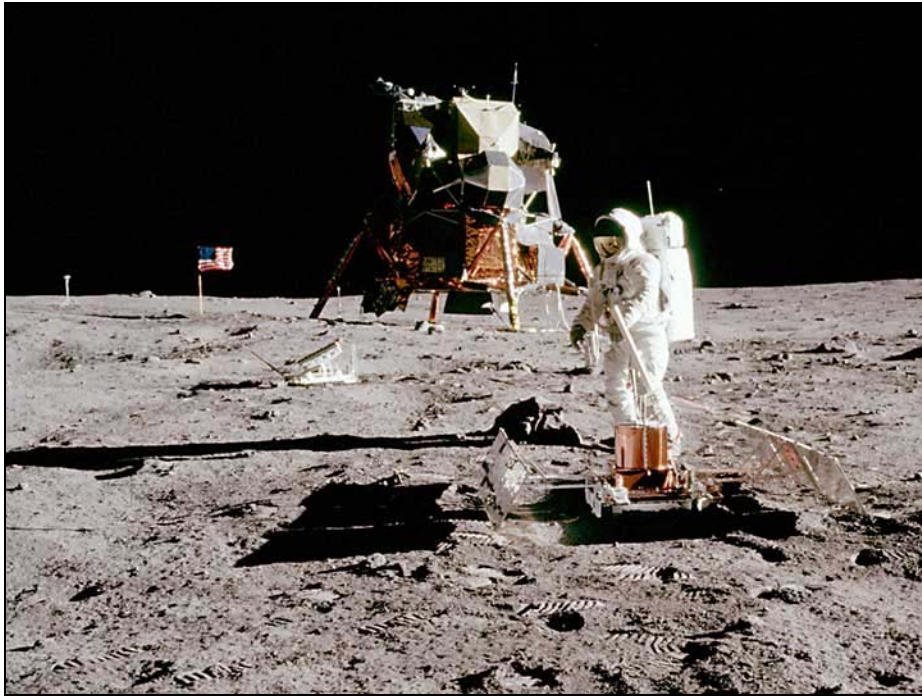
EASEP Deployed on the Moon

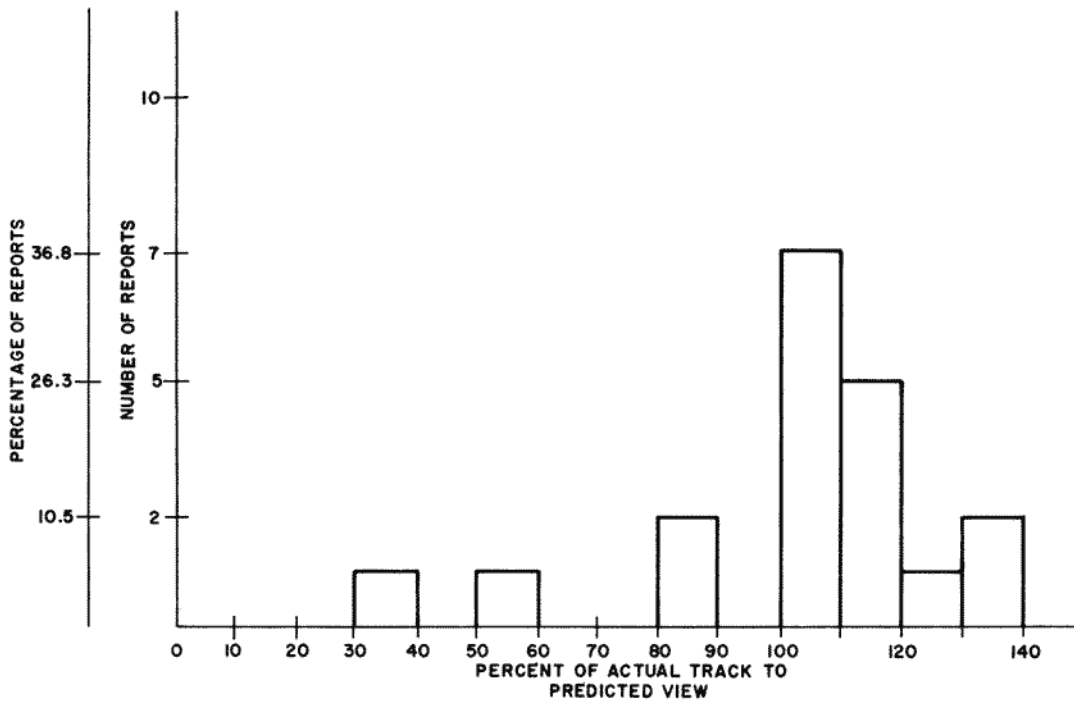
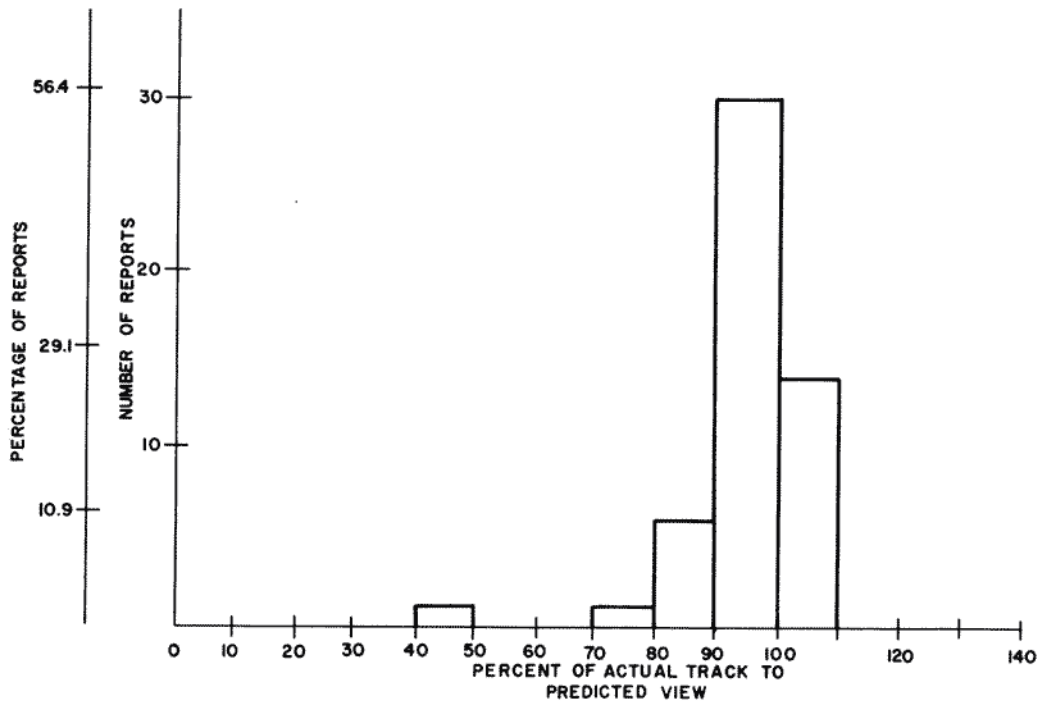
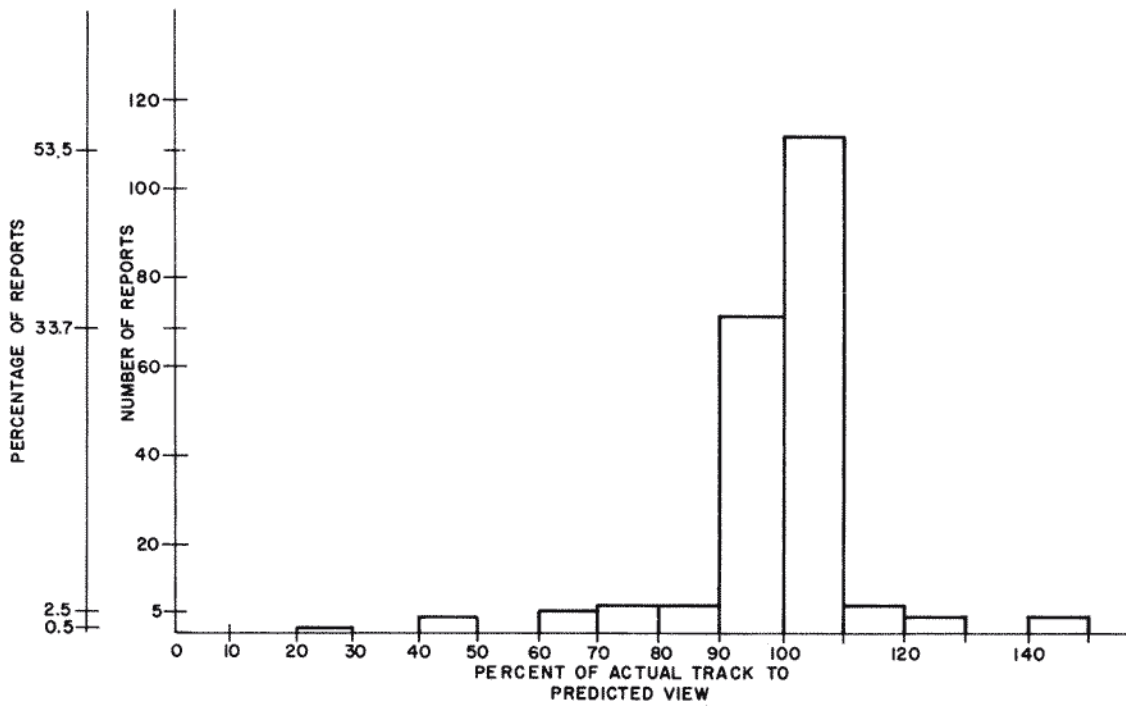
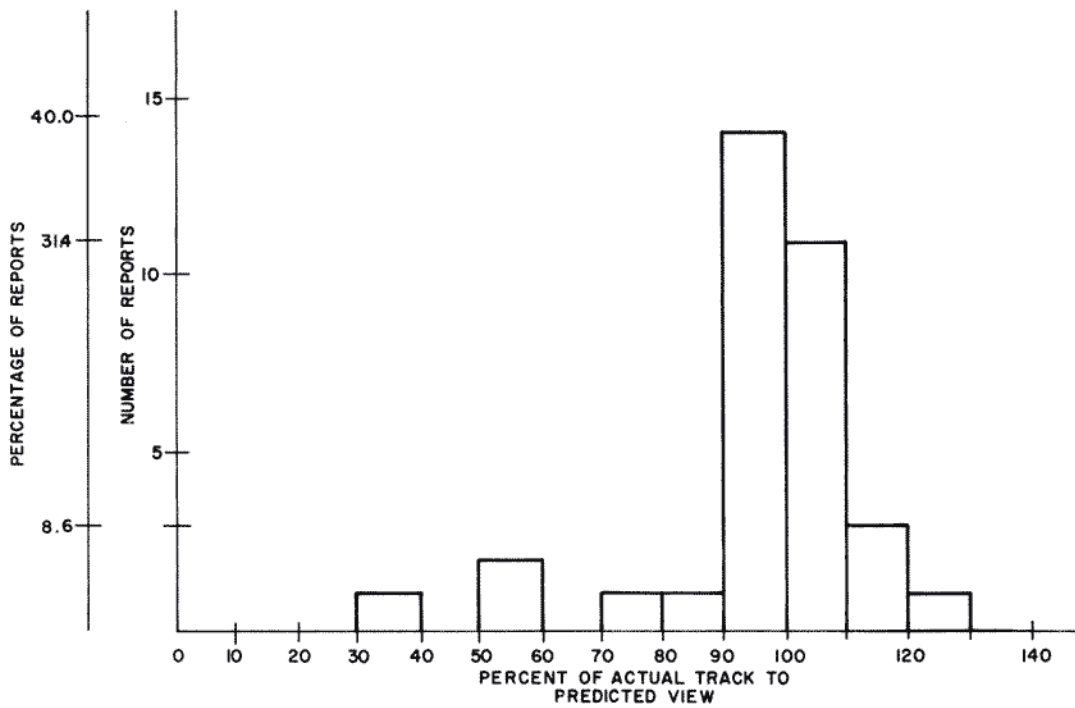
a. Launch and EO

b. TLC

Figure 2-1. Actual S-band Track to Predicted View

c. Lunar Phase

d. TEC and Reentry

Figure 2-1. Actual S-band Track to Predicted View (cont)

(1) Percentage of Actual Track to Predicted View. Figure 2-1 gives in finer detail the data points used in the calculation of percentage of actual track to predicted view, again divided into four phases:

(a) Launch and EO (Figure 2-1a). During launch and EO, 78.9 percent of the reported tracks exceeded the predicted track times and 68.4 percent exceeded the phase average.

(b) TLC (Figure 2-1b). During TLC, 29.1 percent of the reported tracks exceeded the predicted track times and 70.9 percent exceeded the phase average.

(c) Lunar Phase (Figure 2-1c). During the lunar phase, 56.9 percent of the reported tracks exceeded the predicted track times and 78.2 percent exceeded the phase average.

(d) TEC and Reentry (Figure 2-1d). During TEC, 42.8 percent of the reported tracks exceeded the predicted track times and 71.4 percent exceeded the phase average.

The fact that during all phases well over 50 percent of the reports are above the phase average indicates that a few low percentages are inordinately affecting the averages.

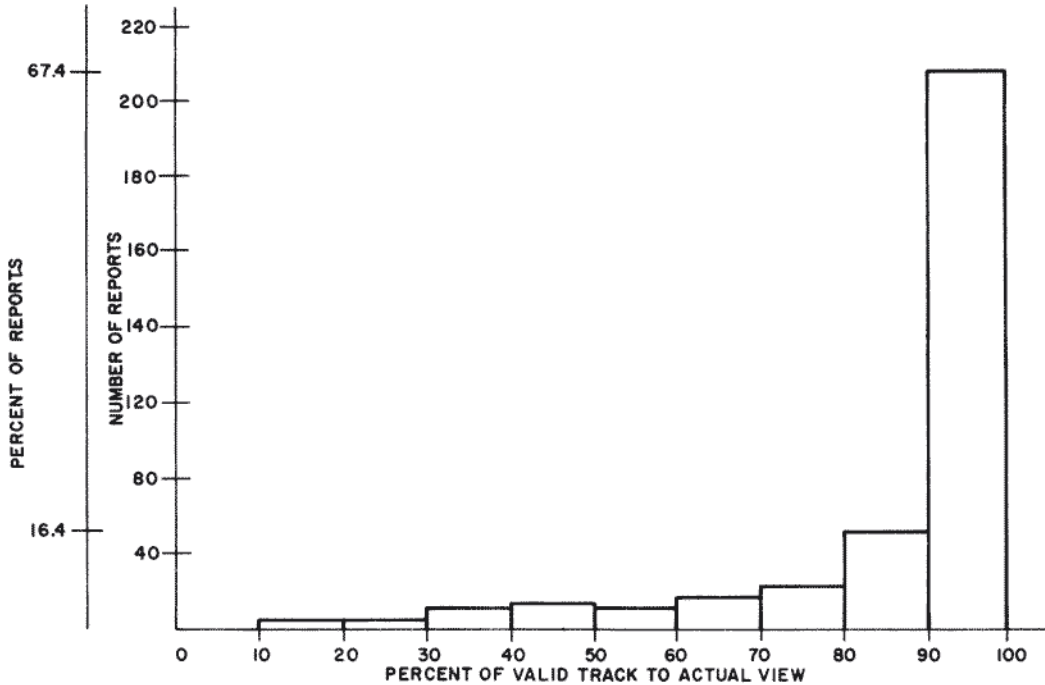
Figure 2-2. Percentage of Valid S-band Tracking to Total Track

(2) Percentage of Valid Track to Total Track. Figure 2-2 is a more detailed presentation of the data used in calculating the percentage of valid track to total track for the mission as a whole. The mean of 89.2 percent for the network was surpassed 69.0 percent of the time in which the vehicles were being tracked. Once again, the fact that well over 50 percent of the reports exceeded the average shows that a small number of low percentages has had an excessive effect on the average.

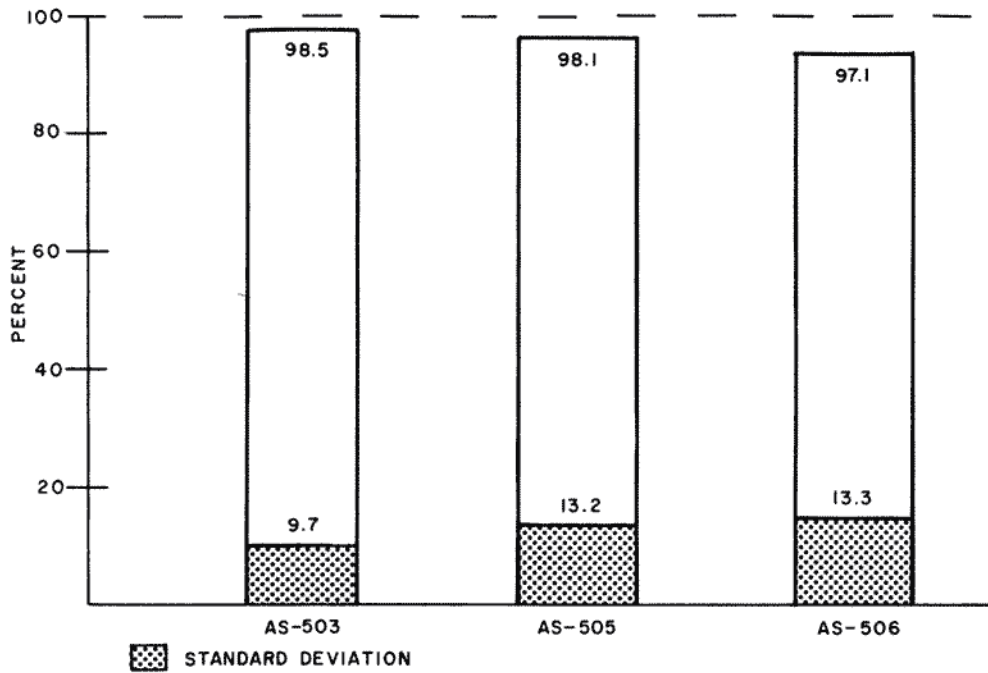
Figure 2-3. Percentage of Actual Track to Predicted View Time (USB)-- by Mission

Table 2-6 shows the USB performance for all three lunar missions. These statistics show great consistency in the overall performance for these missions, with the only significant difference being in the SD for percentage of actual to predicted time between AS-503 and the other lunar missions. The differences in the other statistics are negligible. Figures 2-3 and 2-4 are graphic representations of the data contained in table 2-6.

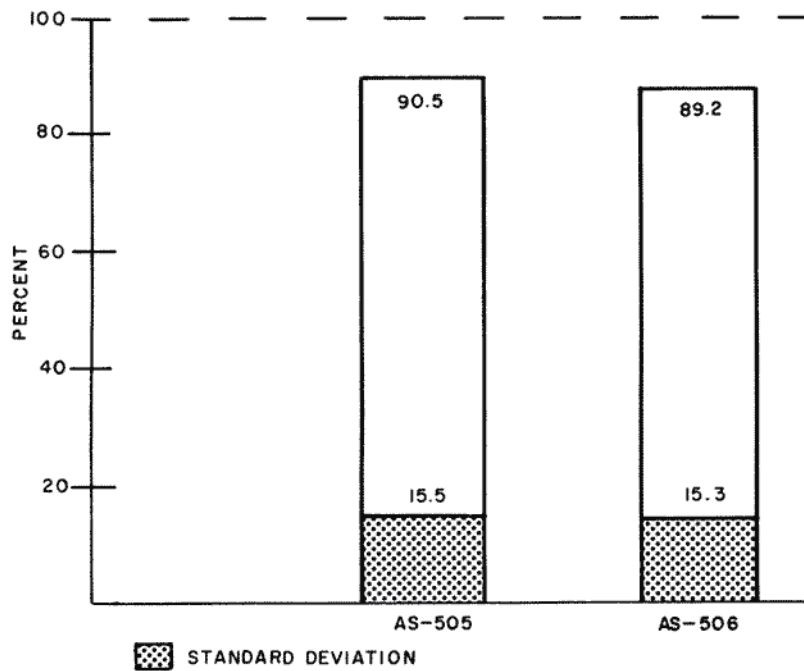
Figure 2-4. Percentage of Valid Track to Total Track (USB)--by Mission

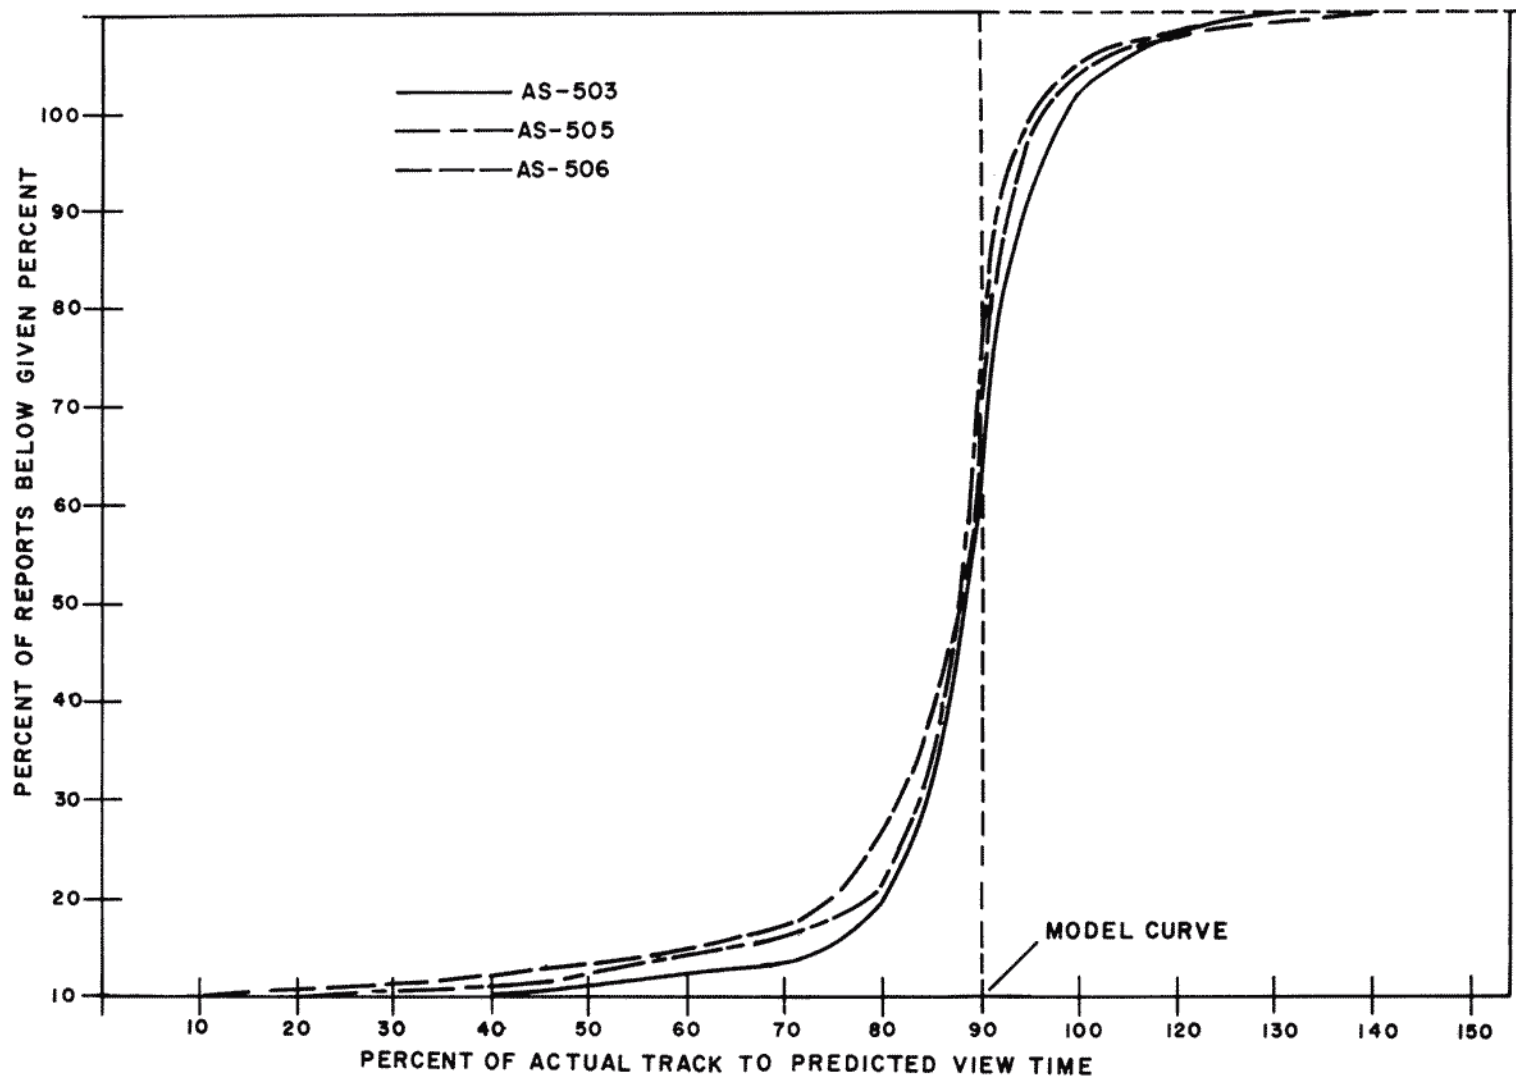
Figure 2-5. Distribution of Percent of Actual Track to Predicted View Data Points for AS-506 and Previous Lunar Missions

Figure 2-5 gives a more detailed representation of the distribution of actual track to predicted view data points derived for the three lunar missions. The graph shows that AS-506 had a higher percentage of points below 90 percent than the others. It also had fewer points exceeding 110 percent than AS-503, but more than AS-505. The following example will illustrate how to read this graph: In order to find out what percentage of the AS-503 distribution falls between 90 and 110 percent, mark the point on the AS-503 line where the value of actual to predicted view is equal to 90 percent. The value for this point on the Y-axis is about 9 percent. This means that 9 percent of the data points were below 90 percent. Now find the point on the AS-503 line which equals 110 percent on the X-axis. The value of this point on the Y-axis is approximately 92 percent. This means that 92 percent of the points are below 110 percent. The percent of points between 90 and 110 percent can be found by subtracting the percentage of reports below 90 percent from the percentage of points below 110 percent, or  $92 - 9 = 83\%$ . Furthermore, we know that since 92 percent of the reports are below 110 percent, 8 percent must be at or above 110 percent.

As can be seen by figure 2-5, the reason for the AS-503 SD being lower than the SD for other missions is that AS-503 did not include the extremely high and especially the extremely low points which are found in the other two missions.

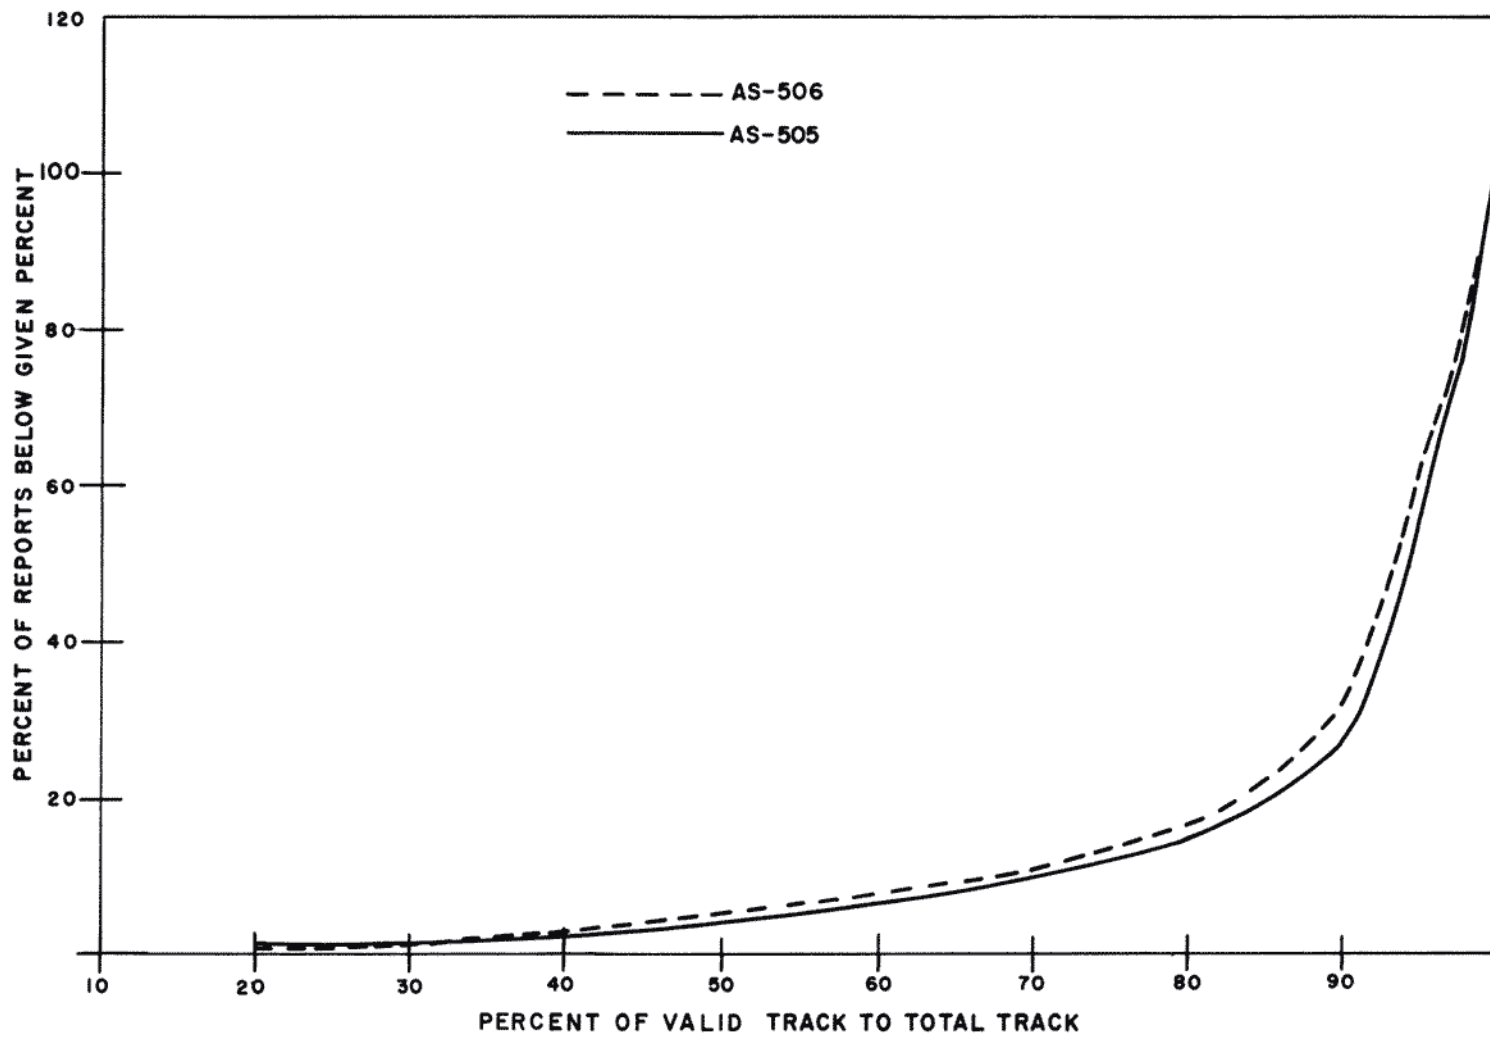
Figure 2-6. Distribution of Percent of Valid to Total Track Data Points for AS-506 and AS-505

Figure 2-6 shows the distribution of points used to compute the percentage of valid to total track for AS-506 and AS-505. This figure shows that AS-506 had more reports below 90 percent than did AS-505.

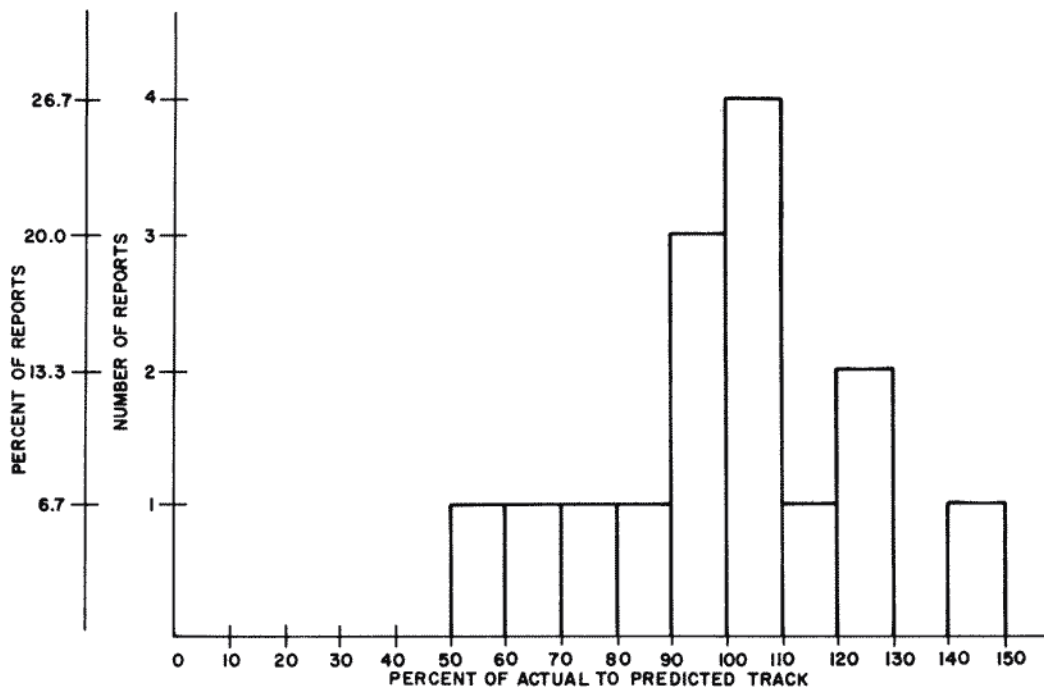
Figure 2-9. Percentage of C-band Actual Track to Predicted View

Figures 2-9 and 2-10 show the distribution of the individual data points used in calculating two of the statistics in table 2-8. Figure 2-9 shows that more than half of the reports indicated actual track times in excess of the predicted times, and almost 75 percent of the reports indicated actual track in excess of 90 percent of the predicted times. Figure 2-10 shows that for almost 70 percent of the reports, valid track was obtained for more than 90 percent of the total track time.

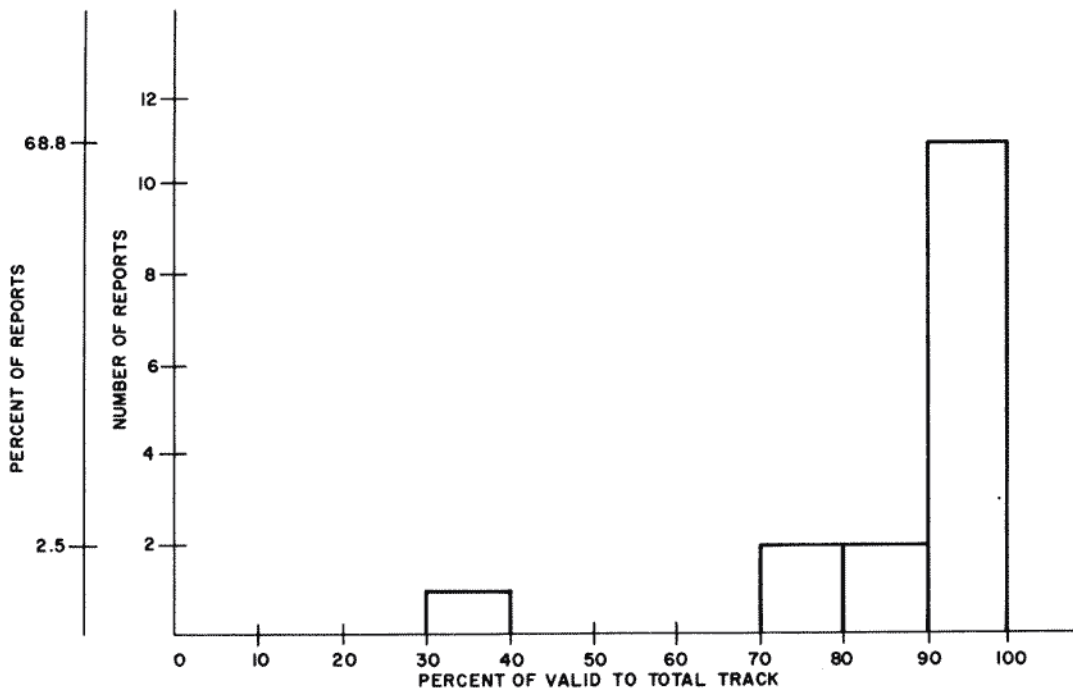
Figure 2-10. Percentage of Valid C-band Track During Total Tracking Time

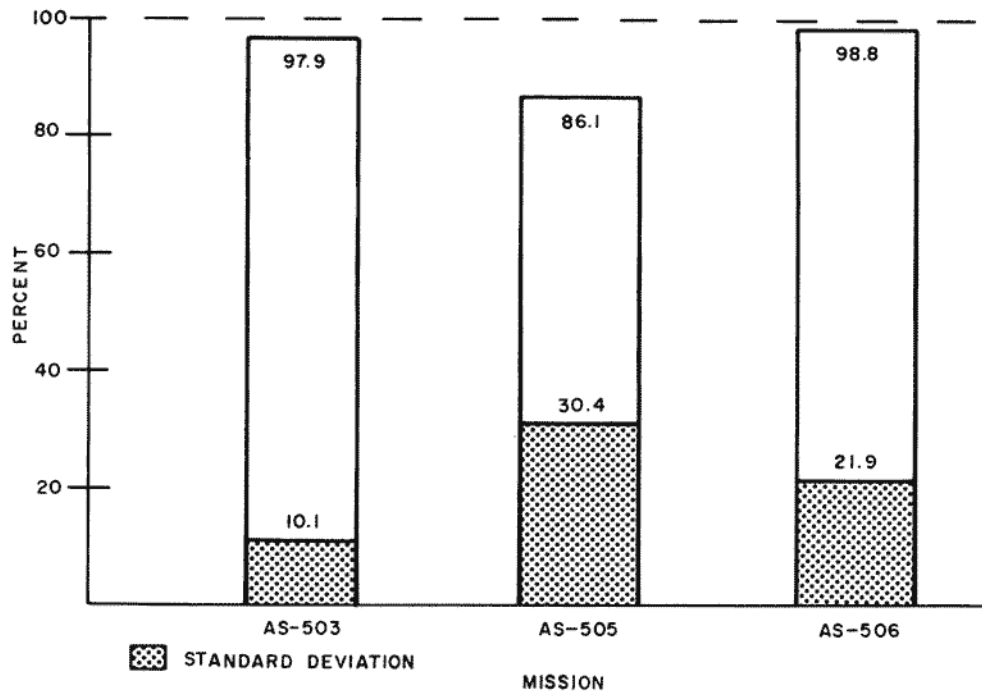
Figure 2-11. Comparison of Percentage of Actual Track to Predicted View (C-band)--by Mission

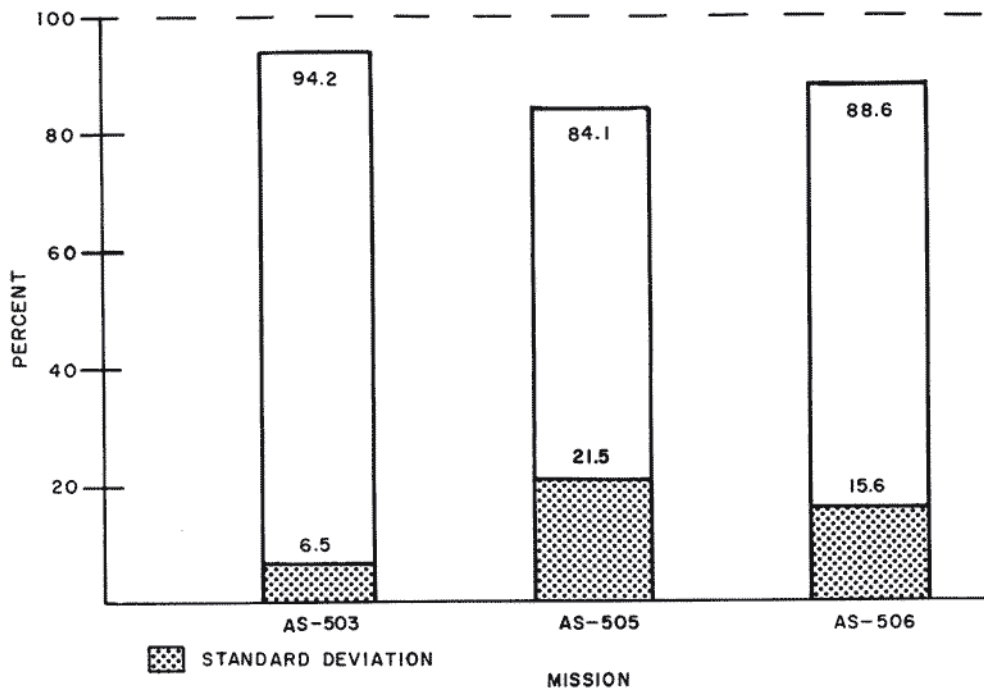
Figure 2-12. Comparison of Percentage of Valid Track to Total Track (C-band)--by Mission

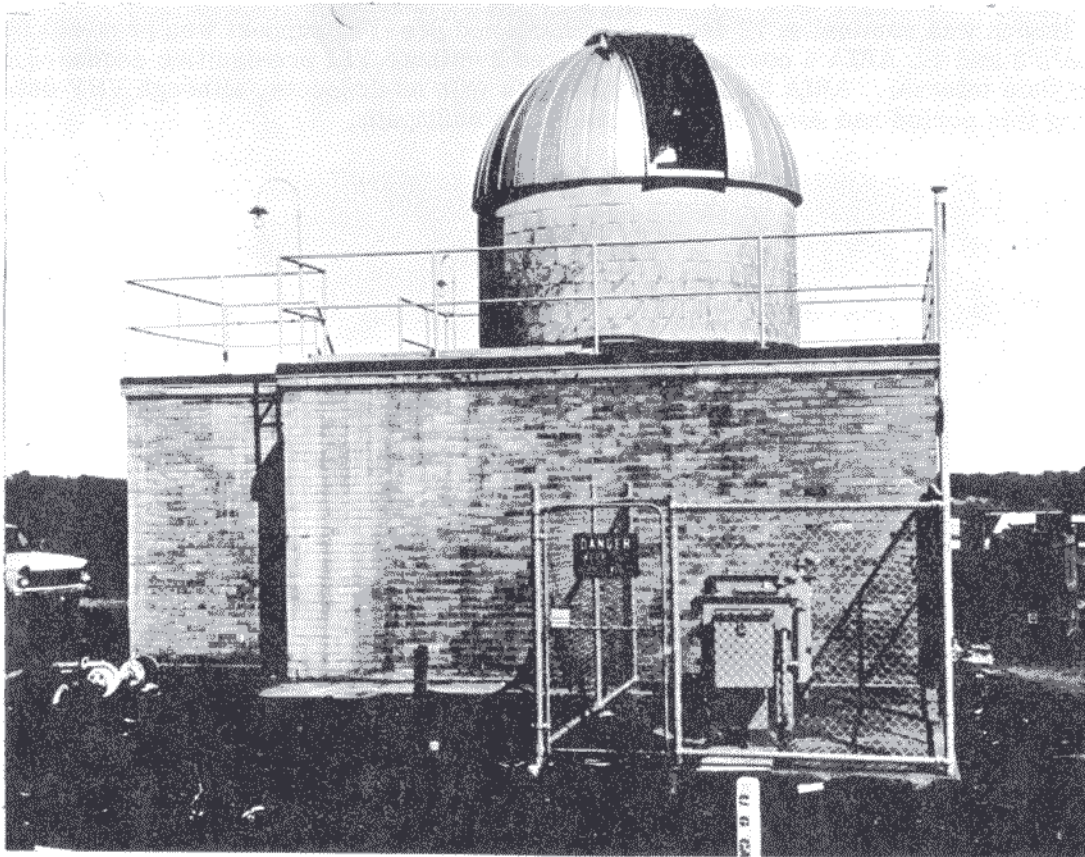
Figure 3-1. A Typical SPAN Station

SPAN facilities at CYI, CRO, and MSC participated in the mission. Each facility consists of an optical telescope in an observatory dome, a radio telescope in a radome, and a building containing photographic, recording, and communications equipment. (See figure 3-1.) Additionally, riometer systems at CYI, CRO, and Lima, Peru provided mission support.

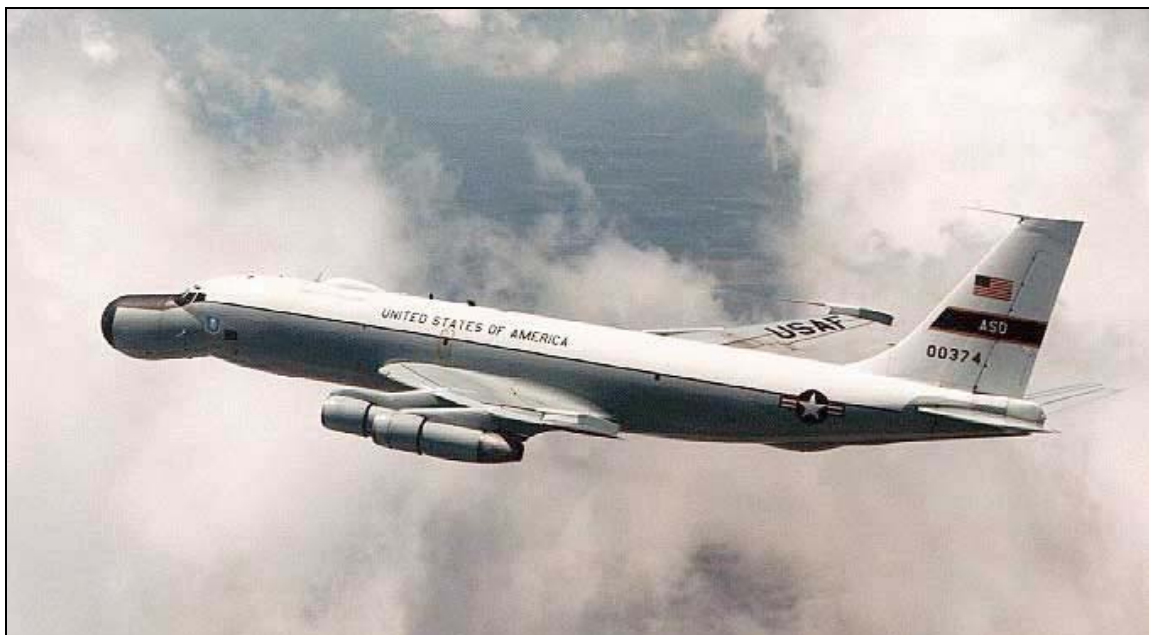
Figure 3-2. ARIA in Flight

Eight aircraft (see figure 3-2) supported the AS-506 mission and at launch were positioned as follows: three at Darwin, Australia, one at Cocos, three at Guam, and one at Mauritius. This deployment provided maximum coverage for all possible launch azimuths.

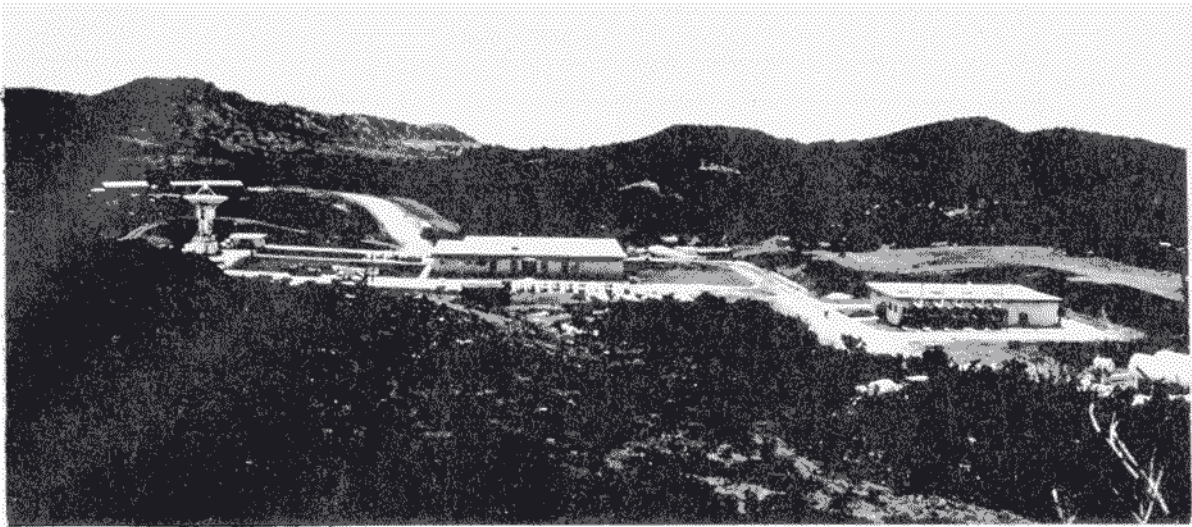
Figure 3-5. ANG Tracking Station

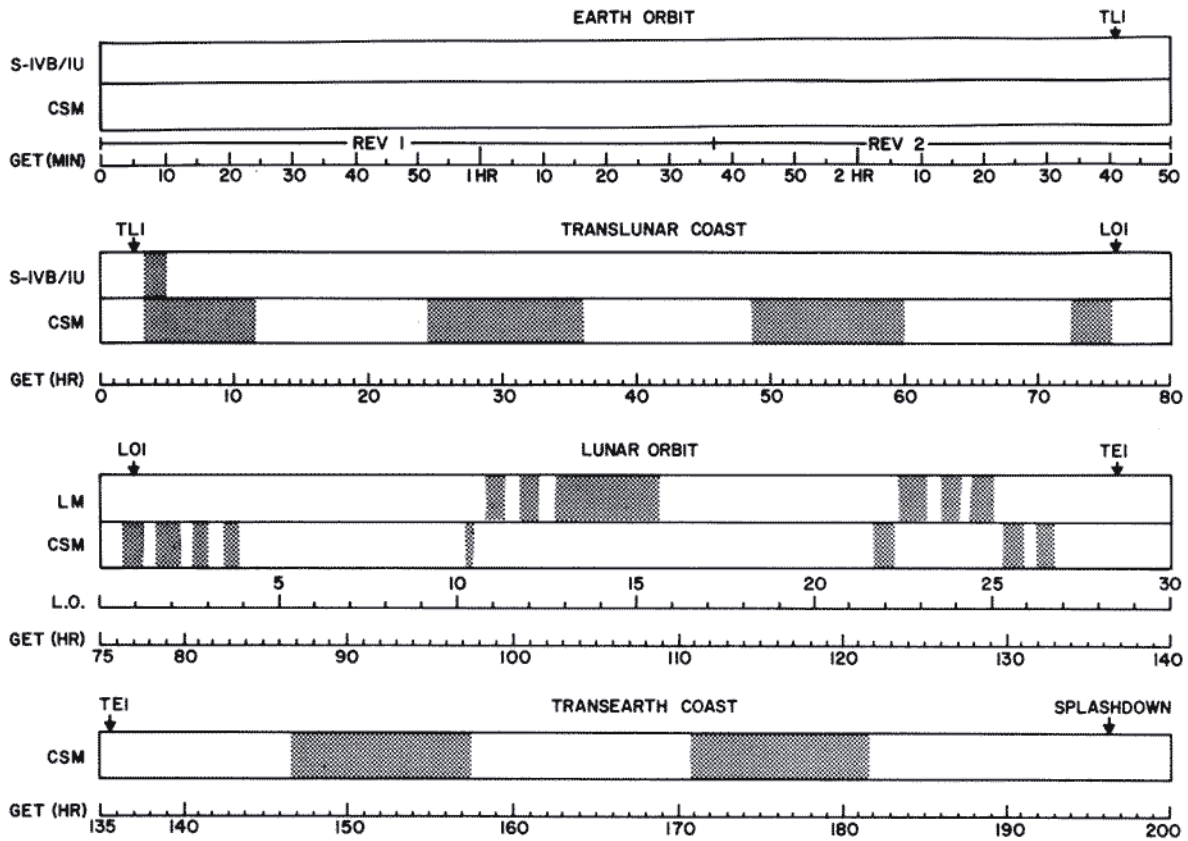
Figure 3-7. ANG Support Periods

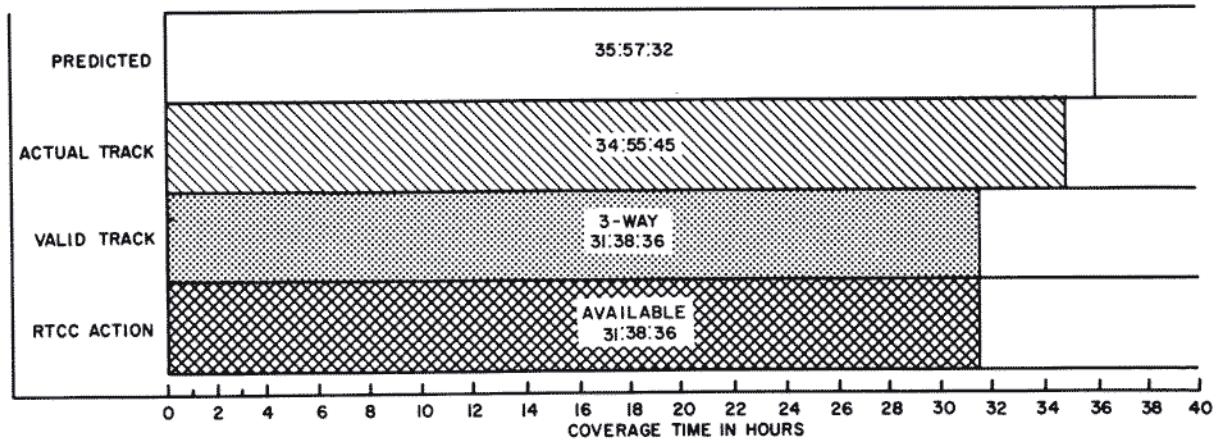
(a) TLC -- CSM

Figure 3-8. ANG USB Tracking Coverage

3.4.2.1 USB (Figure 3-8). During TLC (59:58:00 GET), the optical collimation system became inoperative when operators were unable to focus the boresight TV camera. Investigation revealed a defective connector in the antenna feed-through panel. Replacement of the connector and realignment restored normal operation.

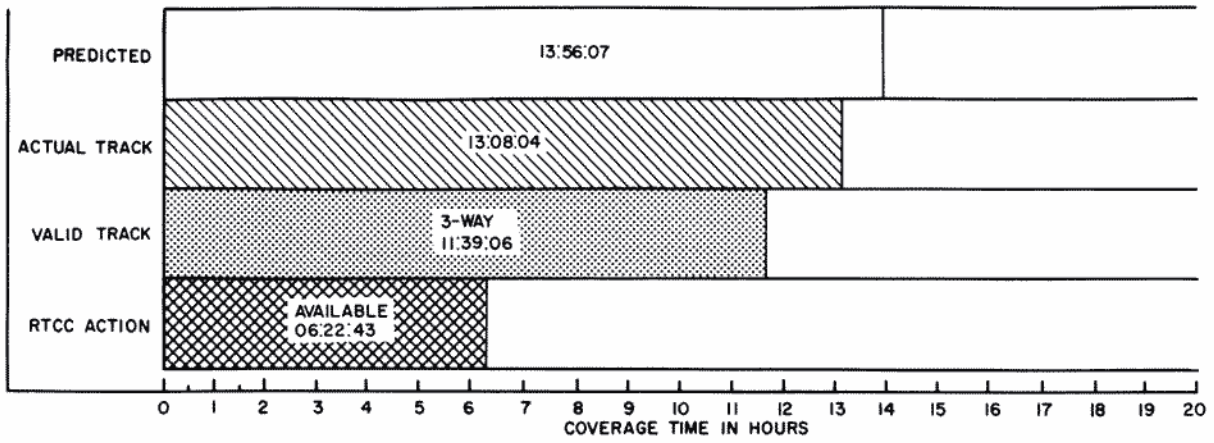
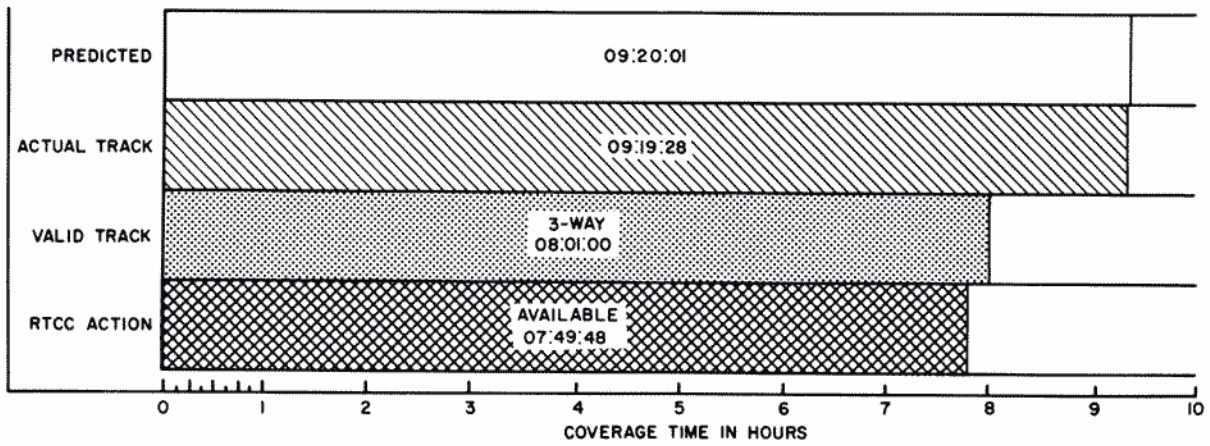
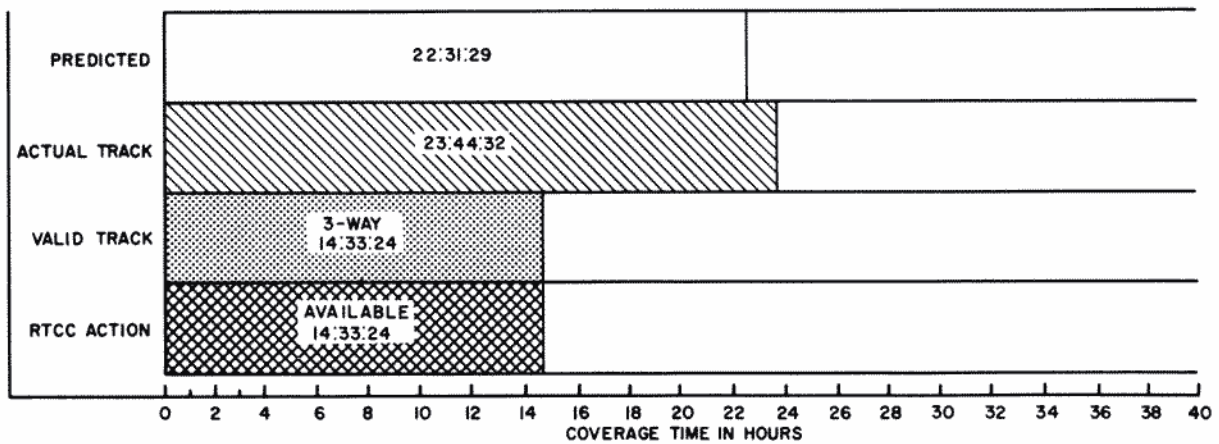
(b) Lunar Phase -- LM

(c) Lunar Phase -- CSM

(d) TEC -- CSM

A PA failed because of ac overcurrent at 97:08:00 GET during the lunar phase and momentarily inhibited uplink capability. Recycling of the PA restored operation (3.1.2.2). At 99:18:00 GET, program mode tracking was interrupted for 4 minutes when 29-point acquisition message errors were transferred into the APP drive tape. When the auto-track mode of operation was selected, antenna movement was normal. The line feed function of the TDP was inhibited at 109:58:00 GET when PC card 2P48 failed. This defective card resulted in the loss of 4 minutes of LSD, although HSD remained normal. LSD was restored when the circuit card was replaced with a spare.

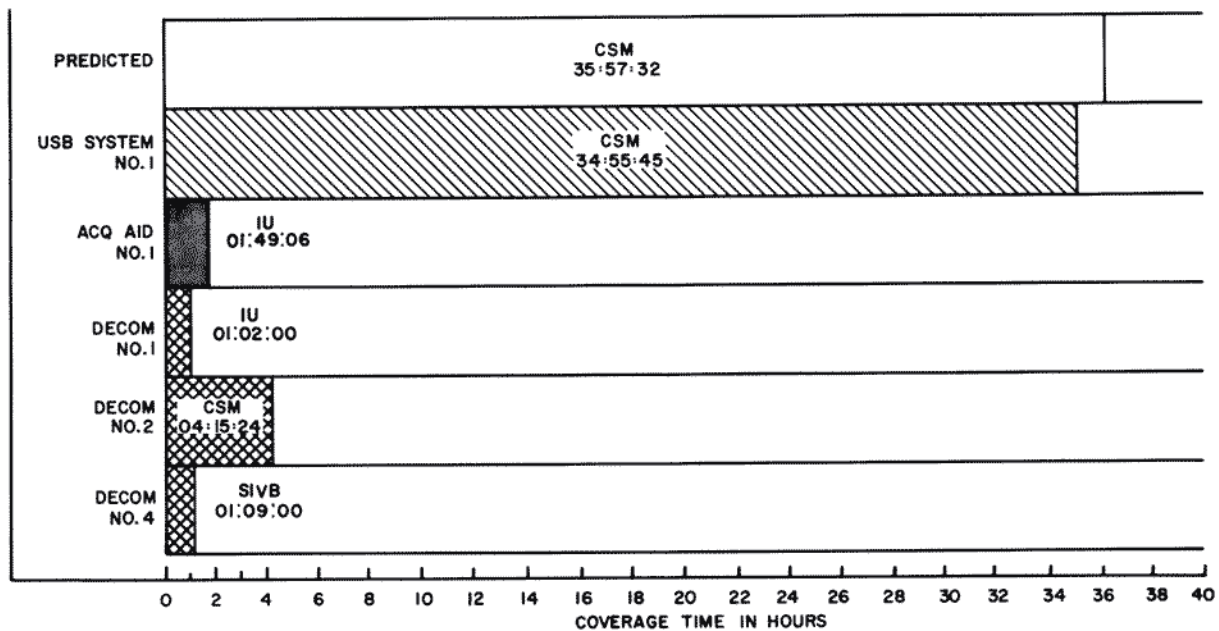
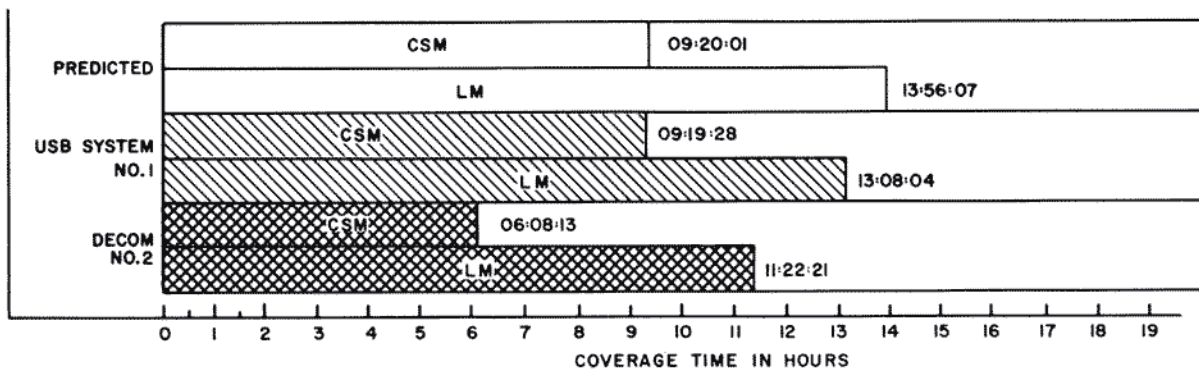
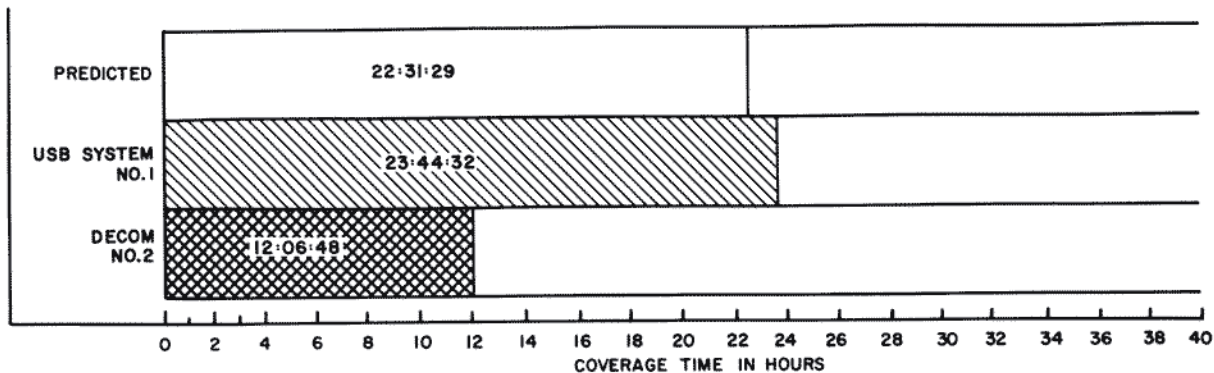
Figure 3-9. ANG Telemetry Coverage

(a) TLC

(b) Lunar Phase

(c) TEC -- CSM

3.4.3.1 USB. Real-time and dump data from the CSM and real-time data from the LM, after separation from the CSM, were received throughout the mission. There were periods when received data was substandard because of weak signals due to spacecraft attitude or its mode of flight (3.1.3.1). There were no significant equipment or operator problems. Approximately 14 seconds of LM data was lost during lunar liftoff due to degraded received signal (3.1.3.2).

3.4.3.2 VHF. The TELTRAC provided support for S-IVB and IU telemetry links simultaneously during TLC (03:04:10 to 04:53:16 GET). VHF tracking was used initially, then, as signal strength decreased with increased distance, the TELTRAC antenna was slaved to the USB to ensure VHF A/G support of the CSM. Decom lock was maintained on the S-IVB/IU link to a distance of approximately 20,700 nmi. There were some dropouts because of weak signals near LOS, which occurred shortly after the "slingshot" maneuver.
