MANNED  
SPACE  
FLIGHT  
NETWORK

# POSTMISSION REPORT ON THE AS-506 (APOLLO 11) MISSION

FEBRUARY 1970

GODDARD  
SPACE  
FLIGHT  
CENTER

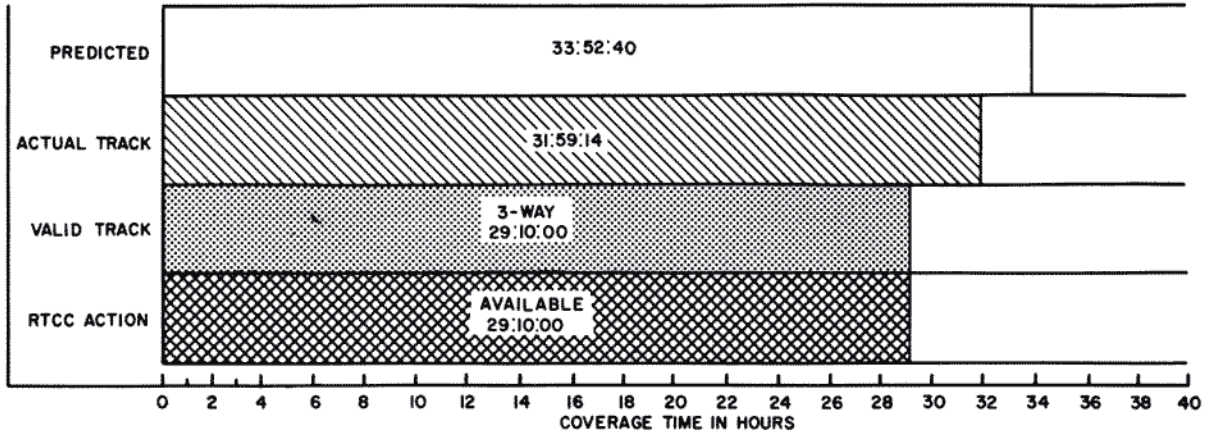
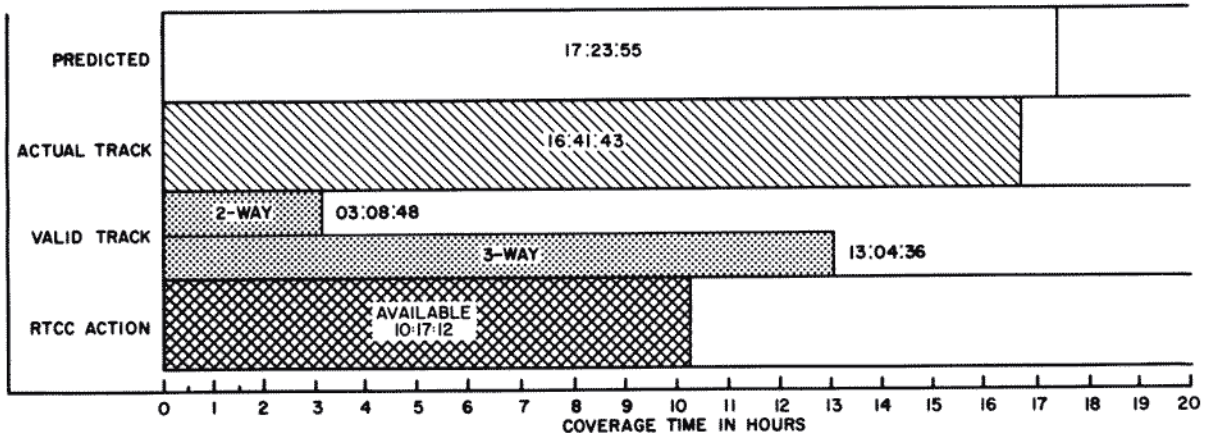
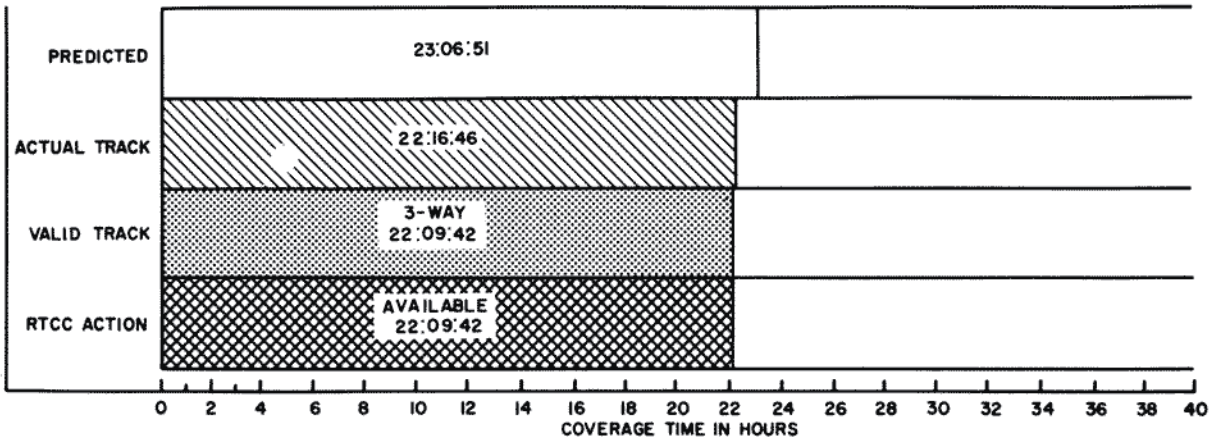
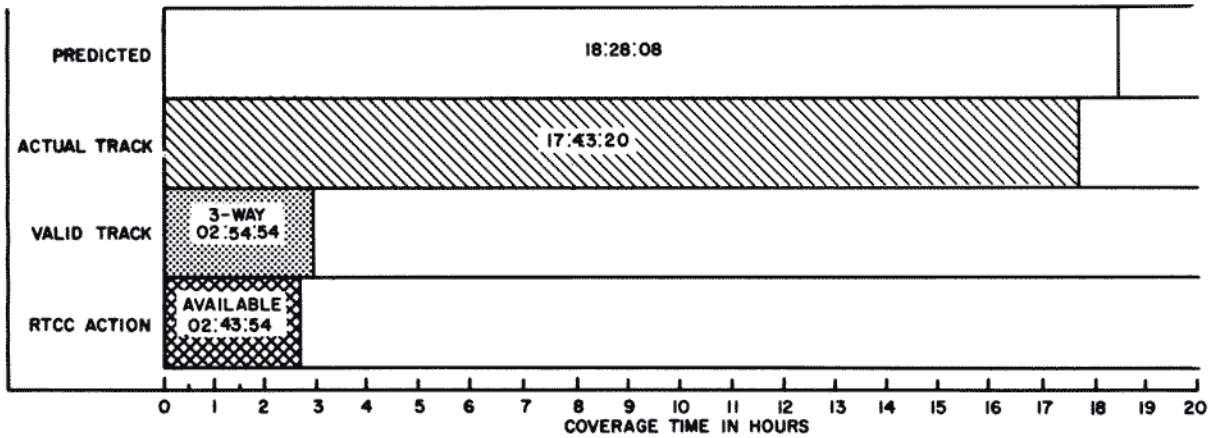
Figure 3-13. ACN USB Tracking Coverage

(1) TLC -- CSM

(2) Lunar Phase -- LM

(a) System No. 1

(3) TEC -- CSM

(b) System No. 2, Lunar Phase -- CSM

3.5.2.1 USB (Figure 3-13). ACN experienced no tracking problems until the lunar phase when the 1218 computer faulted intermittently. During LO 22 through LO 25, a total of 10 faults were observed when the CADGPS program would not process the 29-point acquisition messages properly. The program had to be reloaded after every three or four messages were processed. The computer continued to fault intermittently for the duration of the mission. Occasionally the computer would fault and could not be reloaded and at other times it would not process the acquisition messages properly. The failure did not impact mission support. The source of the problem is believed to have been the incompatibility of memory stacks with serial numbers ending in the digits 01 and 02. Subsequent to the installation of all stacks ending in serial number 01, ACN has had no unresolved problems (3.1.2.1).

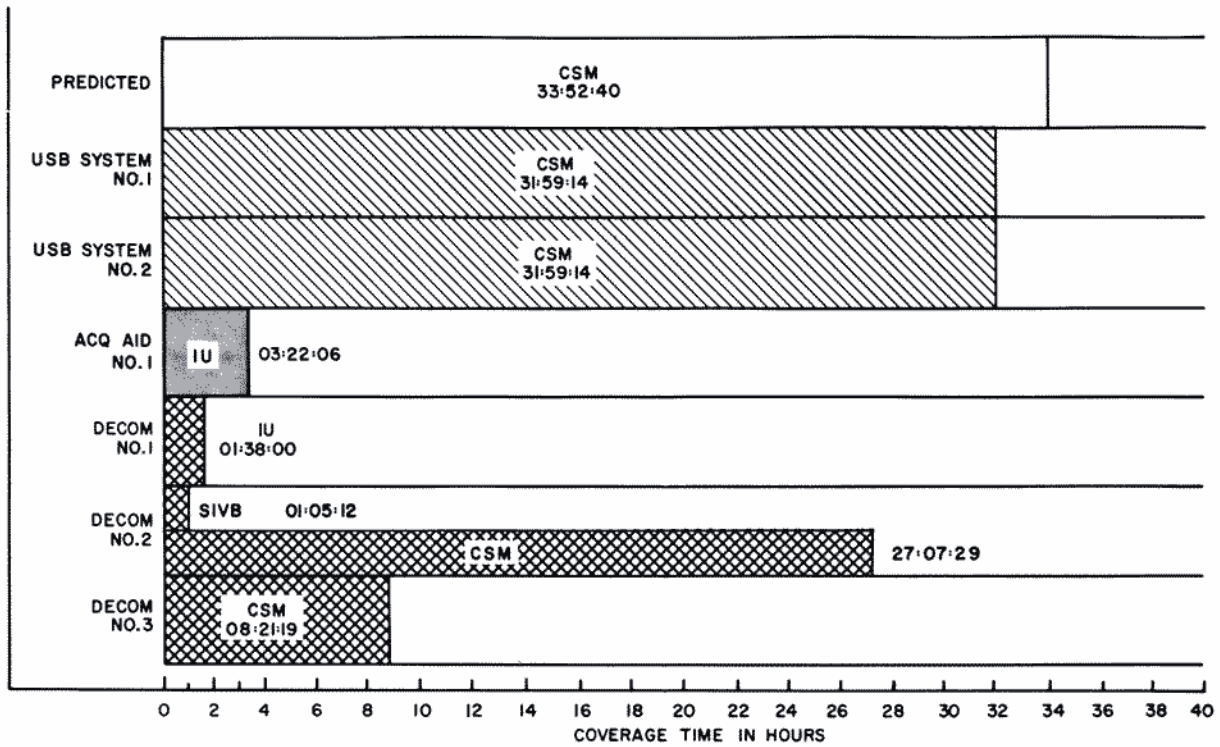
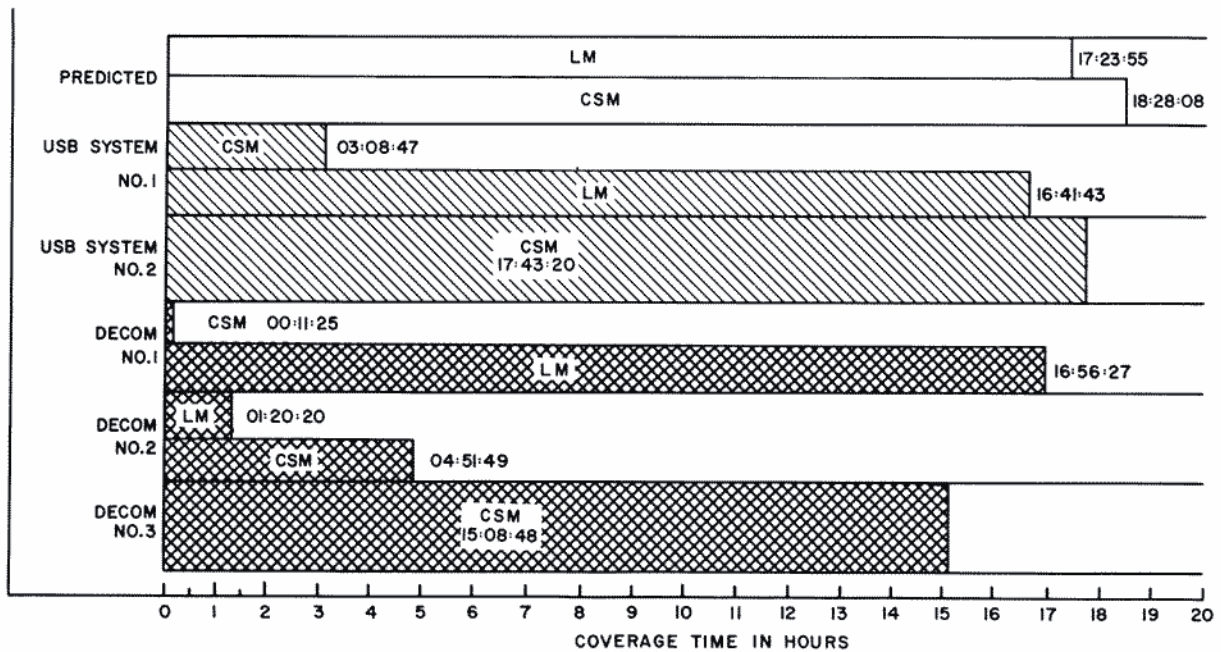
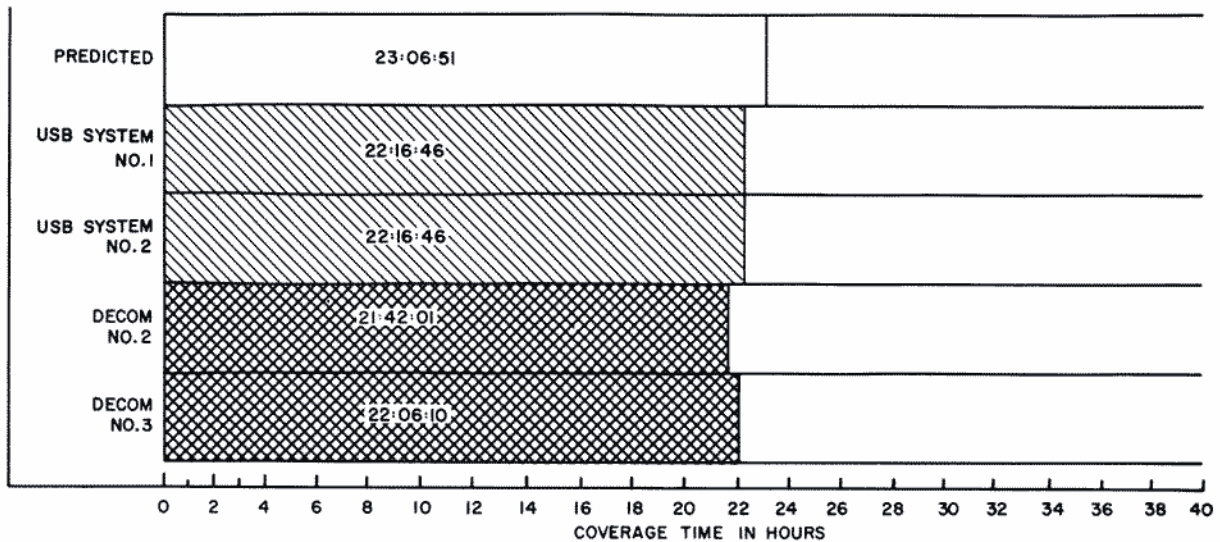
Figure 3-14. ACN Telemetry Coverage

(a) TLC

(b) Lunar Phase

(c) TEC -- CSM

Minor losses of data were encountered by ACN throughout the mission due to signal fluctuations and changing bit rates. This problem was inherent throughout the MSFN (3.1.3.1). An operator error resulted in a 30-second data loss of a DSE dump playback to MCC during the lunar phase. A patch from the magnetic tape recorder output to the decom No. 2 signal conditioner was inadvertently removed at the DSDU. The decom was supporting the data dump playback, but data was not remoted to MCC while the patch was out. MAD was also receiving this data and was requested by MCC to remote CSM DSE data until ACN corrected their patching problem. Minor problems, as outlined in the following paragraphs, were encountered in the decom area, although data losses were insignificant due to the quick switchover to backup systems.

3.5.3.2 VHF. Support of IU and S-IVB data links was required only during the early part of TLC. During premission testing, the TELTRAC system was reported "red, can support," due to no output from the low-noise preamp right-hand circular polarization channel. Necessary parts were ordered and were received on July 15. Repairs were initiated immediately and the system was declared "green" at 1540 GMT the same day. The station provided its required support while slaved to the USB antenna system with no problems. Good signal quality was received with no loss of data.

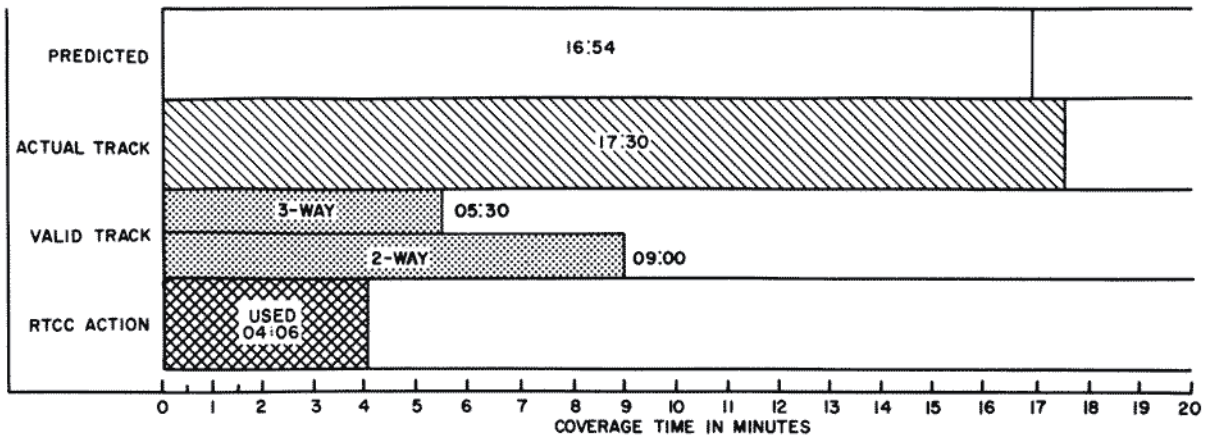
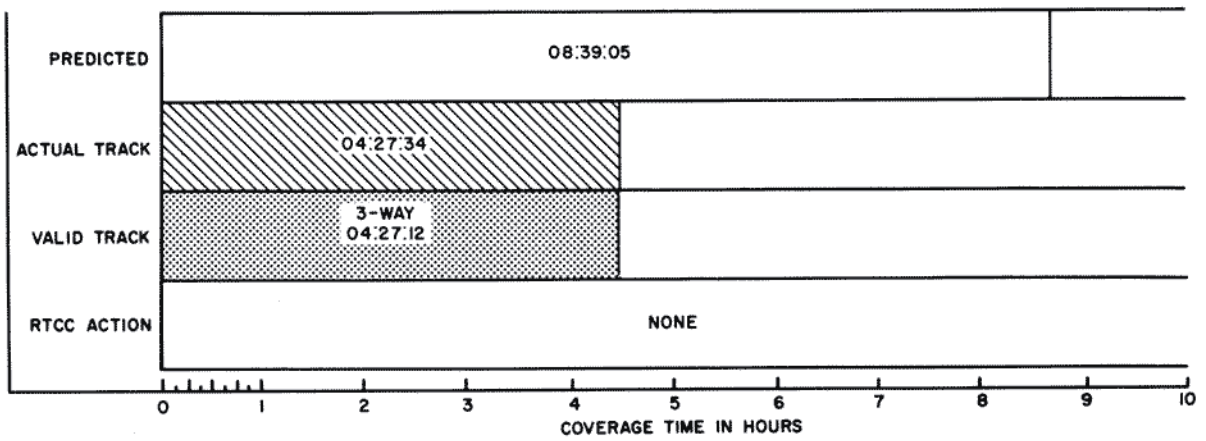
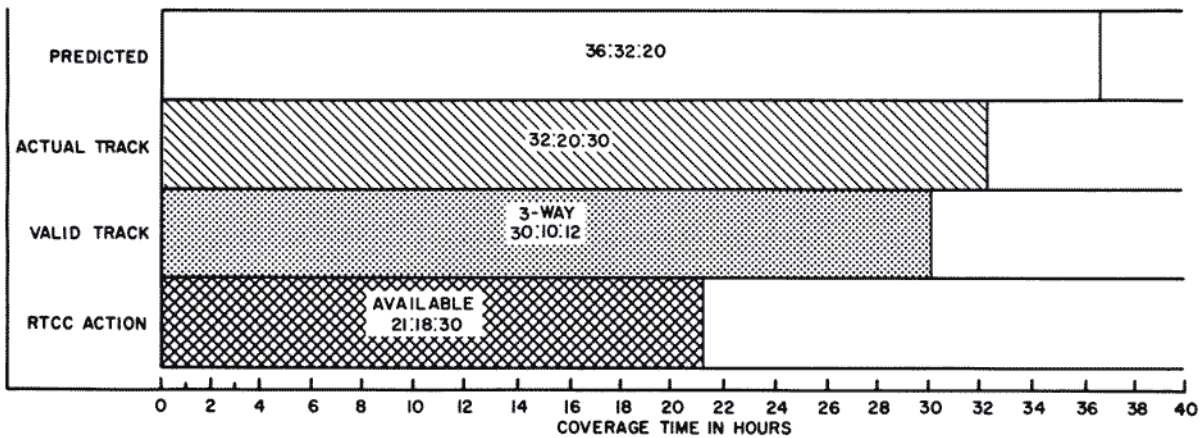
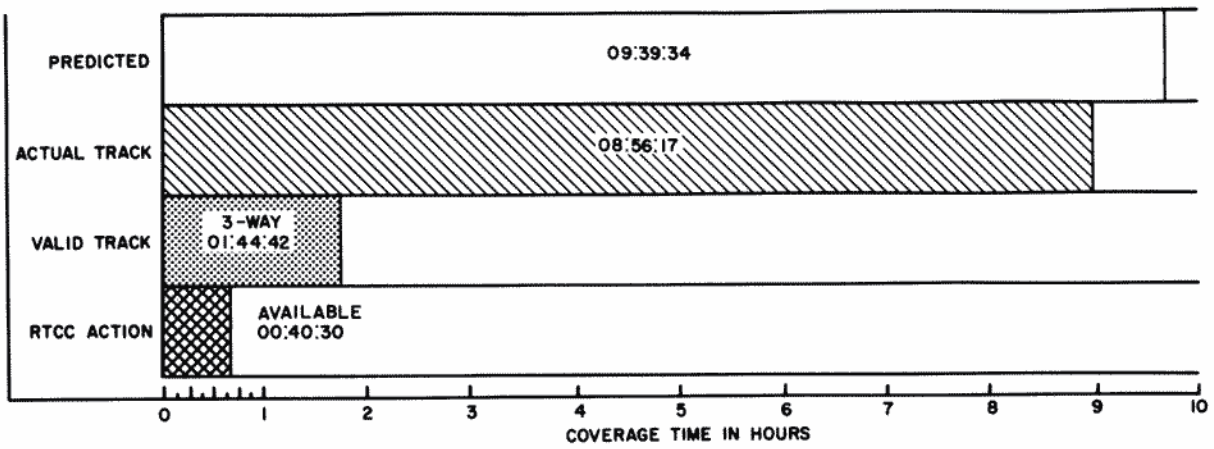
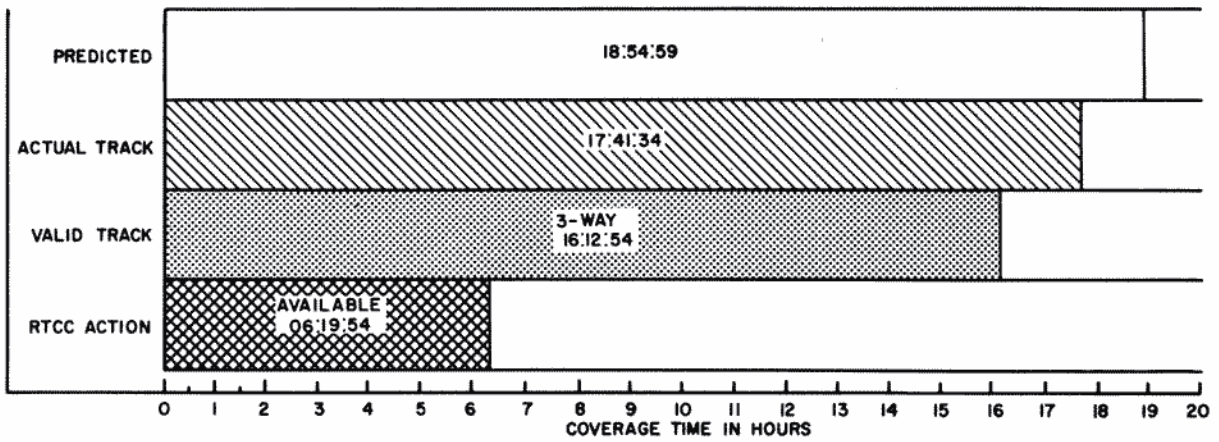
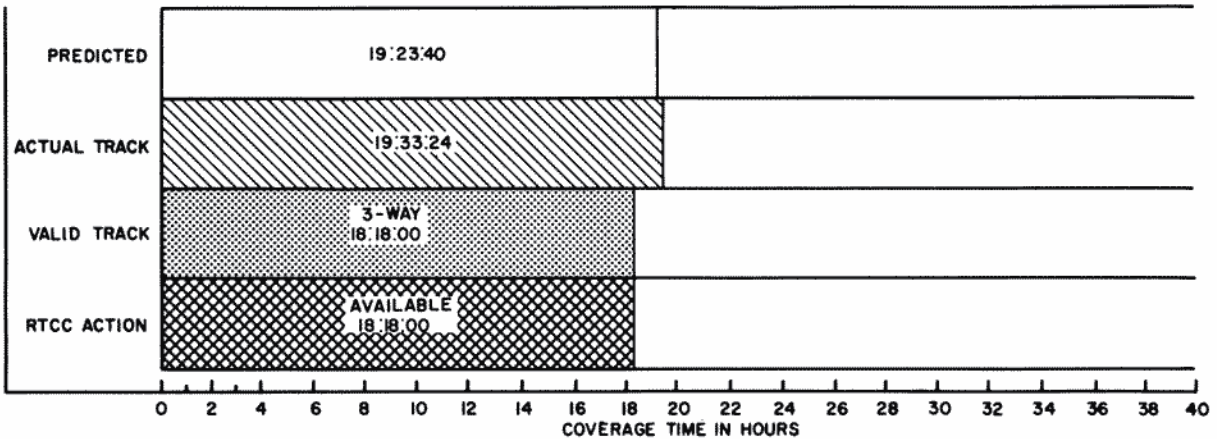
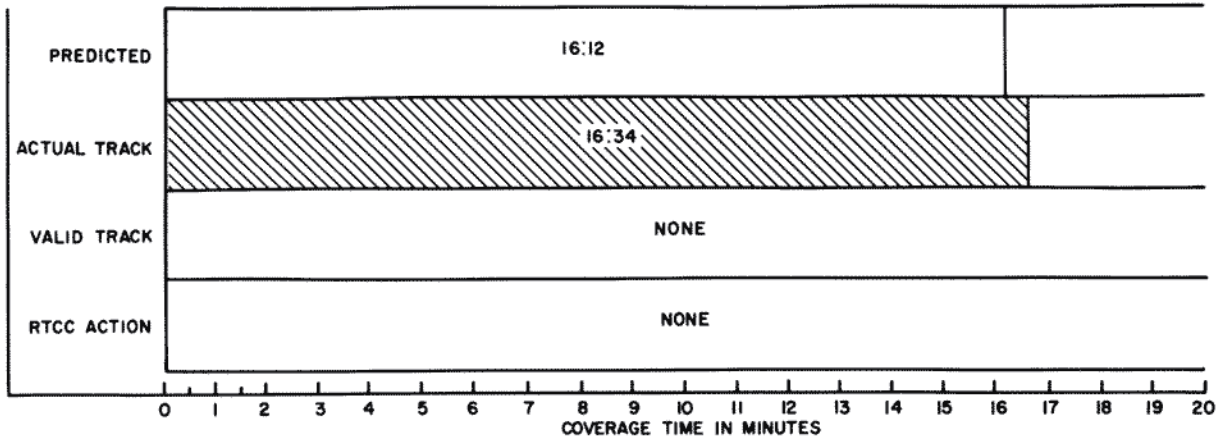
Figure 3-18. BDA USB Tracking Coverage

(1) EO -- CSM

(2) TLC -- IU

(3) TLC -- CSM

(a) System No. 1

(4) Lunar Phase -- LM

(5) Lunar Phase -- CSM

(6) TEC -- CSM

(b) System No. 2, EO--IU

3.6.2.1 USB (Figure 3-18). During the first day of TLC, the tracking data encoder power supply tripped off. This caused improperly encoded metric tracking information to be transmitted to GSFC for about 13 seconds until the circuit breaker was reset. The reason for the malfunction could not be determined.

At the beginning of the lunar phase (81:15:00 GET), the 1218 computer faulted while processing a 29-point acquisition message. This caused a temporary interruption of the message processing sequence. The program was reloaded and processing of the message continued normally with no apparent reason for the fault (3.1.2.1). However, many hours of diagnostic testing indicated that the faulting was not caused by computer hardware.

The station experienced internal arcing of the beam voltage regulator in the high-voltage power supply cabinet UD 10-10 during TEC at 145:13:00 GET (3.1.2.2). The problem was traced to a defective high-voltage relay (K-1). This inhibited uplink capability using the PA until the relay was replaced.

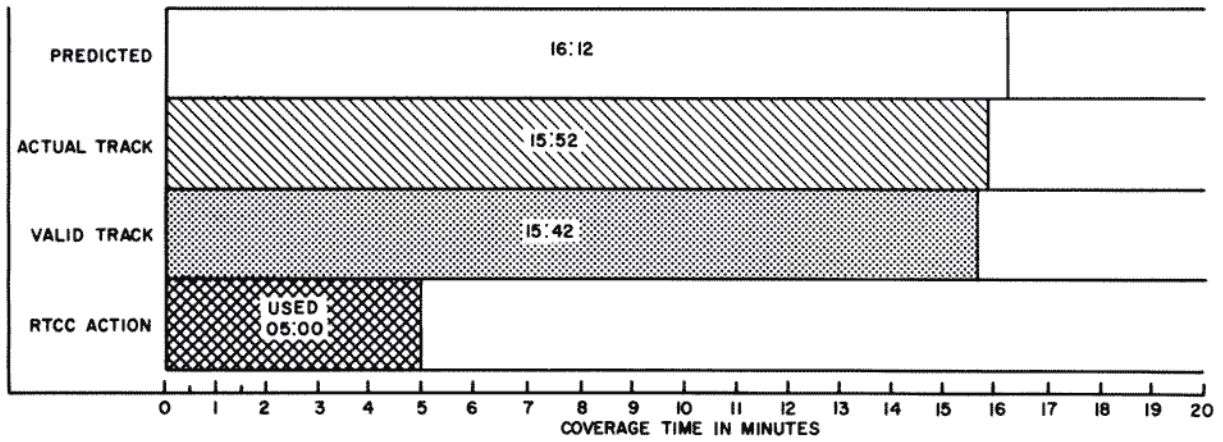
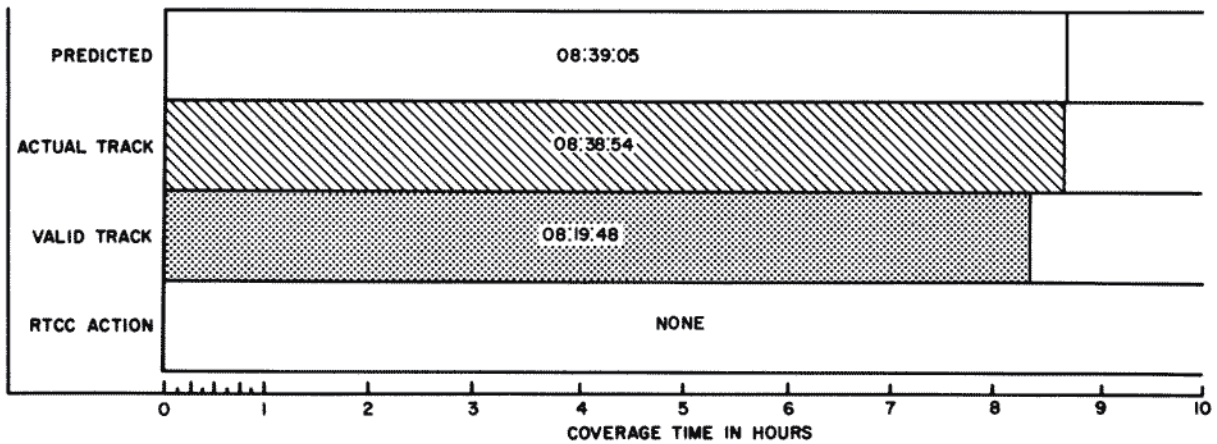
Figure 3-19. BDA FPQ-6 Tracking Coverage

(a) EO -- IU

(b) TLC -- IU

3.6.2.2 Radar (Figures 3-19 and 3-20). During launch, the FPQ-6 was required to provide C-band range safety tracking support and metric data for initial orbital determination. LTDS information was used as an acquisition source. Automatic tracking of the S-IVB/IU beacon was accomplished before the vehicle had reached 1 degree above the horizon. Strong beacon signals were received throughout the pass.

During EO revolution 2, the S-IVB/IU beacon was acquired by slaving to the FPS-16. This was necessary when an attempt to use an IRV failed to acquire the vehicle. At acquisition, the signal returns from the S-IVB/IU beacon were of poor quality. The operator's comment section of the PLIM's attributes this to interrogation of the two S-IVB/IU beacons simultaneously. At PCA, the signal quality had improved but 30 seconds of data were lost due to high azimuth rates when the vehicle passed overhead. Except for this 30-second dropout and delayed acquisition, the remainder of the pass was nominal. During TLC, the S-IVB/IU was beacon-tracked for over 8.5 hours to a range of more than 52,000 nmi. Although this range exceeds the design capabilities of the radar, it was possible to process the data and obtain range verification.

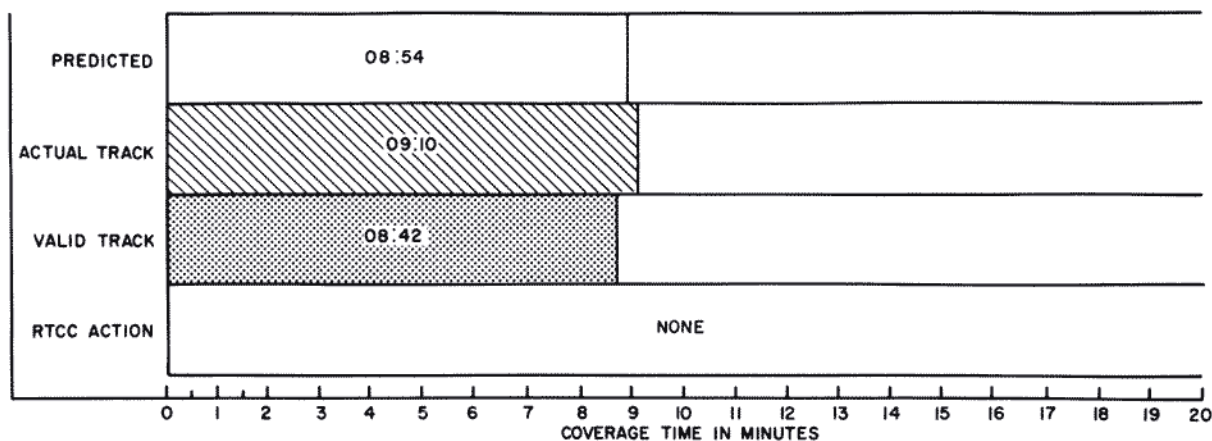
Figure 3-20. BDA FPS-16 Tracking Coverage, EO -- IU

The FPS-16 was scheduled for backup support during launch and was slaved to the FPQ-6. During EO revolution 2, the FPS-16 provided support as an acquisition source for the FPQ-6. There were no tracking requirements other than this unscheduled support.

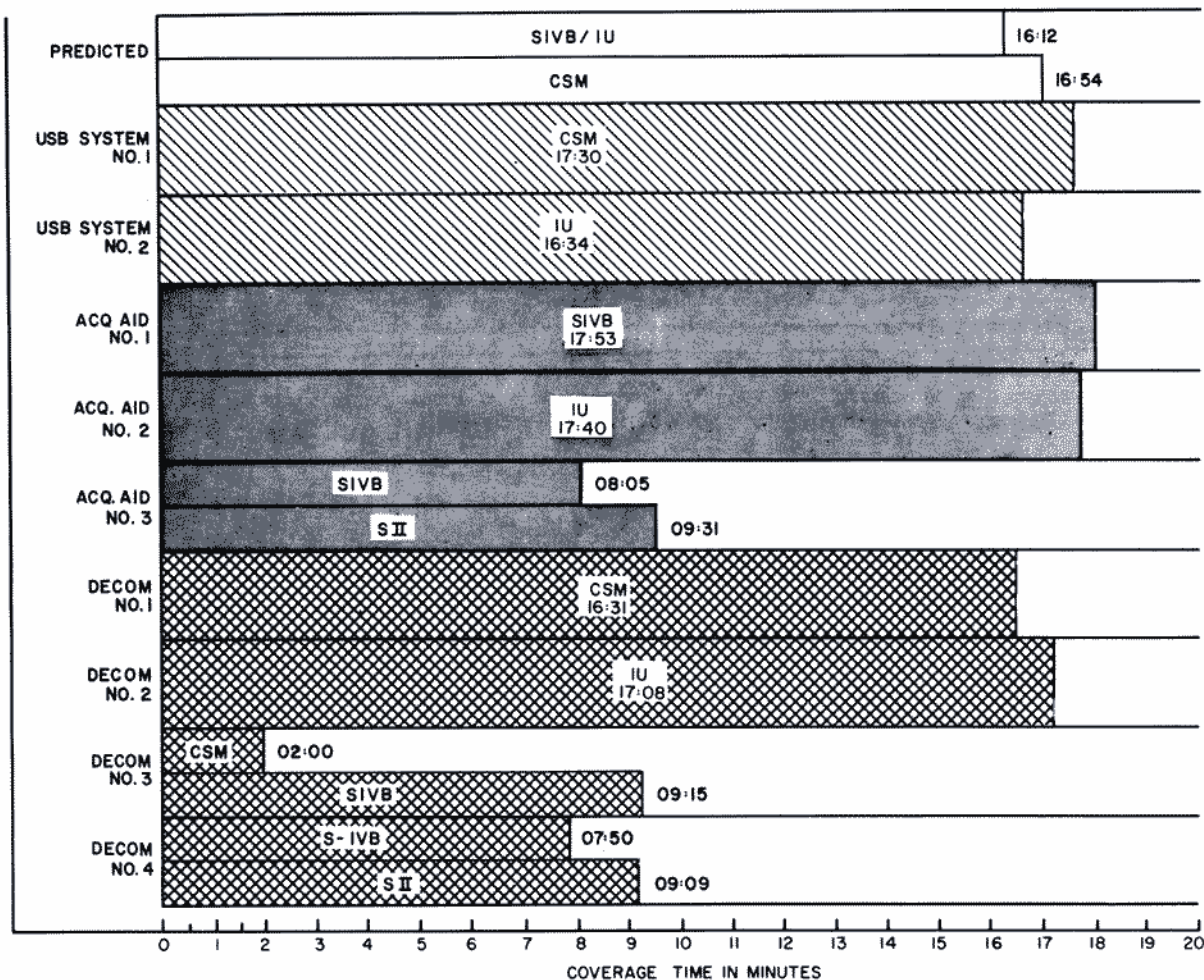
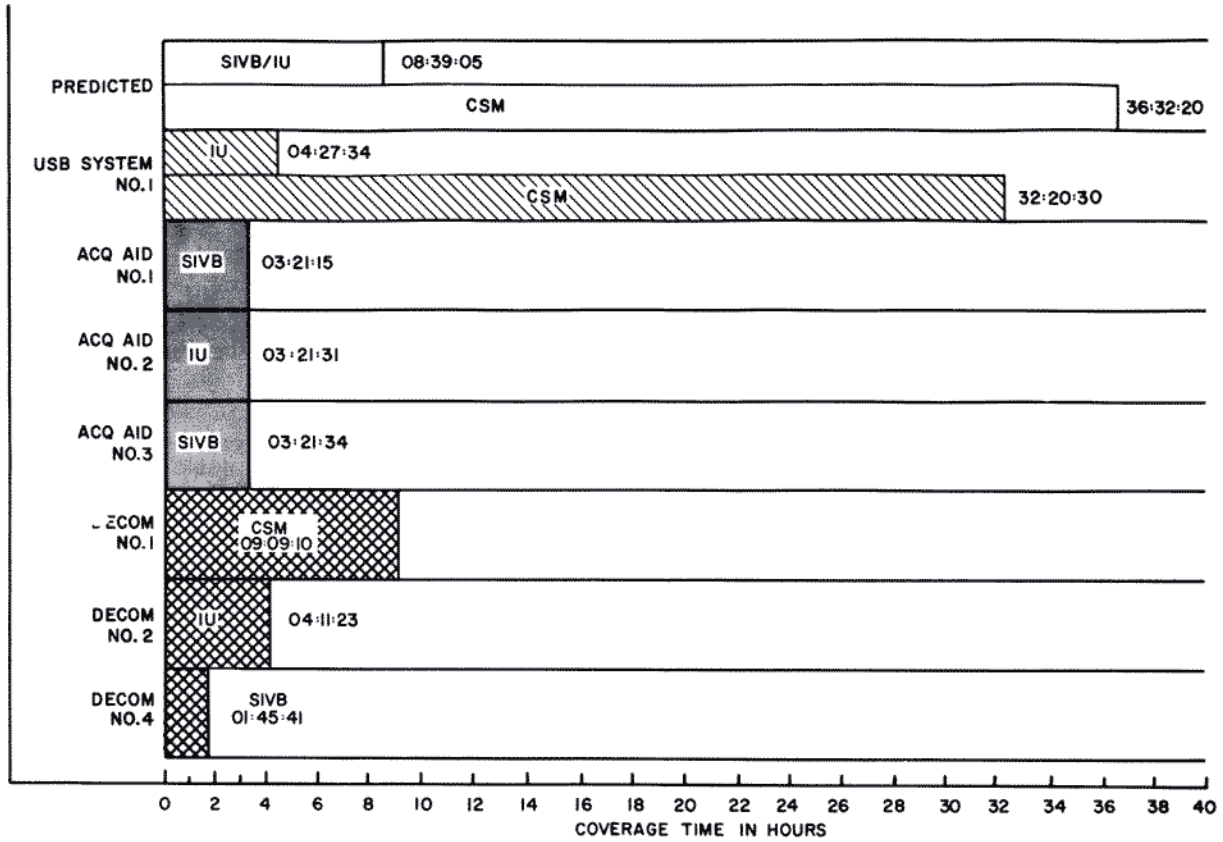
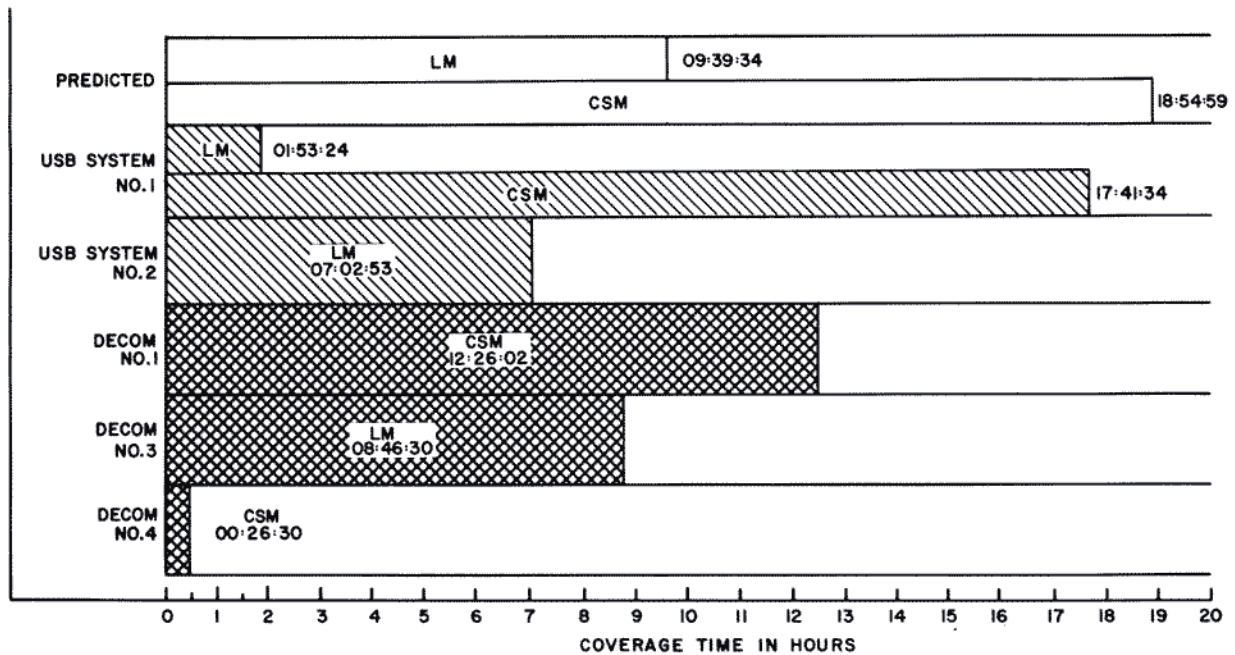
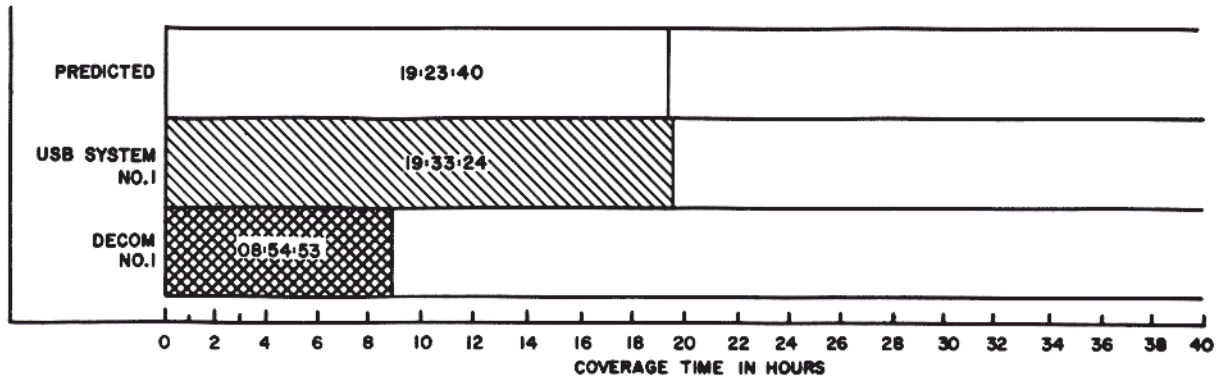
Figure 3-21. BDA Telemetry Coverage

(a) EO

(b) TLC

(c) Lunar Phase

(d) TEC -- CSM

3.6.3.1 USB. Received signal strengths from the IU were good during launch and EO revolution 2, and decreased from fair to poor during TLC. Real-time and dump data from the CSM, and real-time data from the LM were received with a considerable amount of data losses noted during TLC, the lunar phase, and TEC. The losses were primarily a result of omni antenna usage on board the spacecraft and the PTC maneuvers (3.1.3.1).

3.6.3.2 VHF. The three acq aid systems at BDA provided VHF telemetry support during launch, EO revolution 2, and the early portion of TLC. During TLC, received signal strengths decreased as the distance to the spacecraft increased. In addition, RFI with eventual loss of track was encountered during this phase by each acq aid whenever the antennas tracked the spacecraft into the sun. When this occurred, extreme solar noise was introduced into the receivers, degrading reception and causing loss of track. Reacquisition of the assigned vehicles was accomplished by slaving to another tracking system. Loss of signals caused by this phenomenon had no mission impact since the station was instructed to support passively as soon as the RFI was first encountered.

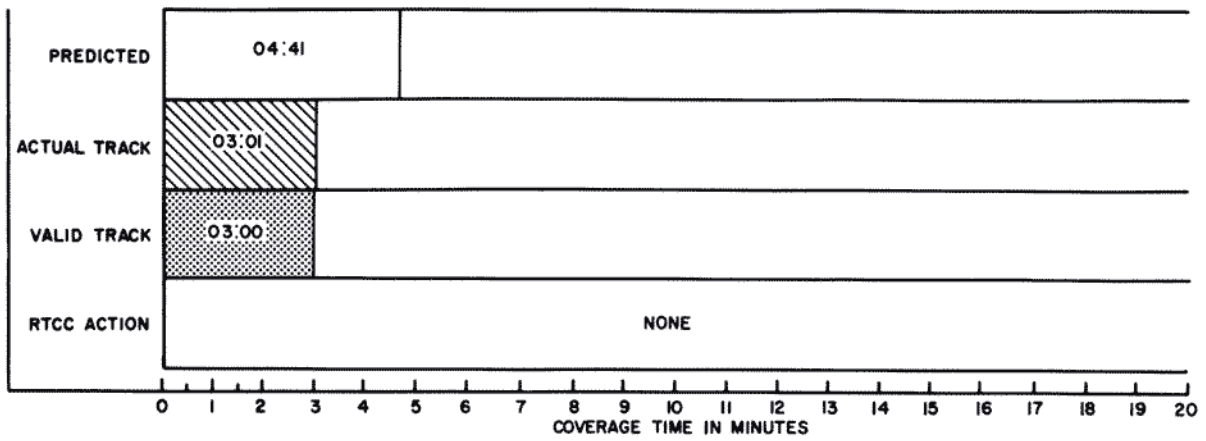
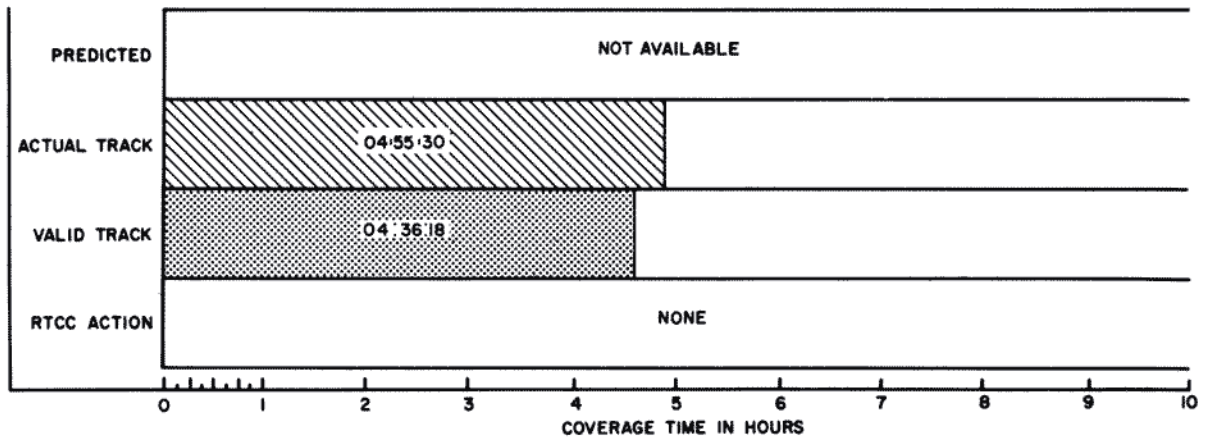
Figure 3-25. CAL TPQ-18 Tracking Coverage

(a) EO -- IU

(b) TLC -- IU

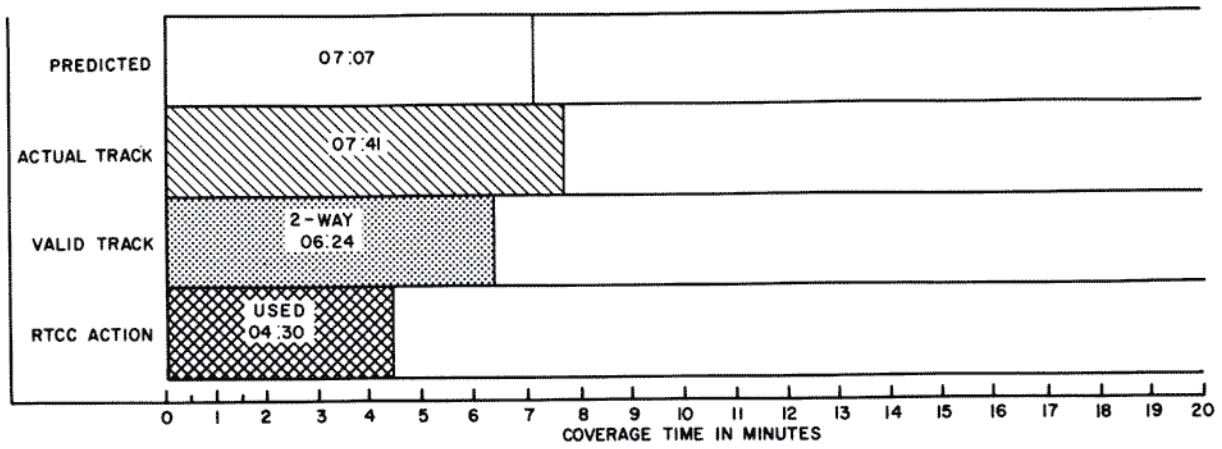
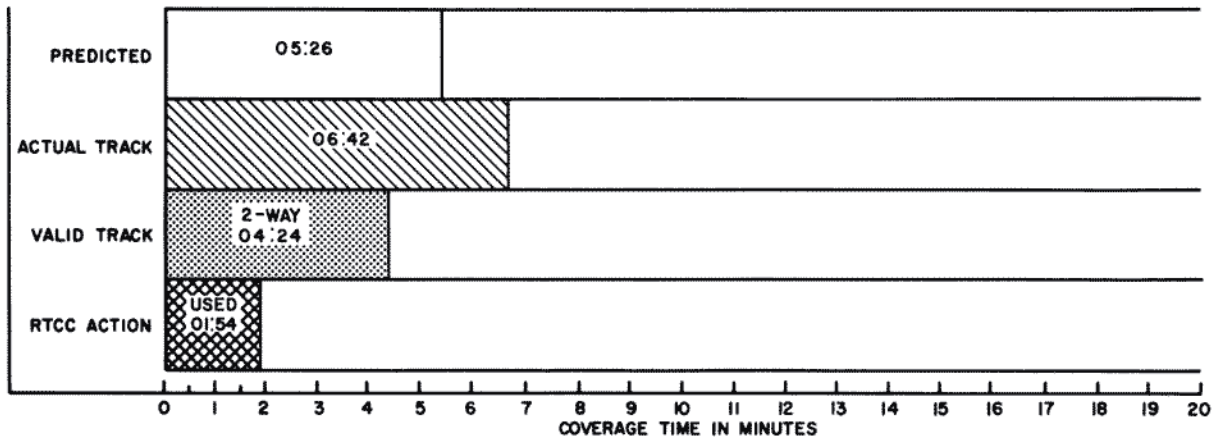
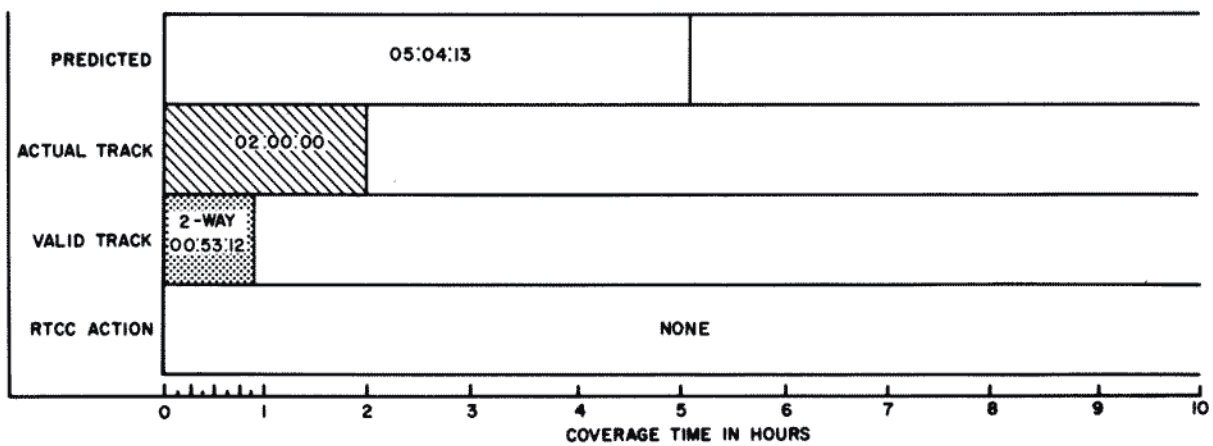
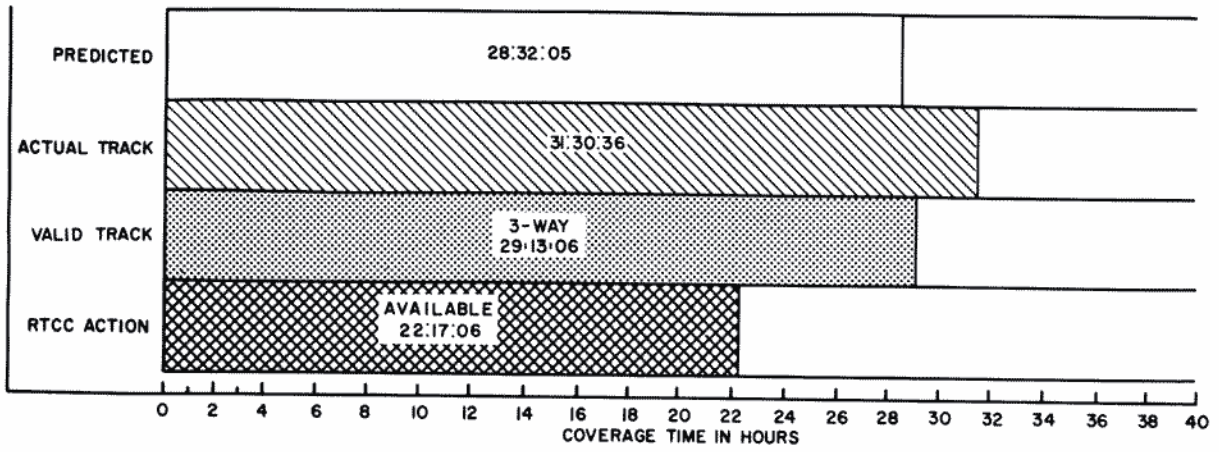
Figure 3-29. CYI USB Tracking Coverage

(a) EO -- IU

(b) EO -- CSM

(c) TLC -- IU

(d) TLC -- CSM

3.8.2.1 USB (Figure 3-28). At 06:00:01 GET during TLC and after termination of IU tracking, difficulty was encountered with the APP which resulted in unreliable program mode tracking. The problem was apparently in the search mode circuitry and

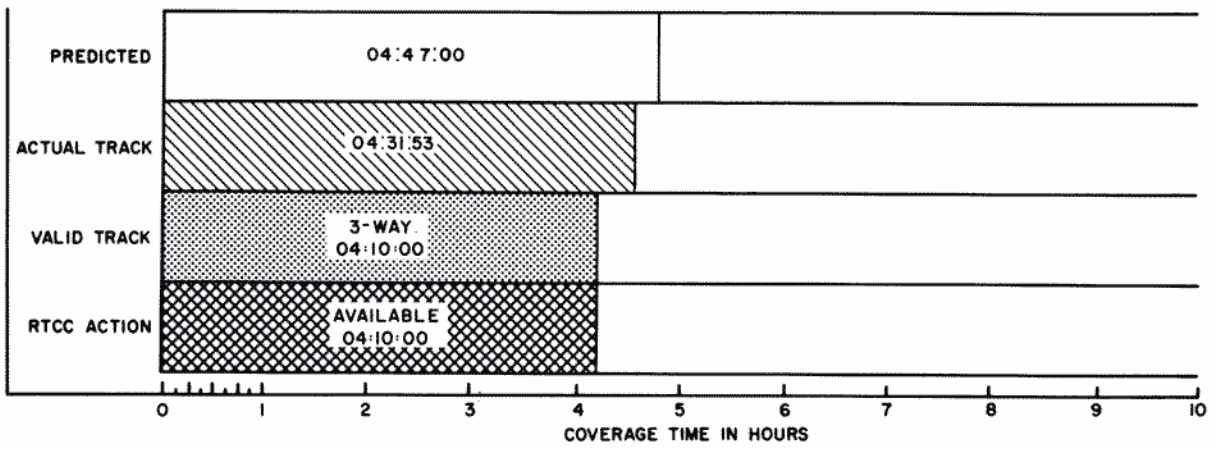
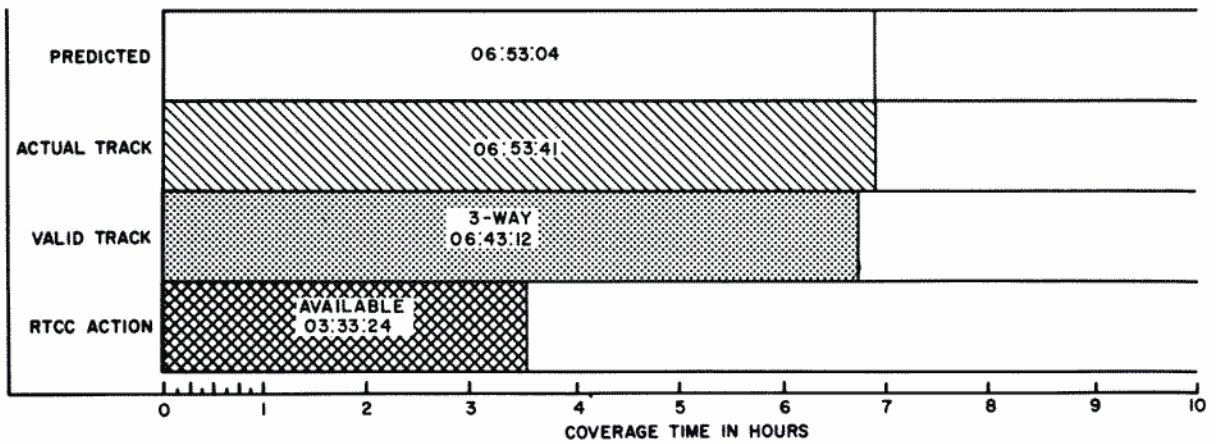
Figure 3-29. CYI USB Tracking Coverage (cont)

(e) Lunar Phase -- LM

(f) Lunar Phase -- CSM

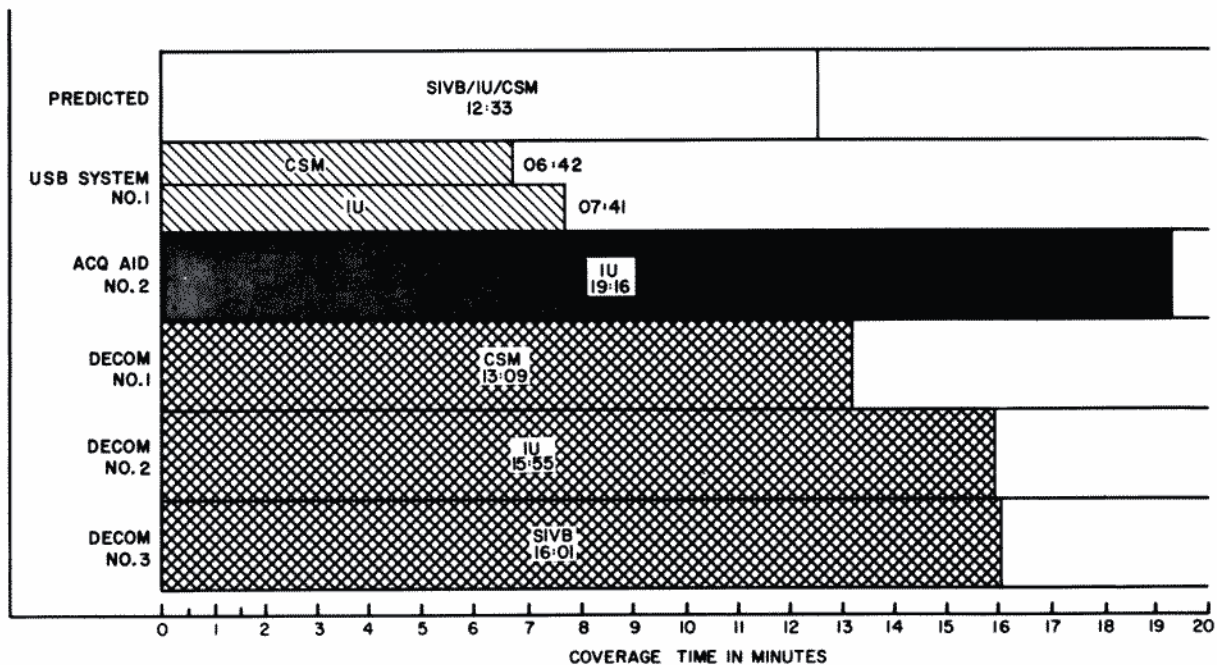
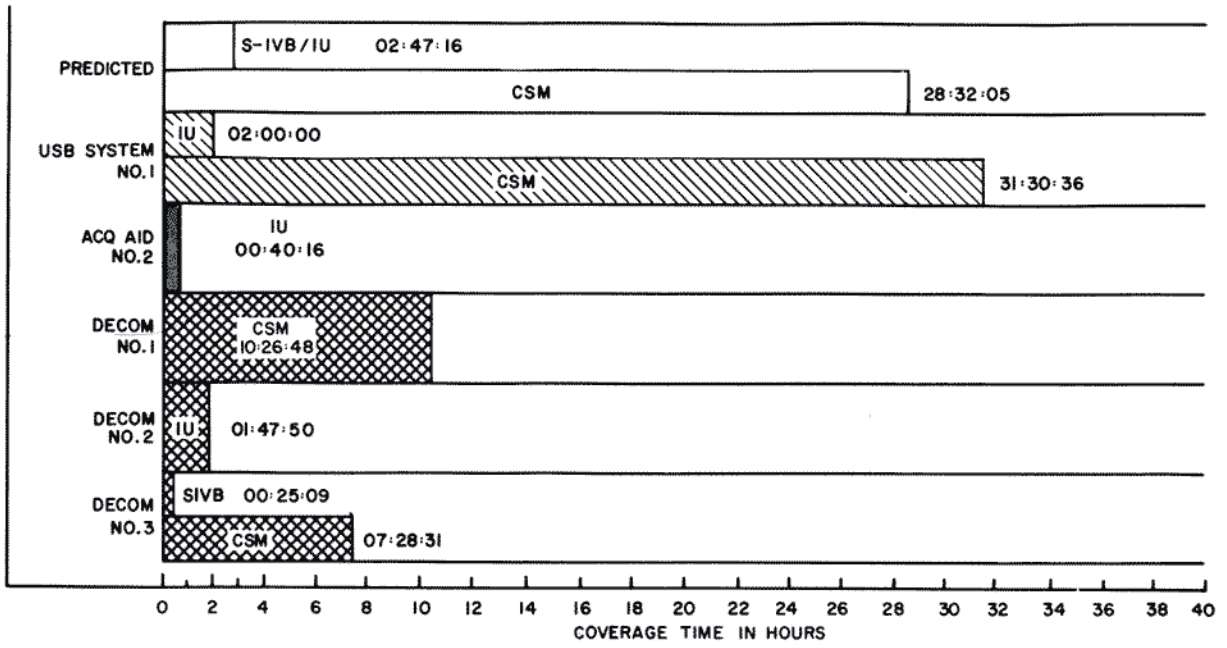
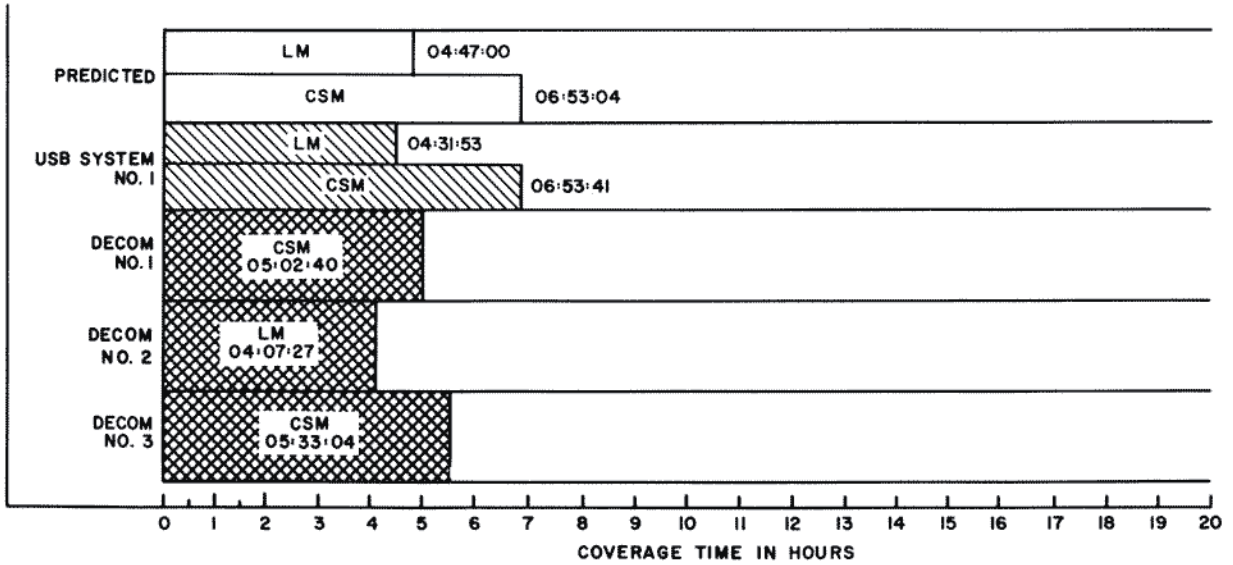
(a) EO

(b) TLC

(c) Lunar Phase

Figure 3-30. CYI Telemetry Coverage (cont)

### 3.8.3 TELEMETRY (Figure 3-30)

3.8.3.2 VHF. Five minutes before launch, acq aid No. 1 experienced an azimuth amplidyne failure. An amplidyne salvaged from an obsolete UHF command system was used as a replacement to restore operation. No impact resulted because there was no requirement for this system to support. Acq aid No. 2 supported during EO and early TLC; however, the latter support was not a mission requirement. CYI elected to passively support until cessation of all VHF requirements. Signals were satisfactory throughout EO, but after TLI, as the spacecraft range increased, signal strength decreased as system limitations were approached.
