MANNED  
SPACE  
FLIGHT  
NETWORK

# POSTMISSION REPORT ON THE AS-506 (APOLLO 11) MISSION

FEBRUARY 1970

GODDARD  
SPACE  
FLIGHT  
CENTER

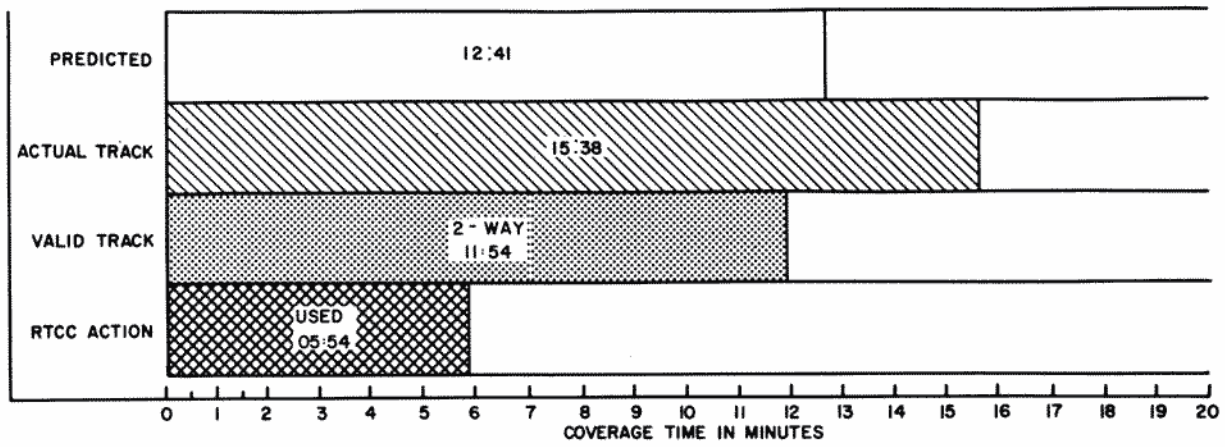
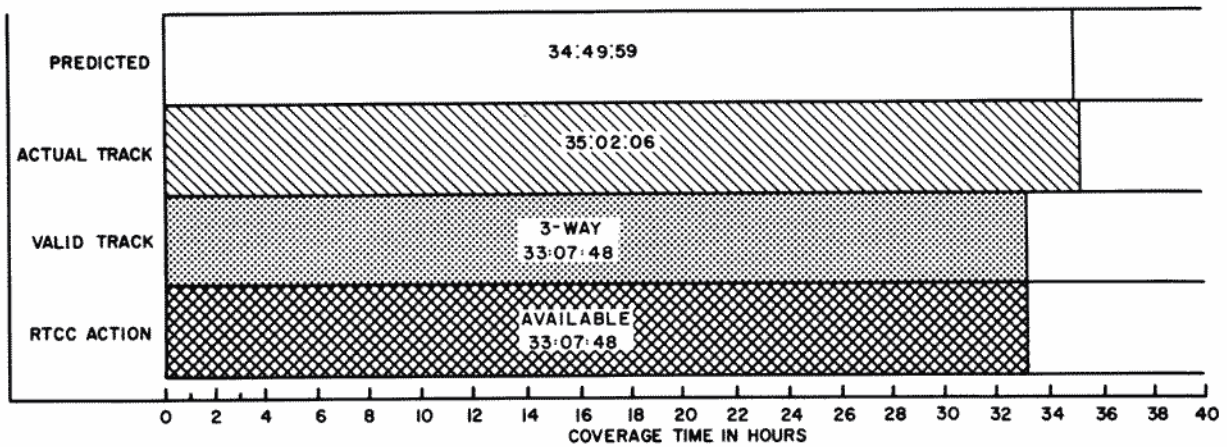
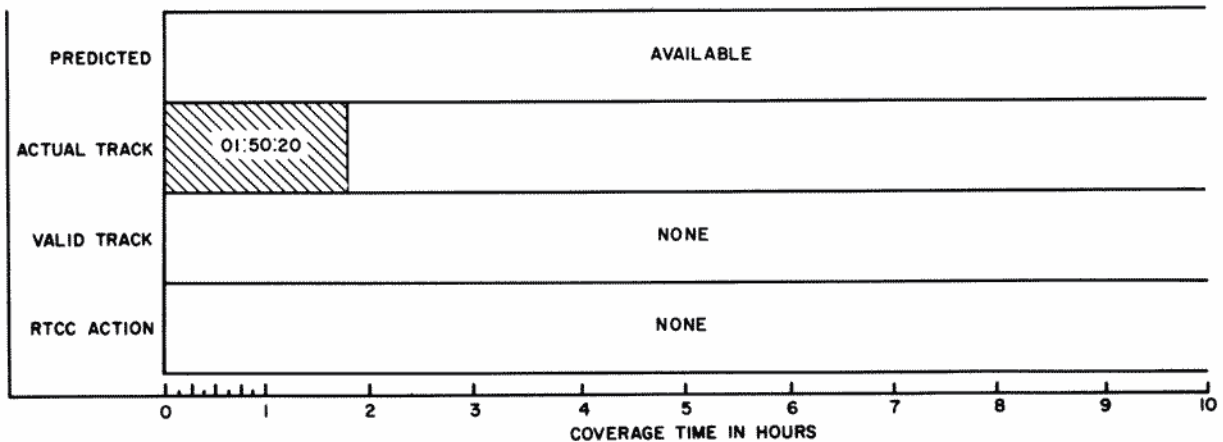
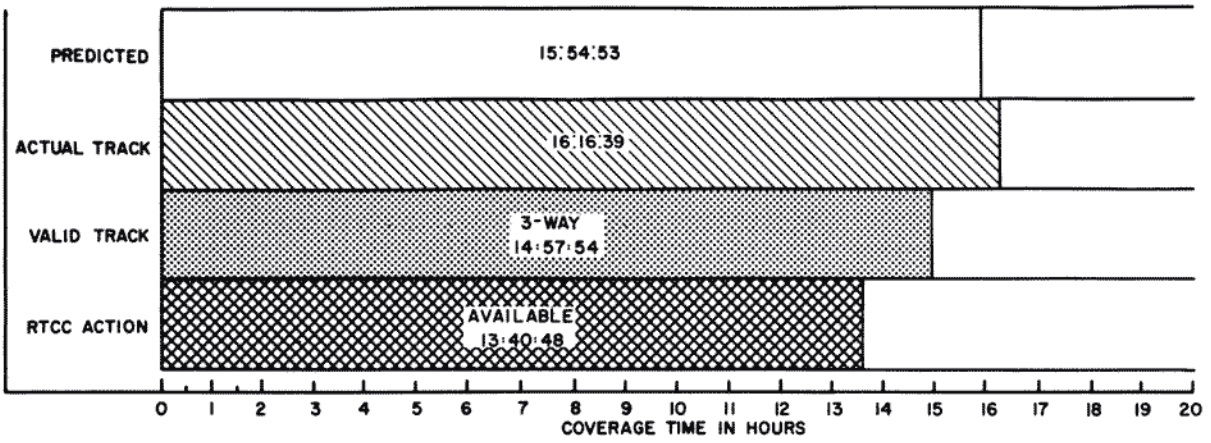
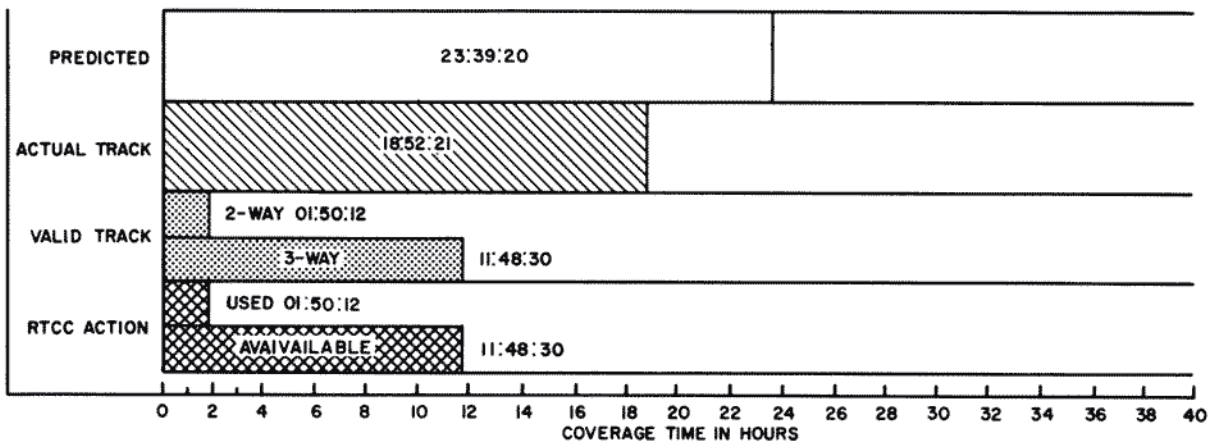
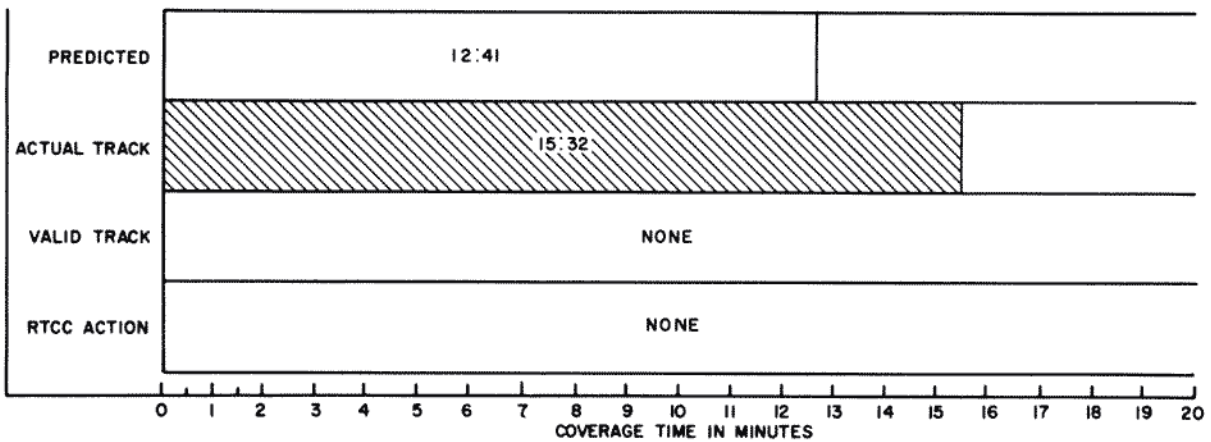
(1) EO -- CSM

(2) TLC -- CSM

(3) Lunar Phase -- LM

(a) System No. 1

(4) Lunar Phase -- CSM

(5) TEC -- CSM

(a) System No. 1 (cont)

(b) System No. 2, EO -- IU

Figure 3-34. CRO USB Tracking Coverage (cont)

3.9.2.1 USB (Figure 3-34). During TLC, paramp oscillations caused momentary interruption to tracking. The paramp gain fluctuations were caused by the output instability of the klystron pump which had become unstable after only a few hours of operation. There was no significant impact as CRO reduced the paramp gain 3 dB and continued support until LOS. After LOS, the unsatisfactory klystron was replaced (3.1.2.3).

Real-time APP tape drive was lost because of occasional 1218 memory defects during the lunar phase. This malfunction was attributed to a failed sense output amplifier. Replacement of the amplifier restored APP antenna real-time drive (3.1.2.1).

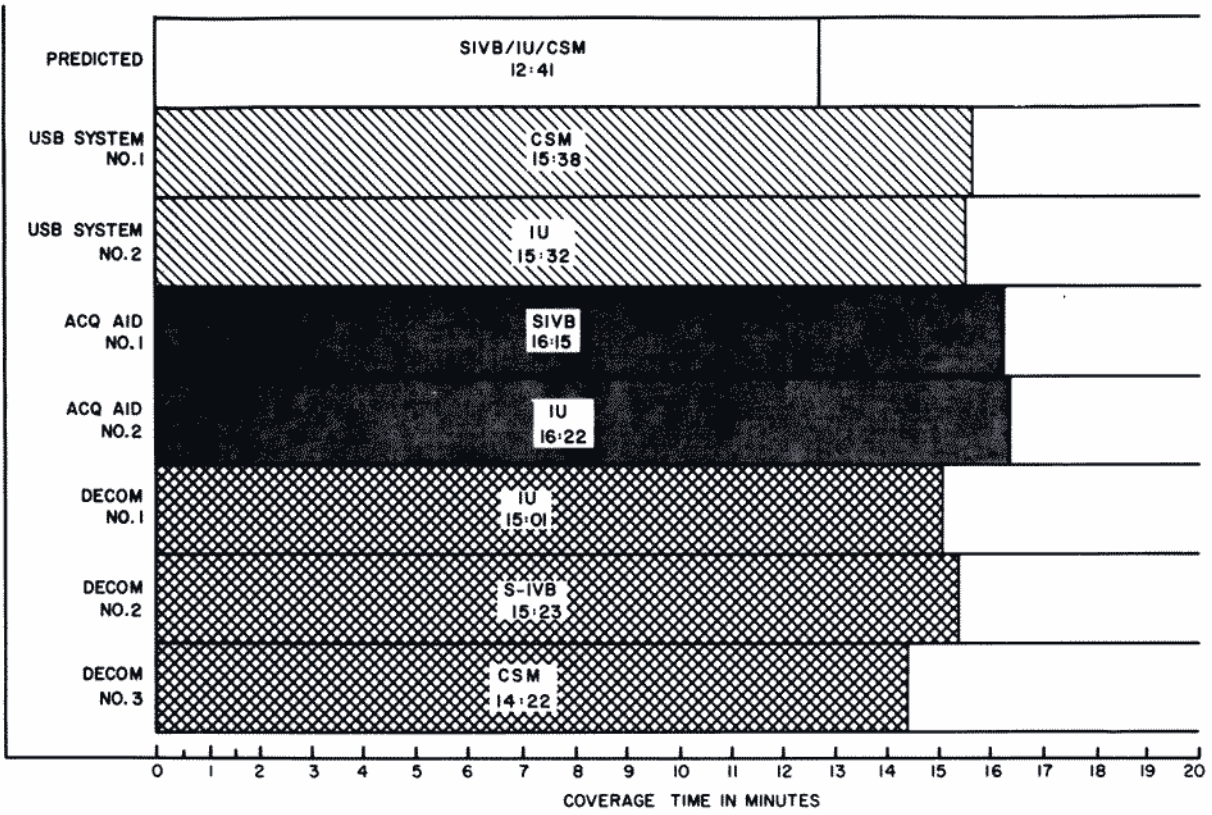
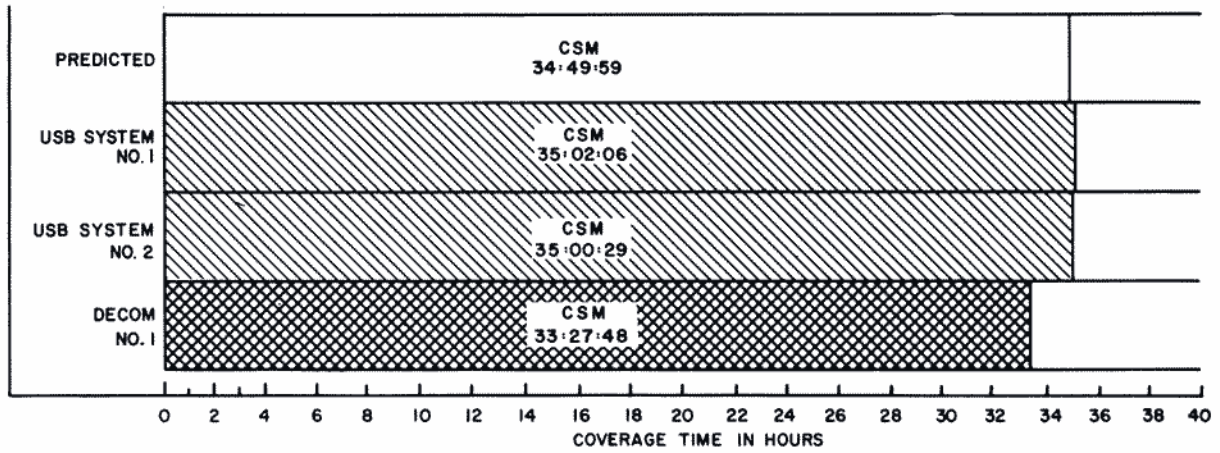
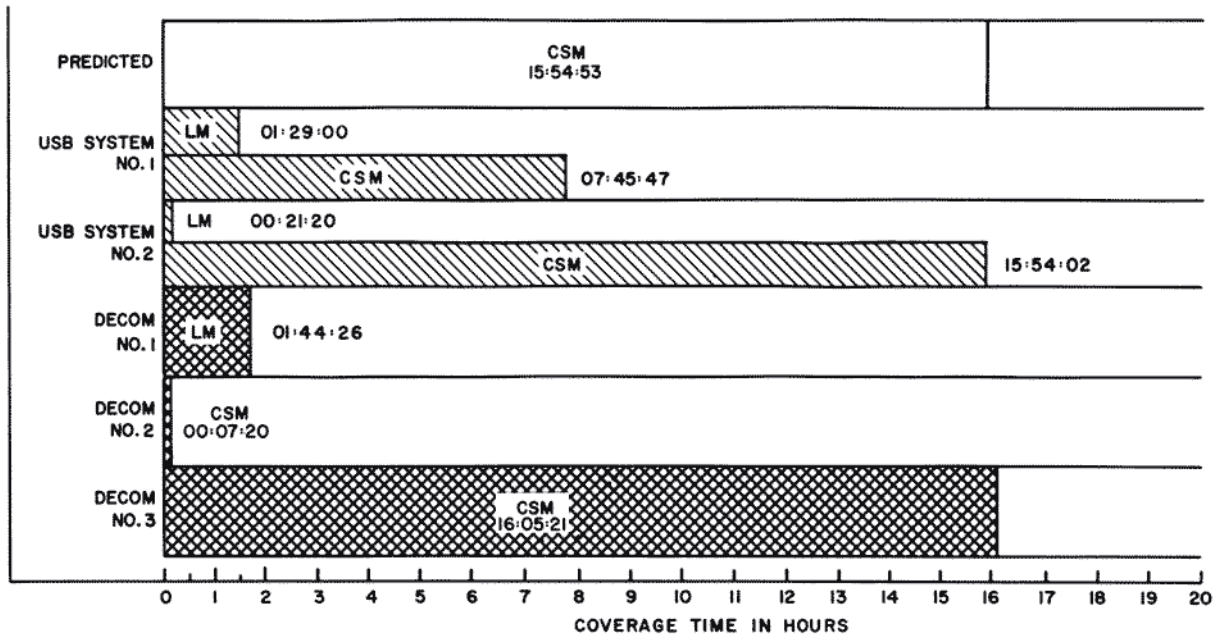
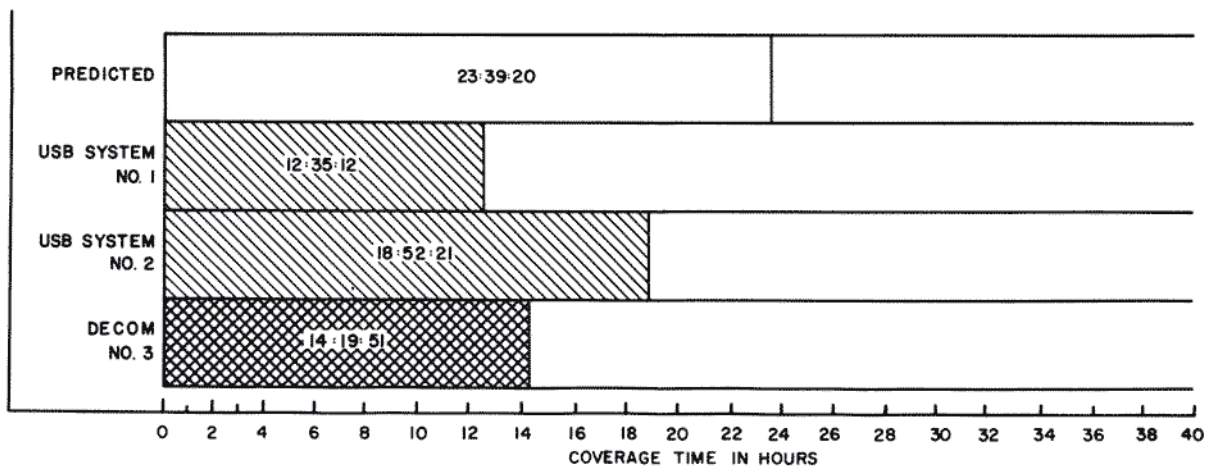
(a) EO

(b) TLC

(c) Lunar Phase

(d) TEC -- CSM

Figure 3-36. CRO Telemetry Coverage (cont)

### 3.9.3 TELEMETRY (Figure 3-36)

3.9.3.2 VHF. Acq aids No. 1 and No. 2 (TELTRAC) supported VHF telemetry links from the S-IVB and IU respectively during EO. During TEC, both aids, slaved to the USB, received very good voice from the CSM at a distance of approximately 9,000 nmi. No remoting requirement was received from MCC as USB A/G voice was prime during this view period.

Acq aid No. 2 operated during the entire mission on a "red, can support" basis, using a temporary antenna cable configuration. There were no significant equipment or operator difficulties encountered with the acq aids during VHF telemetry support.

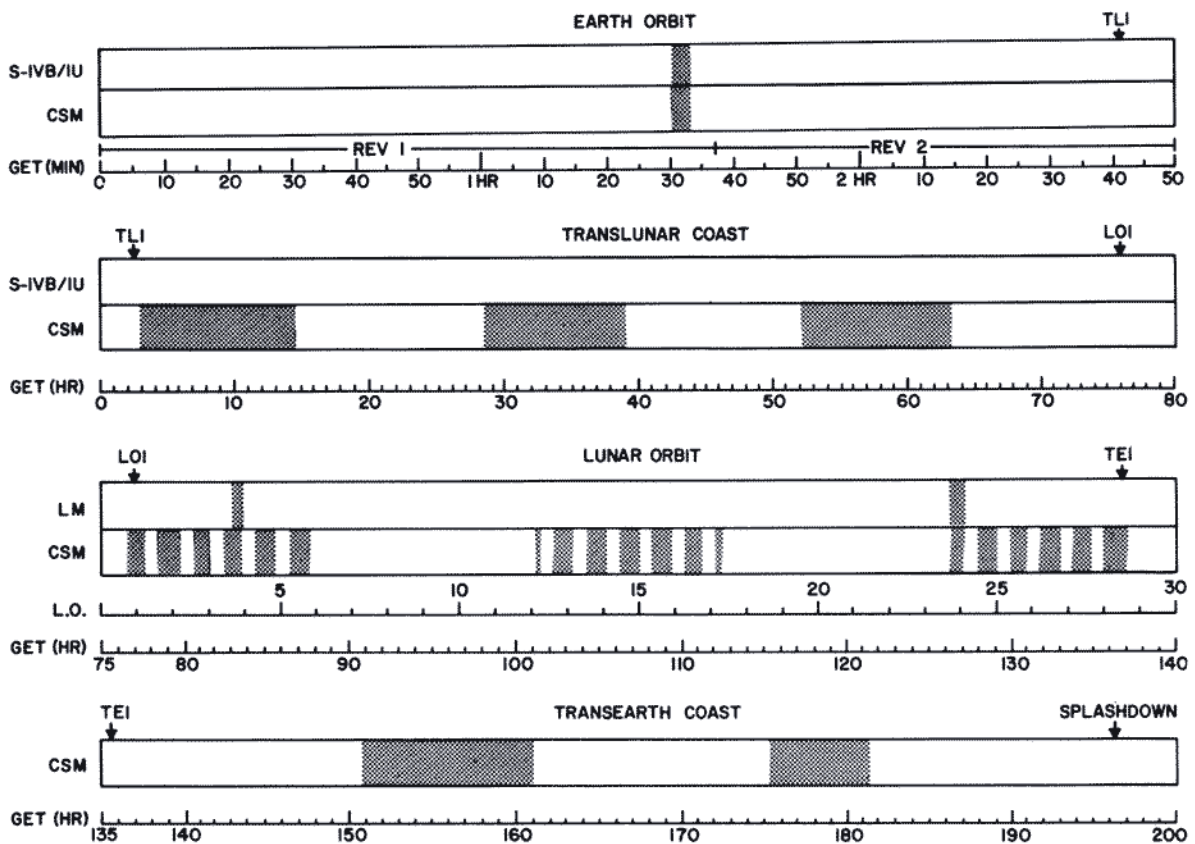
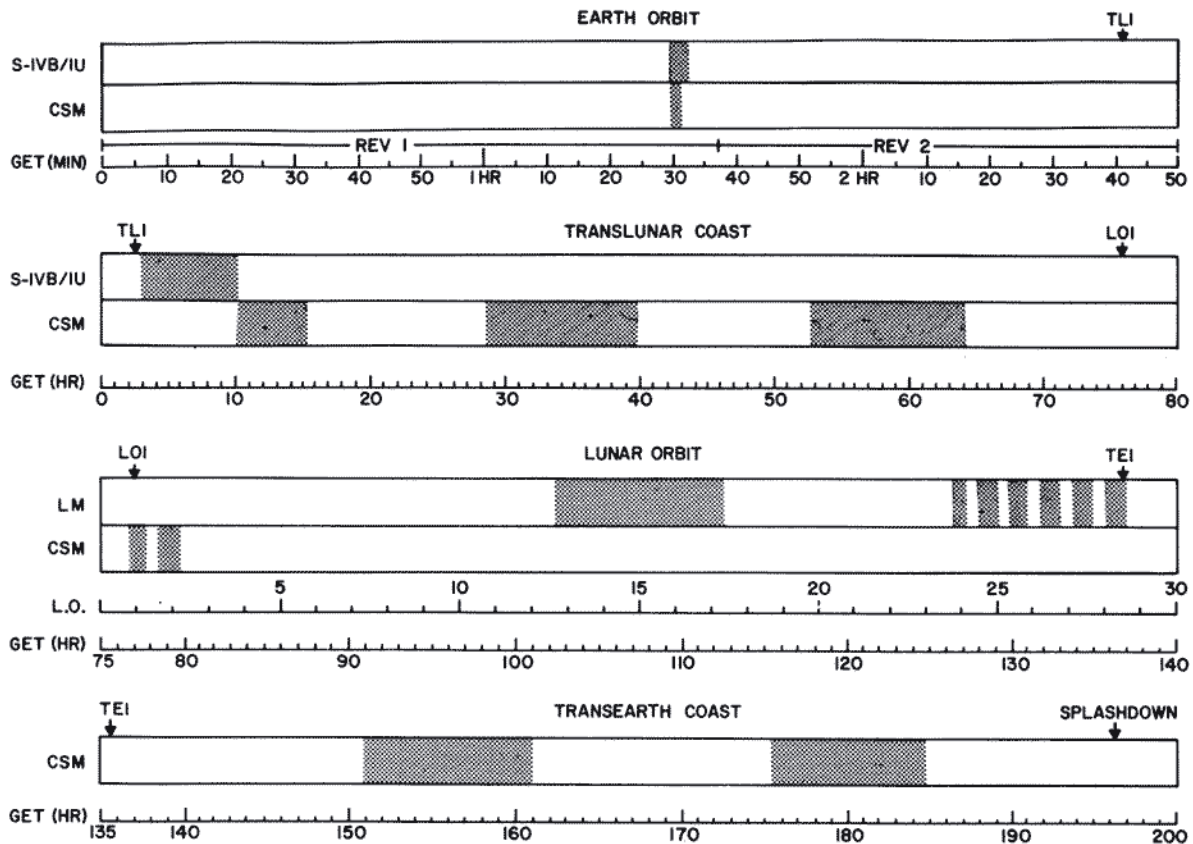
(a) GDS

(b) GDSX

Figure 3-39. Support Periods (cont)

GDS actively supported EO revolution 1, TLC, the lunar phase, and TEC. GDSX supported EO revolution 1, TLC, the lunar phase including the LM lunar stay, and TEC. Limited active support was provided for the CSM and IU on EO revolution 1. Both active and passive support of the CSM and IU were provided while the vehicles were in TLC. After LM separation from the CSM in lunar orbit, active and passive support were provided for the LM in its descent to lunar touchdown, during the lunar stay, through its ascent from the lunar surface, during its rendezvous and docking with the CSM, and until after the LM jettison burn. After that, passive support was shifted to the CSM during TEC. Coverage was supplemented by the MARS 210-foot antenna which supplied TV and telemetry reception from the CSM during TLC and the lunar phase, and from the LM during the lunar phase including EVA.

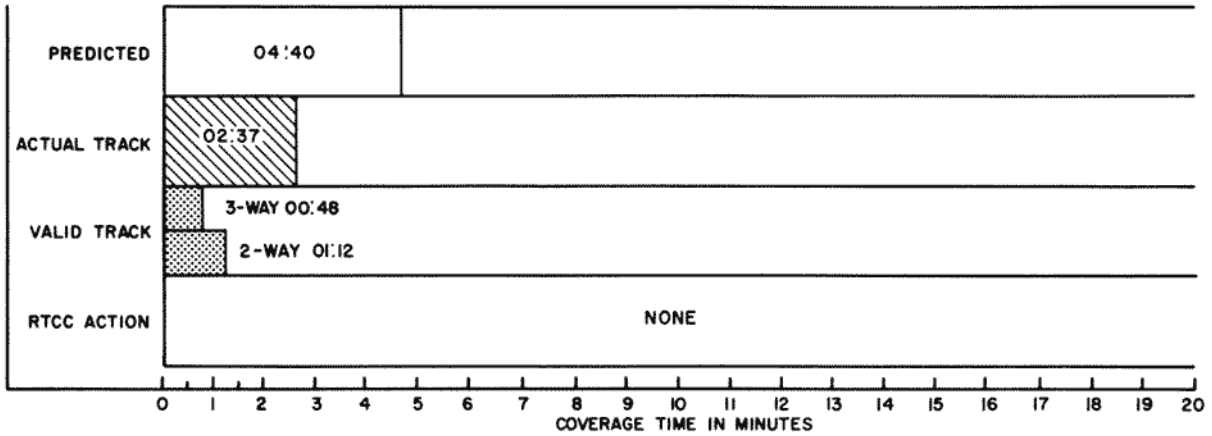
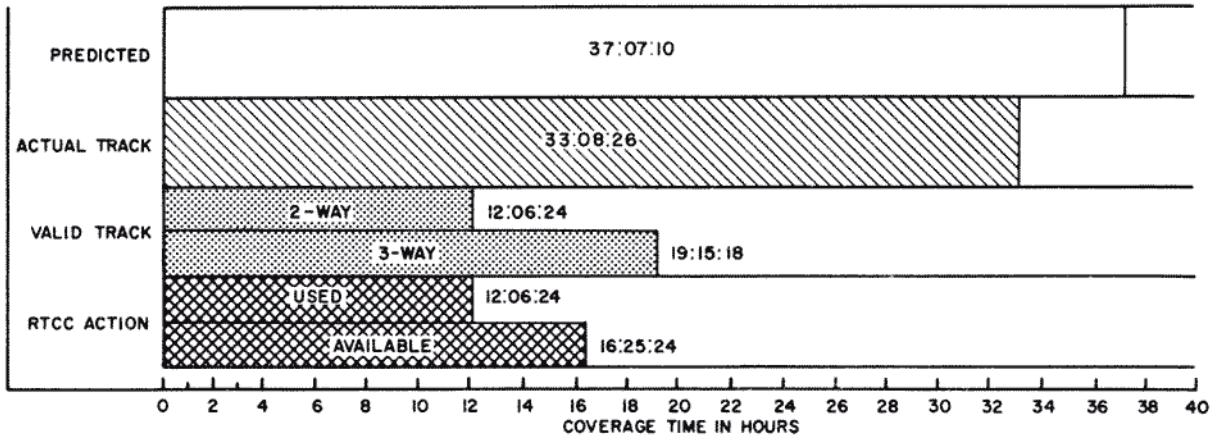
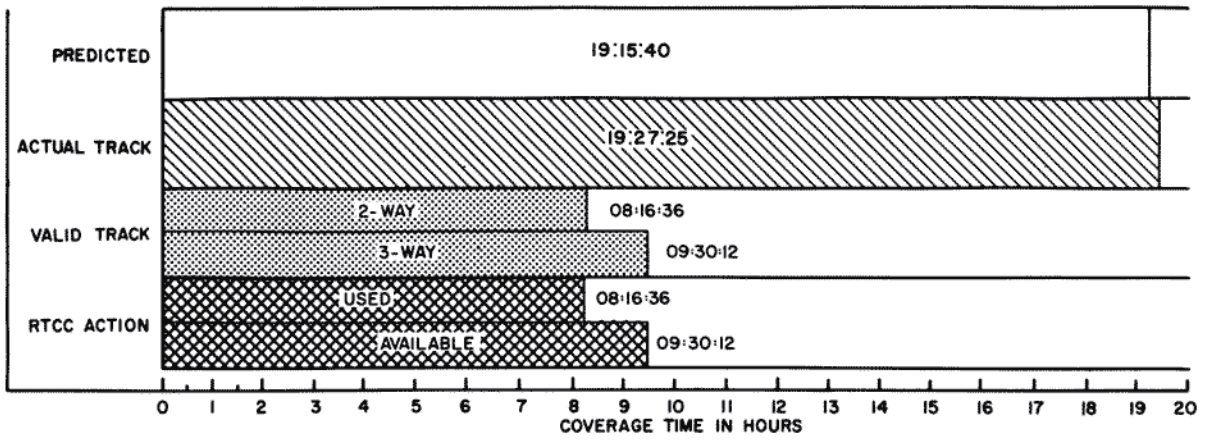
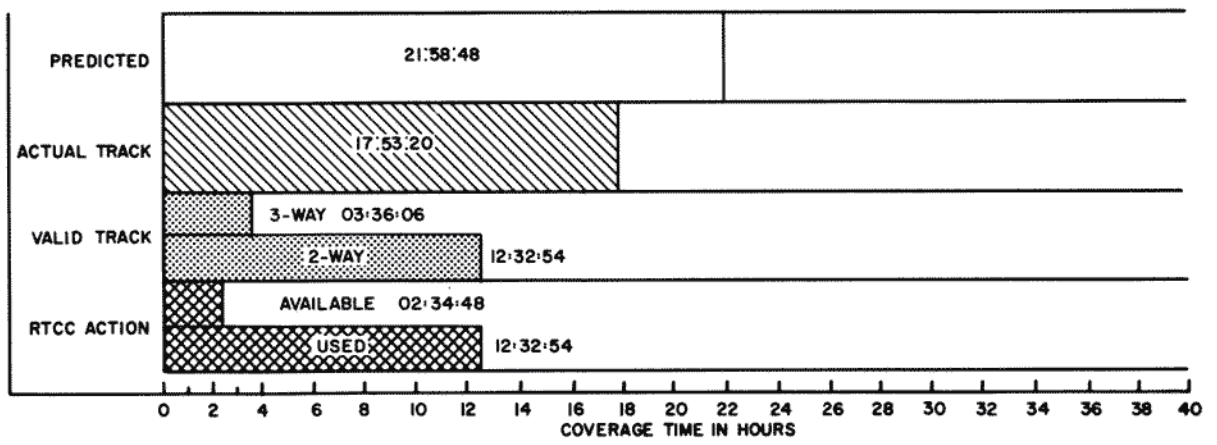
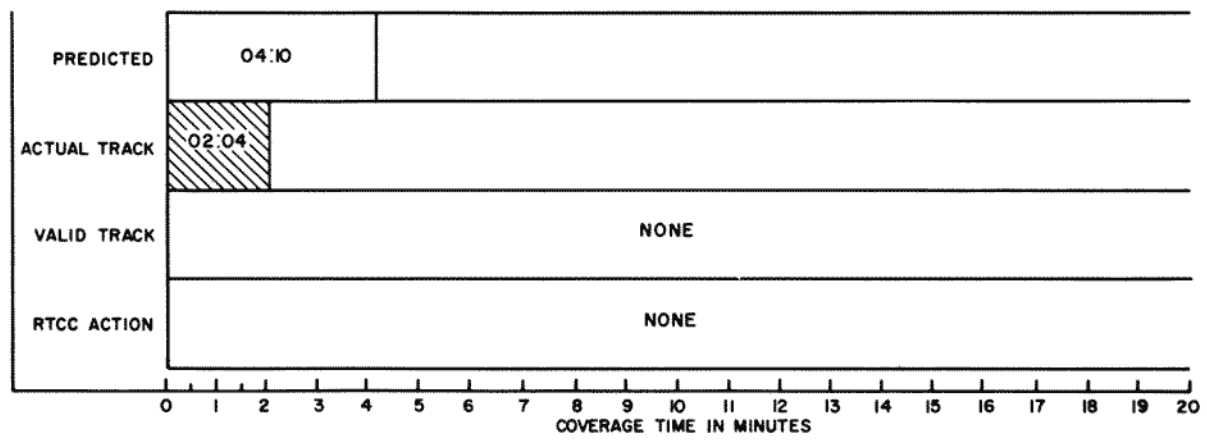
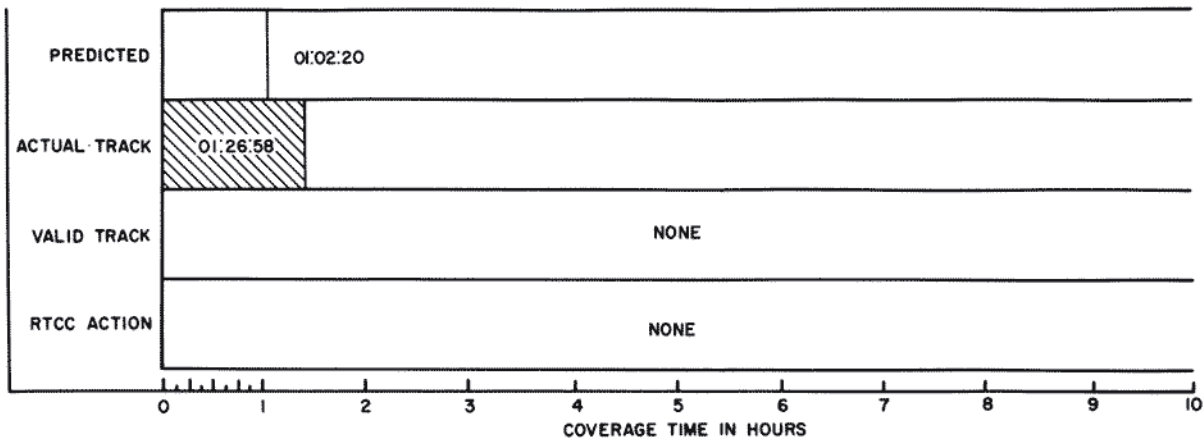
(1) EO -- CSM

(2) TLC -- CSM

(a) System No. 1

(3) Lunar Phase -- CSM

(4) TEC -- CSM

(a) System No. 1 (cont)

(1) EO -- IU

(b) System No. 2

Figure 3-40. GDS USB Tracking Coverage (cont)

(2) Lunar Phase -- LM

(b) System No. 2 (cont)

3.10.2.1 Goldstone (GDS) USB (Figure 3-40). During EO revolution 1, a TV transmission from the spacecraft was not obtained by GDS because of a defective patch cord in SDDS No. 1.

At acquisition following TLI (02:55:00 GET), downlink voice remoted to MCC was distorted and was subsequently bypassed. Investigation revealed that the input cable to voice demod No. 1 was defective and decreased the input level by several volts. Additionally, a substandard PM voice amplifier was discovered in voice demod No. 3.

At 84:44:00 GET during LO 5, failure of a 24-volt dc power supply (acquisition bias) caused receiver data dropouts and eventual receiver No. 1 loss of signal. The exciter operator initiated two-way reacquisition while receiver No. 2 was in lock, sweeping the exciter before shorting the synthesizer loop. This caused the spacecraft HGA to slew off and the reacquisition procedure had to be reinitiated, resulting in delayed AOS.

At 127:57:40 GET, acquisition of the downlink signal for LO 27 was delayed for 6 minutes and 28 seconds when the exciter operator did not initiate the contingency procedure according to the NOD. While attempting two-way lock, loss of signal occurred when the receiver operator selected narrow-loop bandwidth prior to turning off the exciter sweep bias. Reacquisition of the downlink signal was achieved using wide bandwidth.

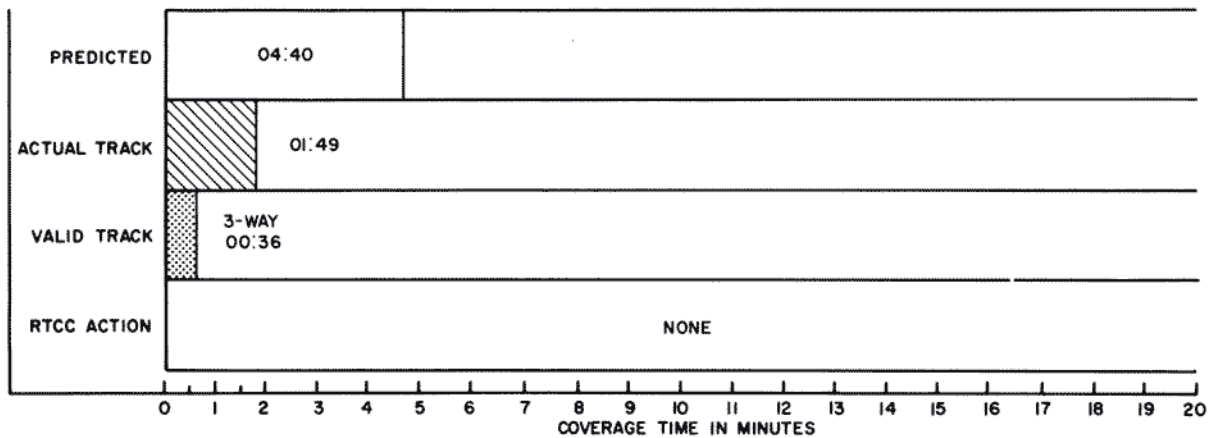
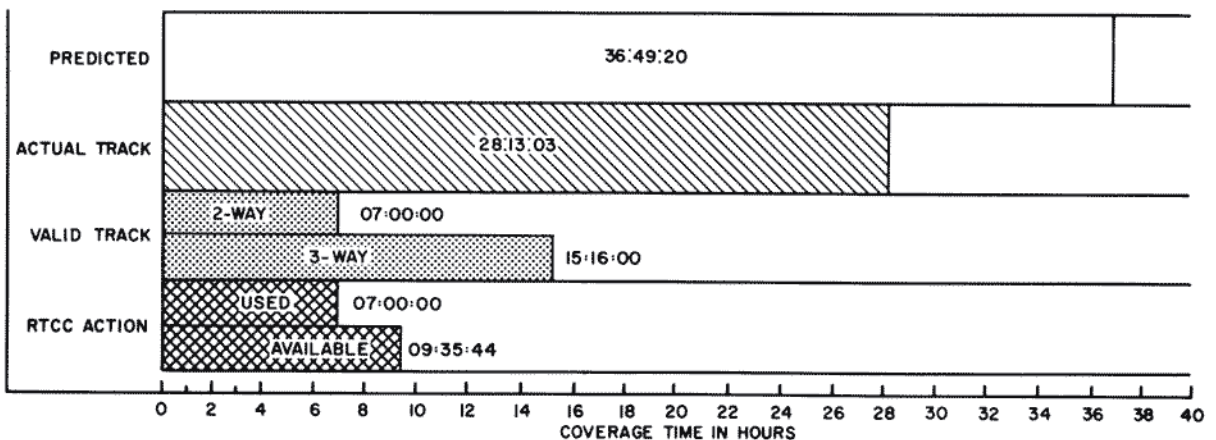
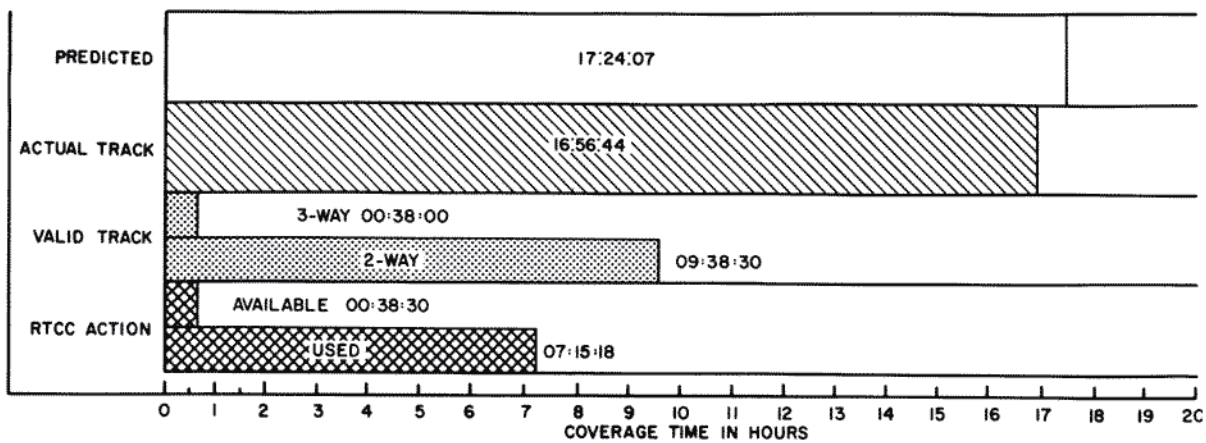
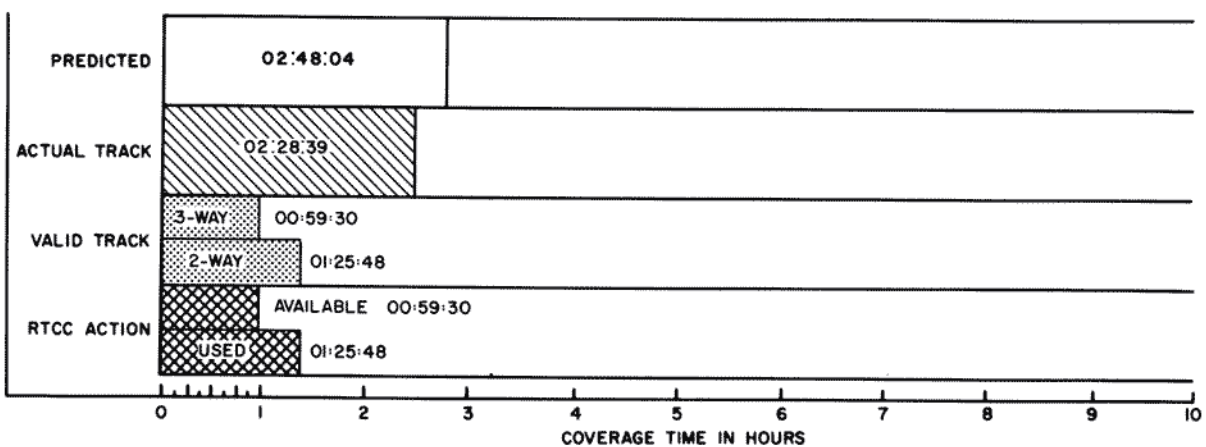
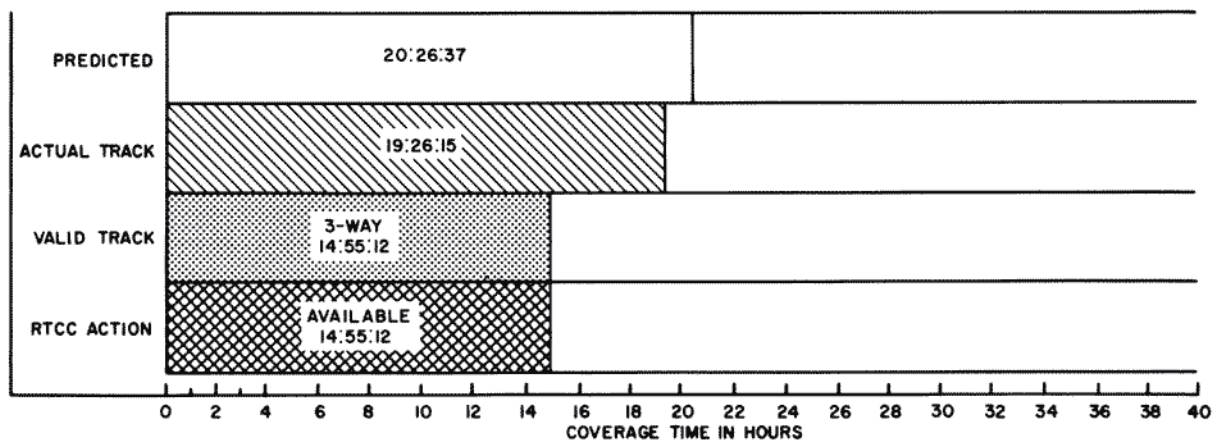
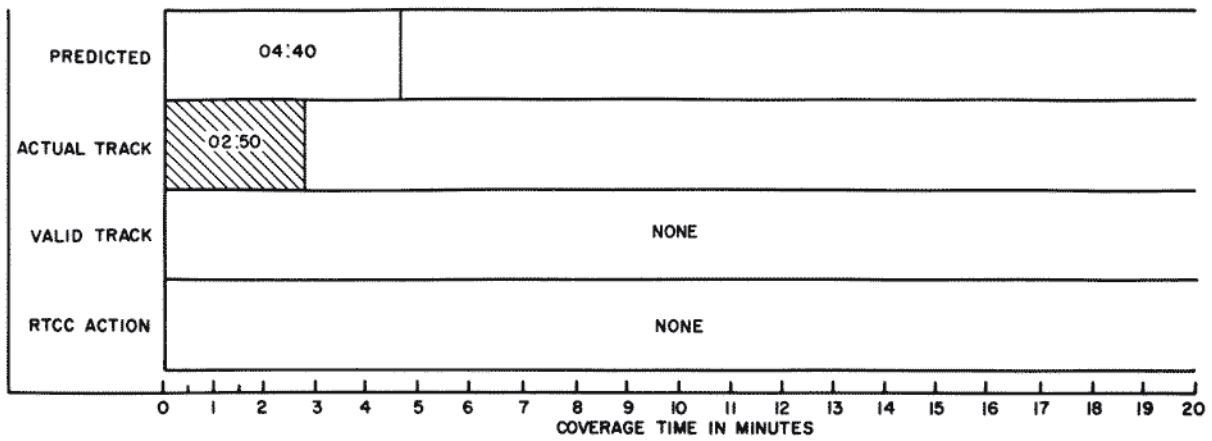
(1) EO -- CSM

(2) TLC -- CSM

(a) System No. 1

(3) Lunar Phase -- LM

(4) Lunar Phase -- CSM

(5) TEC -- CSM

(a) System No. 1 (cont)

Figure 3-41. GDSX USB Tracking Coverage (cont)

(1) EO -- IU

(2) TLC -- IU

(b) System No. 2

3.10.2.2 Goldstone Wing (GDSX) USB (Figure 3-41). Horizon masking on EO revolution 1 prevented GDSX from providing support of a TV transmission.

At 05:50:00 GET, PA No. 1 faulted when the operator was increasing mission power from 2 to 10 kW. The fault was caused by overshooting the beam voltage meter relay setting while increasing power. The PA was reset and the beam voltage returned to the proper value. Momentary activation of the beam and body overcurrent fault interlocks caused this PA to be intermittently unreliable. PA No. 2 was brought up for prime command requirements throughout the remainder of the mission. Later, at 35:29:50 GET, PA No. 2 was momentarily disabled because of body overcurrent, causing loss of uplink capability.

Recycling the PA restored normal operation and tracking was resumed. Numerous PA failures were encountered throughout the MSFN during the mission (3.1.2.2).

While still in TLC at 64:13:00 GET, maser No. 2 became inoperative and was down for 3 hours. Cause of the failure was cryogenics **contamination** and it was necessary to replace the defective unit with a spare pre-cooled maser.

At 76:18:00 GET, after the start of the lunar phase, the high-speed servo tachometer was operating marginally. This unit was replaced postmission because only one spare was available and the high-speed mode was not required. After LM touchdown (103:18:40 GET), a hydraulic failure was encountered by GDSX. Antenna brakes were applied immediately while the antenna was still on track, thus preventing any data loss. When repairs to the hydraulics were completed, autotrack was resumed. The hydraulic difficulty was attributed to moisture in the emergency pushbutton safety interlocks and the problem was corrected when these emergency circuits were bypassed.

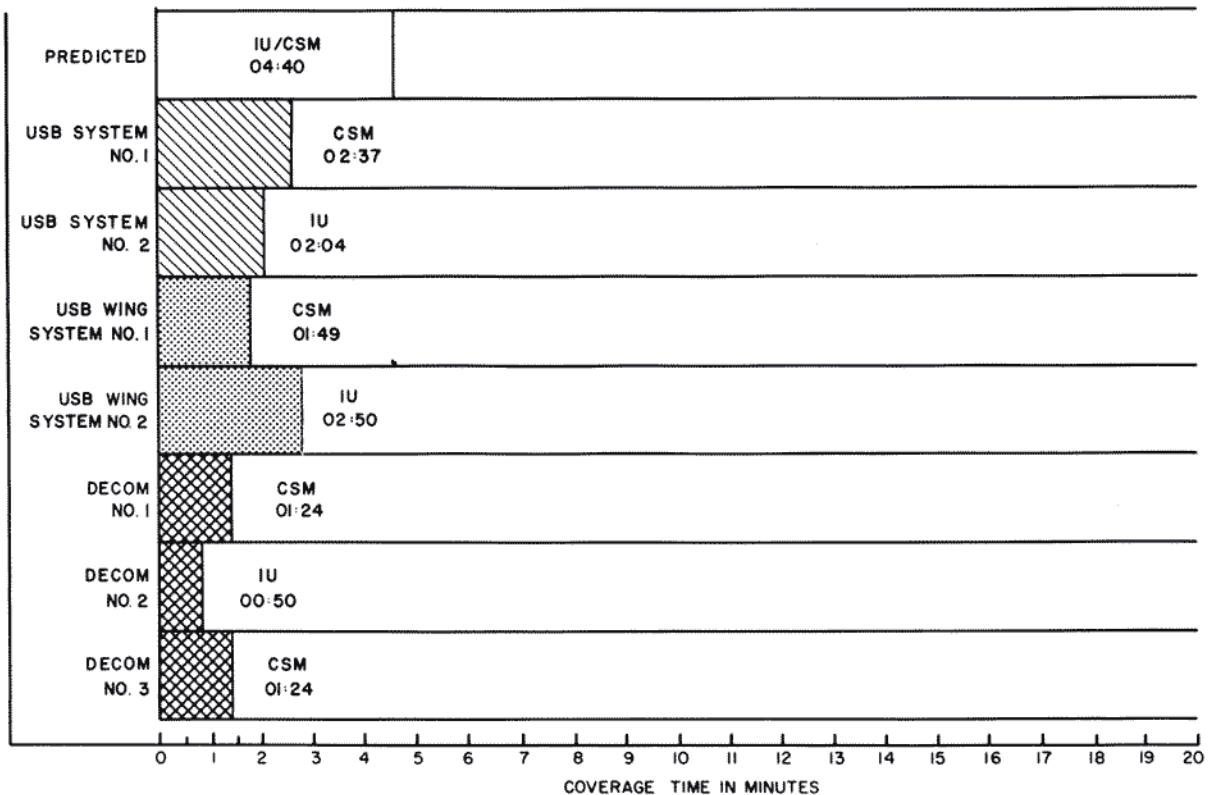
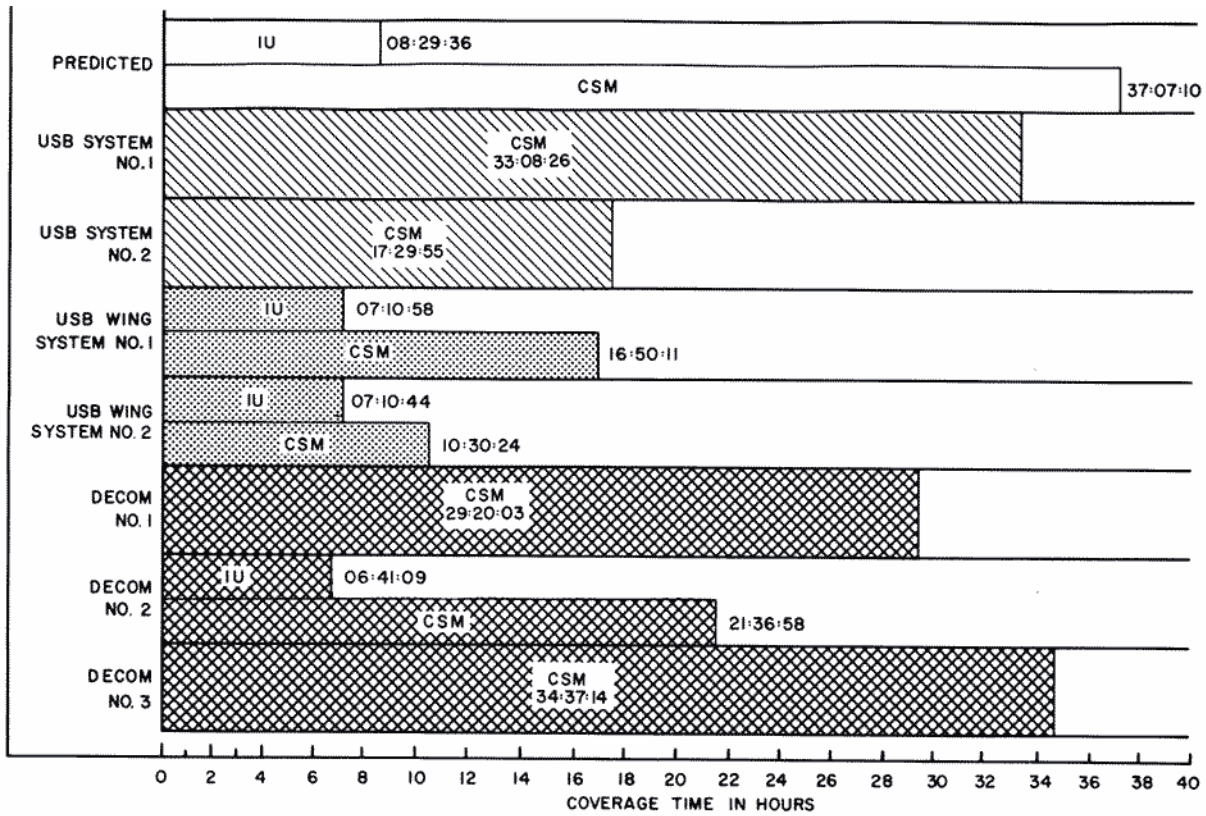
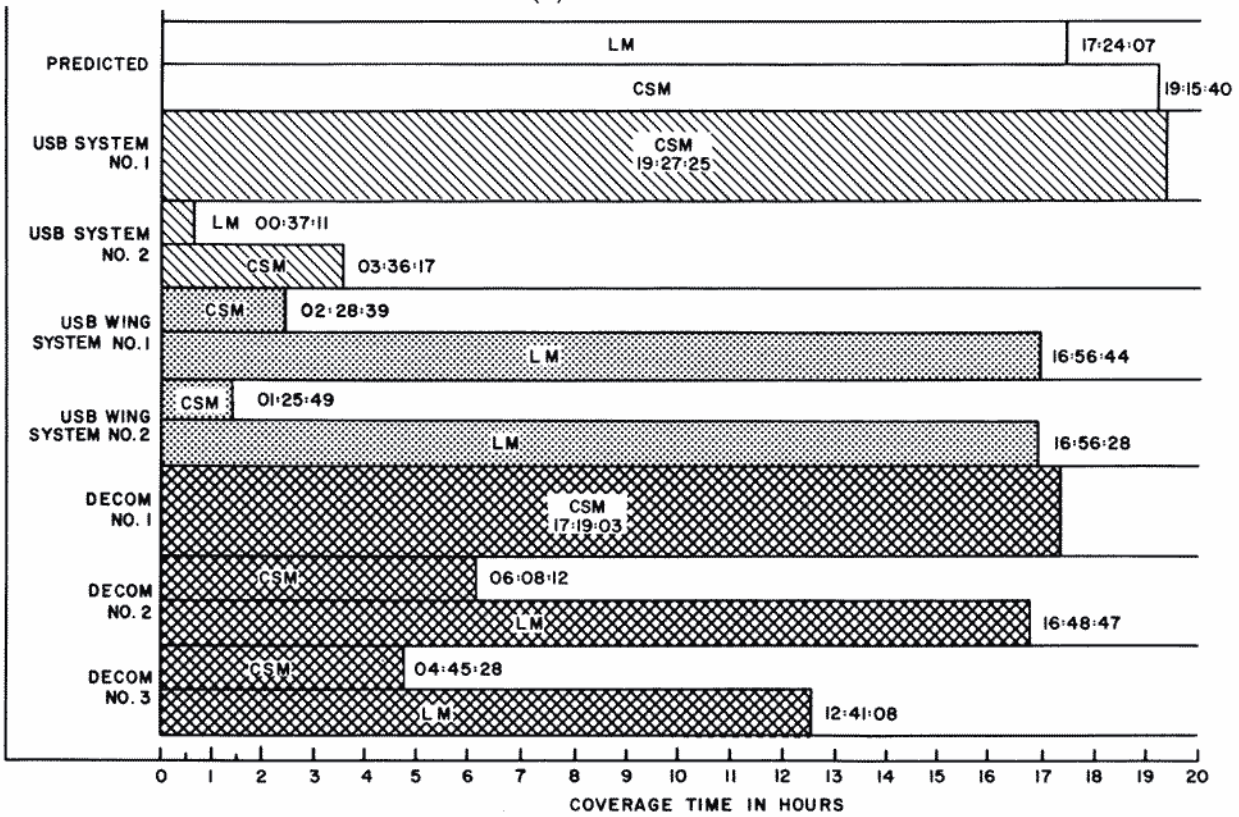
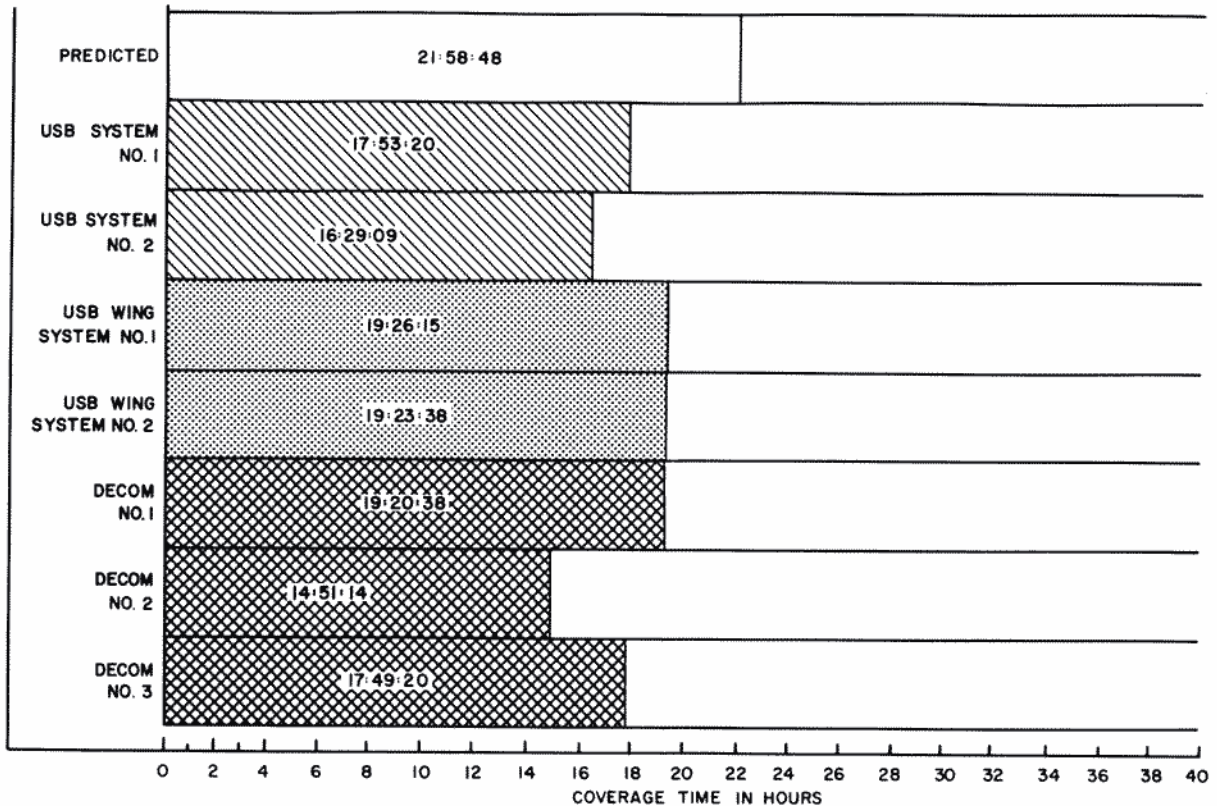
(a) EO

(b) TLC

(c) Lunar Phase

Figure 3-42. GDS/GDSX Telemetry Coverage (cont)

(d) TEO -- CSM

3.10.3 TELEMETRY (Figure 3-42)

3.10.3.1 USB. Keyhole and terrain restrictions, low-elevation passes, fluctuating signal levels due to spacecraft antenna switching, and the PTC mode of flight caused some loss of telemetry data (3.1.3.1).

On launch day, decom No. 3 was unable to pass the telemetry CADFISS test in the terminal count. An invalid IU prime frame synchronization data pattern was being input to the 642B telemetry processor. A PCM error analysis incorporated within the telemetry operational program was initiated to isolate this problem. Two bent connector pins on a PC card in location 19C in the output data buffer were located and repaired. The bent pins were causing bits 9 and 10 of the prime frame synchronization

3.10.3.3 Telemetry Computer. A telemetry computer fault occurred at 35:59:02 GET during TLC, but an automatic recovery was achieved without difficulty. No further difficulty was encountered until TEC when, at 176:26:00 GET, a fault occurred and automatic recovery was not achieved. This necessitated a manual recovery and resulted in a 3-second data loss. Another fault occurred at 176:29:00 GET while using the LUK routine (call up and print out for inspection any location in memory core) in testing for the previous fault. Three seconds of data was lost before handing over to MAD. The cause of these faults was not determined. Several telemetry computer faults were encountered by the MSFN throughout the mission (3.1.3.4).

A telemetry HSD problem occurred at 135:46:00 GET during the lunar phase. Both data lines seemed to lock up and continuously output one data frame while GDS was exercising a time search routine. The third time this routine was initiated, the program seemed to loop and remain in this condition. After loss of signal of the CSM dump data, the program automatically recovered. The time code translator has been observed to generate continuous external interrupts when switched from playback to search. Such a condition could cause a program loop and the repeated data as previously described. This problem is currently being investigated.

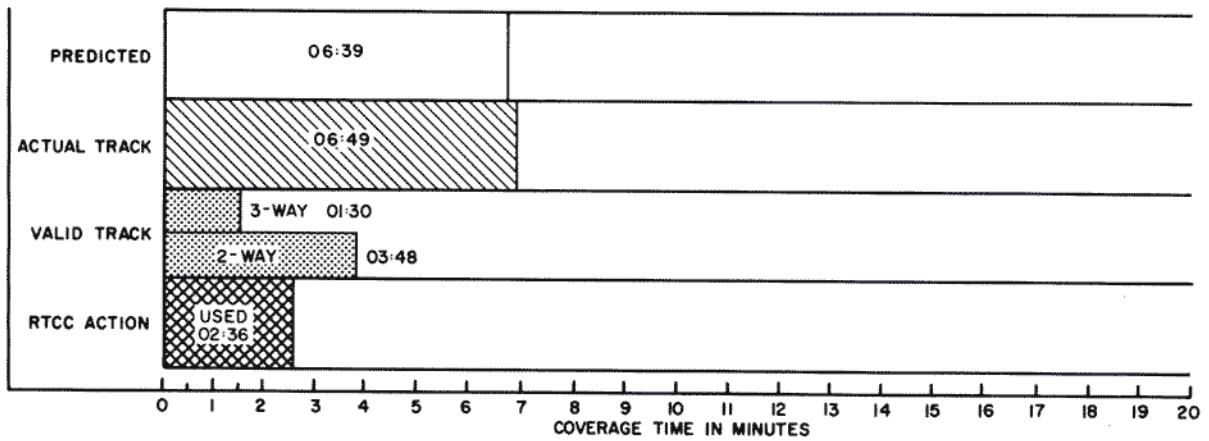
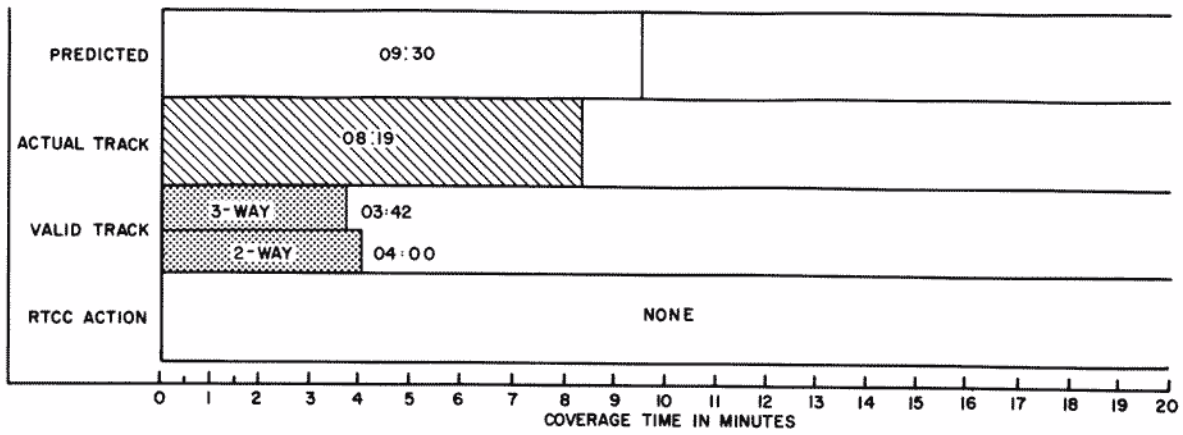
(a) EO -- IU

(b) EO -- CSM

Figure 3-46. GBM USB Tracking Coverage (cont)

3.11.2.1 USB (Figure 3-46). GBM tracked the CSM during launch, and the IU for all their remaining support. Due to an operator error, CSM tracking on launch was terminated 30 seconds early.

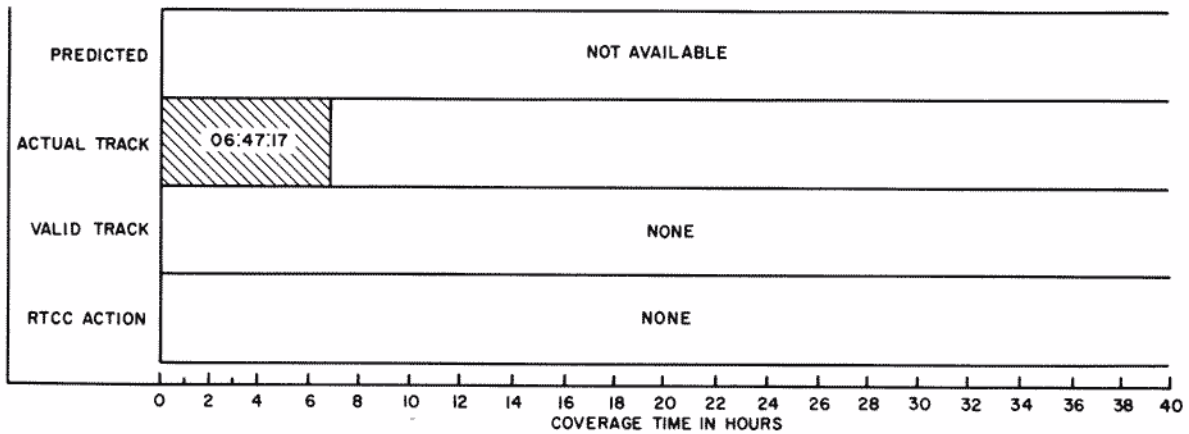
(c) TLC -- IU
