MANNED  
SPACE  
FLIGHT  
NETWORK

# POSTMISSION REPORT ON THE AS-506 (APOLLO 11) MISSION

FEBRUARY 1970

GODDARD  
SPACE  
FLIGHT  
CENTER

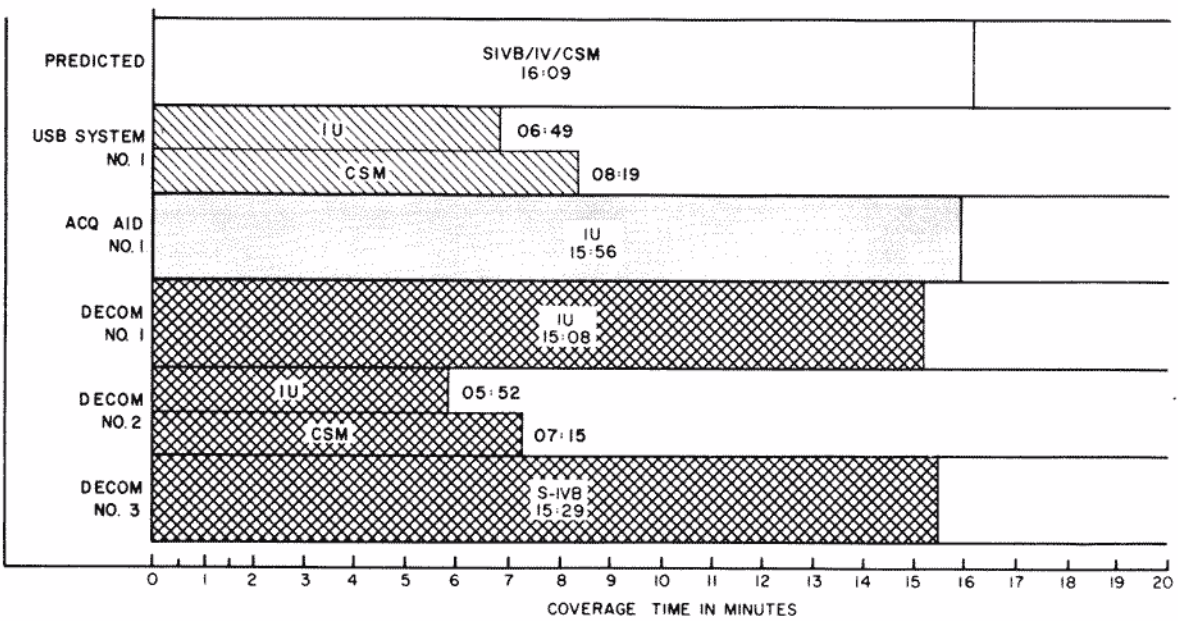
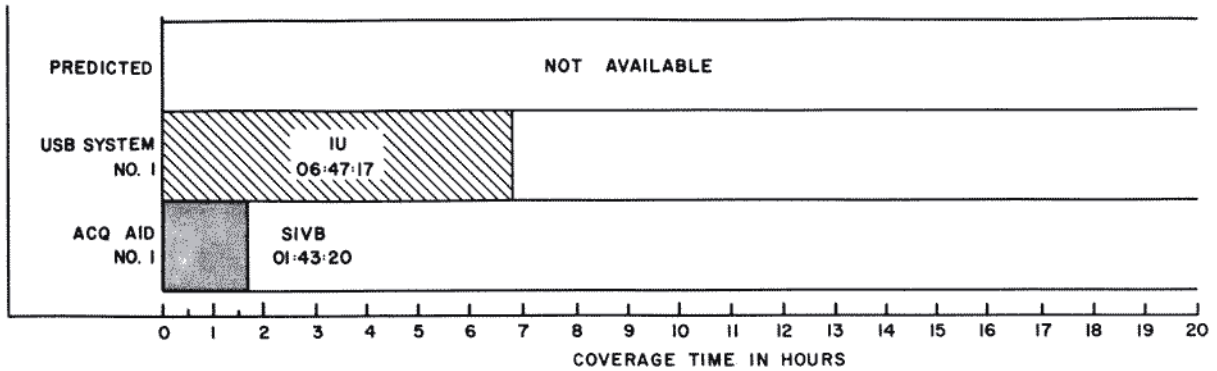
(a) EO

(b) TLC

Figure 3-47. GBM Telemetry Coverage (cont)

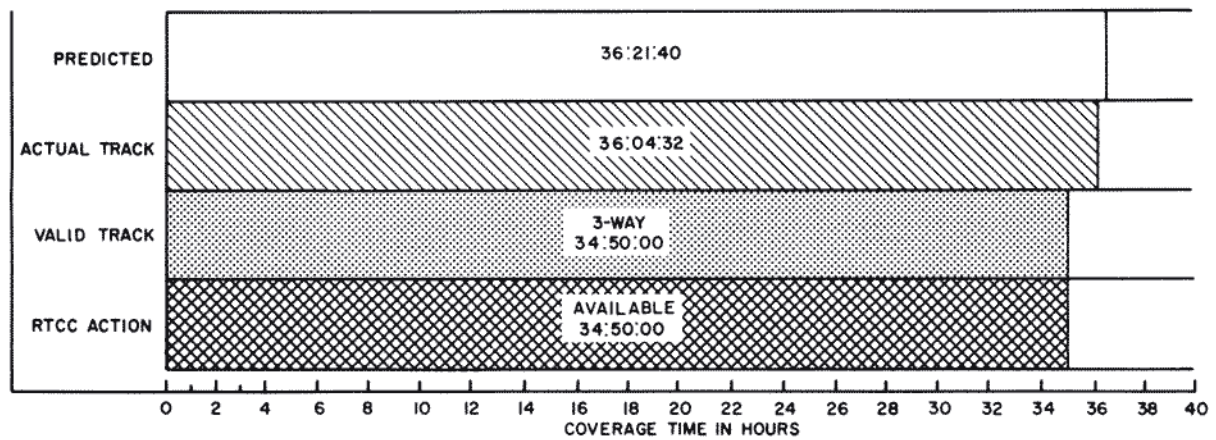
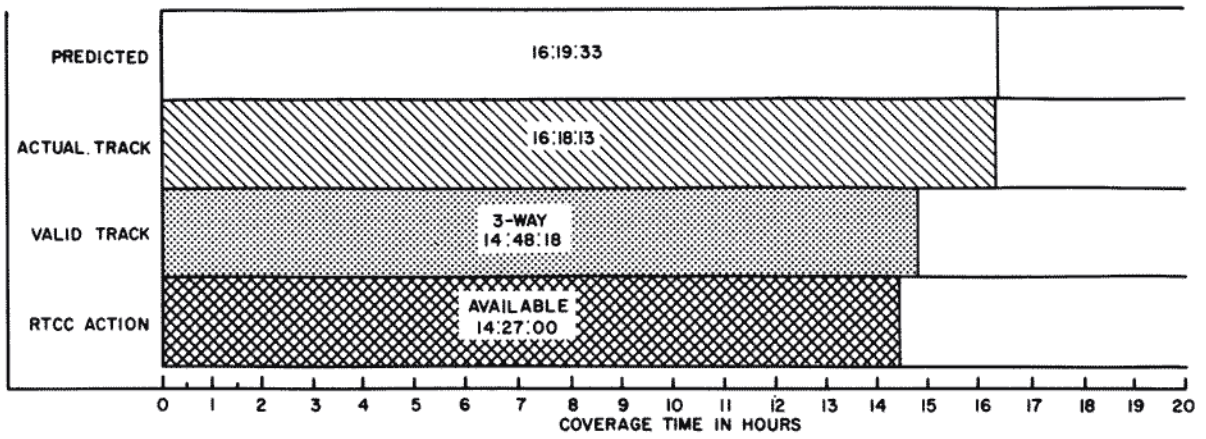
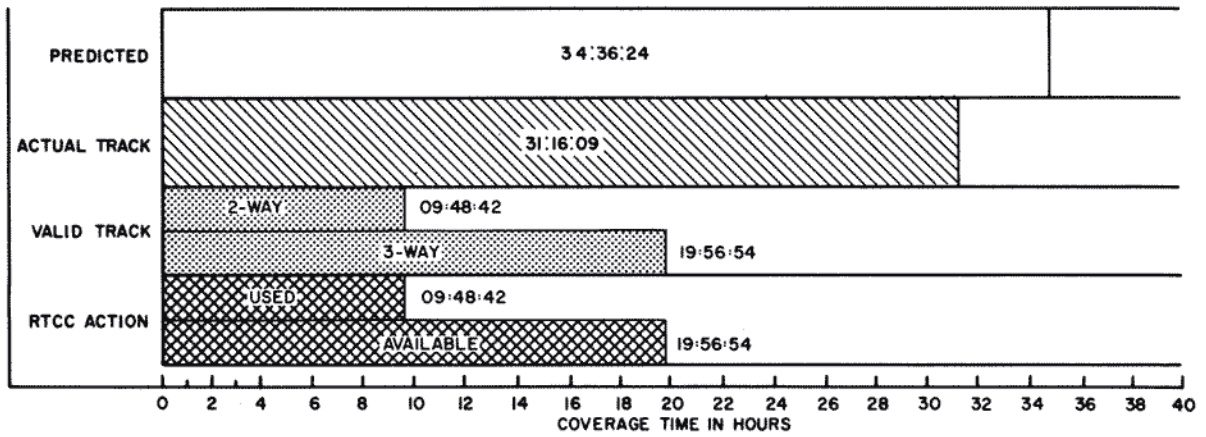
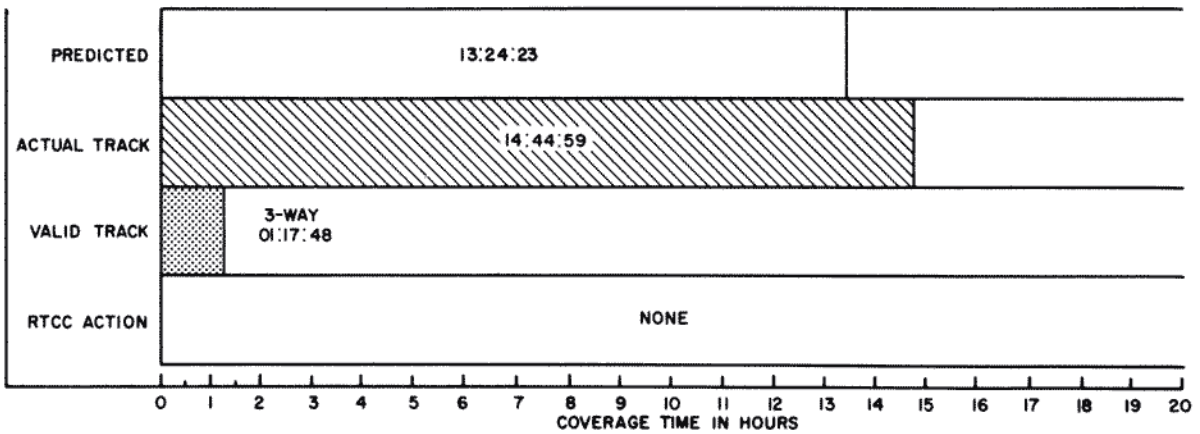
(1) TLC -- CSM

(a) System No. 1

(2) Lunar Phase -- CSM

(3) TEC -- CSM

(a) System No. 1 (cont)

(b) System No. 2, Lunar Phase -- LM

Figure 3-51. GWM USB Tracking Coverage (cont)

3.12.2.1 USB (Figure 3-51). Early during TLC the system No. 1 range receiver became inoperative due to a clock lock relay failure at 18:58:00 GET. This failure necessitated the use of system No. 2 to support a time correlation test while the faulty relay was being replaced. The unit was operational at 19:32:00 GET.

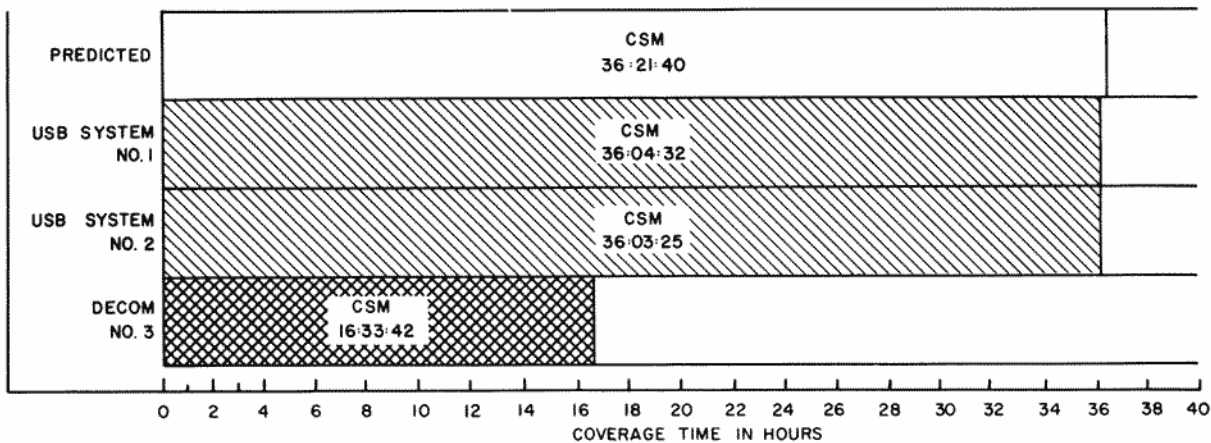
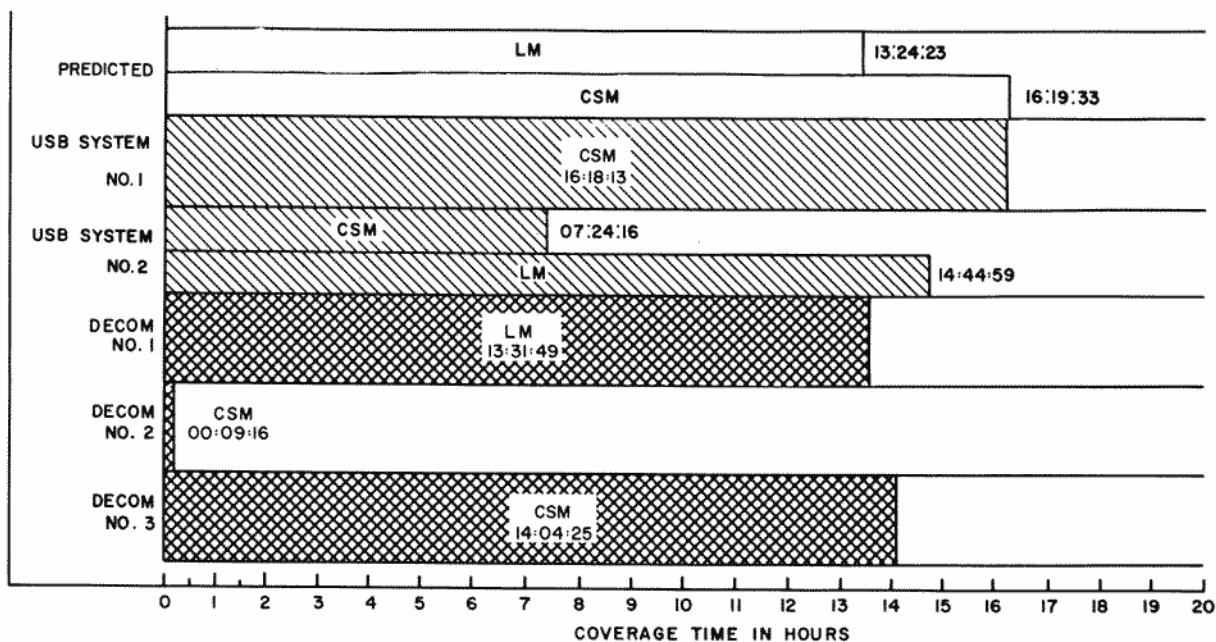
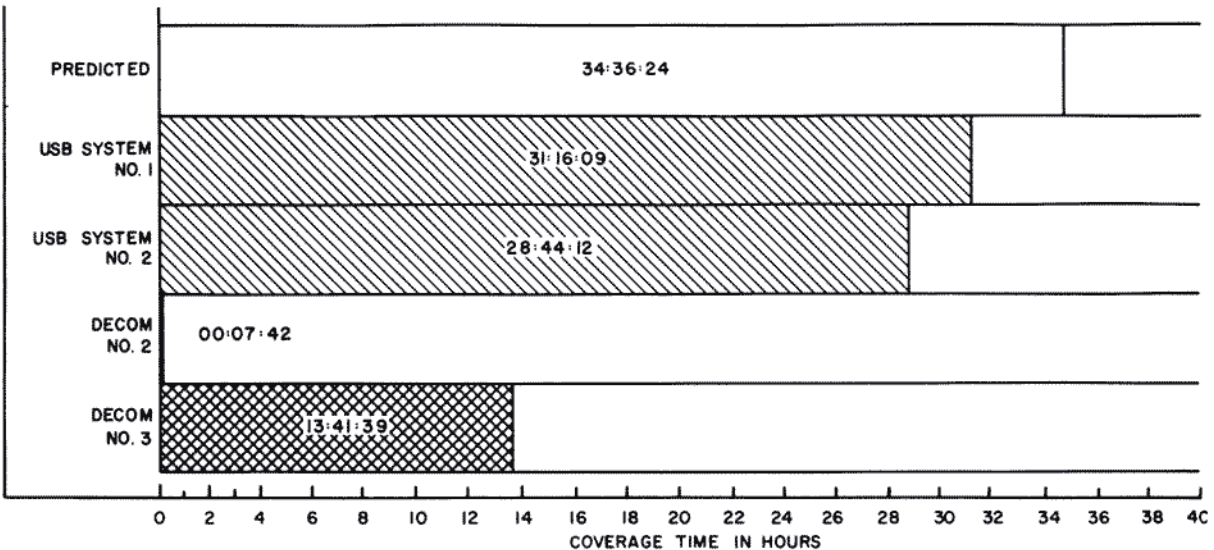
(a) TLC

(b) Lunar Phase

(c) TEC -- CSM

Figure 3-52. GWM Telemetry Coverage (cont)

3.12.3 TELEMETRY (Figure 3-52)

3.12.3.1 USB. As in previous Apollo missions, data dropouts were caused by weak and fluctuating signals as a result of the unfavorable aspect angle of the spacecraft antenna, the spacecraft utilizing the PTC mode of flight, use of the omni antenna at extreme distances, and low to high bit rate changes (3.1.3.1). Approximately 14 seconds of LM data was lost during lunar liftoff due to degraded received signal (3.1.3.2).

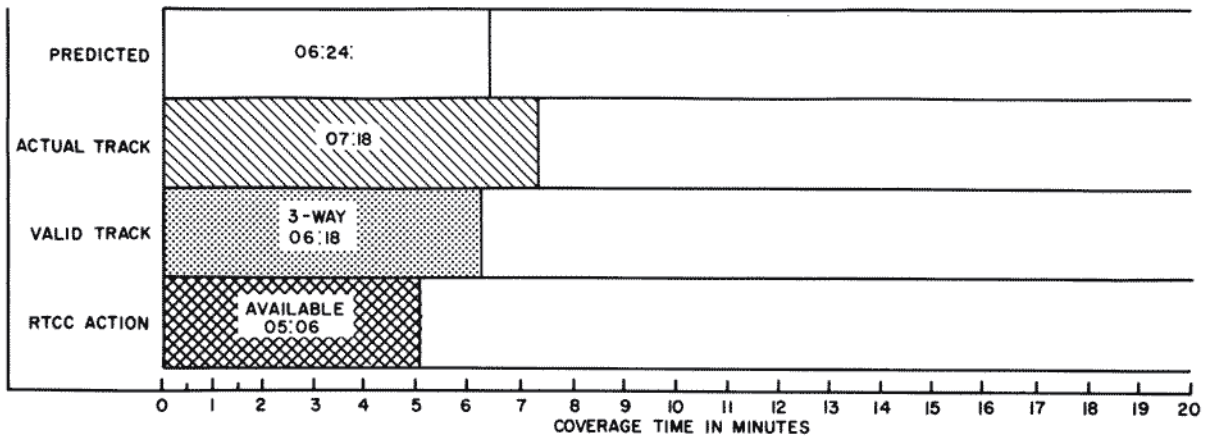
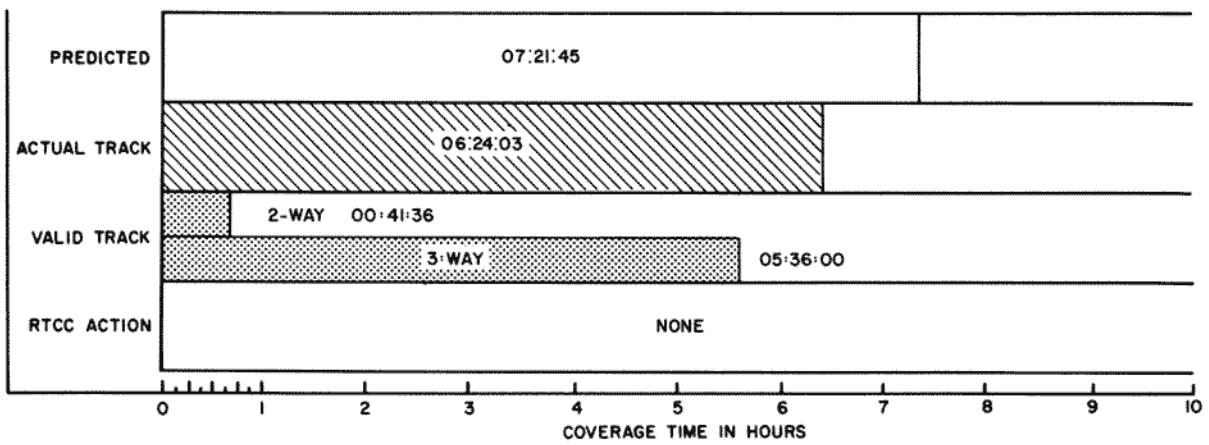
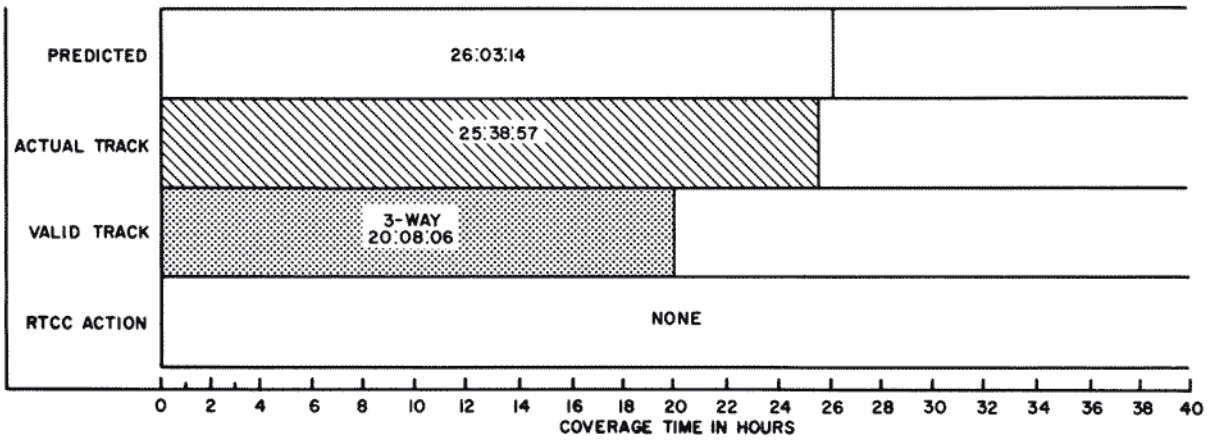
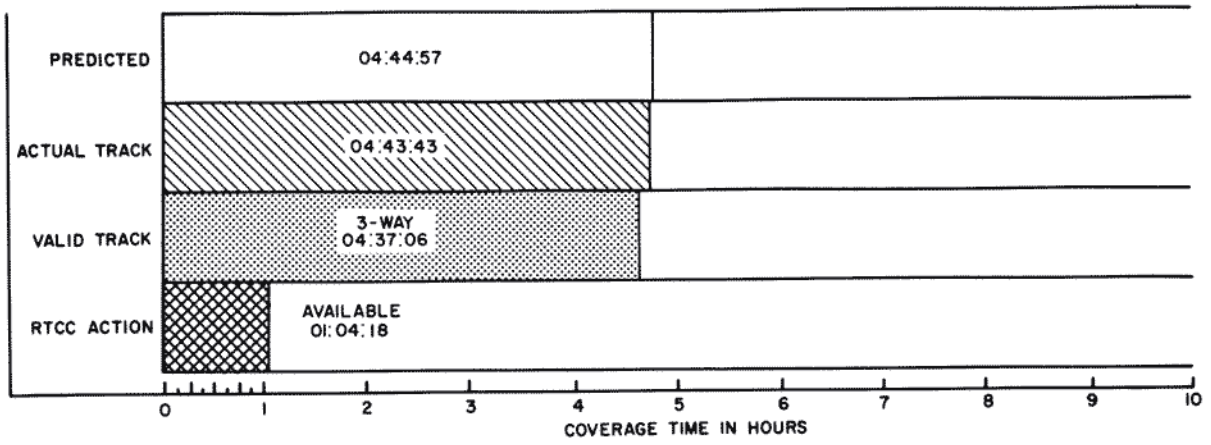
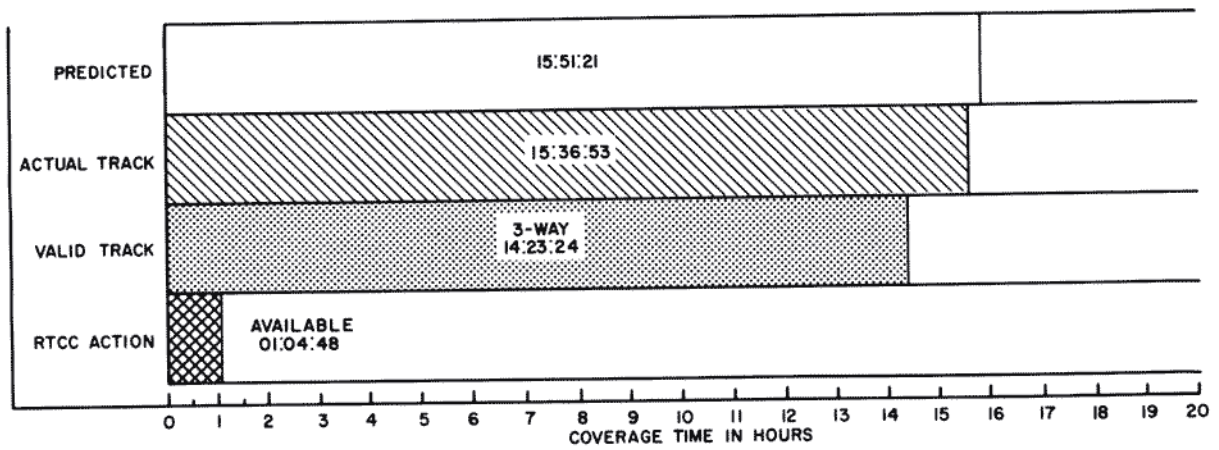
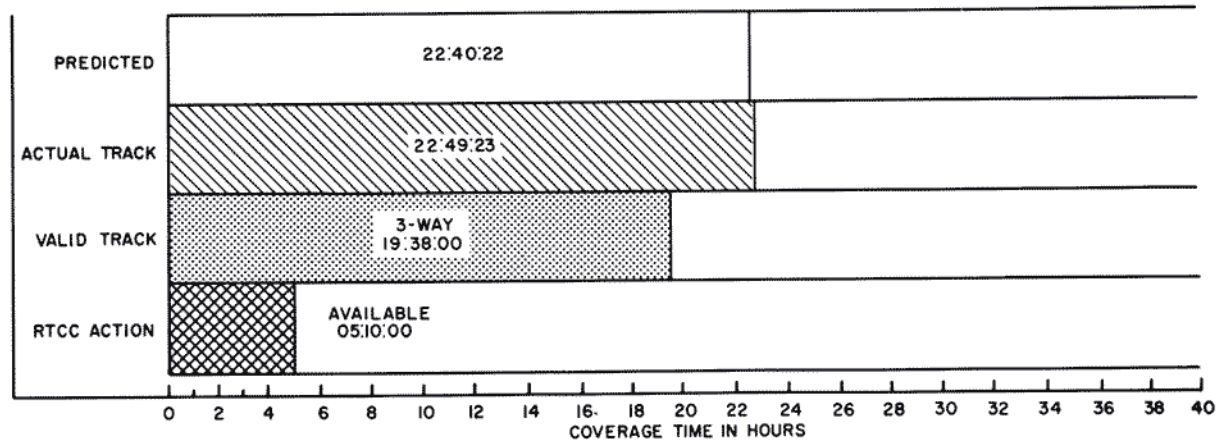
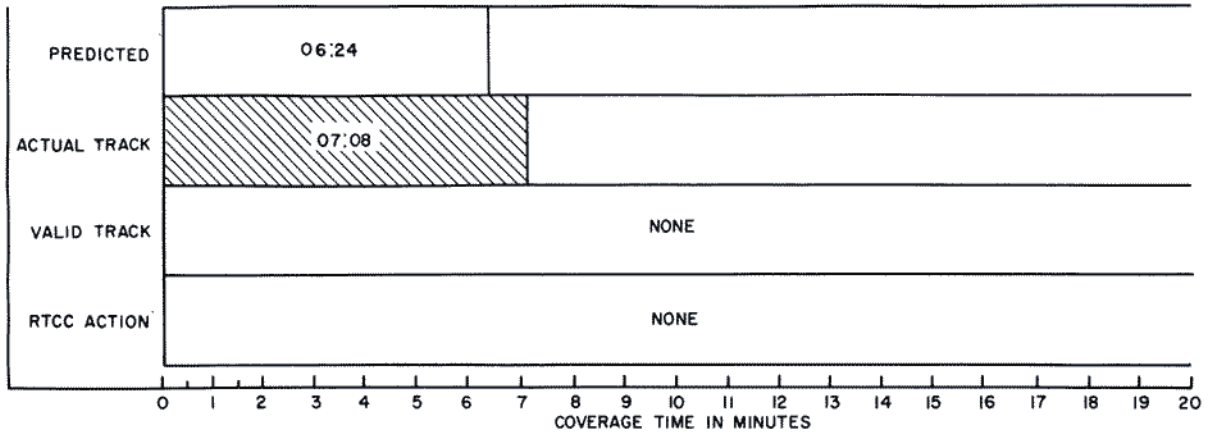
Figure 3-56. GYM USB Tracking Coverage

(1) EO -- IU

(2) TLC -- IU

(3) TLC -- CSM

(a) System No. 1

(4) Lunar Phase -- LM

(5) Lunar Phase -- CSM

(6) TEC -- CSM

(a) System No. 1 (cont)

(b) System No. 2, EO -- CSM

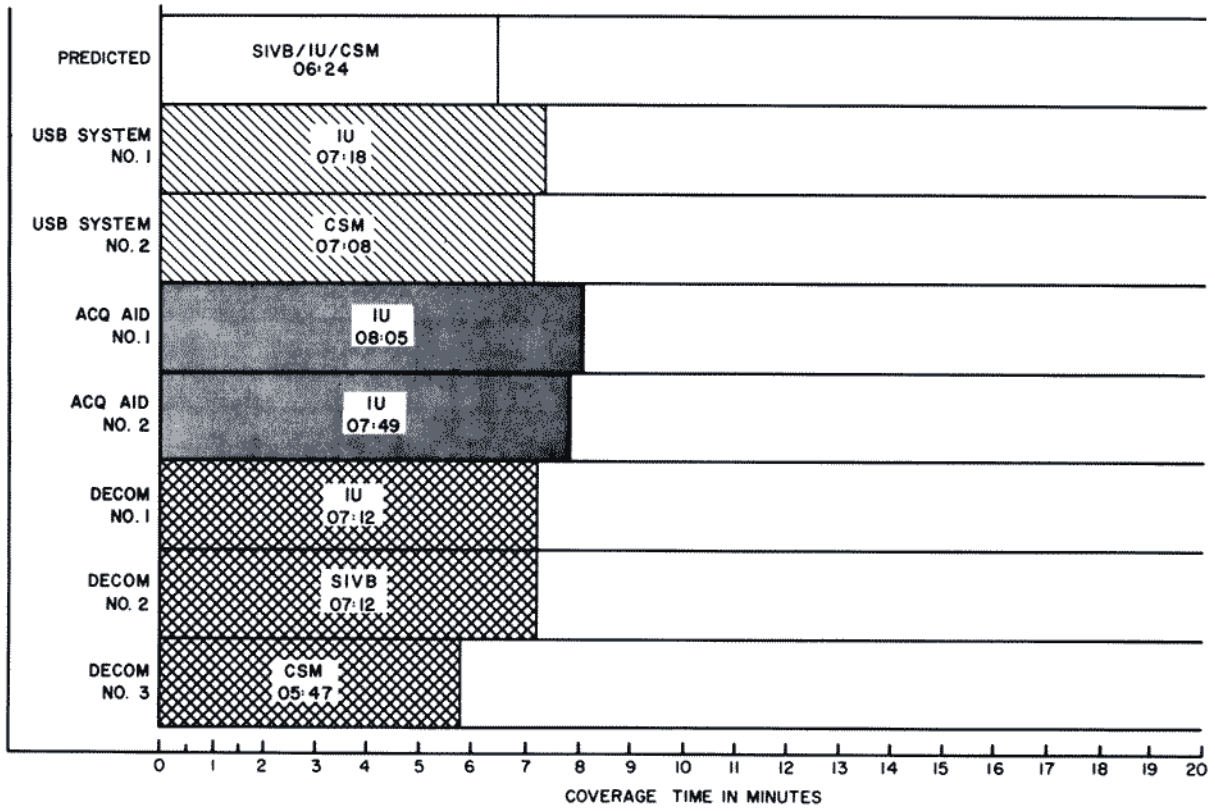
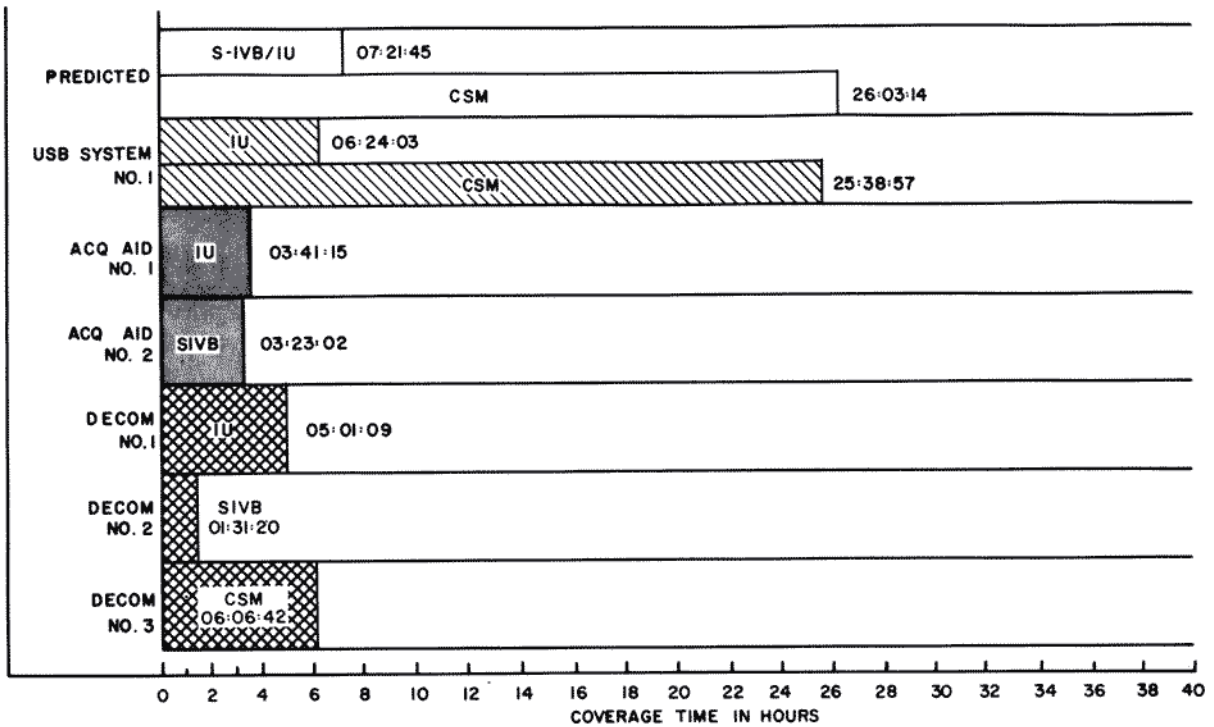
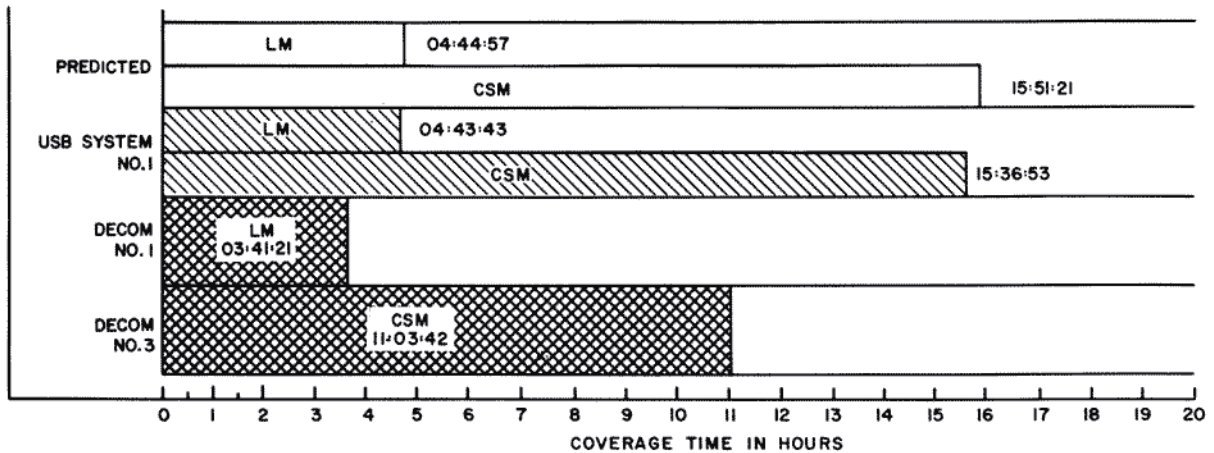
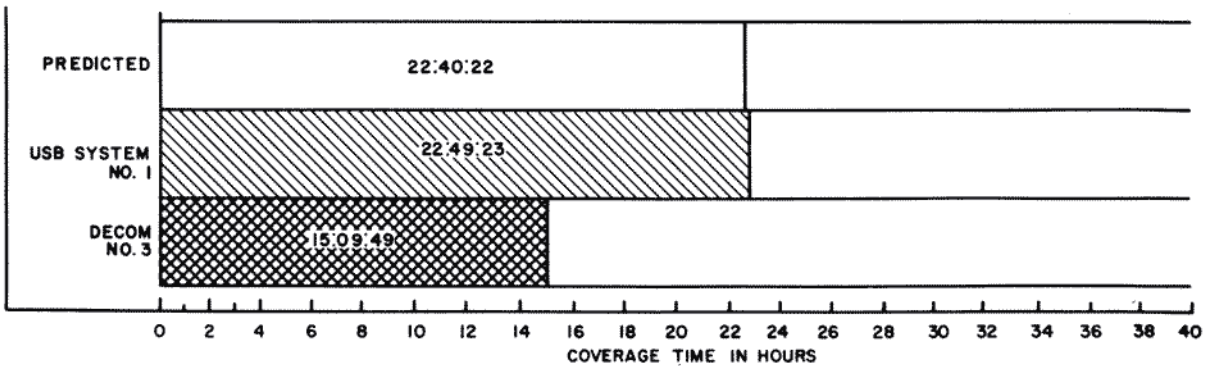
(a) EO

(b) TLC

(c) Lunar Phase

(d) TEC -- CSM

Figure 3-57. GYM Telemetry Coverage (cont)

3.13.3 TELEMETRY (Figure 3-57).

3.13.3.1 USB. CSM S-band telemetry processing was hampered during the mission whenever the omni antenna on board the spacecraft was used, or the PTC mode of operation was initiated. In addition, CSM and LM S-band telemetry received signal strength decreased when bit rates changed from low to high. These problems caused the majority of data losses throughout the network, (3.1.3.1).

3.13.3.2 VHF. Received VHF telemetry signal strength decreased as the range to the S-IVB and IU increased during TLC. During the first view period following TLI (starting at 02:56:00 GET), VHF signals were very noisy because of a local electrical storm and it was difficult to maintain decom lock.

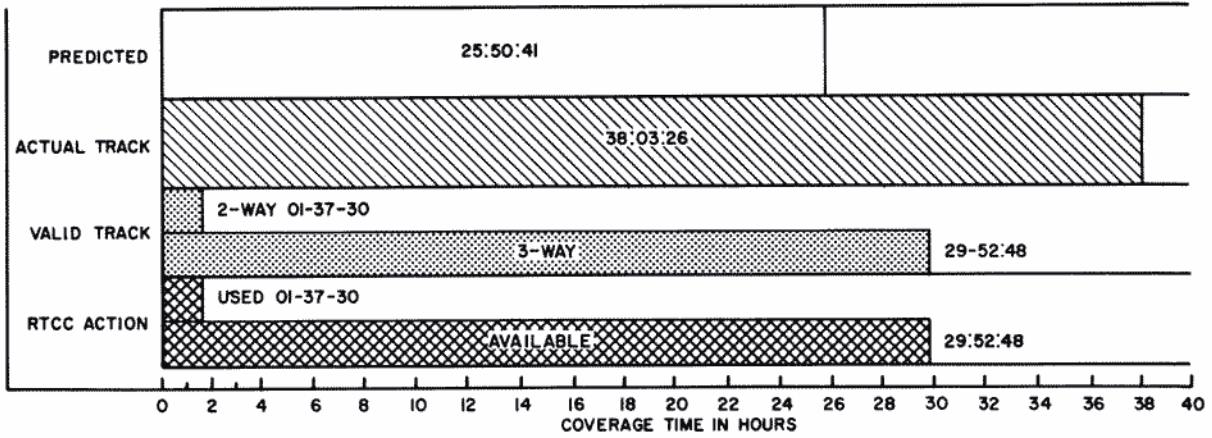
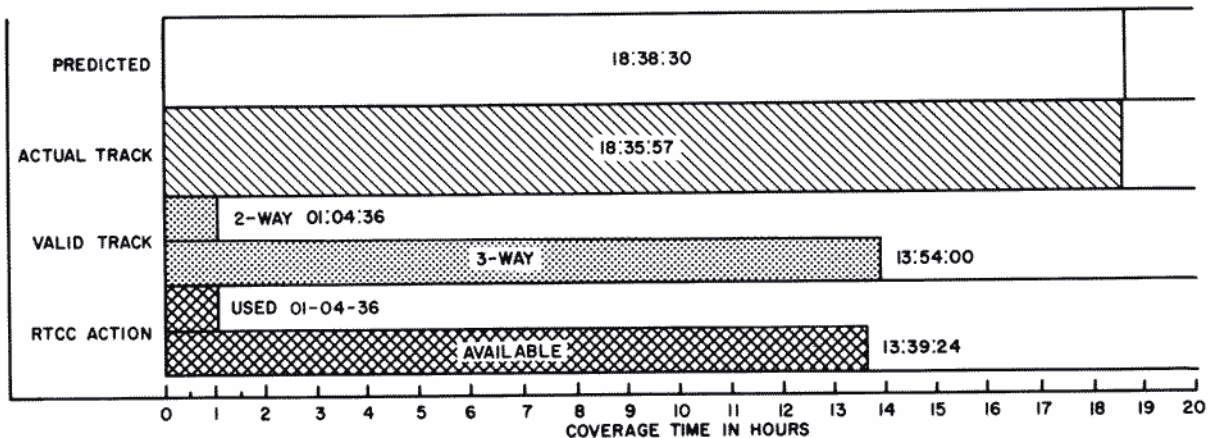
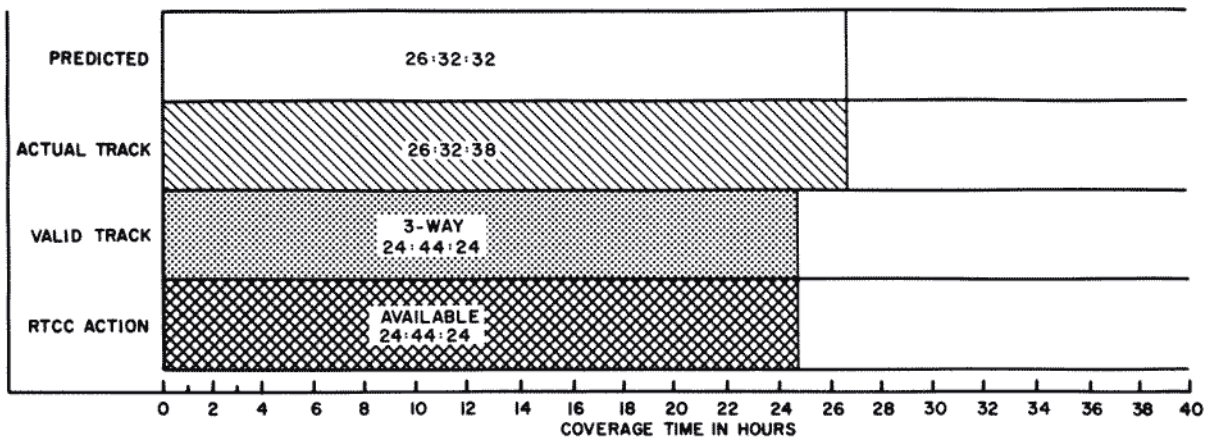
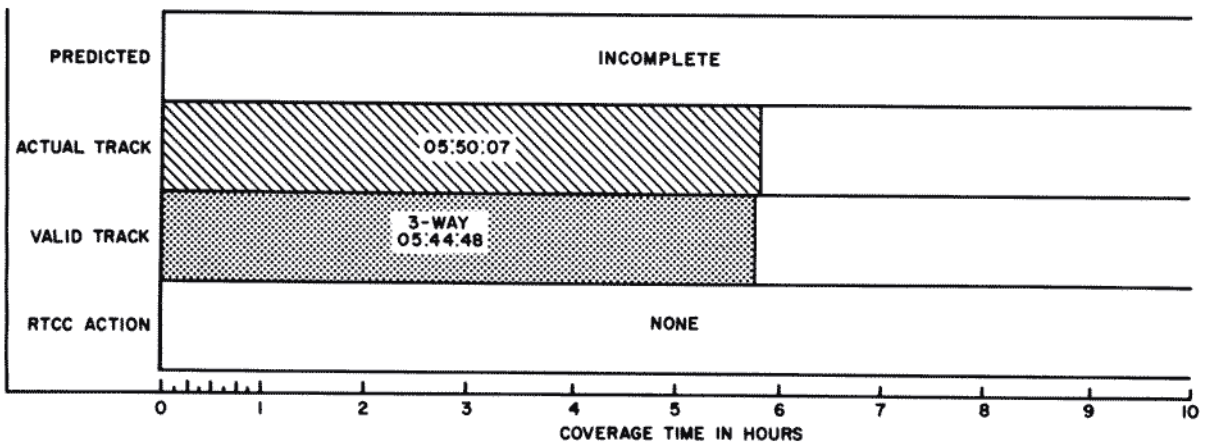
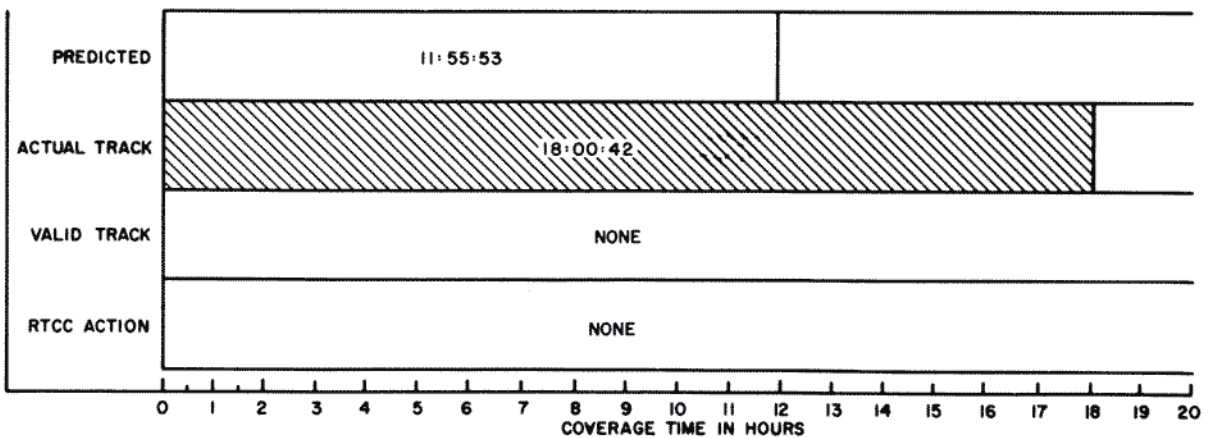
Figure 3-61. HAW USB Tracking Coverage

(1) TLC -- CSM

(2) Lunar Phase -- CSM

(a) System No. 1

(3) TEC -- CSM

(a) System No. 1 (cont)

(1) TLC -- IU

(2) Lunar Phase -- LM

(b) System No. 2

3-61. HAW USB Tracking Coverage (cont)

At 33:14:00 GET during TLC, an anomaly was observed while performing CADFISS testing. The TDP output consisted of erroneous system No. 2 destruct Doppler data. This problem was traced to a "times 10" multiplier board failure in the time interval counter. The defective board was replaced upon receipt of a substitute at 93:06:00 GET. For the interim period, HAW was unable to support CADFISS boresight tests in the dual mode, but was able to operate in the single mode and test each system individually.

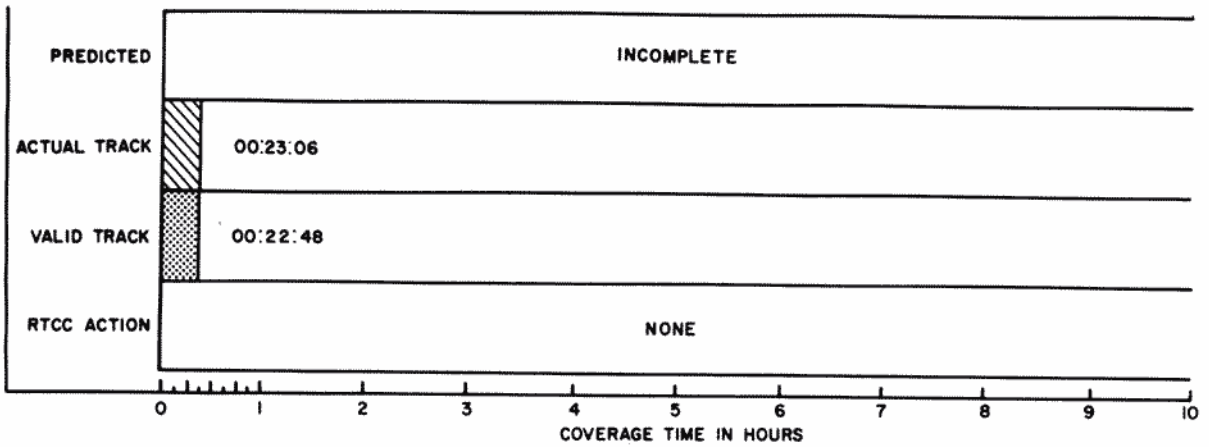
Figure 3-62. HAW FPS-16 Tracking Coverage, TLC -- IU

3.14.2.2 Radar (Figure 3-62). The FPS-16 tracked the IU during the early portion of TLC. The radar acquired the IU after the completion of the TLI burn. There were no signal dropouts, but lobing signals were encountered throughout the pass. During a second view period on the first day of TLC, only weak and sporadic returns were observed from the IU beacon and the radar was unable to acquire.

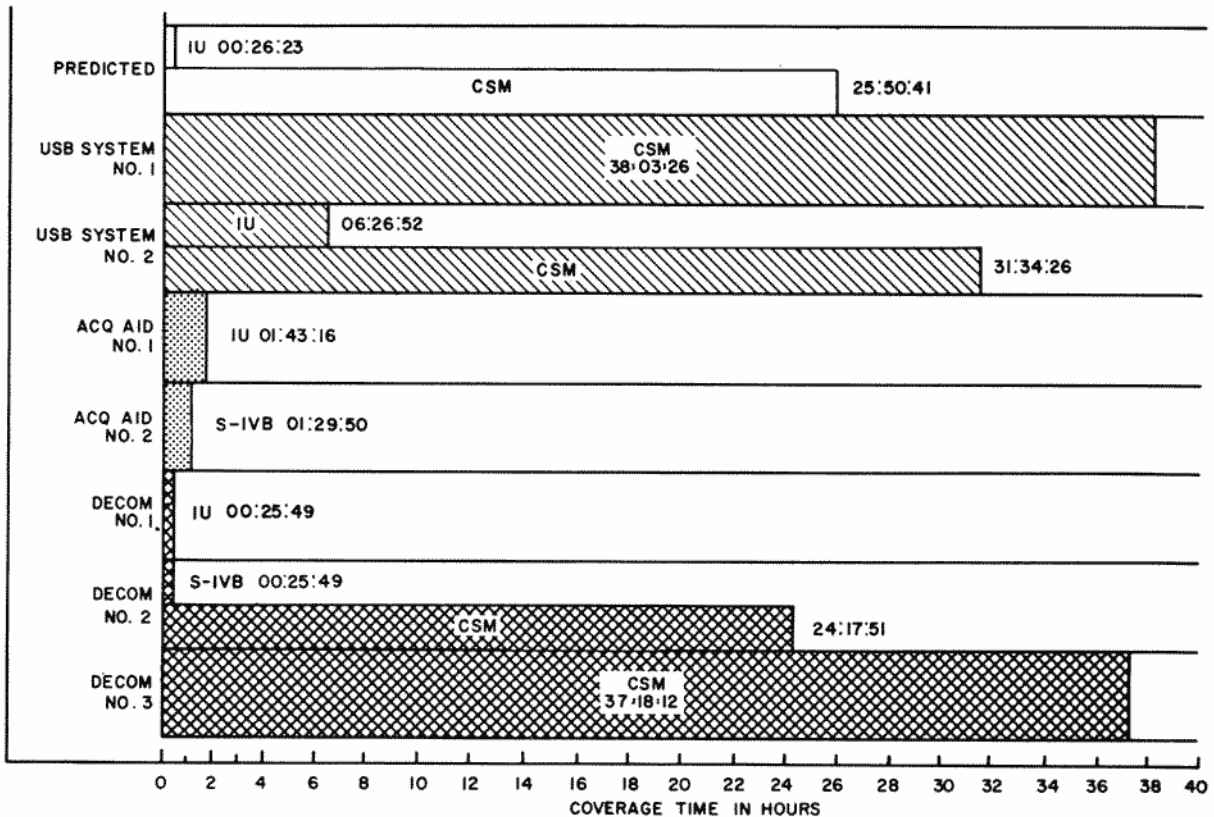
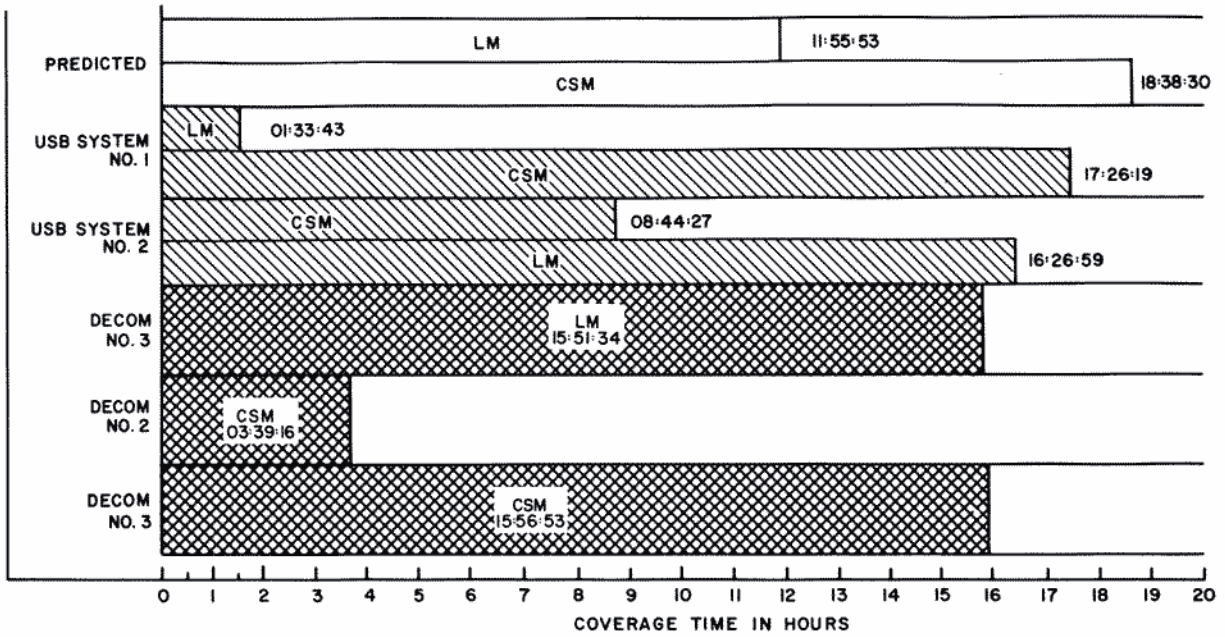
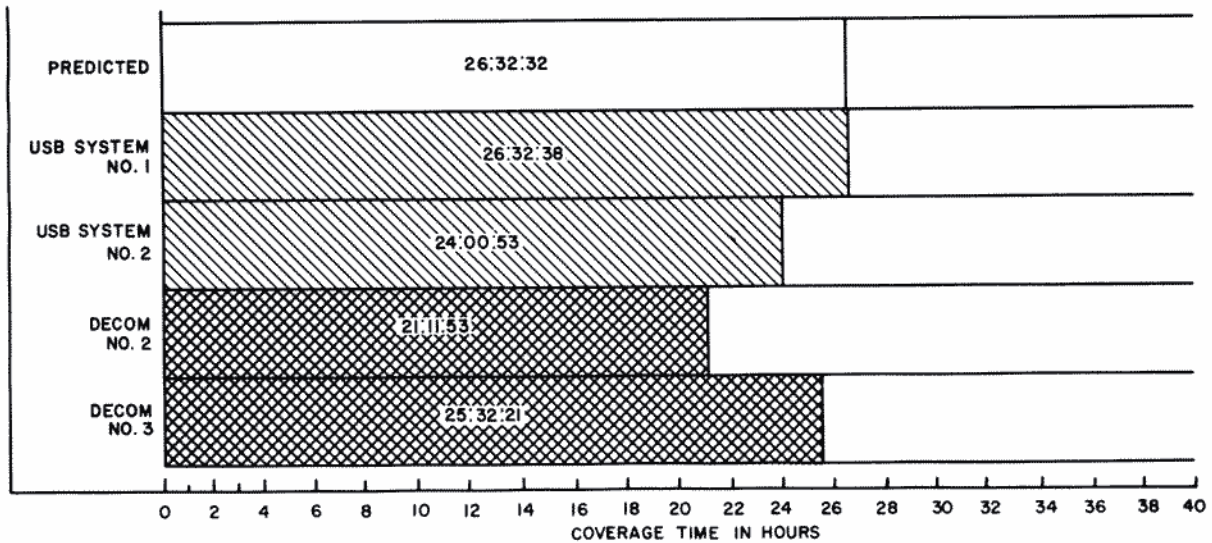
Figure 3-63. HAW Telemetry Coverage

(a) TLC

(b) Lunar Phase

(c) TEC -- CSM

3-63. HAW Telemetry Coverage (cont)

3.14.3 TELEMETRY (Figure 3-63)

3.14.3.1 USB. Signal losses were encountered while supporting the CSM during the coast and lunar phases whenever the omni antenna on board the spacecraft was used to transmit telemetry data. Nominal changes in received signal strength were noted when HBR was used by the CSM for data transmissions. The latter applied equally to the

LM received signal strength during its lunar activities. Also, during the coast phases, whenever PTC operations were initiated by the CSM, degradation of received signals was noted (3.1.3.1).

3.14.3.2 VHF. Acq aids No. 1 (TELTRAC) and No. 2 (AGAVE retrofit) provided IU and S-IVB VHF telemetry support, respectively, during the last minute of TLI and approximately the first 25 minutes of TLC. A second view period, supported in the same configuration, began after the CSM evasive maneuver and continued until HAW VHF telemetry requirements were terminated at 06:28:00 GET.

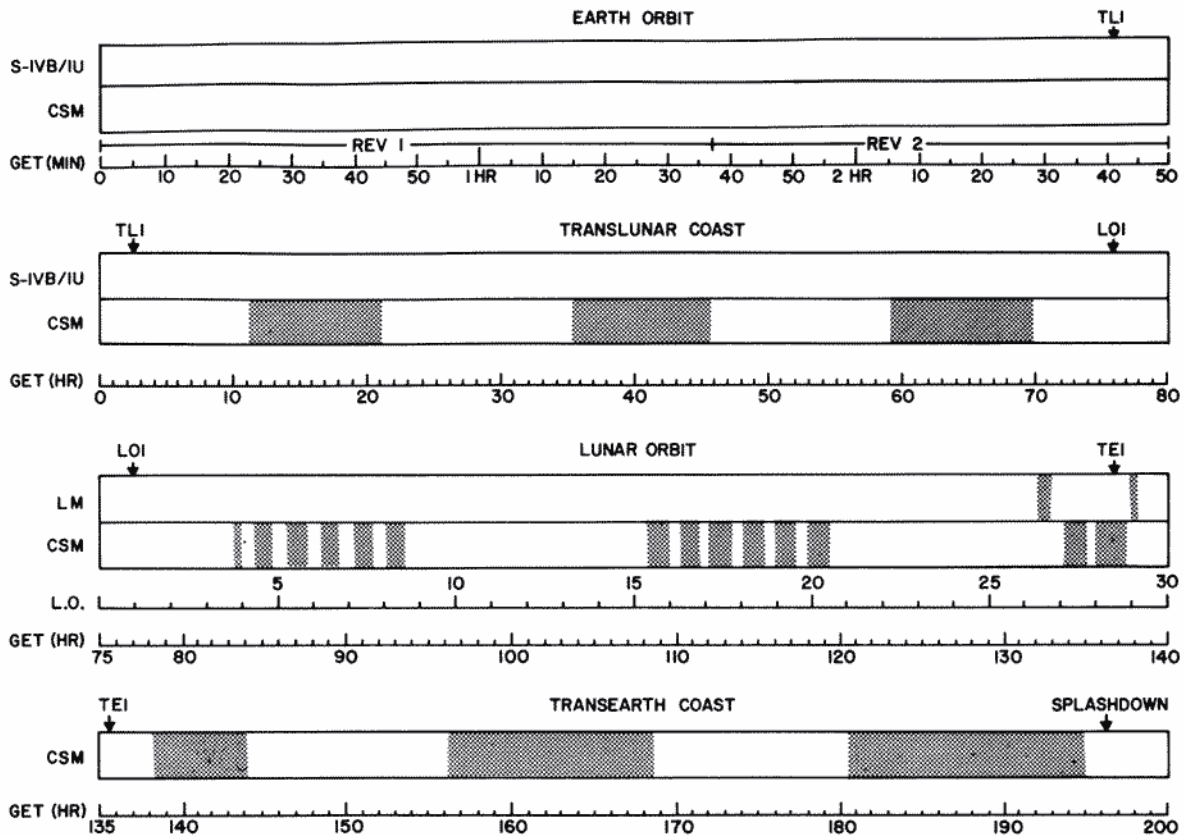
Figure 3-66. Support Periods (cont)

(b) HSKX

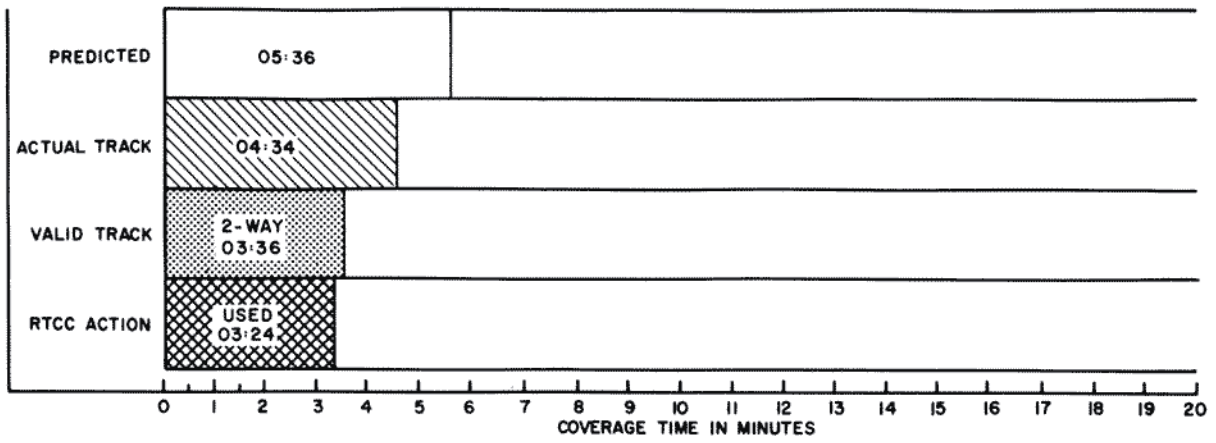
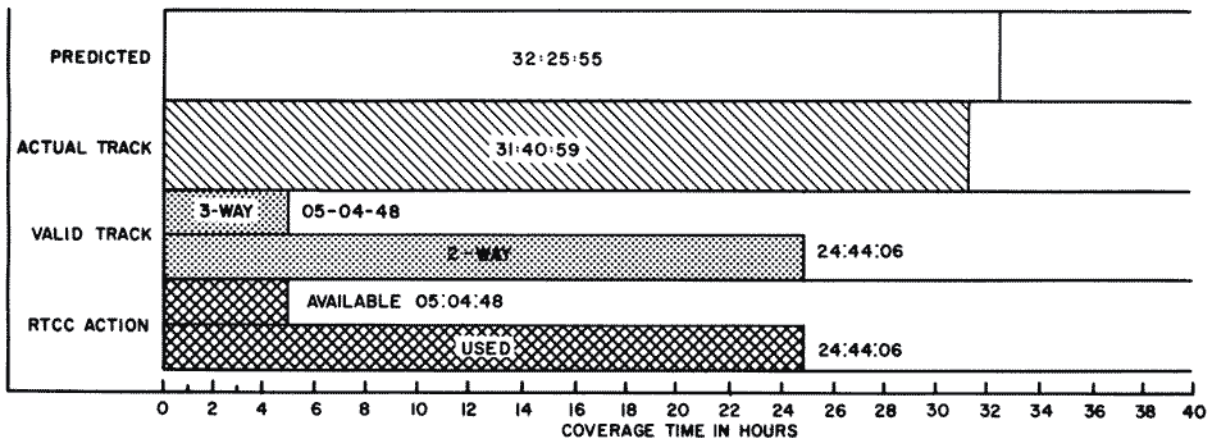
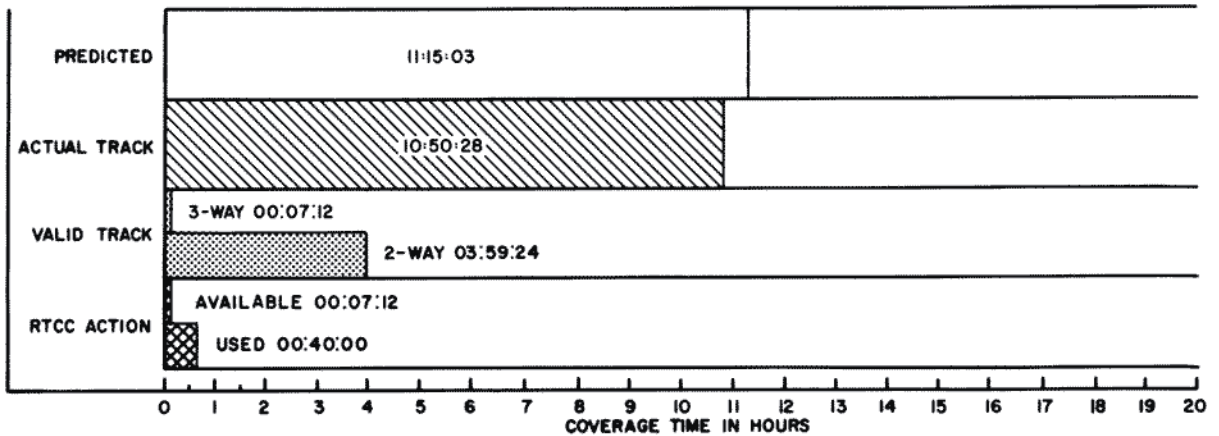
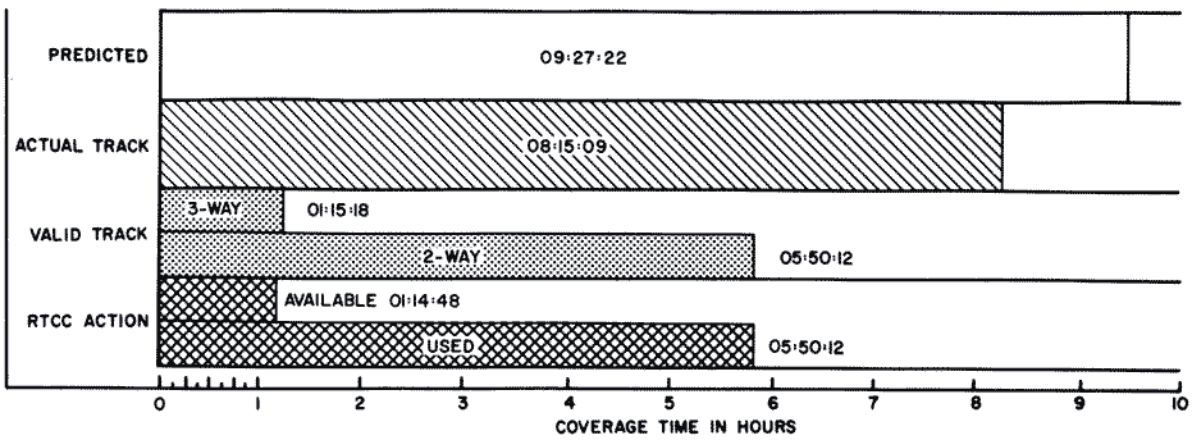
Figure 3-67. HSK USB Tracking Coverage

(1) EO -- CSM

(2) TLC -- CSM

(3) Lunar Phase -- LM

(a) System No. 1

(4) Lunar Phase -- CSM

3.15.2.1 Honeysuckle Creek (HSK) USB (Figure 3-67). During TLC at 20:50:00 GET, tracking was momentarily interrupted when the antenna slewed off in the X-axis while autotracking. The antenna was returned to the proper position after program track was initiated. Postpass investigation revealed a corroded connector on the X-axis channel cable. As a temporary solution the connector was cleaned and the problem did not recur. After a postmission investigation, however, the connector was replaced. Near the end of the lunar phase (132:15:00 GET), a 10-dB discrepancy in cooled paramp gain was noted, apparently caused by a decrease in klystron pump power. Downlink signal degradation resulted, so the paramp was retuned. However, at the beginning of TEC, HSK noted an increase in paramp system noise, which caused a loss of approximately 5 minutes of CSM HBR data. Two-way lock was maintained, although paramp gain dropped sharply and oscillations were observed. Contingency handover between HSK and HSKX was initiated and accomplished in order for HSK to reconfigure from cooled to uncooled paramp operation. Over an hour was required to complete the changeover, after which tracking was returned to HSK (3.1.2.3).
