MANNED  
SPACE  
FLIGHT  
NETWORK

# POSTMISSION REPORT ON THE AS-506 (APOLLO 11) MISSION

FEBRUARY 1970

GODDARD  
SPACE  
FLIGHT  
CENTER

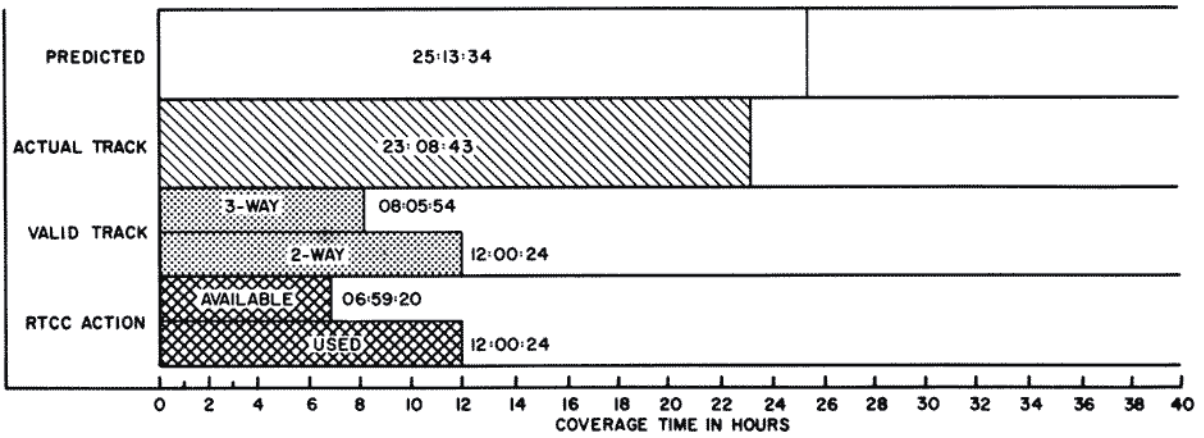
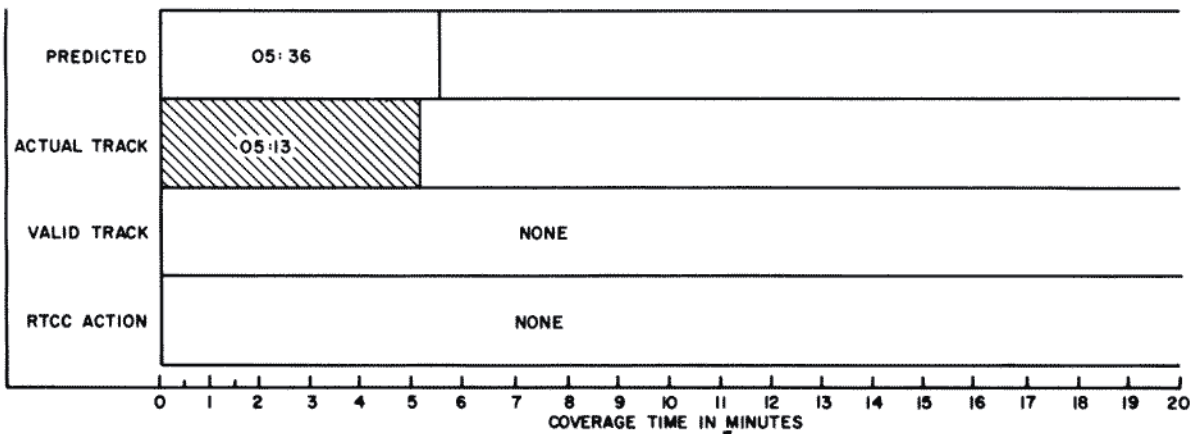
Figure 3-67. HSK USB Tracking Coverage (cont)

(4) Lunar Phase -- CSM

(5) TEC -- CSM

(a) System No. 1 (Cont)

(b) System No. 2, EO -- IU

3.15.2.1 Honeysuckle Creek (HSK) USB (Figure 3-67). During TLC at 20:50:00 GET, tracking was momentarily interrupted when the antenna slewed off in the X-axis while autotracking. The antenna was returned to the proper position after program track was initiated. Postpass investigation revealed a corroded connector on the X-axis channel cable. As a temporary solution the connector was cleaned and the problem did not recur. After a postmission investigation, however, the connector was replaced. Near the end of the lunar phase (132:15:00 GET), a 10-dB discrepancy in cooled paramp gain was noted, apparently caused by a decrease in klystron pump power. Downlink signal degradation resulted, so the paramp was retuned. However, at the beginning of TEC, HSK noted an increase in paramp system noise, which caused a loss of approximately 5 minutes of CSM HBR data. Two-way lock was maintained, although paramp gain dropped sharply and oscillations were observed. Contingency handover between HSK and HSKX was initiated and accomplished in order for HSK to reconfigure from cooled to uncooled paramp operation. Over an hour was required to complete the changeover, after which tracking was returned to HSK (3.1.2.3).

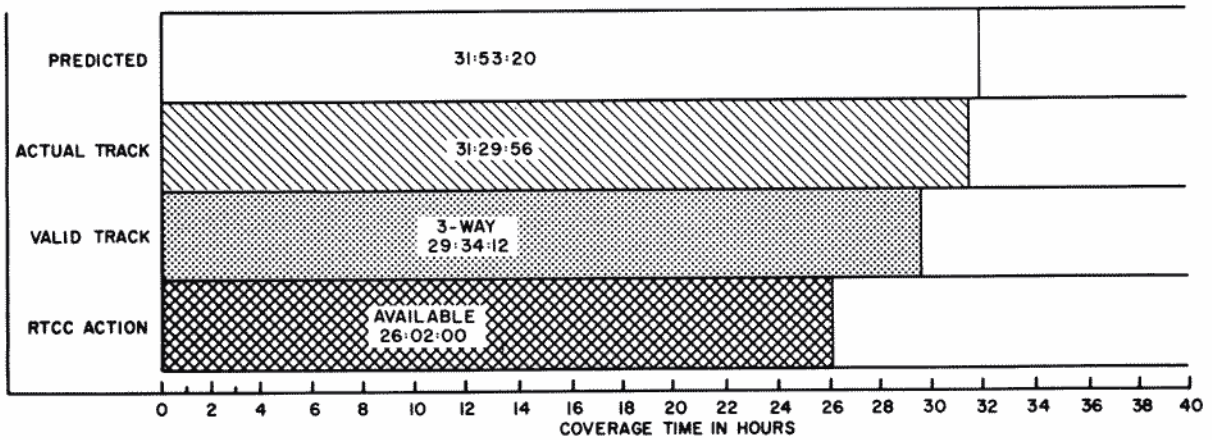
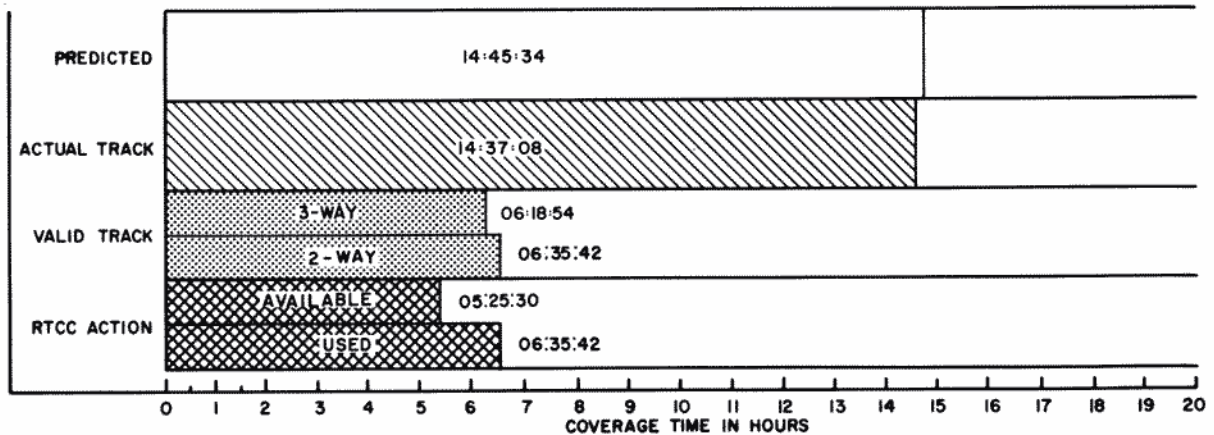
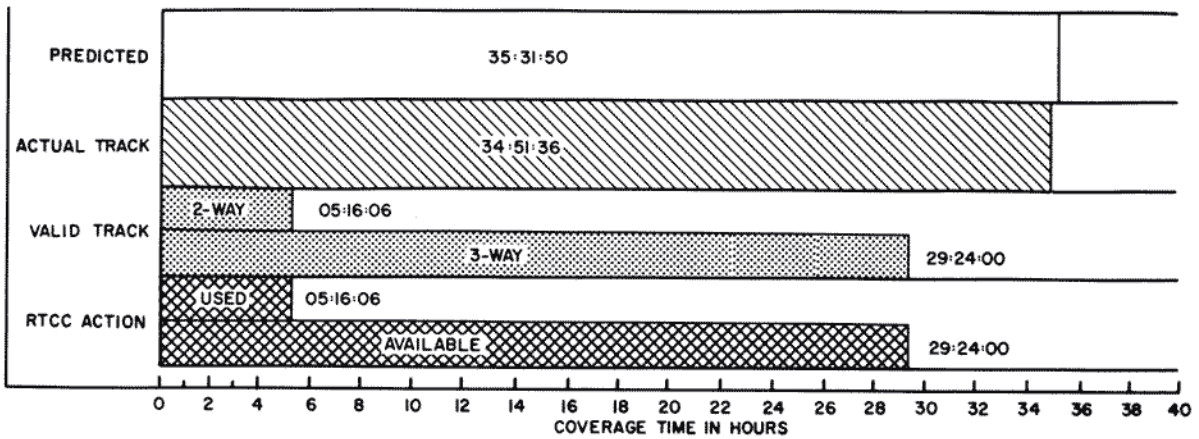
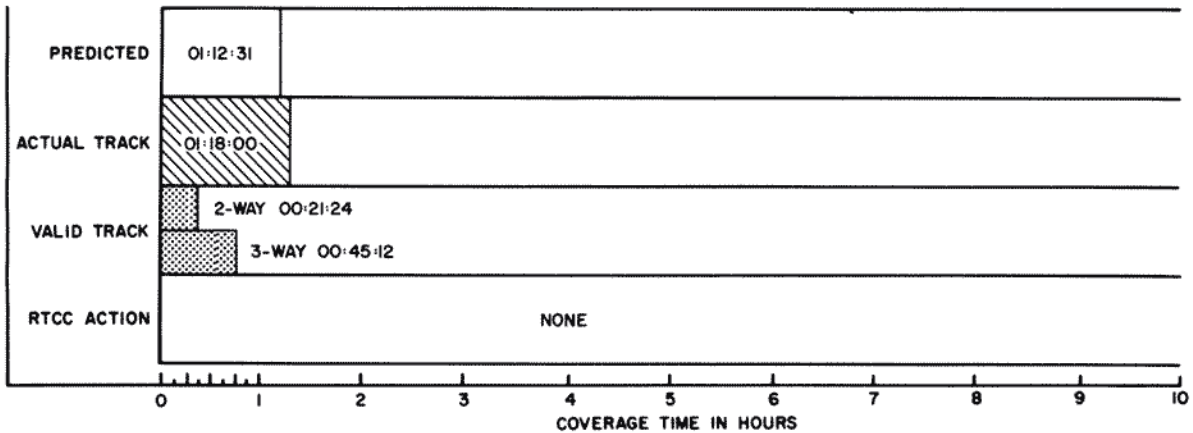
Figure 3-68. HSKX USB Tracking Coverage

(1) TLC -- CSM

(2) Lunar Phase -- CSM

(a) System No. 1

(3) TEC -- CSM

(a) System No. 1 (cont)

(b) System No. 2, Lunar Phase -- LM

3.15.2.2 Honeysuckle Creek Wing (HSKX) USB (Figure 3-68). Interruption of timing signals of two stripchart recorders occurred at 09:58:00 GET. The problem was a faulty timing cable. Repair to this cable restored normal timing annotation to the recorders at 16:40:00 GET.

At 42:52:00 GET, the supply control system of PA No. 2 was severely damaged from an electrical fire caused by a short circuit in the 400-volt, three-phase power supply. Considerable damage was sustained to internal wiring, along with some melting and fusing of the metal work and cabinet panels. Uplink capability was lost using this PA, but PA No. 1 was available and was brought into service for command and voice transmissions while repairs were being performed on the damaged unit. The DSN is responsible for supporting M&O requirements of HSKX; parts and technical assistance were provided by the DSN's Tidbinbilla station near Woomera. PA No. 2 was restored to an operational status in less than 38 hours by a commendable joint effort of HSKX and Tidbinbilla personnel (3.1.2.2).

During TEC at 138:58:00 GET, erratic range data from system No. 1 was noted. The USB was reconfigured and system No. 2 provided all remaining tracking support. The cause of the problem could not be determined.

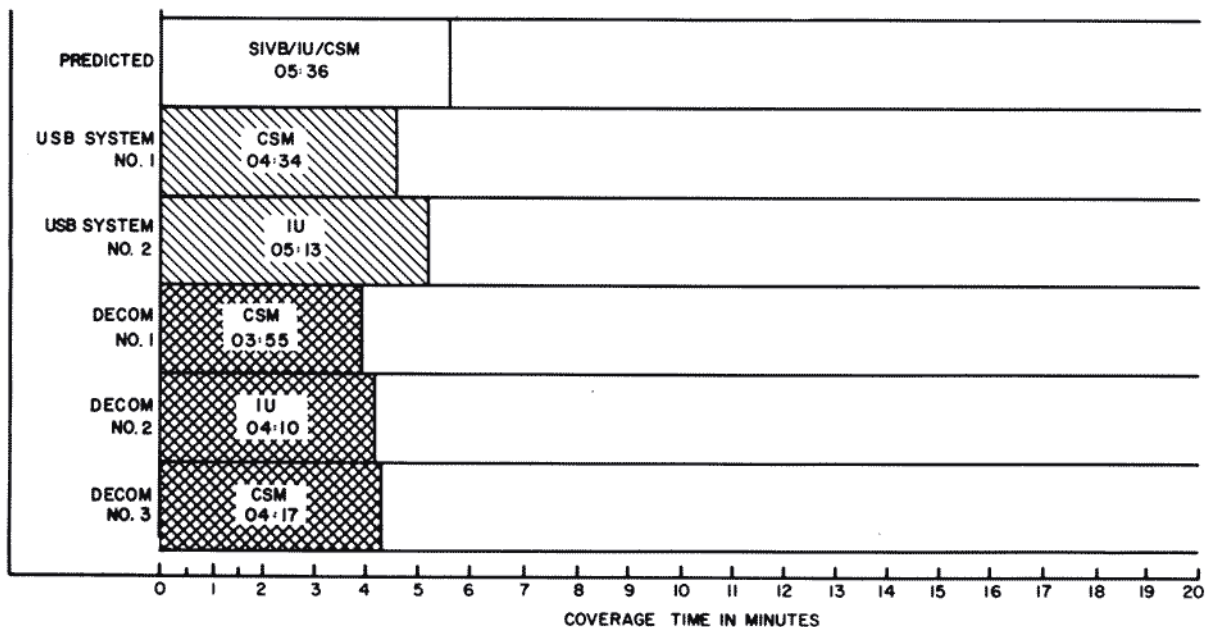
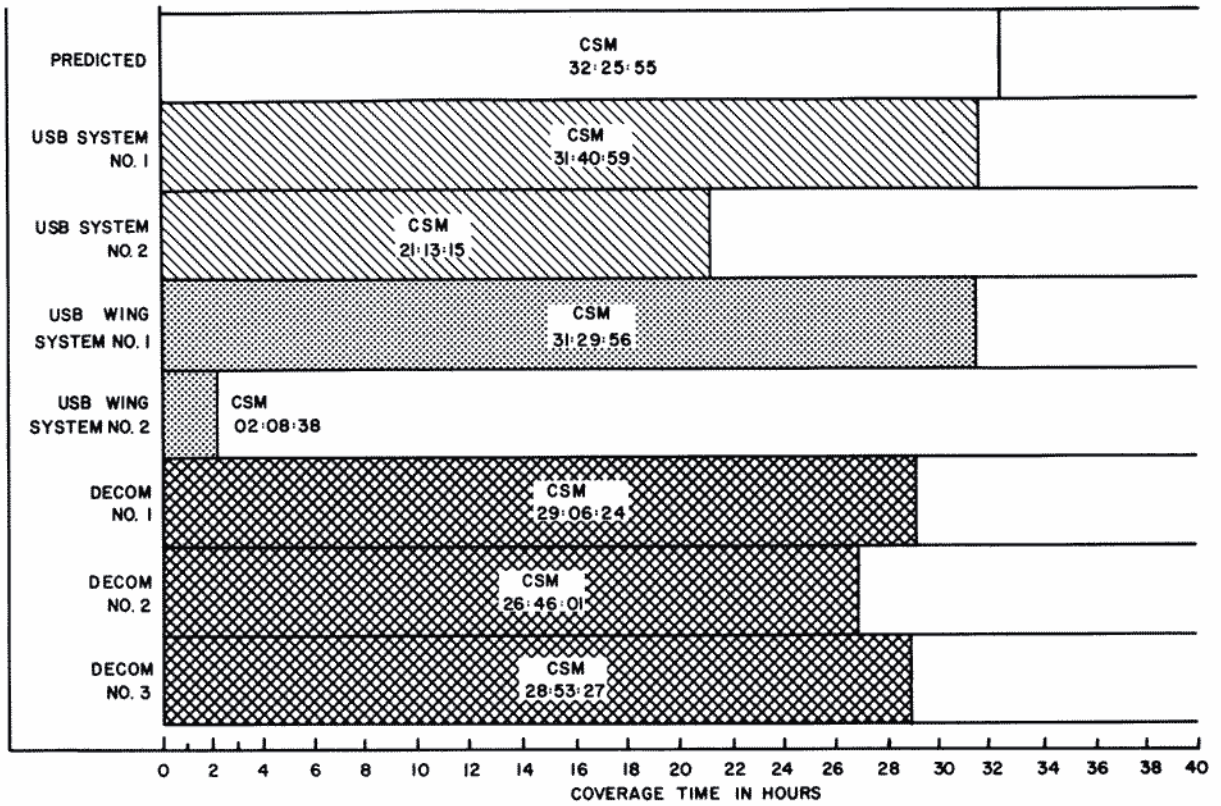
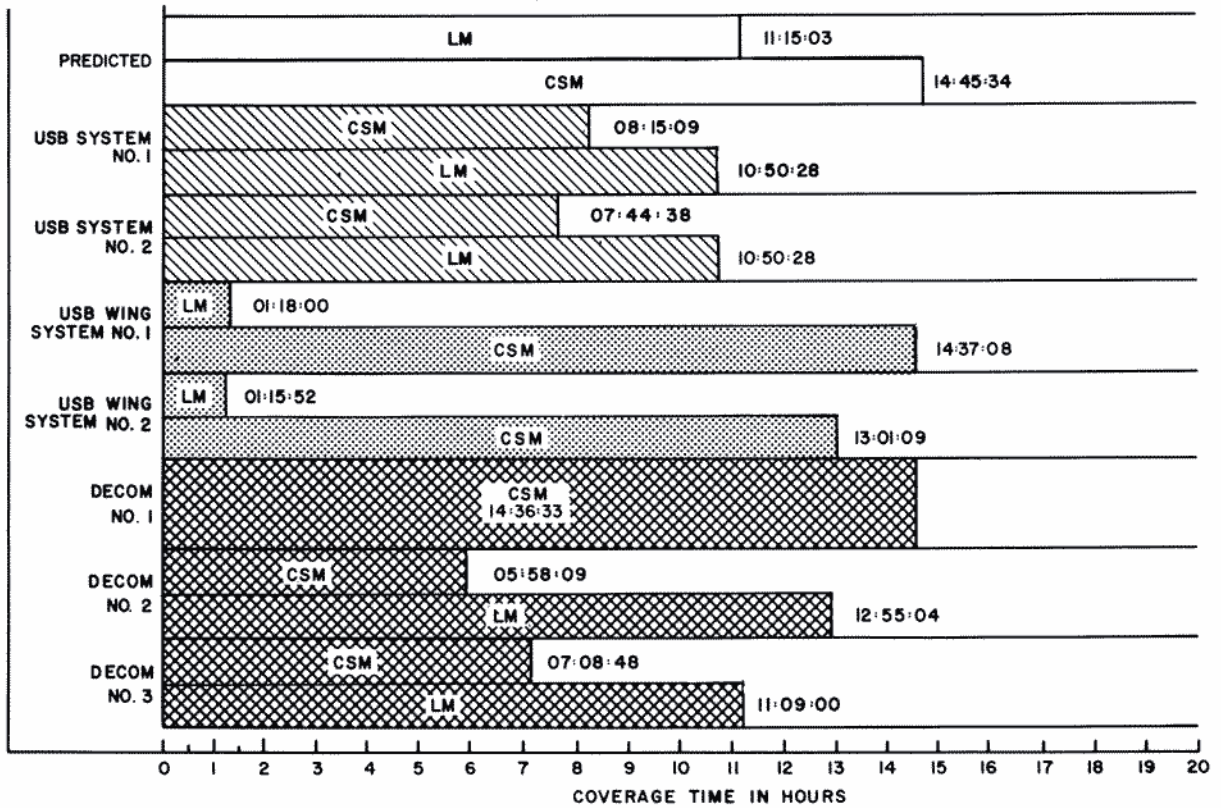
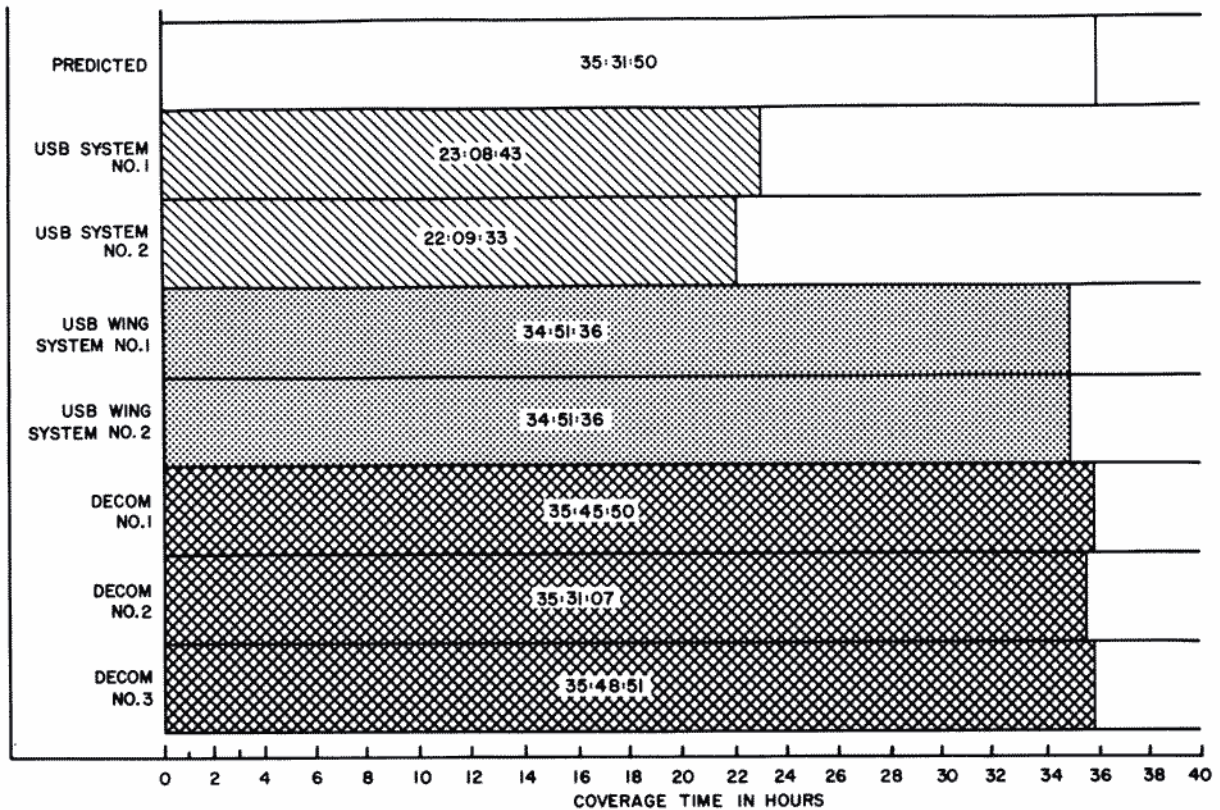
Figure 3-69. HSK/HSKX Telemetry Coverage

(a) EO

(b) TLC

(c) Lunar Phase

(d) TEC -- CSM

### 3.15.3 TELEMETRY (Figure 3-69).

3.15.3.1 USB. Real-time and dump data from the CSM were processed during EO, TLC, the lunar phase, and TEC. Real-time LM data was processed during the lunar phase, including the lunar stay, and until requirements for this vehicle were terminated. Limited support for EASEP was required during the final portion of TEC. Data loss other than that caused by spacecraft antenna usage was minimal (3.1.3.1). The primary cause of data loss was the HSK paramp problem already described in paragraph 3.15.2.1. Handover to the wing station minimized loss of telemetry data.

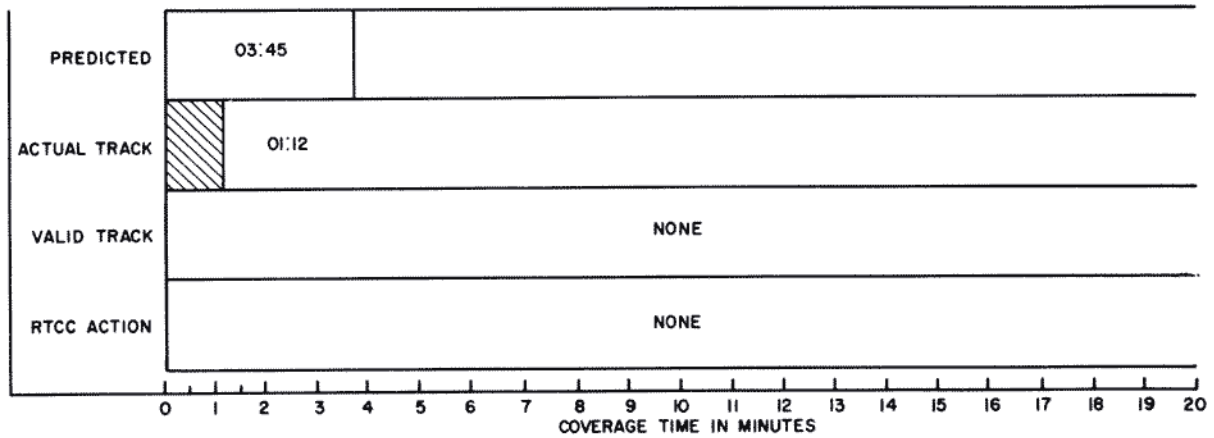
Figure 3-73. HTV USB Tracking Coverage, Reentry -- CSM

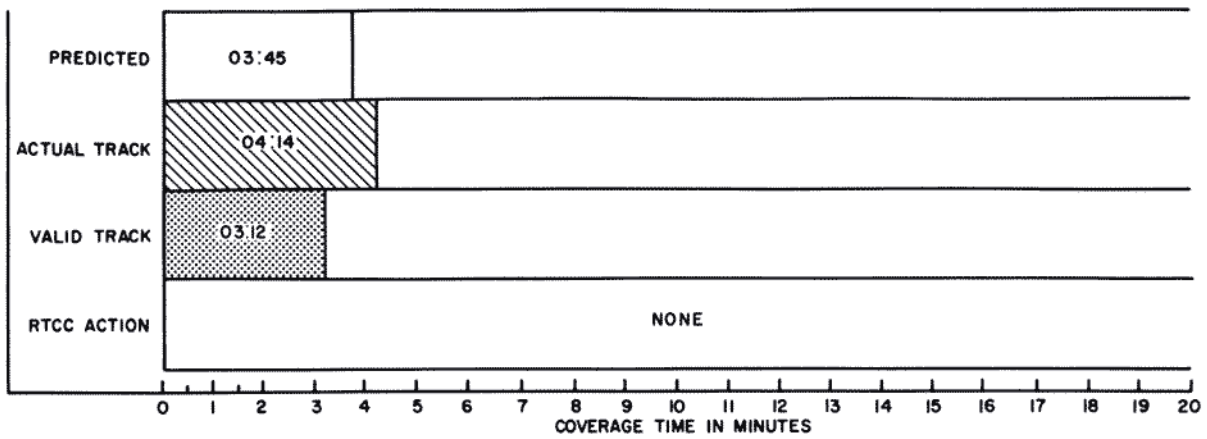
Figure 3-74. HTV CAPRI Tracking Coverage, Reentry -- CM

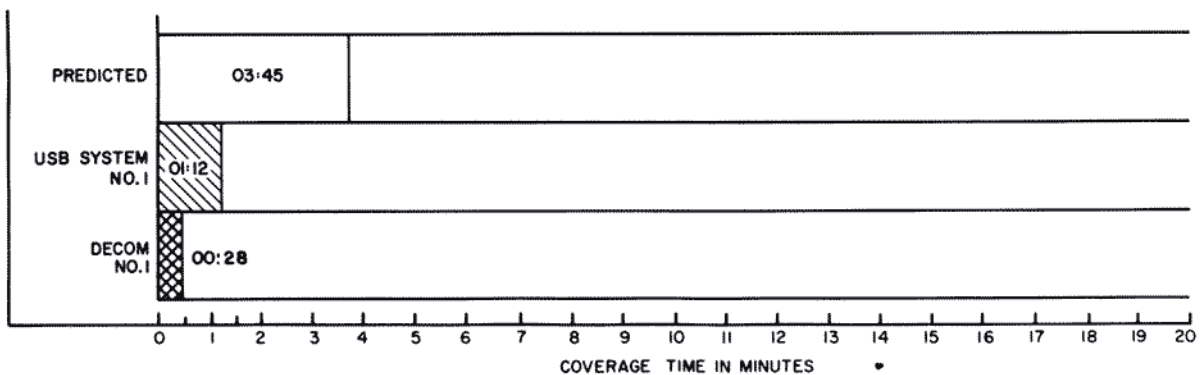
Figure 3-75. HTV Telemetry Coverage, Reentry -- CM

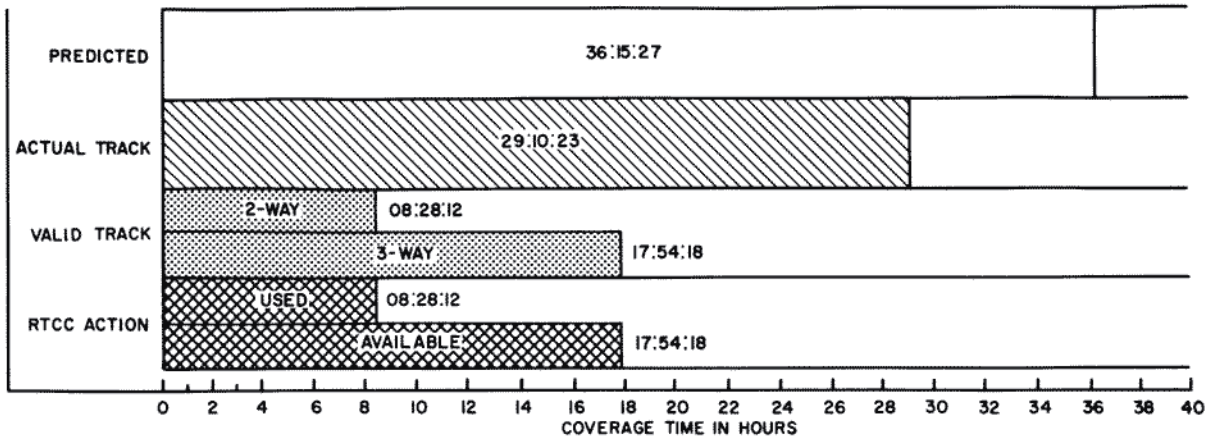
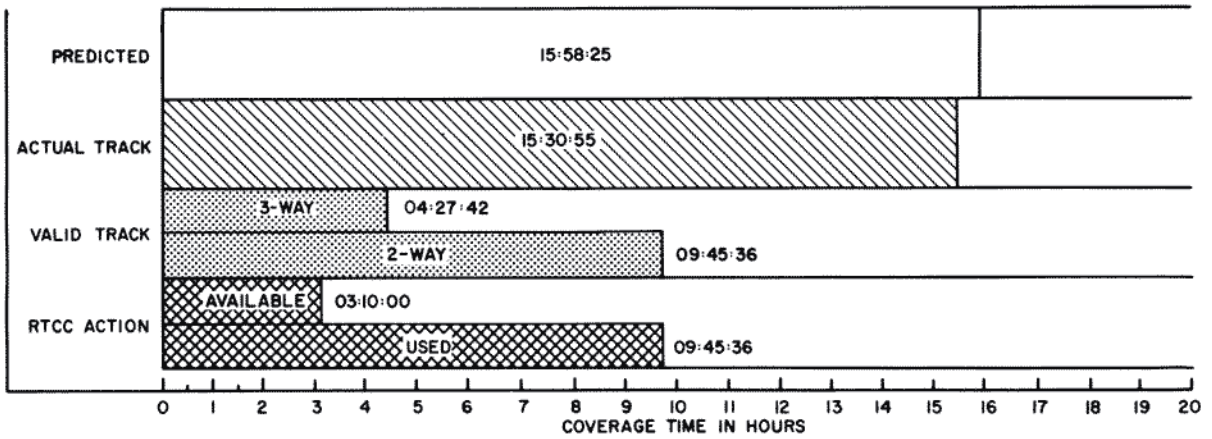
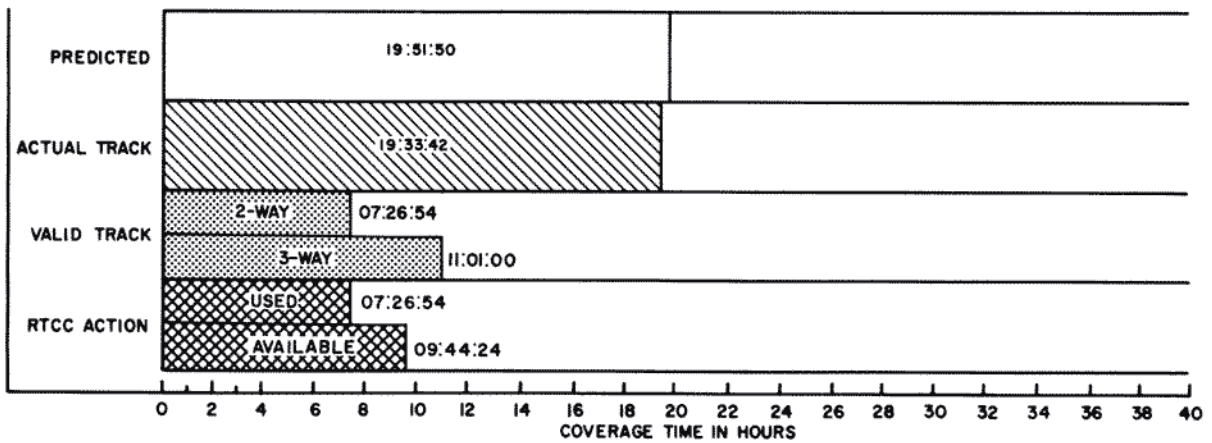
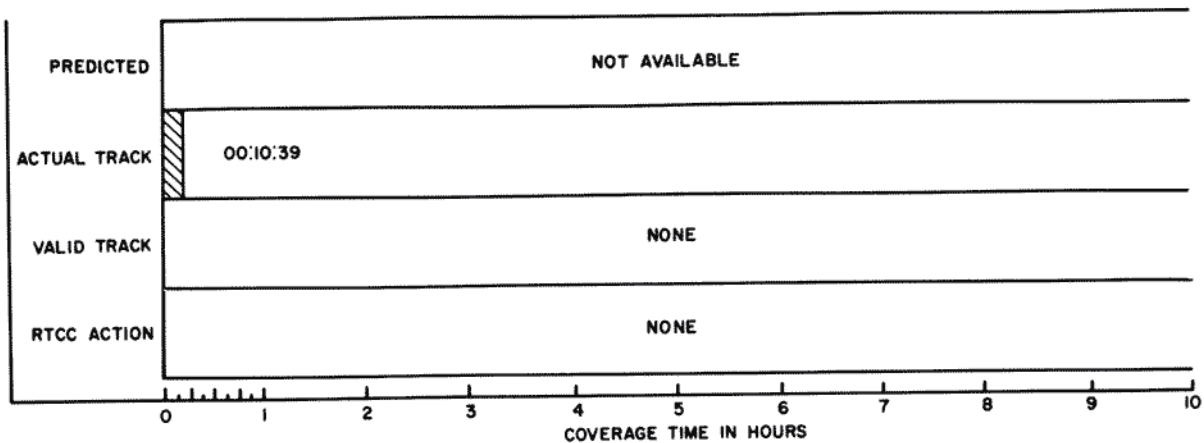
Figure 3-79. MAD USB Tracking Coverage

(1) TLC -- CSM

(2) Lunar Phase -- CSM

(3) TEC -- CSM

(a) System No. 1

(b) System No. 2, Lunar Phase -- LM

3.17.2.1 Madrid (MAD) USB (Figure 3-79). Early in TLC (04:02:00 GET), an operator error at GDS occurred during a GDS to MAD HGA handover. The GDS operator used omni-antenna procedures as opposed to those for HGA. However, MAD initiated uplink and was able to acquire two-way lock with no appreciable loss of track.

At 98:08:30 GET, the failure of a timing system distribution amplifier disabled PFS channel No. 1 (3.1.2.4). The problem was resolved prior to AOS for LO 12 by switching to channel No. 2 and resynchronizing the time standards, and had no impact on mission support.

During LO 25 at 124:28:24 GET, severe oscillations were observed in the antenna X-axis. This difficulty was caused by a defective position amplifier in the servo system. Antenna motion in the X-axis was halted, the amplifier replaced, and autotrack maintained for the remainder of the view period.

Shortly after AOS on LO 26, a cooled paramp problem resulted in the loss of autotrack at 126:04:00 GET. The amplifier began oscillating and had to be retuned to restore normal operation (3.1.2.3). The uncooled paramp was placed in service to provide backup voice.

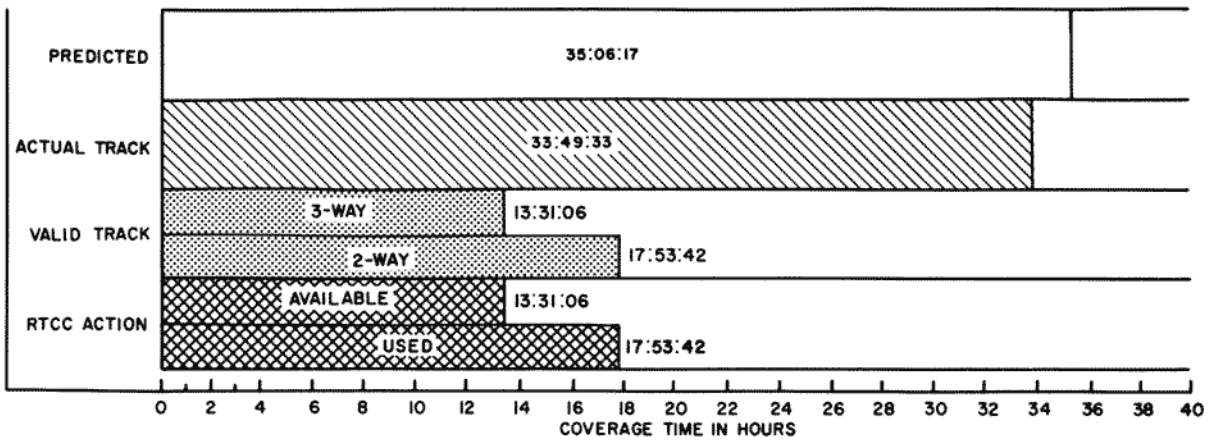
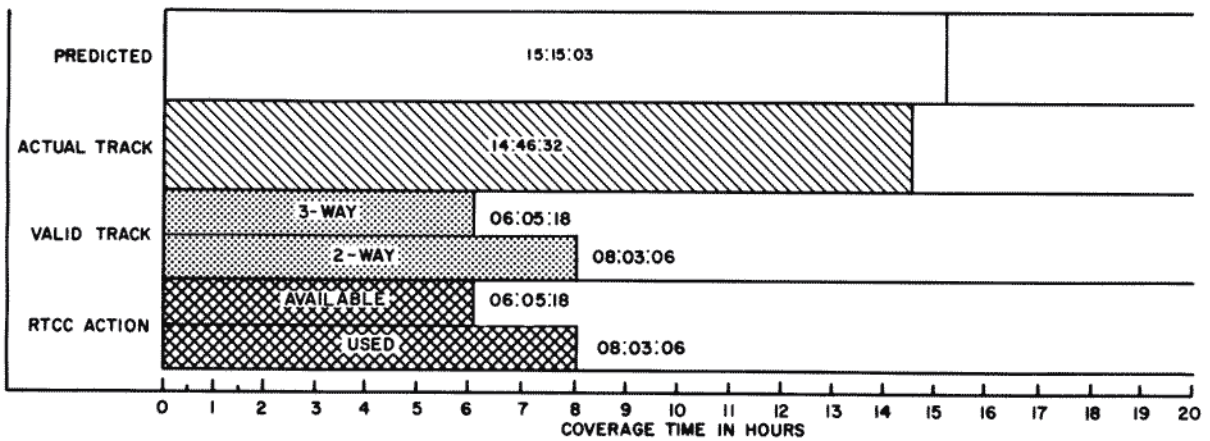
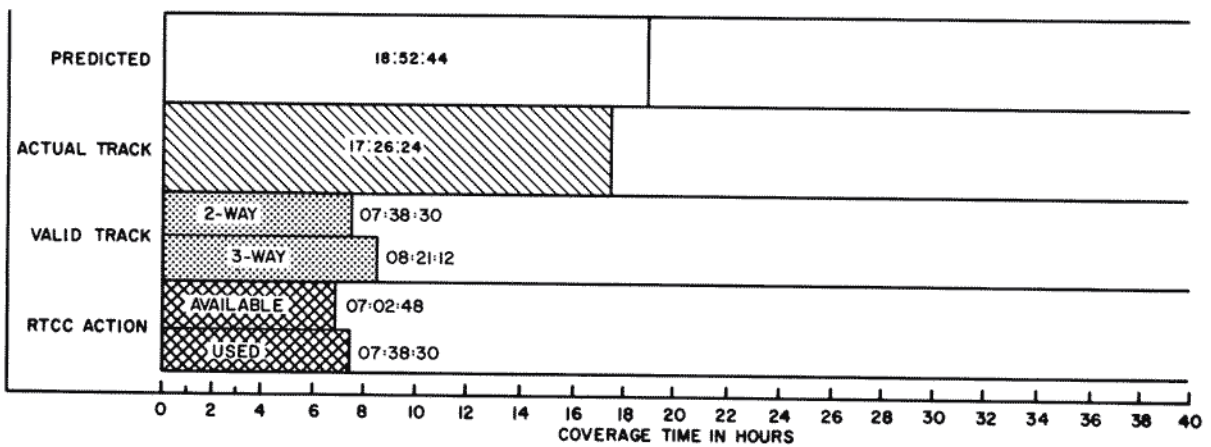
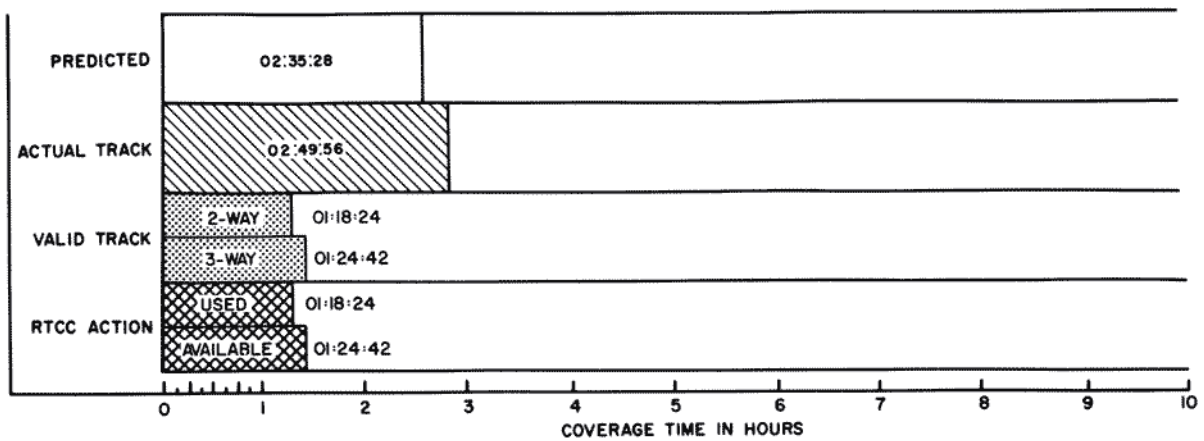
Figure 3-80. MADX USB Tracking Coverage

(1) TLC -- CSM

(2) Lunar Phase -- LM

(3) TEC -- CSM

(a) System No. 1

(b) System 2, Lunar Phase -- CSM

3.17.2.2 Madrid Wing (MADX) USB (Figure 3-80). Marginal operation of the 1218 computer high-speed tape punch caused a faulty drive tape to be supplied for the APP during TLC at 03:25:30 GET (3.1.2.1).

The high ambient temperature in the hydro-mechanical building was the cause of problems at MADX. At 47:10:00 GET, the wing station transmitters were disabled when the main circuit breaker of the 400-Hz generator tripped. Approximately an hour later at 48:18:10 GET, an ac overcurrent relay tripped on the beam high-voltage generator, again disabling the transmitters. This resulted when MADX raised the beam voltage to maximum limits. Uplink capability was interrupted on both occasions and an unscheduled handover to the prime station was performed.

At 69:15:00 GET, large range jumps of several thousand meters were observed in the ranging data. Troubleshooting revealed a defective PC card (FD-10, slot 13) in the readout register. This card provided bits 12 and 13 of the 30-bit range. Replacement of the card resolved the problem and no further difficulty was encountered.

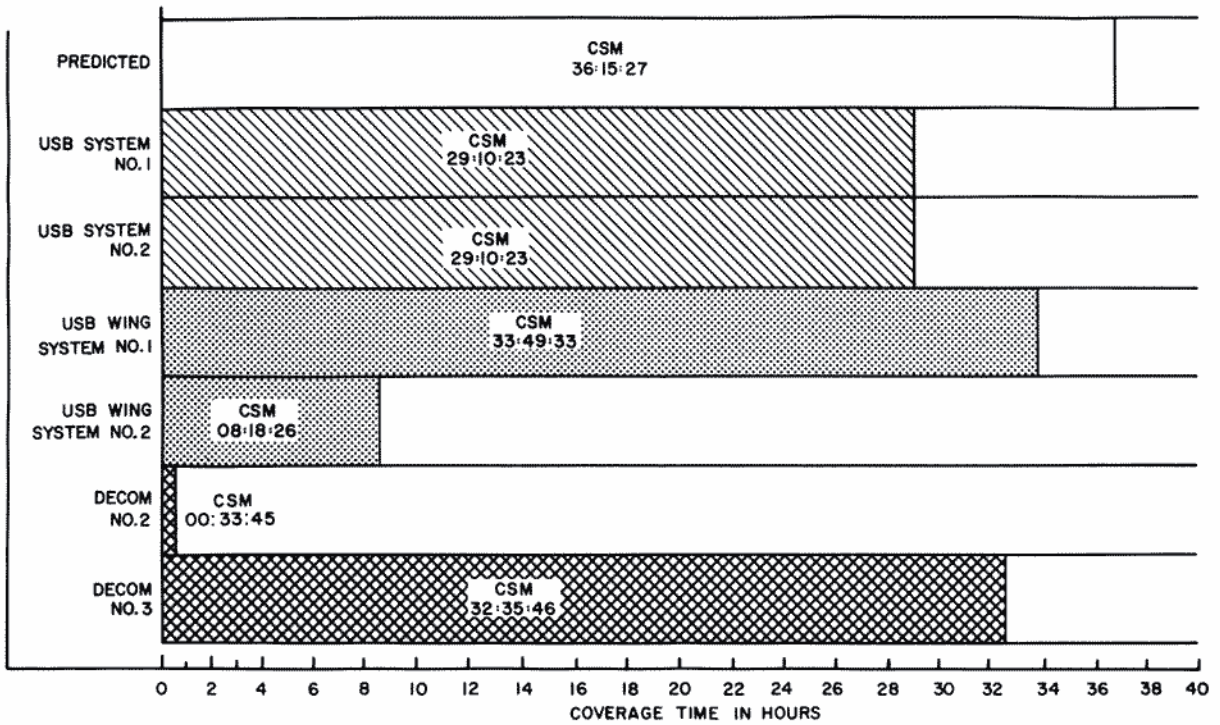
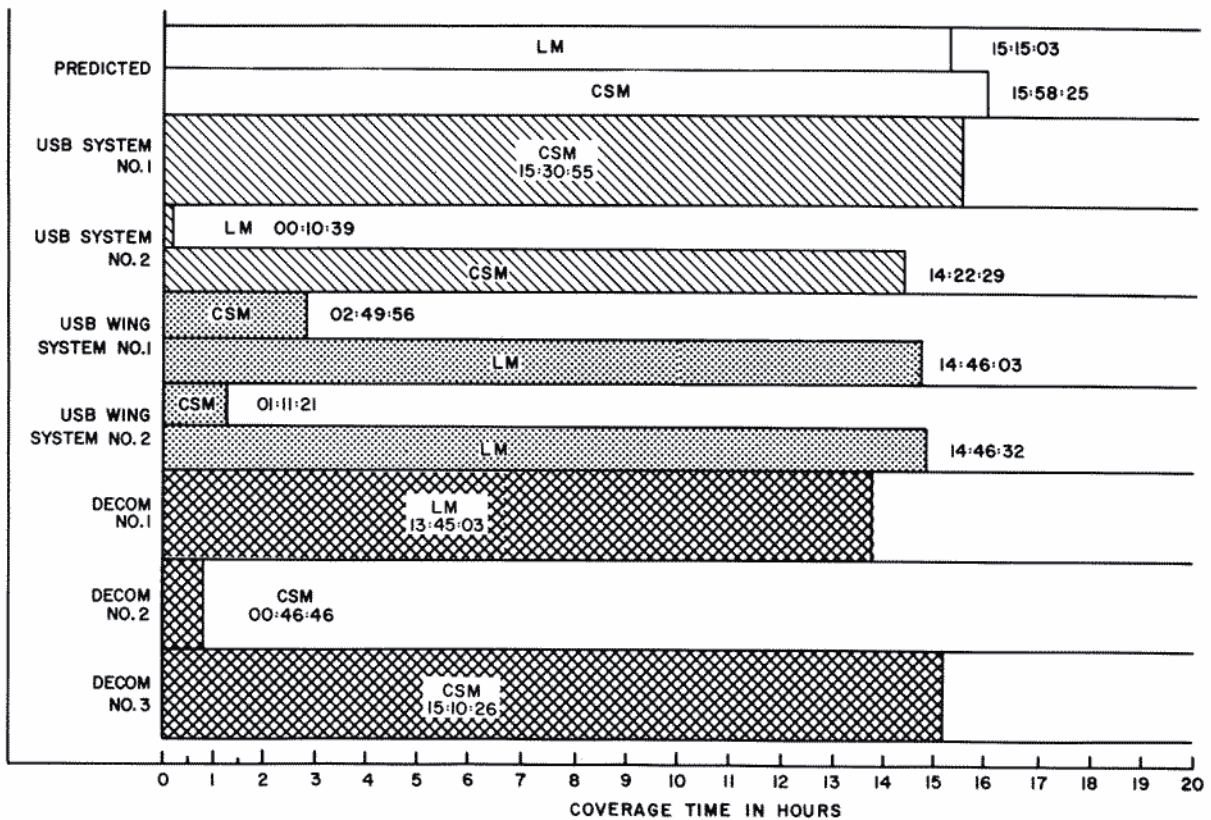
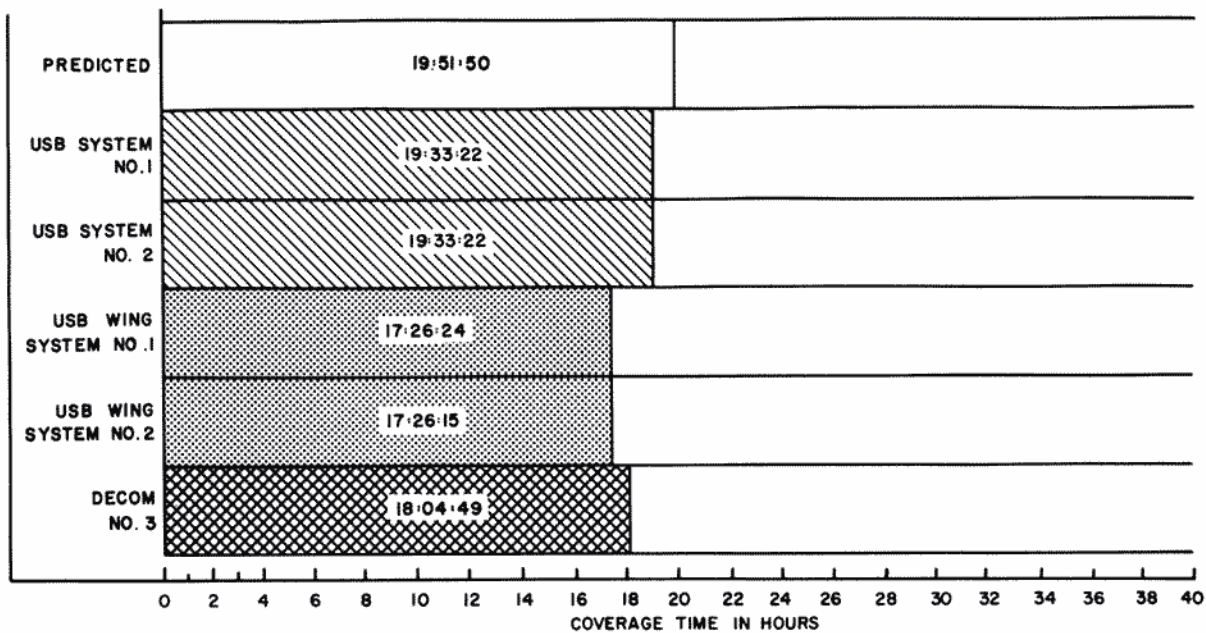
Figure 3-81. MAD/MADX Telemetry Coverage

(a) TLC

(b) Lunar Phase

(c) TEC -- CSM

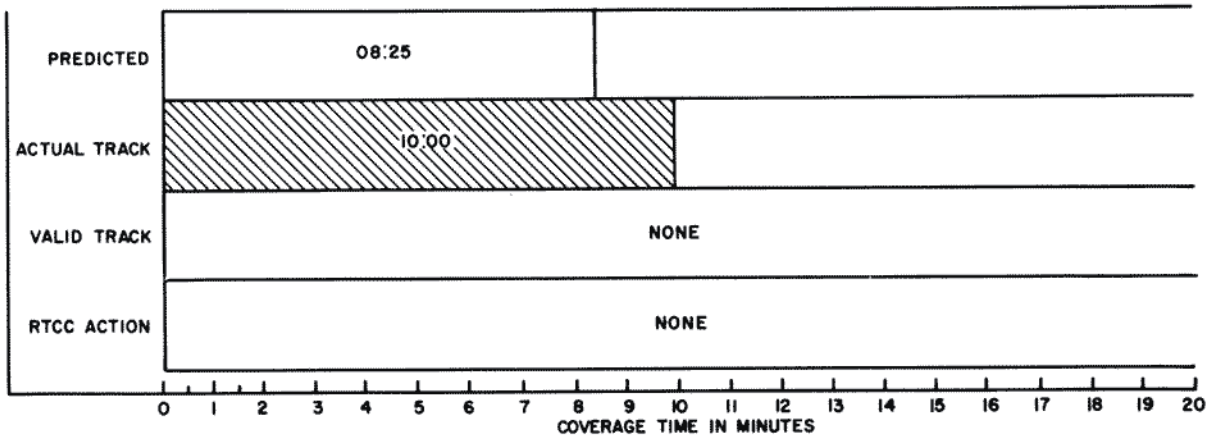
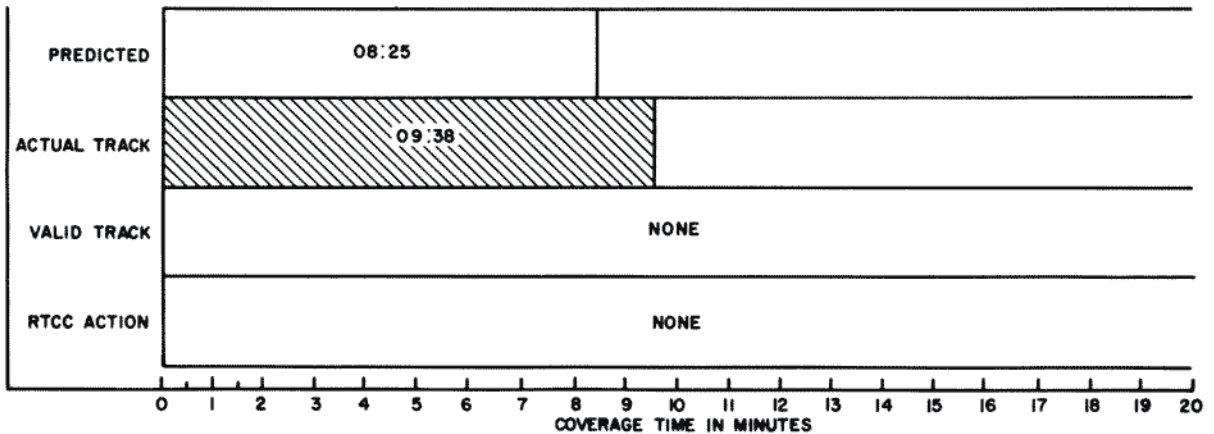
Figure 3-85. MER USB Tracking Coverage

(a) System No. 1, EO -- CSM

(b) System No. 2, EO -- IU

"go" for CSM command at 02:47:43 GET. At this time, signals were noisy and numerous tracking losses occurred due to attenuation of the S-band carrier caused by the S-IVB flame plume. As a result, USB metric data was not flagged two-way and the data was rejected by MSC. HAW had AOS at 02:49:04 GET and MSC, dubious of MER support capabilities, initiated contingency handover procedures from MER to HAW. The early handover was successfully accomplished at 02:49:46 GET. All MER data received from this point on was ignored by MSC.

MER had a flexure monitor equipment failure prior to the pass due to a shorted transistor. Upon replacement, the equipment was declared operational. However, the same transistor shorted again during the pass at 02:45:00 GET. The flexure monitor contingency procedures contained in the NOD were exercised. But an attempt to load the misalignment coefficients in accordance with ISI 043, while the computer was cycling in real time, caused a CDP fault. MER's MMR stated that the problem was due to software within the CDP, but the exact nature was not given (3.1.2.5).

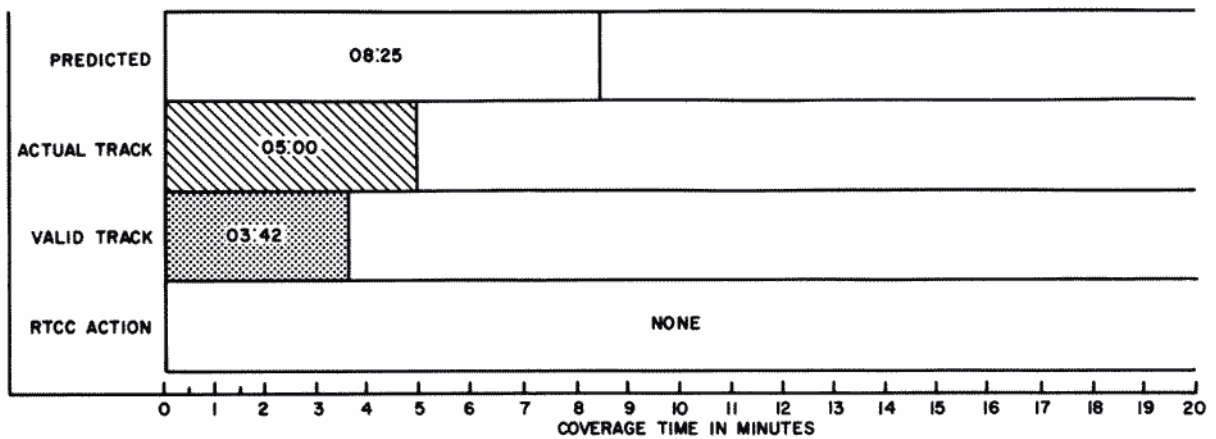
Figure 3-86. MER FPS-16 Tracking Coverage, EO -- IU

3.18.2.2 Radar (Figure 3-86). During TLI, the S-IVB/IU was acquired 2 minutes and 36 seconds later than predicted. As a result, MER provided only limited TLI support. Acquisition was not accomplished until the TLI burn was nearly completed. This was caused by MER's failure to comply with ISI 053 which directed the use of beam intercept

techniques for acquisition. Instead, MER initially elected to use the IRV to acquire. When this failed, the S-IVB/IU was finally acquired by slaving to the USB and using manual offset. An additional loss of data resulted from phasing problems with another radar. All MER C-band data was inhibited by MSC RTCS because of the higher priority for USB metric data.

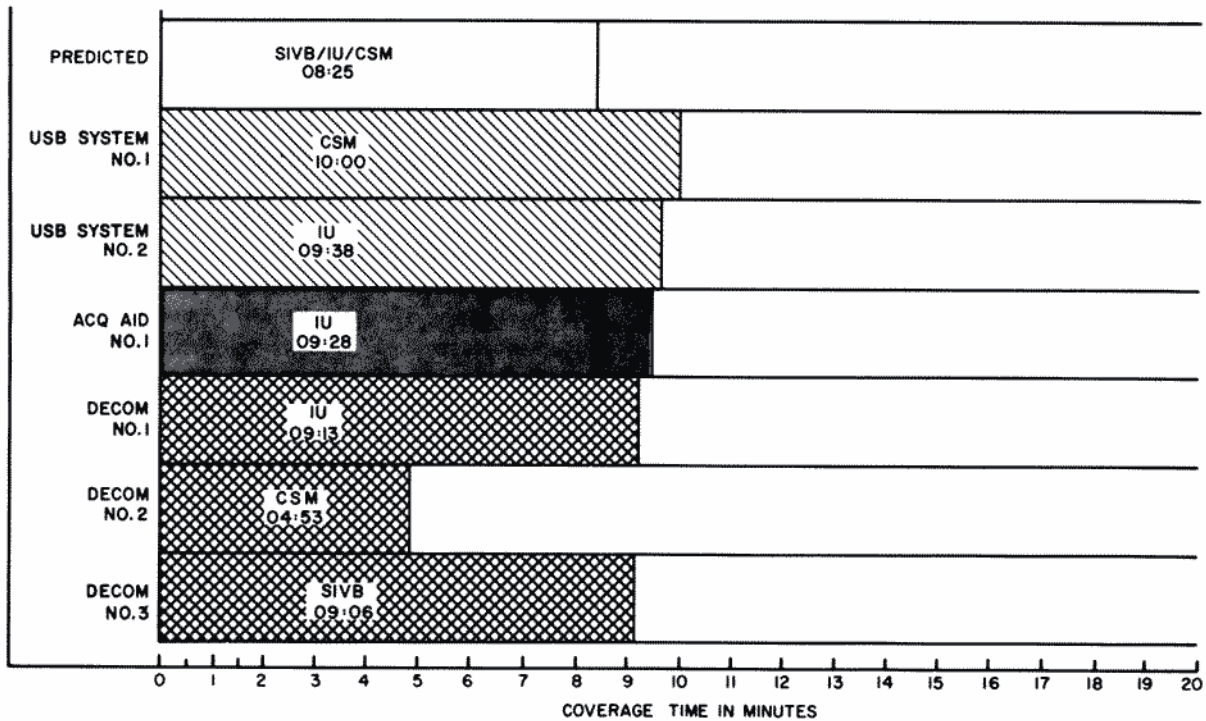
Figure 3-87. MER Telemetry Coverage, EO

3.18.3.1 USB. The received signals from the CSM were erratic and noisy during the TLI burn due to S-band tracking problems and flame attenuation previously mentioned. Therefore, the primary requirement of providing CSM telemetry processing during the burn and at engine cutoff did not satisfy mission requirements.

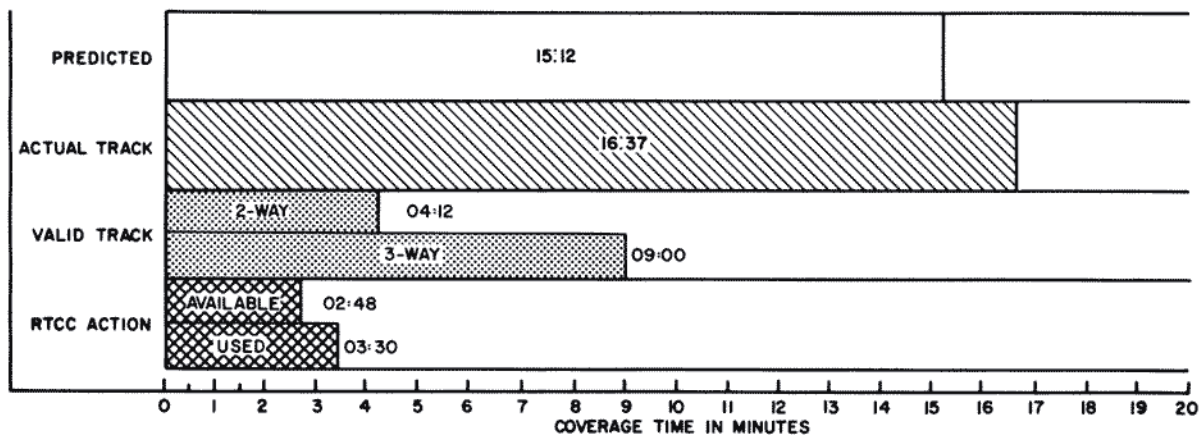
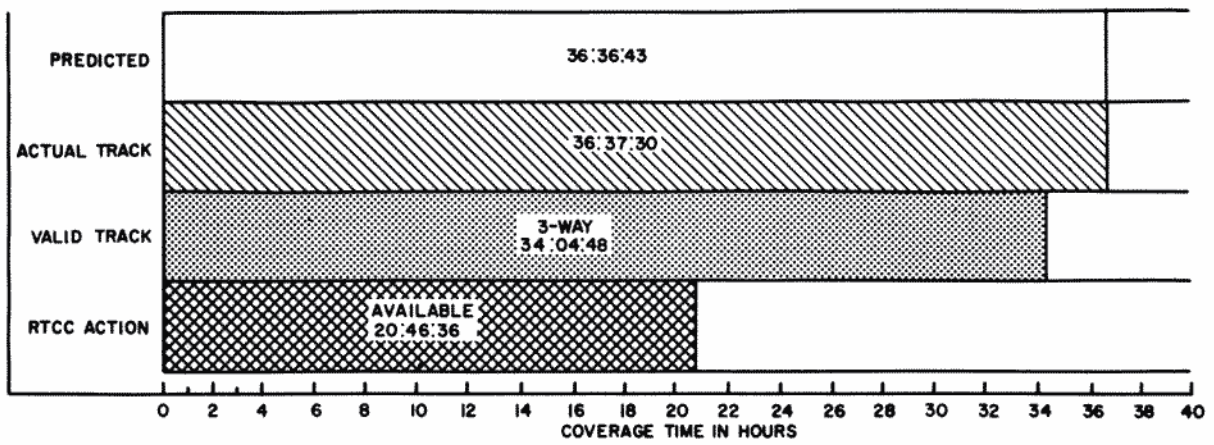
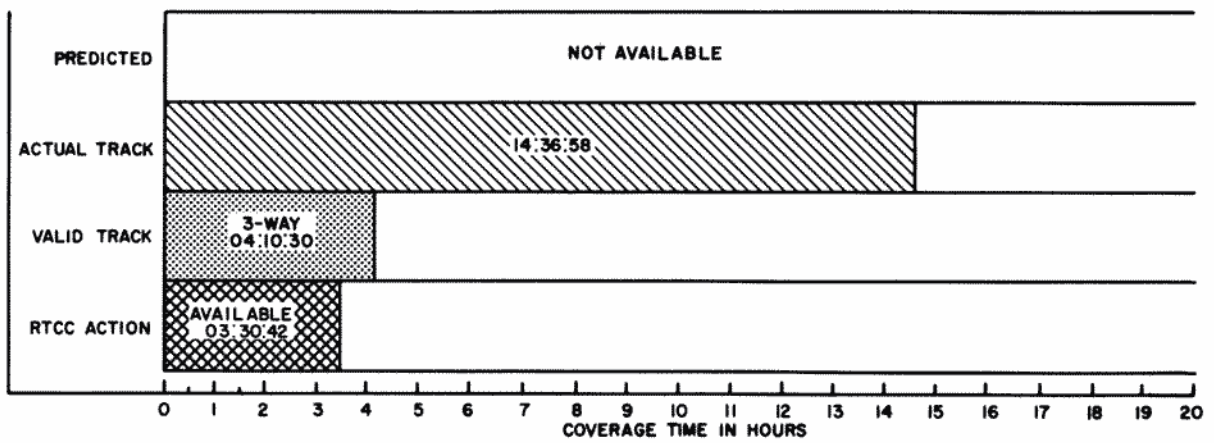
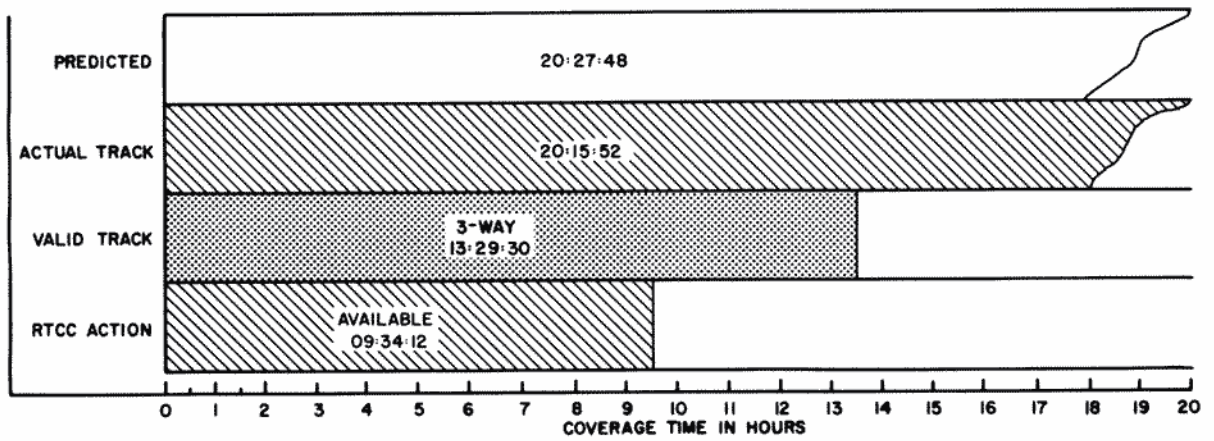
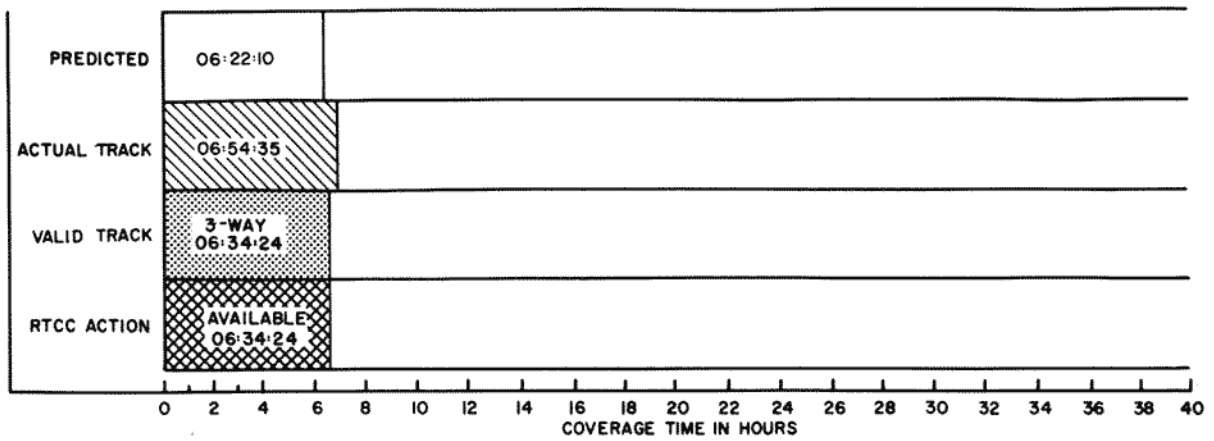
Figure 3-91. MIL USB Tracking Coverage

(1) EO -- CSM

(a) System No. 1

(2) TLC -- CSM

(3) Lunar Phase -- LM

(4) Lunar Phase -- CSM

(5) TEC -- CSM

3.19.2.1 USB (Figure 3-91). At 56:19:00 GET, momentary oscillations on channel 1 of the PFS caused an intermittent 1-MHz timing signal to the R/E. An immediate selection of distribution amplifier channel 2, followed by reselection of channel 1, cleared the problem without any loss of data (3.1.2.4).

Following postpass calibrations during the lunar phase at 88:08:00 GET, the antenna was observed entering prelimits 4 degrees early and exiting late. The problem was caused by dirty and pitted contacts on the Y-axis south limits. Cleaning and burnishing the contacts restored the system to operational status.
