MANNED  
SPACE  
FLIGHT  
NETWORK

# POSTMISSION REPORT ON THE AS-506 (APOLLO 11) MISSION

FEBRUARY 1970

GODDARD  
SPACE  
FLIGHT  
CENTER

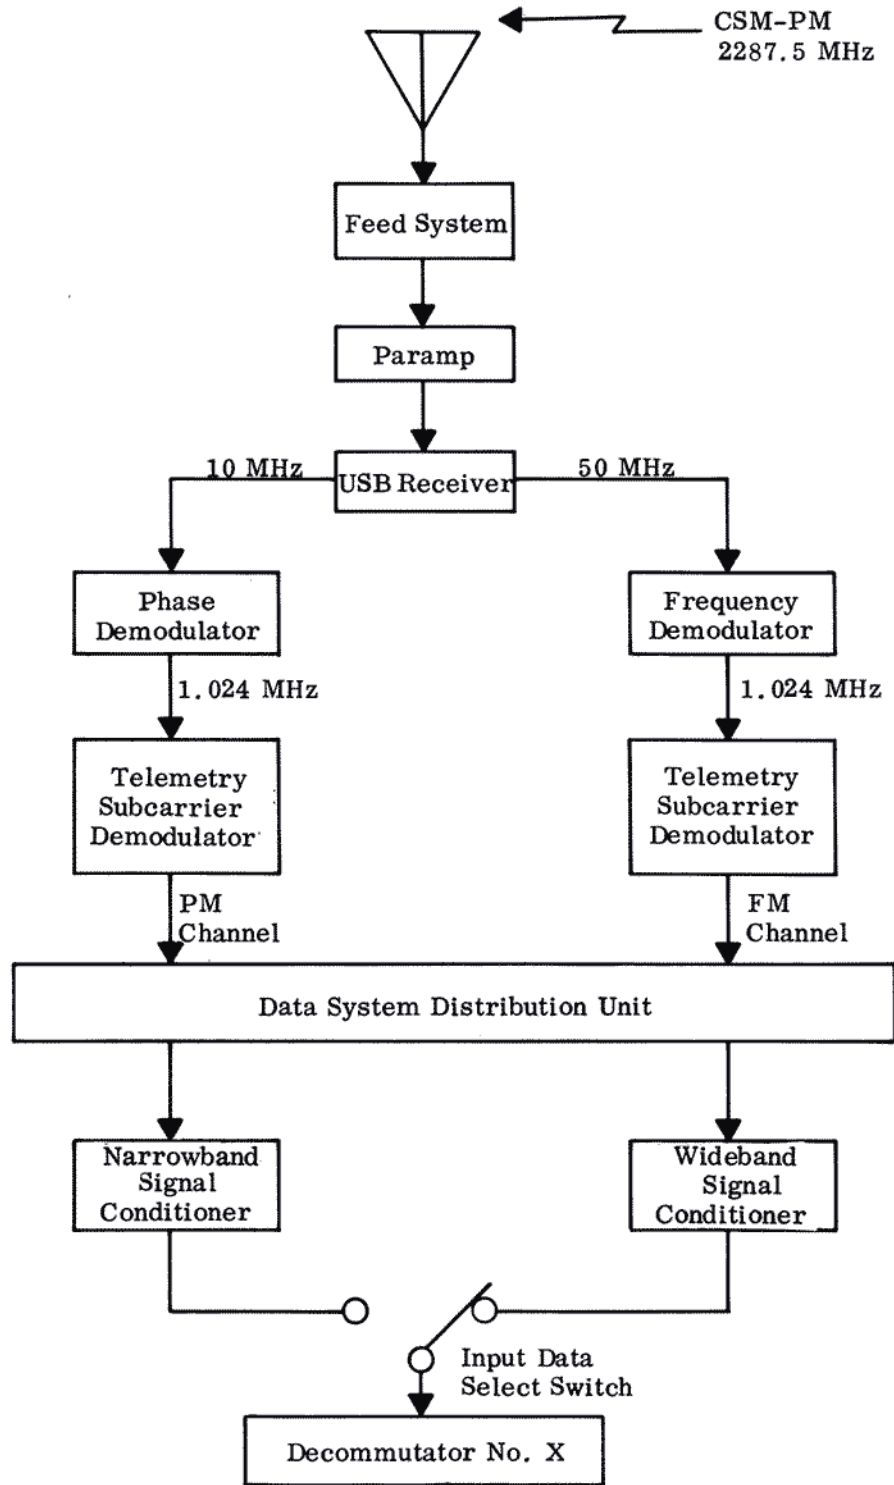
Figure 3-92. MIL USB CSM PM Downlink Telemetry Configuration -- Launch Only.

During the first 7 minutes of launch, CSM PM data was routed through the FM data demod. This configuration was selected because the FM demod does not require a phase lock loop in order to process data, whereas the PM demod is dependent upon the correct phasing to maintain lock. During the initial part of the launch phase, PM downlink data is phase-shifted due to the booster flame and usually causes the PM demod and, subsequently, the decom, to drop lock. In this new configuration, continuous CSM PM data processing was assured even though a 6- to 7-dB loss in signal strength could be expected. Since the downlink signal level is extremely strong during launch because of the close proximity of the vehicle, this loss was considered negligible. MIL tested the new configuration during AS-505, and the net result indicated that better support could be provided using the FM demod arrangement during the early portion of launch. Also, it afforded the PCM operator an option to select either PM or FM channel inputs to the decom. Since the need for good PM USB data is mandatory during launch, this configuration is expected to be used during future missions for launch support. Figure 3-92 is a block diagram depicting data flow when PM data is routed through the FM/demod and the switching capability.

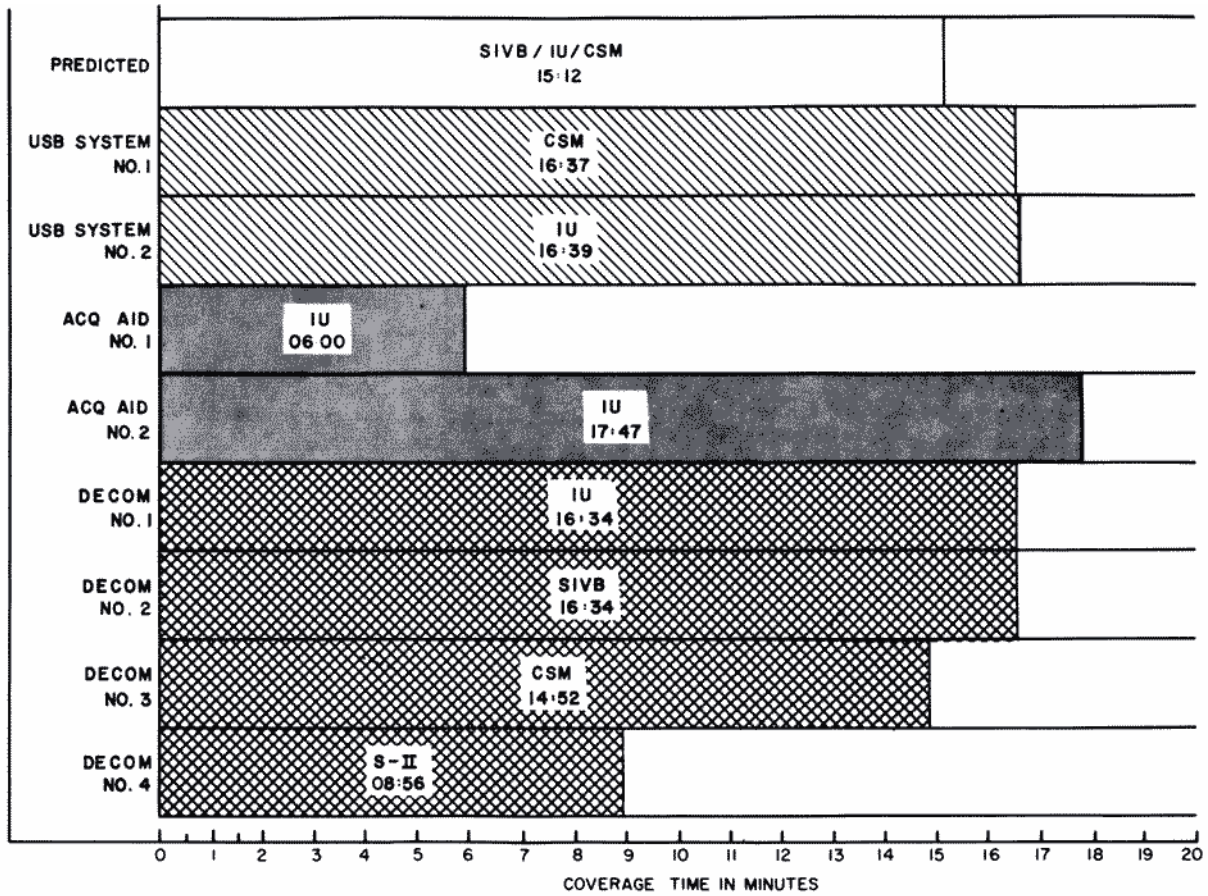
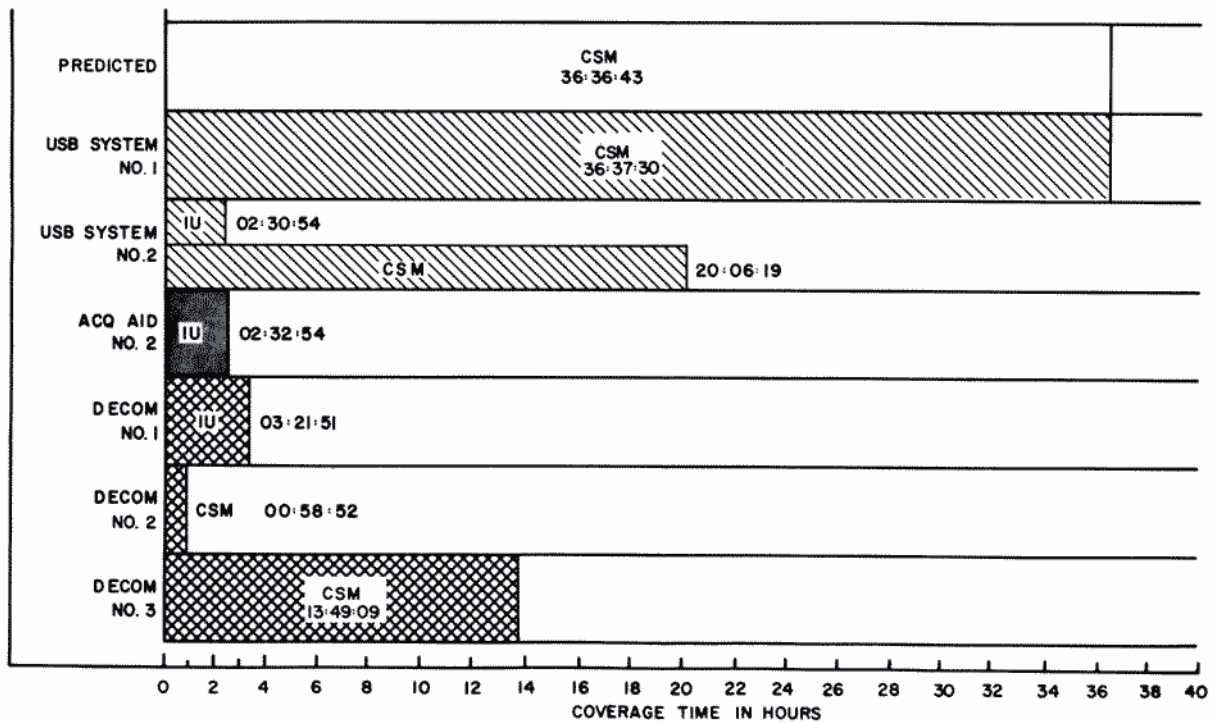
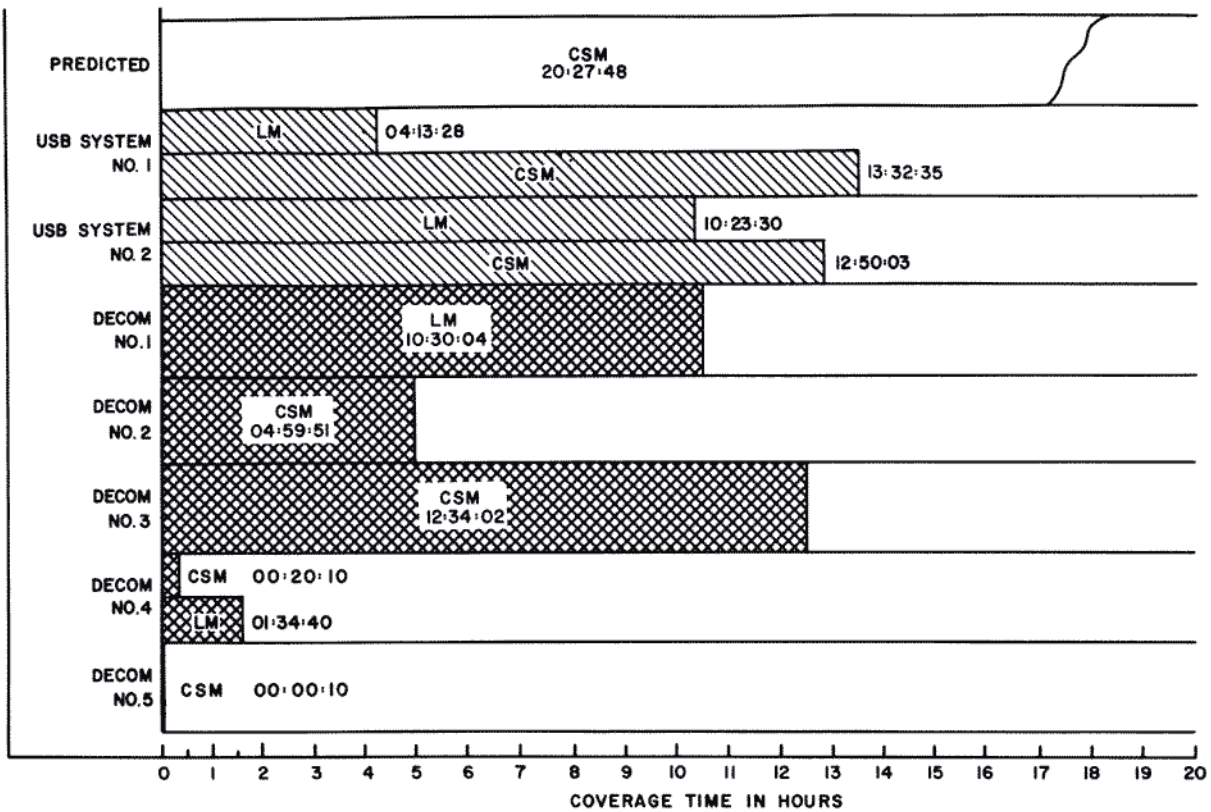
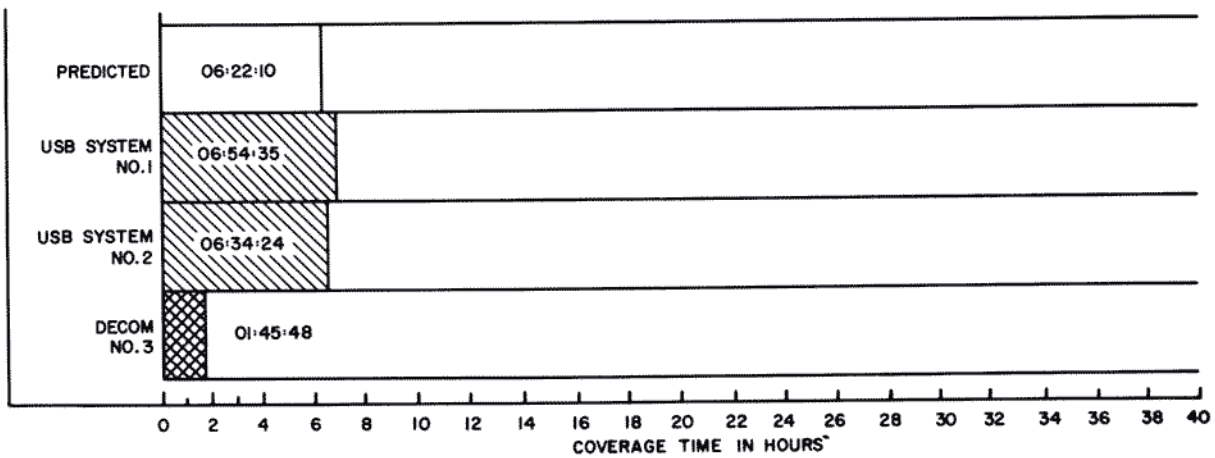
Figure 3-93. MIL Telemetry Coverage

(a) EO

(b) TLC

(c) Lunar Phase

(d) TEC -- CSM

### 3.19.3 TELEMETRY (Figures 3-92 and 3-93)

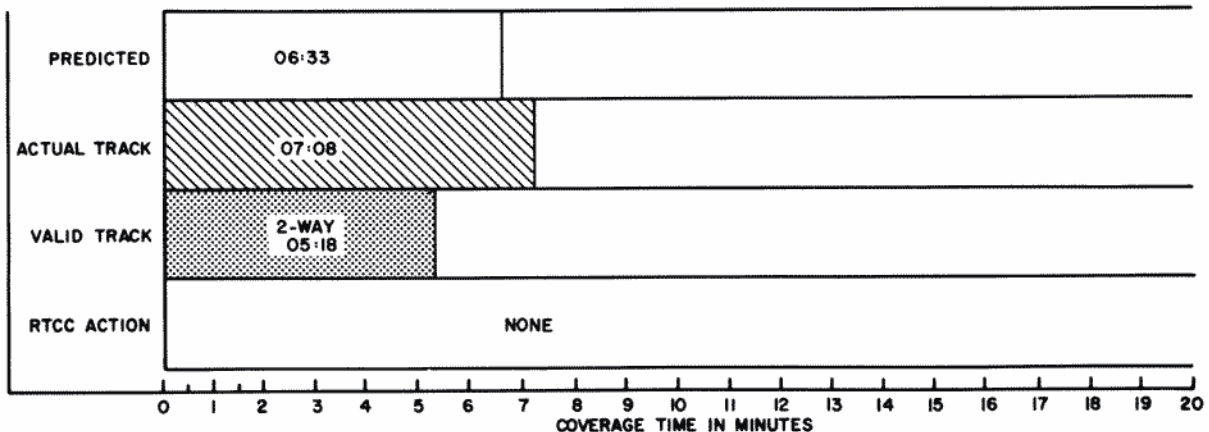
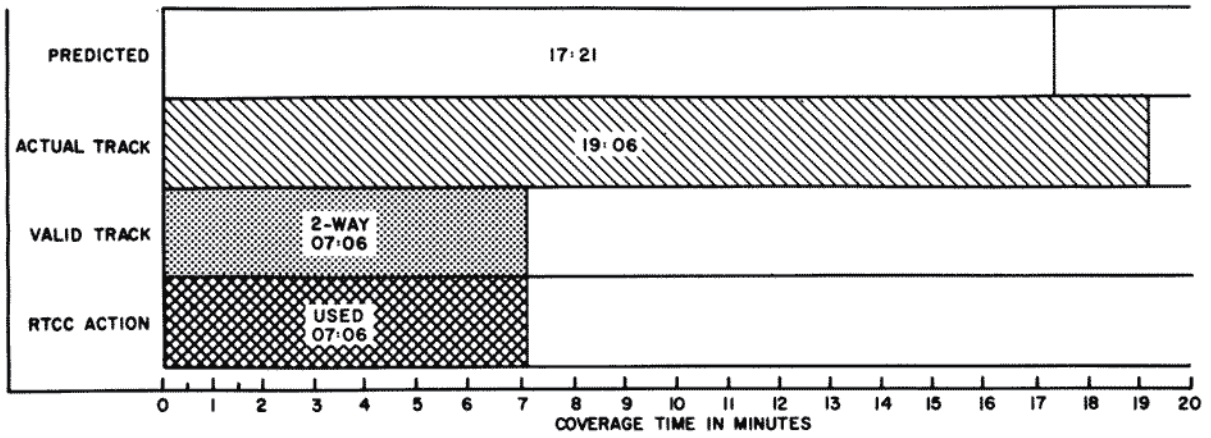
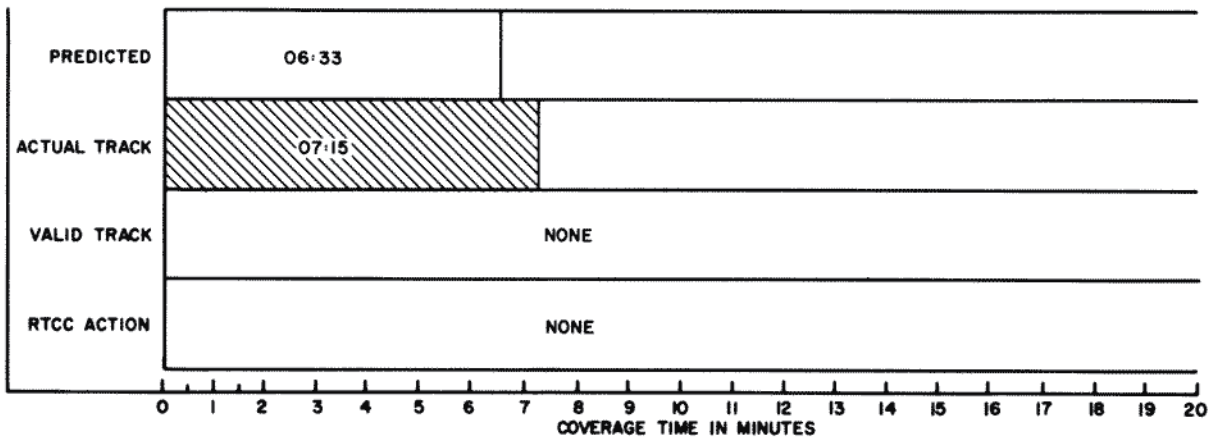
Figure 3-97. RED USB Tracking Coverage

(1) EO -- CSM

(a) System No. 1

(2) Reentry -- CM  
(a) System No. 1 (cont)

(b) System No. 2, EO -- IU

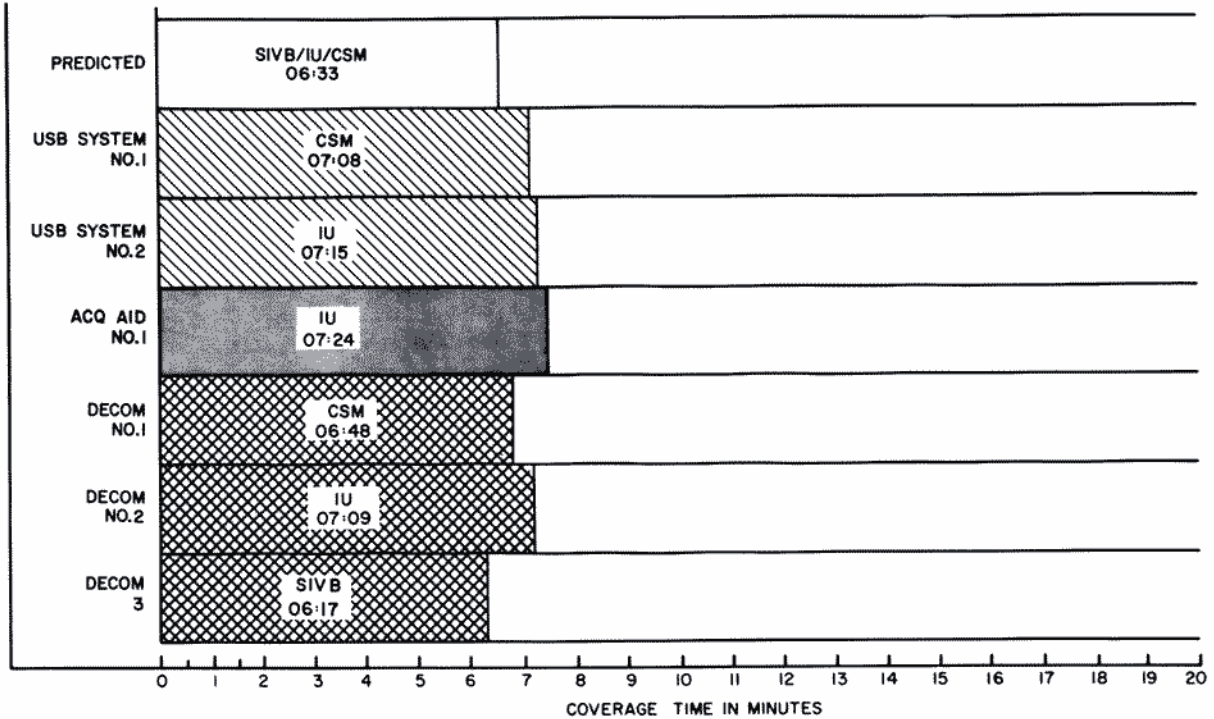
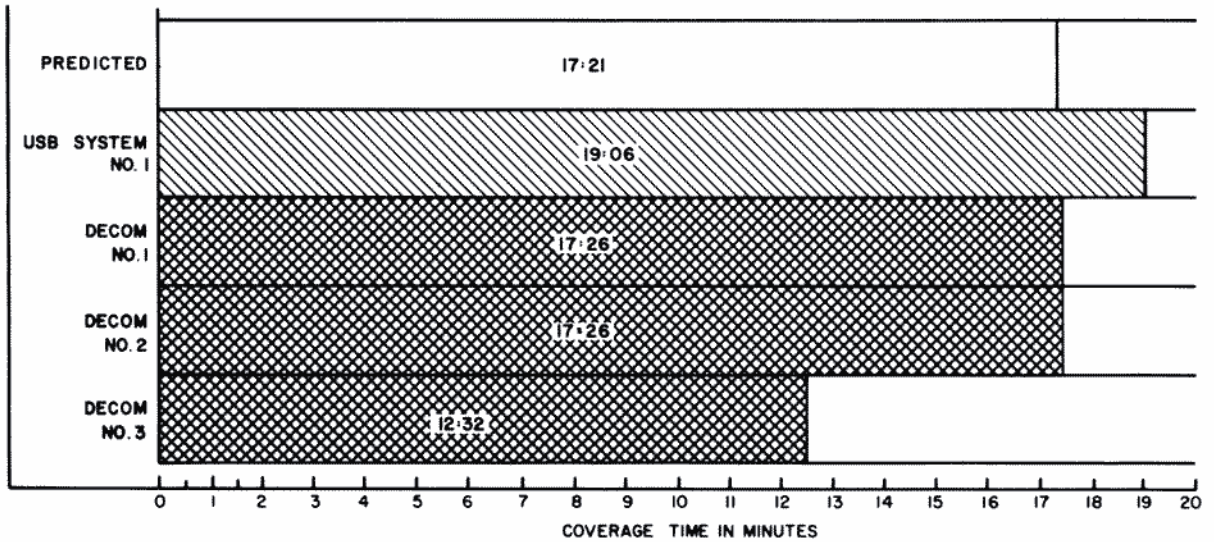
Figure 3-99. RED Telemetry Coverage

(a) EO

(b) Reentry -- CM

3.20.3.1 USB. The Redstone provided S-band telemetry support for the CSM and IU during EO revolution 2, including TLI and the CSM during reentry. Some data losses occurred while performing a contingency handover to MER during the TLI burn.

3.20.3.2 VHF. The 4-1 antenna supported the S-IVB and IU during the TLI burn and provided good telemetry data from both vehicles. Two seconds of IU and 55 seconds of S-IVB data was lost because of inadequate signal levels. The CM was tracked for approximately 19 minutes during reentry and good telemetry was provided.

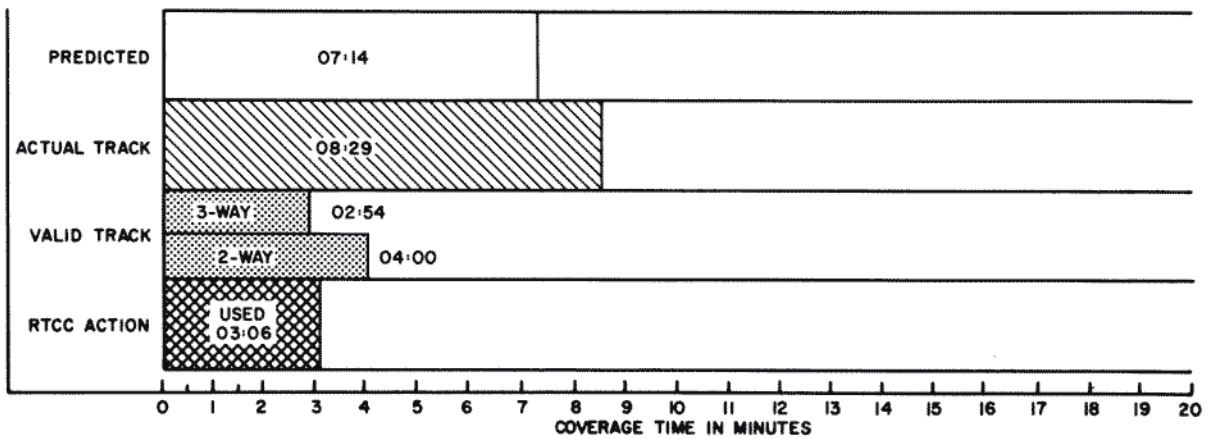
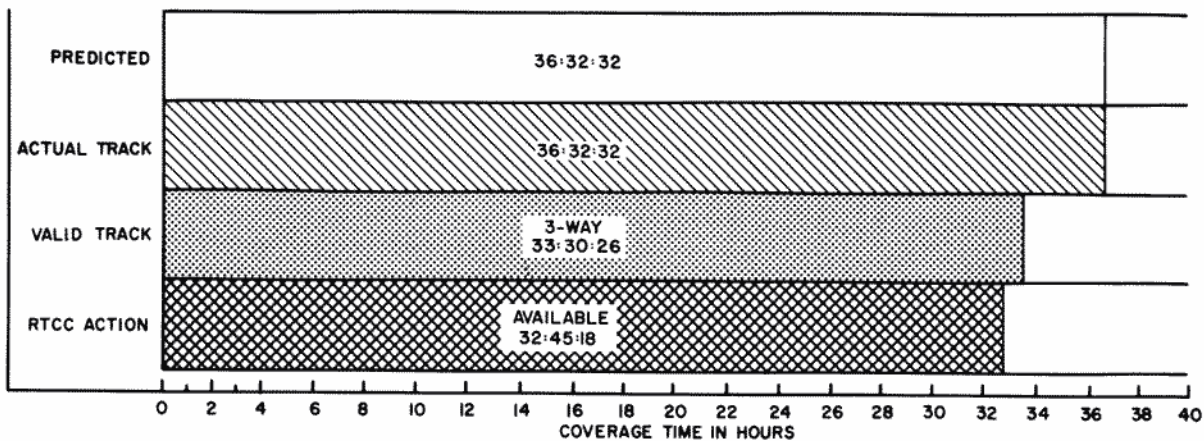
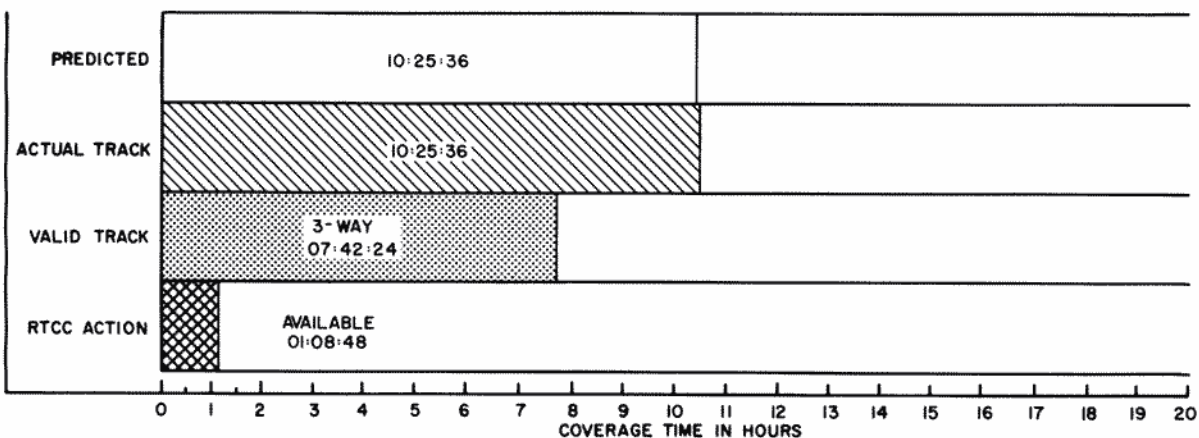
Figure 3-108. TEX USB Tracking Coverage

(a) EO -- CSM

(b) TLC -- CSM

(c) Lunar Phase -- CSM

3.22.2.1 USB (Figure 3-108). During TLC at 25:35:00 GET, the USB PA failed due to a motor generator shutdown. A buildup of carbon deposits on the motor generator field rheostat (used for optimizing power factors) caused arcing and tripped the primary power circuit breaker. This resulted in the loss of uplink capability. The rheostat was cleaned and adjusted, and the PA became operational at 27:06:00 GET (3.1.2.2).

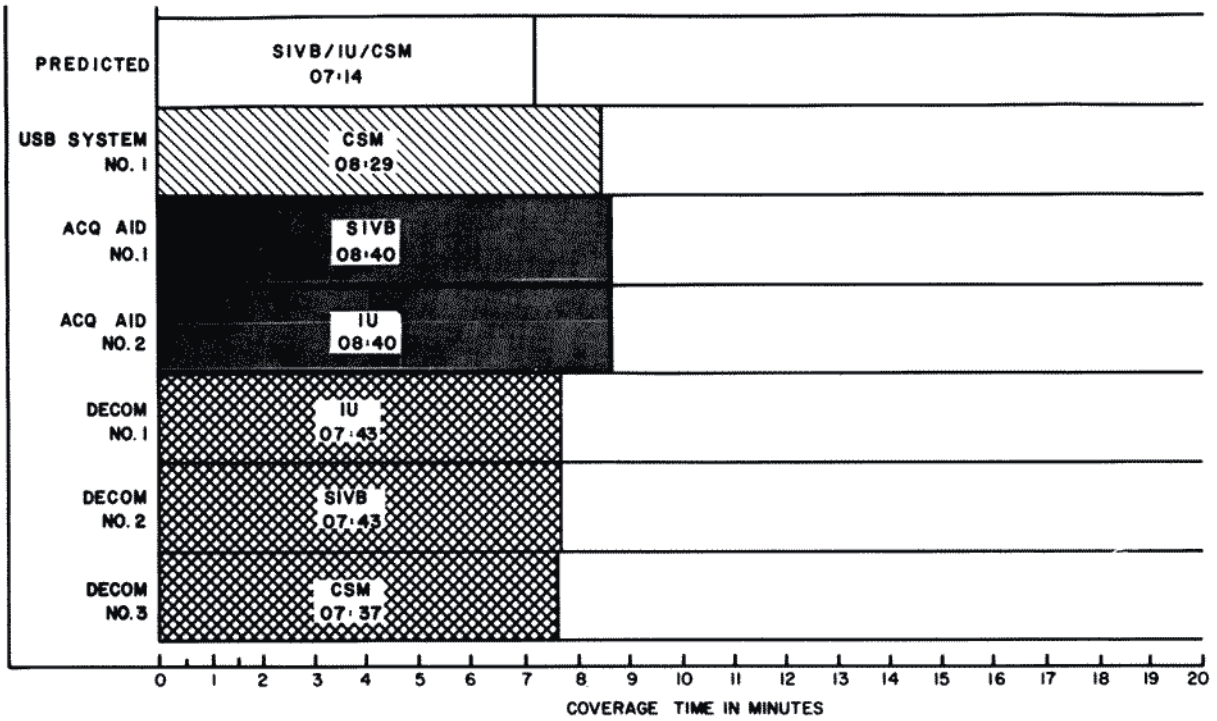
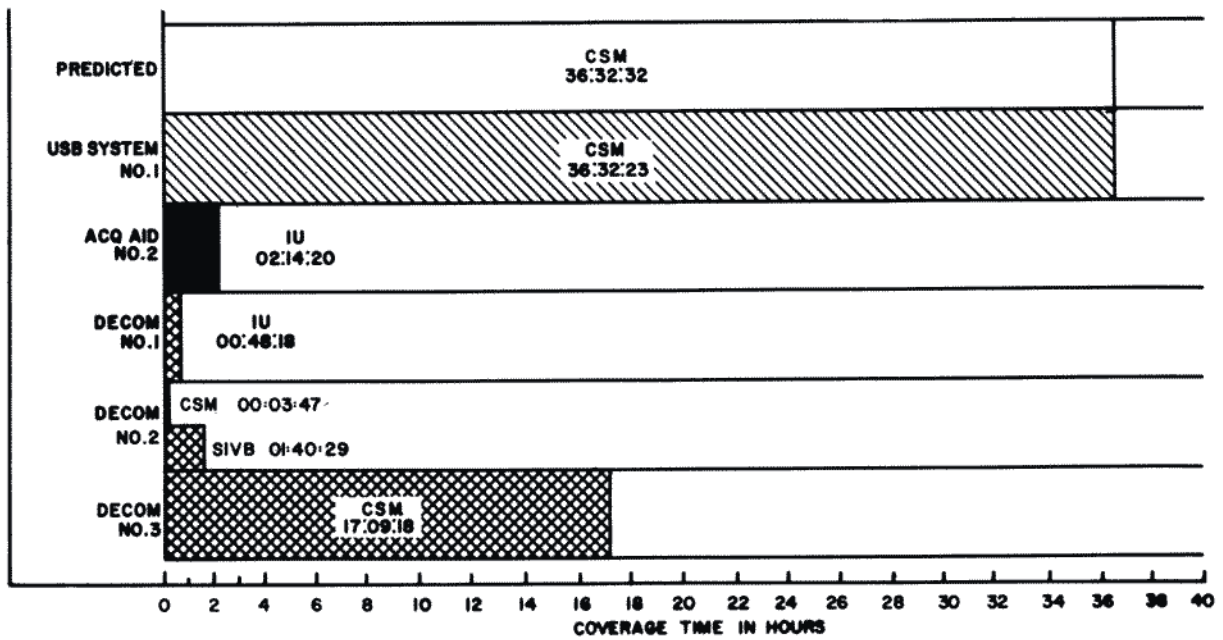
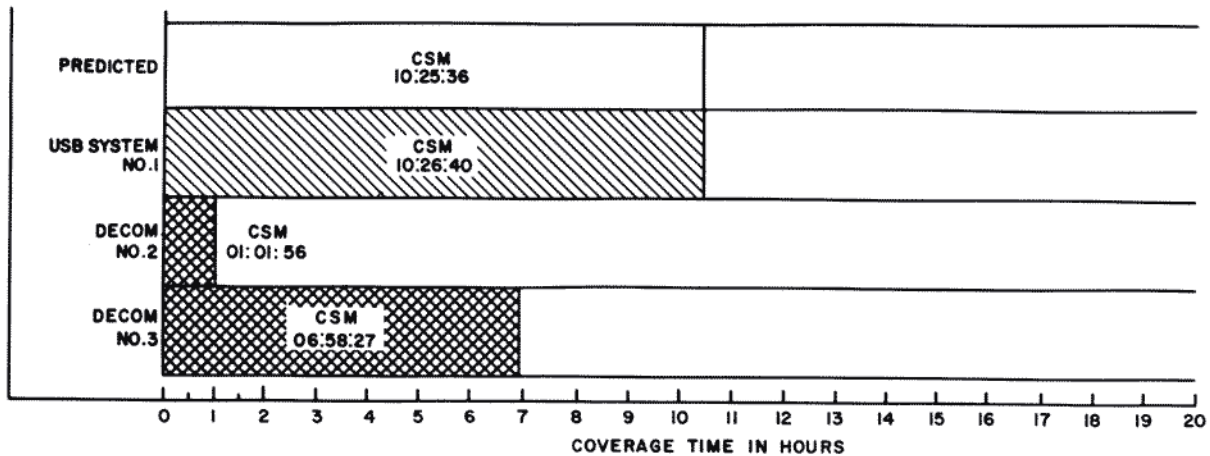
Figure 3-109. TEX Telemetry Coverage

(a) EO

(b) TLC

(c) Lunar Phase

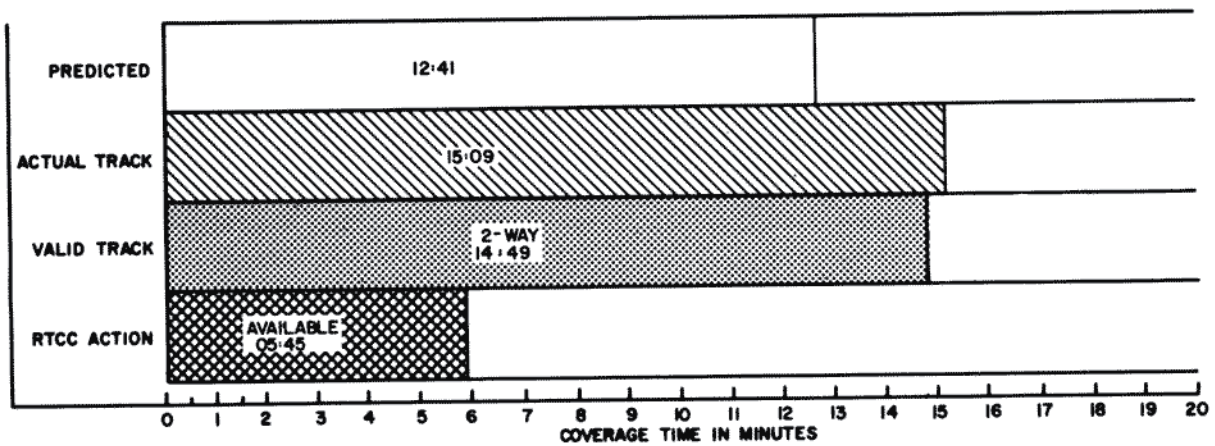
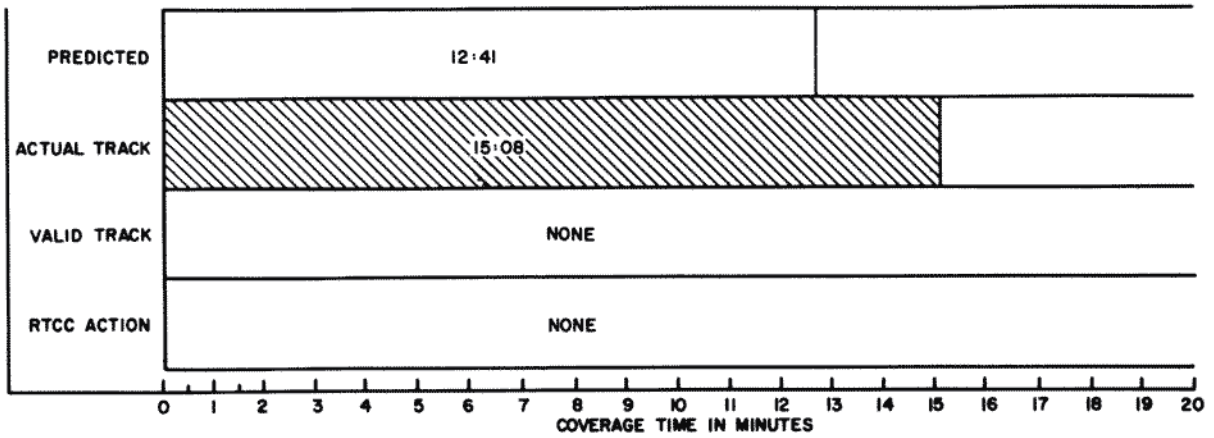
Figure 3-113. VAN USB Tracking Coverage

(a) System No. 1, EO -- CSM

(b) System No. 2, EO -- IU

3.23.2.1 USB (Figure 3-113). After the ship departed Port Canaveral, a USB flexure monitor tube failed on July 7. No spare was available and replacement was not possible while at sea. During mission support, VAN used contingency procedures contained in the NOD supplements to zero out misalignment coefficients (3.1.2.5).

VAN did not receive a 29-point acquisition message for launch and locked on a carrier sideband on the initial two-way attempt. This degraded two-way data until successful acquisition of the main carrier.

Postpass analysis of the S-band metric data for both VAN view periods showed the quality of data to deteriorate toward the end of the pass. The problem proved to be minor and of no mission impact but, because no known problem exists on the ship, it is under the investigation of MFED for corrective action if required.

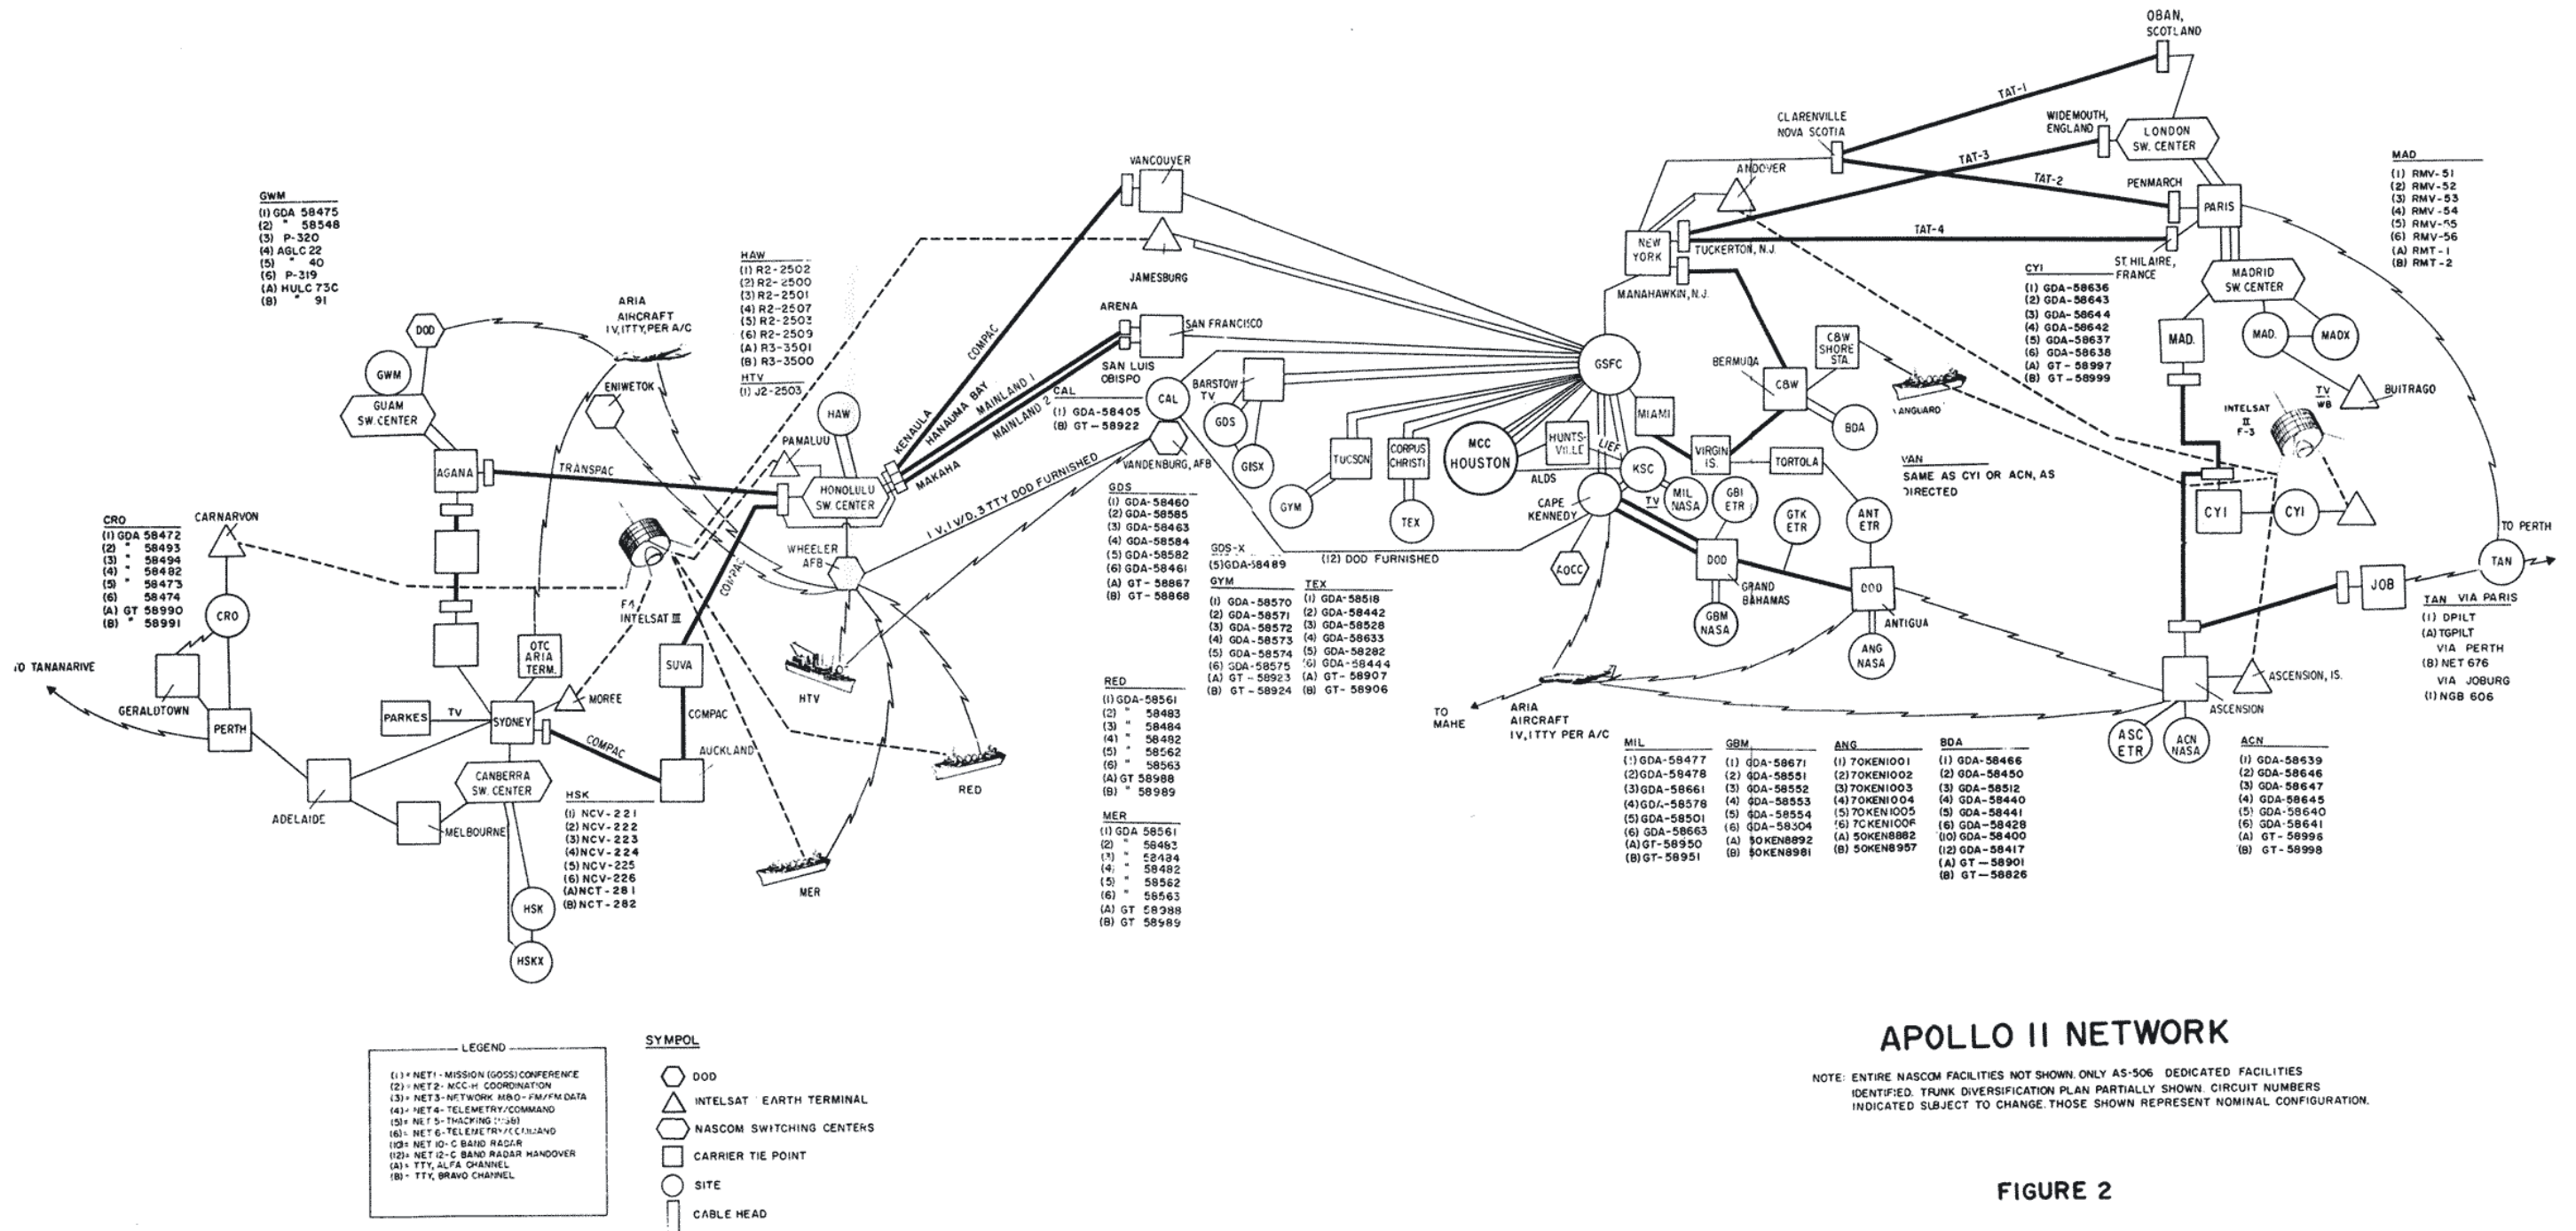
FIGURE 2

## APOLLO II NETWORK

NOTE: ENTIRE NASCOM FACILITIES NOT SHOWN. ONLY AS-506 DEDICATED FACILITIES IDENTIFIED. TRUNK DIVERSIFICATION PLAN PARTIALLY SHOWN. CIRCUIT NUMBERS INDICATED SUBJECT TO CHANGE. THOSE SHOWN REPRESENT NOMINAL CONFIGURATION.

For the APOLLO 11 Mission, portions of the network were specifically configured to provide the required communications support. The network configuration for this mission support is shown in Figure 2, page 5. One or more circuits of each net were monitored during the entire mission flight period. Results of this monitoring are presented in this report.

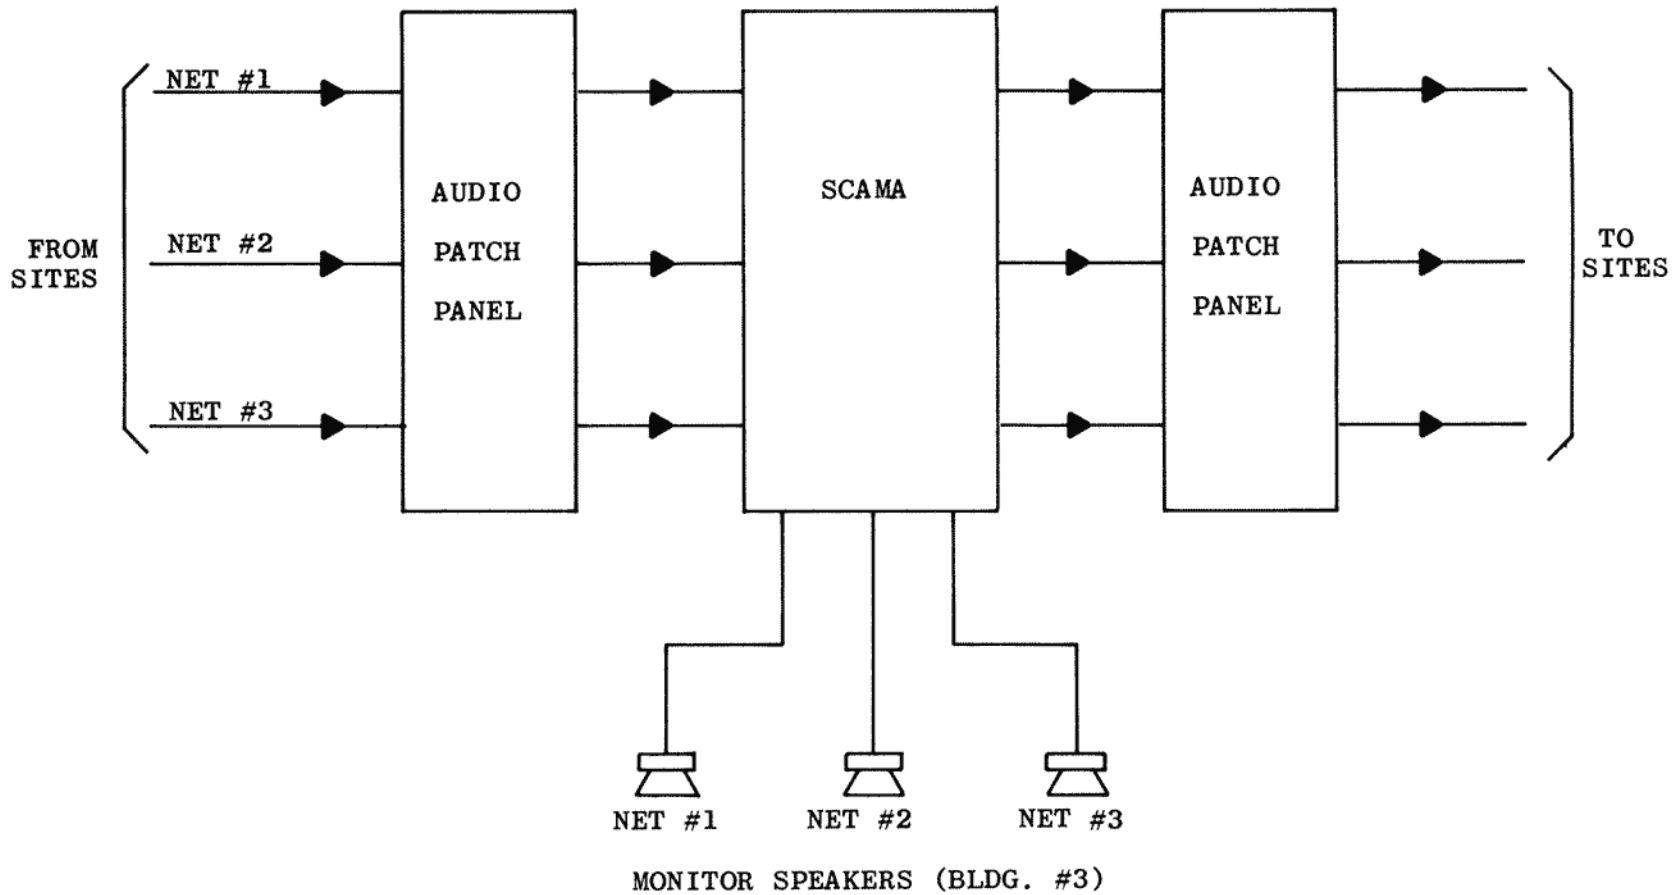
FIGURE 3

VOICE MONITORING  
EQUIPMENT CONFIGURATION

Voice monitoring was accomplished on Net 1, as shown in Figure 3, page 10.

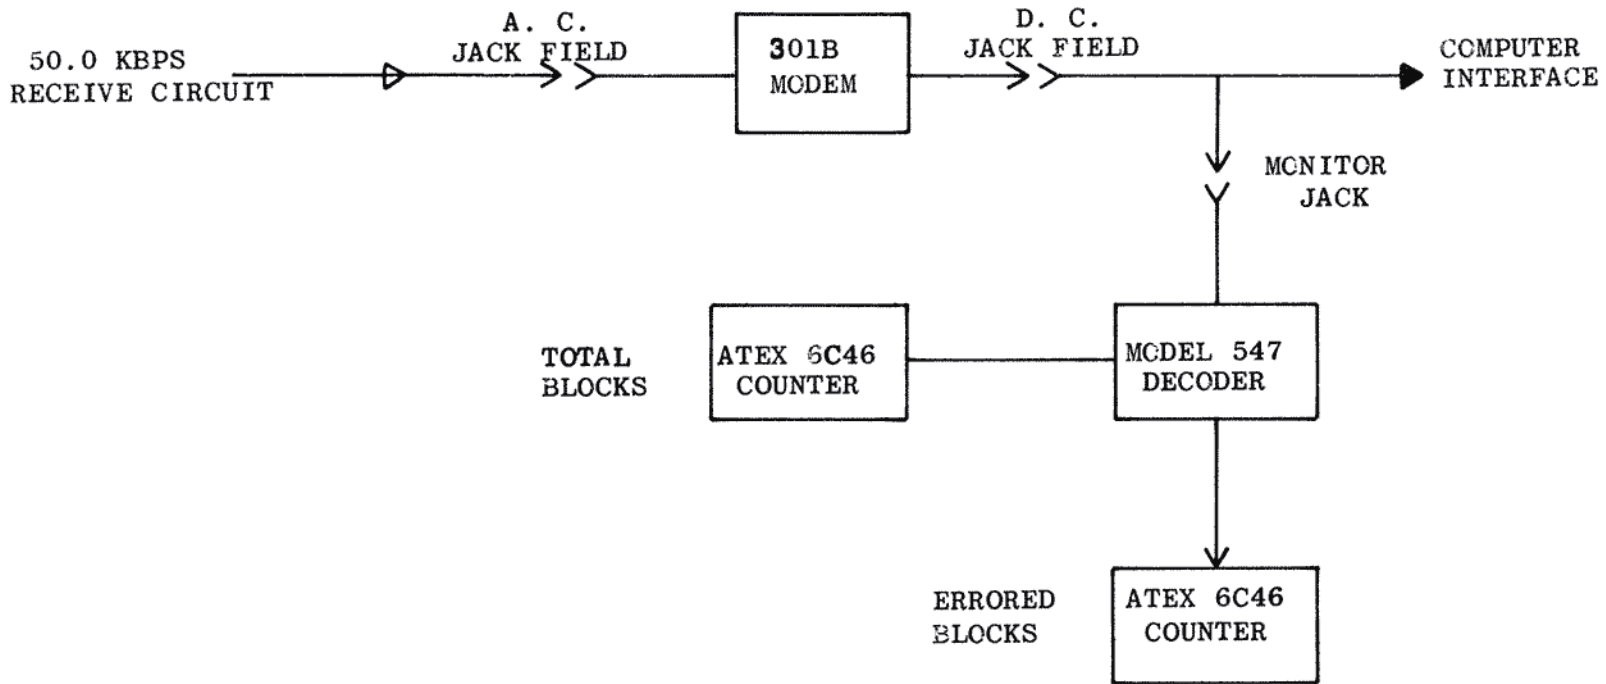
FIGURE 4

MONITOR EQUIPMENT CONFIGURATION  
HOUSTON WIDEBAND DATA SYSTEM

The Houston (Wideband) 50.0 kbps primary and secondary data channels from GSFC to MCC-H were monitored to determine the ratio of errored blocks\* to total blocks received. The primary and alternate circuits GW-58526 and GW-58527 passed a 50.0 kbps data stream configured in 600 bit message blocks. The test equipment configuration is illustrated in Figure 4, page 11.

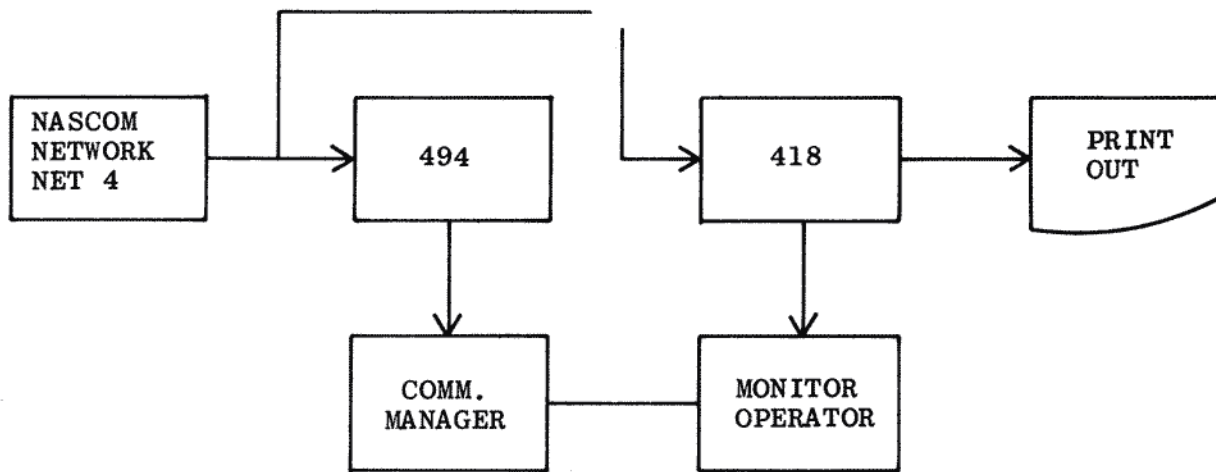
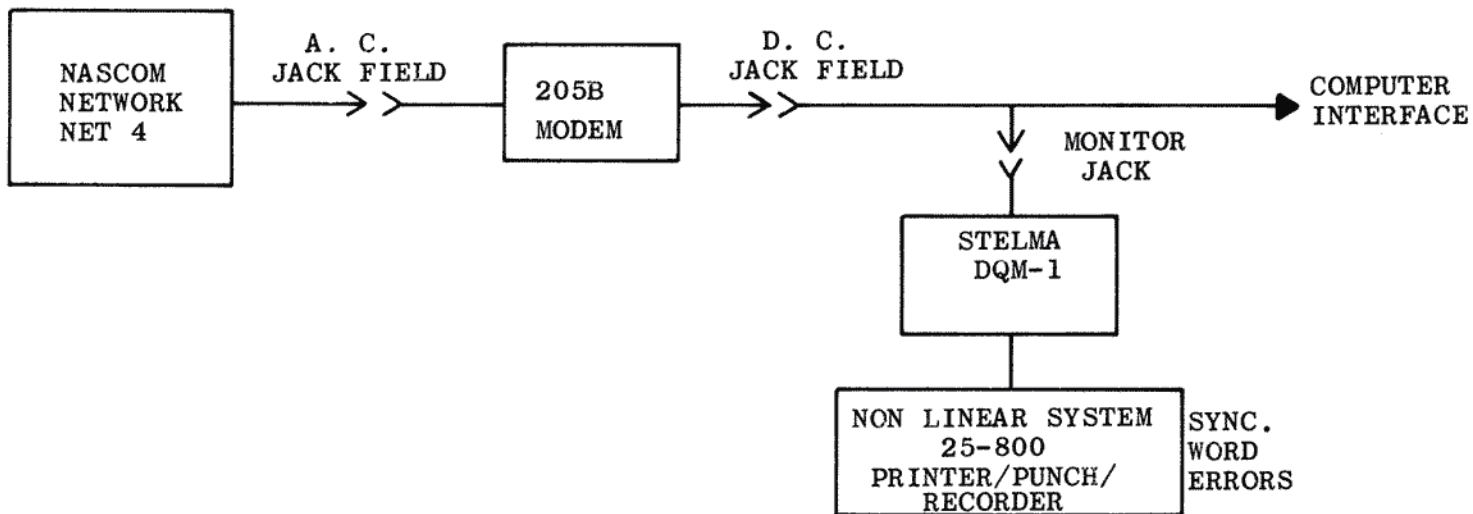
FIGURE 5

MONITOR EQUIPMENT CONFIGURATION  
TELEMETRY DATA

Net 4 (Telemetry Data) projected block error rates were determined by: Using the DQM-1 and Model 25-800 Non-Linear System equipment as shown in Figure 5, page 12, and by analyzing the output of telemetry monitored in real time by the Univac 418 with the system at GSFC configured as in Figure 5, page 12. The 418 output provided an octal print-out of the first 20 eight-bit characters and the last eight-bit character which comprise the subframe ID counter of the data stream. To provide this data, errored messages were flagged and the sync group inspected for errors.
