PREFACE TO APPENDICES

Appendix B1

ESEM/EDS Data for Test #4, Day-15 Fiberglass in Low-Flow Zones

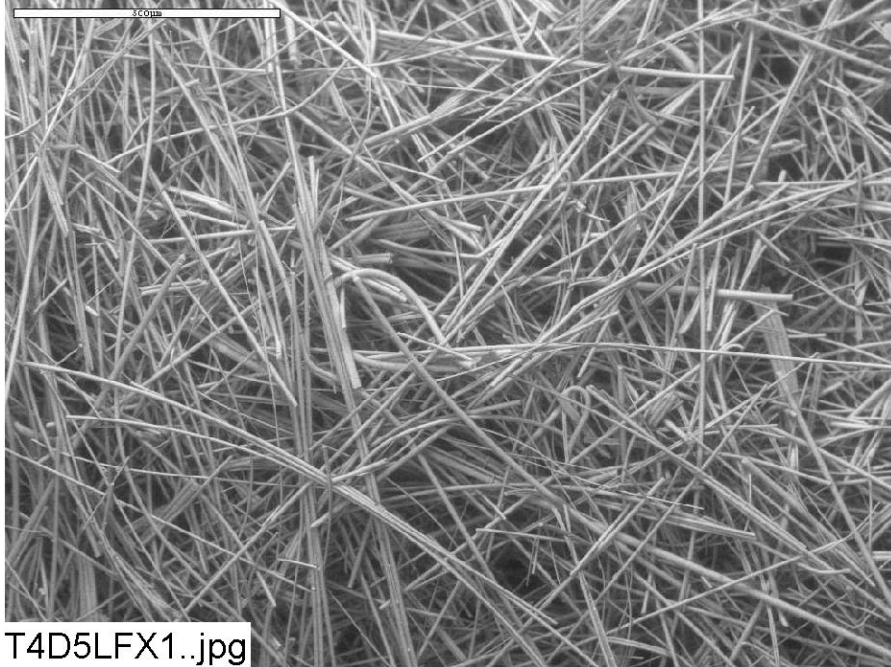
Figure A-1. Environmental SEM image magnified 80 times for a Test #4, Day-5 low-flow exterior fiberglass sample. (T4D5LFX1.jpg)

| Image: | T4D5LFX1 | 80 × | ESEM image | Figure A-1 |

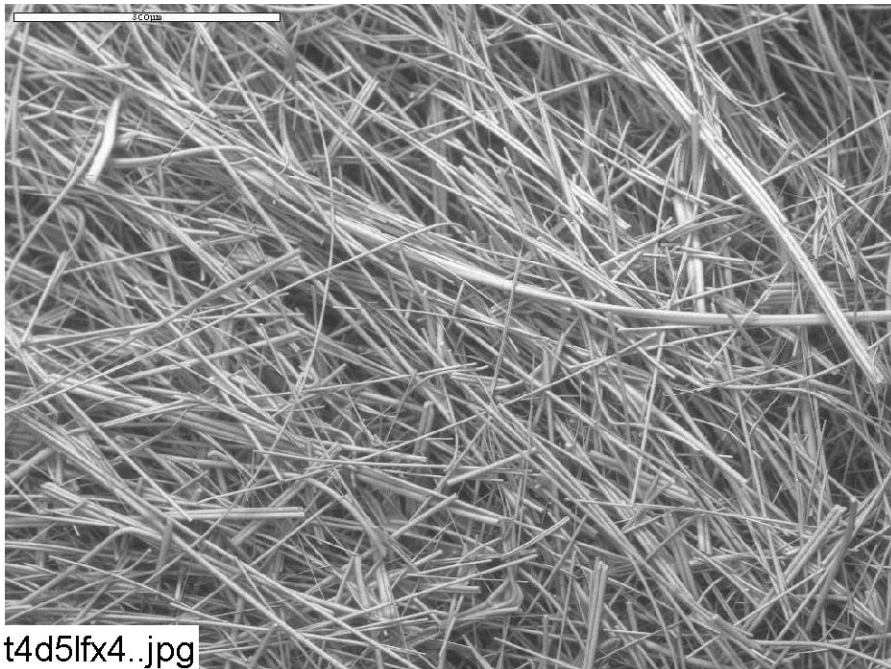
Figure A-2. Environmental SEM image magnified 80 times for a Test #4, Day-5 low-flow exterior fiberglass sample. (t4d5lfx4.jpg)

| | t4d5lfx4 | 80 × | ESEM at higher magnification | Figure A-2 |

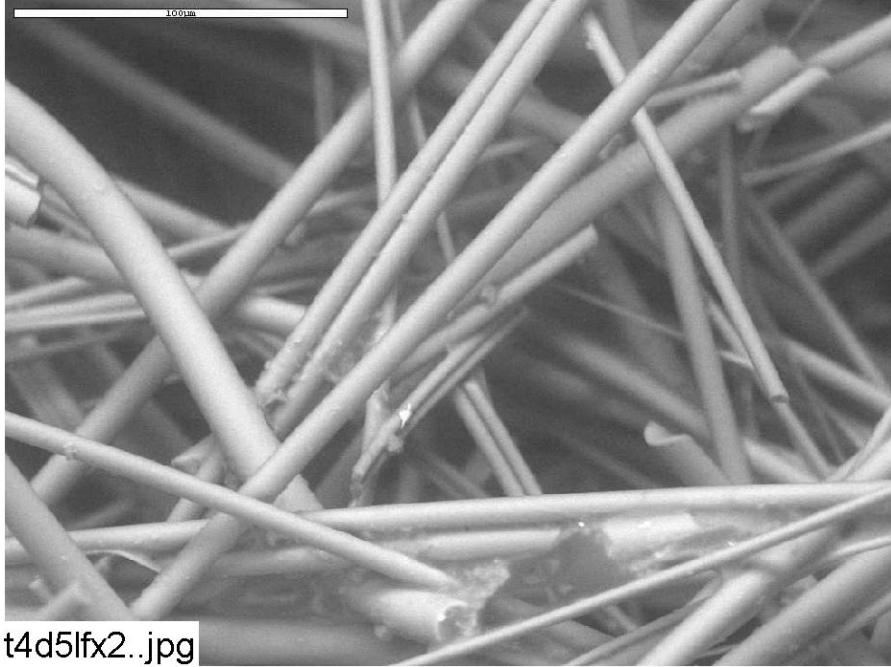
Figure A-3. Environmental SEM image magnified 500 times for a Test #4, Day-5 low-flow exterior fiberglass sample. (t4d5lfx2.jpg)

| | t4d5lfx2 | 500 × | | Figure A-3 |

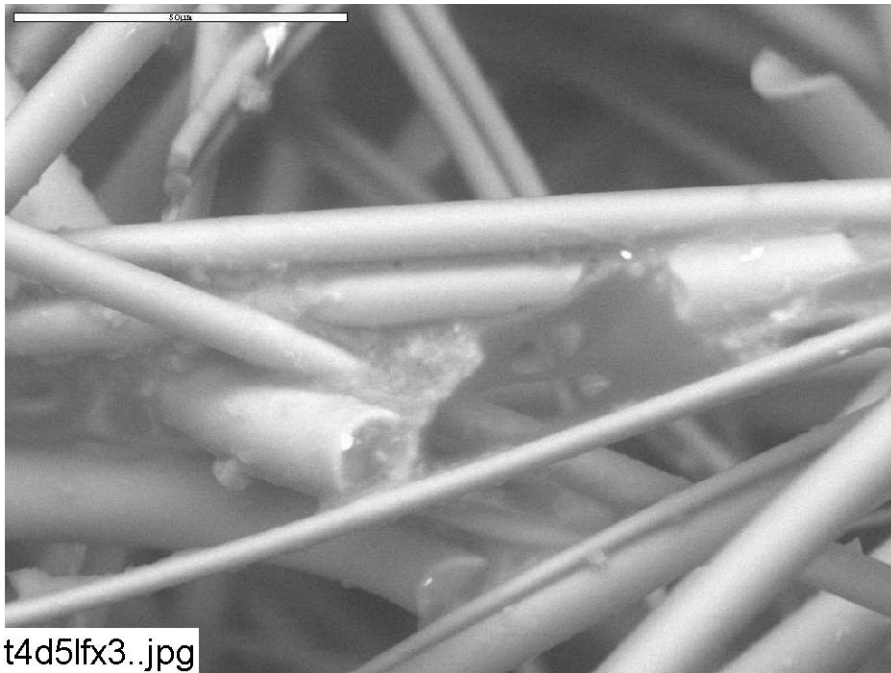
Figure A-4. Environmental SEM image magnified 1000 times for a Test #4, Day-5 low-flow exterior fiberglass sample. (t4d5lfx3.jpg)

| | t4d5lfx3 | 1000 × | | Figure A-4 |

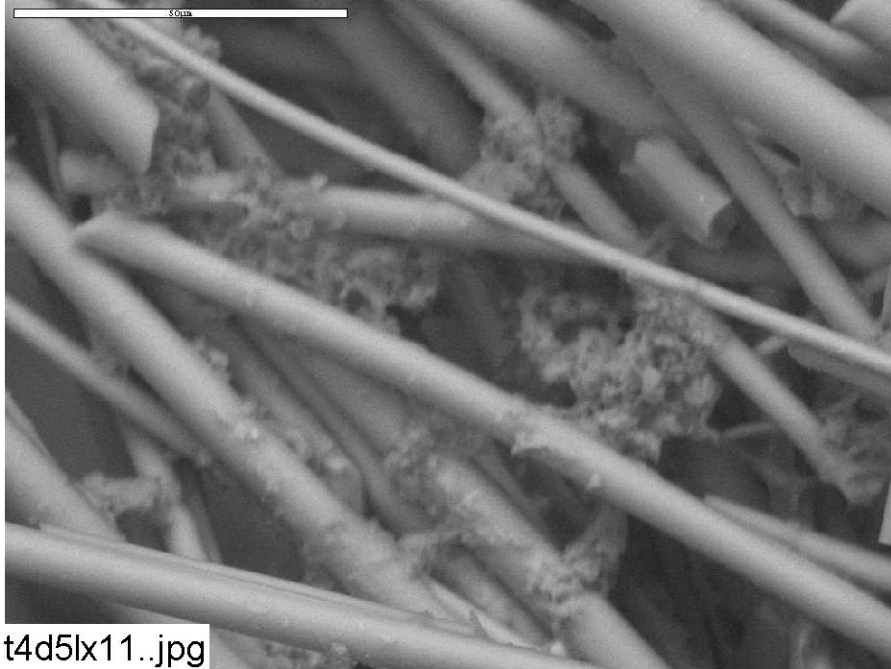
Figure A-5. Environmental SEM image magnified 1000 times for a Test #4, Day-5 low-flow exterior fiberglass sample. (t4d5lx11.jpg)

| | t4d5lx11 | 1000 × | | Figure A-5 |

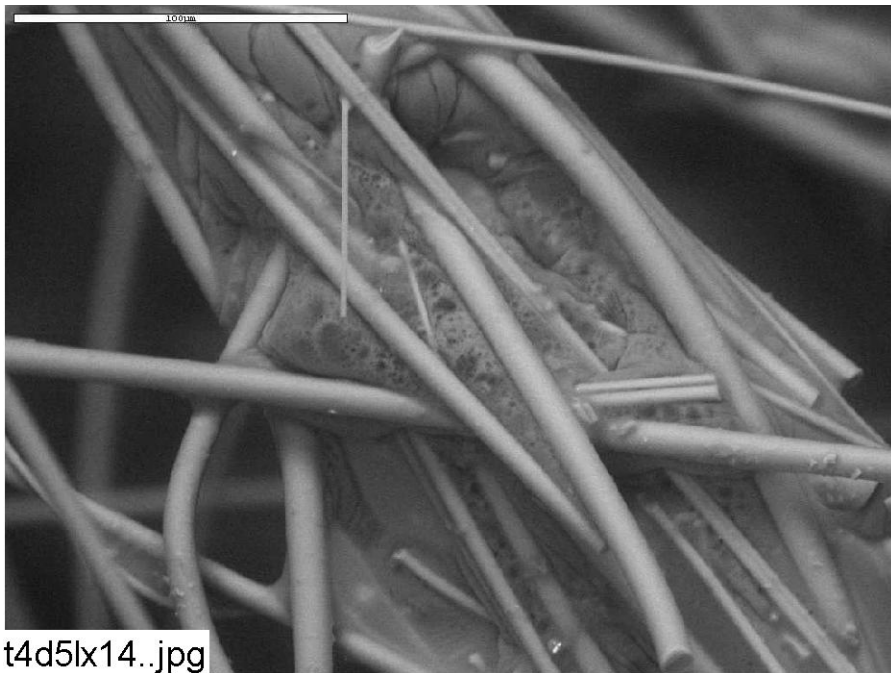
Figure A-6. Environmental SEM image magnified 500 times for a Test #4, Day-5 low-flow exterior fiberglass sample. (t4d5lx14.jpg)

| | t4d5lx14 | 500 × | | Figure A-6 |

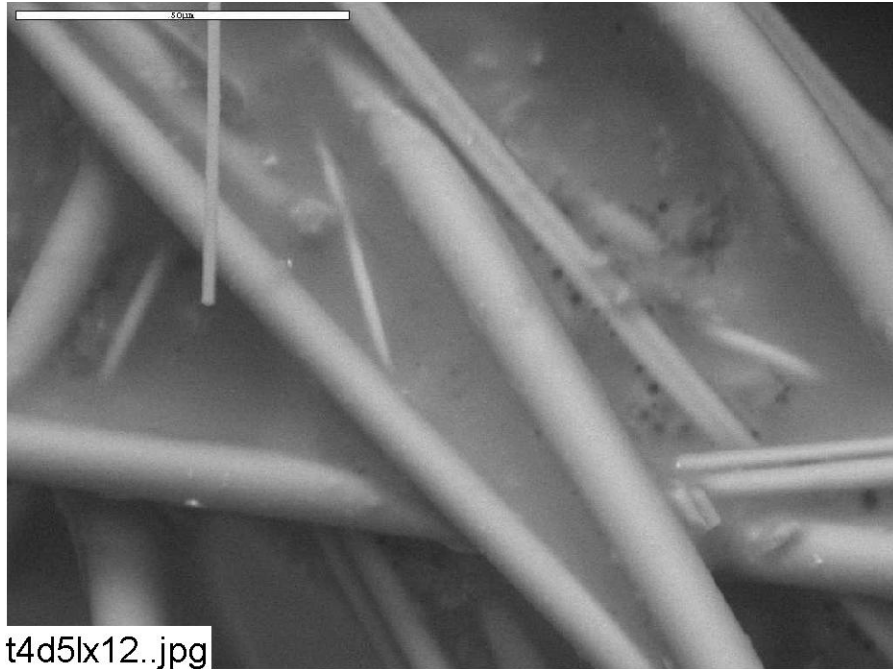
Figure A-7. Environmental SEM image magnified 1000 times for a Test #4, Day-5 low-flow exterior fiberglass sample. (t4d5lx12.jpg)

| | t4d5lx12 | 1000 × | | Figure A-7 |

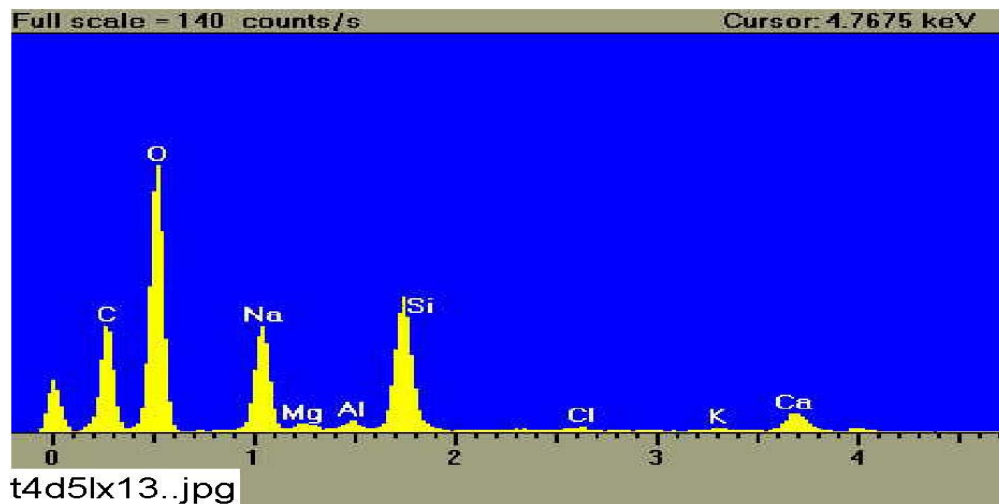
Figure A-8. EDS counting spectrum for the film between the fibers shown in Figure A-7. (t4d5lx13.jpg)

| EDS: | t4d5lx13 | | | Figure A-8 |

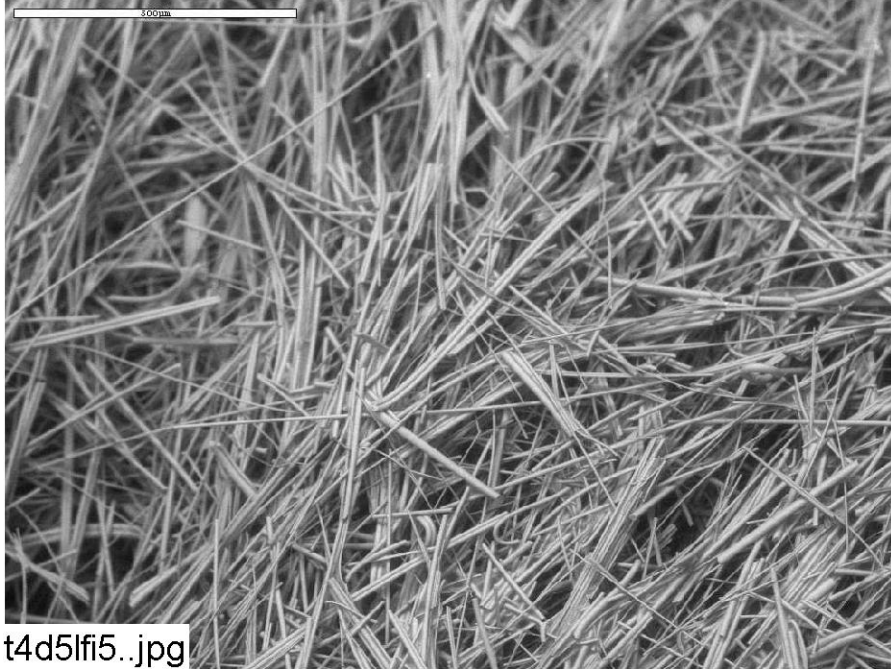
Figure A-9. Environmental SEM image magnified 80 times for a Test #4, Day-5 low-flow interior fiberglass sample. (t4d5lf15.jpg)

| Image: | t4d5lfi5 | 80 × | ESEM image | Figure A-9 |

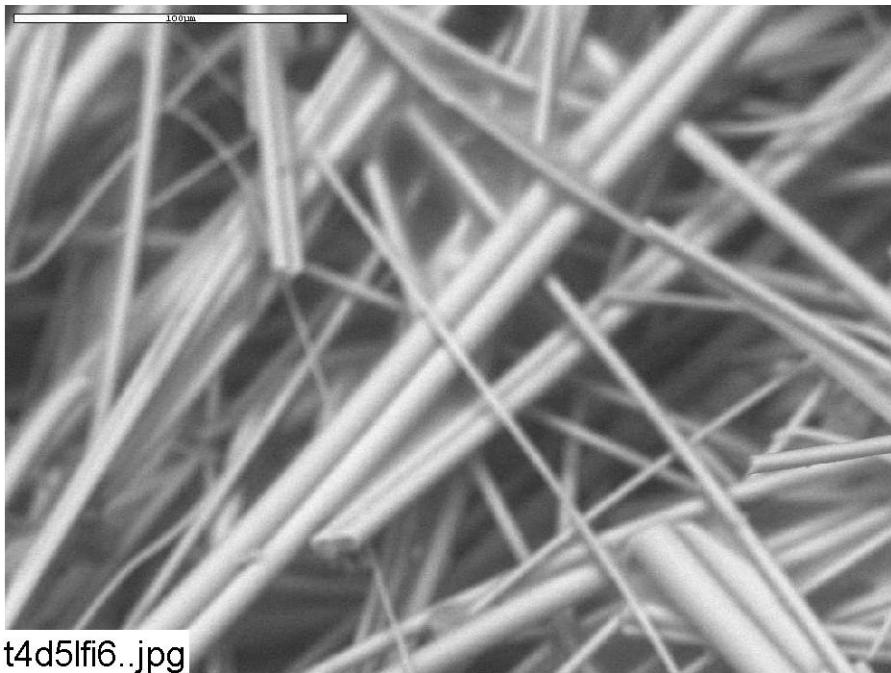
Figure A-10. Environmental SEM image magnified 500 times for a Test #4, Day-5 low-flow interior fiberglass sample. (t4d5lf16.jpg)

| | t4d5lfi6 | 500 × | ESEM at higher magnification | Figure A-10 |

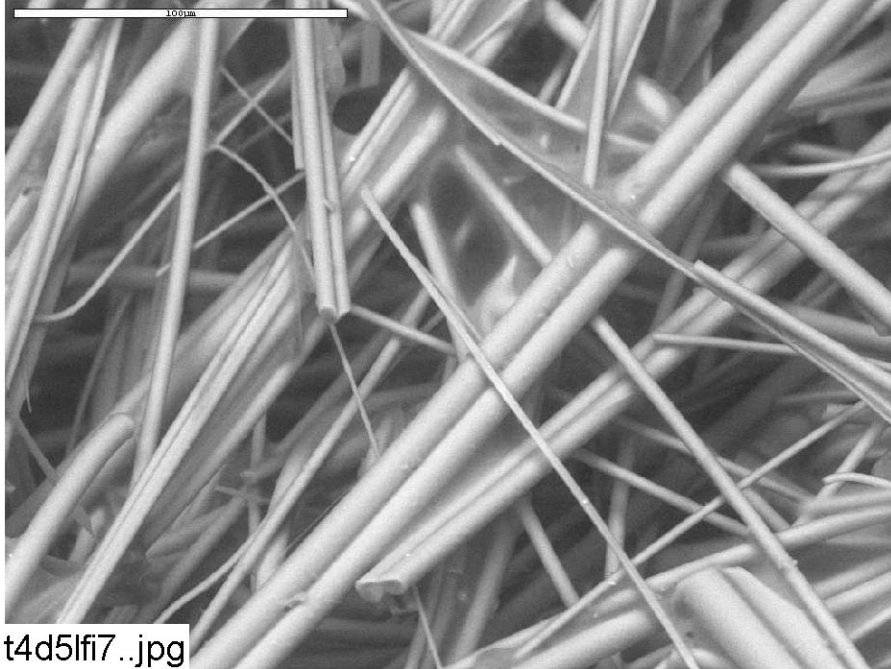
Figure A-11. Environmental SEM image magnified 500 times for a Test #4, Day-5 low-flow interior fiberglass sample. (t4d5lf17.jpg)

| | t4d5lfi7 | 500 × | | Figure A-11 |

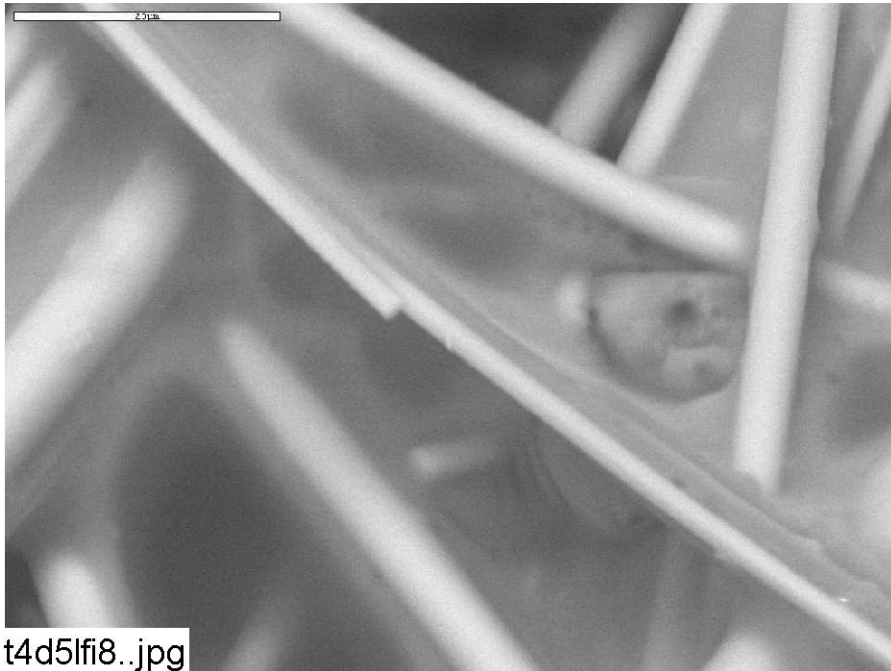
Figure A-12. Environmental SEM image magnified 2000 times for a Test #4, Day-5 low-flow interior fiberglass sample. (t4d5lf18.jpg)

| | t4d5lfi8 | 2000 × | | Figure A-12 |

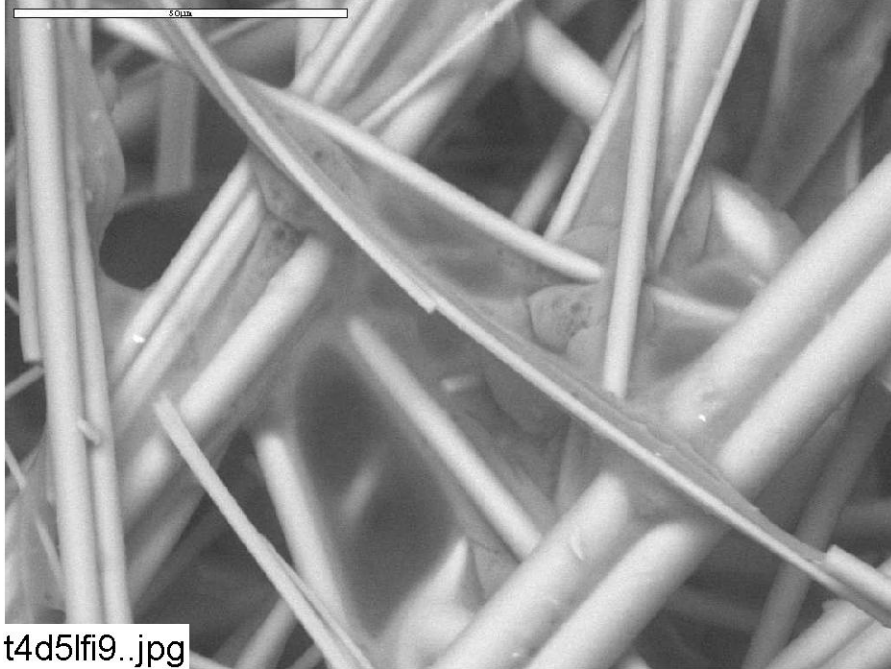
Figure A-13. Environmental SEM image magnified 1000 times for a Test #4, Day-5 low-flow interior fiberglass sample. (t4d5lf9.jpg)

| | t4d5lfi9 | 1000 × | | Figure A-13 |

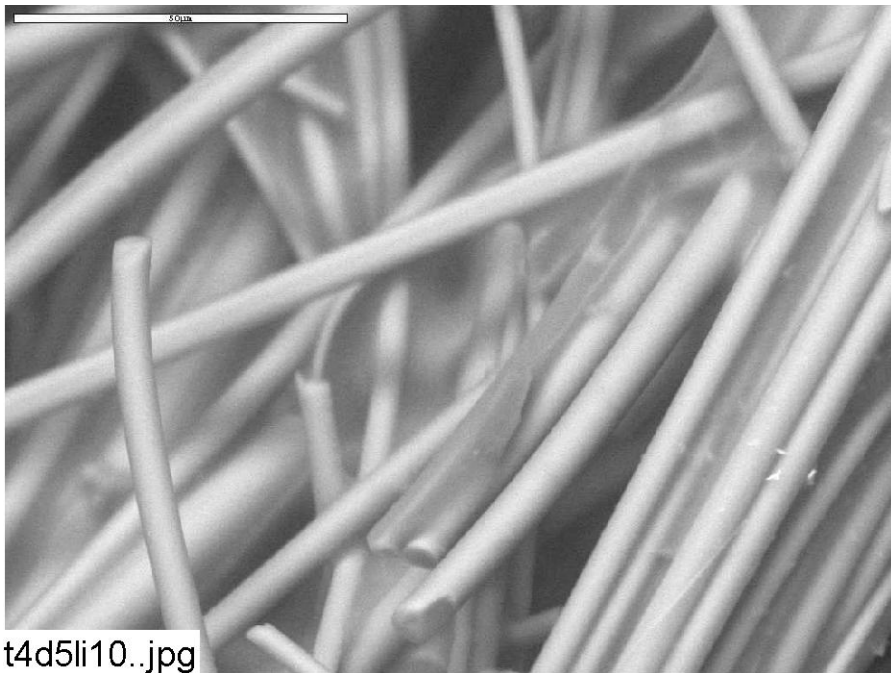
Figure A-14. Environmental SEM image magnified 1000 times for a Test #4, Day-5 low-flow interior fiberglass sample. (t4d5li10.jpg)

| | t4d5li10 | 1000 × | | Figure A-14 |

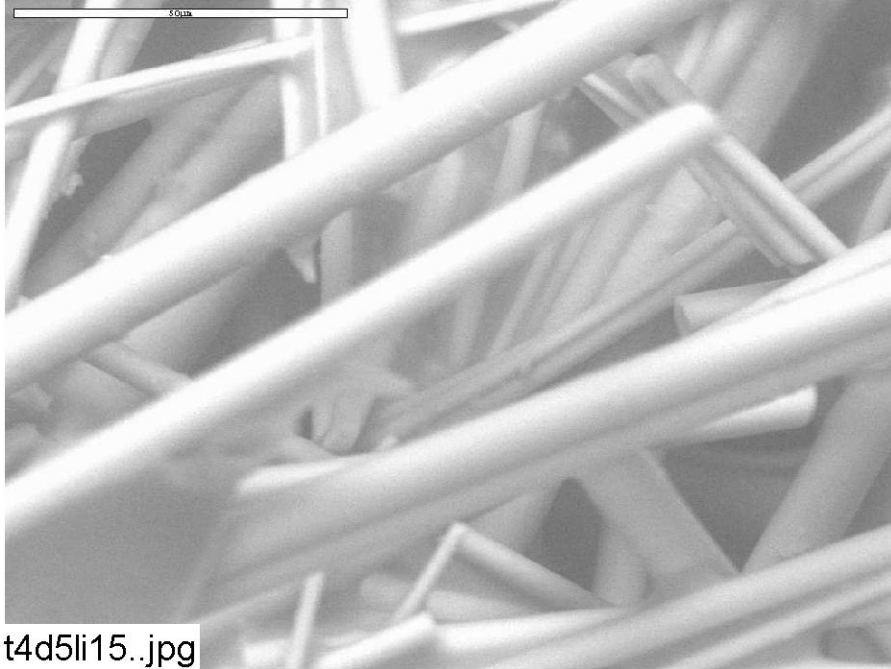
Figure A-15. Environmental SEM image magnified 500 times for a Test #4, Day-5 low-flow interior fiberglass sample. (t4d5li15)

| | t4d5li15 | 500 × | | Figure A-15 |

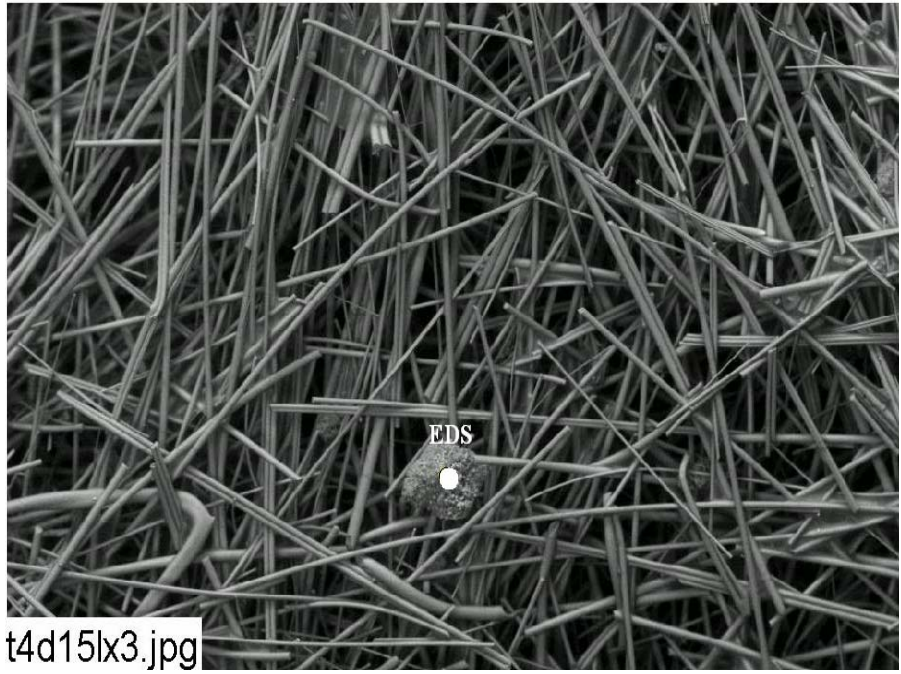
Figure B1-1. Annotated environmental SEM image magnified 100 times for a Test #4, Day-15 exterior low-flow fiberglass sample. (t4d15lx3.jpg)

| Image: | t4d15lx3 | 100 × | ESEM annotated image | Figure B1-1 |

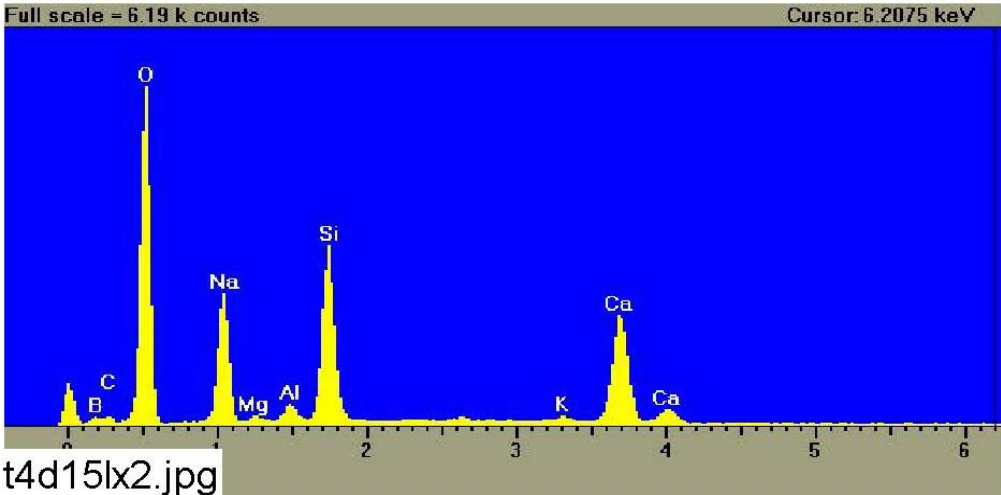
Figure B1-2. EDS counting spectrum for the particulate deposit on fiberglass shown in Figure B1-1. (t4d15lx2.jpg)

| EDS: | t4d15lx2 | | EDS image on particles in t4d15lx3 | Figure B1-2 |

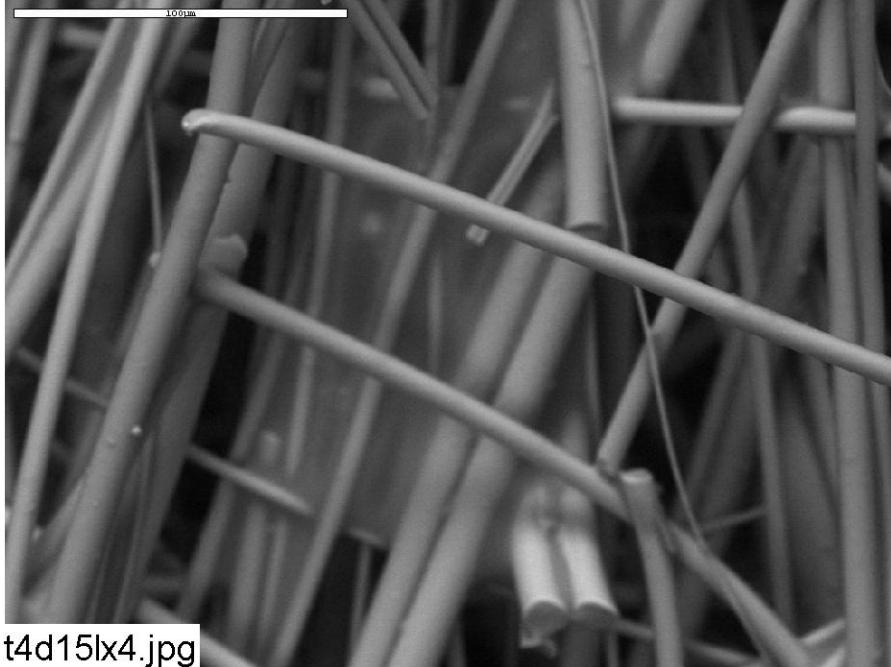
Figure B1-3. Environmental SEM image magnified 500 times for a Test #4, Day-15 exterior low-flow fiberglass sample. (t4d15lx4.jpg)

| Image: | t4d15lx4 | 500 × | ESEM image of fiberglass | Figure B1-3 |

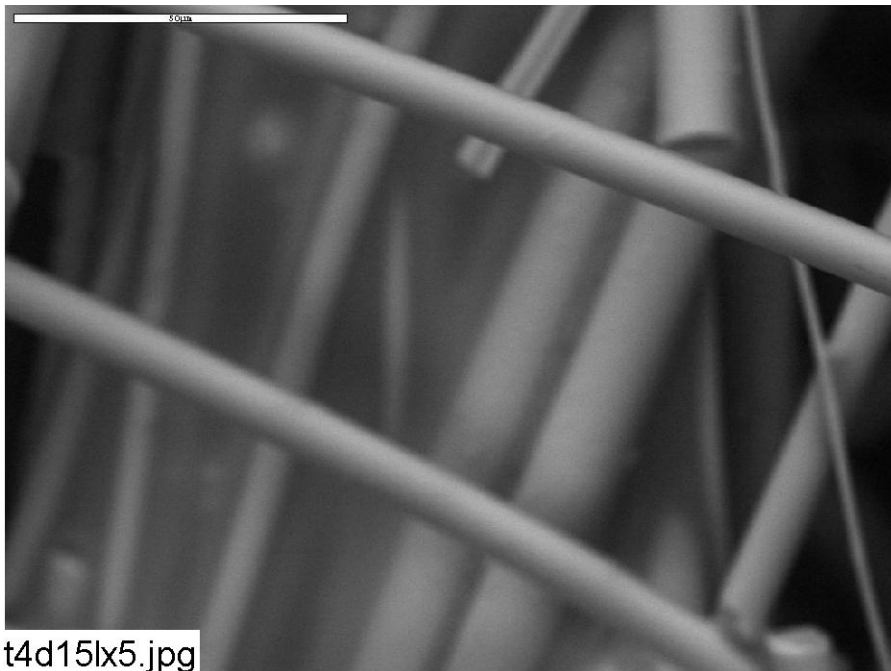
Figure B1-4. Environmental SEM image magnified 1000 times for a Test #4, Day-15 exterior low-flow fiberglass sample. (t4d15lx5.jpg)

| | t4d15lx5 | 1000 × | ESEM image at higher magnification | Figure B1-4 |

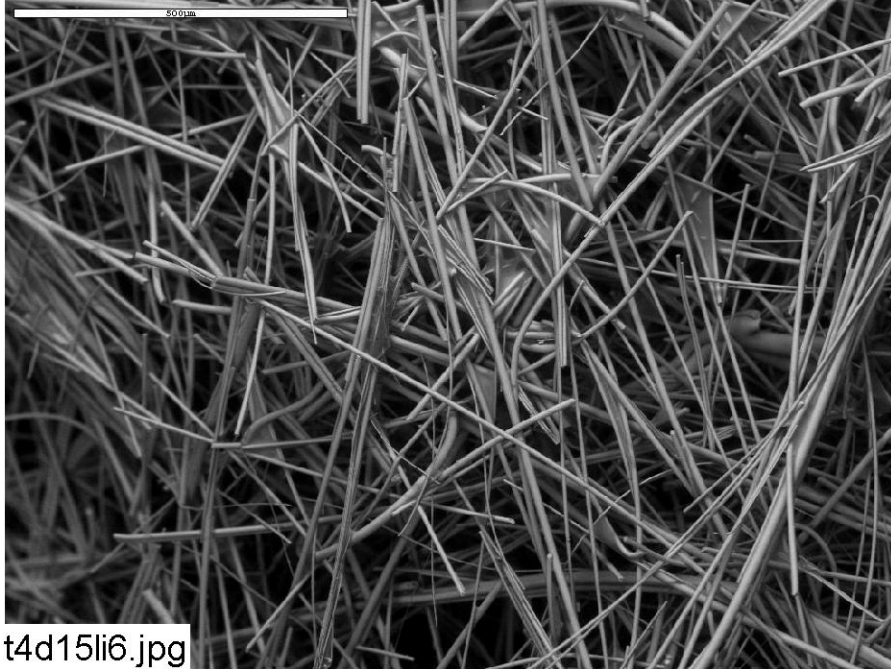
Figure B1-5. Environmental SEM image magnified 100 times for a Test #4, Day-15 interior low-flow fiberglass sample. (t4d15li6.jpg)

| Image: | t4d15li6 | 100 × | ESEM image of fiberglass | Figure B1-5 |

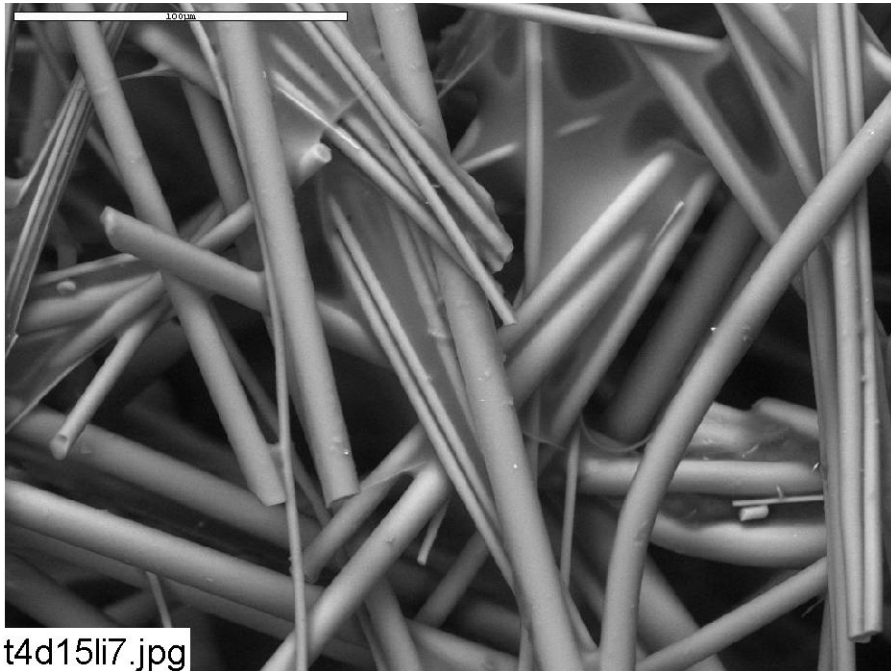
Figure B1-6. Environmental SEM image magnified 500 times for a Test #4, Day-15 interior low-flow fiberglass sample. (t4d15li7.jpg)

| | t4d15li7 | 500 × | ESEM image of fiberglass | Figure B1-6 |

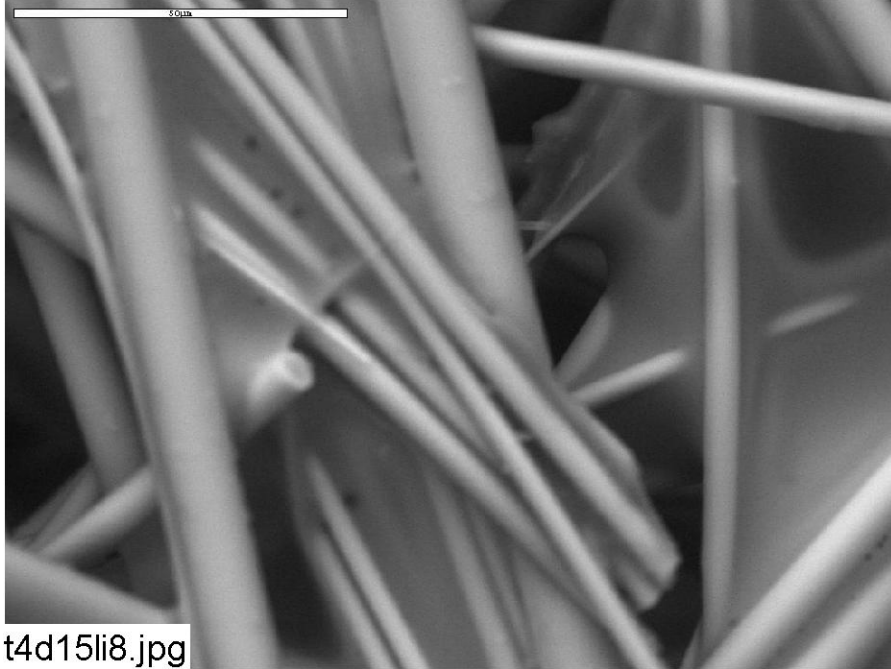
Figure B1-7. Environmental SEM image magnified 1000 times for a Test #4, Day-15 interior low-flow fiberglass sample. (t4d15li8.jpg)

| | t4d15li8 | 1000 × | ESEM image at higher magnification | Figure B1-7 |
