## Appendix C6

# ESEM/EDS Data for Test #4, Day-30 Drain Collar Fiberglass

In this appendix, ESEM/EDS results are shown from the examination of the fiberglass samples within the drain collar submerged in the tank. The fiberglass samples within the drain collar were extracted on the date Test #4 was shut down (June 23, 2005). The fiberglass samples located at the outside exterior (away from the drain screen), the inside exterior (next to the drain screen), and the interior were examined. ESEM was employed to analyze the wet fiberglass samples without any coating under a low-vacuum condition (i.e., 80 Pa) to minimize the modification of the fiberglass samples through a drying process. ESEM/EDS results of the Test #4, Day-30 drain collar fiberglass samples were obtained on June 30, 2005. EDS results provide an elemental composition analysis of the debris attached on fiberglass.

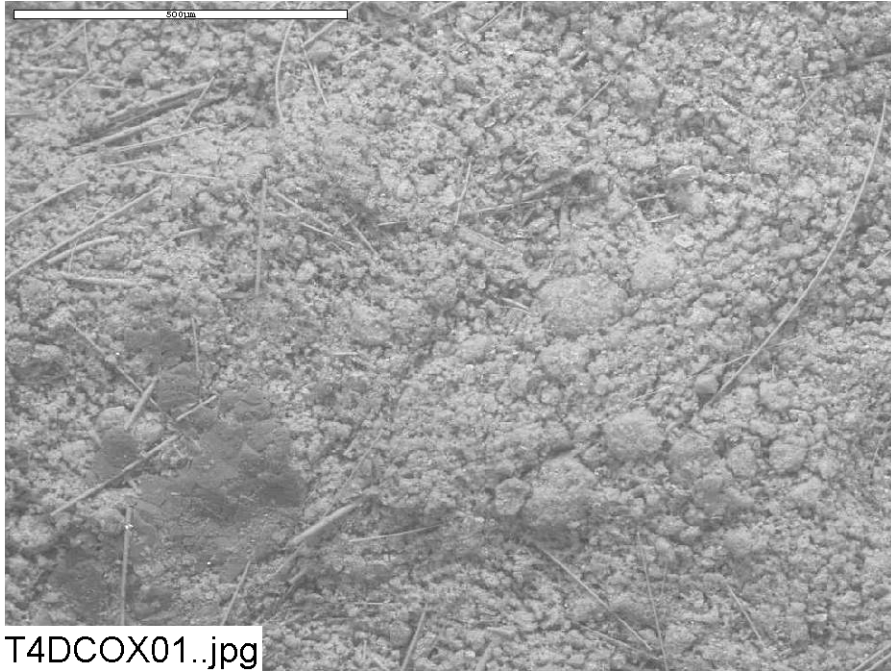
**Figure C6-1.** Environmental SEM image magnified 100 times for a Test #4, Day-30 exterior fiberglass sample on the drain collar (away from the drain screen). (T4DCOX01.jpg)

Image:	T4DCOX01	100 ×	ESEM image	Figure C6-1
	t4dcox05	100 ×	ESEM image	Figure C6-2
	t4dcox02	500 ×	ESEM image	Figure C6-3
	t4dcox03	1000 ×	ESEM at higher magnification	Figure C6-4
EDS:	t4dcox04		EDS on particles in t4dcox03	Figure C6-5

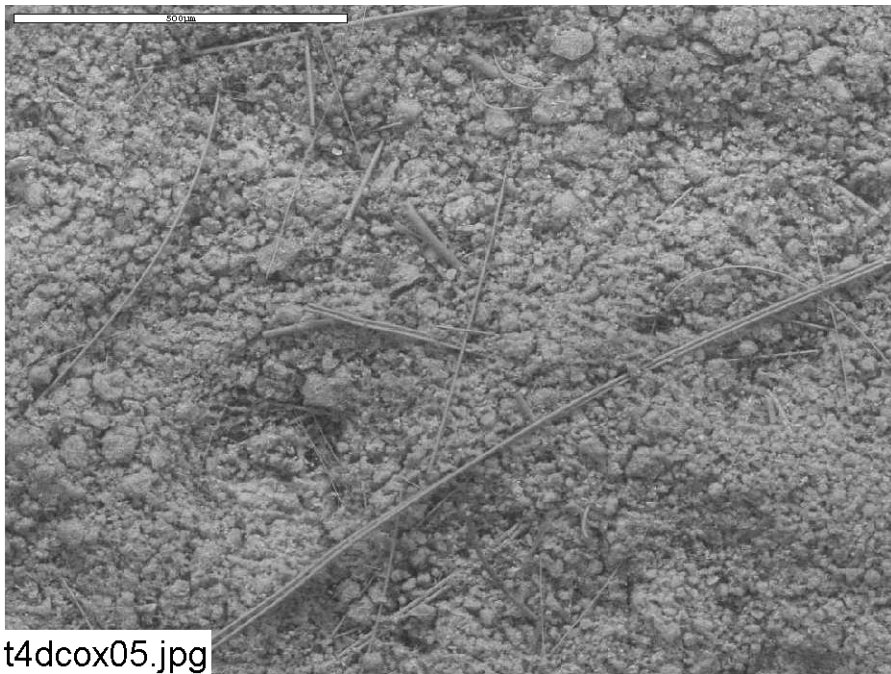
**Figure C6-2.** Environmental SEM image magnified 100 times for a Test #4, Day-30 exterior fiberglass sample on the drain collar (away from the drain screen). (t4dcox05.jpg)

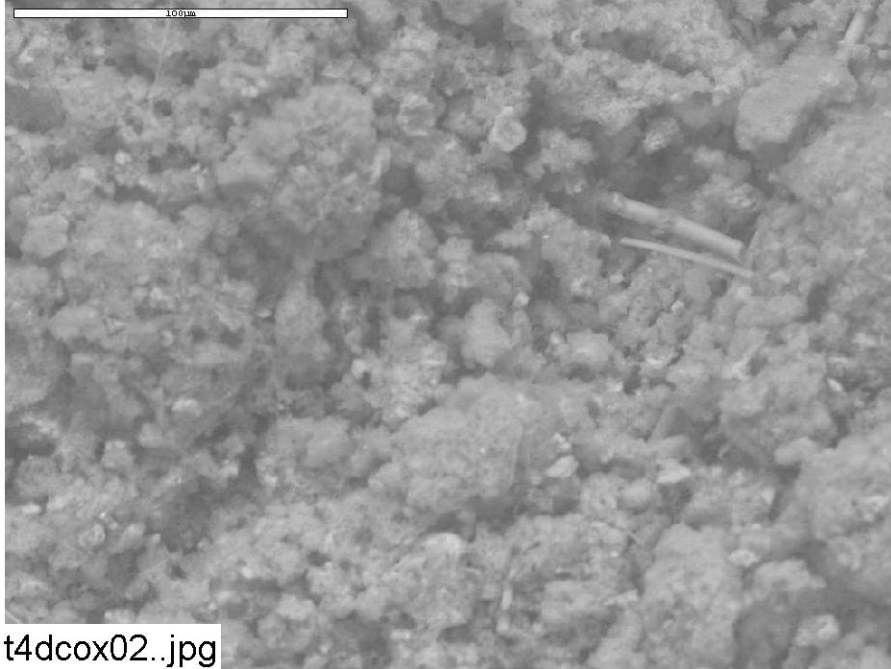
**Figure C6-3. Environmental SEM image magnified 500 times for a Test #4, Day-30 exterior fiberglass sample on the drain collar (away from the drain screen). (t4dcox02.jpg)**

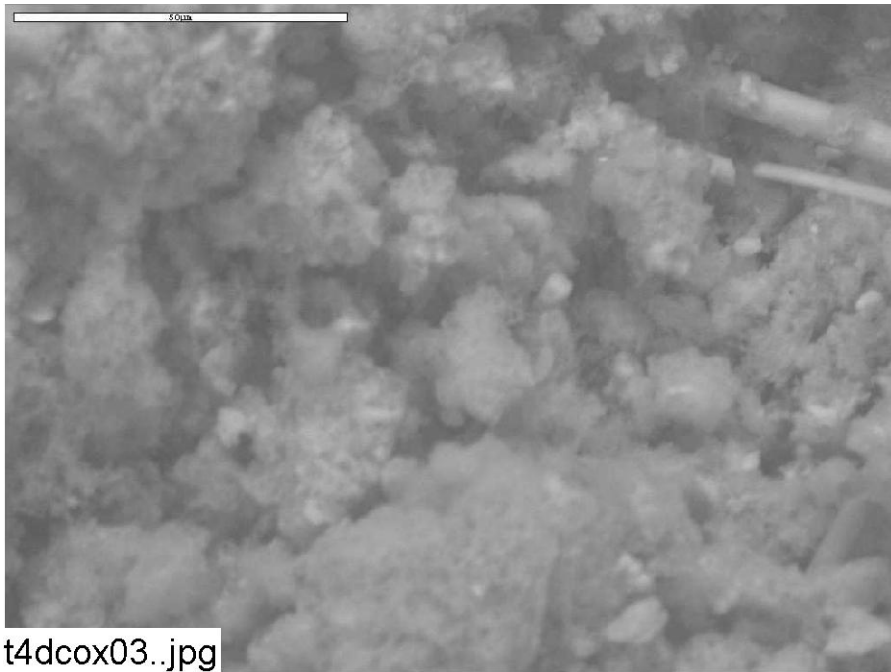
**Figure C6-4. Environmental SEM image magnified 1000 times for a Test #4, Day-30 exterior fiberglass sample on the drain collar (away from the drain screen). (t4dcox03.jpg)**

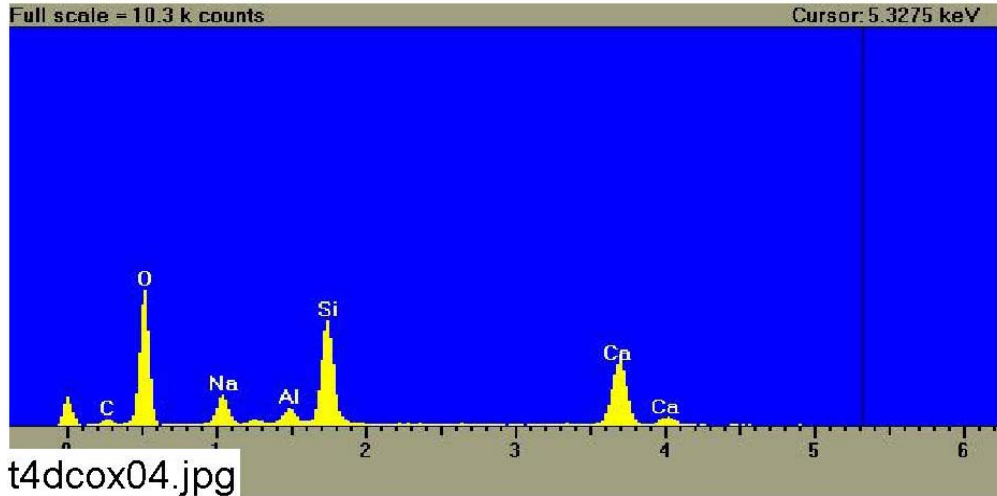
Figure C6-5. EDS counting spectrum for the large mass of particulate deposits on fiberglass shown in Figure C6-4. (t4dcox04.jpg)

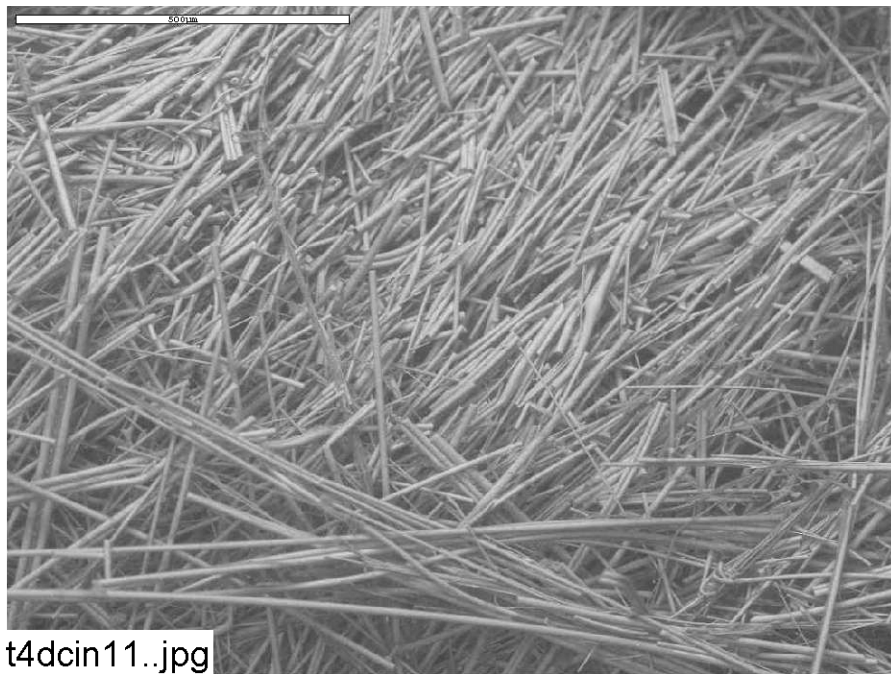
Figure C6-6. Environmental SEM image magnified 100 times for a Test #4, Day-30 interior fiberglass sample on the drain collar. (t4dcin11.jpg)

Image:	t4dcin11	100 ×	ESEM image	Figure C6-6
	t4dcin14	100 ×	ESEM image	Figure C6-7
	t4dcin12	500 ×	ESEM image higher magnification	Figure C6-8
	t4dcin13	500 ×	ESEM image high magnification	Figure C6-9
	t4dcin15	500 ×	ESEM image high magnification	Figure C6-10

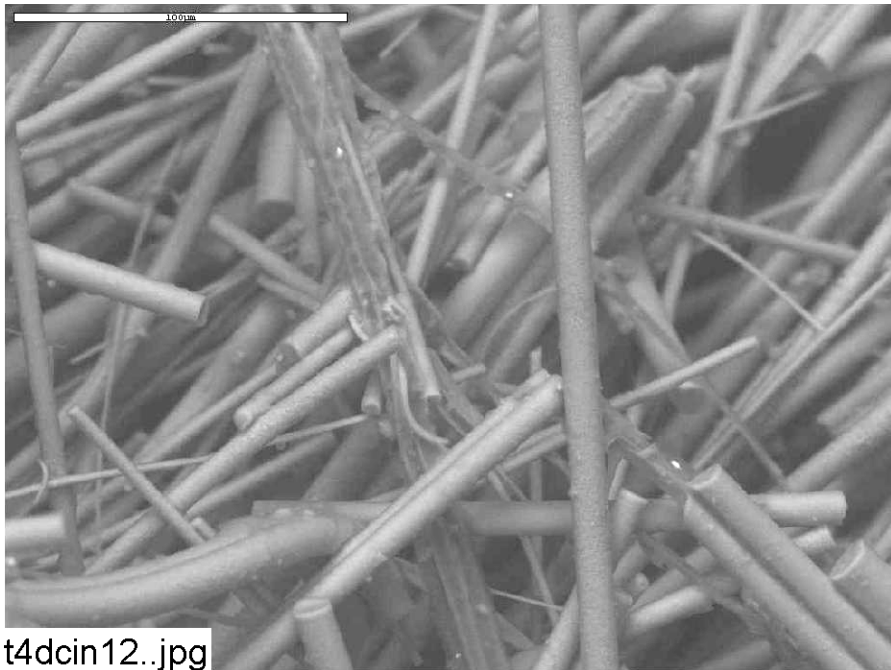
t4dcin12..jpg

**Figure C6-8.** Environmental SEM image magnified 500 times for a Test #4, Day-30 interior fiberglass sample on the drain collar. (t4dcin12.jpg)

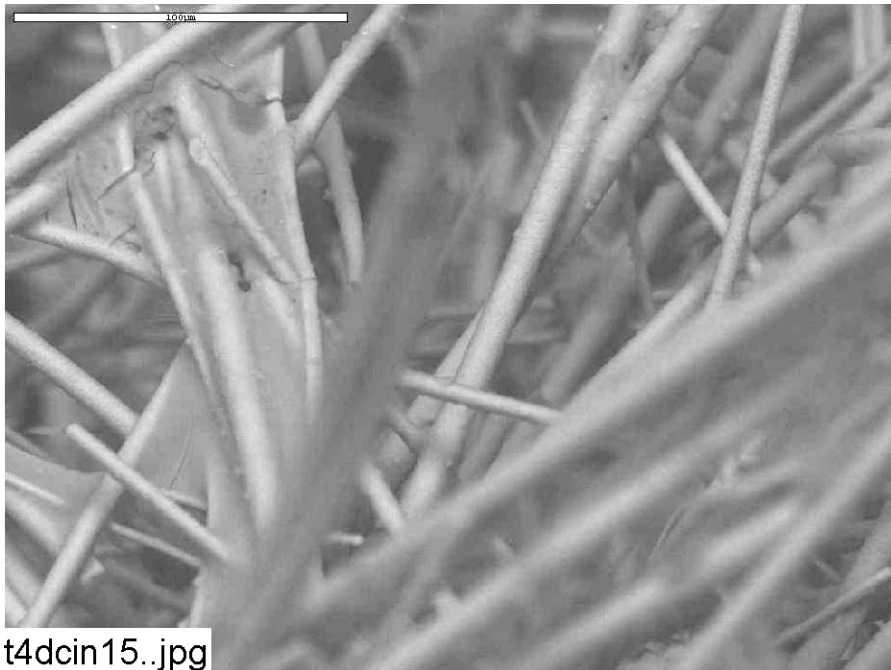
**Figure C6-10.** Environmental SEM image magnified 500 times for a Test #4, Day-30 interior fiberglass sample on the drain collar. (t4dcin15.jpg)

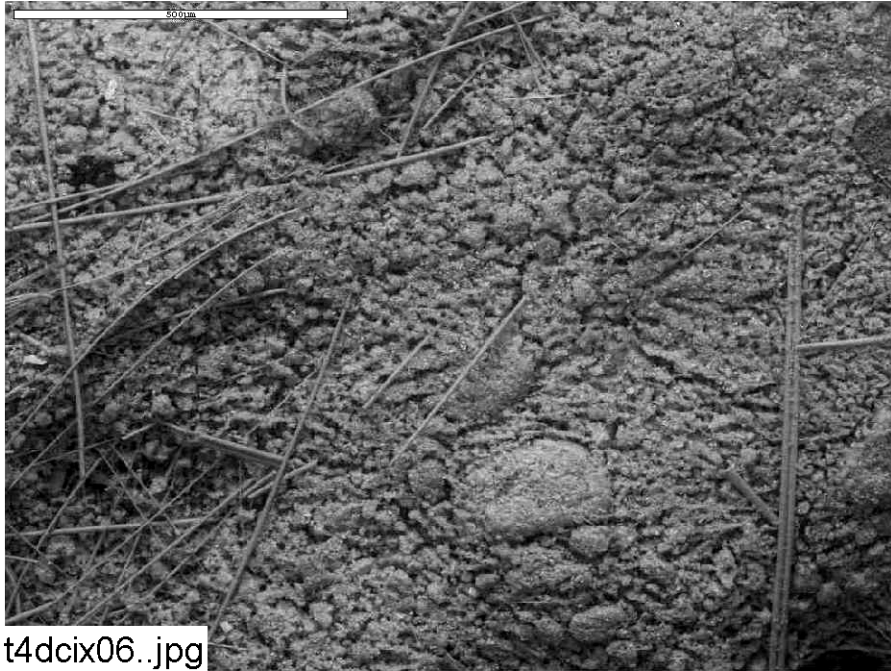
**Figure C6-11. Environmental SEM image magnified 100 times for a Test #4, Day-30 exterior fiberglass sample on the drain collar (next to the drain screen). (t4dcix06.jpg)**

Image:	t4dcix06	100 ×	ESEM image	Figure C6-11
	t4dcix10	100 ×	ESEM image	Figure C6-12
	t4dcix07	500 ×	ESEM image	Figure C6-13
	t4dcix08	1000 ×	ESEM image higher magnification	Figure C6-14
EDS:	t4dcix09		EDS on particles in t4dcix08	Figure C6-15

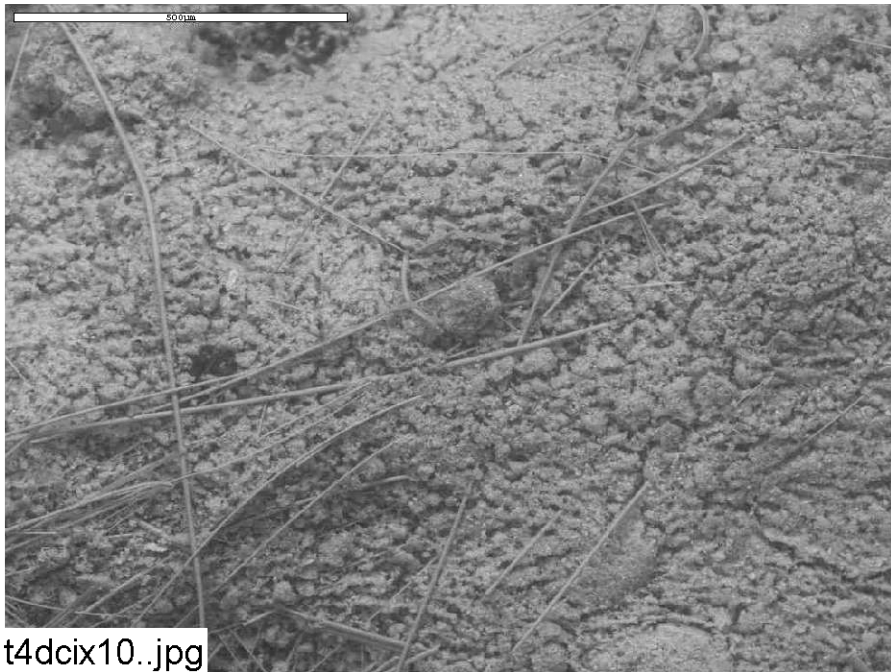
**Figure C6-12. Environmental SEM image magnified 100 times for a Test #4, Day-30 exterior fiberglass sample on the drain collar (next to the drain screen). (t4dcix10.jpg)**

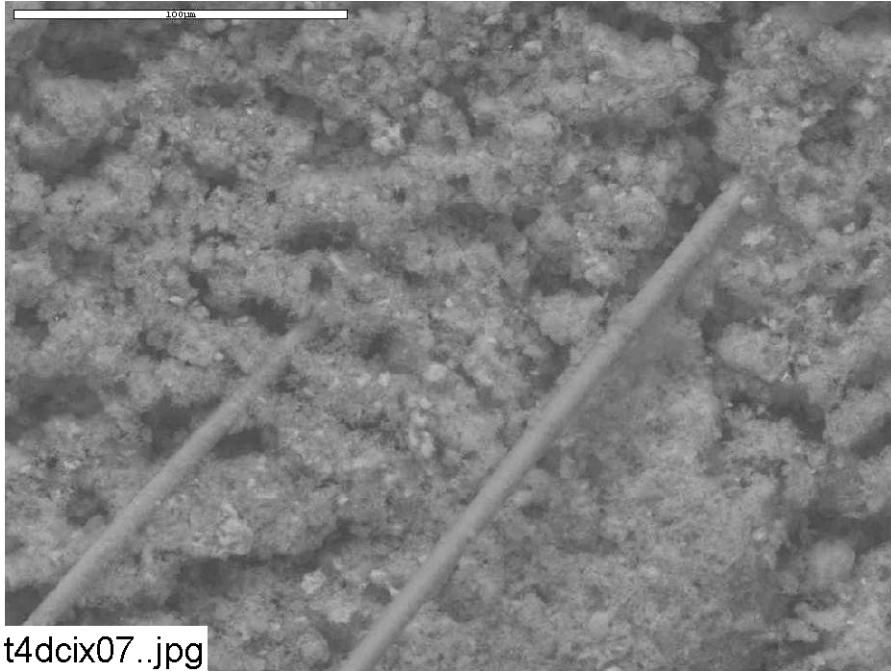
**Figure C6-13. Environmental SEM image magnified 500 times for a Test #4, Day-30 exterior fiberglass sample on the drain collar (next to the drain screen). (t4dcix07.jpg)**

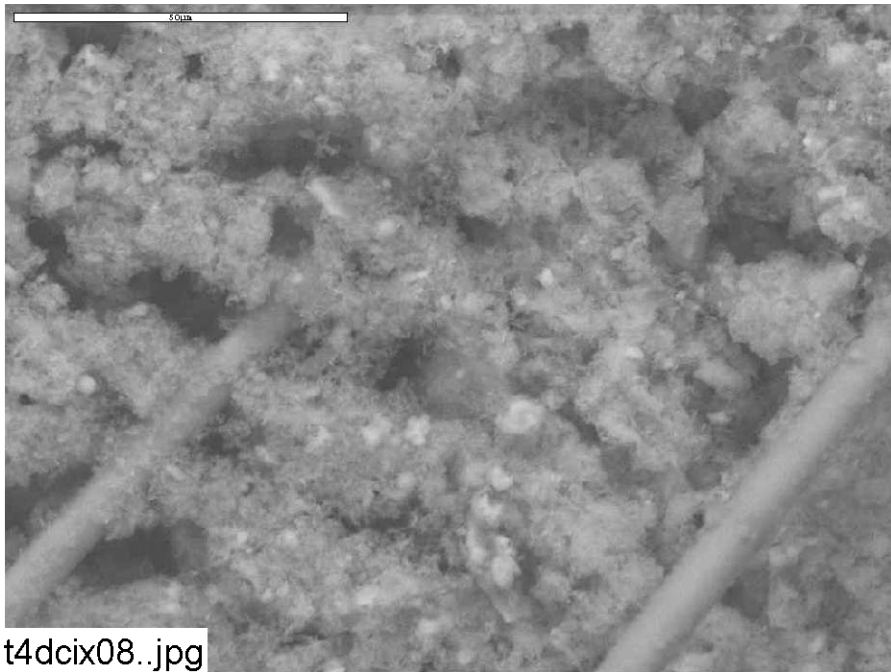
**Figure C6-14. Environmental SEM image magnified 1000 times for a Test #4, Day-30 exterior fiberglass sample on the drain collar (next to the drain screen). (t4dcix08.jpg)**

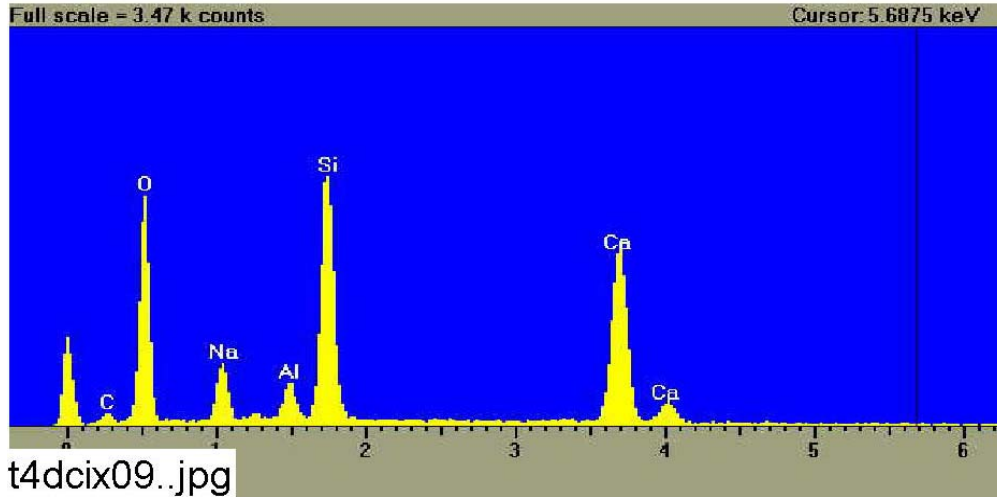
Figure C6-15. EDS counting spectrum for the large mass of particulate deposits on fiberglass shown in Figure C6-14. (t4dcix09.jpg)

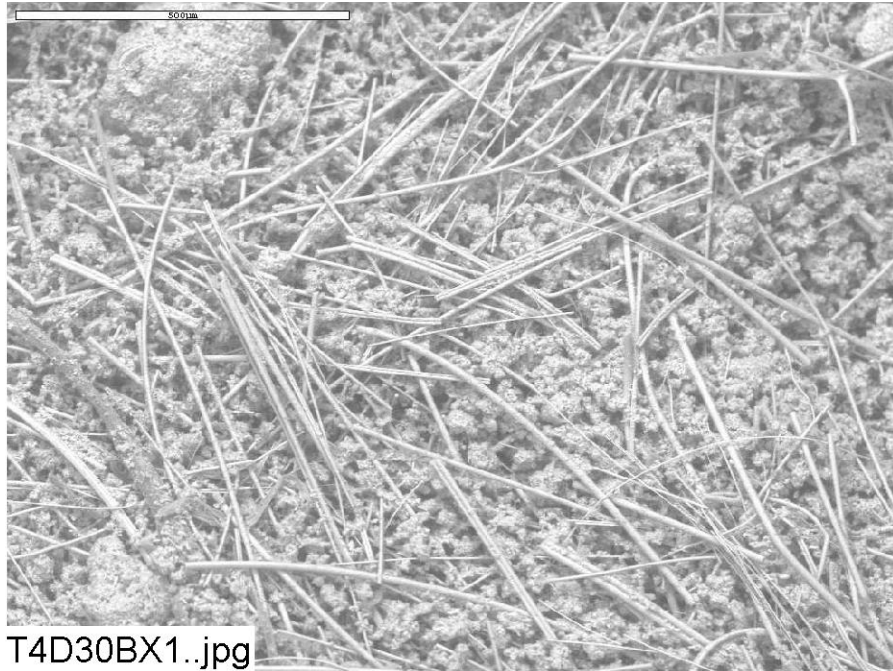
**Figure C7-1.** Environmental SEM image magnified 100 times for a Test #4, Day-30 exterior fiberglass sample within the birdcage. (T4D30BX1.jpg)

Image: T4D30BX1	100 ×	ESEM image	Figure C7-1
t4d30bx4	500 ×	ESEM annotated image	Figure C7-2
EDS: t4d30bx3		EDS on particles in t4d30bx4	Figure C7-3

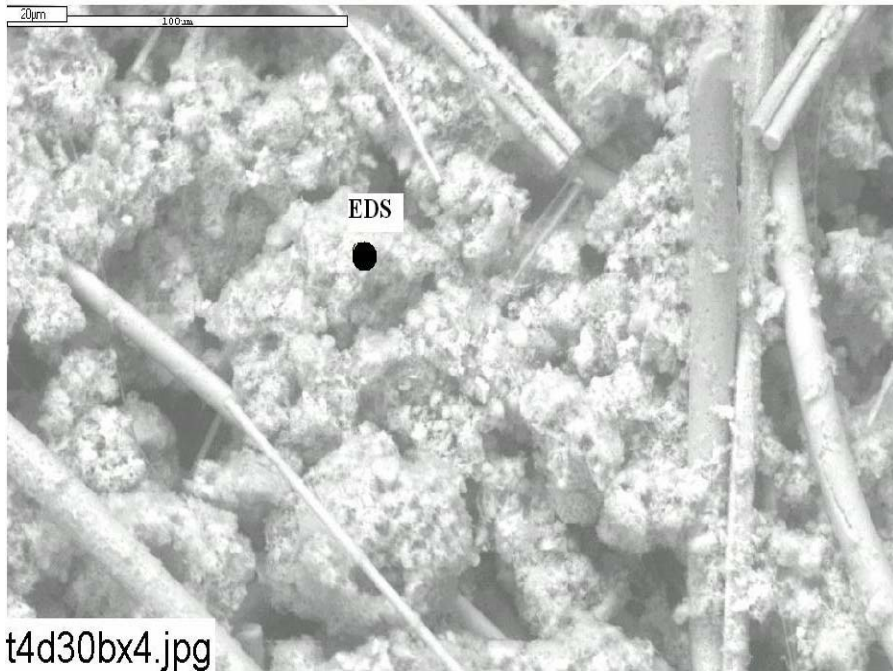
**Figure C7-2.** Annotated environmental SEM image magnified 500 times for a Test #4, Day-30 exterior fiberglass sample within the birdcage. (t4d30bx4.jpg)

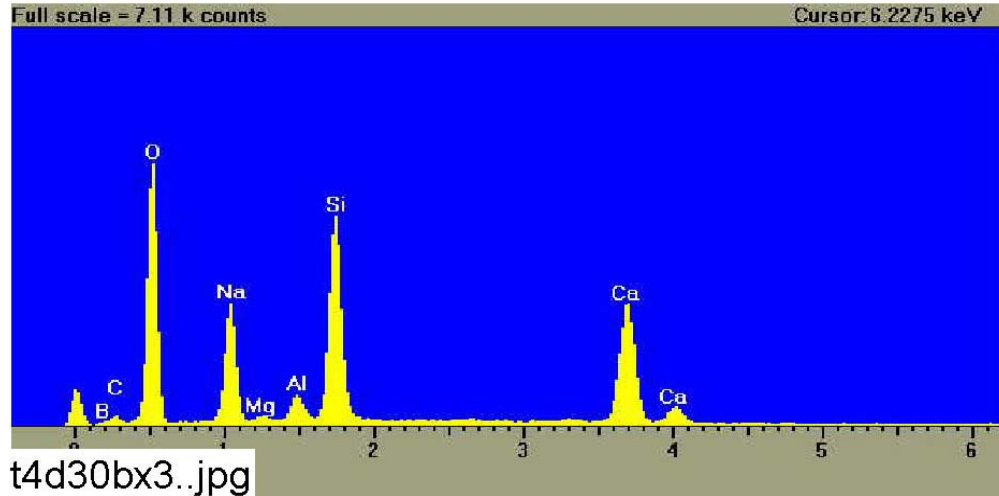
Figure C7-3. EDS counting spectrum for the particulate deposits on fiberglass shown in Figure C7-2. (T4D30bx3.jpg)

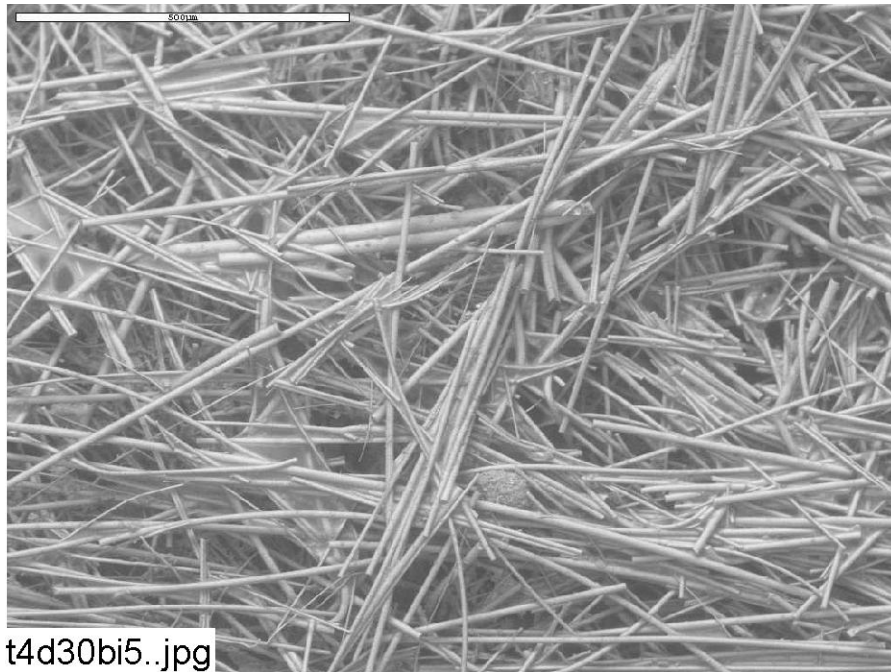
Figure C7-4. Environmental SEM image magnified 100 times for a Test #4, Day-30 interior fiberglass sample within the birdcage. (t4d30bi5.jpg)

Image: t4d30bi5	100 ×	ESEM image of fiberglass	Figure C7-4
t4d30bi6	500 ×	ESEM image higher magnification	Figure C7-5
t4d30bi7	500 ×	ESEM image	Figure C7-6

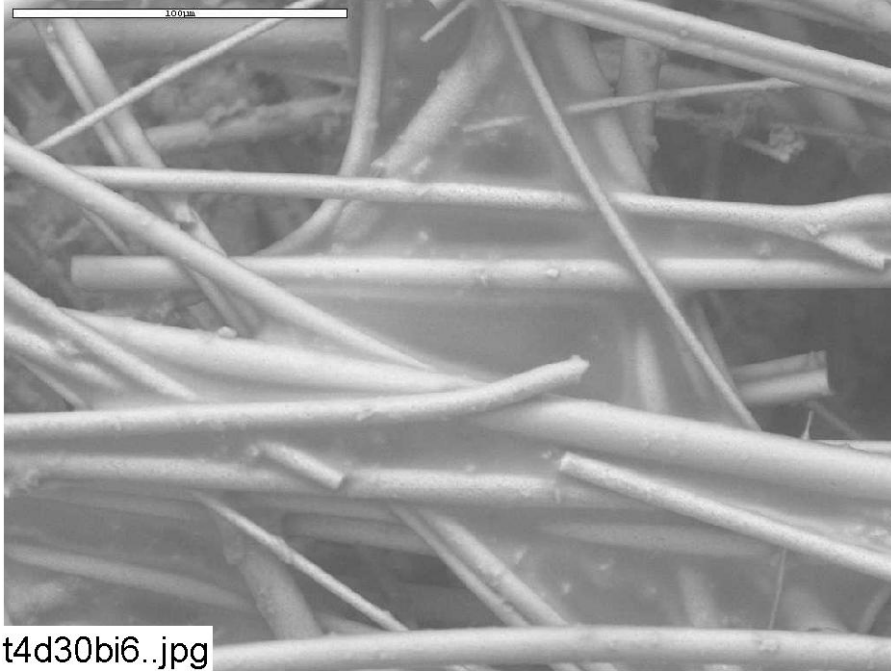
**Figure C7-5. Environmental SEM image magnified 500 times for a Test #4, Day-30 interior fiberglass sample within the birdcage. (t4d30bi6.jpg)**

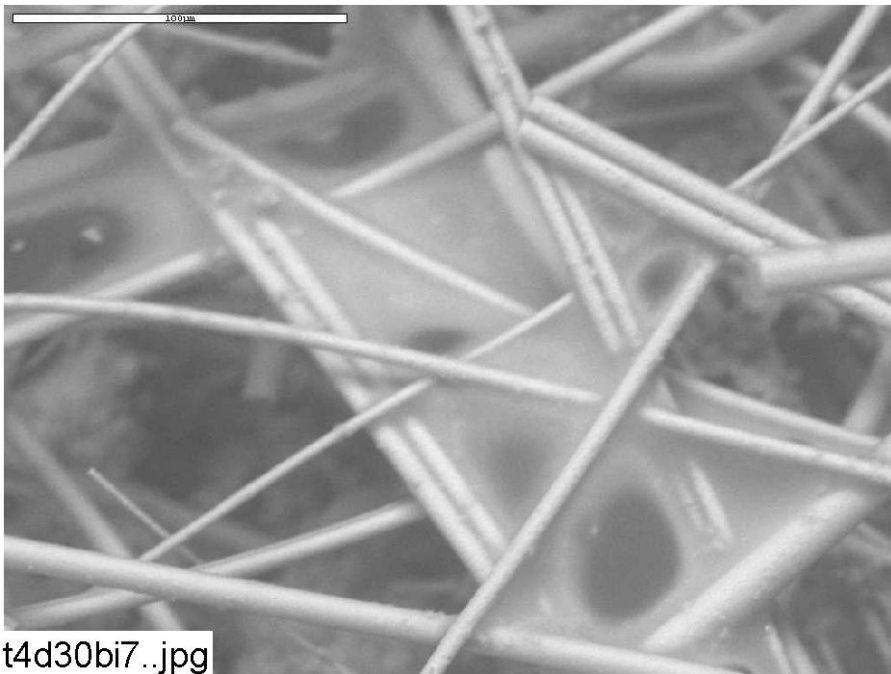
**Figure C7-6. Environmental SEM image magnified 500 times for a Test #4, Day-30 interior fiberglass sample within the birdcage. (t4d30bi7.jpg)**
