## 3.4. Metallic and Concrete Samples

### 3.4.1. Weights and Visual Descriptions

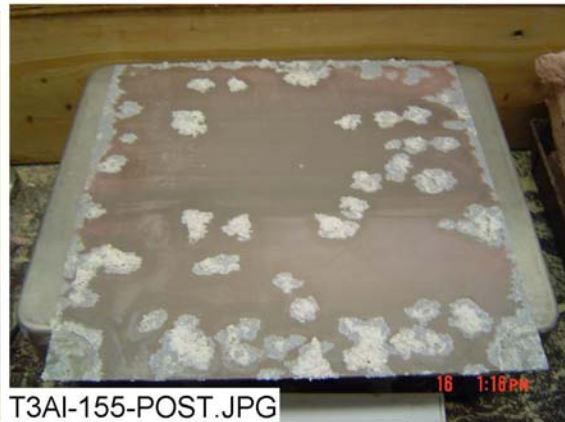
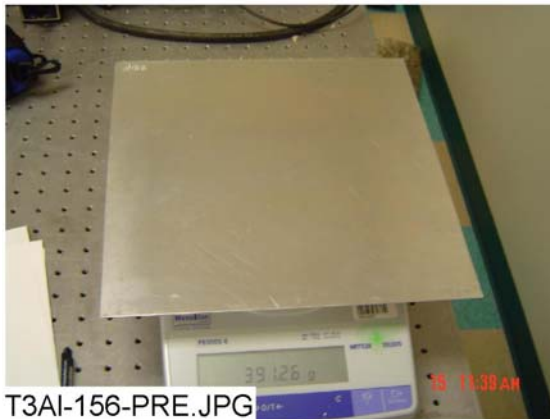
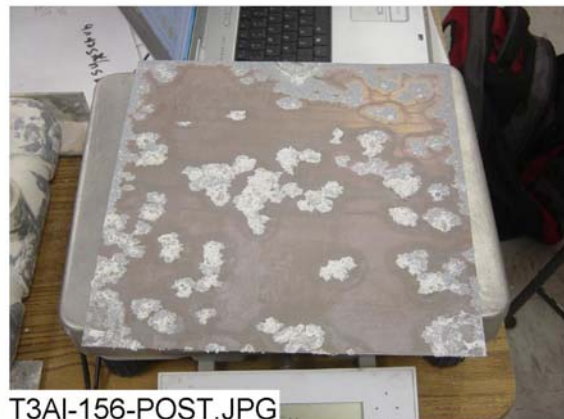
There are three submerged aluminum coupons in each test. Figures 3-80 through 3-85 display the pre- and post-test pictures of those coupons that were in Test #3. Each post-test aluminum coupon exhibits a pattern of white particulate deposition. In addition, each post-test coupon is a light reddish-brown, which may be attributable to copper's leaching into the test solution. The particulate deposition patterns for post-test aluminum coupons 155 and 156 are similar. However, the deposition pattern for the post-test Al-157 possesses a grayish tint, and a stream of white deposition runs from the rack contact point at the top to the bottom of the coupon. The relative spatial location of these coupons, given in order from the west side of the tank to the east side of the tank, is as follows: Al-155, Al-156, and Al-157. The concentration of particles increases slightly from the western-most coupon to the eastern-most coupon.

**Figure 3-80. Al-155, submerged, pre-test.**

**Figure 3-81. Al-155, submerged, post-test.**

**Figure 3-82. Al-156, submerged, pre-test.**

**Figure 3-83. Al-156 submerged, post-test.**

Figure 3-84. Al-157, submerged, pre-test.

Figure 3-85. Al-157, submerged, post-test.

Type	Coupon No.	Pre-Test Wt. (g)	Post-Test Wt. (g)	Net Gain/Loss
AI	155	393.0	398.7	5.7
AI	156	391.2	392.2	1.0
AI	157	395.5	390.8	-4.7
GS	468	1058.1	1074.0	15.9
IOZ	156	1600.9	1602.4	1.5
CU	207	1317.6	1318.8	1.2
CU	225	1317.9	1317.8	-0.1
US	11	1026.8	1025.7	-1.1
Conc	5	8020.0	8200.5	180.5

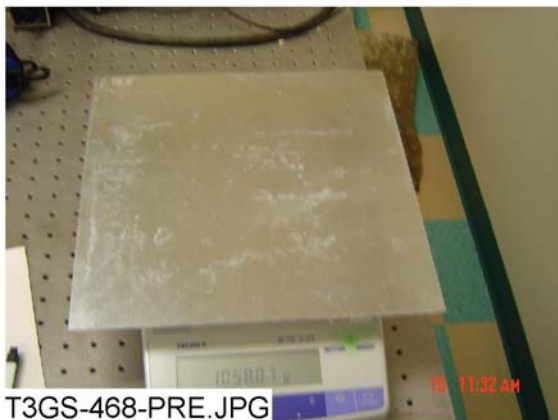
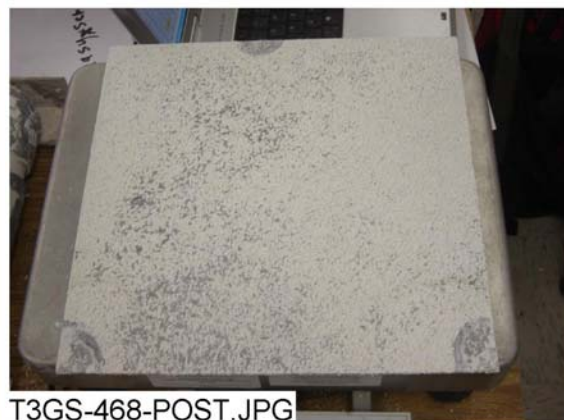
The galvanized steel coupons exhibited nearly identical patterns of dense gray particle deposition. Figures 3-86 and 3-87 present the pre- and post-test pictures of one submerged galvanized steel coupon. There were no observable differences in post-test appearance based on the coupon's location in the rack.

Figure 3-86. GS-468, submerged, pre-test.

Figure 3-87. GS-468, submerged, post-test.

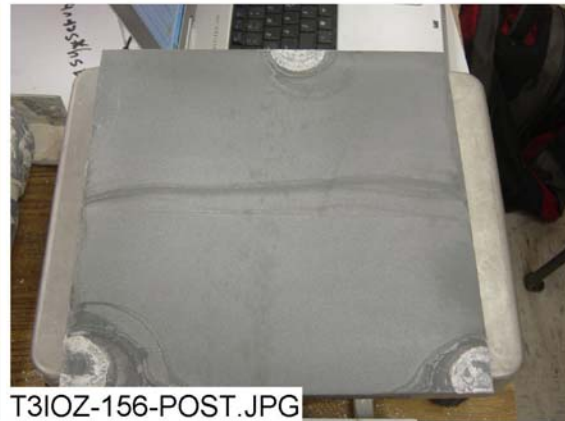
Figures 3-88 and 3-89 present the pre- and post-test pictures of a typical submerged IOZ-coated steel coupon. Each post-test coated steel coupon exhibited a similar pattern of white particle deposition.

**Figure 3-88. IOZ-156, submerged, pre-test.**

**Figure 3-89. IOZ-156, submerged, post-test.**

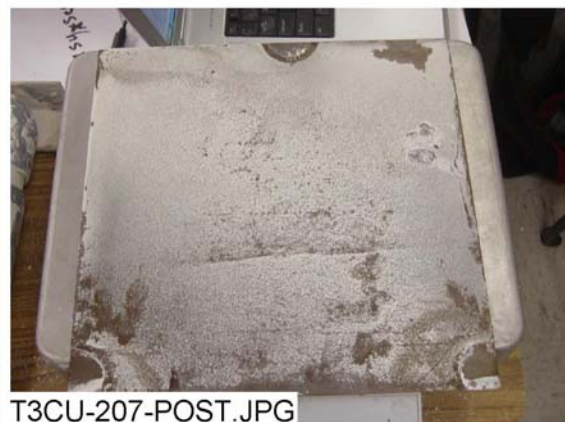
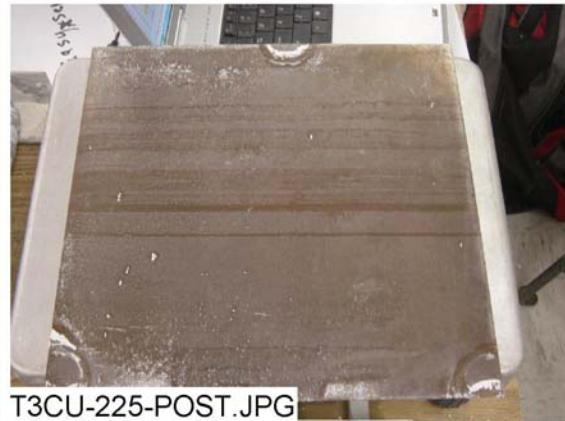
Figures 3-90 through 3-93 present the pre- and post-test pictures of two submerged copper coupons. The patterns of white deposition are different for these post-test coupons. The CU-207 post-test coupon is almost completely covered with a dense collection of white deposits. The CU-225 post-test coupon, in contrast, exhibits faint horizontal streak-lines of white deposits. The CU-207 coupon was located on the west side of the tank in relation to the CU-225 coupon. The CU-207 coupon gained 1.2 g, while the CU-225 coupon lost 0.1 g.

**Figure 3-90. CU-207 submerged, pre-test.**

**Figure 3-91. CU-207, submerged, post-test.**

Figure 3-92. CU-225, submerged, pre-test.

Figure 3-93. CU-225, submerged, post-test.

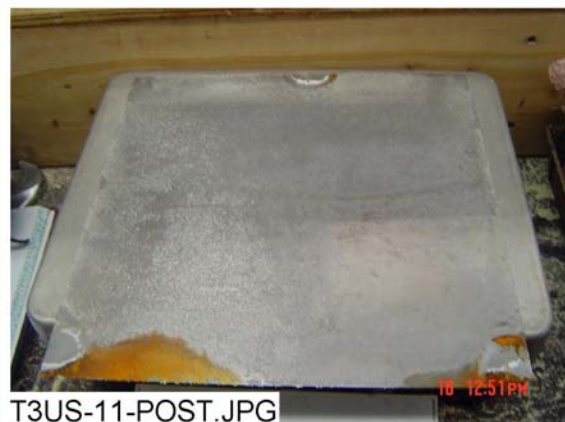
Figures 3-94 and 3-95 present the pre- and post-test pictures of the single submerged carbon steel coupon. It has a light coating of white deposits over a large portion of the surface area. Also, there is observable rust along the bottom edge of the coupon. The rust deposits are mainly congregated near the lower corners of the coupon, near the rack's contact points. Differences in corrosion or deposits at the location of the coupon rack contact points may have been due to stagnant solution conditions that may have limited mass transfer to or from the surface and caused local differences in solution composition. Coupon US-11 lost 1.1 g.

Figure 3-94. US-11, submerged, pre-test.

Figure 3-95. US-11, submerged, post-test.

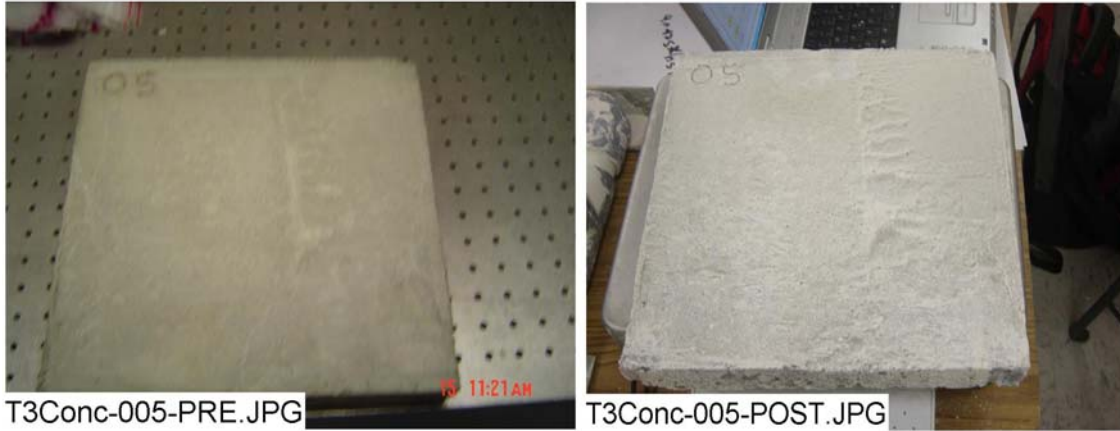
Figures 3-96 and 3-97 present the pre- and post-test pictures of the submerged concrete coupon. The post-test concrete coupon exhibits an enhanced gray compared with the pre-test coupon. The concrete coupon gained 180.5 g, which is estimated to be primarily water absorption.

Figure 3-96. Conc-005, submerged, pre-test.

Figure 3-97. Conc-005, submerged, post-test.

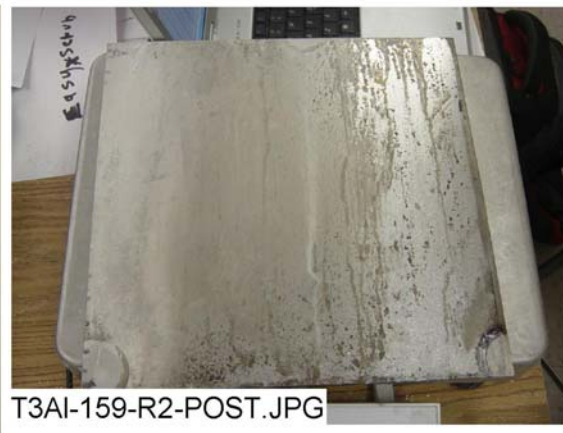
Figures 3-98 and 3-99 show the pre- and post-test pictures of a typical unsubmerged aluminum coupon. The coupons exhibit a light pattern of deposition. Also, each post-test coupon has coarser texture and a less-lustrous surface.

Figure 3-98. AI-159, unsubmerged, pre-test.

Figure 3-99. AI-159, unsubmerged, post-test.

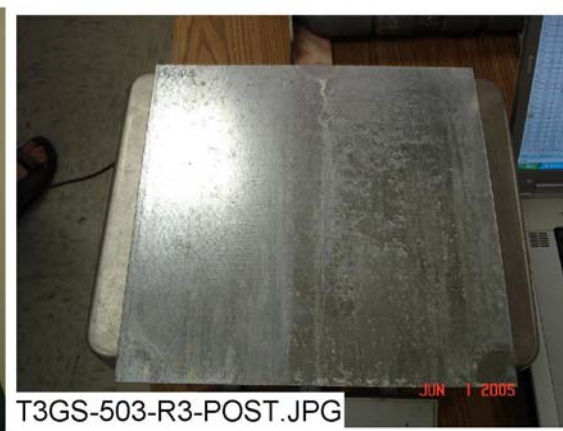
Figures 3-100 and 3-101 show the pre- and post-test pictures of a typical unsubmerged galvanized steel coupon. Each post-test galvanized steel coupon exhibited a similar light deposition.

Figure 3-100. GS-503, unsubmerged, pre-test.

Figure 3-101. GS-503, unsubmerged, post-test.

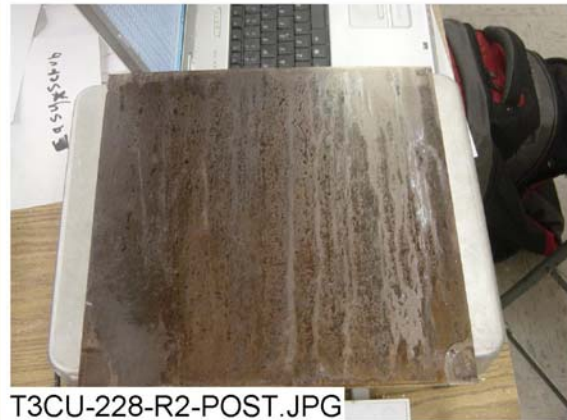
Figures 3-101 and 3-102 present the pre- and post-test pictures of a typical unsubmerged copper coupon. Each post-test copper coupon exhibited a similar pattern of streak-like deposition.

Figure 3-102. CU-228, unsubmerged, pre-test.

Figure 3-103. CU-228 unsubmerged, post-test.

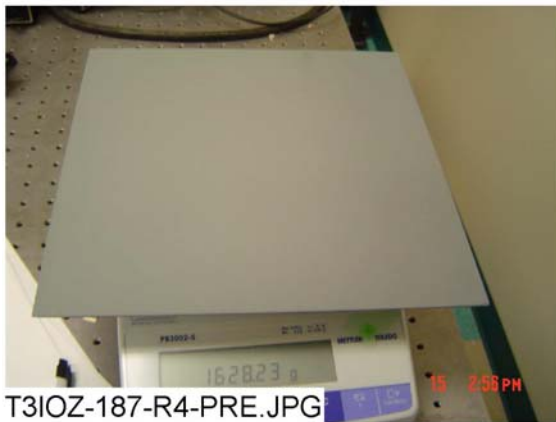
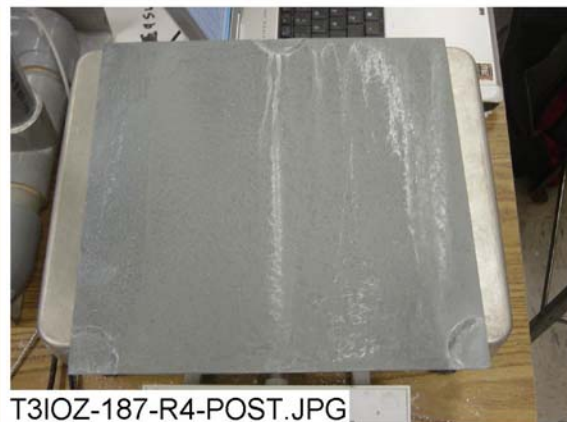
Figures 3-104 and 3-105 present the pre- and post-test pictures of a typical unsubmerged IOZ-coated steel coupon. Each post-test coated steel coupon exhibited a similar pattern of deposition.

Figure 3-104. IOZ-187, unsubmerged, pre-test.

Figure 3-105. IOZ-187, unsubmerged, post-test.

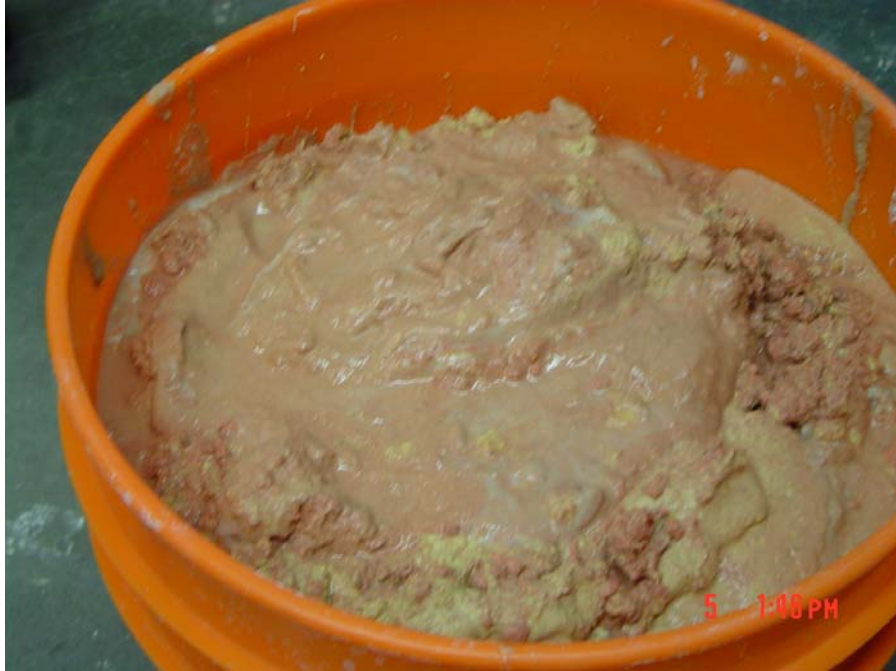
**Figure 3-108.** Sediment removed from the tank. Some gel appears on the top.

Sediment was collected from the tank bottom after the test solution was drained. It consisted of two main macroscopic quantities, a particulate sediment on the bottom covered in many places with a whitish-pink gel-like material. Figure 3-108 shows this sediment. In addition, Figure 3-109 shows SS mesh holding insulation samples after it was pulled from the tank bottom. The pink and yellow particulate sediment covers much of the mesh, and the gel-like material is seen above it and is being pointed to in the figure.

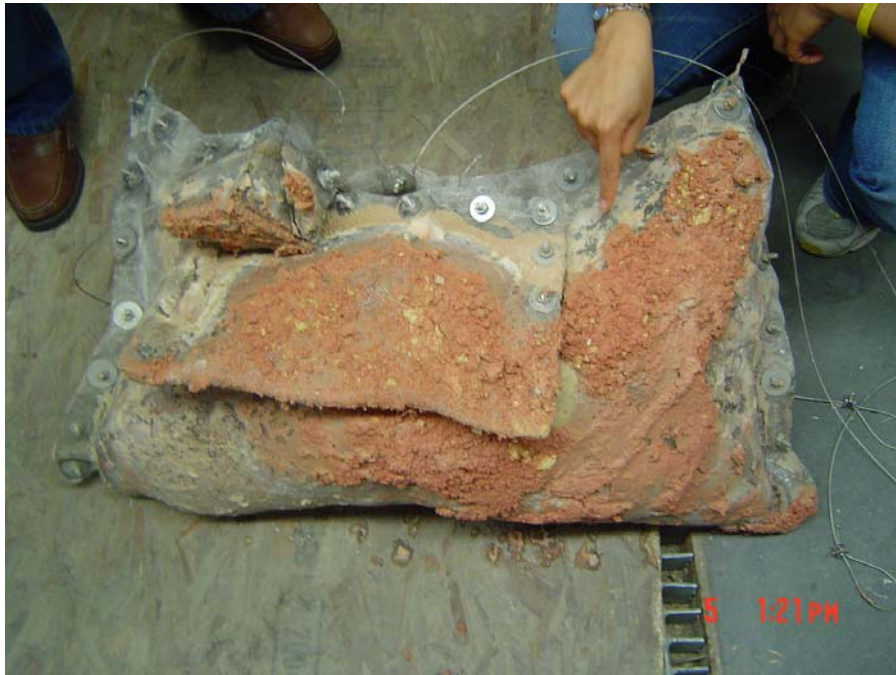
**Figure 3-109.** Samples removed from the tank bottom.

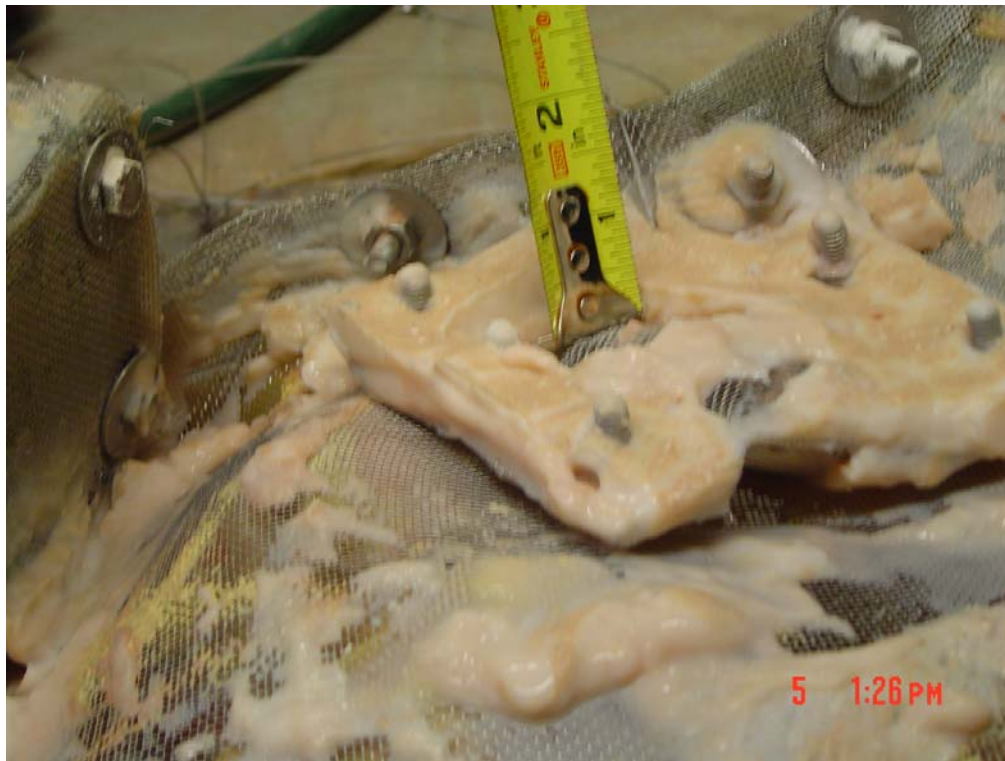
Figure 3-118. Gel-like material covering SS mesh on the bottom of the test tank.

In ICET Test #3, one significant phenomenon is the presence of white gel-like precipitates in the test solution, especially during and after the injection of TSP on the first day of the test. When Test #3 was shut down, deposits of the pinkish-white gel-like precipitates were observed on the top of the birdcage and on other objects on the tank's bottom. Figures 3-118 and 3-119 show the gel-like precipitates.

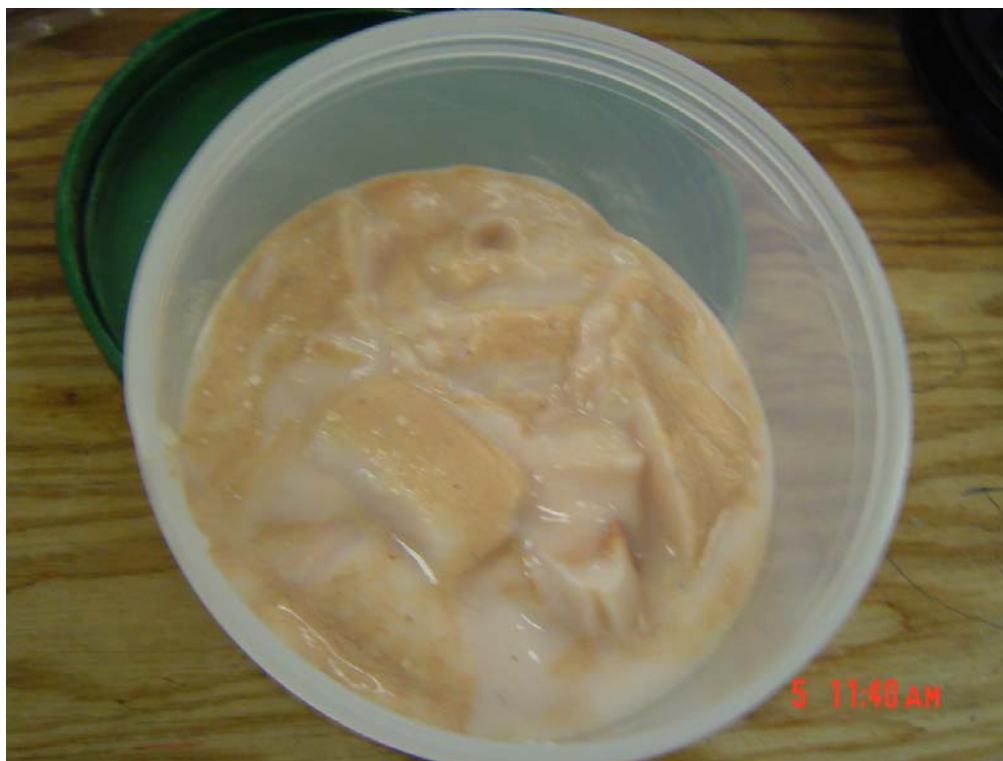
Figure 3-119. Gel-like material recovered from the bottom of the test tank.
