Appendix B2

ESEM/EDS and SEM/EDS Data for Test #3, Day-15 Fiberglass in Low-Flow Zones

Test #3, Day-15 fiberglass in low-flow zones

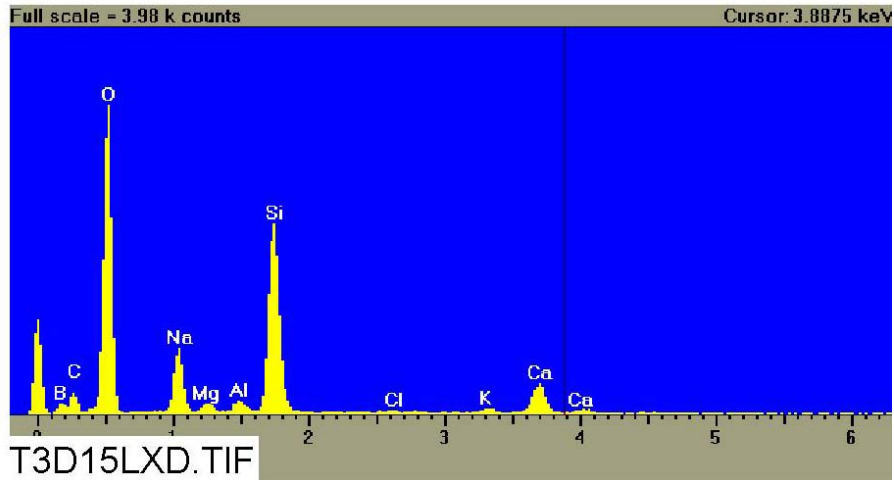
Figure B2-7. EDS counting spectrum for the deposits between the fibers on ESEM image shown in Figure B2-6. (T3D15LXD)

Image:	T3D15LX9	110 ×	Figure B2-5
	T3D15LX0	1000 ×	Figure B2-6
EDS:	T3D15LXD	EDS on particles shown in T3D15LX0	Figure B2-7

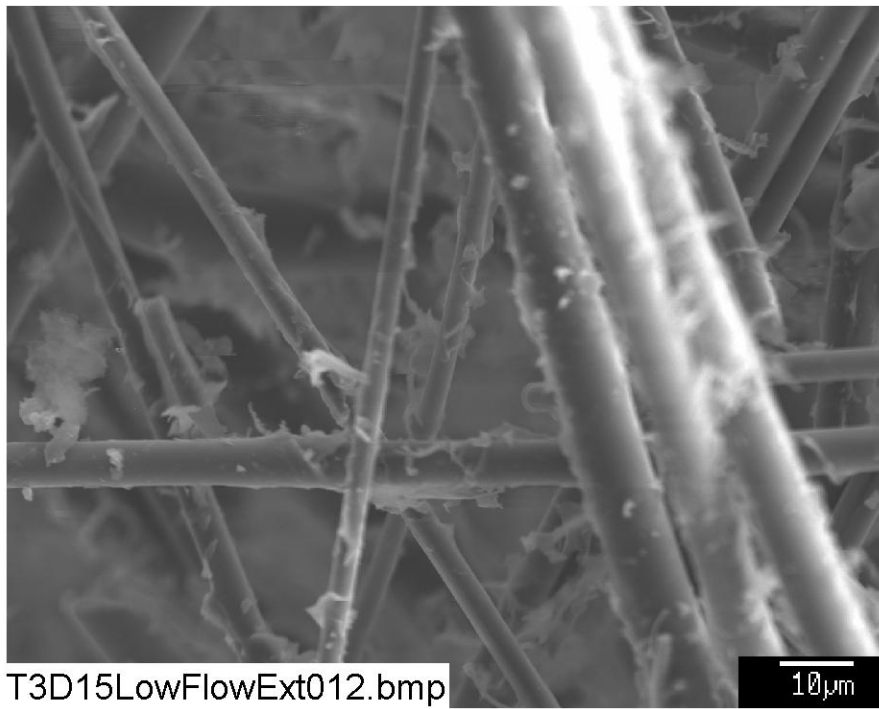
Figure B2-12. SEM image magnified 1000 times for a Test #3, Day-15 low-flow exterior fiberglass sample. (T3D15LowFlowExt012)

Image:	T3D15LowFlowExt011	100 ×	Figure B2-11
	T3D15LowFlowExt012	1000 ×	Figure B2-12
	T3D15LowFlowExt013	1000 ×	Figure B2-13
EDS:	T3D15LowFlowExtEDS3	EDS on particles shown in Ext007	Figure B2-14

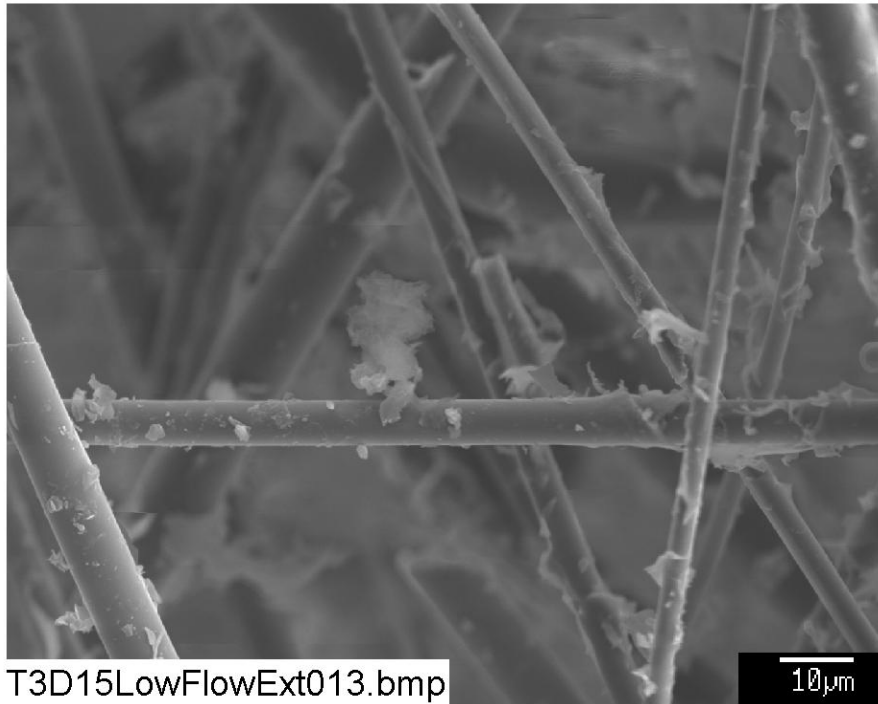
Figure B2-13. SEM image magnified 1000 times for a Test #3, Day-15 low-flow exterior fiberglass sample. (T3D15LowFlowExt013)
