Appendix C1

ESEM/EDS Data for Test #3, Day-30 Fiberglass in High-Flow Zones

Appendix C2

ESEM Data for Test #3, Day-30 Fiberglass in Low-Flow Zones

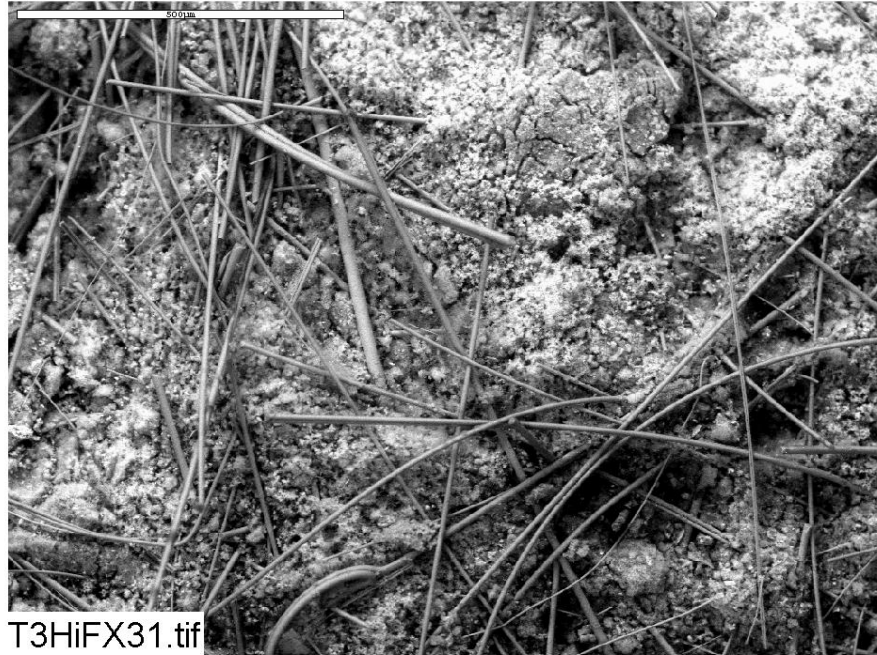
Figure C1-1. ESEM image magnified 100 times for a Test #3, Day-30 exterior high-flow fiberglass sample. (T3HiFX31)

Image: T3HiFX31	100 ×	ESEM image	Figure C1-1
t3hifX32	1000 ×	ESEM image higher magnification	Figure C1-2
t3hifX33	100 ×	ESEM image	Figure C1-3
EDS: t3hifX34		EDS on particles in T3HiFX33	Figure C1-4
Image: t3hifX35	600 ×	ESEM image on fiberglass	Figure C1-5

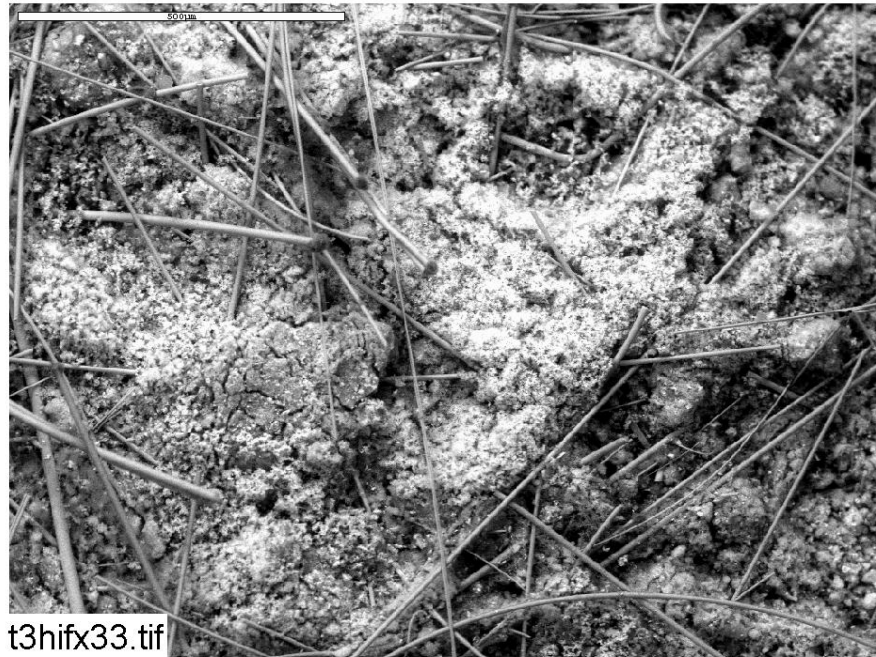
Figure C1-3. ESEM image magnified 100 times for a Test #3, Day-30 exterior high-flow fiberglass sample. (t3hifx33)

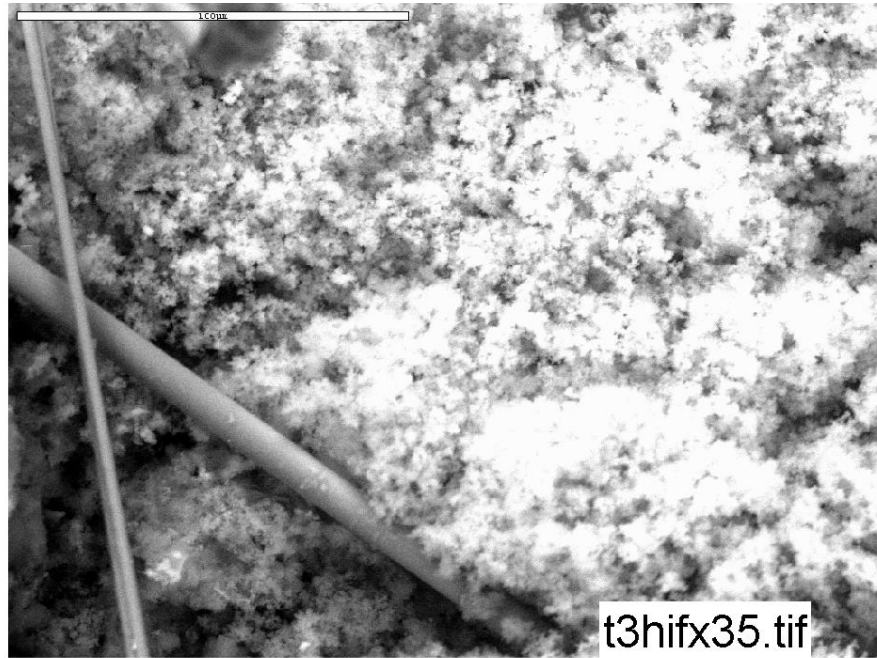
Figure C1-5. ESEM image magnified 600 times for a Test #3, Day-30 exterior high-flow fiberglass sample. (t3hifx35)
