HIGH TEMPERATURE CORROSION OF ADVANCED CERAMIC
MATERIALS FOR HOT GAS FILTERS AND HEAT EXCHANGERS

Final Report

August 1995

ORNL/Sub/94-SS111/01

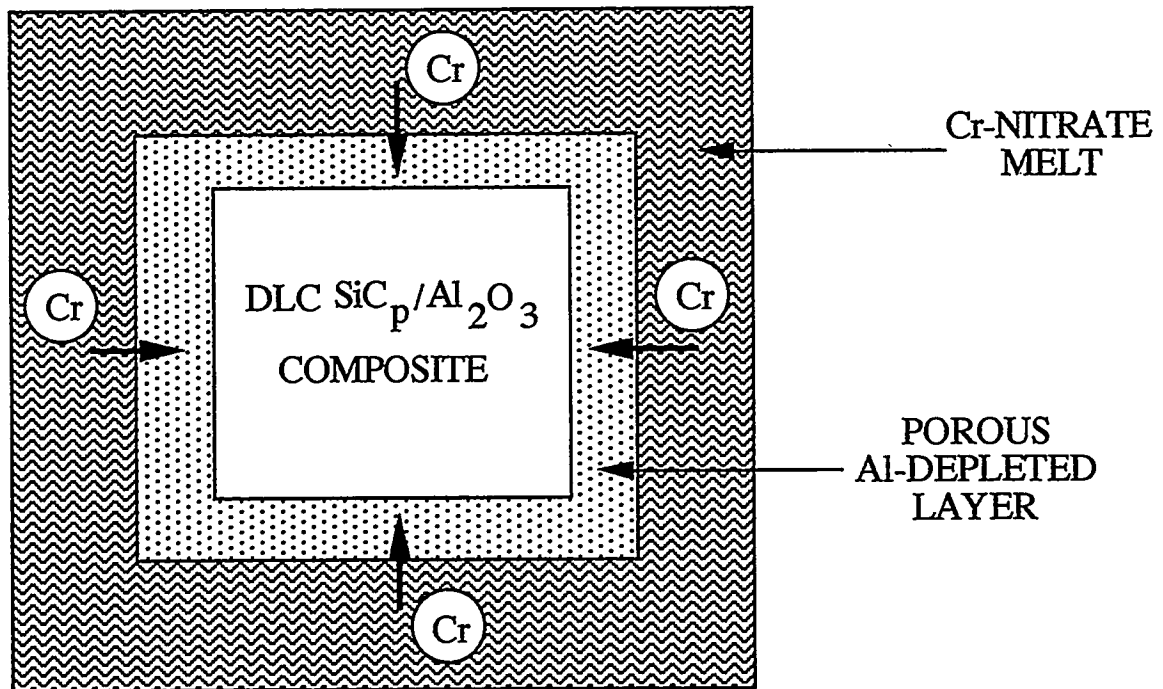
Fig. 8. Schematic of the Cr-infiltration of a DLC SiC_p/Al₂O₃ composite in molten Cr(NO₃)₃ · 9 H₂O.

(2), the heat treatment at 1100°C (equivalent to the Dimox™ process) or, alternatively, the chemical treatment in concentrated HCl (by etching the residual Al) allowed for the formation of additional porosity on the specimen surfaces. The molten chromium (III) nitrate was subsequently expected to penetrate the surface pores by capillary action (Fig. 8). Prior to surface equilibration at 1500°C, the Cr-nitrate was decomposed into an oxide at 600°C.

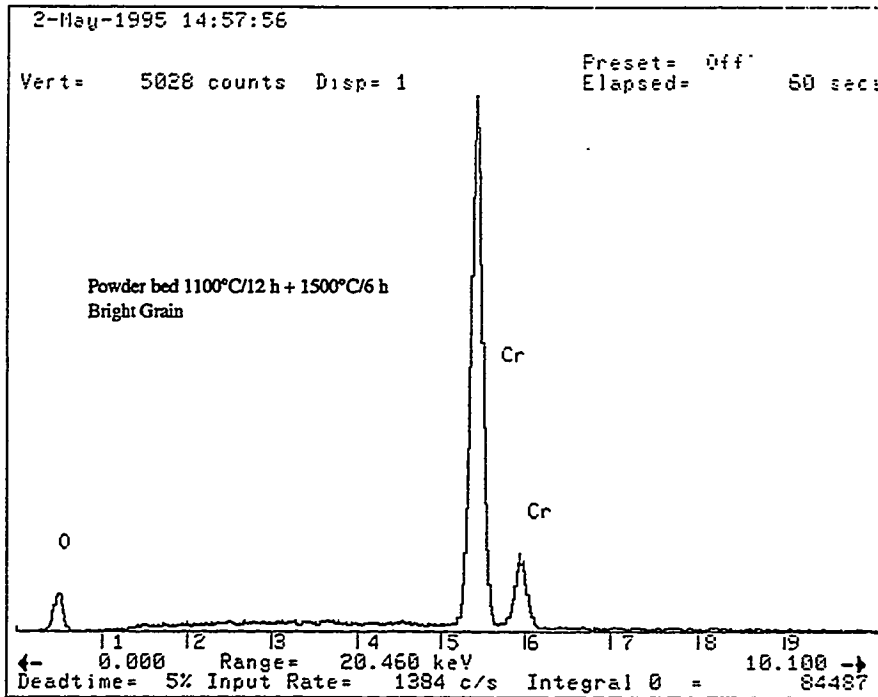
Fig. 10. EDX spectra corresponding to (a) the bright phase, and (b) the dark phase observed in the upper portion of Fig. 9 (b).

The SEM micrographs of the near-surface layers of specimens No. 1 and No. 4 are shown in Figs. 9 (a) and (b), respectively. The EDX spectra corresponding to the brighter and darker phases in specimen No. 4 are shown in Figs. 10 (a), and (b), respectively. Minor quantities of Ca detected within the darker phase indicated that the Ca was used as an additive in the fabrication of the DLC SiC_p/Al₂O₃ composite.⁹ The Cr-rich layer observed in the upper portion of the photographs in Fig. 9 consisted of the Cr₂O₃ grains (brighter phase) embedded in a chrome-aluminosilicate matrix (darker phase). The appearance and
