Investigation of Mechanical Processes for Removing Lead-Based Paint (LBP) from Wood Siding

Robert H. Falk, John Janowiak, Richard G. Lampo,
Thomas R. Napier, Stephen D. Cosper, Susan A. Drozdz,
Steven Larson, and Edgar D. Smith

September 2006

Final report

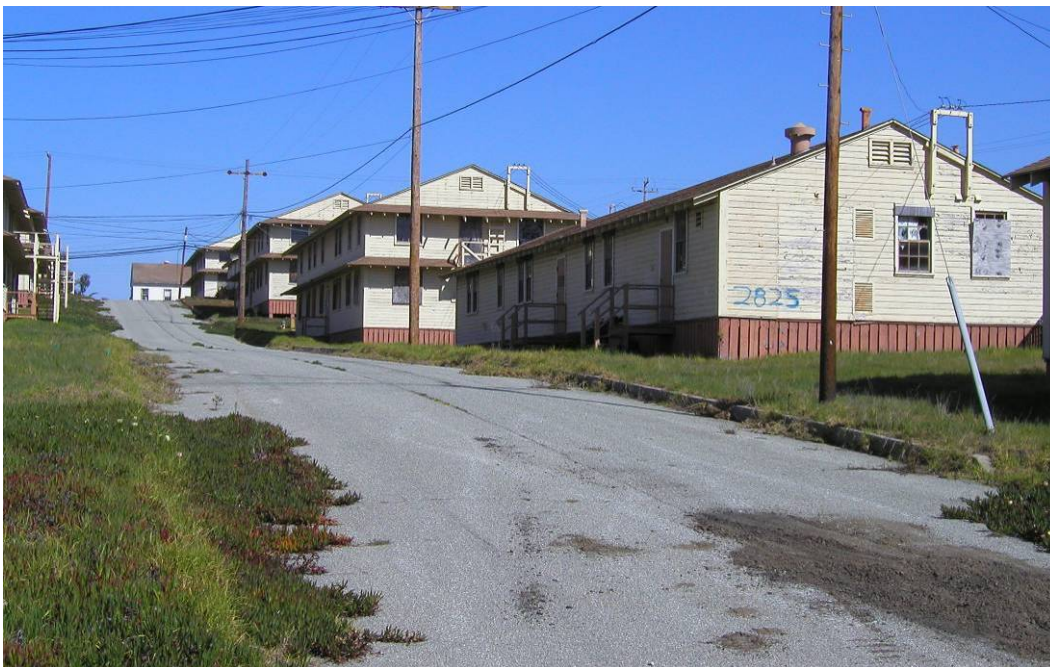
Figure 1. Typical World War II-era wooden barracks at Fort Ord, showing Building T2825 in right foreground.

Fort Ord provided the principal source of salvaged siding evaluated in this study. Using hand tools, the siding was manually removed from two single-story barracks buildings (24 x 82 ft), numbered T2824 and T2825. These buildings were scheduled for removal in the summer of 2002 as part of a local municipal road improvement construction project (commonly referred to as the 12th Street Project). These two buildings are representative of many other one- and two-story wood frame barracks still standing at Fort Ord. This project made use of two single-story barracks for ease of access and siding removal. The total siding recovered from two single-story barracks would approximately equal the amount recovered from one two-story barracks, not including the extra board-feet available from the gable area of the second single-story building. Typical World War II-era temporary wooden barracks are shown in Figure 1.

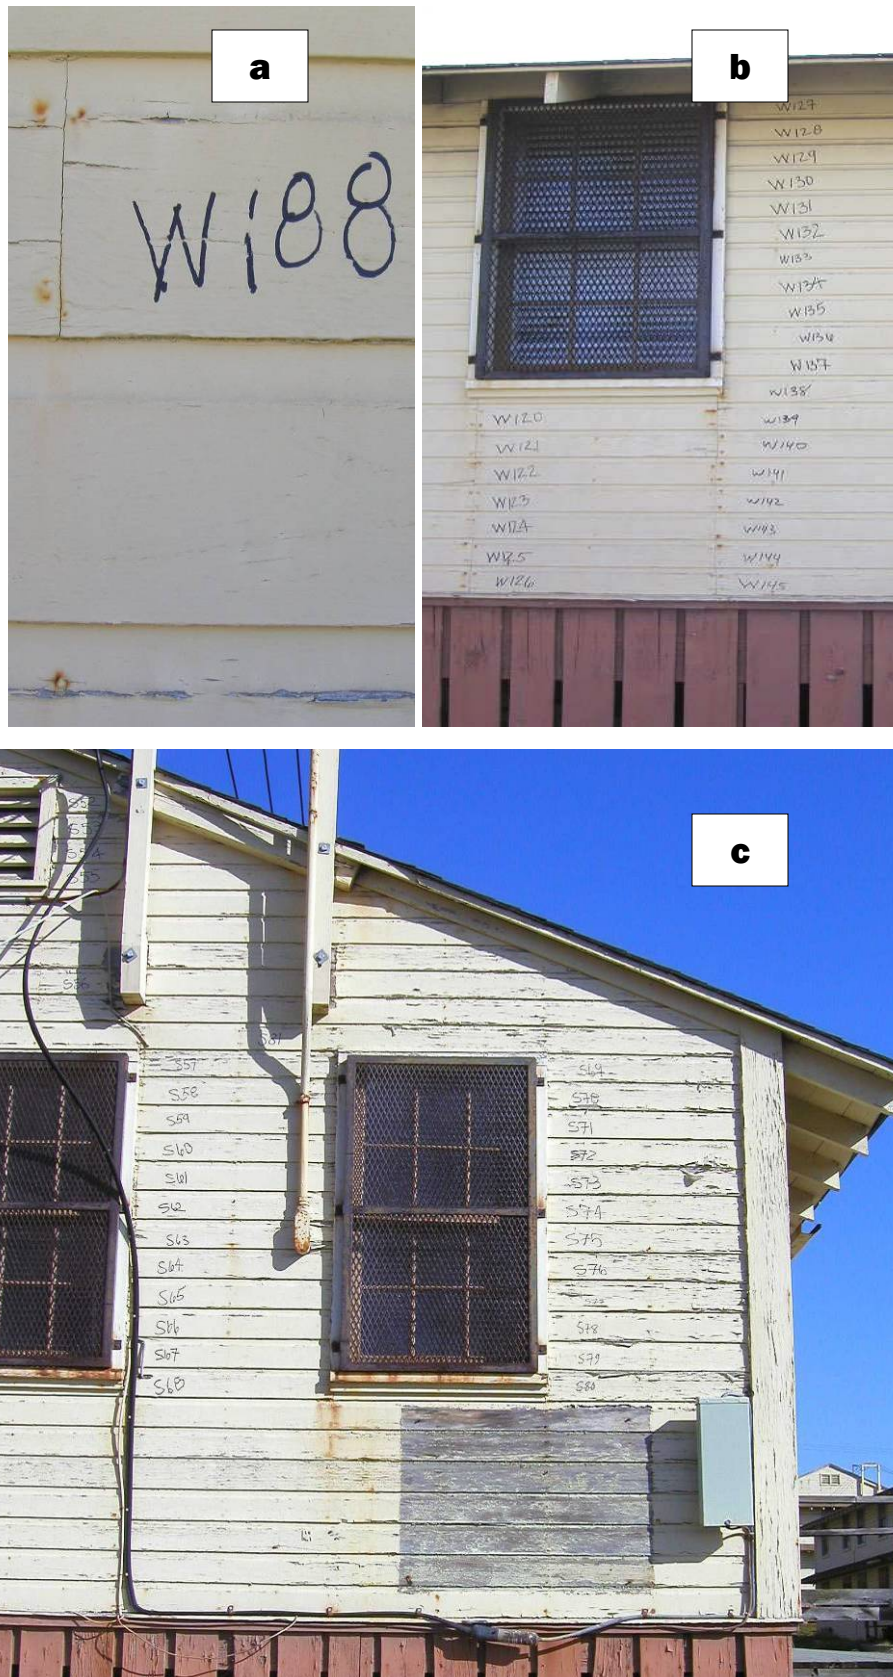
Figure 2. Typical ID numbering of individual siding pieces at Fort Ord.

An onsite appraisal of the barracks siding materials at Fort Ord was completed in April 2002. The siding was visually inspected and photographed to document building exterior conditions. During the visit, each piece of siding on each building was given an identification (ID) number. The ID number included a letter prefix indicating wall orientation – north (N), east (E), south (S) or west (W) – and a number giving vertical location Figure 2 (a, b, and c). Building T2824 was marked with a red permanent marker and Building T2825 was marked with black.

In Figure 2a, note double nail pattern at left, indicated by rust spots. Also, note the difference in siding condition in Figures 2b (west wall) and 2c (south wall), which is apparently a result of differences in weathering and exposure.

In spite of a difference in siding width, both the Fort Campbell and Fort Ord siding were nailed to the building framing using a double nail pattern spaced 24 in. on-center, as shown in Figure 2. Because the Fort Campbell buildings had wood siding overlaid with vinyl siding, additional nail holes were evident in every piece. Nail holes in salvaged siding are a significant factor that can reduce its value or limit its usefulness in certain ready-to-finish millwork products.

The siding salvaged from Fort Ord (Figure 6) was generally in much better condition than the Fort Campbell siding. In general, the same defects as described for Fort Campbell were found in the Fort Ord siding, but with much less frequency. The paint loss and wood weathering of the Fort Ord siding was more location-specific; the most severe degree of weathering and checking were found on pieces from the south sides of the building, where solar exposure was highest. Figure 2c shows a typical southern exposure and Figure 2b shows a typical western exposure.

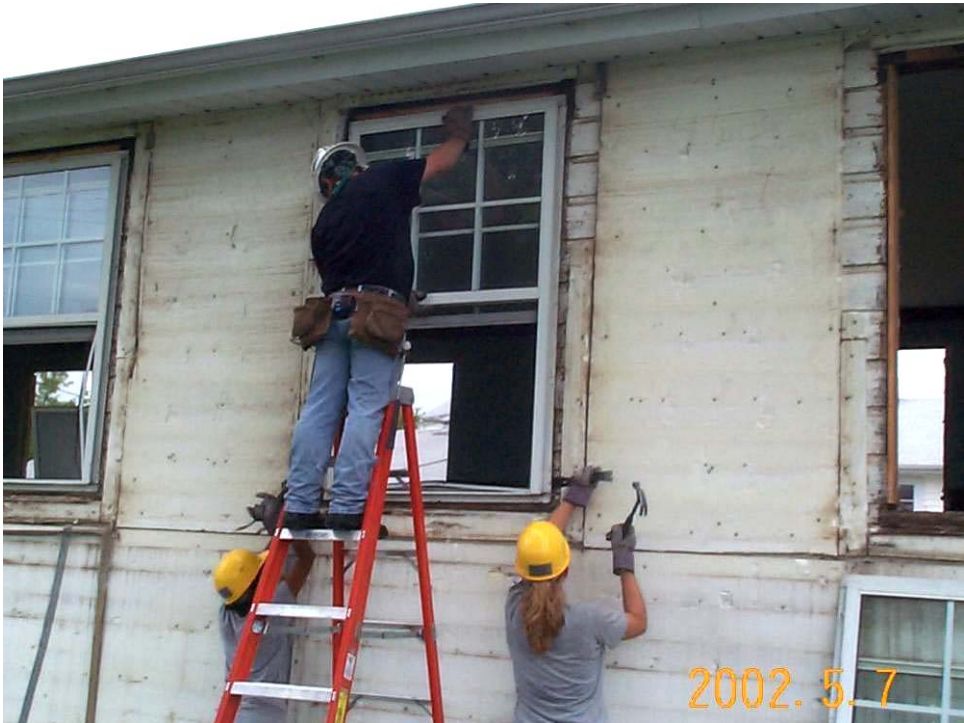
Figure 3. Deconstruction at Fort Campbell.

The scheduled deconstruction of five buildings at Fort Campbell (Figure 3) provided another source of wood siding for evaluation. The siding from those buildings was separated from the other salvaged materials because of its LBP content and the poor condition of the paint film. The siding was disposed of as debris except for boards from one two-story barracks building. Those boards were removed, bundled, banded, and shipped to FPL. In order to assess the condition of the siding boards relative to their position on the building, a coding scheme was adopted similar to that used at Fort Ord, with N, E, S, and W indicating compass orientation and a number indicating vertical and horizontal location of each piece. ERDC-CERL personnel coded each siding piece, and the boards were removed by Austin Habitat for Humanity, Austin, TX, the deconstruction contractors for this project.

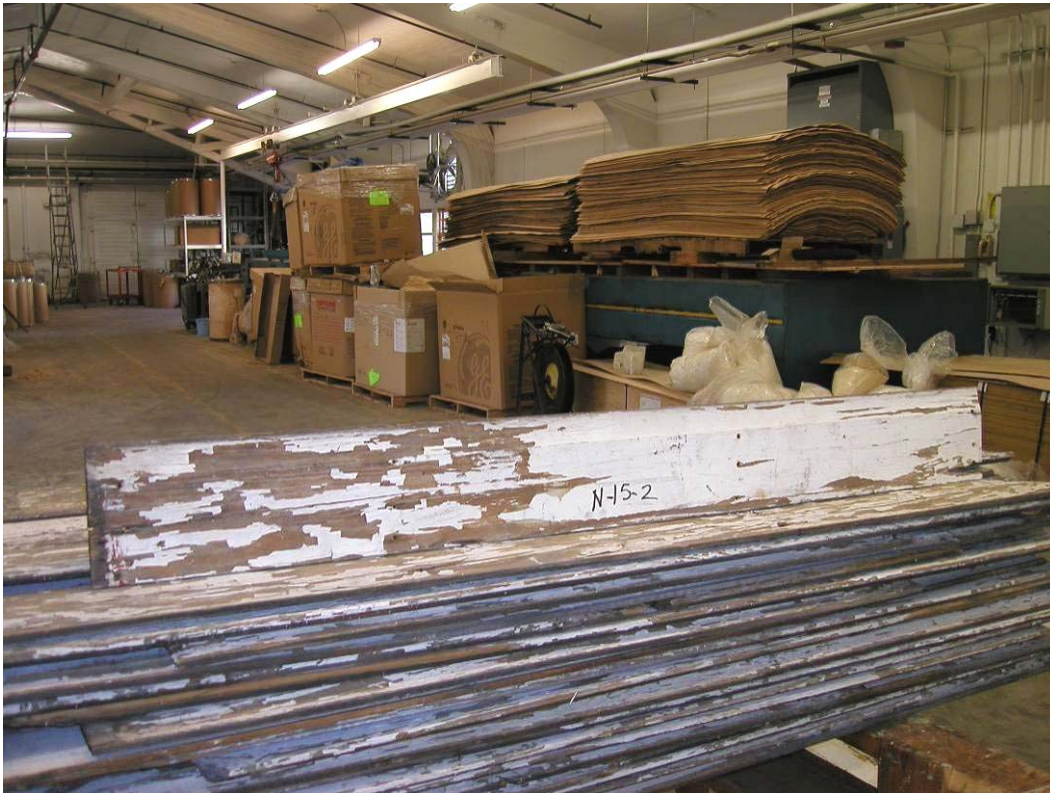
Figure 5. Salvaged siding from Fort Campbell.

A visual assessment of the siding specimens from Fort Campbell indicated that it had been painted several times, but the paint surface was in poor condition. Surface quality varied considerably, and paint film separation and flaking were evident in most pieces (Figure 5). This paint failure was problematic because many siding pieces lost the hand-marked ID numbers during handling and transportation. This problem limited the ability to accurately account for and track all the siding back to its original building position.

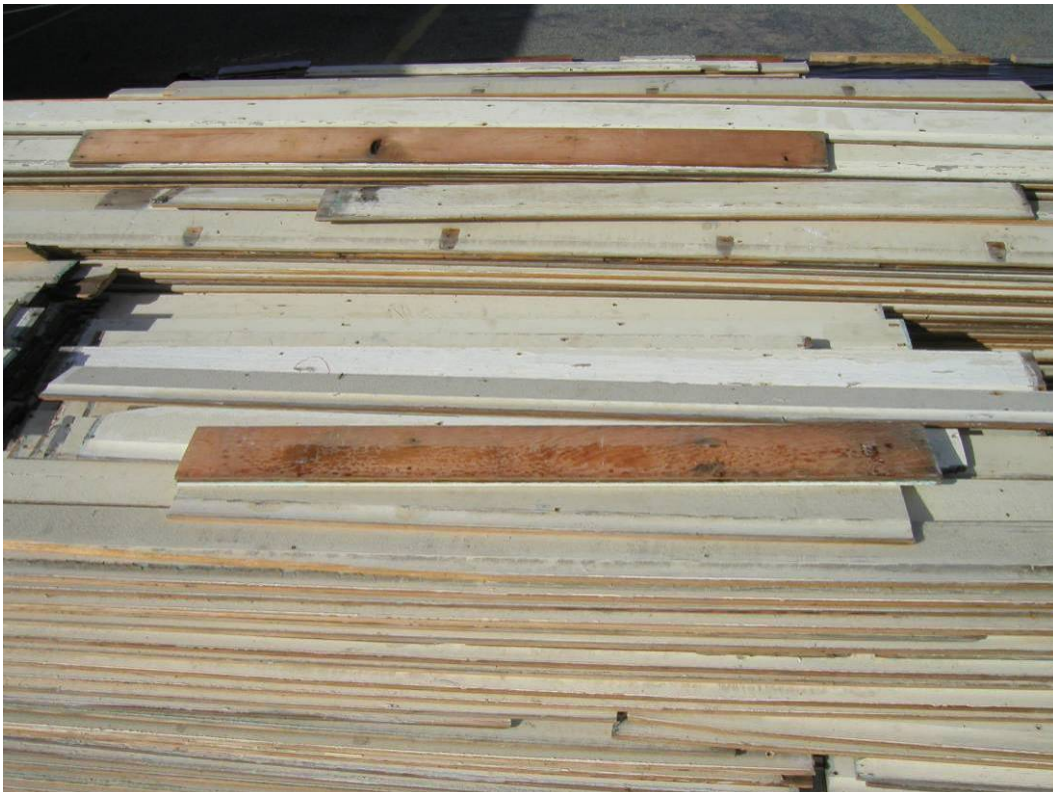
Figure 6. Douglas fir siding salvaged from Fort Ord.

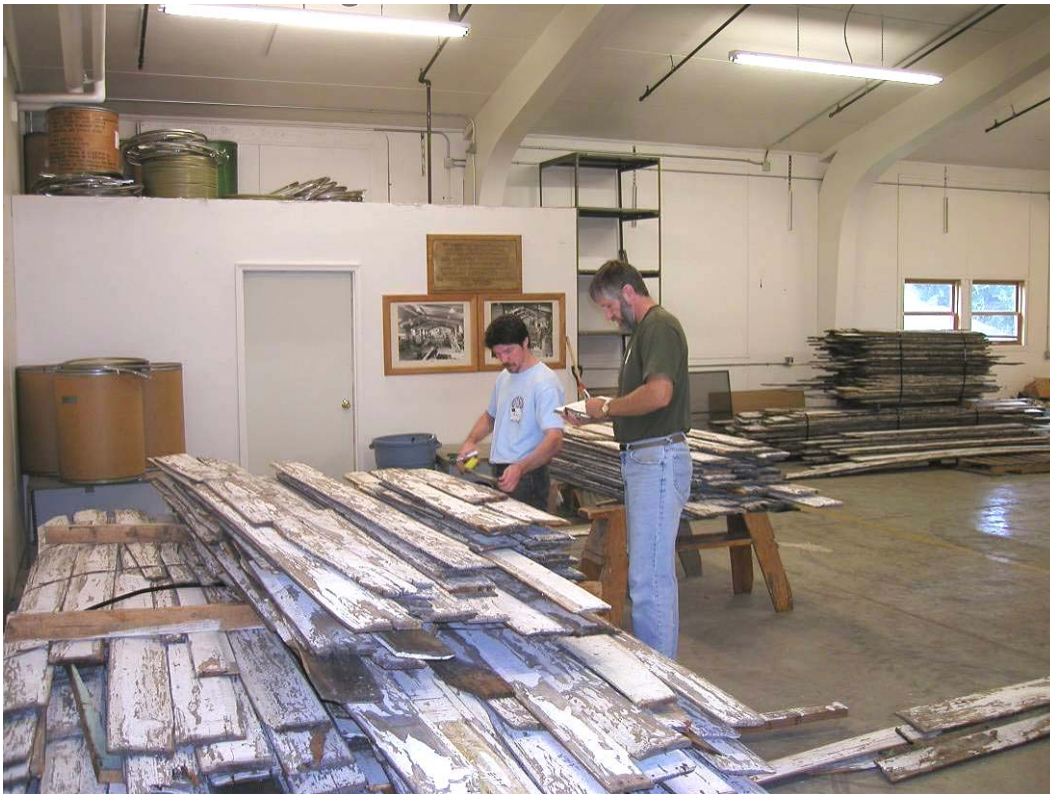
Figure 7. Quantitative inspection of Fort Campbell siding.

Separation by profile classification was based mainly on recoverable length. Because wood flooring grades allow pieces as short as 16 in., pieces up to 7 ft in length were classified as tongue and groove (T&G) flooring. Wood paneling is typically sold in lengths greater than 8 ft, often to 10 ft, to accommodate vertical placement on interior walls. Therefore, siding pieces from 8 – 10 ft were separated for remanufacture into V-groove paneling. Lengths more than 10 ft were segregated as bevel siding for remanufacture, because longer siding is preferred in the home building market and commands the highest price. Figure 7 shows the first inspection in progress.

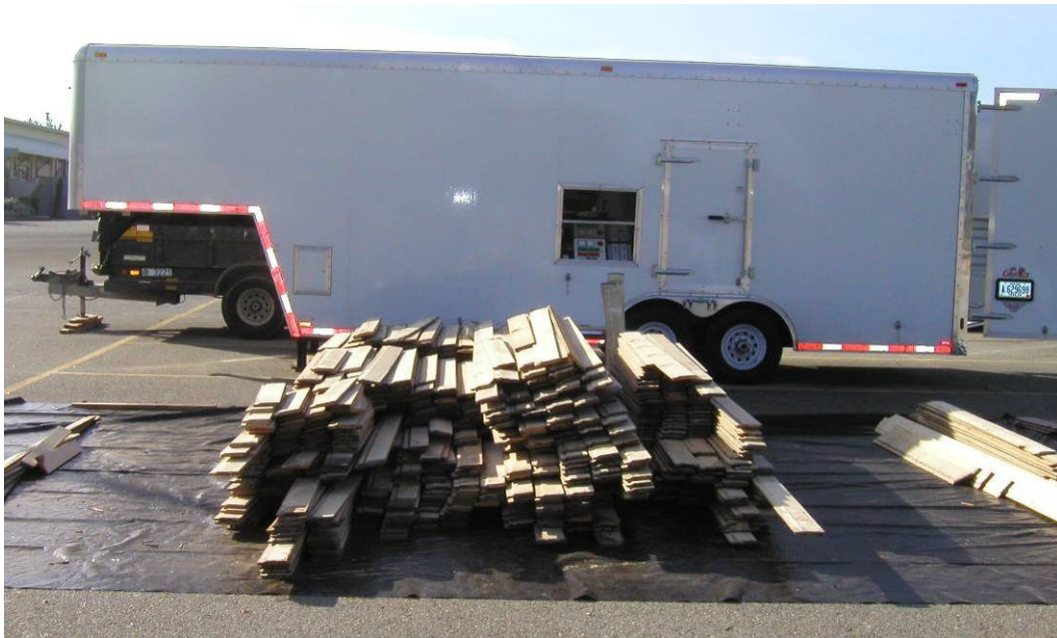
Figure 8. Fort Ord siding provided for remanufacture by Auburn.

FORA donated 1,226 pieces of siding (7,830 lf) from previous deconstruction projects for use in the demonstration by Auburn Machinery, Inc. (later renamed Auburn Enterprises, Inc., Auburn, ME). The siding had been stored for many years under cover and was left over from a previous deconstruction project. A visual inspection of the wood indicated no discernable difference between this siding and the siding shipped to FPL. For this reason, all conclusions on the quality of the siding evaluated at FPL can be assumed applicable for the siding remilled by Auburn. The siding made available to Auburn at Fort Ord is shown in Figure 8.

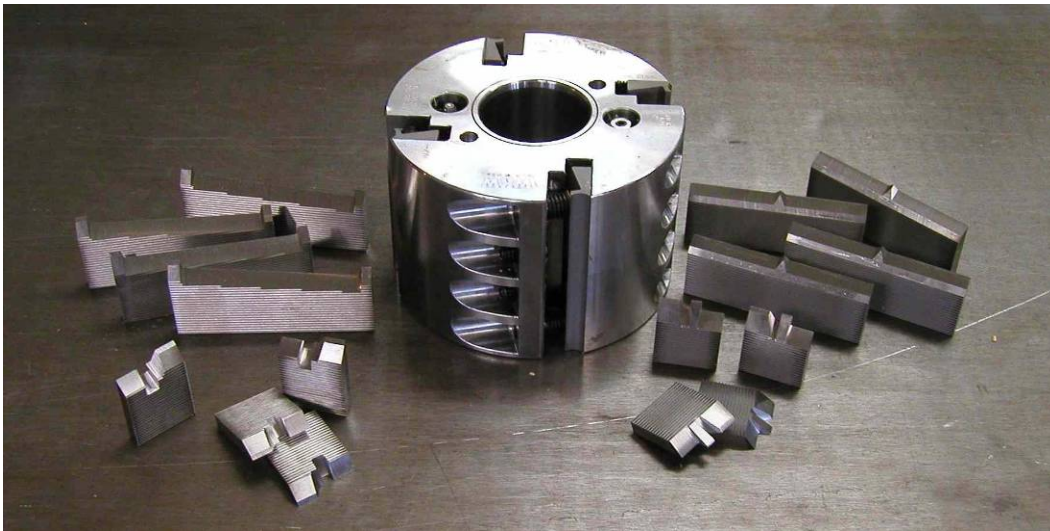
Figure 13. High-speed steel profile knives and Hydroloc™ cutter head.

Inspection of the molder indicated that the cutter heads and arbor assemblies needed to be replaced. The existing rotor-style cutter heads with hub lockdowns for constant axial setup were replaced with precision chamber pressure sleeve cylinder cutter heads. This substitution was made to as-

sure accuracy, uniformity, and concentricity for quality processing performance. These replacement parts are shown in Figure 13.

New Hydroloc™ cylinder 150 mm diameter, 150 mm height body (2-1/8 in. bore) surface cutter heads and 150 mm diameter, 60 mm body height (1-13/16 in. bore) side cutter heads were purchased from Hermance Machinery, Inc., in Williamsport, PA. All four cylinder heads were ordered with a 12-degree cutting angle. This cutting angle is optimal for Douglas fir, but less efficient for other pine species, which machine better at different cutting angles.

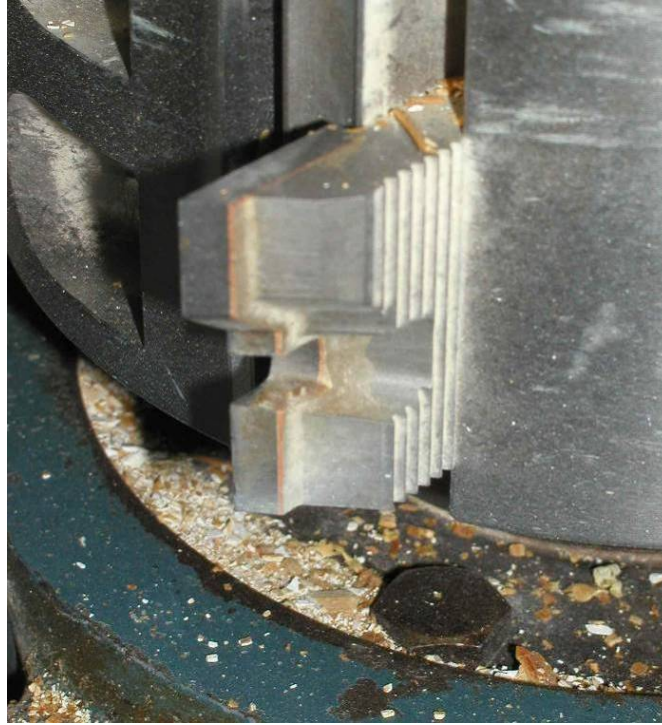
Figure 14. Carbide knife used to machine southern pine, showing corrugation on back.

Most of the Fort Ord siding was milled using the ordinary steel blades; the remainder of the Fort Ord siding and all of the Fort Campbell siding was milled using carbide steel blades. The Fort Ord Douglas fir siding was processed using flat and profile M-2 grade, high-speed steel (HSS) knives manufactured by Wisconsin Knife Works, Beloit, WI. Four knives were used in each cutter head. These 35-degree bevel knives with 16/60 corrugated back blades were matched to the replacement cutter heads. The corrugations on the backs of the knives simplified installation, removal, and mechanical locking of the knife in the cutter head; they are shown in Figure 14.

The excessive wear of HSS knives witnessed in early machining trials suggested that carbide knives could be a logical alternative. In addition to the abrasive nature of the paint, the Southern Pine siding from Fort Campbell

had a larger number of knots, which also tends to rapidly dull knives, also shown in Figure 14.

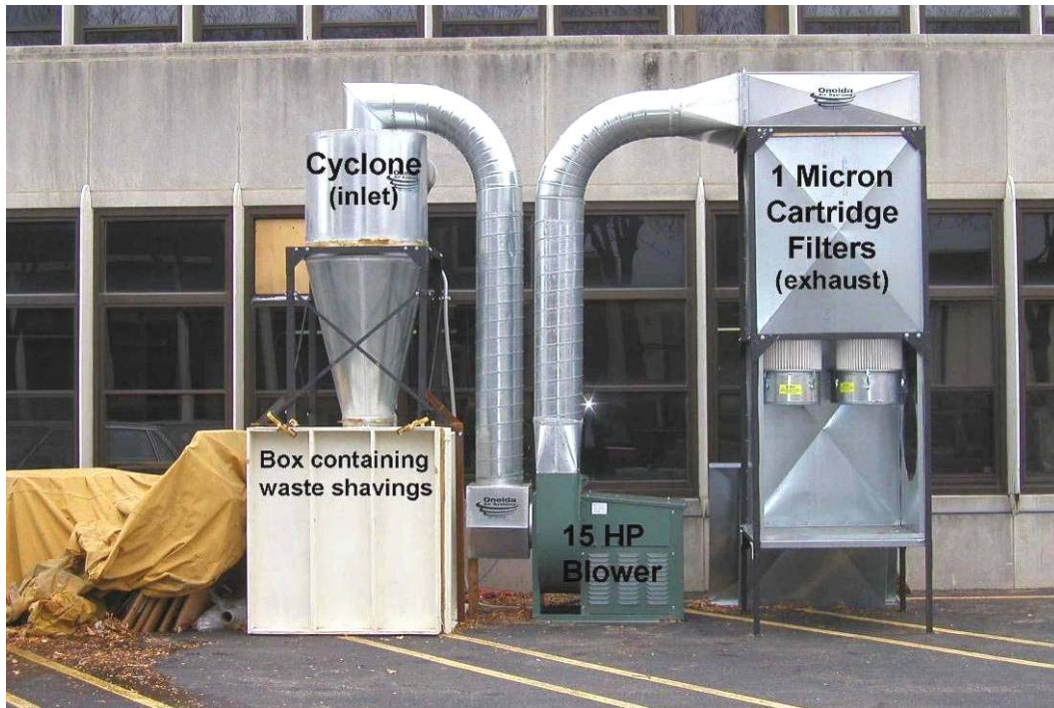
Figure 15. Oneida dust collection system as installed outdoors at FPL.

As shown in Figure 15, the new dust collection system was installed outside the FPL mill shop in order to help reduce potential LBP exposure hazards.

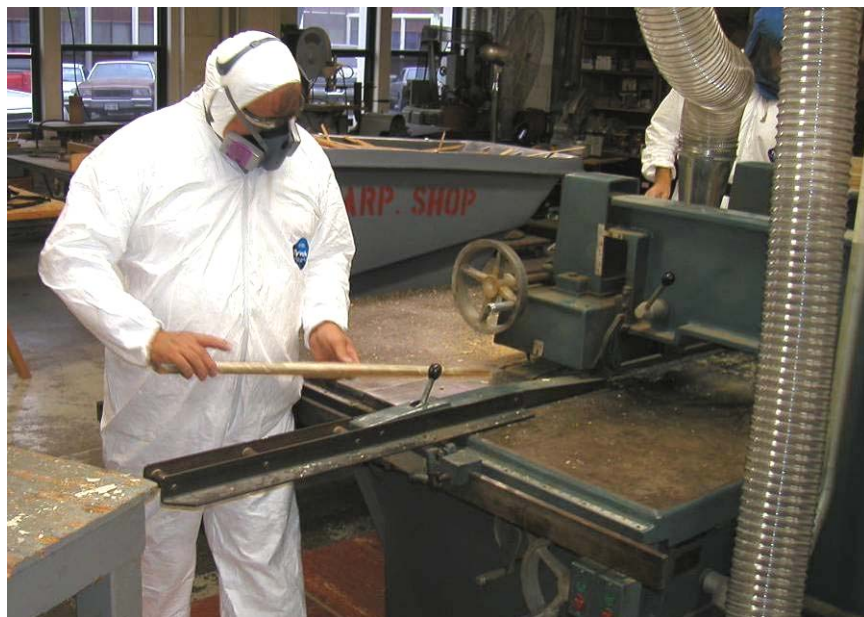
Figure 17. Ripping of siding to width.

Directly after end-trimming, all siding pieces were ripped to a consistent width that was appropriate for the profile to be manufactured. The inline rip saw used in this step is shown in Figure 17.

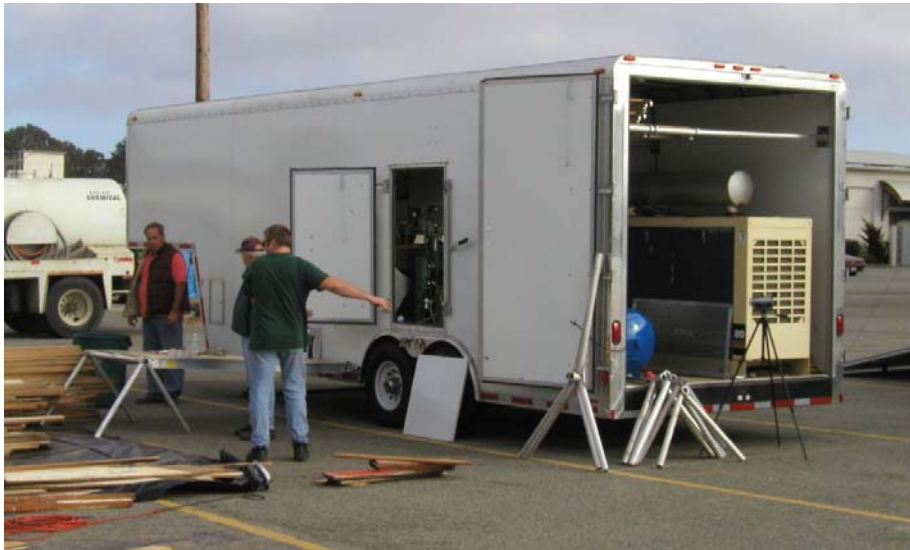
Figure 19. Auburn's Yield Pro mobile unit at Fort Ord.

The Yield Pro machine evaluated in this study consisted of two planing heads (one top and one side head) and a side-ripping blade. (The side-ripping blade can be replaced with a hogging blade to grind up the removed material rather than leaving it in the form of a strip.) The machine is enclosed in a self-contained trailer that includes an electrical generator, an air compressor, a dust collection and storage system, and a fire suppression system (Figure 19).

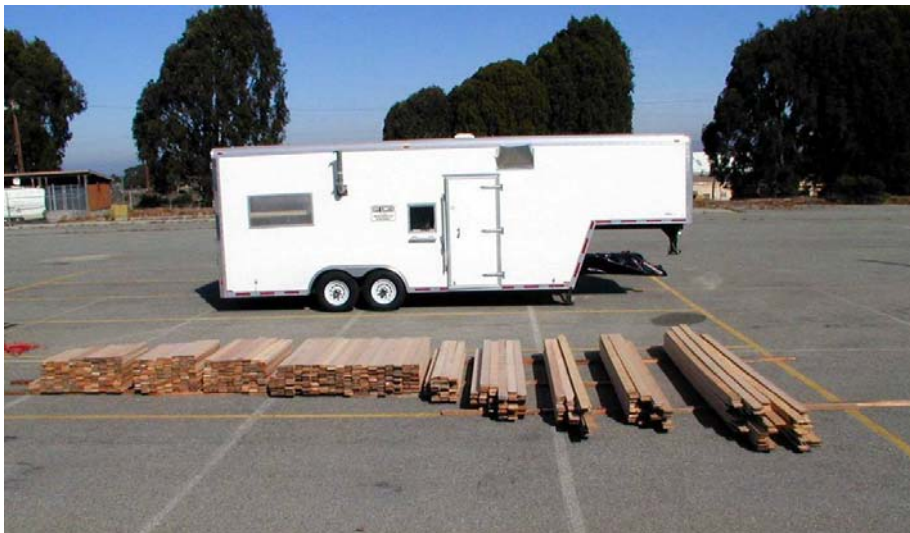
Figure 20. Salvaged Fort Ord wood siding remilled into 5/8 x 4 in. boards for molding into value-added wood products.

Using cutting tools designed to process wood with embedded nails and surface coatings, this system can resize and profile salvaged wood into uniformly-dimensioned stock. Figure 20 shows the 5/8 in. x 4 in. rectangular blanks produced from salvaged wood using the Auburn system.

As indicated in Figure 20 and Figure 25, Auburn mobile unit operations were conducted in a very large parking lot at Fort Ord. This location provided good conditions for isolating mobile unit operations from nearby activities and the general public.

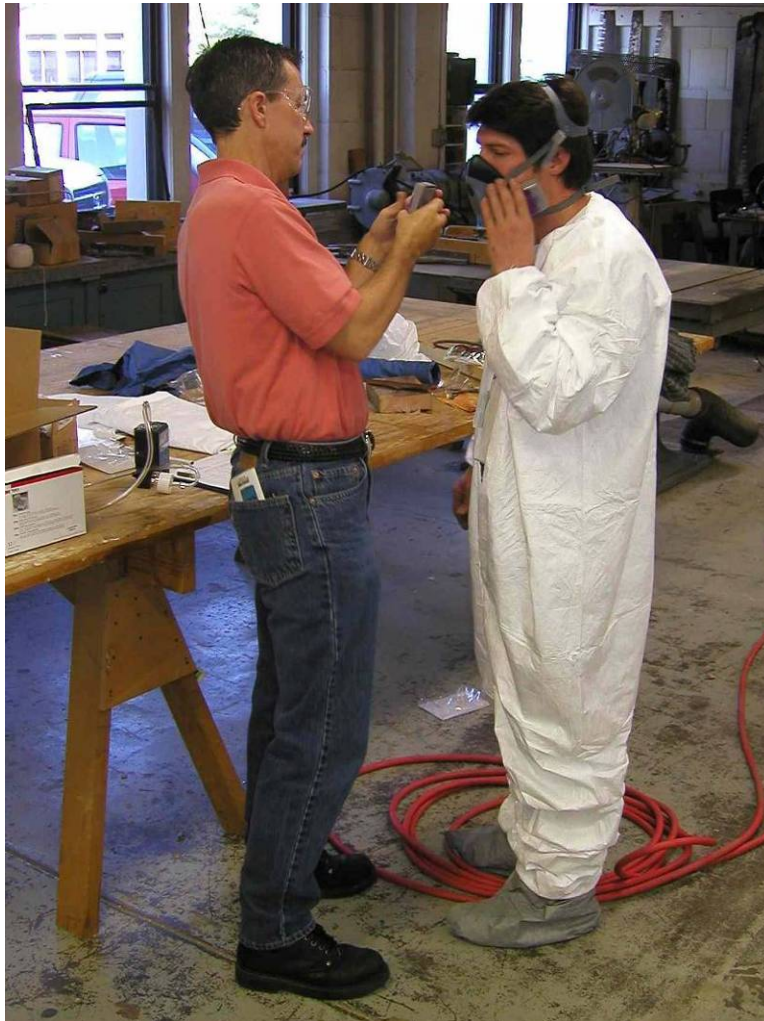
Figure 21. Fitting of safety equipment by FPL safety officer.

were tested for a baseline blood lead level by a local hospital before machining began. All participants were fitted by a local safety equipment company with the type of HEPA dust mask recommended by OSHA safety regulations for protection from lead-contaminated dust, and they were instructed in proper use of the mask. Disposable Tyvek protective suits (Figure 21) also were provided for each worker to minimize the transfer of lead-contaminated dust to the employees' clothing, homes, or other parts of the shop. These suits were disposed of after each use.

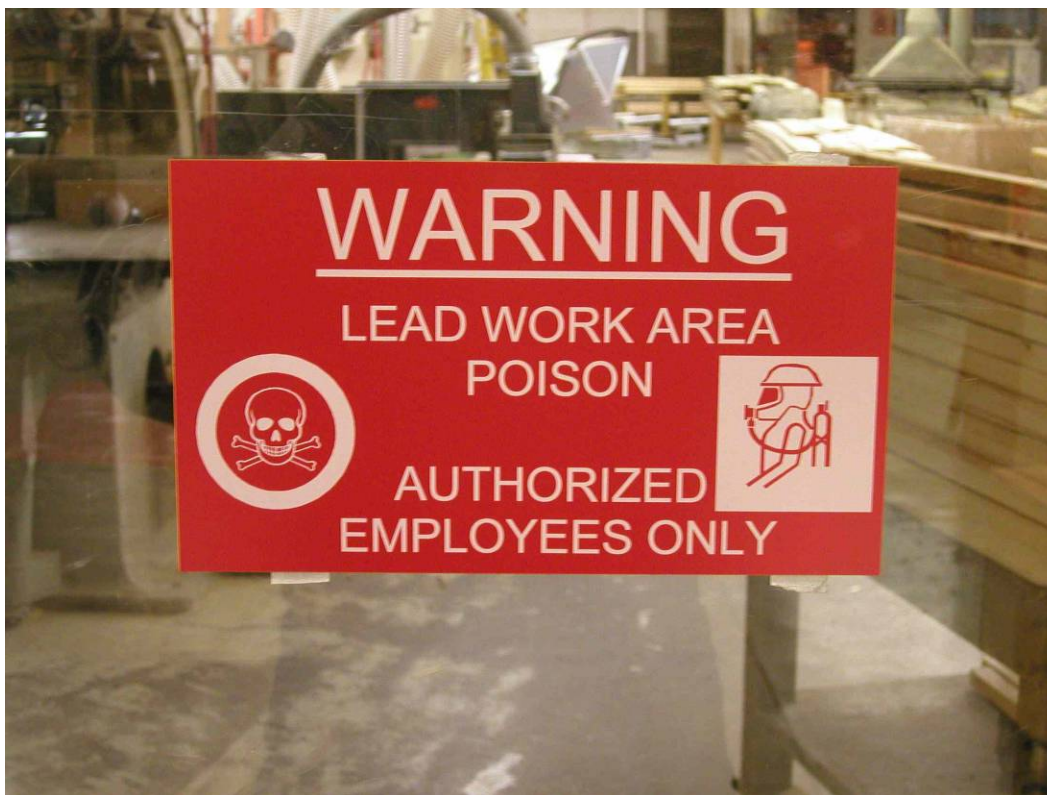
Figure 22. Signage warning staff of lead hazard in the work area.

nouncements to staff about ongoing operations were made through the local daily bulletin. Work areas directly involved with milling operations were cordoned, either using signage or visible barriers like those shown in Figure 22.

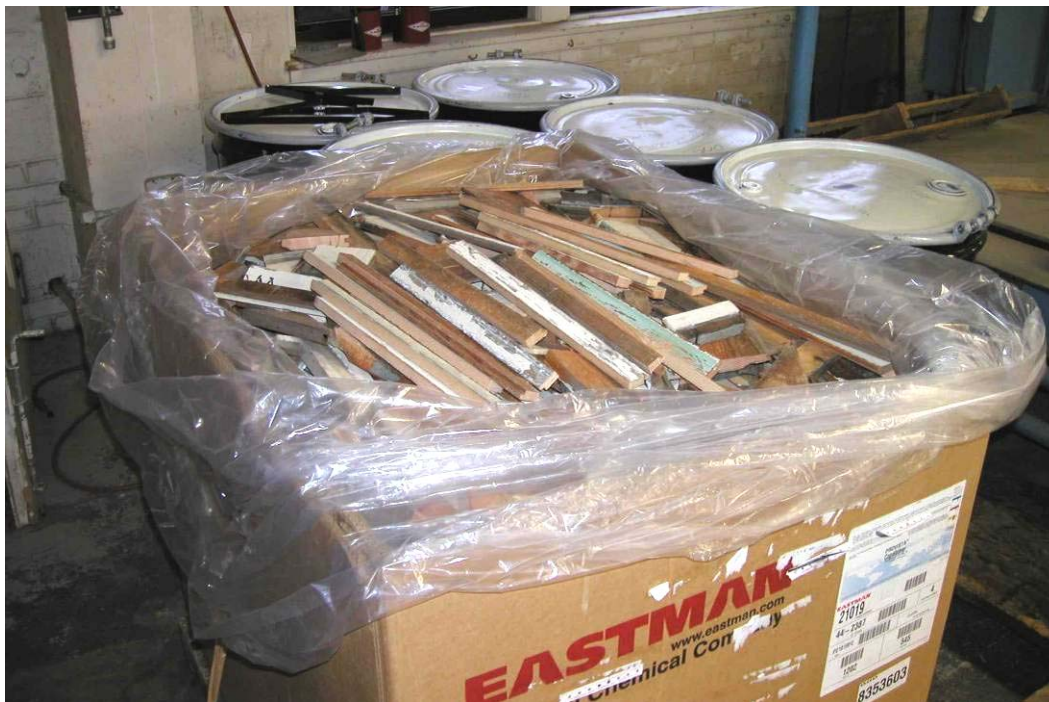
Figure 24. Containers used for storage and shipping of lead-contaminated wood waste.

ERDC-CERL requested that all wood waste materials generated by the re-milling work be placed in containers to be shipped to other locations for further waste treatability studies. All cutoff scraps, edge trim pieces, and shavings from the molding operations were placed in either 55 gal* steel drums or standard Gaylord-type corrugated shipping boxes with plastic liners, as shown in Figure 24.

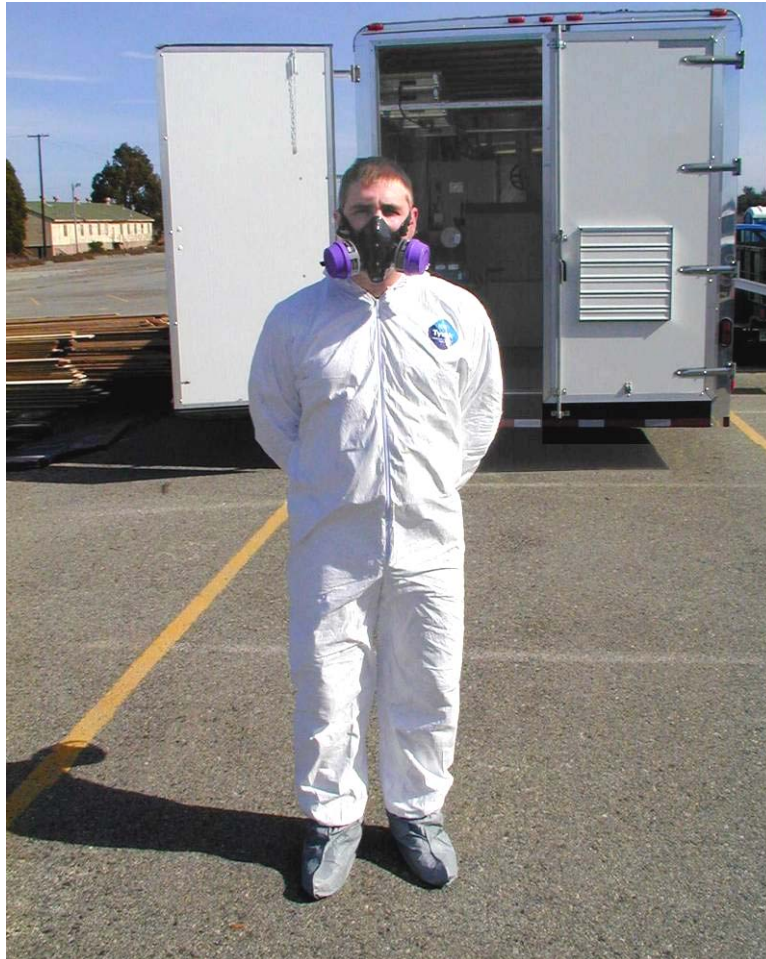
Figure 25. Personal safety equipment used in the Yield Pro demonstration.

Auburn and Wood Waste Diversion personnel used safety equipment similar to that used at FPL (i.e., HEPA face masks and Tyvek suits). Unlike the indoor operations at FPL, the Auburn mobile unit was operated outdoors, and it was determined that only personnel in the immediate vicinity of the work would need the personal safety equipment shown in Figure 25.

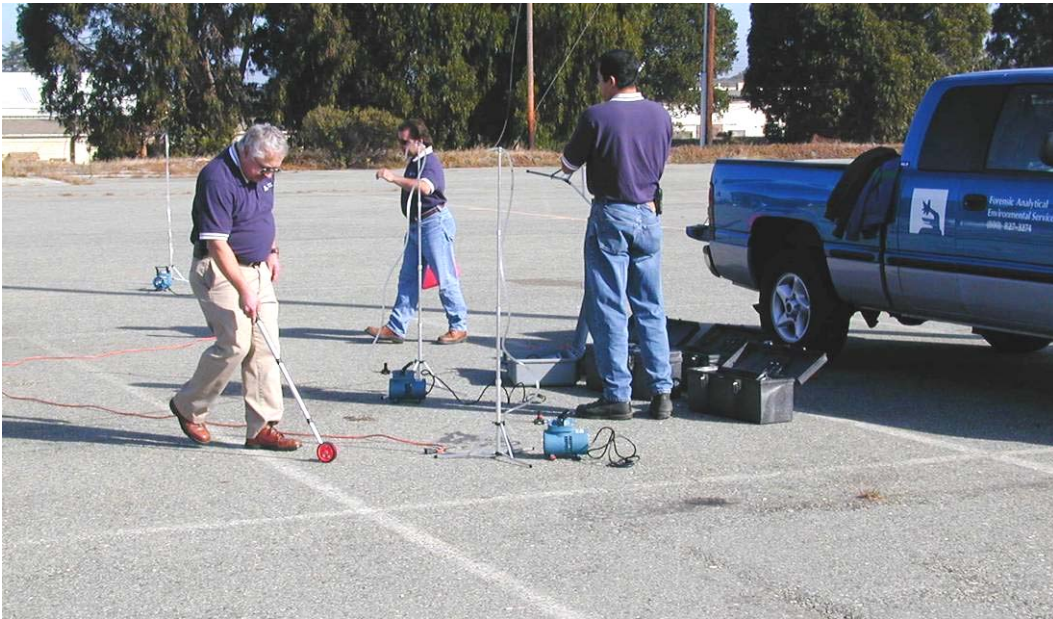
Figure 26. Setting up for air monitoring at Fort Ord demonstration.

During demonstration of the mobile unit on October 31, 2002, air quality was measured both inside and outside the unit. Forensic Analytical, a California-based environmental consulting firm, was contracted to perform the air sampling. As shown in Figure 26, measurement stations were established around the perimeter of the mobile unit at distances up to 65 ft.

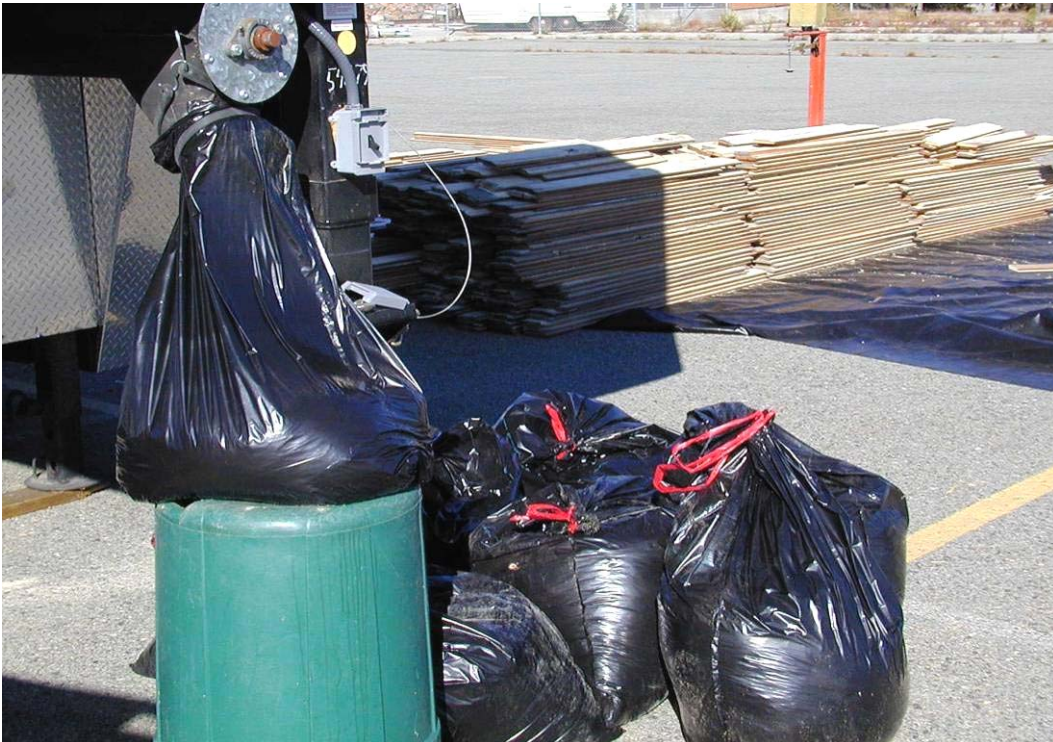
The waste materials generated by mobile unit operations were sequestered from the dust collection area into plastic bags using an auguring system (Figure 27). These materials were disposed of by Wood Waste Diversion.

Figure 27. Waste collection from mobile processing unit.

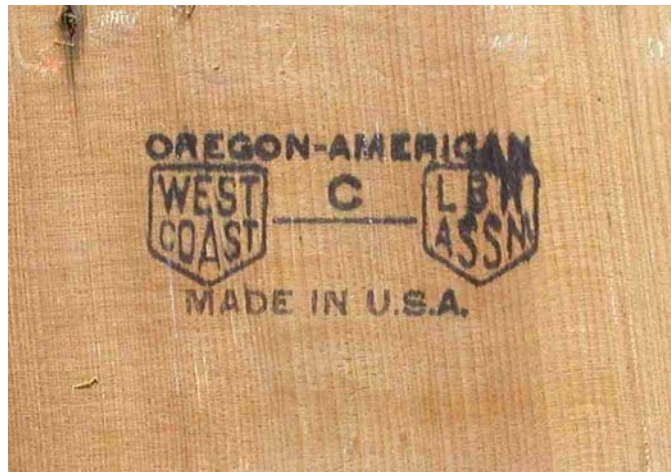
(C = visual grade, Oregon-American = Mill ID)

Figure 28. West Coast Lumber Association grade stamp on sample of salvaged Fort Ord siding.

A visual assessment of all pieces indicated that the siding recovered from Fort Ord was manufactured of very high quality Douglas fir. This determination was confirmed by the discovery of old grade stamps on the siding, as shown in Figure 28. This stamp shows that the siding as installed was grade C or better which, at the time, represented the highest grade of Douglas fir siding available. The condition of the siding as recovered was generally very good, with good paint adhesion and relatively little wood damage or degradation.

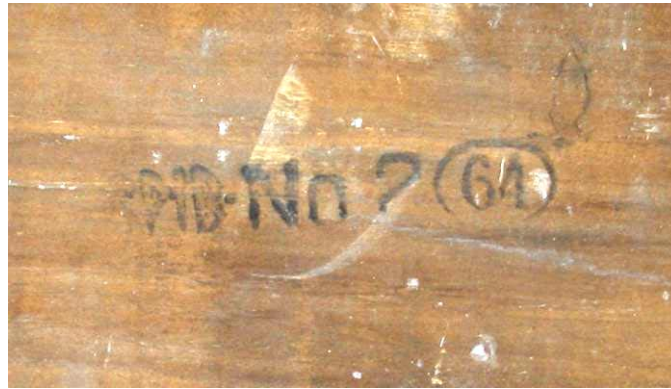
(SPIB = Southern Pine Inspection Bureau, No. 2 = visual grade, 64 = mill number.)

Figure 29. Southern Pine Inspection Bureau grade stamp on sample of salvaged Fort Campbell siding.

Visual inspection of all the pieces indicated that the Fort Campbell siding was manufactured from Southern Pine and contained many larger knots. The siding was generally in poor condition, with considerable flaking paint, warping and cracking, and a significant amount of deconstruction damage. More importantly, the grade stamps found on the siding indicated that the original wood was only of moderate quality —No. 2 lumber board stock , which allows much larger knots than siding grades. It is likely that, because these barracks were classified as temporary structures with an assumed service life of 3 years, No. 2 stock was considered adequate for the application. The stamp is shown in Figure 29.

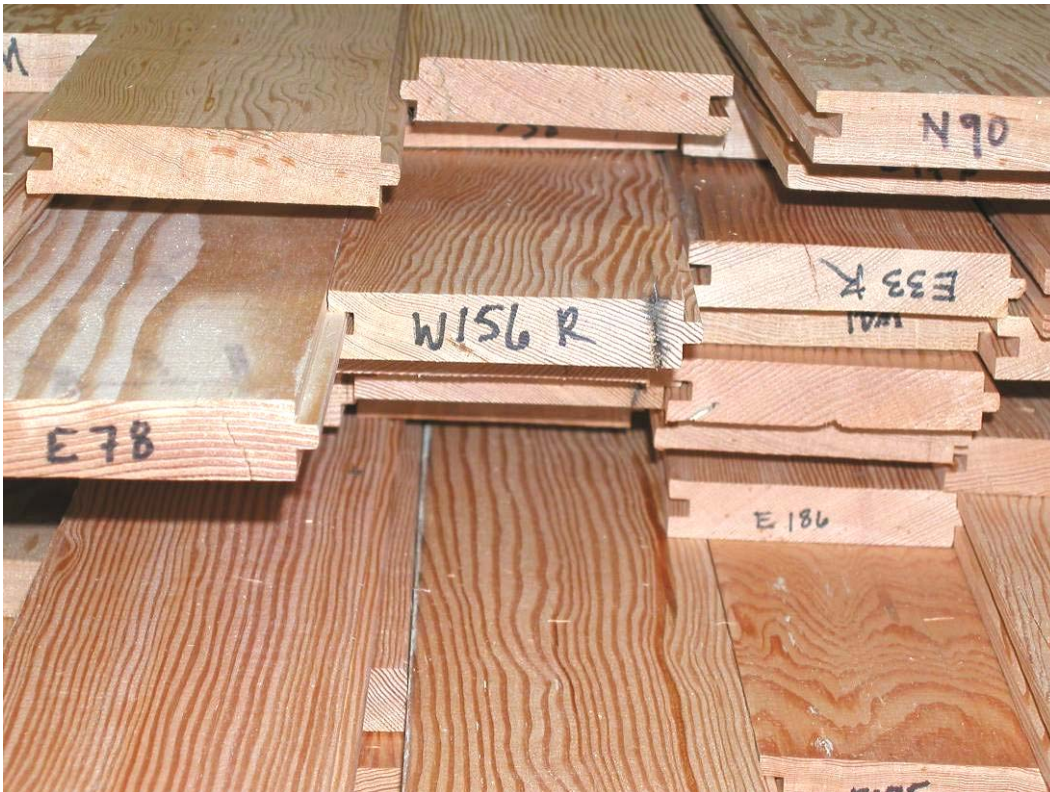
Figure 30. T&G flooring produced from Fort Ord siding.

Figure 30 – Figure 32 show examples of the T&G flooring, V-groove paneling, and bevel siding, respectively, remanufactured from the Fort Ord siding.

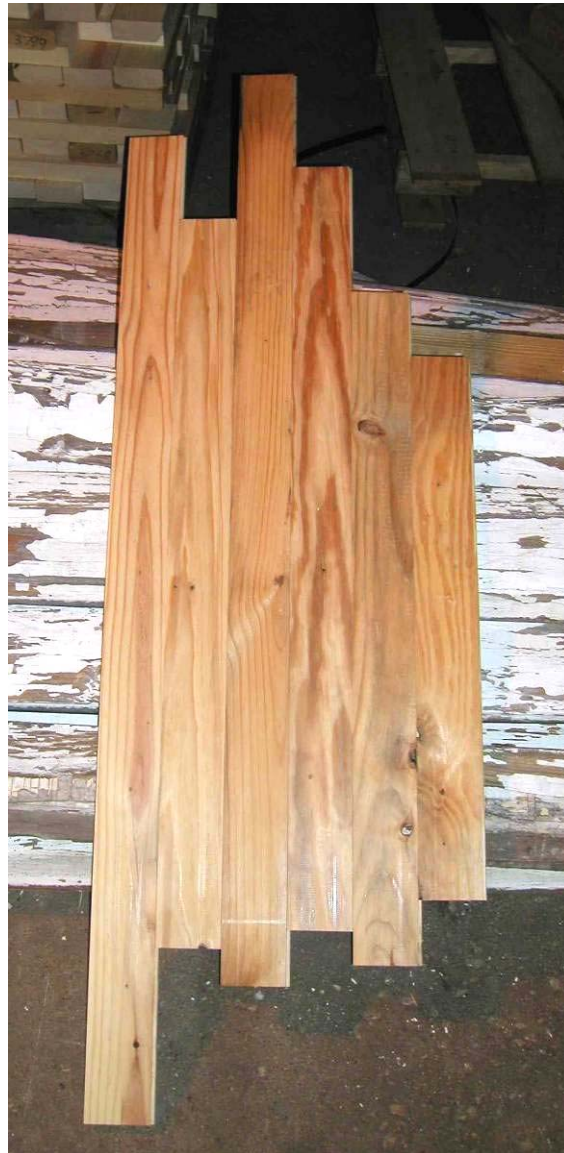
Figure 33 shows T&G flooring produced from the Fort Campbell siding. Although there were many knots in the product because of the original grade of wood used, it appeared to be attractive and marketable.

Figure 33. T&G flooring produced from Fort Campbell siding.

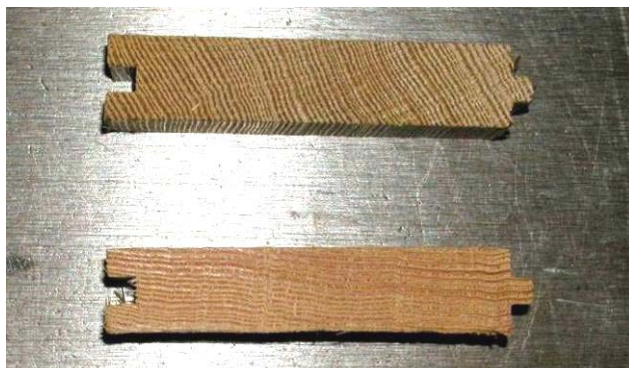
Figure 34. Samples of vertical grain (top) and flat grain (bottom).

As discussed in Chapter 2, the remanufactured products were visually inspected after processing to determine the losses due to defects not detected in the feedstock or otherwise not allowed by the applicable grading standard. For the Fort Ord materials this inspection also included examination of a large percentage of the milled pieces to determine grain orientation (i.e., either vertical or flat). Grain is an important characteristic for pricing wood because vertical grain commands a much higher price in some niche markets than flat grain due to its warp resistance, superior paint adhesion, and evenness of grain appearance. Figure 34 shows the difference between these two grain orientations. Table 7 indicates the distribution of vertical versus flat grain from the Fort Ord siding. Because the

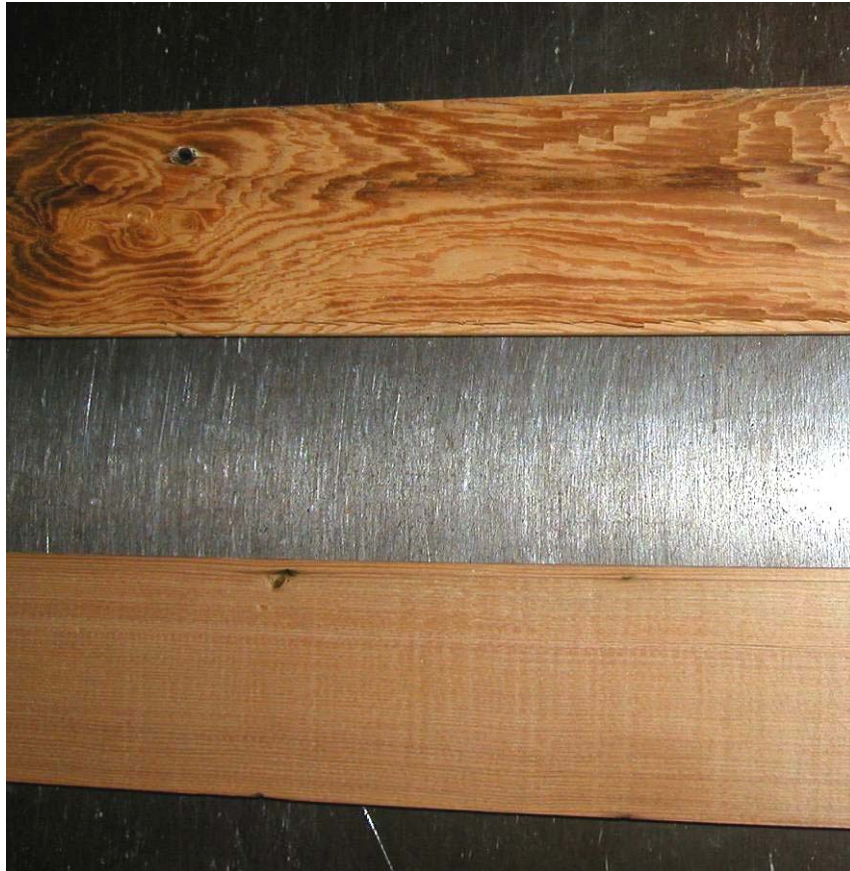
Figure 36. Degradation of wood surface quality (top) due to dulling of HSS knives.

As shown in Figure 35, the machining of the LBP siding was very abrasive to HSS knives; the knife was razor sharp when installed but dulled dramatically after machining less than 1,000 lf of siding. This dulling in turn degraded the surface quality of the machined wood, as shown in Figure 36.

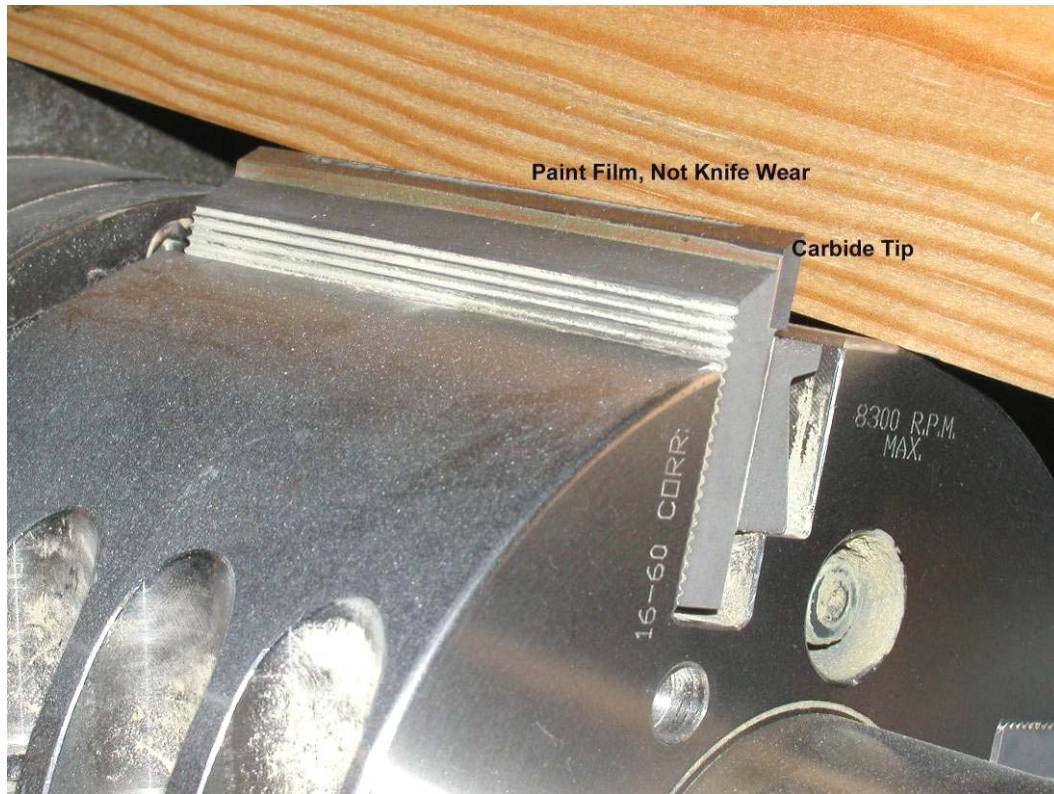
Figure 37. Carbide knife after machining, showing sharp edge with traces of paint residue.

Carbide knives were investigated in machining the Fort Campbell siding. As shown in Table 10, 882 lf of siding were machined with HSS knives before serious dulling of the knives occurred. Using carbide tipped knives, 3,277 lf of siding were machined with no noticeable knife wear or surface quality degradation, as illustrated in Figure 37. This is nearly four times the amount of siding produced with the HSS knives. The test had to be discontinued at 3,277 lf, since no more siding was available to be machined. It was felt that significantly more footage of siding could be produced with these carbide knives before re-sharpening.
