Investigation of Mechanical Processes for Removing Lead-Based Paint (LBP) from Wood Siding

Robert H. Falk, John Janowiak, Richard G. Lampo,
Thomas R. Napier, Stephen D. Cosper, Susan A. Drozdz,
Steven Larson, and Edgar D. Smith

September 2006

Final report

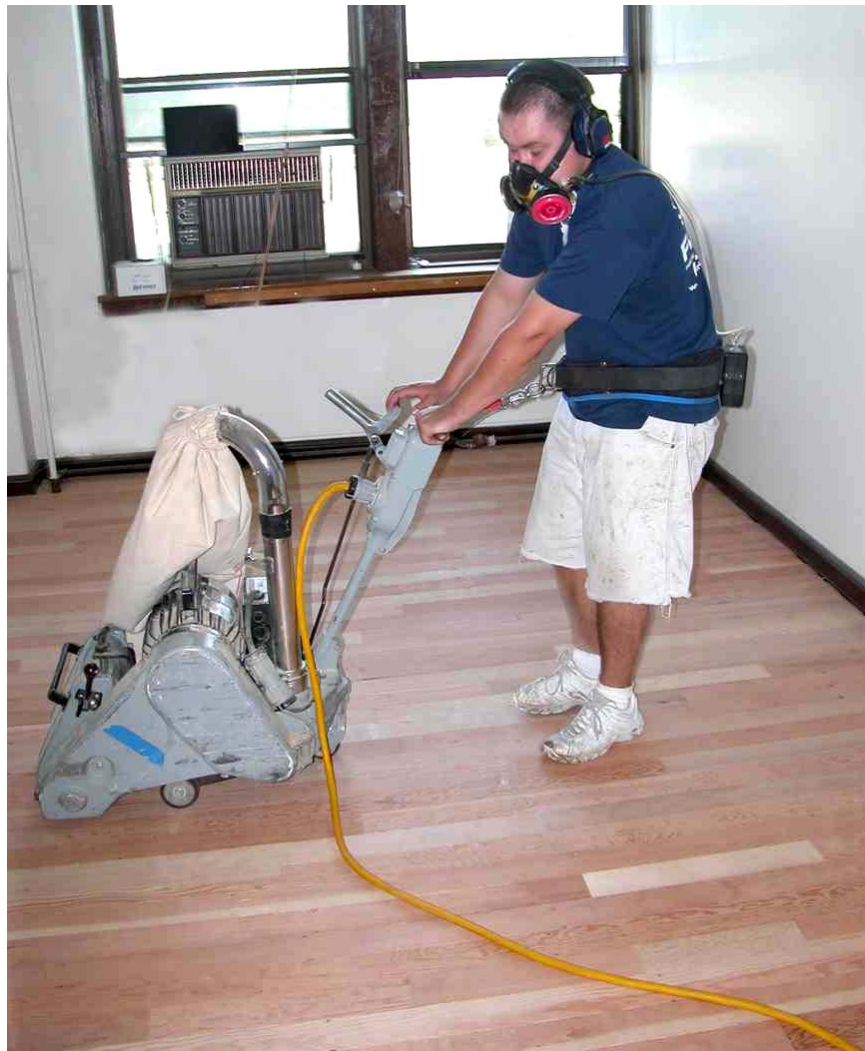
Figure 38. Sanding process for remanufactured flooring, showing air monitoring pump fitted at operator's waist.

A portion of the produced T&G flooring was installed in two rooms at the FPL for display purposes. Although the lead penetration tests indicated that only a trace amount of lead was likely to be present in the remanufactured flooring (because more than 0.06 in. was removed from the painted surface), the air was monitored during the floor sanding process to ensure that the workers were not exposed to an unsafe level of lead-containing dust. A personal air monitoring pump was fitted to the floor sander operator (Figure 38). No lead was detected in the air sample, indicating that the remanufactured flooring product was free of any significant lead content. A swab test for lead, after the floor was finished with polyurethane, produced negative results. Figure 39 shows the floor after finishing.

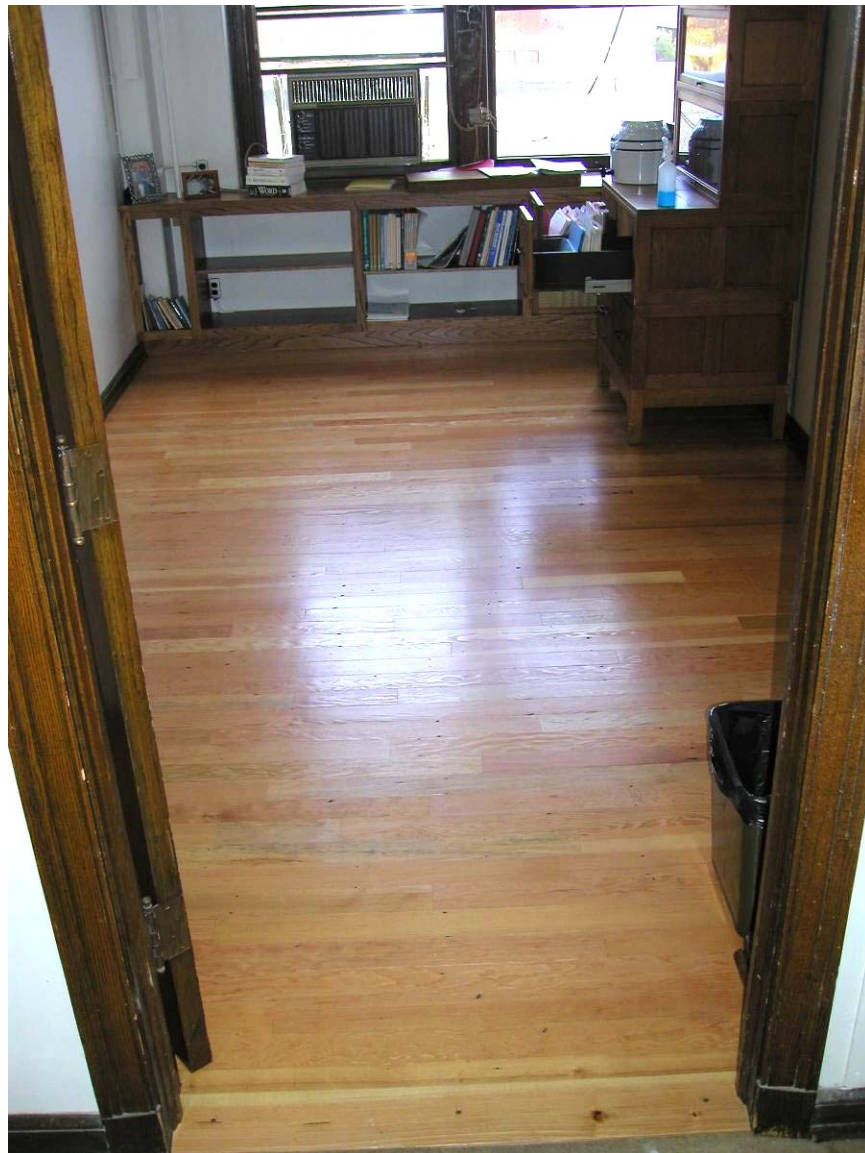
Figure 39. Installed floor after finishing.
