General
Technical
Report
FPL-GTR-174

Review of In-Service Moisture and Temperature Conditions in Wood- Frame Buildings

Samuel V. Glass
Anton TenWolde

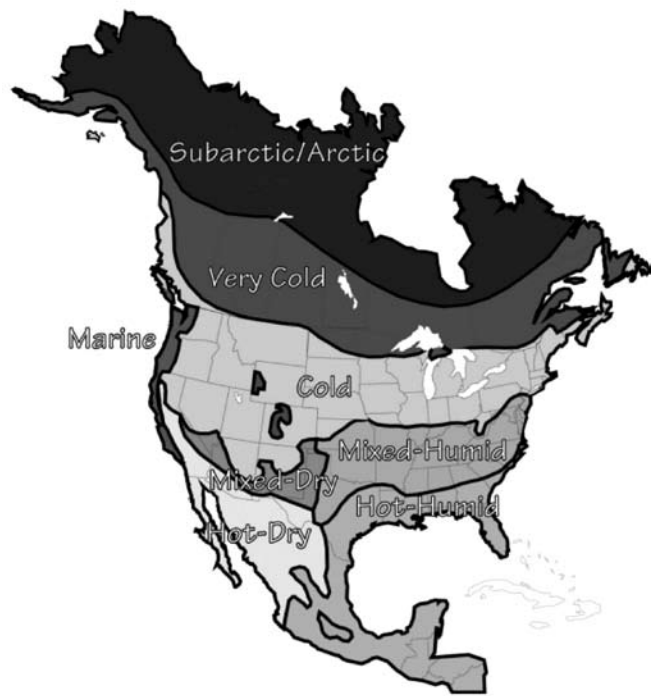
Figure 3—Climatic regions of North America (Lstiburek 2006a). Used with permission of Building Science Corporation, Westford, Massachusetts.

Given the importance of climate to thermal and moisture transport in buildings, we organize this review according to a recent classification of the climatic regions of North America (Lstiburek 2006a) (Figure 3, Table 1). A number of other similar classifications are given by Straube and Burnett (2005). Measurements of moisture and temperature conditions are reported for most climatic regions; however, due to lack of data, we have omitted the Subarctic/Arctic, Mixed-Dry, and Hot-Dry climates.
