Characteristics of and Areas Contributing Recharge to Public-Supply Springs in Massachusetts

Prepared in cooperation with the
MASSACHUSETTS DEPARTMENT OF ENVIRONMENTAL PROTECTION

Water-Resources Investigations Report 03-4266

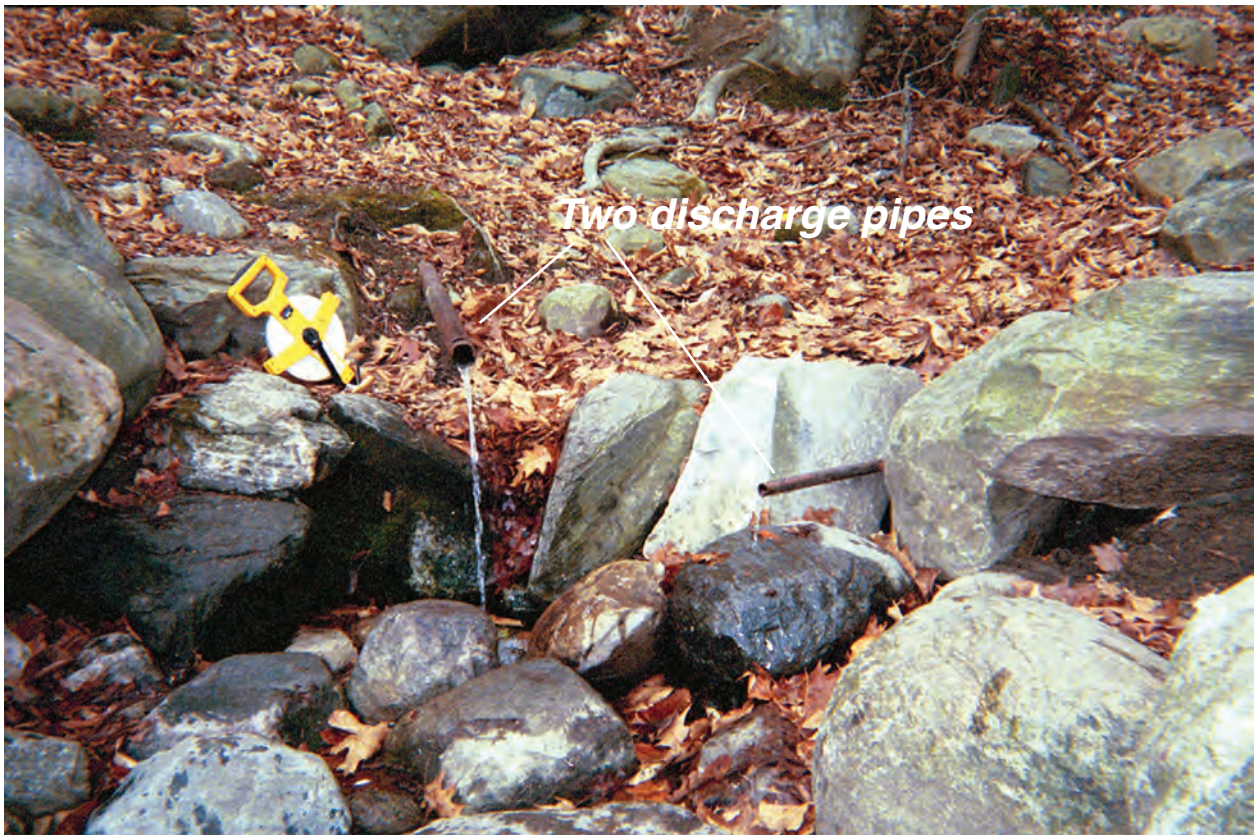
Figure 3. Becket Spring with two discharge pipes, northwestward view, Becket, Massachusetts. Photograph by Joseph Cerutti, Massachusetts Department of Environmental Protection.

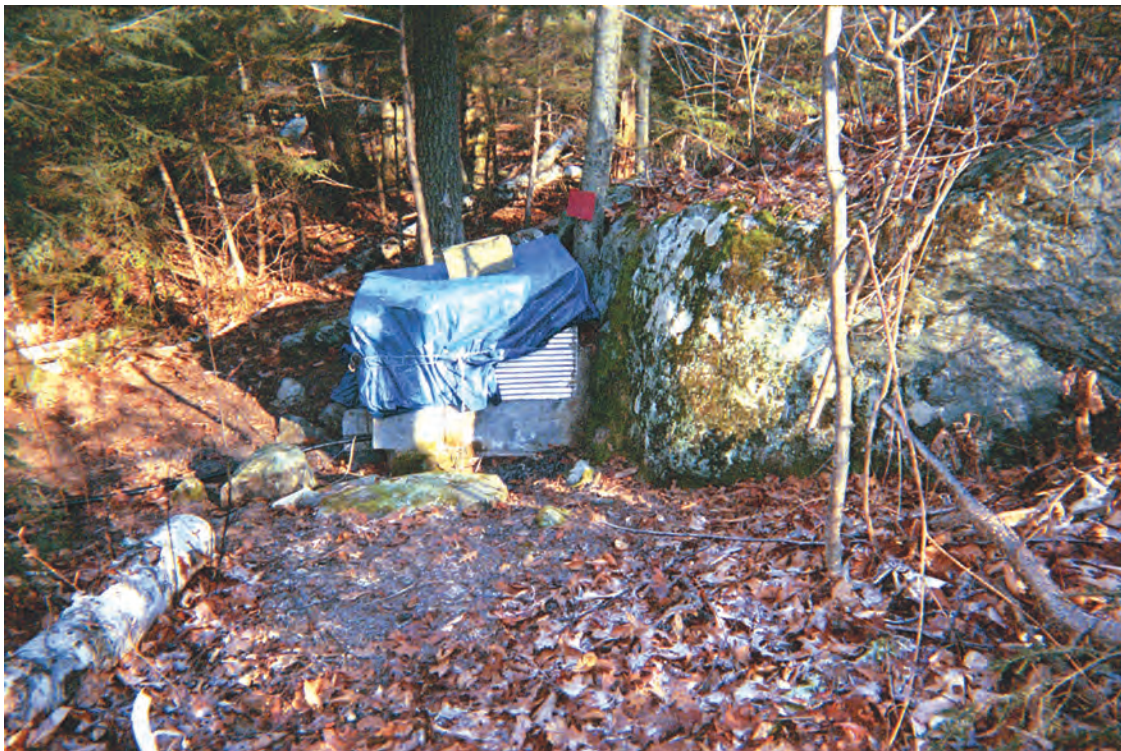
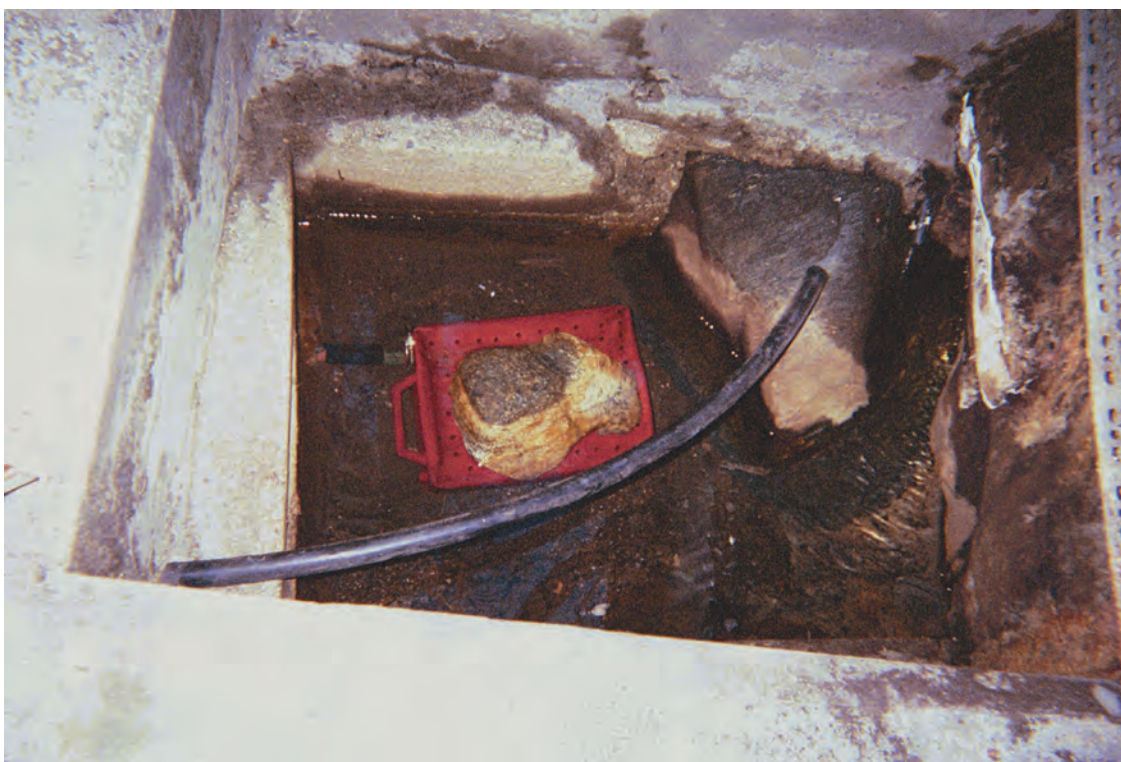
Figure 5. New Belden Tavern Spring in Becket, Massachusetts showing *A*, covered collection basin against boulder, northwestward view; and *B*, water flowing into collection basin from under boulder. Photographs by Joseph Cerutti, Massachusetts Department of Environmental Protection.

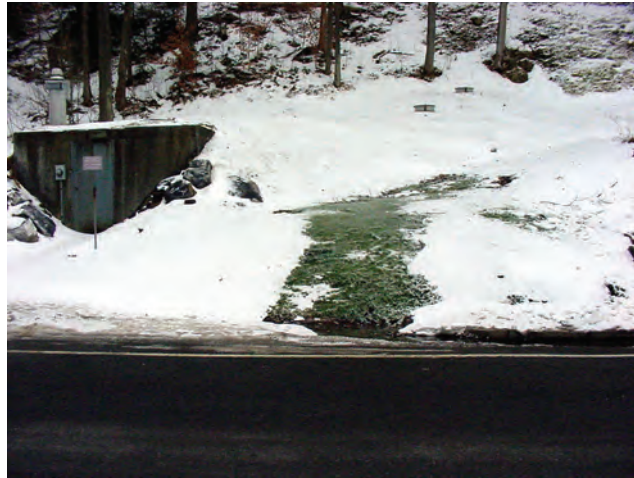
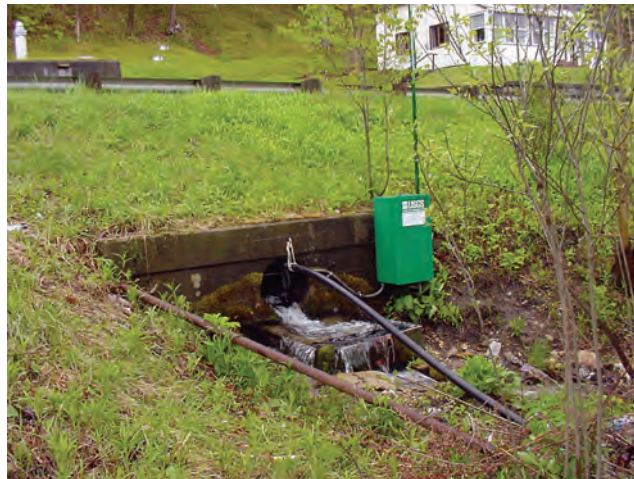
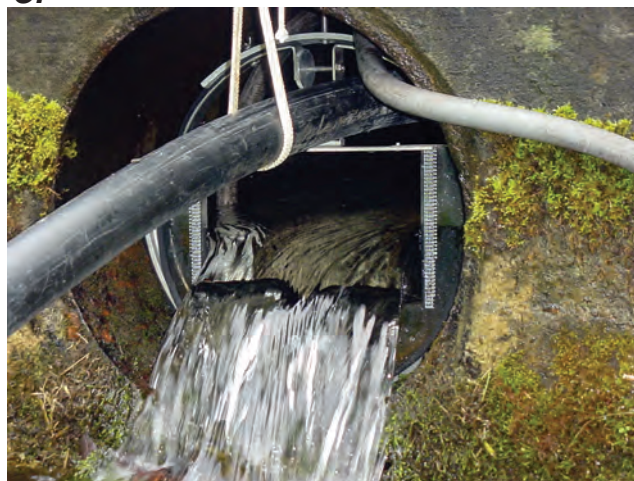
Figure 7. Red Mill Spring in Clarksburg, Massachusetts, showing *A*, two cisterns at upper center right, storage tank at left, and seepage melting snow at center, southeastward view; *B*, stage-discharge recording site on northwest side of Route 8, southeastward view; and *C*, close-up of weir installed in culvert with suspended 2-inch intake pipe for golf-course pump.

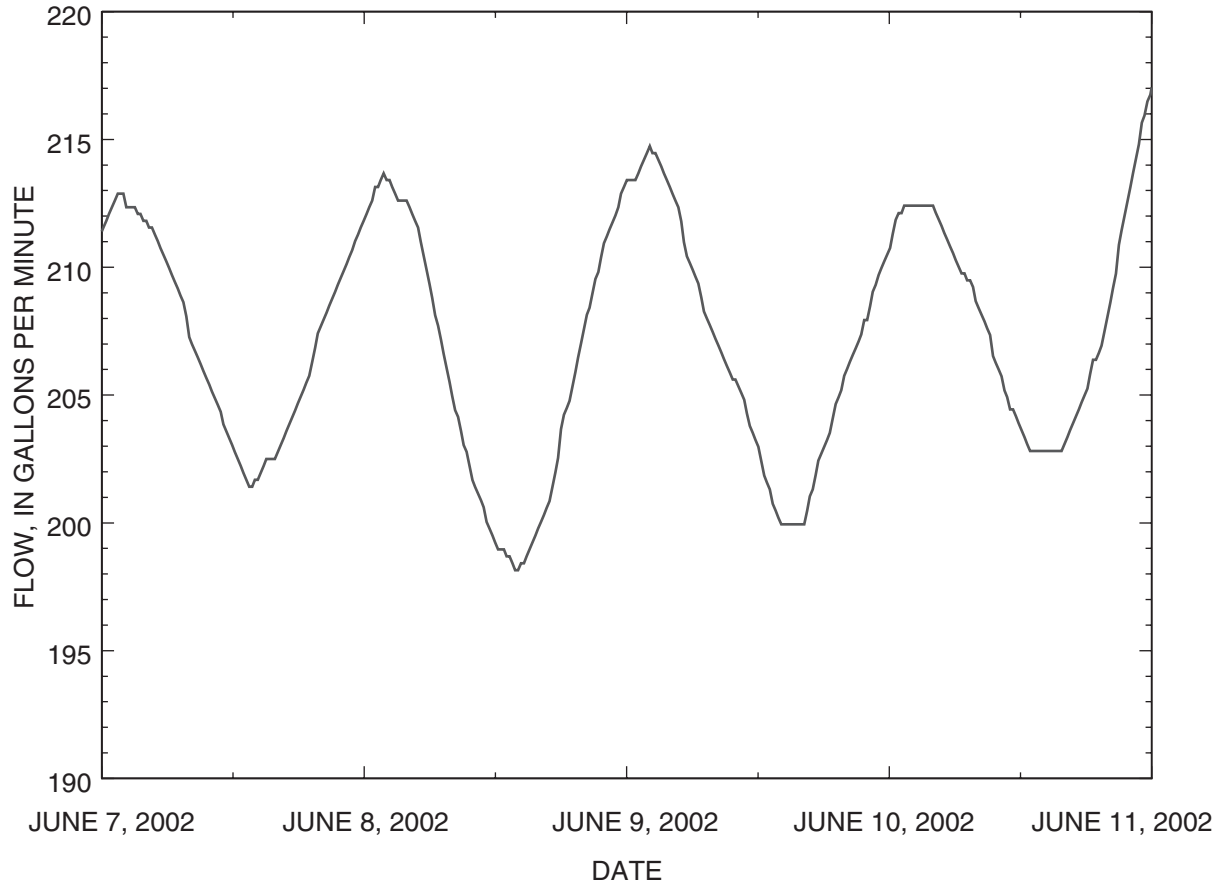
Figure 8. Record of continuous overflow discharge from Red Mill Spring, Clarksburg, Massachusetts, June 7–11, 2002.

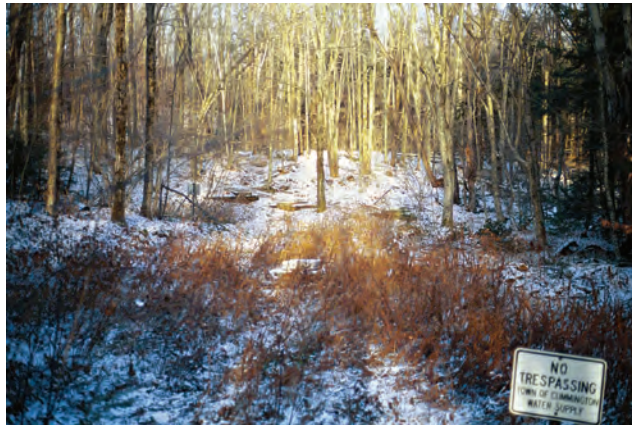
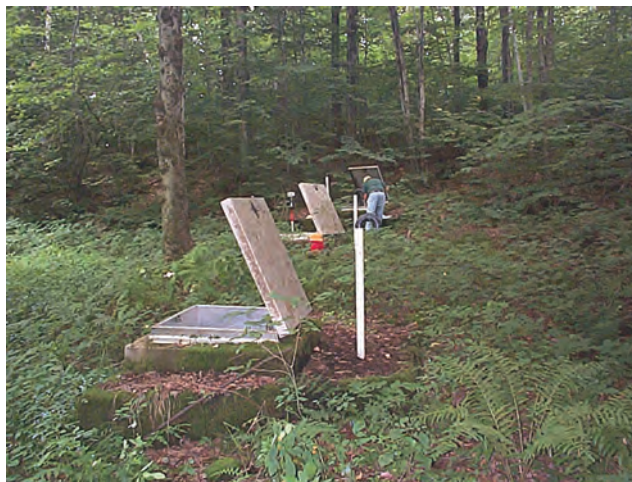
Figure 11. Fanny Rogers Spring in Cummington, Massachusetts showing A, three springs at top and collection cistern at center, northwestward view (photograph by Paul Blain, Massachusetts Department of Environmental Protection); B, three spring structures with stainless steel covers, southwestward view; and C, fracture that appears to be yielding water.

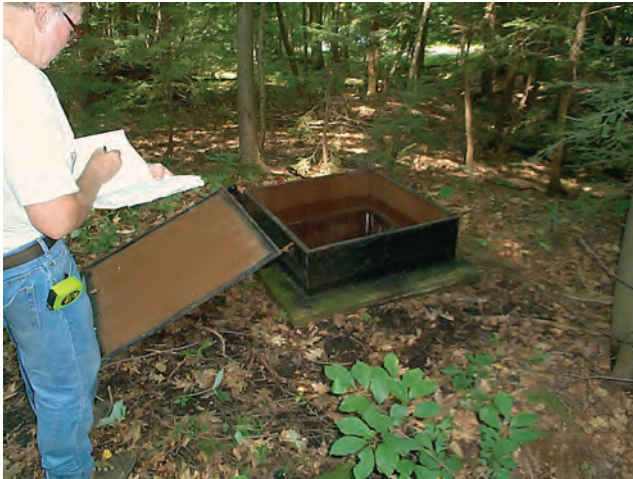
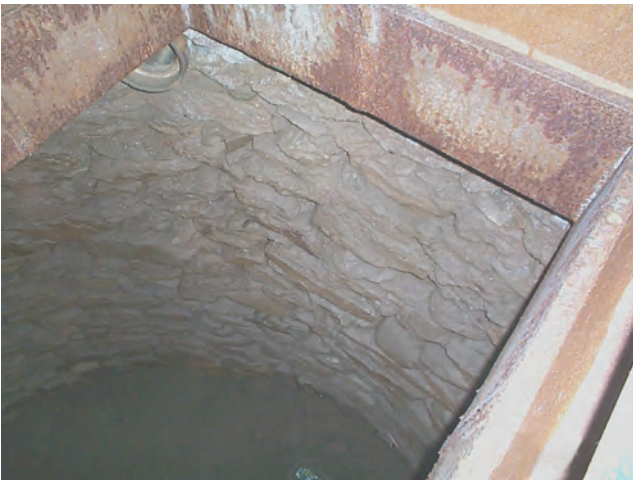
Figure 13. Keats Spring in Deerfield, Massachusetts showing *A*, exterior of spring with Pine Nook Road visible in the light areas at upper center, northeastward view; and *B*, interior of stone-lined spring cistern with overflow pipe near top, eastward view.

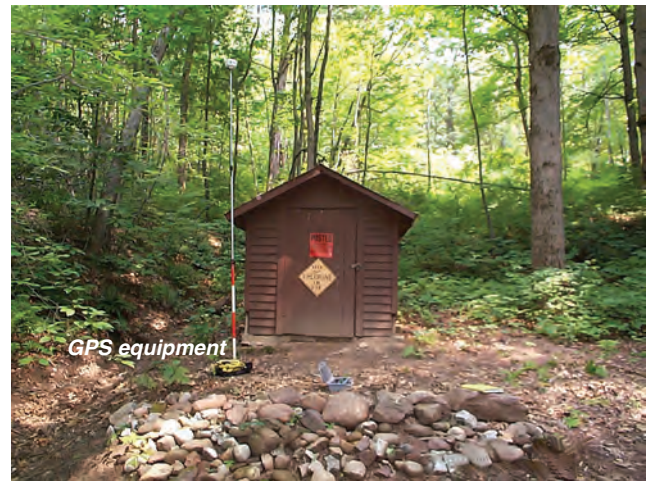
Figure 14. Wells Spring with spring house and global-positioning-system equipment used for determining spring locations, eastward view, Deerfield, Massachusetts.

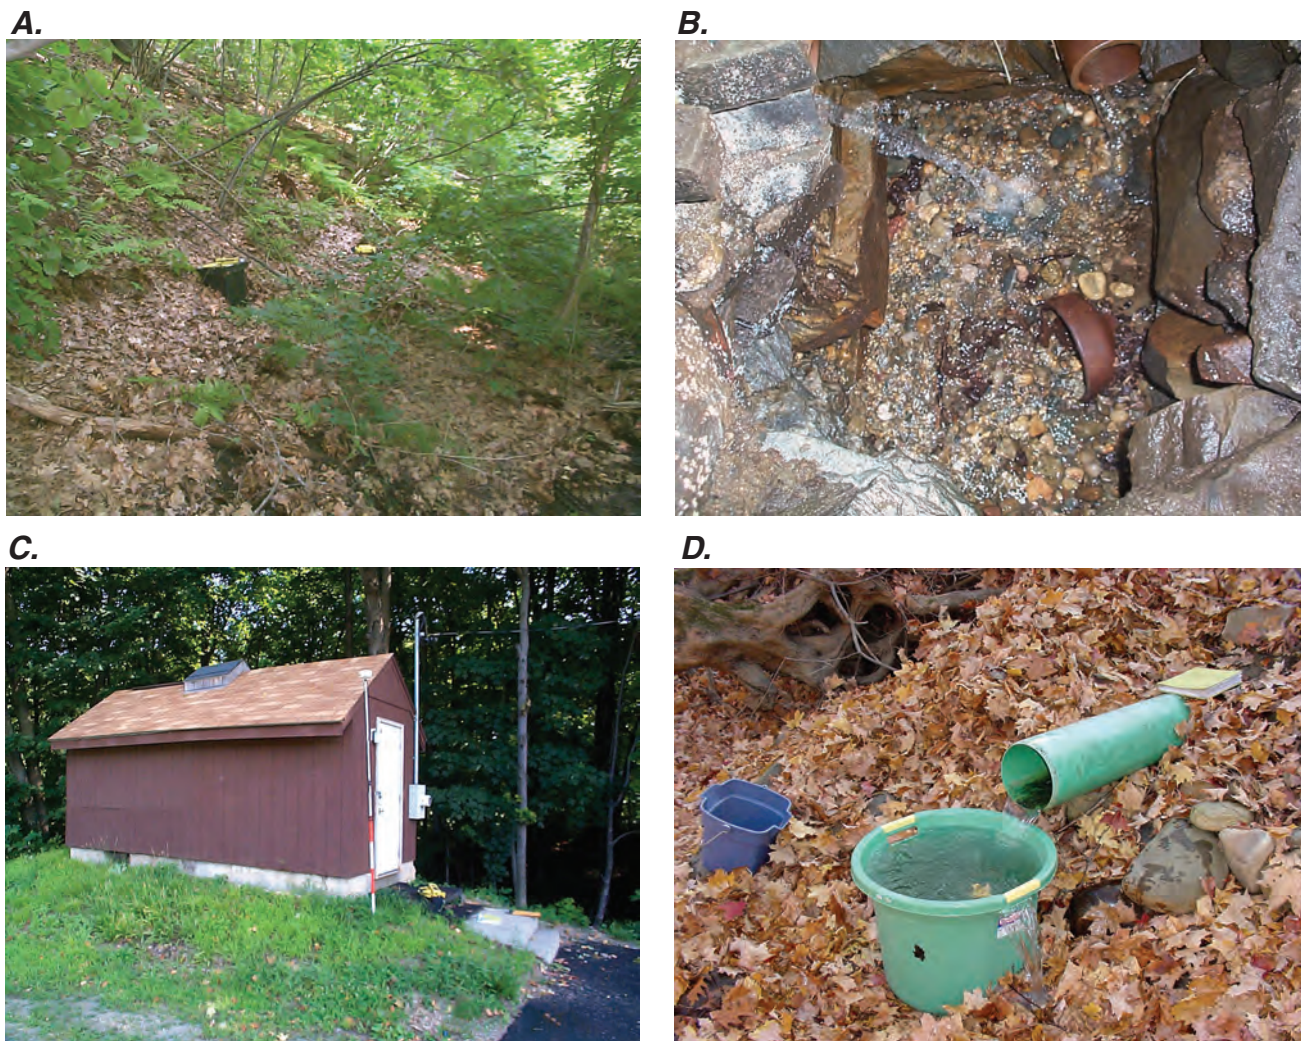
Figure 16. Stillwater and Harris Springs in Deerfield, Massachusetts showing *A*, two collection structures along the base of the scarp at Stillwater Spring, northwestward view; *B*, interior of a collection structure at Harris Spring; *C*, combined reservoir and pump house, northward view; and *D*, measuring combined discharge.

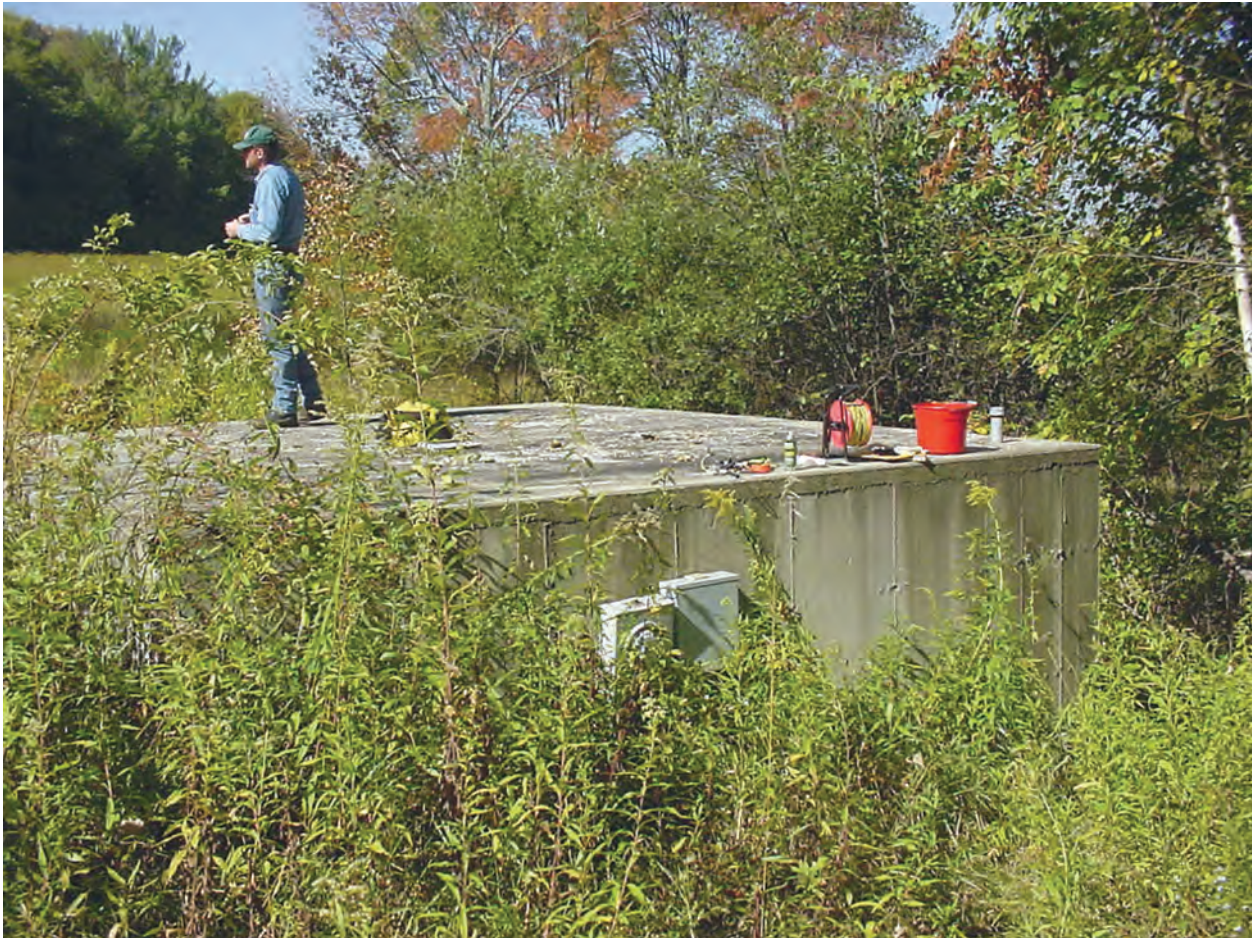
Figure 18. Guilder Hills Spring with combined collection structure, reservoir, and pump house, northward view, Egremont, Massachusetts.

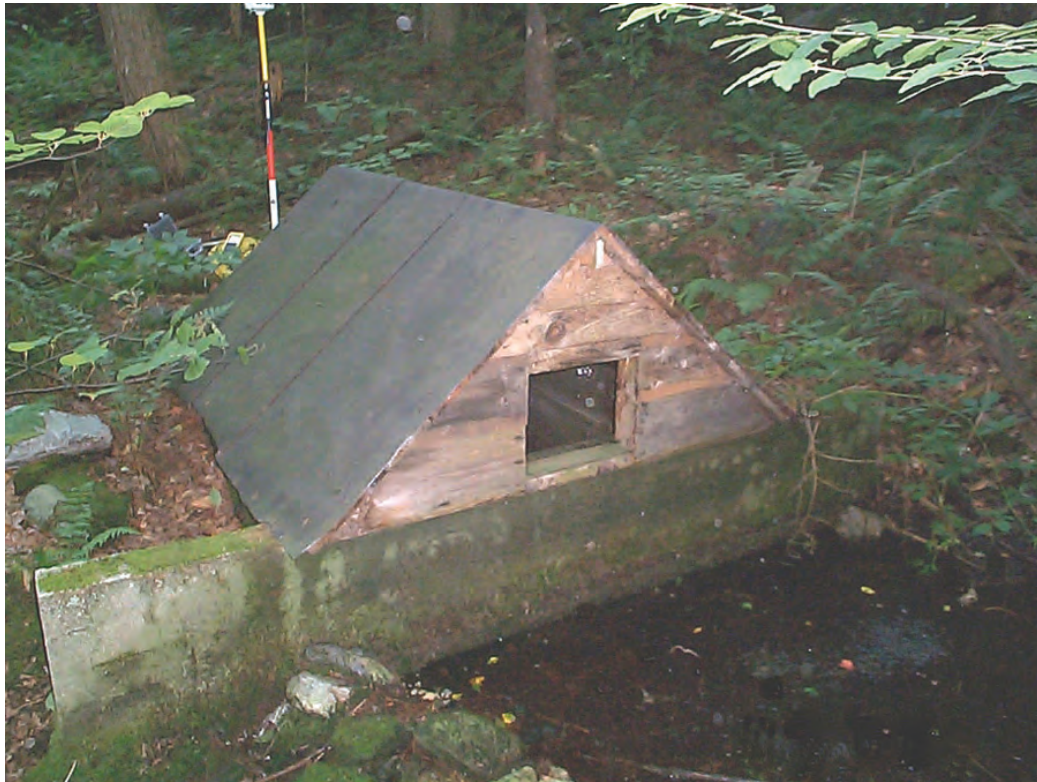
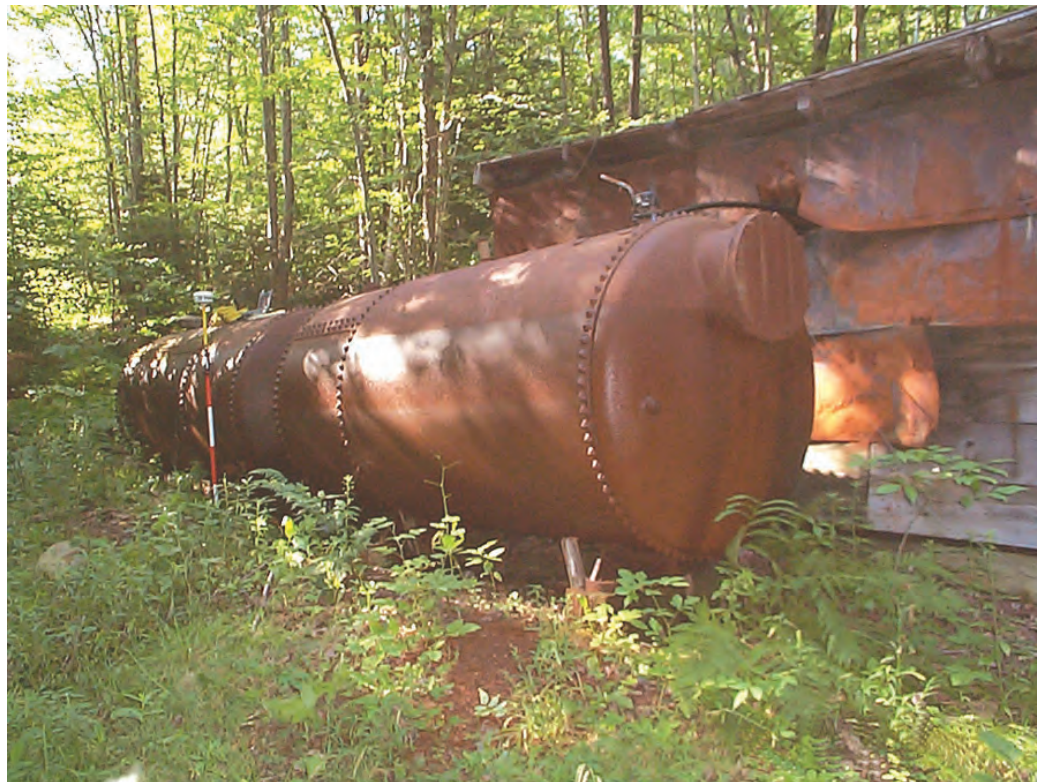
Figure 20. Whitcomb Summit Spring in Florida, Massachusetts, showing *A*, collection structure, southwestward view; and *B*, steel collection tanks and pump house, northward view.

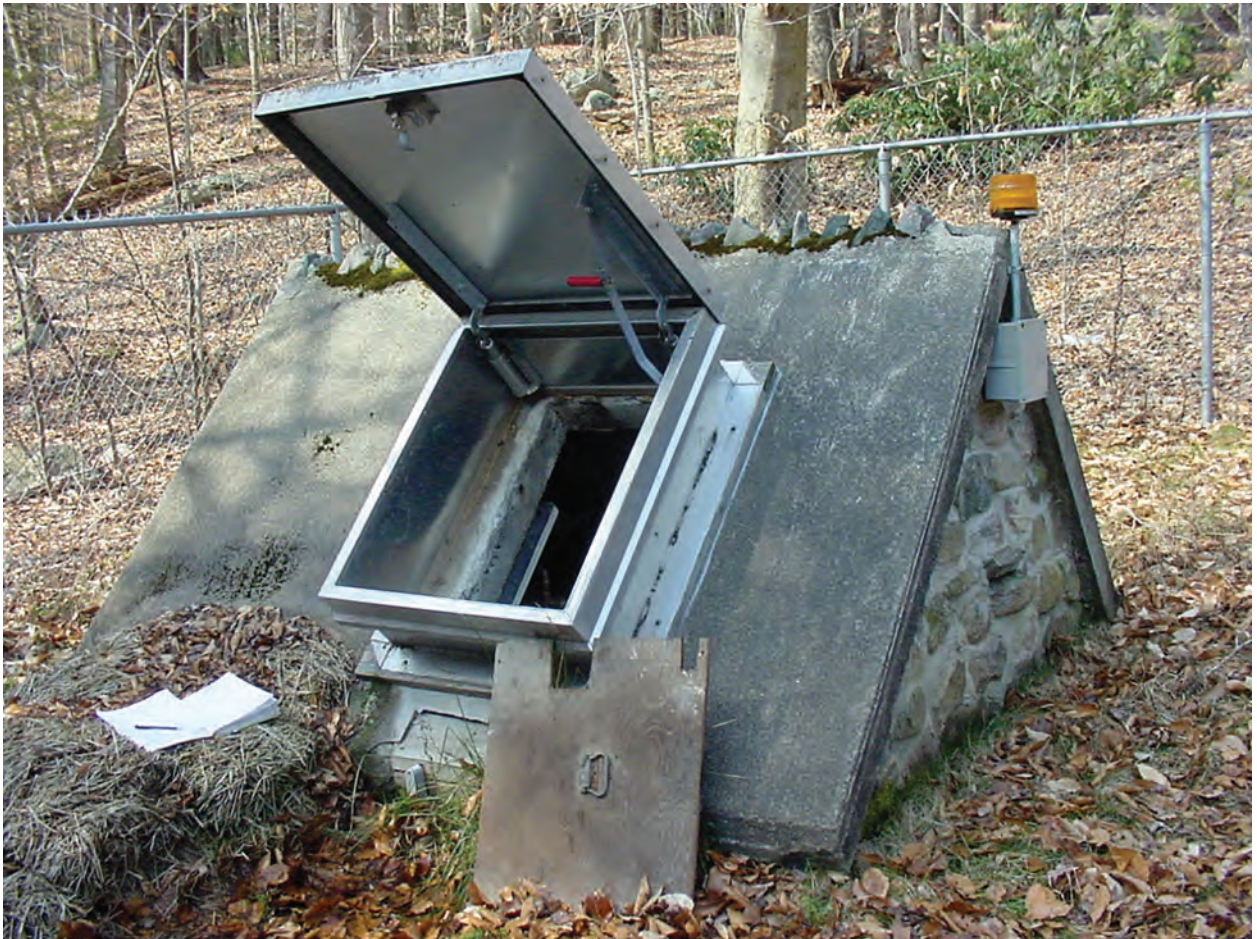
Figure 24. Mount Blue Spring, westward view, Hingham, Massachusetts.

cistern that is covered by an A-frame building with a stainless-steel hatch (fig. 24, at back of report). On demand, spring discharge is pumped from the collection cistern through an ultraviolet-light (UV) disinfection unit to taps in a small adjacent building where transient users fill water containers. An overflow pipe in the collection structure maintains a constant water level in the cistern. Unused spring water discharges to waste about 50 ft east of the spring.

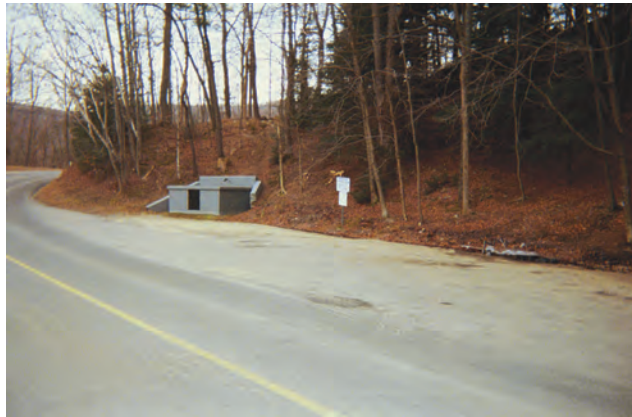
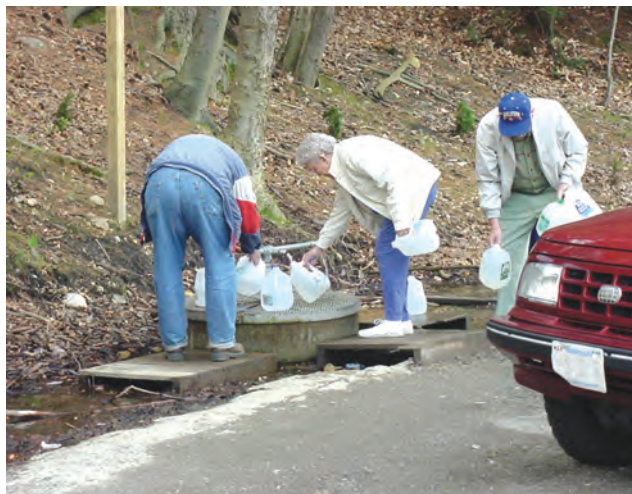
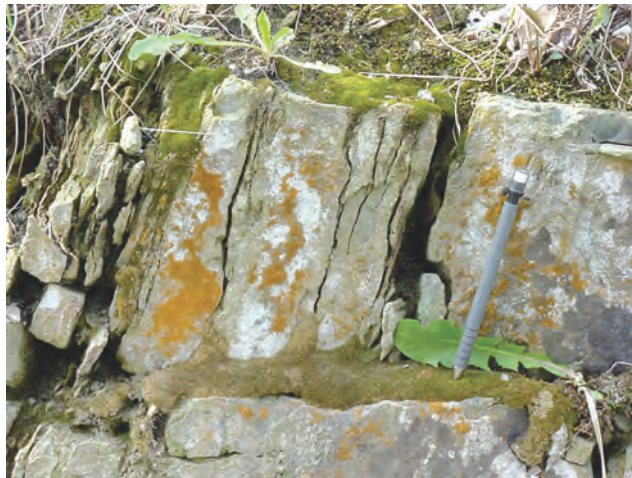
Figure 26. Berkshire Spring in Lanesborough, Massachusetts, showing *A*, vault over spring, eastward view (photograph by Bruce Bouck of the Massachusetts Department of Environmental Protection); *B*, transient users filling bottles with spring water; and *C*, high-angle fractures on outcrop just east of spring, southward view.

Berkshire Spring in Lanesborough, MA, is just south of Summer Street about 350 ft west of its intersection with State Road (figs. 1 and 25, at back of report, table 1). The spring is enclosed by a cement vault (fig. 26A, at back of report) whose dimensions are approximately 10.8 by 11.7 by 9.7 ft; 2.6 ft of the 9.7-ft height is below land surface. The enclosed reservoir has a storage capacity of about 2,081 gal. Four pipes draw water from the reservoir: one supplies the Berkshire Cooperative pump house on the north bank of the Hoosic River about 250 ft east of the spring, a second feeds a public watering trough just west of the spring that serves a large number of transient users (fig. 26B), a third feeds two or three private homes on the shore of Cheshire Reservoir, and a fourth tile pipe just above land surface serves as an overflow to drain excess spring flow. The drain outlet could not be located and presumably discharges into Cheshire Reservoir north of the spring. The estimated discharge is 50 to 60 gal/min. This value is based on measurements of some of the flow components and estimates of others.

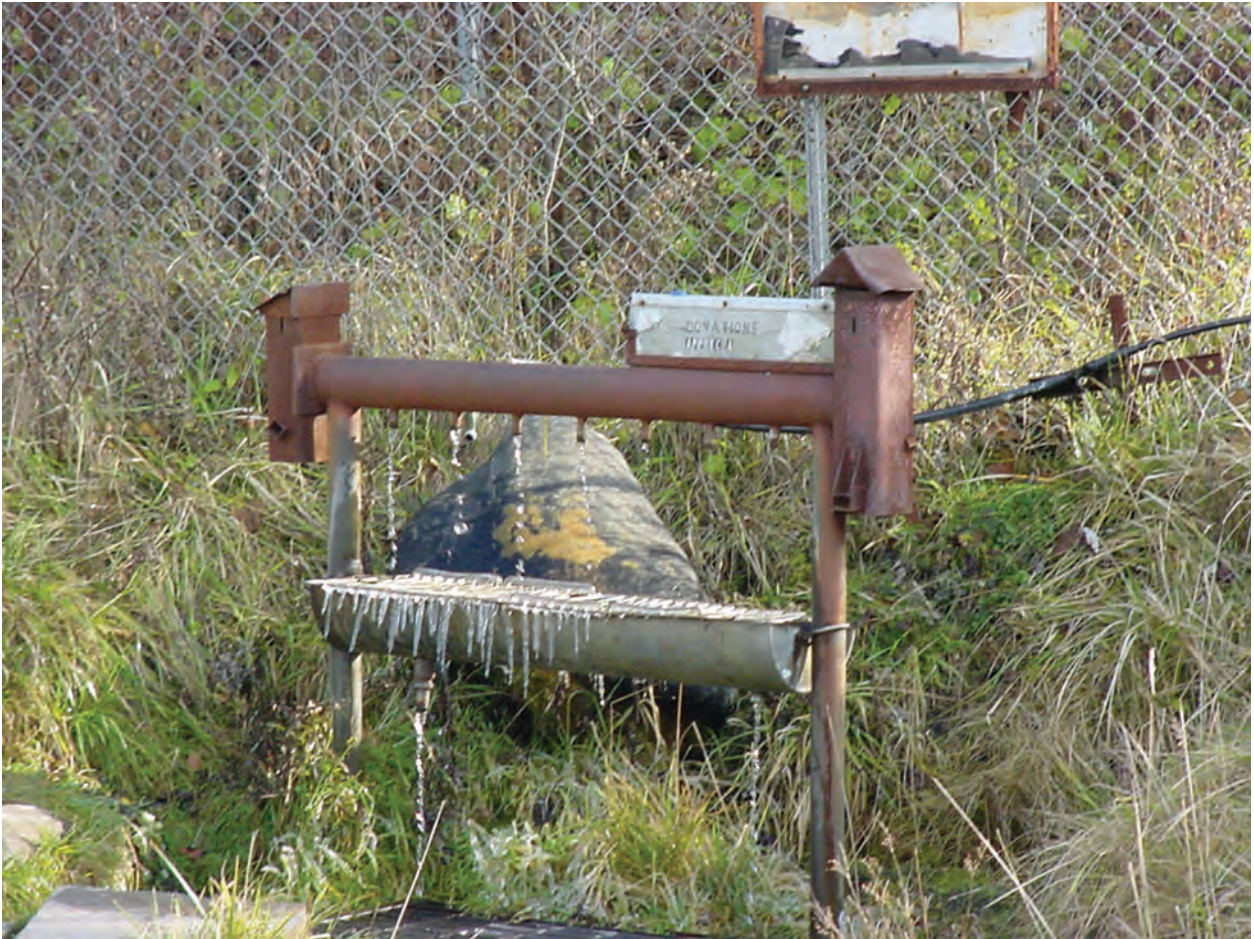
Figure 28. Collection trough at Cold Spring, eastward view, Lee, Massachusetts.

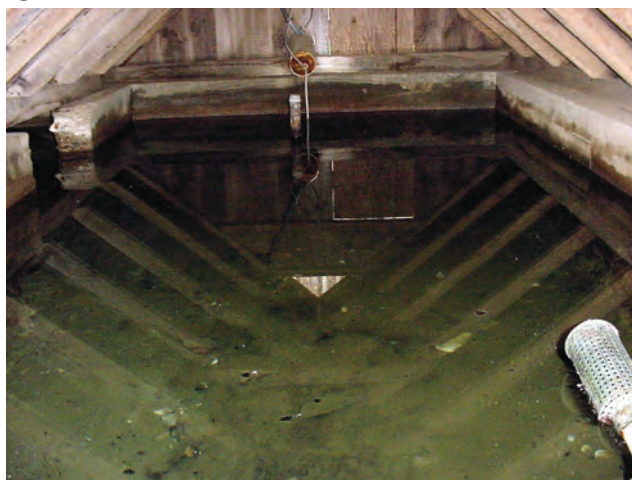
C.

Figure 30. Mill River Road Springs 1 and 2 in New Marlborough, Massachusetts showing *A*, Spring 1 in foreground, Mill River Road and spring house covering Spring 2 in background, southwestward view; *B*, Spring 2 spring house to left and chlorination-equipment house to right, eastward view; and *C*, Spring 2 collection basin and reservoir inside spring house, southeastward view.

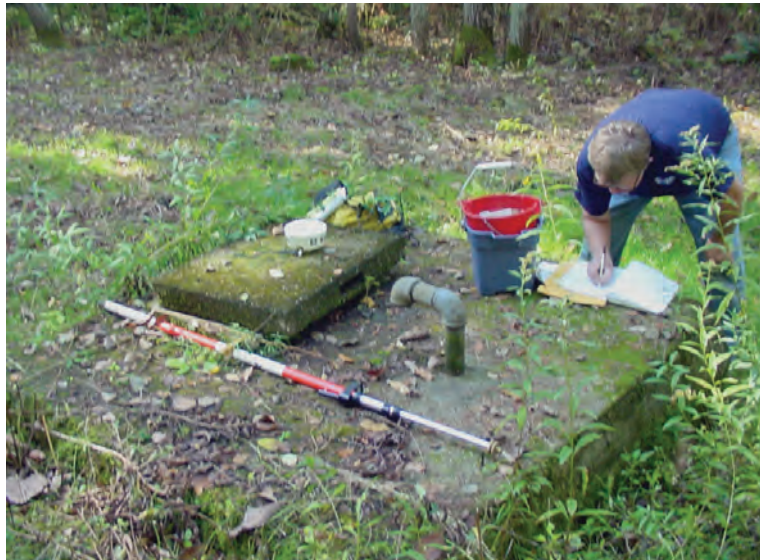
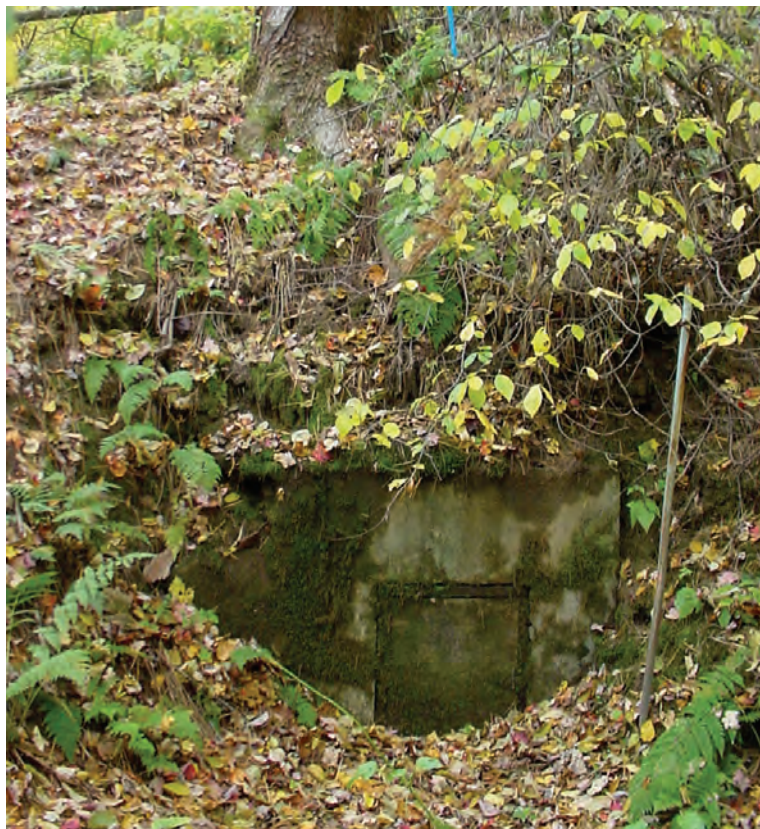
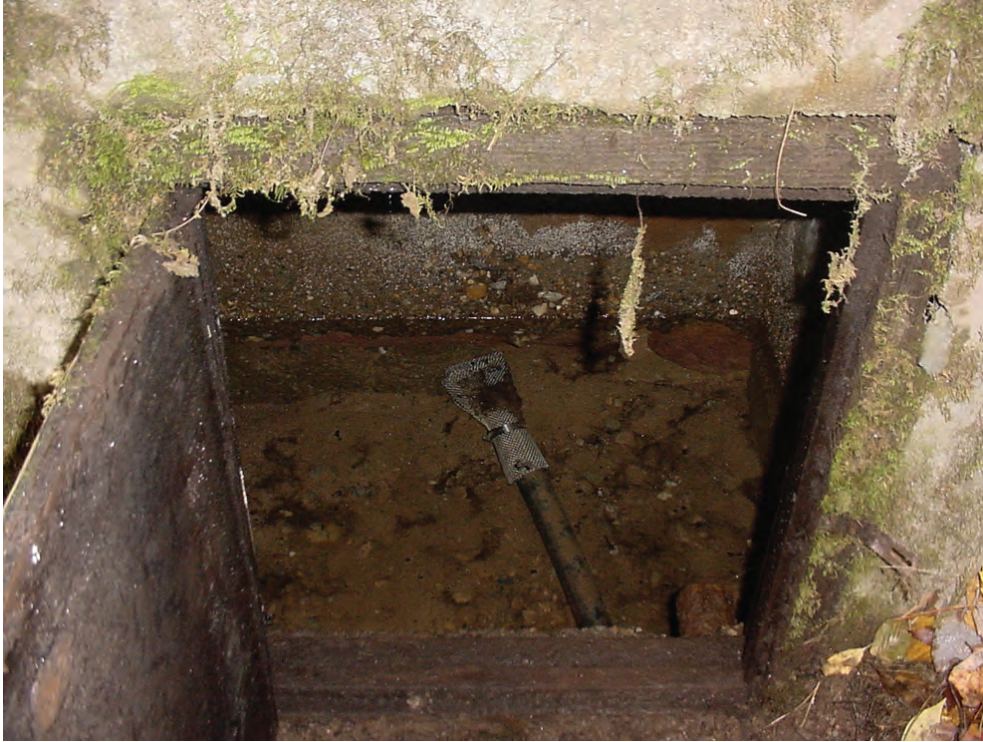
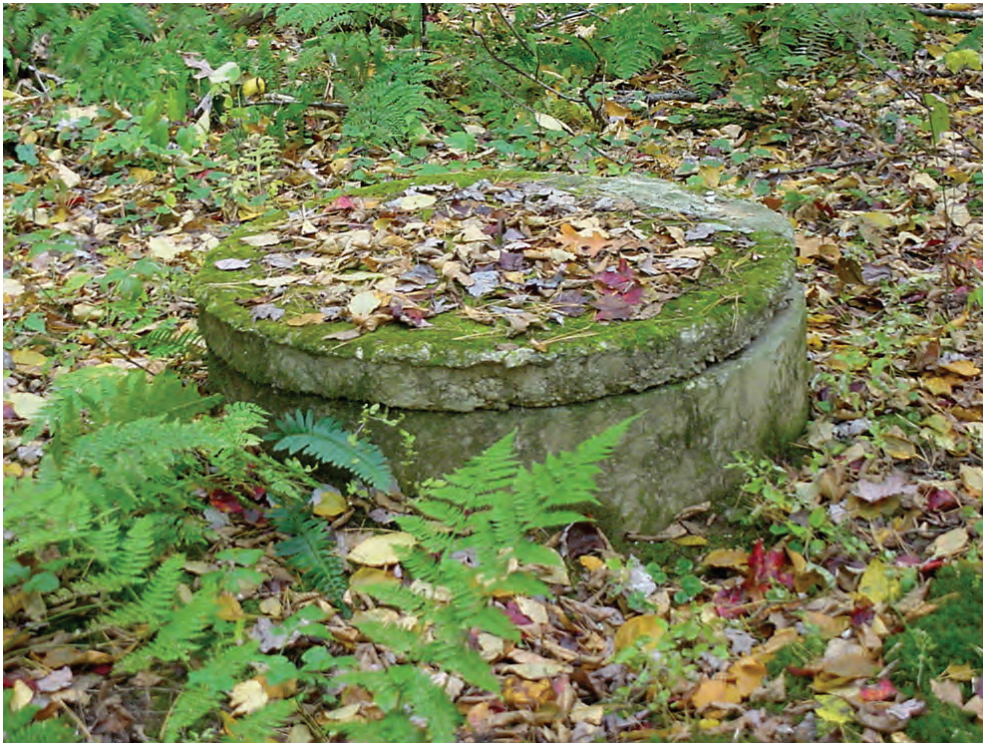
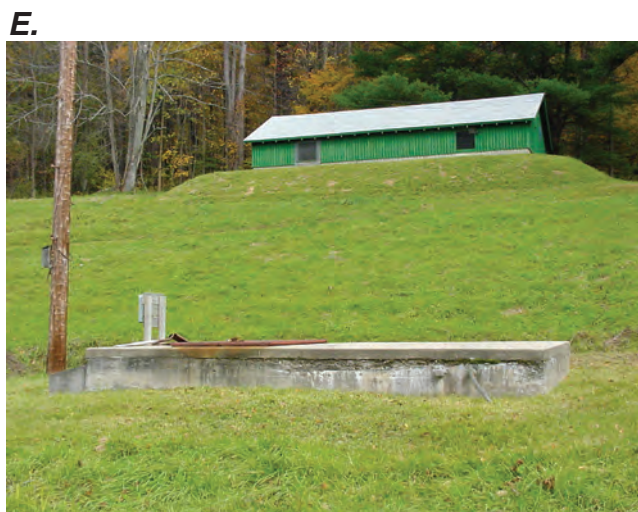
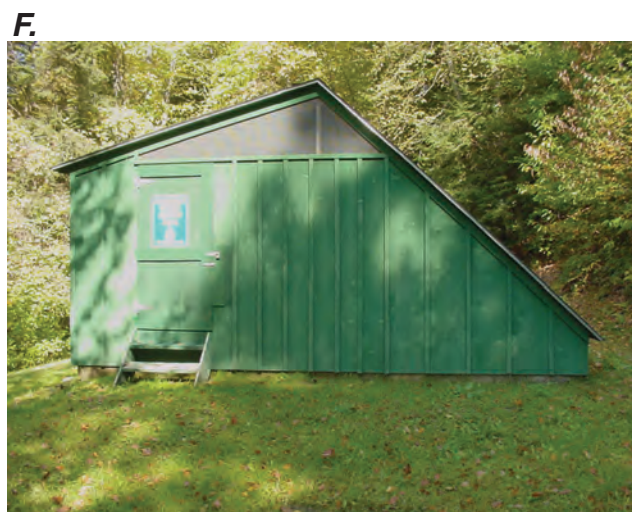
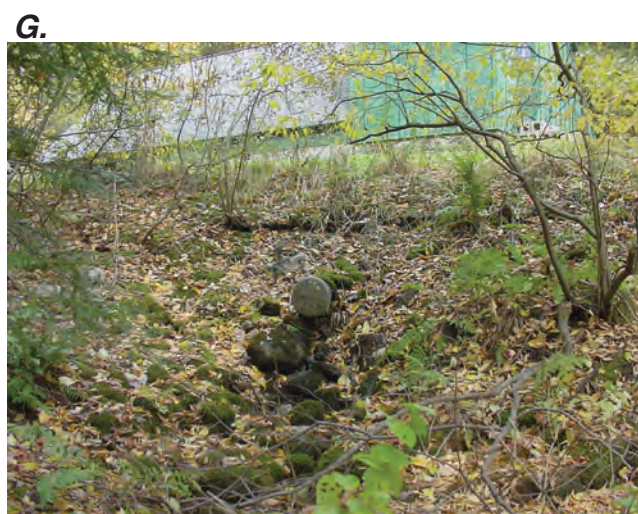
Figure 34. A, Farm House Spring, northwestward view; B, Red Rock Spring, northward view, all in Sheffield, Massachusetts.

Figure 34—Continued. *C*, interior of Red Rock Spring house with discharge pipe; *D*, Barrel Spring, all in Sheffield, Massachusetts.

Figure 34—Continued. *E*, vault containing Farm House Spring reservoir and pump station in foreground and reservoir for Barrel and Red Rock Springs in background, northeastward view; *F*, Smith Spring House, northwestward view; *G*, Smith Spring overflow pipe, northward view; and *H*, Smith Spring overflow, northeastward view, all in Sheffield, Massachusetts.

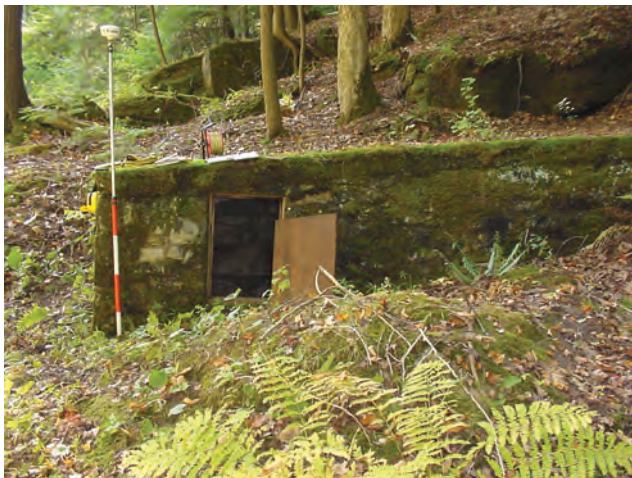
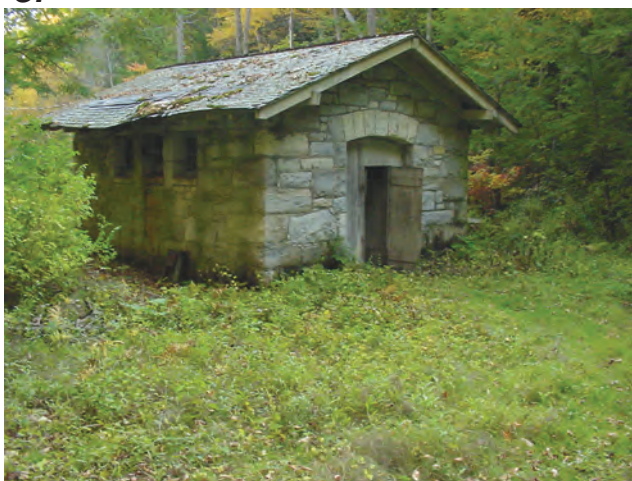
Figure 38. High Lawn Farm Spring in Stockbridge, Massachusetts, showing *A*, spring house, southward view; *B*, solution-enlarged fracture yielding water to spring, westward view; and *C*, pump house, southeastward view.

High Lawn Farm Spring in Stockbridge, MA, is at the base of Rattlesnake Hill about 0.81 mi northwest of the intersection of Route 7 and West Road (fig. 1, table 1). Spring improvements include a mortared-stone spring house (fig. 38A, at back of report) that is 24 ft long, 10.2 ft wide, and 8.2 ft deep. The spring house is built against a bedrock outcrop. The spring flows from a solution-enlarged fracture (fig. 38B). From the spring house discharge flows by gravity to two 6,000-gal buried cement storage tanks at a pump house about 100 ft southeast of the spring (fig. 38C). Water is pumped to a 100,000-gal storage reservoir 3000 ft northwest of the pump house near the ridge line of Rattlesnake Hill. From this reservoir, water gravity feeds to a distribution system at High Lawn Farm on Summer Street in Lee, MA. The farm's dairy and approximately 14 households use the spring water. A spring discharge of 47 gal/min, was measured in August 2002 (table 2). A spring discharge ranging from 50 to 80 gal/min, had previously been reported (Peterson and Maevsky, 1962 and Norvitch and Lamb, 1966).

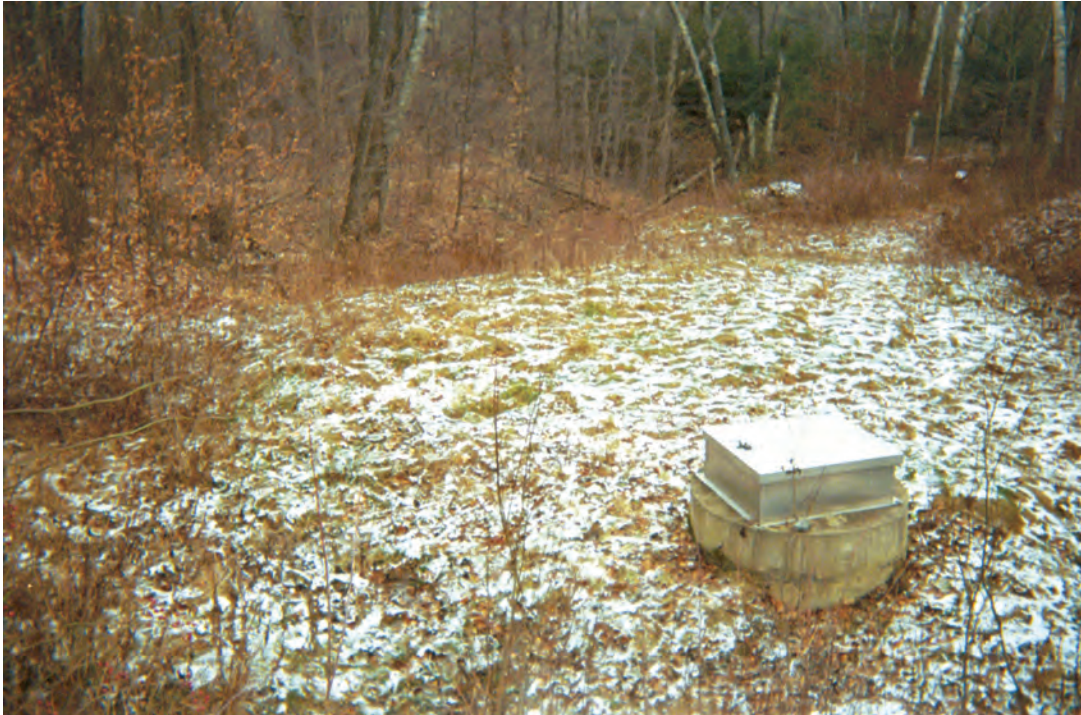
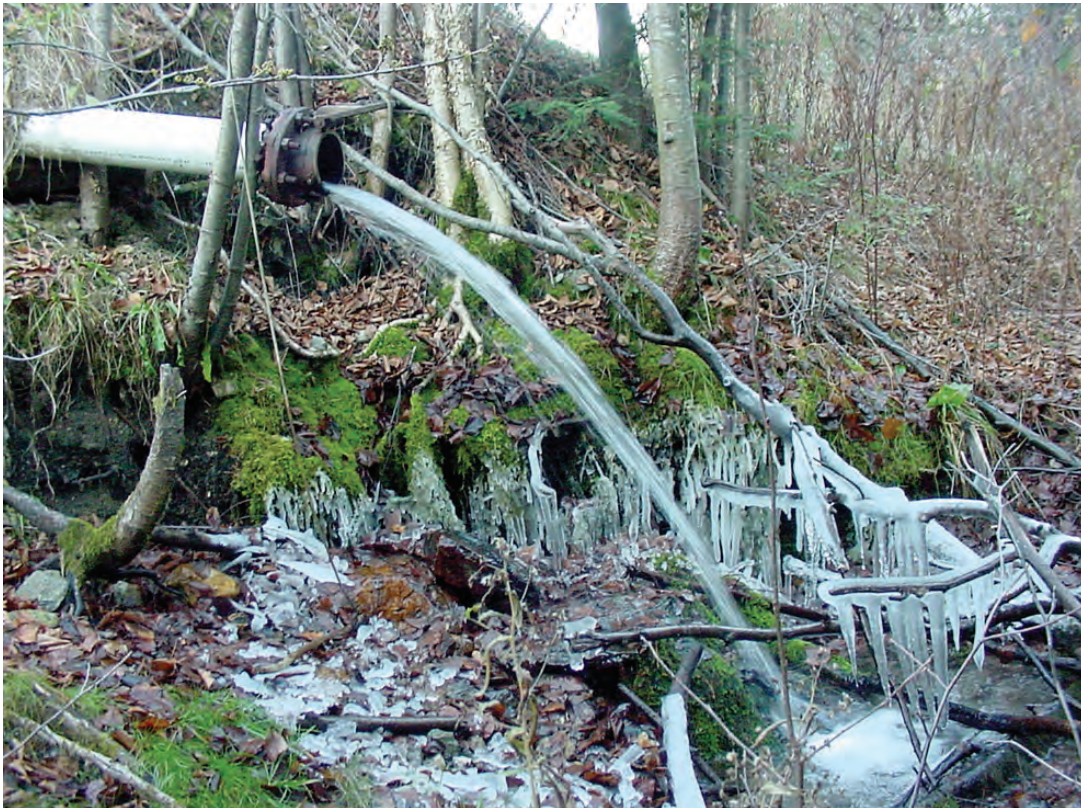
Figure 40. Waubeeka Spring in Williamstown, Massachusetts, showing A, spring collection structure, northward view (photograph by Bruce Bouck, Massachusetts Department of Environmental Protection); and B, overflow from reservoirs, eastward view, November 2001.

Spring improvements include 4-ft-diameter, open-bottom, cement collection structures that extend 13.9 ft (west spring) and 8.4 ft (east spring) below land surface. These structures have cement covers with stainless-steel hatches (fig. 40A, at back of report). Plastic discharge pipes with 10-in. diameters near the bottoms of the structures conduct discharge about 425 ft downslope to two 10,000-gal buried cement storage tanks. Each spring structure has a 10-in.-diameter plastic overflow pipe that discharges excess water about 100 ft downslope from each spring. The downslope storage tanks have one 10-in.- and two 4-in.-diameter overflow pipes that drain excess discharge from both tanks (fig. 40B). Water flows by gravity from the storage tanks to the center of South Williamstown, where there are about 20 domestic and commercial connections (Alan Kapiloff, Waubeeka Springs Deeded Users, oral commun., 2001). Discharge measured during the study ranged from 49 to 240 gal/min; these measurements don't include water usage at the time of the measurement (table 2). Discharge is so large at times that all of the spring and reservoir overflow pipes are full and additional water overflows from beneath the reservoir covers (Alan Kapiloff, Waubeeka Springs Deeded Users, oral commun., 2001). This information indicates that the maximum discharge is larger than was measured during this investigation.
