Characteristics of and Areas Contributing Recharge to Public-Supply Springs in Massachusetts

Prepared in cooperation with the
MASSACHUSETTS DEPARTMENT OF ENVIRONMENTAL PROTECTION

Water-Resources Investigations Report 03-4266

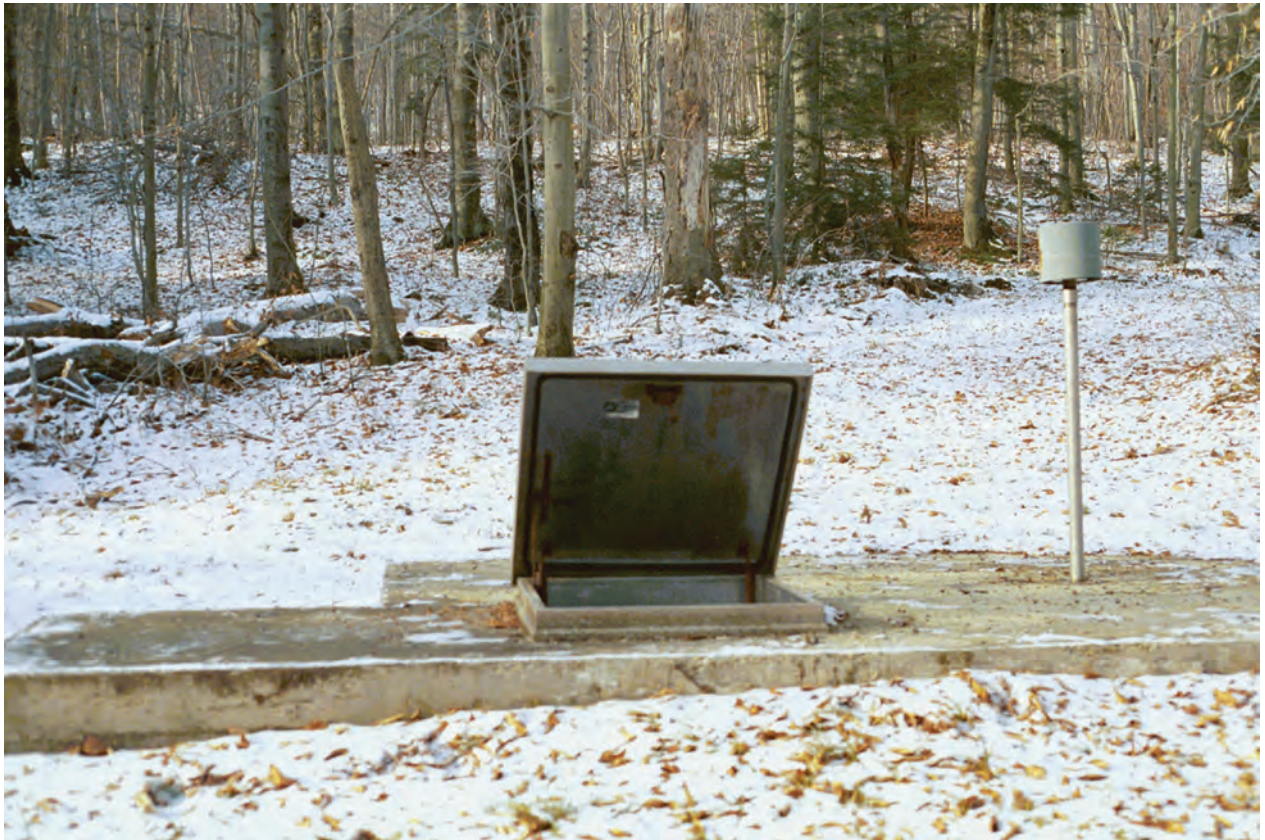
Figure 42. Worthington Fire District Spring 2, westward view, Worthington, Massachusetts.

Improvements at springs 1–3 are similar. Each spring has an open-bottom cement collection vault with a stainless-steel hatch (fig. 42, at back of report). The bottoms of the vaults are 5.2 to 6.1 ft below land surface and rest on the bedrock surface (John Sullivan, Worthington Fire District Operator, oral commun., 2001). The vault for Spring 1 is connected to a second vault that contains WFD Bedrock Well No. 2. A valved, 4-in.-diameter plastic pipe located about 1 ft above the bottom of the vault drains discharge from each spring. Each spring vault has a valved 4-in.-diameter cleanout drain on the bottom of the vault. The three springs drain to a large covered reservoir about 650 ft east of Cold Ridge Road. Spring 4, which is presently unused, is an open bottom cement vault 5.2 ft wide and 7 ft long. The bottom of the vault is only 1.6 ft below land surface. During an average year, the springs dry up by late June and start flowing again by late October (John Sullivan, Worthington Fire District Operator, oral commun., 2001). During the study, no discharges were measured because the plumbing made discharge inaccessible.

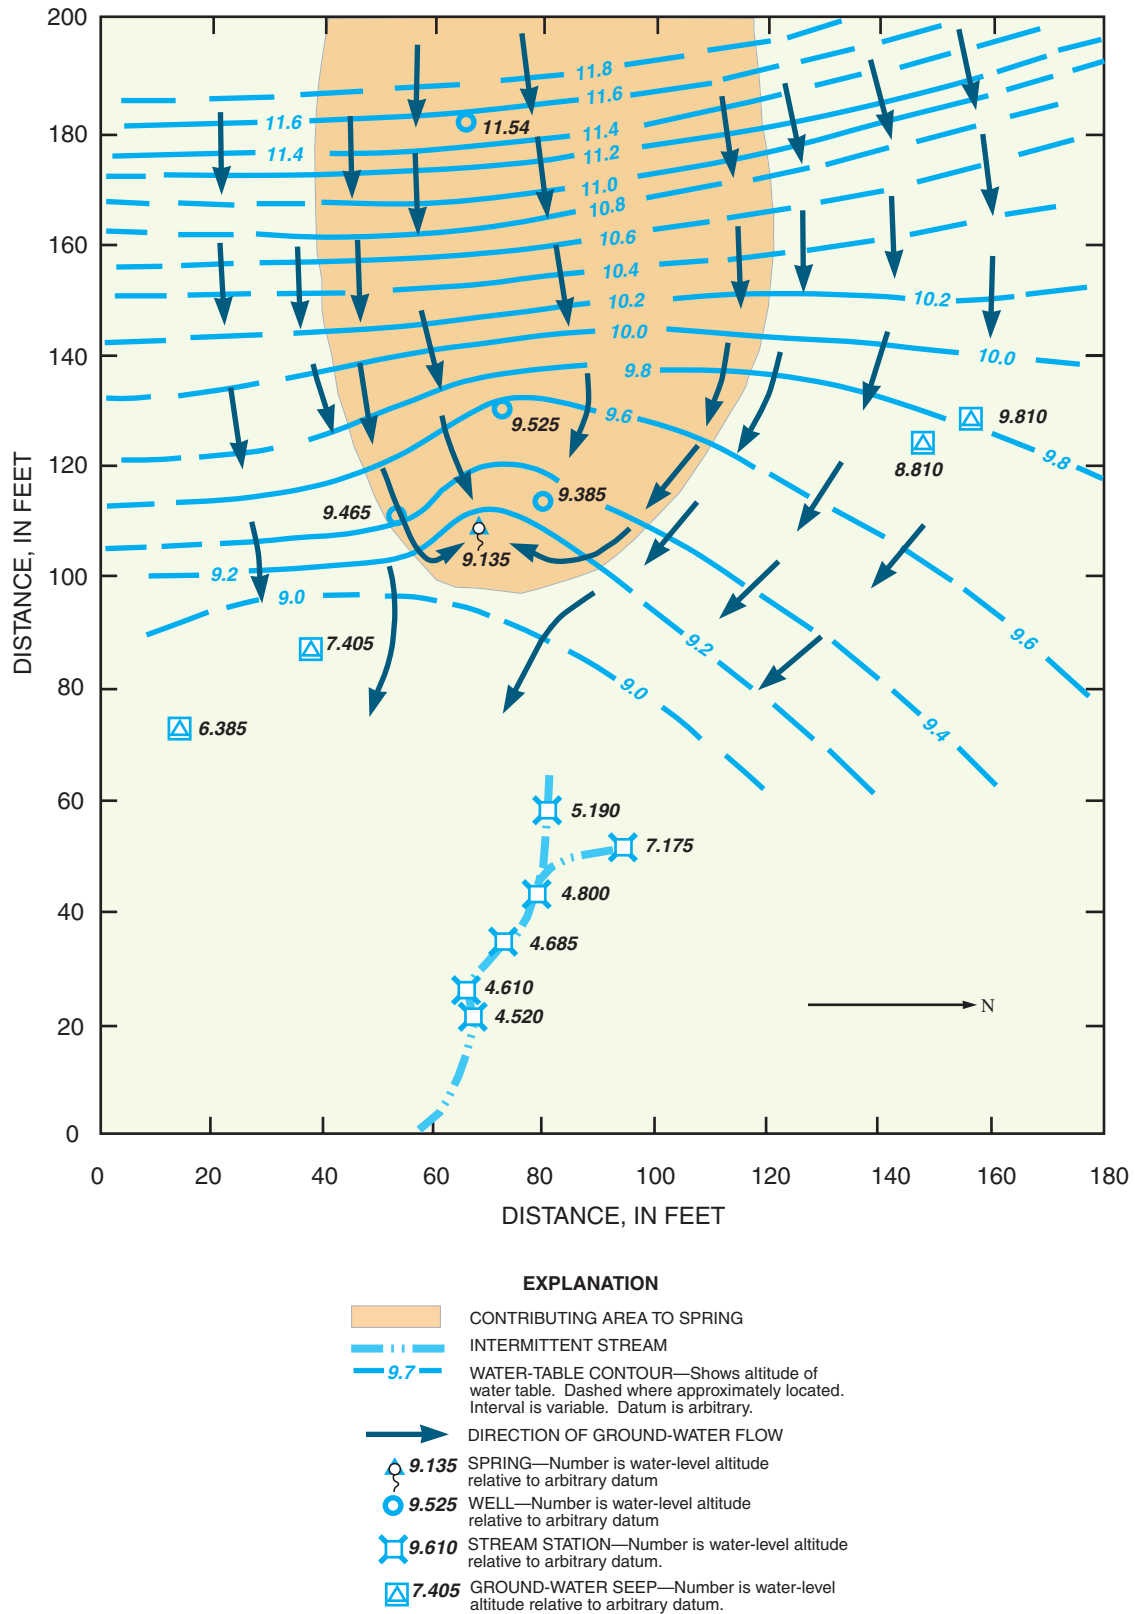
Figure 43. Water-table altitude, ground-water-flow direction, and part of the area contributing recharge to Mount Blue Spring in Hingham, Massachusetts.

Lithologic samples indicate that the shallow subsurface is characterized by a sand and gravel layer that is overlain by about 3 ft of dense low-permeability till that acts as a confining layer, as evidenced by the seeps and small springs east and west of the main spring where the confining layer has been locally breached. A water-table map for the immediate vicinity of Mount Blue Spring was constructed from the water-level data (fig. 43). Ground-water-flow lines were drawn on the water-table map and the zone contributing water to the spring was delineated and is shown on figure 43. The area contributing recharge based on the detailed water-table map fits well within the 457-ft-square MADEP Zone 1 Protective Area (fig. 23 and table 4) and is narrower (0.2 times the original width) than the area contributing recharge determined during the reconnaissance study. Additional water-level data from the area just south of the area contributing recharge delineated in the detailed investigation may have resulted in defining a slightly larger area contributing recharge.

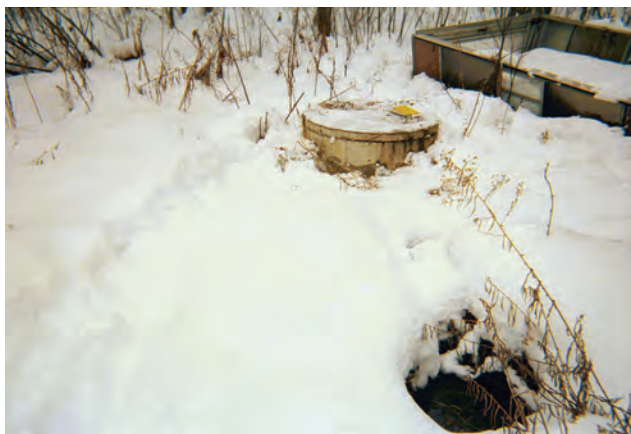
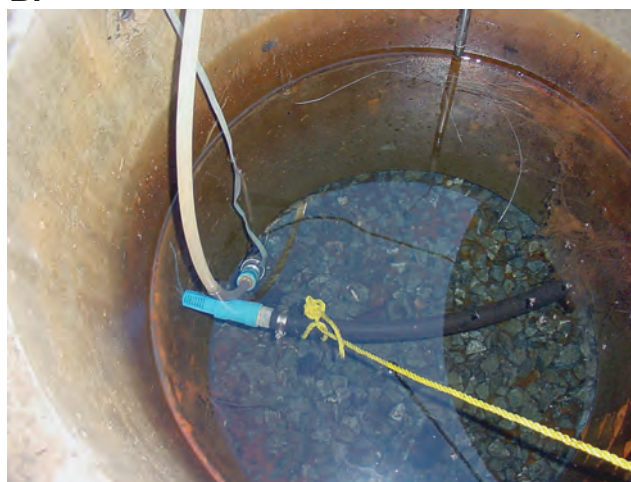
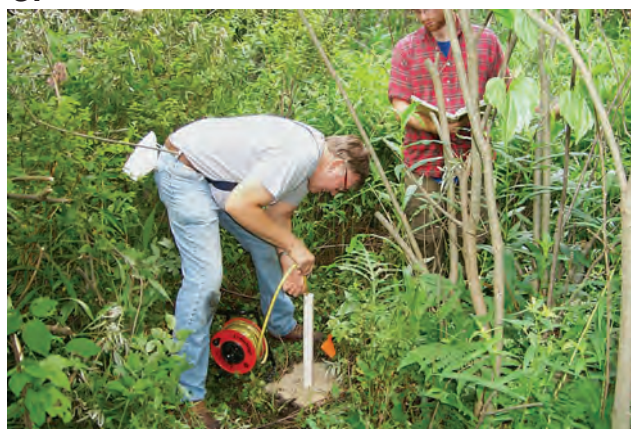
Figure 45. Silver Brook Café water source in Sandisfield, Massachusetts, showing *A*, collection structure at upper center and seepage melting snow at lower right, westward view (photograph by Bruce Bouck, Massachusetts Department of Environmental Protection); *B*, blue pump intake in collection structure; and *C*, measuring water level in small-diameter observation well.

Café, which is located in this area, consists of an open-bottom 3-ft-diameter covered cement pipe that serves as a collection structure (fig. 45, at back of report). The bottom of the pipe is 3.2 ft below land surface. Water is pumped from the site to the Silver Brook Café. The MADEP has recently classified this source as a well because the plumbing allows the water level to be drawn below a natural level in the collection structure and thus can induce additional discharge. Therefore, no Zone 1 and area contributing recharge are reported for this water source formerly classified as a spring.

The investigation at this site included the installation of nine hand-augured wells, collection and logging of lithologic samples, measurement of water levels in the nine wells (fig. 45C) and in the supply well, and an elevation survey of all surface- and ground-water observation and measurement points.
