**Alpine Satellite Development Plan
Final Environmental Impact Statement**

CLOVER MINE SITE REHABILITATION PLAN

ECOLOGICAL RESTORATION OF THE CLOVER A MINE SITE, ALPINE SATELLITE DEVELOPMENT PROJECT, ALASKA

July 2004

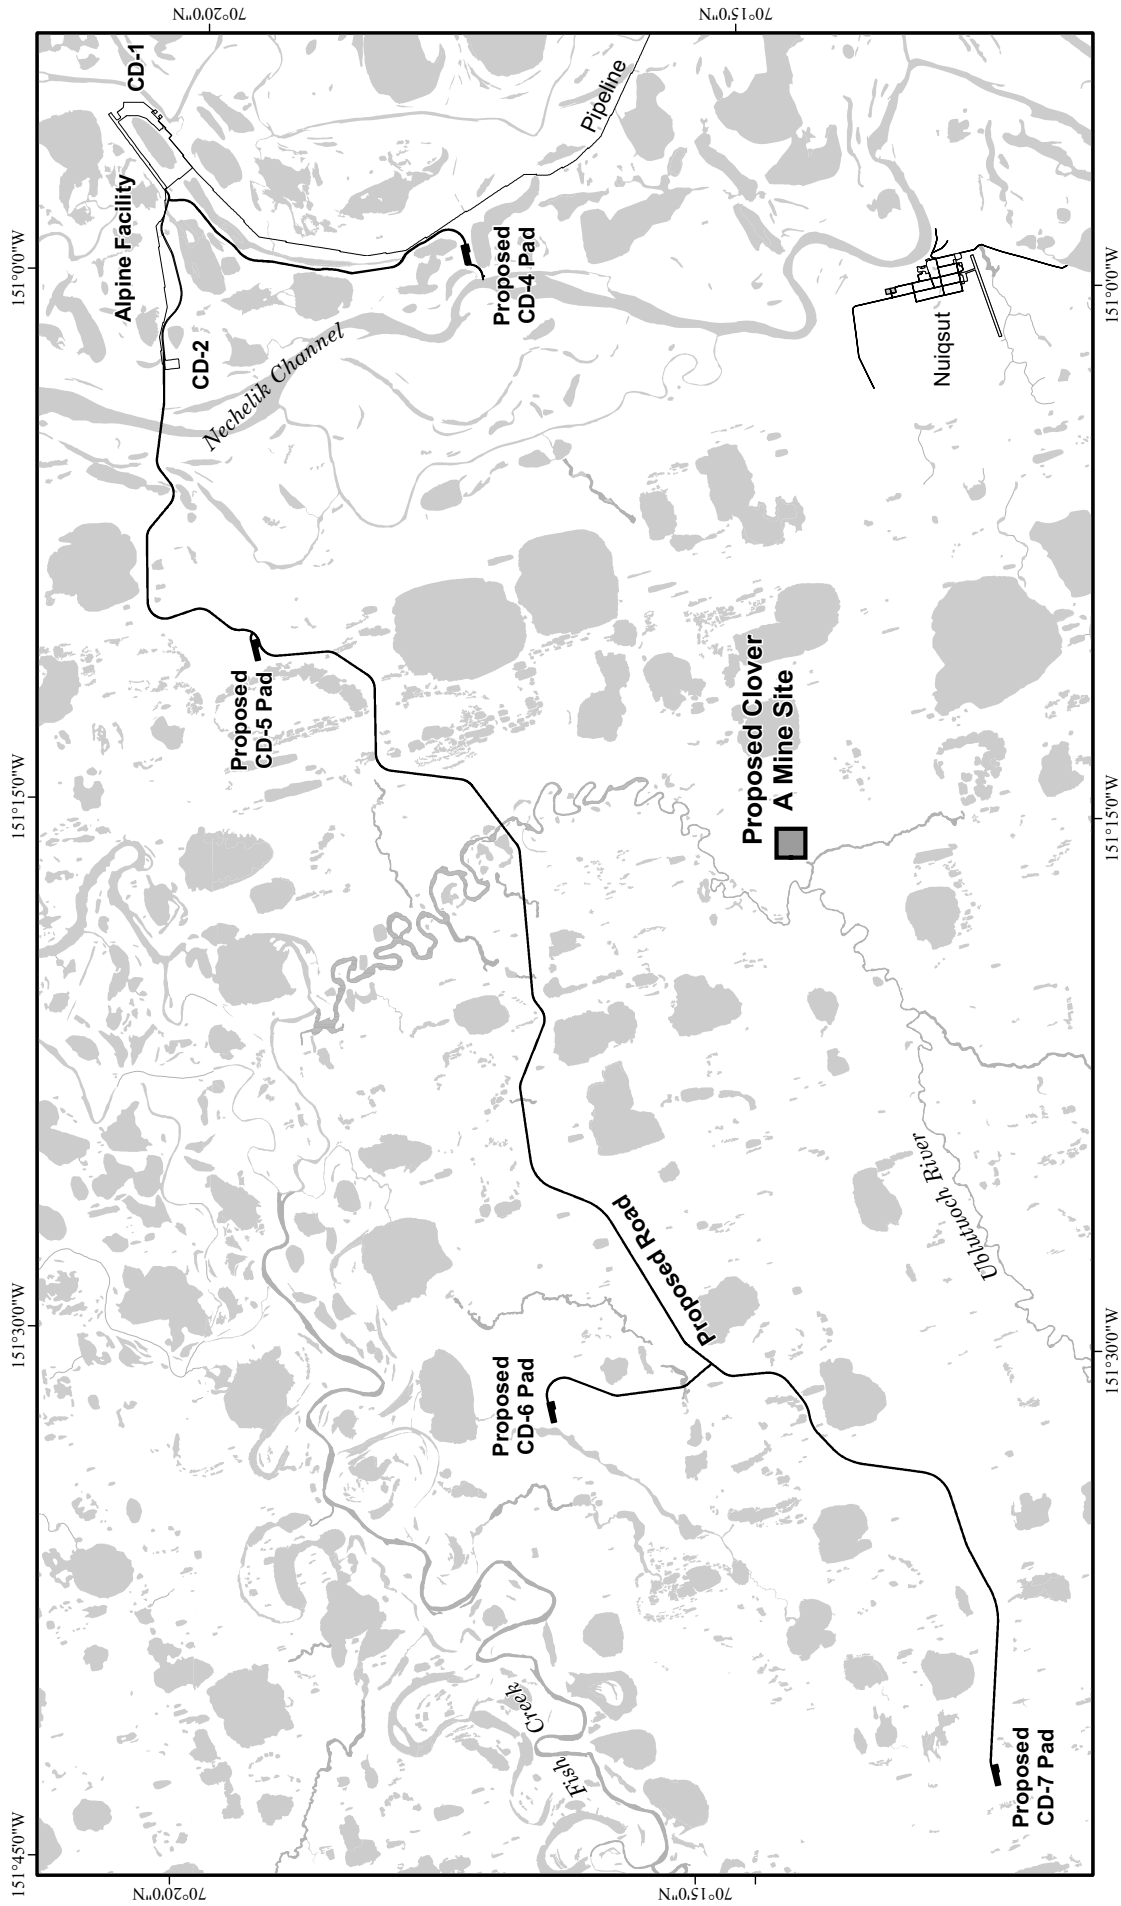
Figure 1.
Location of Proposed Clover A Mine Site, Alpine Satellite Development Project Area, Northern Alaska, 2004.

Photo-interpretation of waterbodies based on color orthophoto mosaic by AeroMap U.S., Inc.; Pixel resolution: 2.0 ft;
 Dates of photography: 30 June 1999 and 14 & 15 July 2001
 Map accuracy meets national map spatial accuracy standards.
 Projection: Alaska State Plane Zone 4 (units feet); Datum: NAD 83.
 ABR file: F:\CloverA_Rehab_Loc_03-119.mxd; 9 June 2004

The proposed Clover A Mine Site is located in the National Petroleum Reserve Alaska (NPR), approximately 13.8 km east of the Alpine Oilfield and 13 km south of Harrison Bay (Figure 1). The vegetation consists primarily of Moist Sedge-Shrub Meadow and Moist Tussock Tundra. Small inclusions of Patterned Wet Meadow also occur within the Moist Tussock Tundra (Figure 2) Restoration plans for this mine site call for the creation of high-value waterbird habitat, which is uncommon in this area.

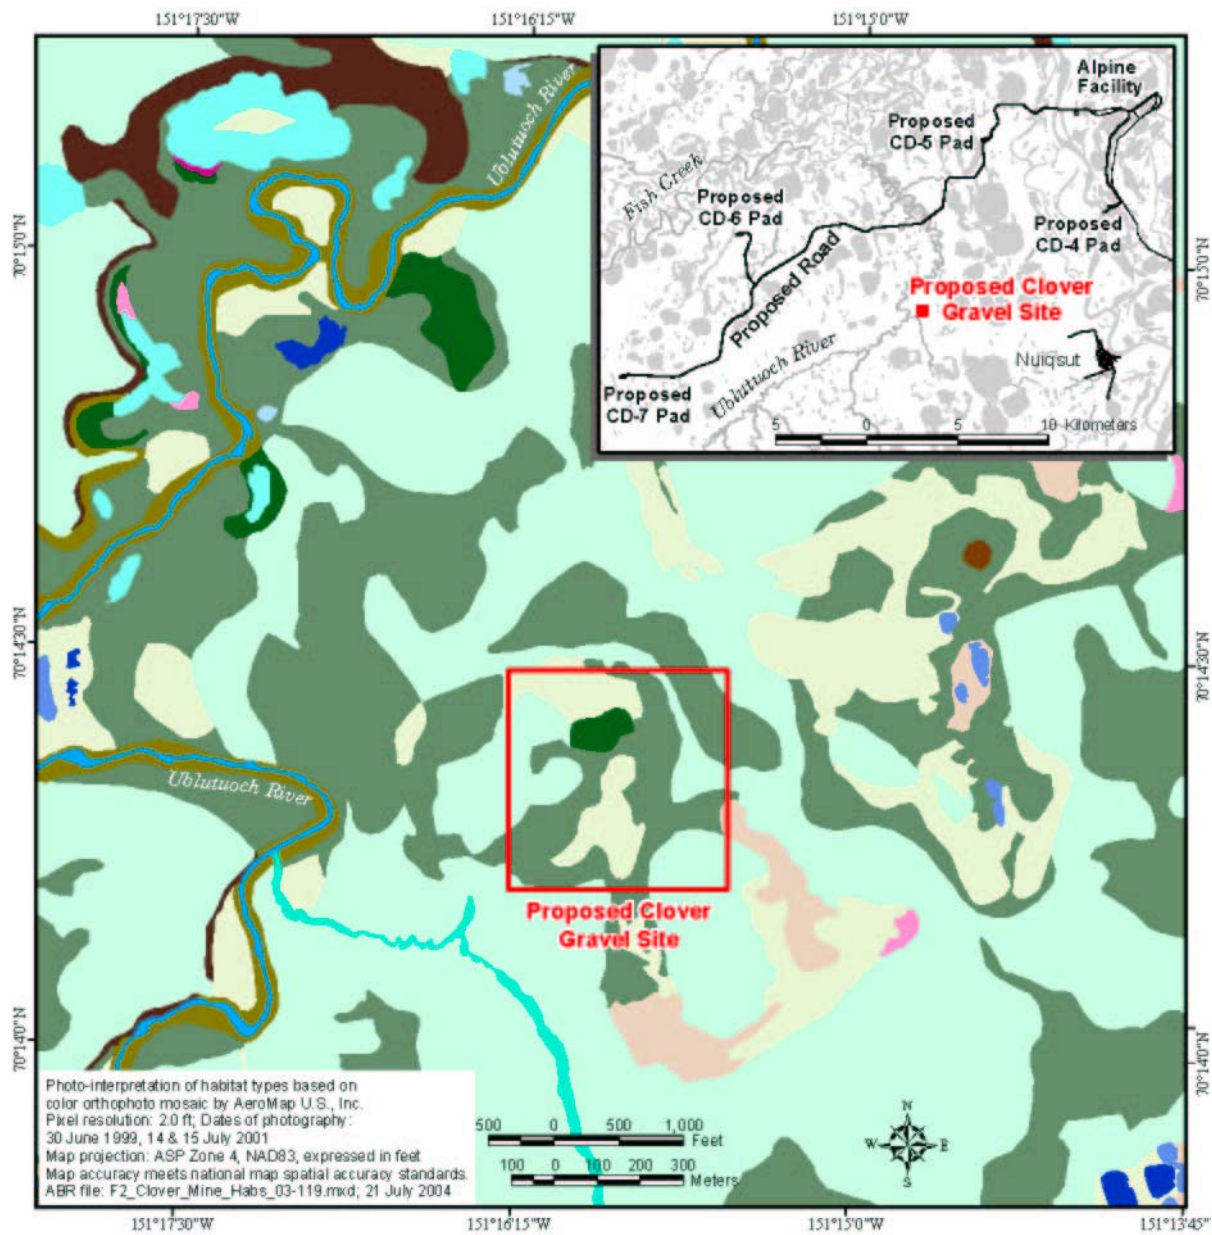
Figure 2.
Wildlife Habitats near
the Proposed Clover
Gravel Site, ASDP Area,
Northern Alaska, 2004.

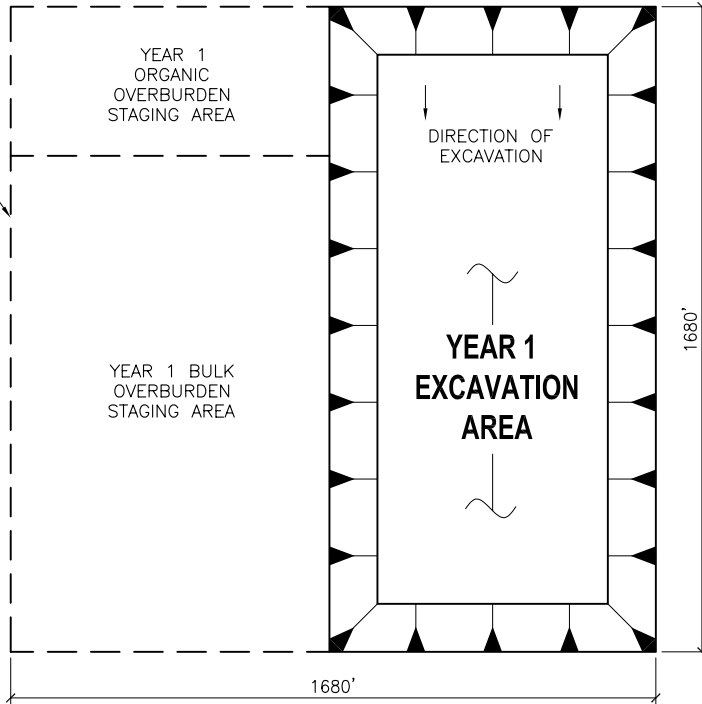
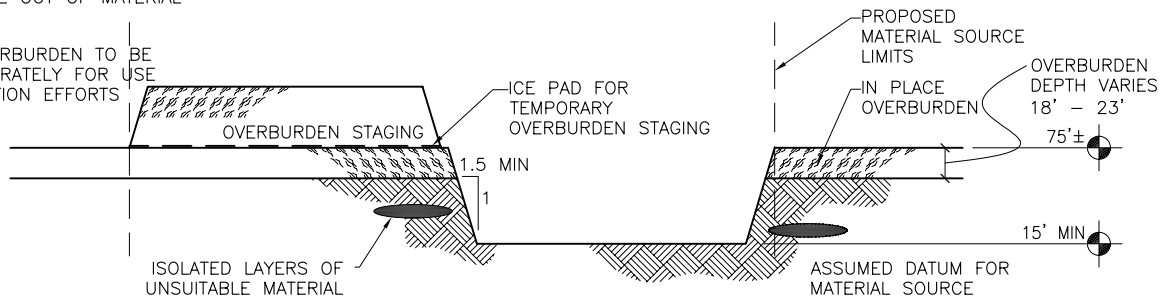
AREA: 00 MODULE: XXXX UNIT: R1
ALPINE SATELLITE DEVELOPMENT PROGRAM
CLOVER A GRAVEL SOURCE, DRAWING 1 OF 3
YEAR 1

PROPOSED MATERIAL SOURCE LIMITS

PLAN

SECTION

Materials unsuitable for road or pad construction will remain within the proposed material source boundaries and will be used in rehabilitating the mine site once mining is complete. Construction activities are currently scheduled for two winter construction seasons, not necessarily concurrent (Appendix Figures 1 and 2). An exposed working face will remain open after the first year’s mining efforts. The site will be accessed using seasonal ice roads.

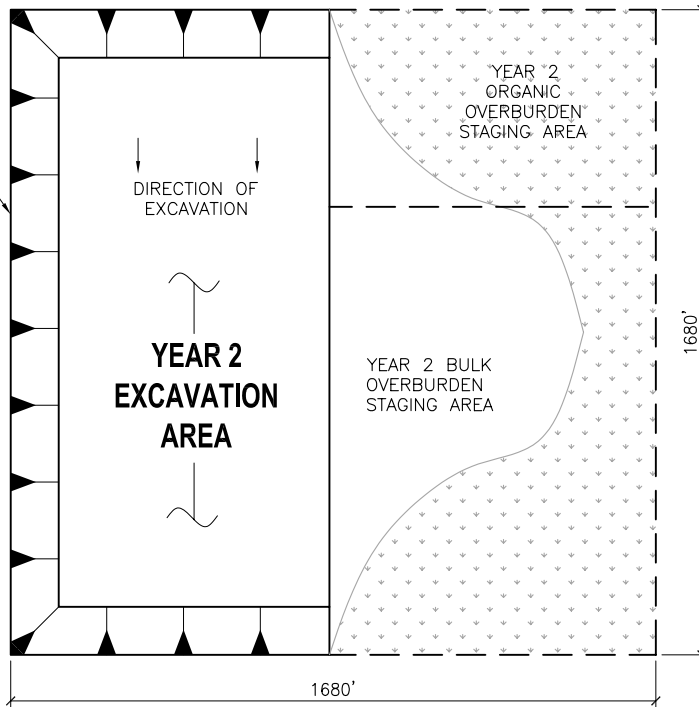
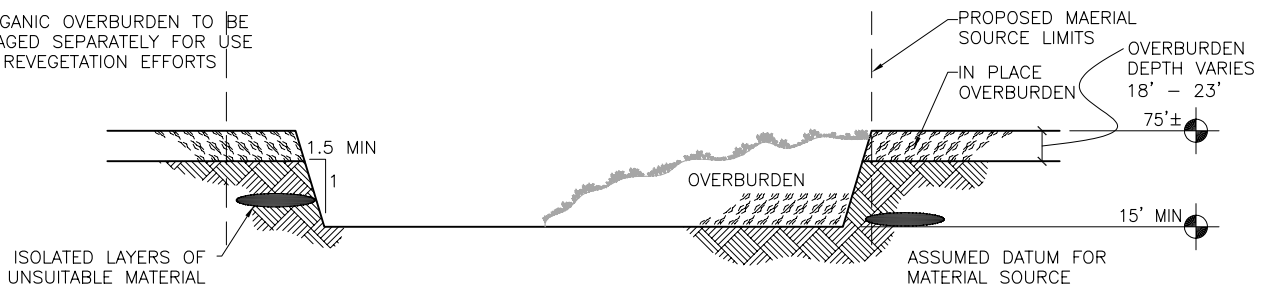
AREA: 00 MODULE: XXXX UNIT: R1
ALPINE SATELLITE DEVELOPMENT PROGRAM
CLOVER A GRAVEL SOURCE, DRAWING 2 OF 3
YEAR 2

PROPOSED MATERIAL SOURCE EXCAVATION LIMITS

PLAN

SECTION

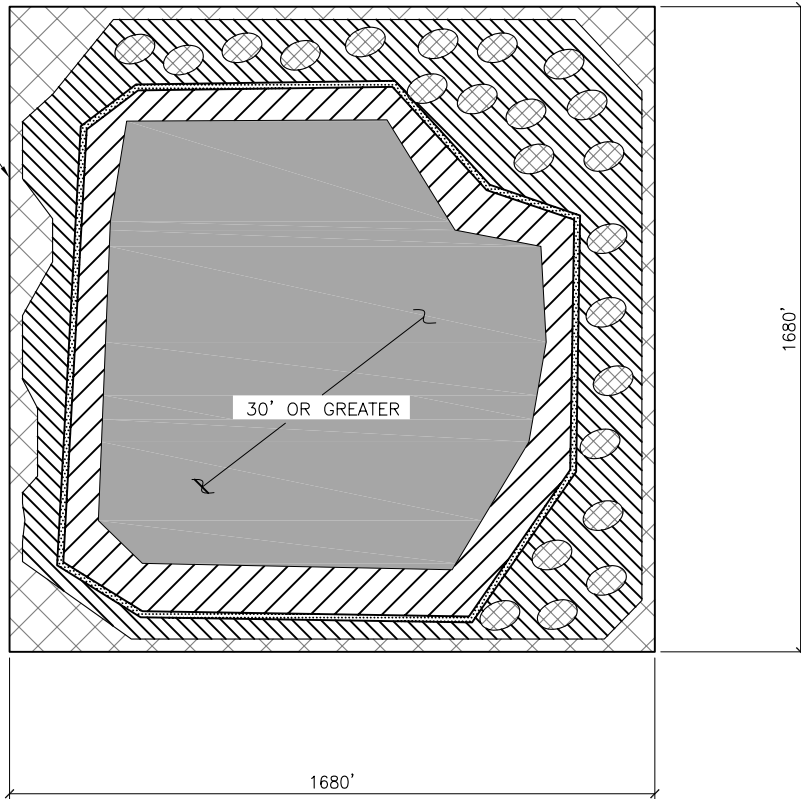
MATERIAL SOURCE LIMITS

PLAN
