## Ombudsman Report

# Ombudsman Review of the Marjol Battery Site, Throop, Pennsylvania

Report No. 2004-P-00017

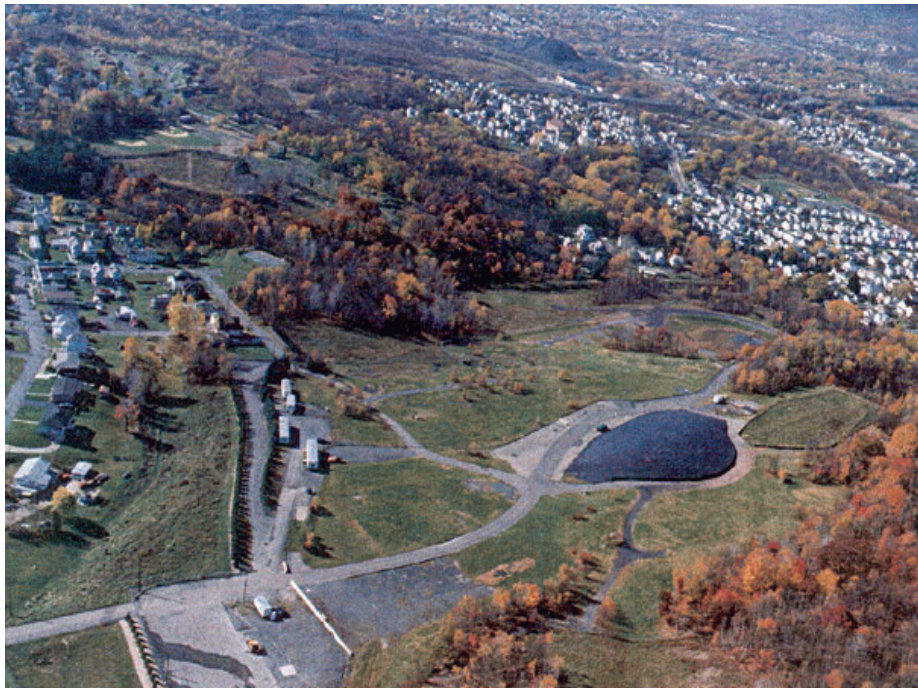
**Cover photo:** Aerial view of the Marjol Battery Site, courtesy of EPA Region 3.
