Appendix IV. Risks Associated with Conventional Uranium Milling Operations

Background

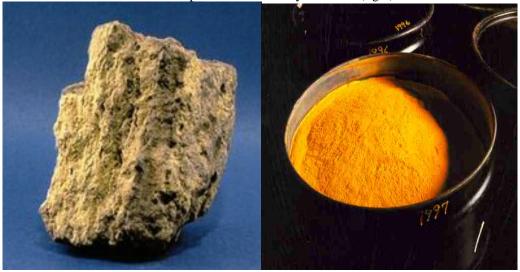
Figure AIV-1. Raw Uranium Ore and Yellowcake Product

This figure shows the incoming raw uranium ore as it enters the uranium milling process (left), as well as the final product of uranium yellowcake (right)

Uranium milling is the process of converting raw ore as it arrives from mining operations into a product known as uranium yellowcake. The raw uranium ore and resultant yellowcake are shown in Figure AVI-1, and a generalized schematic of a typical milling process is shown in Figure AVI-2.

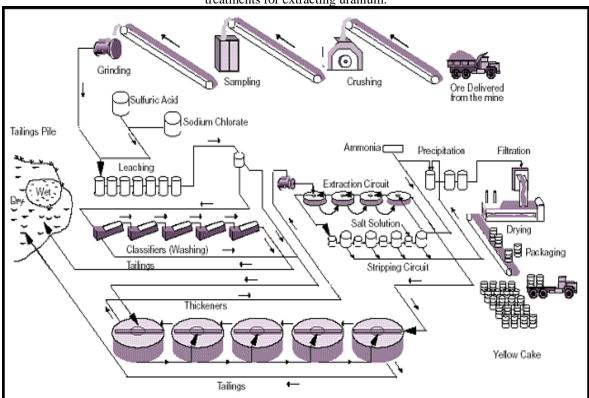
Figure AIV-2. Generalized Uranium Mill Physical Layout

This figure shows how a uranium mill is physically set up to crush raw ore into particles amenable to chemical treatments for extracting uranium.

After the leaching stage, the pregnant lixiviant generally contains about 50-60% solids. These solids, called "tailings," are filtered out and sent to on-site tailings piles or impoundments in the form of sands and slimes. Once most of the solids have been removed, the filtered lixiviant is transferred to an extraction circuit where the desired uranium is stripped from the pregnant lixiviant, followed by a precipitation and drying process, which produces the desired yellowcake product.

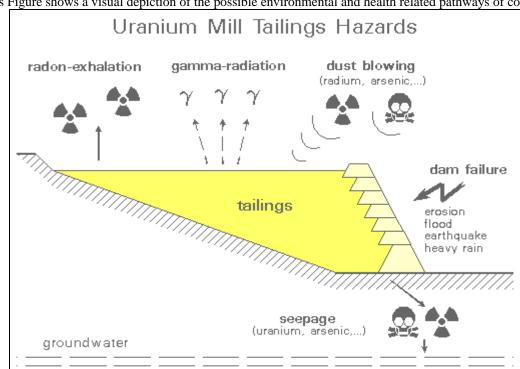
Figure AIV-3: On-Site Accident and Risk Scenarios Associated with Uranium Mill Tailings
This Figure shows a visual depiction of the possible environmental and health related pathways of concern

The five on-site environmental pathways through which these tailings impoundments pose a risk are represented schematically in Figure AVI-3. In addition to the on-site scenarios, tailings have also been taken off-site and used as an inexpensive building material by some local populations. Each of these hazard pathways is listed below and the associated risks are discussed later.

- (i) The release of gaseous radon-222 to the atmosphere and subsequent inhalation
- (ii) Possible dust loading of contaminants from the impoundment due to natural wind conditions
- (iii) The localized effect of direct external gamma radiation exposure from the tailings impoundment
- (iv) Ground seepage and subsequent contamination of local aquifers, which has the potential to affect the water supply
- (v) Dam failure due to erosion or natural disasters (flood, earthquake, etc.)
- (vi) Improper use of tailings as a building material
