Detectable Warnings: Synthesis of U.S. and International Practice

Accessible Design for the Blind

12 May 2000

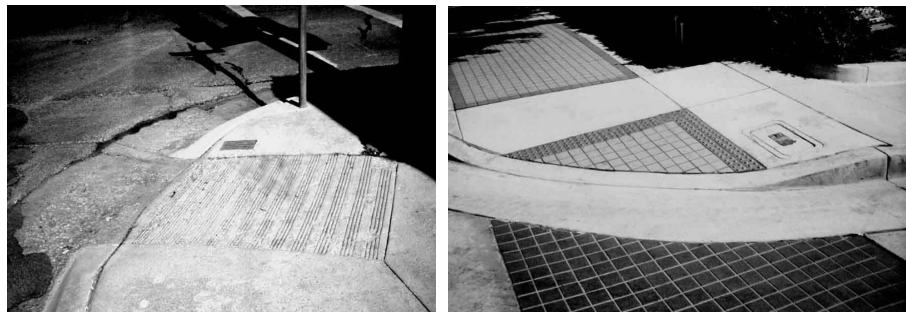
FIG. 1-4. (LEFT) CURB RAMP WITH A MINIMALLY DETECTABLE GROOVED SURFACE IN PHOENIX. FIG. 1-5 (RIGHT) A CURB RAMP WITH A NARROW BORDER OF DETECTABLE WARNING PAVERS AT THE SIDES AND SMOOTH PAVERS IN THE MIDDLE. BLIND PEDESTRIANS COULD EASILY MISS THE NARROW BORDER OF DETECTABLE WARNING PAVERS.

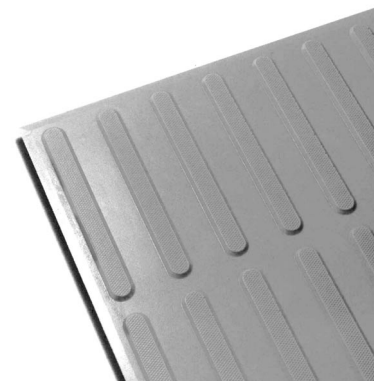
FIG. 1-7. DIRECTIONAL TACTILE TILE (DETECTABLE WARNING SYSTEMS)

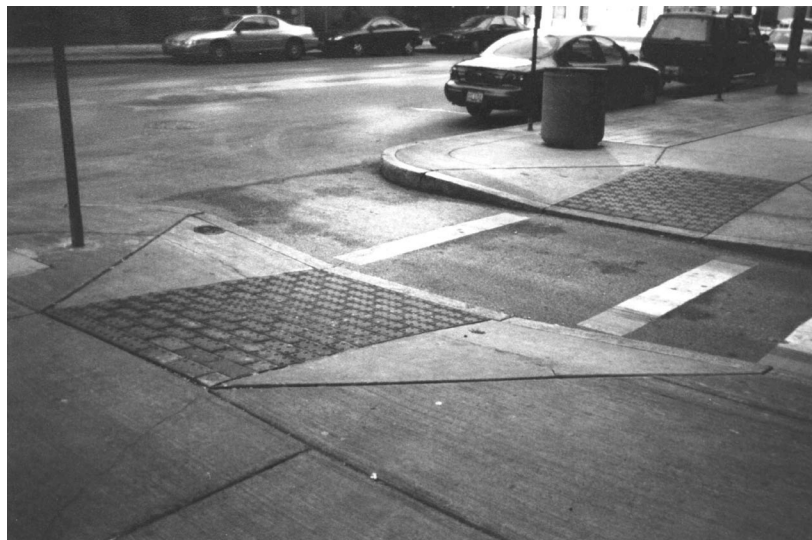
FIG. 1-8. CURB-RAMPS WITH TRUNCATED DOME DETECTABLE WARNINGS ON OPPOSITE SIDES OF AN ALLEY, CLEVELAND, OH.

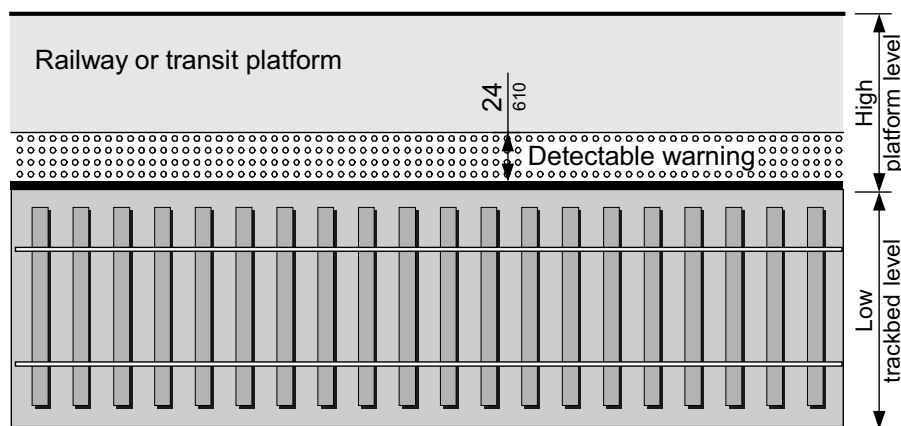
FIG. 2-3. DETECTABLE WARNING USED AT PLATFORM EDGE BORDERING A DROP-OFF.

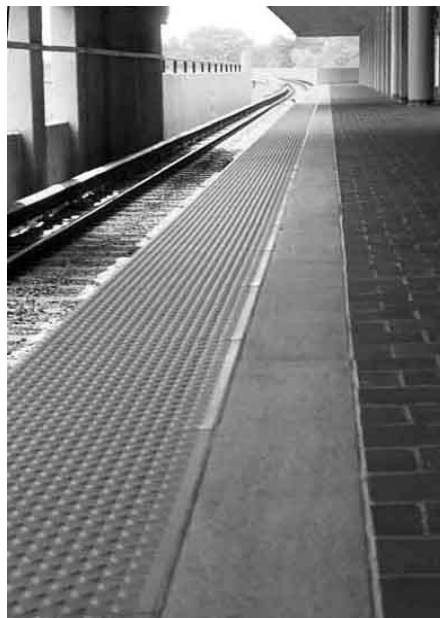
FIG. 2-4. DETECTABLE WARNING SURFACE AT MARTA STATION, ATLANTA, GA.

Also contributing to the rationale for ADAAG specifications regarding both width and placement of detectable warnings on transit platform edges was a decrease in accidents for all riders on BART (McGean, 1991) and Metro Dade (A. Hartkorn, Metro Dade Safety Manager, personal communication, 1994) in the years following installation of 24 in wide detectable warnings at platform edges in those systems.

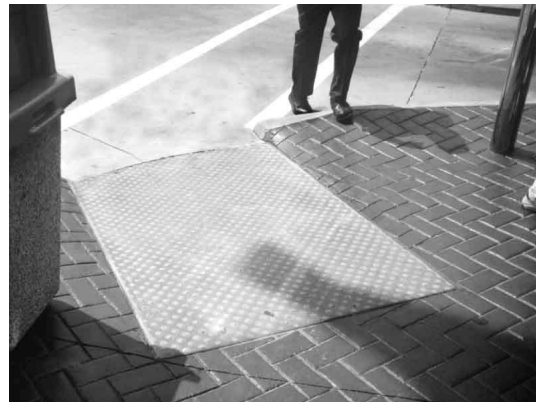
FIG. 2-5. FLORIDA CURB RAMP COMPLYING WITH ADAAG 4.7.7.

A curb ramp shall have a detectable warning complying with [ADAAG] 4.29.2. The detectable warning shall extend the full width and depth of the curb ramp.

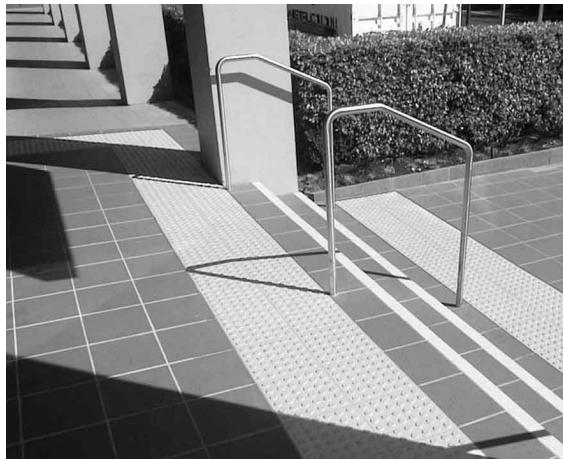
FIG.3-5. DETECTABLE WARNING AT TOP & BOTTOM OF STAIRS, EXTERIOR USE IN AUSTRALIA.

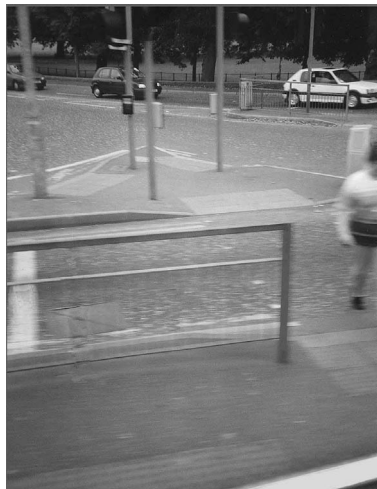
FIG. 3-6. (LEFT) DETECTABLE WARNINGS (BLISTER SURFACE) ON THE THREE CURB-RAMPS AT A SPLITTER ISLAND, IRELAND

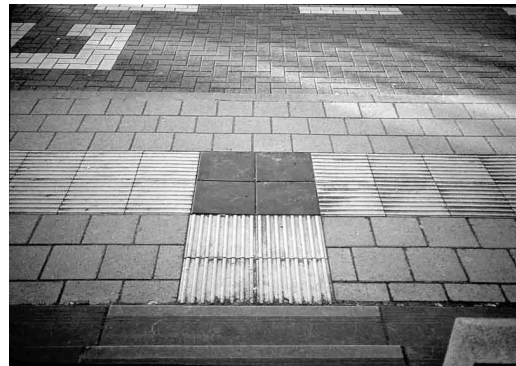
FIG. 3-7. (RIGHT) TACTILE GROUND SURFACE INDICATORS LEADING AWAY FROM STAIRS, LOUVAIN, BELGIUM.

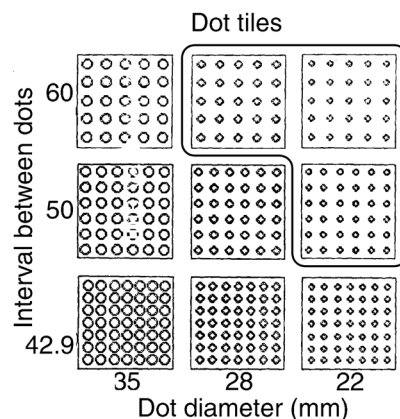
FIG. 4-3. JAPANESE RESEARCH VARIED THE SIZE OF TRUNCATED DOMES (DOT DIAMETER) AND THE SPACING INTERVAL BETWEEN DOMES (DOTS).

OF THE NINE DETECTABLE WARNING TEST SURFACES, THREE (SHOWN ENCLOSED BY THE LINE) WERE IDENTIFIED AS DOT (VERSUS BAR) TILES ON AT LEAST 90% OF TRIALS.

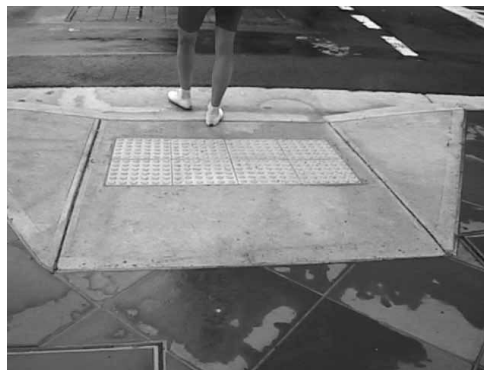
FIG. 4-5. (LEFT)
AUSTRALIAN CURB RAMP
WITH DETECTABLE
WARNING.

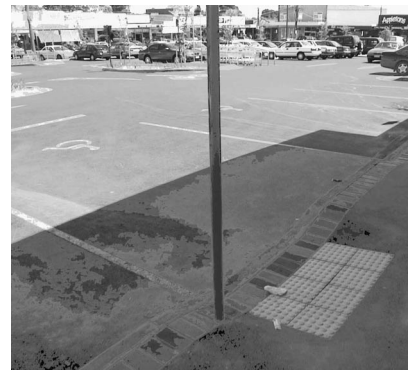
FIG. 4.6. (RIGHT)
CURB RAMP LEADING TO
HANDICAPPED PARKING
SPACE, AUSTRALIA.

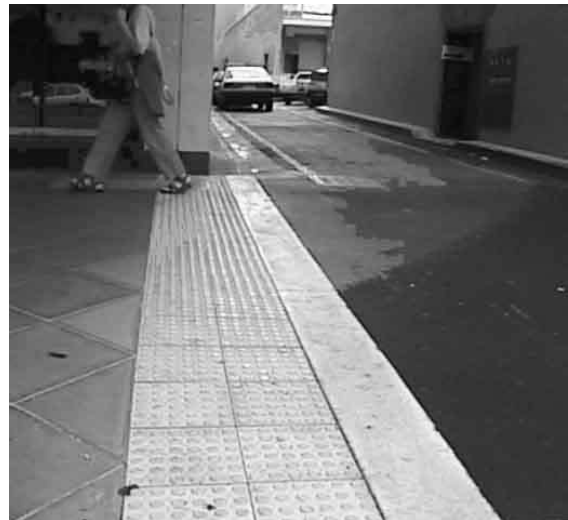
FIG. 4-7. DETECTABLE WARNING SURFACE ACROSS FULL WIDTH OF SIDEWALK AT AN ALLEYWAY (HAZARDOUS VEHICULAR WAY) IN AUSTRALIA.

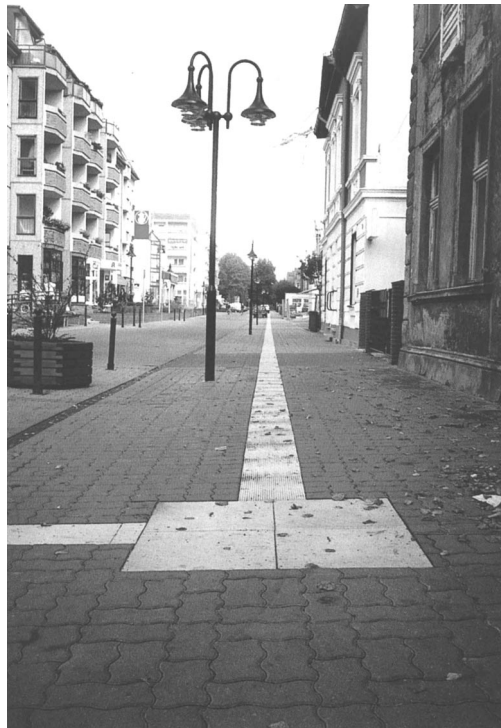
FIG. 4-12. GERMAN TGSi PATH DOWN A SIDEWALK AND TO A CROSSWALK.

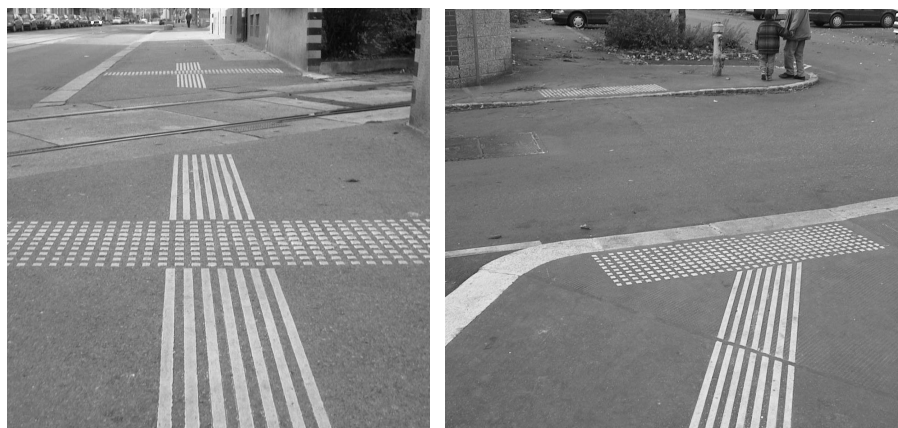
FIG. 4-13. (LEFT) A LINEAR DIRECTIONAL SURFACE LEADS TO AND BEYOND A LEVEL RAIL CROSSING. A DETECTABLE WARNING SURFACE EXTENDS FROM BUILDING TO CURB LINE ON BOTH SIDES OF TRACKS, VIENNA, AUSTRIA.

FIG. 4-14. (RIGHT) A LINEAR DIRECTIONAL SURFACE LEADS TO A DETECTABLE WARNING SURFACE AT A CURB, VIENNA, AUSTRIA.

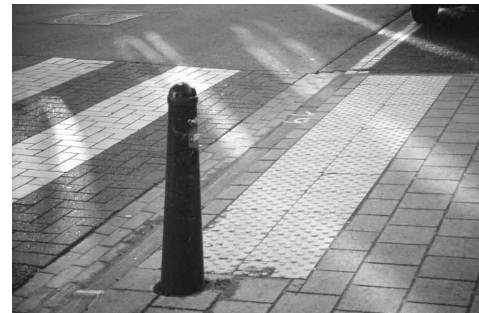
The product currently recommended is a metal plate that has been pre-formed with blisters, glued on 30 x 30 cm concrete, then coated with a gritty white or yellow epoxy layer.

FIG. 4-15. DETECTABLE WARNING PAVERS AT A BLENDED CURB.

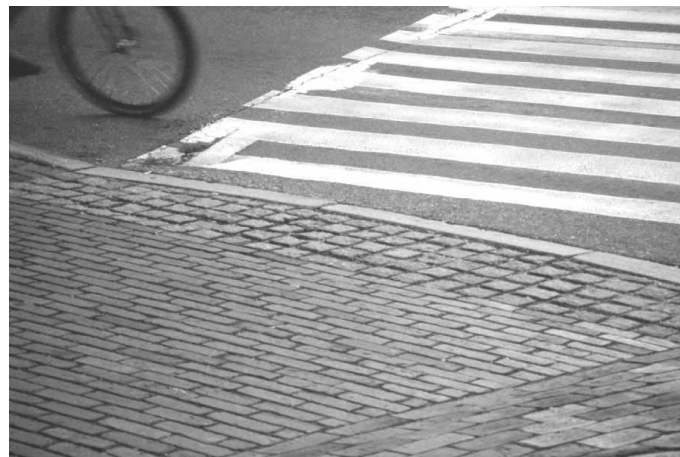
FIG. 5-1.
A MINIMALLY DETECT-
ABLE WARNING SURFACE
IN PORTLAND, ME.

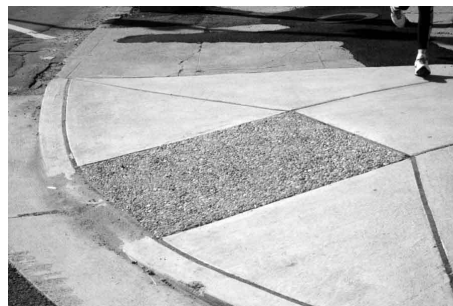
FIG. 5-2. CURB RAMP EXPOSED AGGREGATE SURFACE IN VIRGINIA. PEDESTRIANS WHO ARE BLIND DO NOT RELIABLY DETECT EXPOSED AGGREGATE CONCRETE.

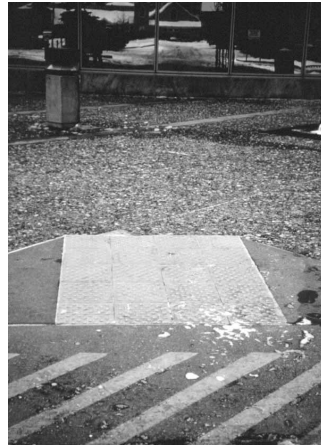
FIG. 5-3. (LEFT)
CURB RAMP IN
ANCHORAGE, AK.

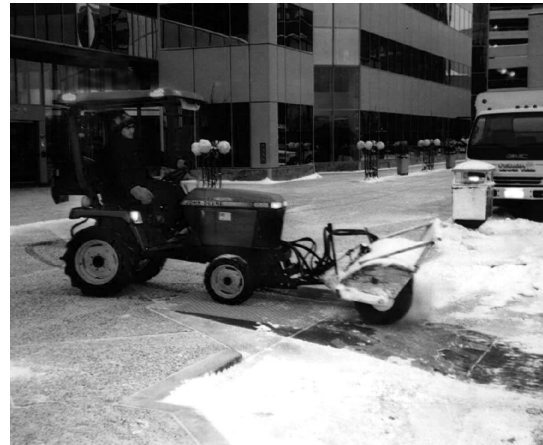
FIG. 5-4. (RIGHT)
CURB RAMP IN
ANCHORAGE, AK
SHOWING SNOW
REMOVAL WITH A
BRUSH.

- A detectable warning, thought to be Pathfinder Tile, was installed before 1996 in Fairbanks, AK, and it is still in good condition. It is across a driveway and subject to extreme cold, regular plowing, and some traffic by heavy vehicles. On a similar detectable warning installed in Anchorage, Alaska, snow is regularly removed with the same brush used for sidewalk snow removal (see Fig. 5-4).

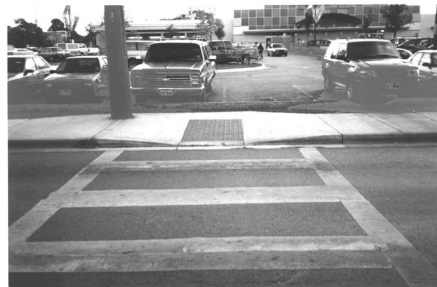
FIG. 5-6. MID-BLOCK CROSSING WITH CURB RAMP, AUSTIN.

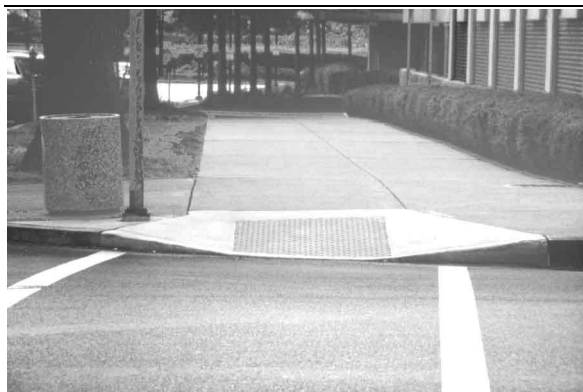
FIG. 5-11. BRICK
DETECTABLE WARNING
SURFACE CONTRASTS
WITH ADJACENT
CONCRETE,
HARRISBURG, PA.

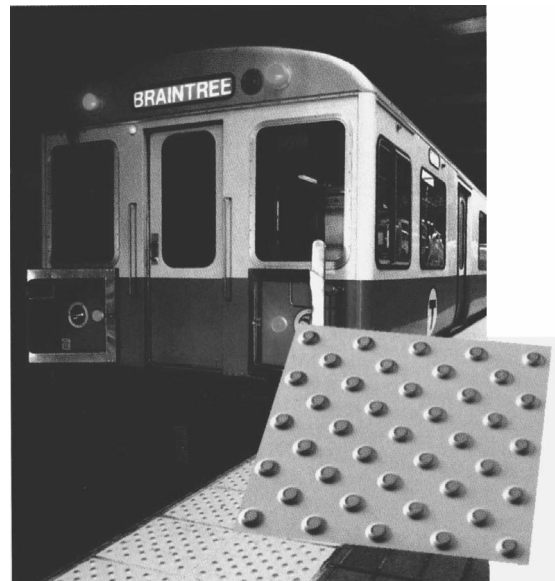
FIG. 5-12. MBTA STATION WITH DETECTABLE WARNING TILE (SUMMITVILLE).

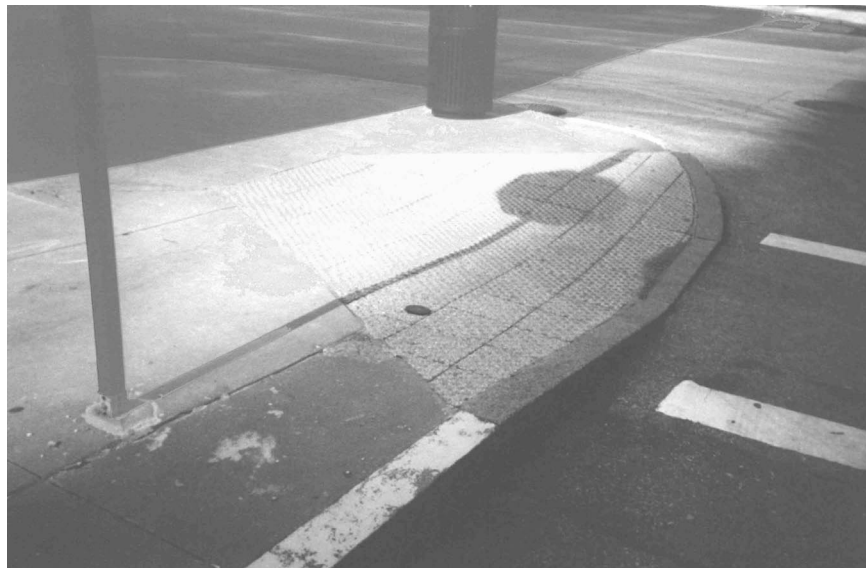
FIG. 5-13. TRUNCATED
DOME PAVERS CUT AND
FITTED TO THE ENTIRE
SURFACE OF A PERPEN-
DICULAR CURB RAMP,
INCLUDING FLARES,
CLEVELAND, OH.

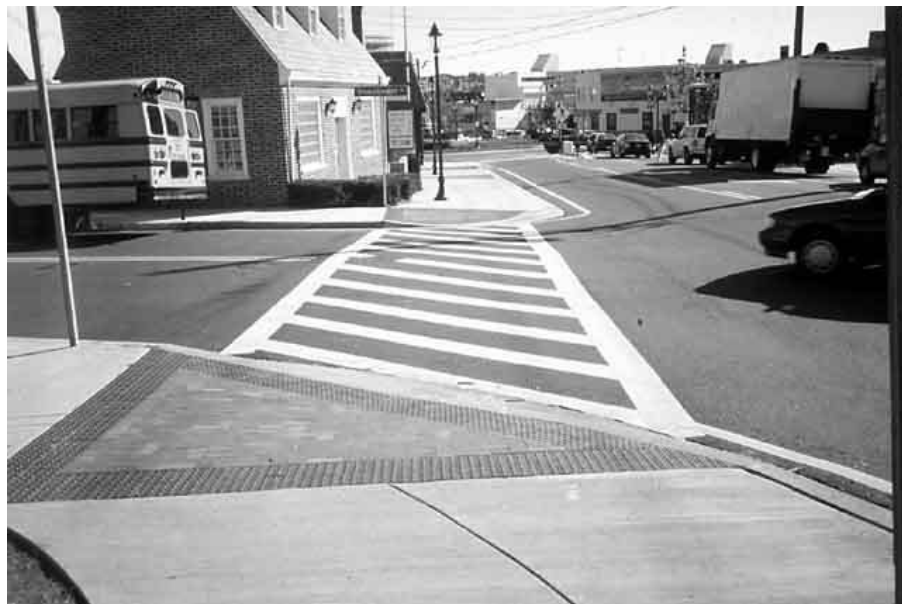
FIG. 5-14. A BAND OF DETECTABLE WARNING PAVERS OUTLINES THE TRIANGULAR SHAPE OF THIS CURB RAMP IN TOWSON, MD.

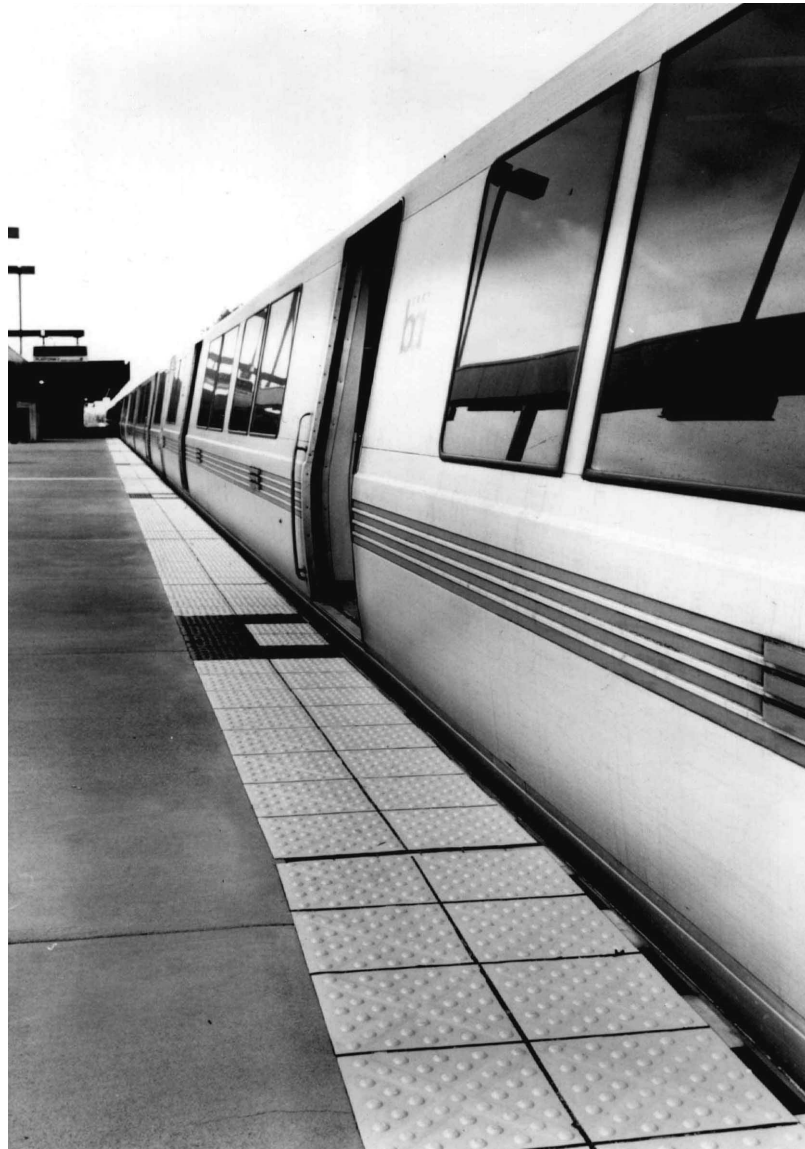
Armor-Tile installations are attached with adhesives and mechanical fasteners. Two types of Armor-Tile materials have been used. One is flat (1/2 in) tile, attached in a recessed fashion to the platform surface. In a few stations, a 3 in thick Armor-Tile product has been used. This tile replaced the concrete on the platform edge; it was used where there were problems with the concrete of the platform.

FIG. 5-15.
DETECTABLE WARNING
SURFACE AT A BART
STATION, CALIFORNIA.

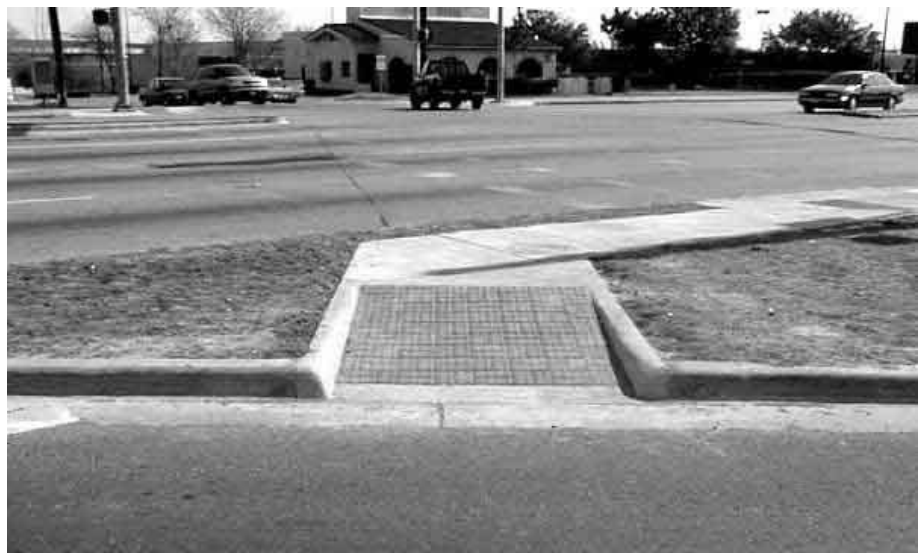
FIG. 6-2. SPLITTER ISLAND WITH DETECTABLE WARNING ON FULL SURFACE OF CURB RAMP, AUSTIN, TX.

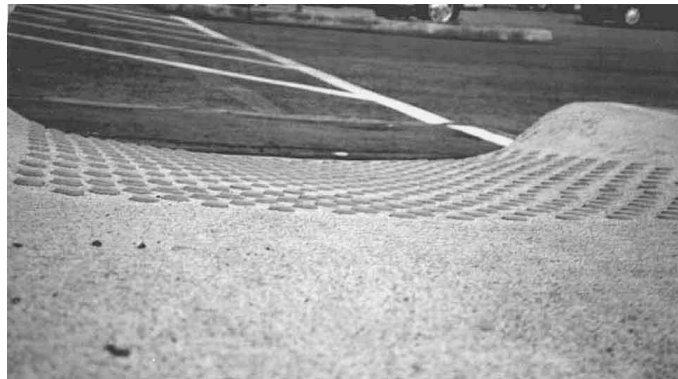
FIG. 7-12.
SURFACE-APPLIED
TRUNCATED DOMES
SHOWN CONFORMING TO
IRREGULAR SURFACE
(VANGUARD / TILCO).

The domes of the Vanguard product (Tilco) may be applied to a surface as shown in Fig. 7-12. The underlying surface is not otherwise coated in this installation. Vanguard also offers a concrete micro-coating system which can be applied to the domes and immediately surrounding surface. This coating provides a high level of visual contrast in white or safety yellow.

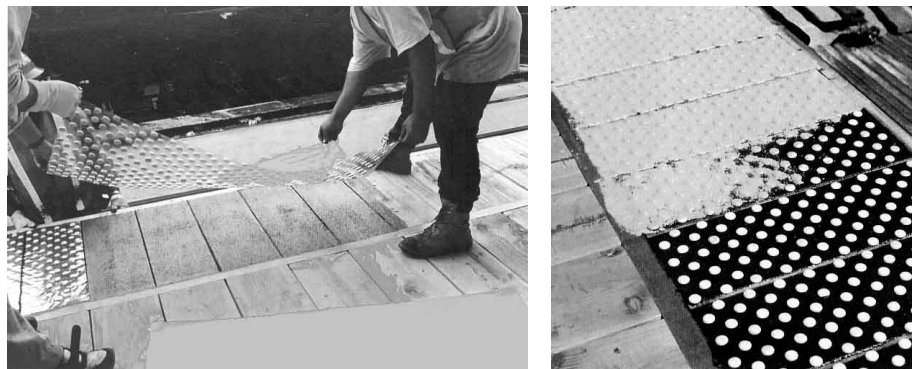
FIG. 7-13. (LEFT)
TRUNCATED DOMES ARE
ARRAYED ON A CARRIER
SHEET (COTE-L).

FIG. 7-14. (RIGHT)
DOMES SHOWN
ADHERED TO PLATFORM
SURFACE. A SAFETY
YELLOW POLYURE-
THANE COATING IS BEING
APPLIED (COTE-L)

In one product application (COTE-L), a polyurethane coating is applied to the underlying surface. The coating includes rubber granules that give increased friction and resilience. Rubber truncated domes, which come attached to a carrier sheet, are pressed on top of the fresh polyurethane coating. The plastic carrier sheet is peeled off, and three additional coats of polyurethane coating are applied.

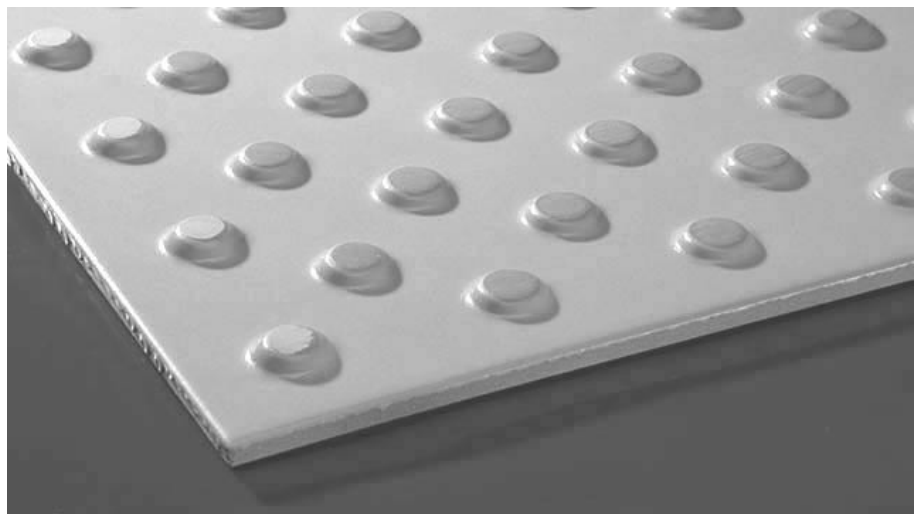
FIG. 7-19.
**SUMMITVILLE
TILES, INC.**
TACTILE-TREAD
CERAMIC TILE.

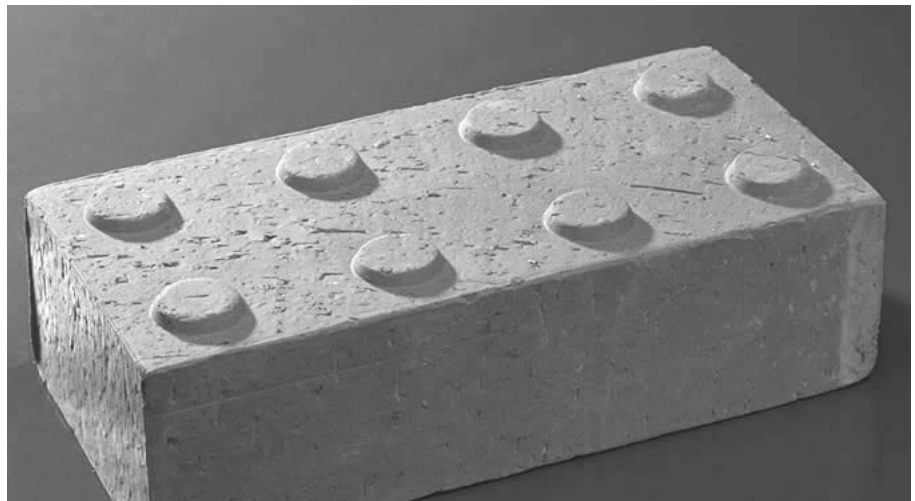
FIG. 7-21.
**ENDICOTT CLAY
PRODUCTS CO.**
HANDICAP DETECTABLE
WARNING PAVER.

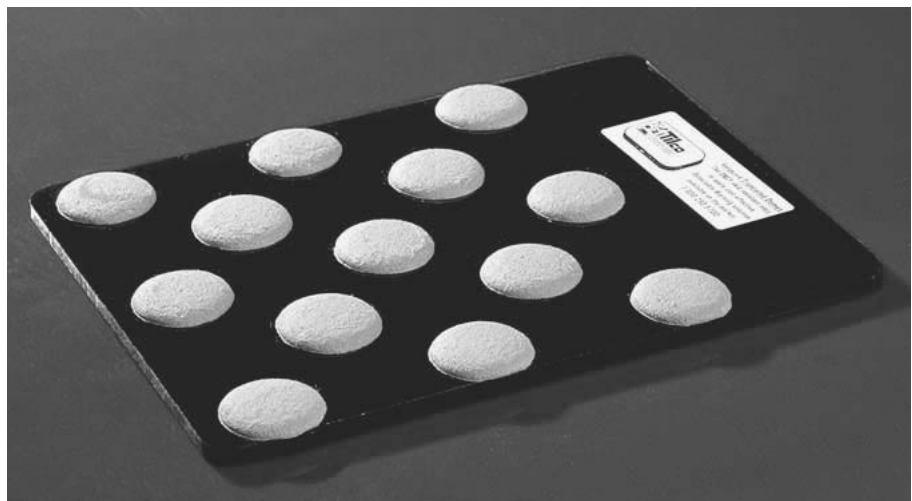
FIG. 7-28.
**VANGUARD ADA
PRODUCTS OF AMERICA,
TILCO, INC.**
APPLIED TRUNCATED
DOMES (SHOWN ON
BLACK SHEET ACRYLIC
BACKING FOR SAMPLE
ONLY).

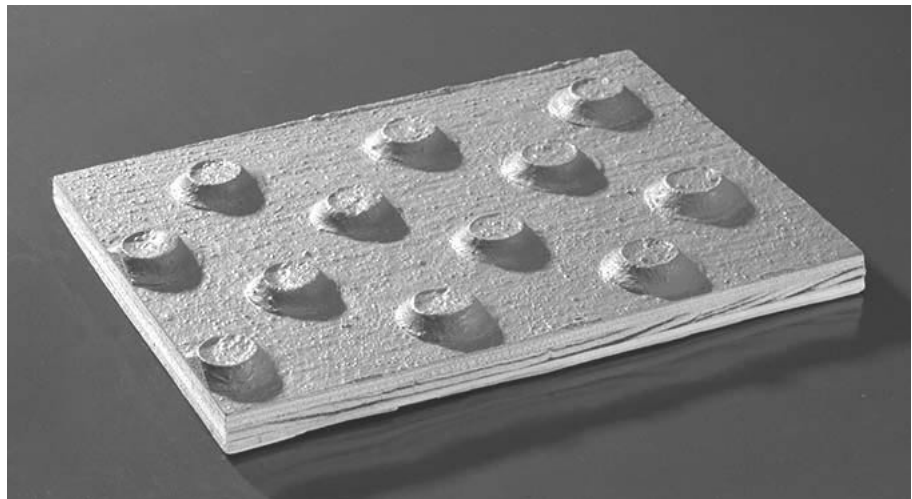
FIG. 7-30.
STRONGWALL
INDUSTRIES, INC.
APPLIED LATEX-
MODIFIED MORTAR
DOMES & TRAFFIC DECK
MEMBRANE SYSTEM
(SHOWN ON PLYWOOD
BACKING FOR
SAMPLE ONLY).
