**FIVE-YEAR REVIEW REPORT  
FOR THE  
DUTCHTOWN TREATMENT PLANT SUPERFUND SITE  
ASCENSION PARISH, LOUISIANA**

**September 2002**

**U.S. ENVIRONMENTAL PROTECTION AGENCY  
1445 Ross Avenue  
Dallas, TX 75202-2733**

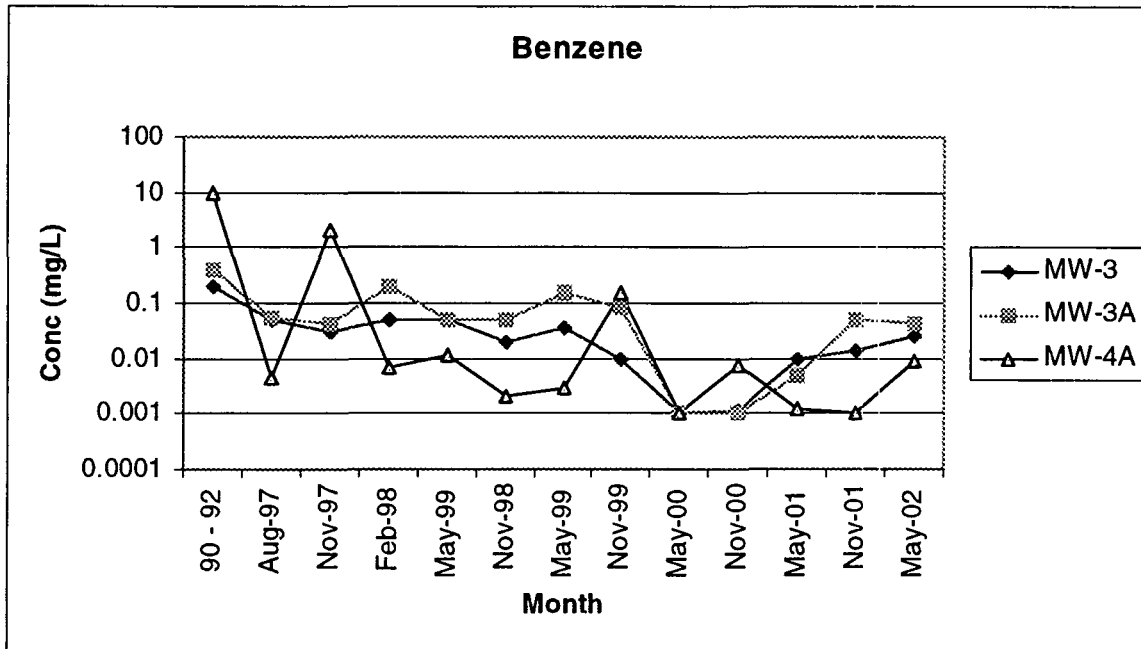
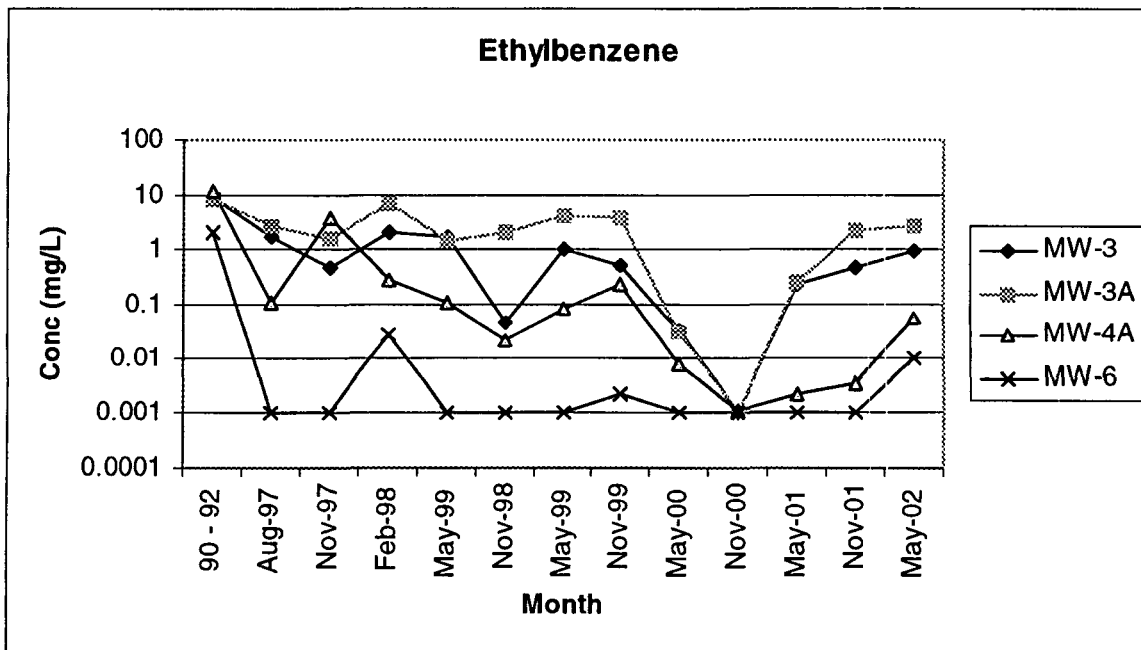
FIGURE 3

CONTAMINANT CONCENTRATION IN GROUND WATER VERSUS TIME

1. Concentrations below the detection limit have been assumed equal to the detection limit
2. Benzene was not detected at MW-6 throughout the monitoring period
