Locomotive Crashworthiness Research: Locomotive Crew Egress Evaluation

1. Report No. DOT/FRA/ORD-02/03		2. Government Accession No.		3. Recipient's Catalog No.	
4. Title and Subtitle Locomotive Crashworthiness Research: Locomotive Crew Egress Evaluation				5. Report Date May 2002

6. Performing Organization Code	
7. Author(s) Stephen J. Kokkins				8. Performing Organization Report No.	
9. Performing Organization Name and Address Foster-Miller, Inc. 350 Second Avenue Waltham, MA 02154-1196				10. Work Unit No. (TRAIS)

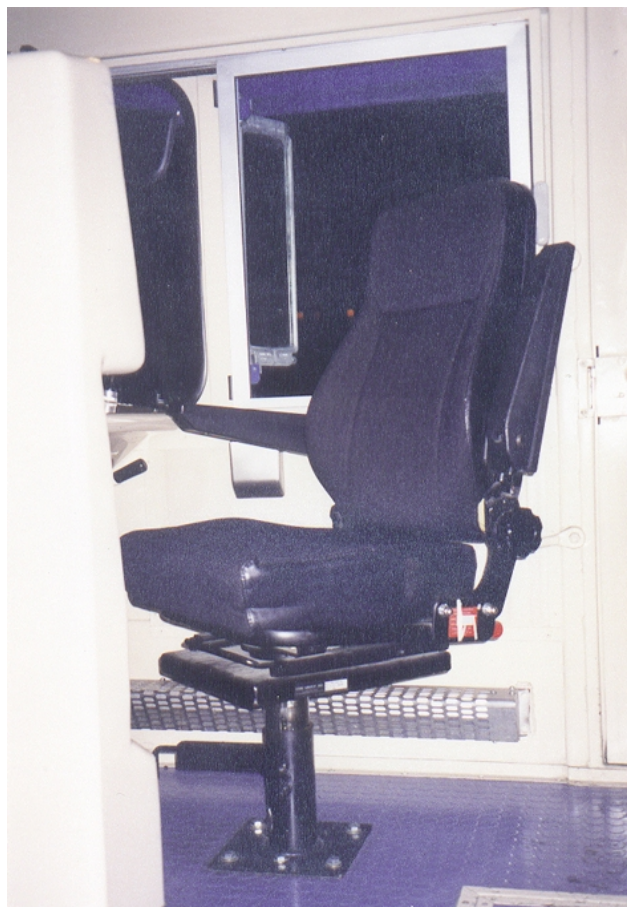
- Cab seats shall be securely mounted and braced and that cab doors shall be equipped with a secure and operable latching device. Section 238.233 further states that seats must be attached to withstand loads of 8-4-4 g’s (longitudinal, lateral and vertical, respectively) (Figures 1, 2).

Figure 1. Cab seat mounting - F59 rebuild

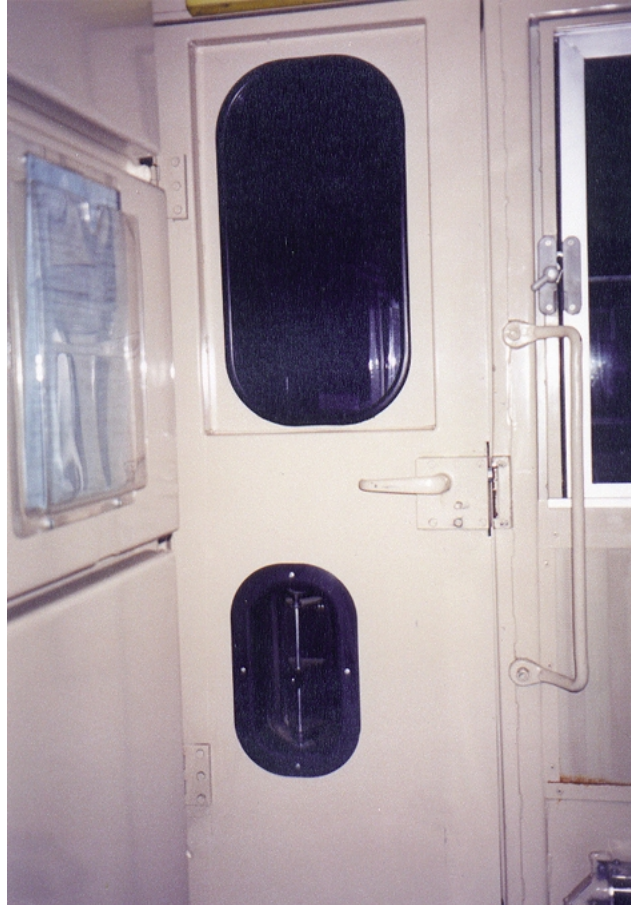
Figure 2. Cab door latching device - F59 rebuild

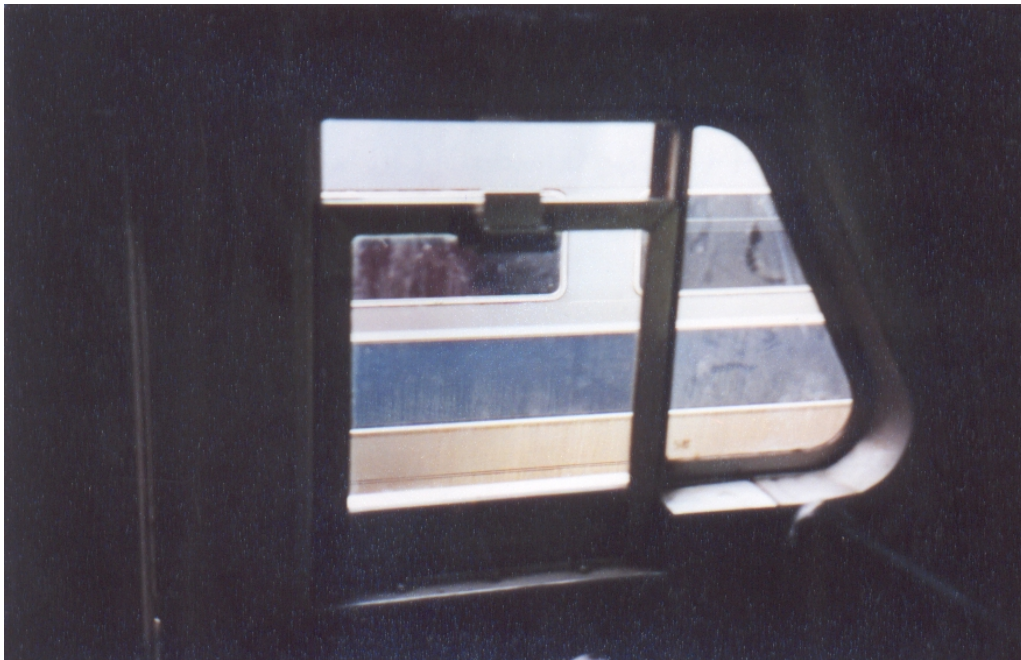
Figure 6. *FL9AC single lever 16 x 18 side window*

Surveys were made of several of Metro North Commuter Railroad's locomotive fleet. Two locomotives, the FL9-M and FL-9-AC (Figures 4, 5) were originally built by GM and remanufactured by Morrison Knudson and ABB, respectively. One interesting variation on this type of locomotive is the operation of the cab side windows, which are opened by pushing down on the handle or handles at the top of the window frame and then sliding down. Figures 6, 7 and 8 illustrate three varieties of rebuilt FL-9 locomotives used on one property with three different side windows.

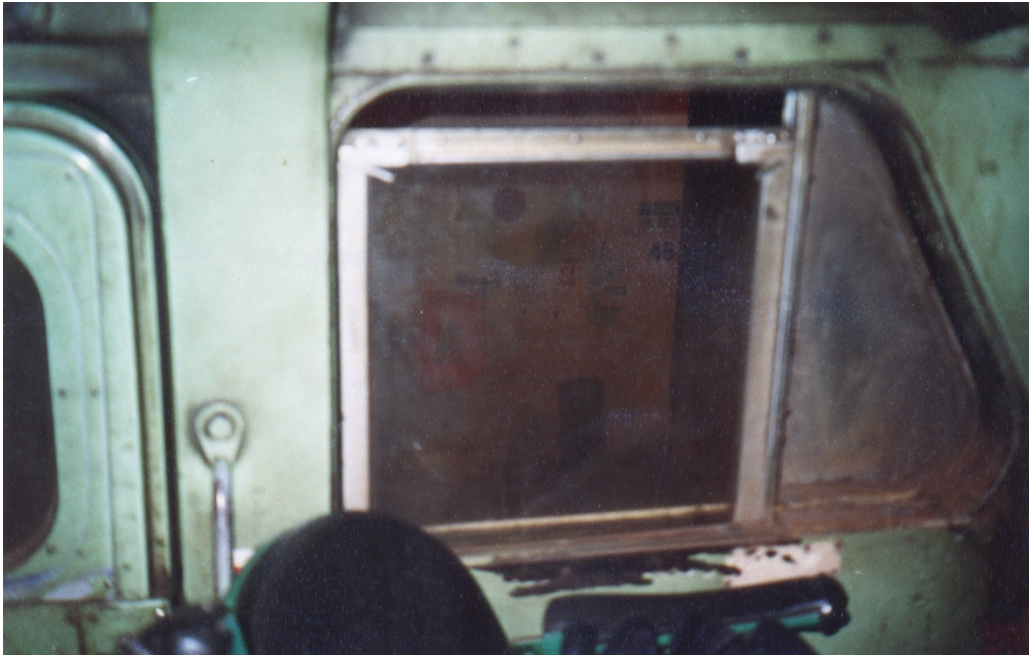
Figure 7. FL9C two lever side window (21 x 22)

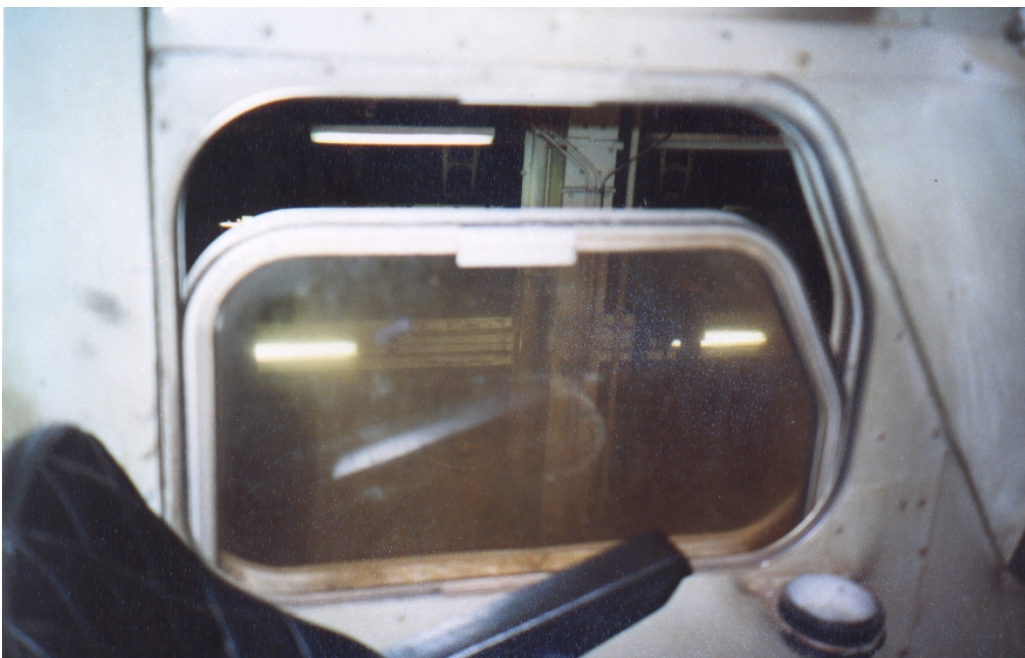
Figure 8. FL9M side window slides up and down (29 x 22)

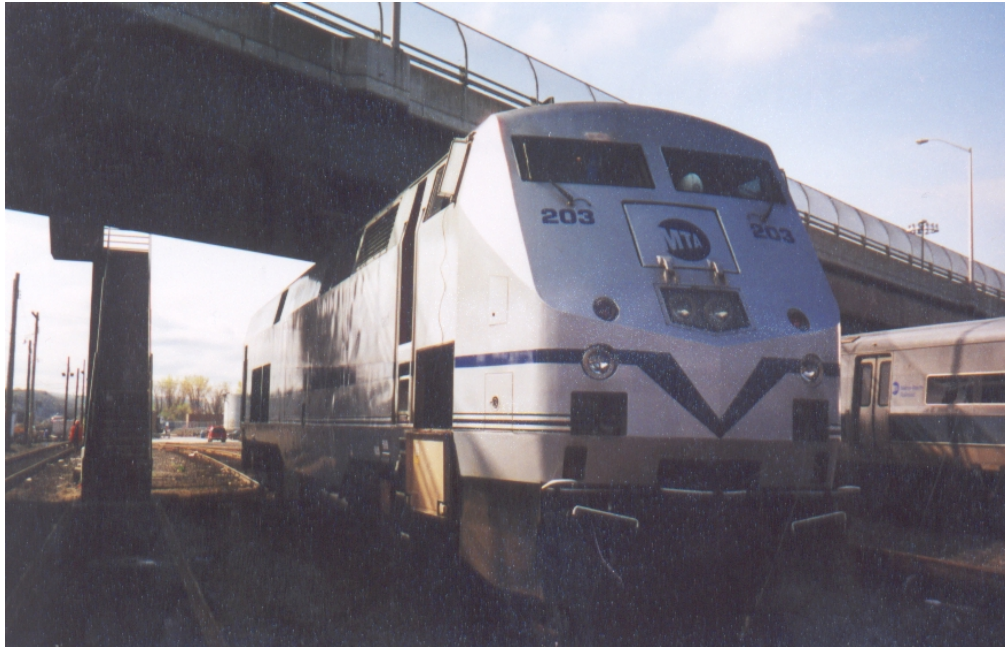
Metro North's P32AC-DM, manufactured by GE has a flat, angled front (Figure 9) with two side doors, and a nose hatch hinged at the bottom edge opening out (Figure 10). Access to the emergency nose hatch, however, is impeded by the location of a refrigerator that would have to be moved in order to exit via this route (Figure 11).

Figure 9. GE P32AC-DM

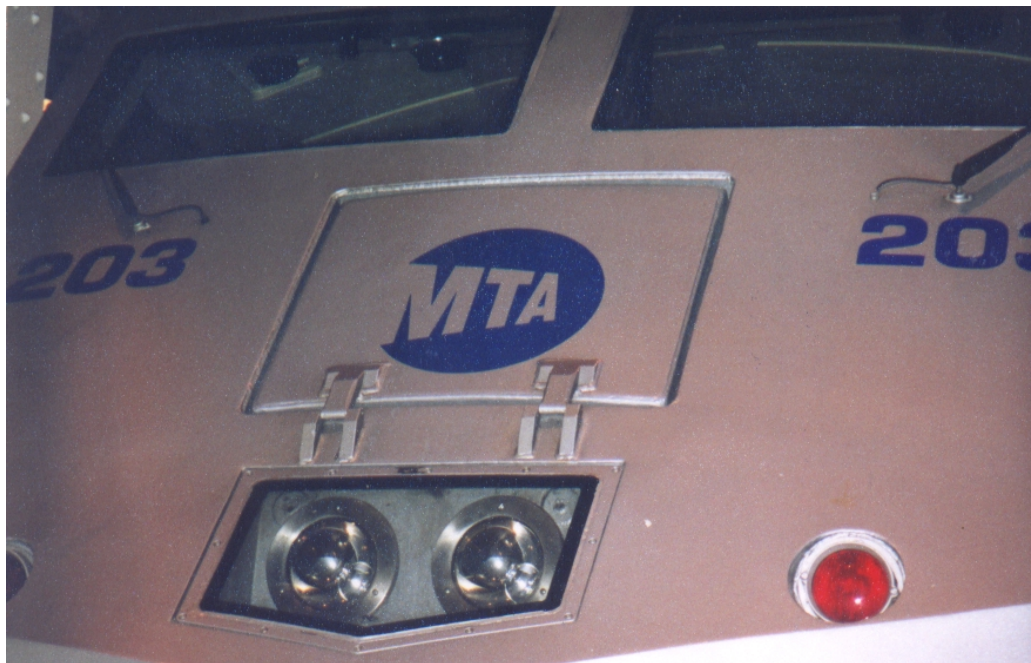
Figure 10. Close-up view of nose hatch

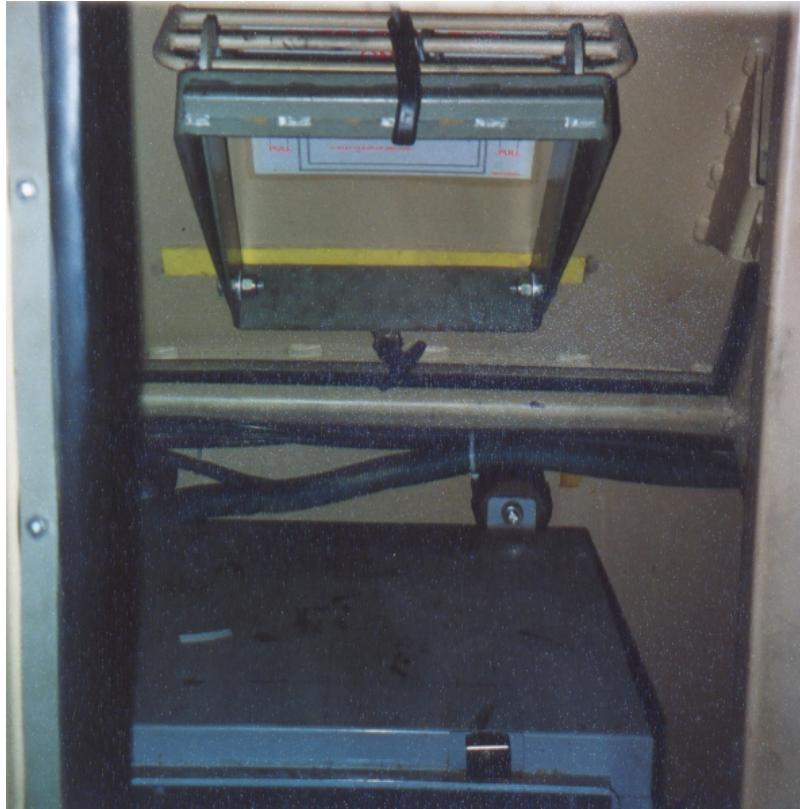
Figure 11. Interior view of nose hatch (refrigeration unit located below)

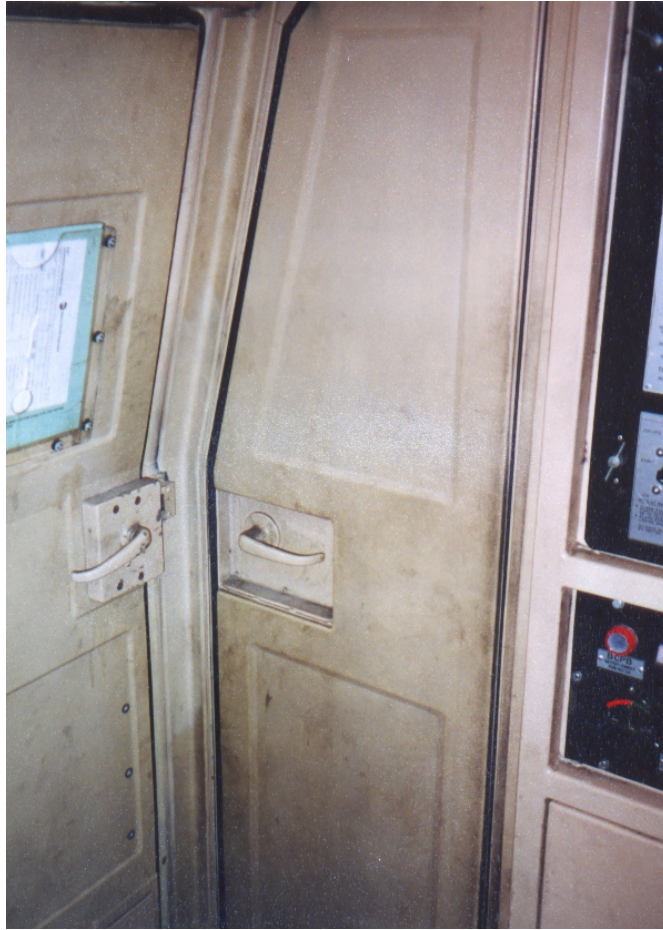
The door to the engine room, located adjacent to the side door on the engineer's side, behind the engineer's seat and the side doors had inconsistent door handle placement, where the side door handles are located to the right, while the engine room door handle is located to the left. Also, both doors open differently, the side door by pulling towards you to open (into the cab occupied space) while the engine room door opens by pushing outward (into the engine room) (see Figure 12).

This arrangement comes about because doors (or any other hardware) cannot open outward into the section envelope; therefore side doors open inward. But, the adjacent engine room door would then interfere if it also opened inward, so it opens outward into the engine room.

Figure 12. *Side cab entry/exit door on left of photo: handle on right side of door, pull open into cab. Engine room door on right: handle (recessed) on left side of door, push to open into engine room*

However, with the hinging direction on the right hand exit door, it could block the engine room opening if it were open (into the cab).

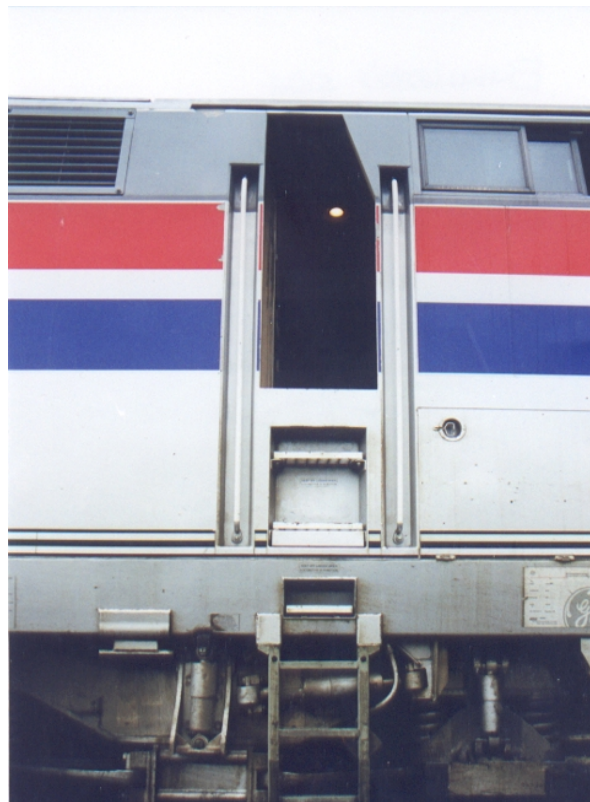
- On the sides of the locomotive with ladder-like steps (Figure 14)
- At the nose of the locomotive and behind the engineer's seat (Figures 15, 16), or

Figure 14. GE Genesis P42 side view

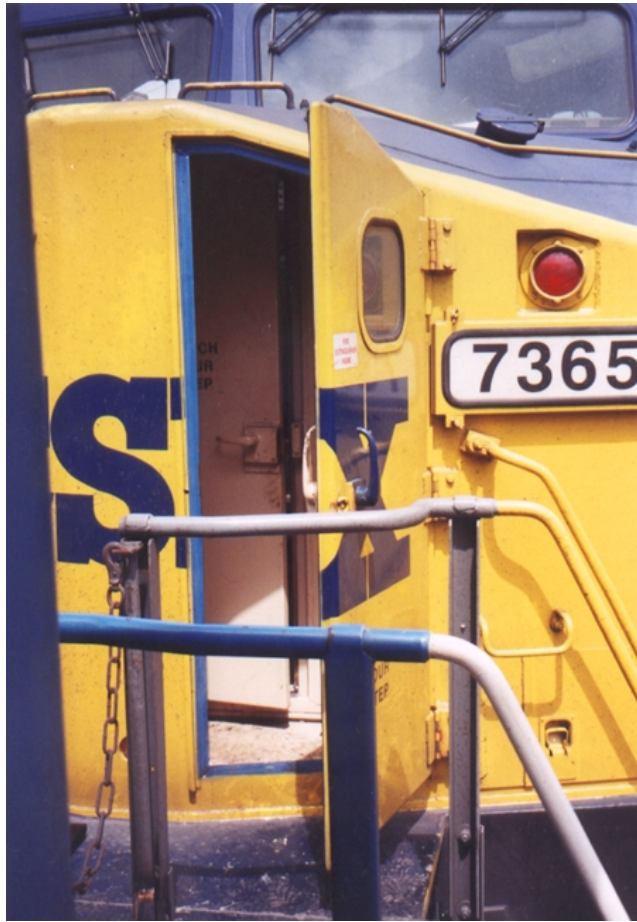
Figure 15. SD 70 MAC nose door to platform, stairs on either side

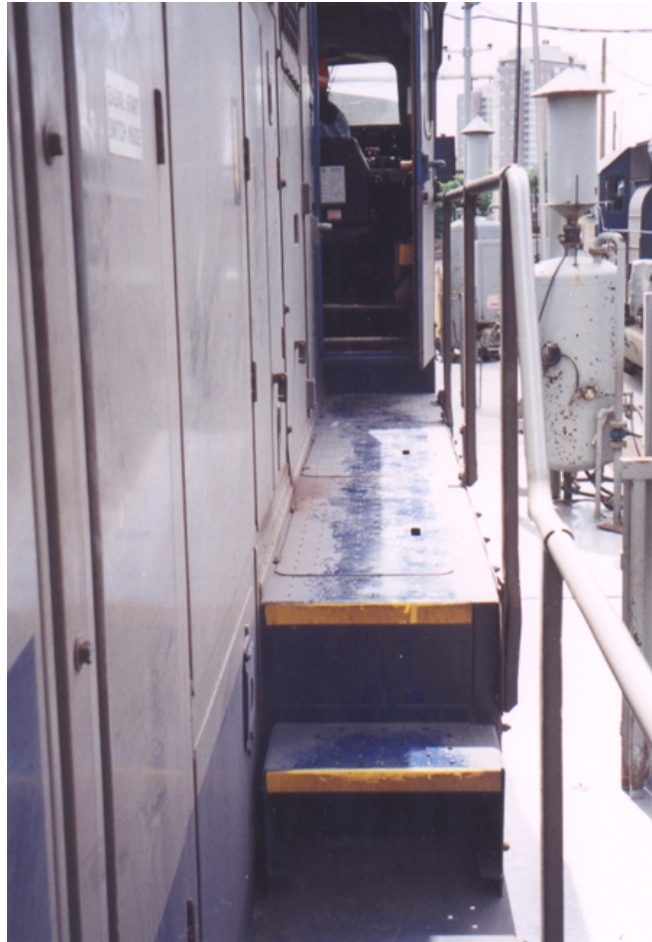
Figure 16. Door to rear of engineer's seat, to walkway

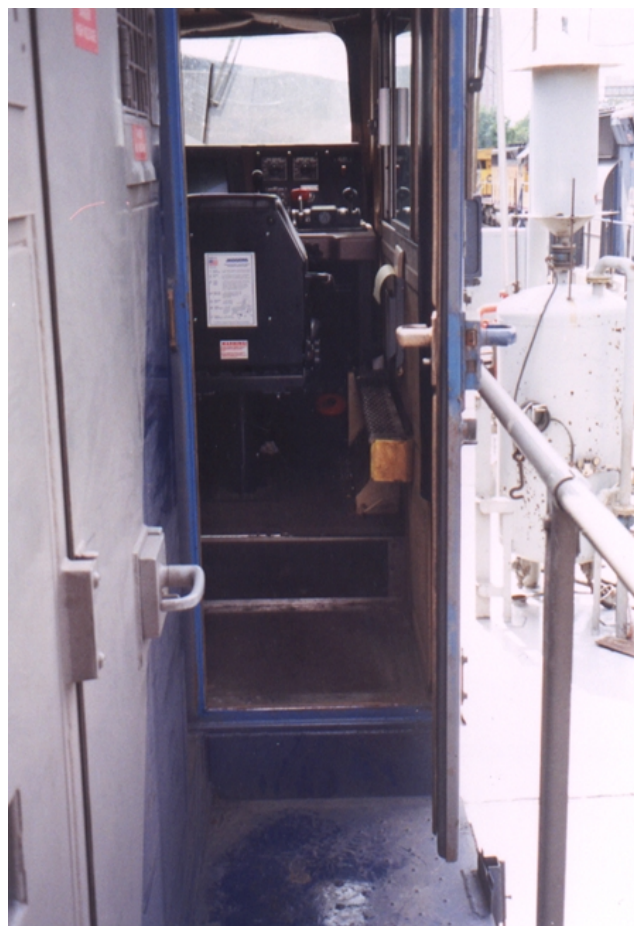
Figure 18. GE CW40-8 - door behind engineer's seat to exterior walkway

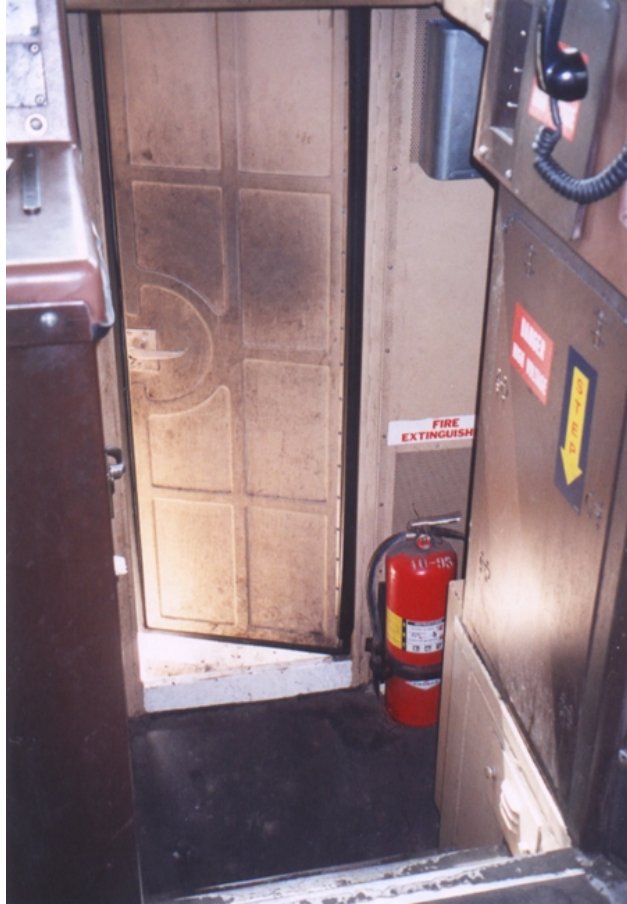
For both the SD70 and the CW40-8 (Figure 19), there are stairs leading from the cab to the vestibule area containing the toilet room, and then a door leading to a small compartment, with access to the nose door leading to the outside. The vestibule door opens outwards to the left with the handle on the right side of the door, while the nose door opens to the right, with the handle on the left side of the door. This inconsistency in placement of handles and difference in the side on which the doors are hinged could arise as an egress issue in the case of a collision.

Figure 19. Steps from cab interior to door leading to vestibule, GE CW40-8

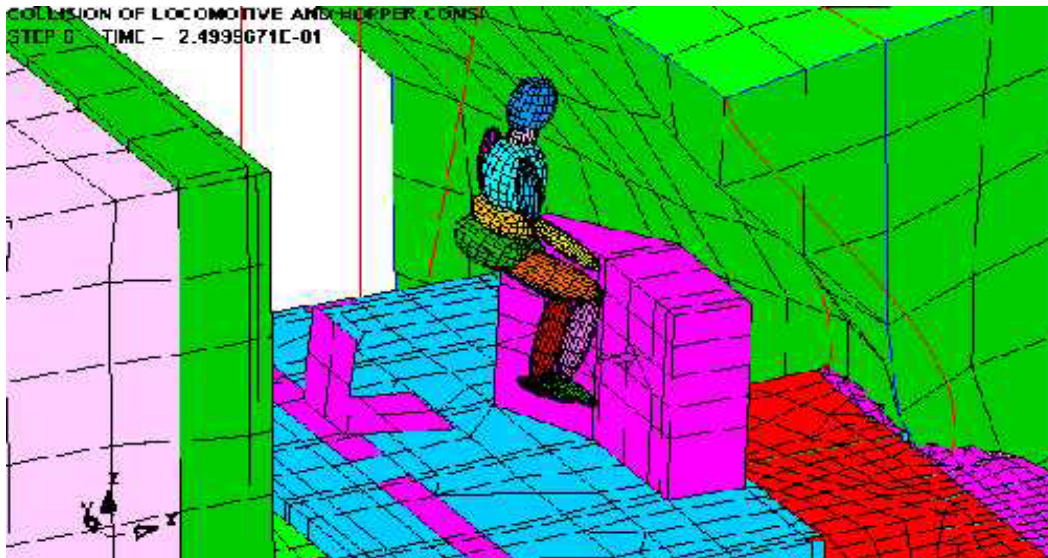
Figure 24. "Snapshot" of seated crewmember "dummy" during a 30 mph offset collision of a typical passenger locomotive

The g-loads during a rollover or collision process occur during a fraction of a second. The survivability of a human during this process will also depend on the environment conditions such as the cabin loss of volume, debris/glass fragments, and loose equipment. Observations of the kinematics made during the collision process (a typical "snapshot" during an offset collision of a passenger locomotive is shown in Figure 24), clearly show that the anatomical parts of the unbelted engineer will make contact with the surrounding structural parts of the cabin and could sustain injuries or even death. The severity of the injury/death can be measured at the in-cab floor level as well as the g-loads at the head. The NHTSA FMVSS 208 criterion for survival is about 60 g's at the chest level.

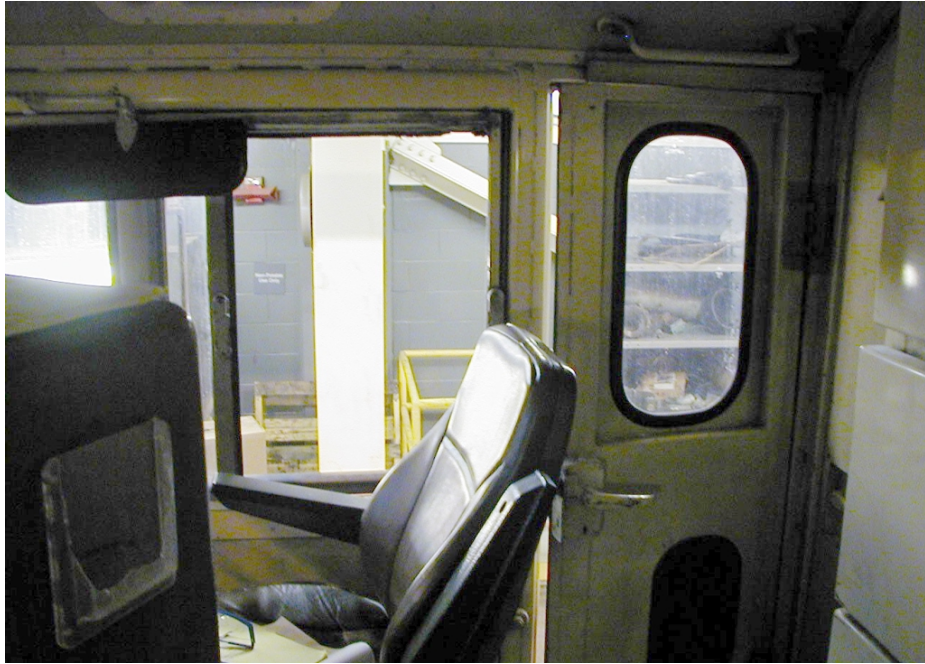
Figure 66. Cab view of side window and door for F40-PH locomotive

Examples of windows in passenger and freight locomotives are shown in the following figures. Figures 66 and 67 are the side window and front windshield of an F40-PH type passenger locomotive. The 23 inches wide x 9 inches high side window is opened by horizontally sliding it forward. The front of the locomotive has two barred and relatively large windshields. Figures 68 and 69 show the side window and windshield for a Dash 8 type freight locomotive, manufactured by General Electric. The side window for this unit contains two windowpanes, but only one of which is movable. As seen in Figure 69, this unit is a wide-nose locomotive and has two relatively large windshields and an outward opening nose door.

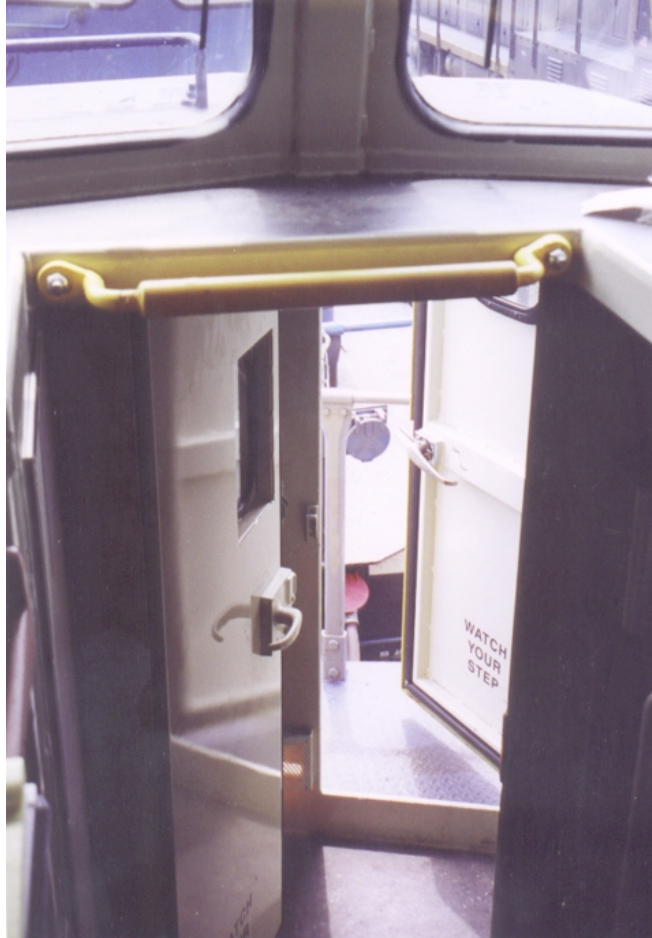
Figure 85. *View from locomotive cab of SD-70 MAC to nose door (door sill 3 to 4 inches high)*

The F-59 locomotives have a succession of doors (leading to the exit door in the nose of the locomotive). All of these doors have raised sills of 2 to 3 inches in height. This presents a tripping hazard, particularly in low-level lighting conditions and in an emergency situation, where haste and panic may be factors in evacuation. Designing interior doors so that sills are flush or nearly flush with floor could help to prevent tripping hazards. Figures 85 and 86 show raised door sills.

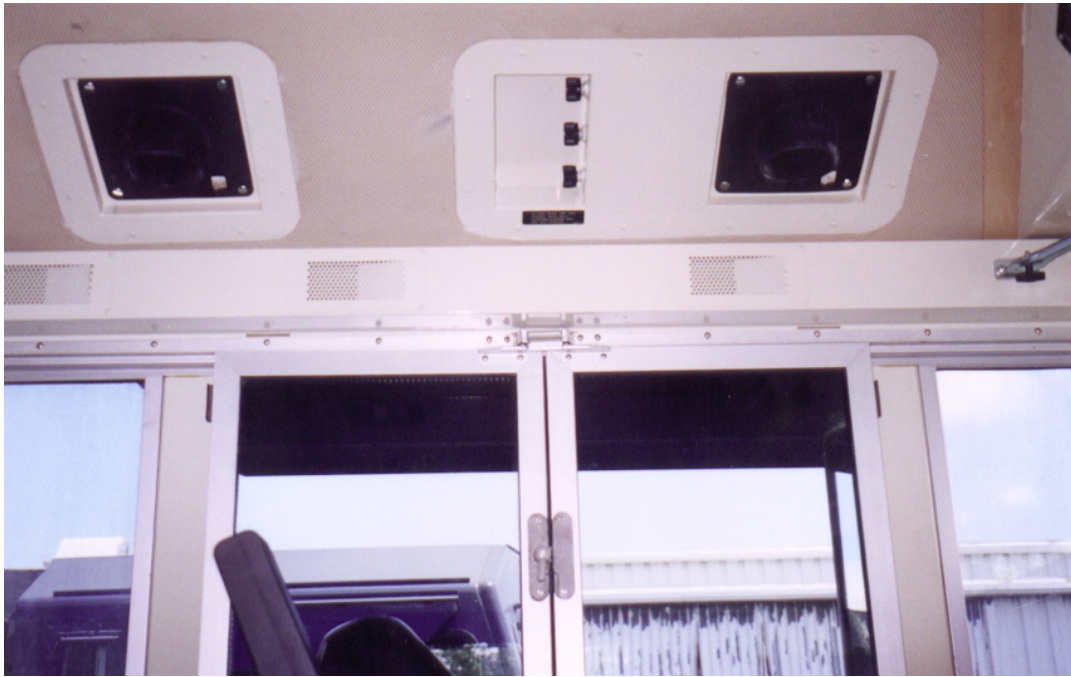
Figure 91. *Overhead cab lighting, over the seat opposite engineer's seat (SD-70 MAC)
(Note double-opening window)*

Improvements have been made to locomotive cab lighting such as those observed on a new SD-70 MAC, with the placement of continuously illuminated directional lighting, aimed at illuminating potential tripping hazards. Figures 89 and 90, SD-70 MAC show low location lighting and improvements to overhead cab lighting as well, Figure 91.

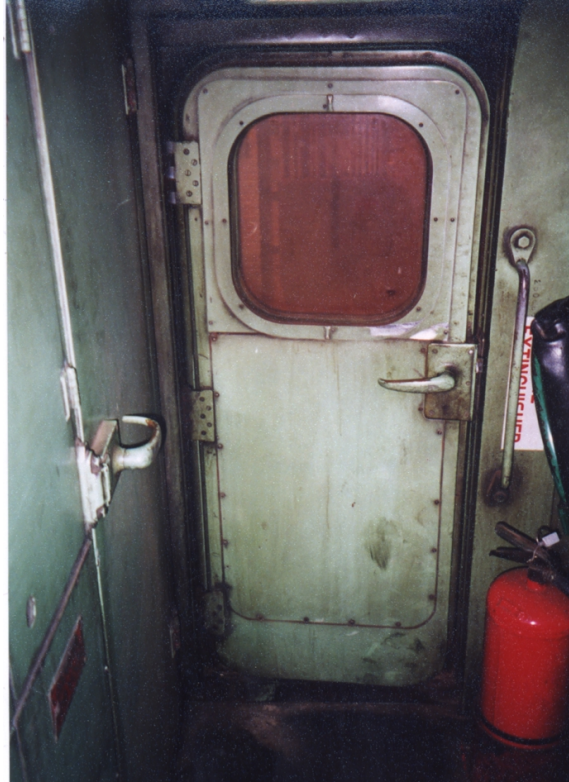
Figure 93. Side doors that open in cannot be used if obstructed

The classic AAR control stand location can be seen in Figures 3 through 5 in this section, and a photo is seen in Section 5, Figure 92. In this arrangement, the older-style controls are on a tall console placed to the engineer's left so that forward vision is clear. The newer "clean cab" type of configuration has a more compact set of gages and quadrant-type controls on a desk-like surface ahead of the engineer. Thus, the floor area in the cab center is unobstructed. This can be seen in the photo in Section 5, Figure 93.

During site visits, it was sometimes observed that clutter, debris, unsecured fire extinguishers, crew accessories, etc. provided obstructions to the exit paths from the cab. Crew training (both operating and mechanical) should provide heightened awareness of the importance of keeping passageways and pathways clear of obstructions (see Figures 92 and 93).

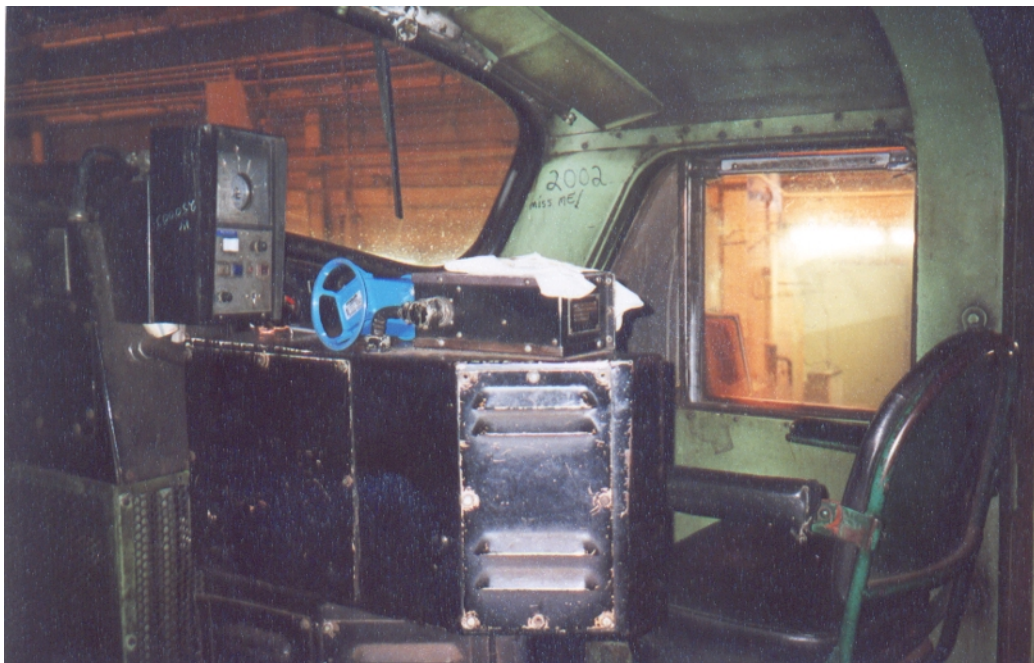
Figure 100. AAR type control stand in front of engineer

integral skin. For the second type of improvement, a breakaway design for the levers should be used: see Figure 100 for the old-style control stand, and Figure 101 for the newer console or desk-type station. This would either be a literal breakaway type of lever or a load-limit-release type joint for the lever, designed to fold up at high loads not normally reached in operation. These would typically fall in the 50 to 100 pounds range, applied normal to the lever. Also, the ball-end on later console levers reduced lethality.

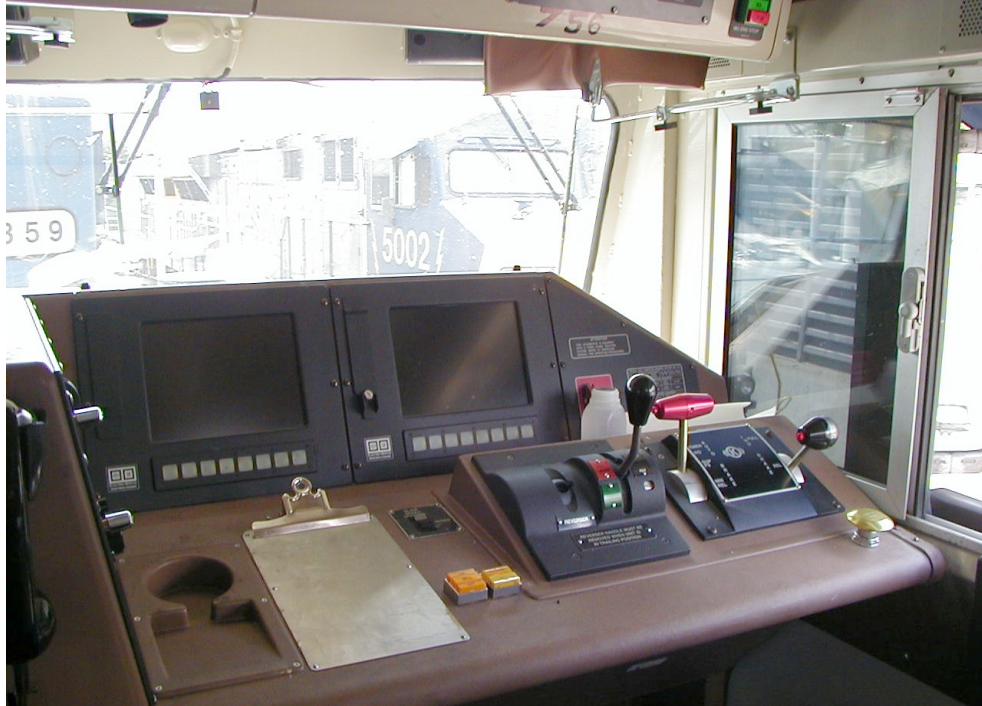
Figure 101. Desk-type station control stand

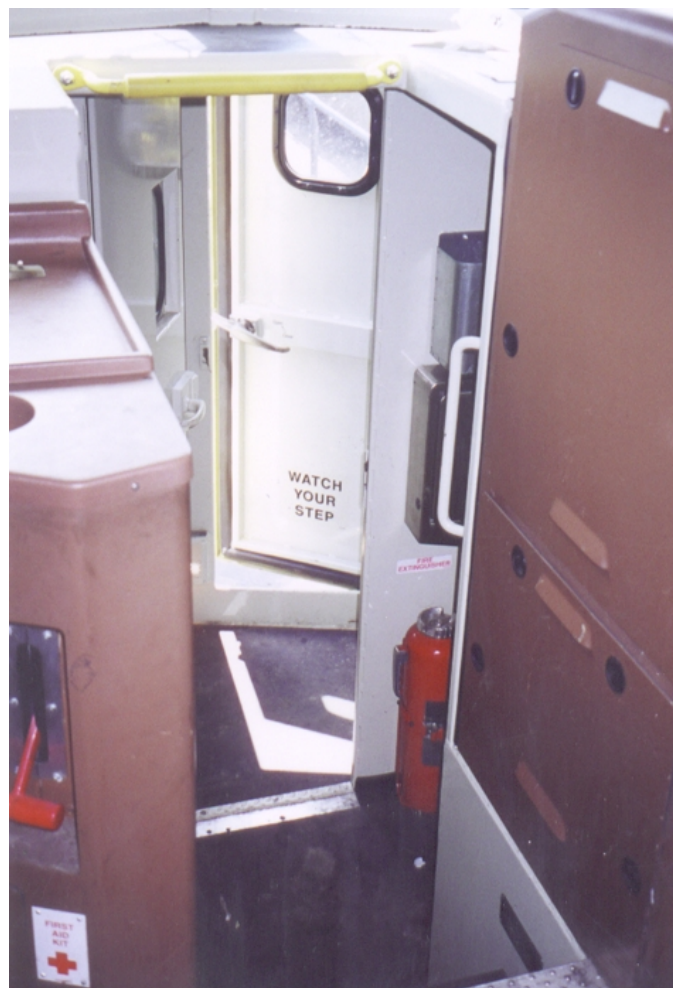
Figure 103. *SD-70 MAC fire extinguisher located on cab side wall near the observer's station*

Wide nose locomotives similar to the SD-70 MAC have a closed off foyer in the nose section. This area would appear to offer a good place for the storage of portable cab mounted equipment in that it is isolated from the occupant portion of the cab. Figure 103 is a view of the foyer as seen from the cab for the SD-70 MAC. As seen from this figure, a fire extinguisher is located adjacent to the stairway down to the nose. Its location here would appear to be based on the need for immediate access. Also shown in Figure 103 directly below the emergency brake lever is the first aid kit. A close-up view of this is shown in Figure 104, which shows the kit installed behind a flush-mounted cover on the conductor's console. The emergency tools and other components are located in the nose side of the foyer. Figure 105 shows the fusee and torpedo box, which for this locomotive is mounted on the nose interior door. Figure 106 shows the location and mounting arrangements for other emergency tools. The location appears to be ideal from the perspective of eliminating the potential for flying projectiles. Some of the collision scenarios we analyzed shows that this portion of the locomotive could experience severe damage, thus preventing access.

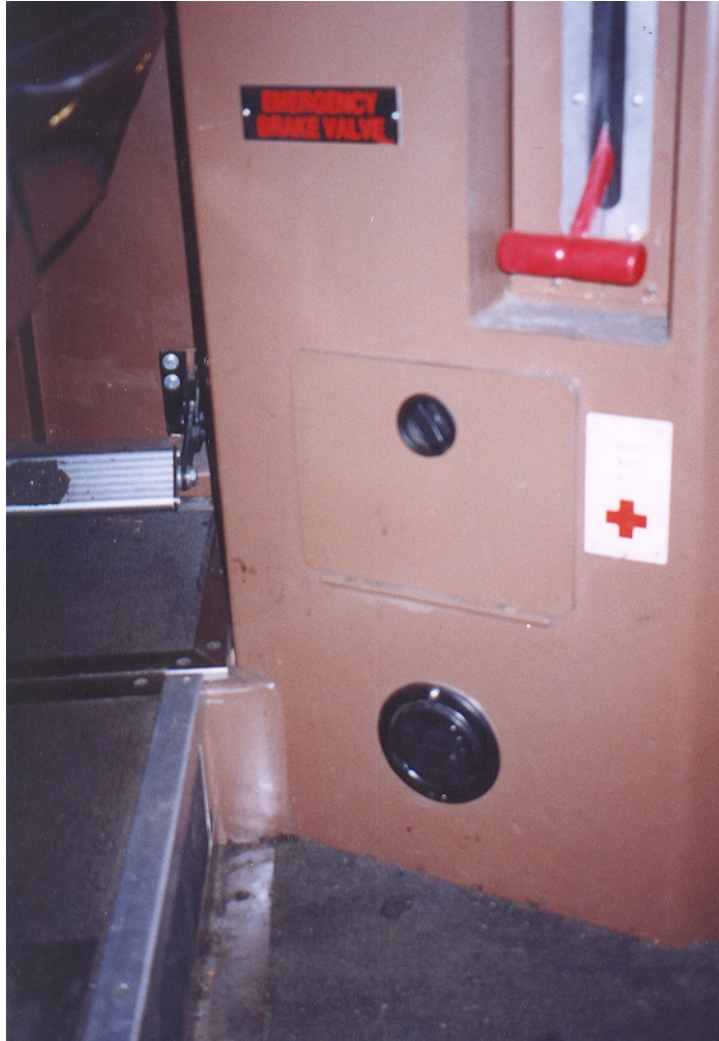
Figure 104. *SD-70 MAC recessed first aid kit located near the conductor's chair*

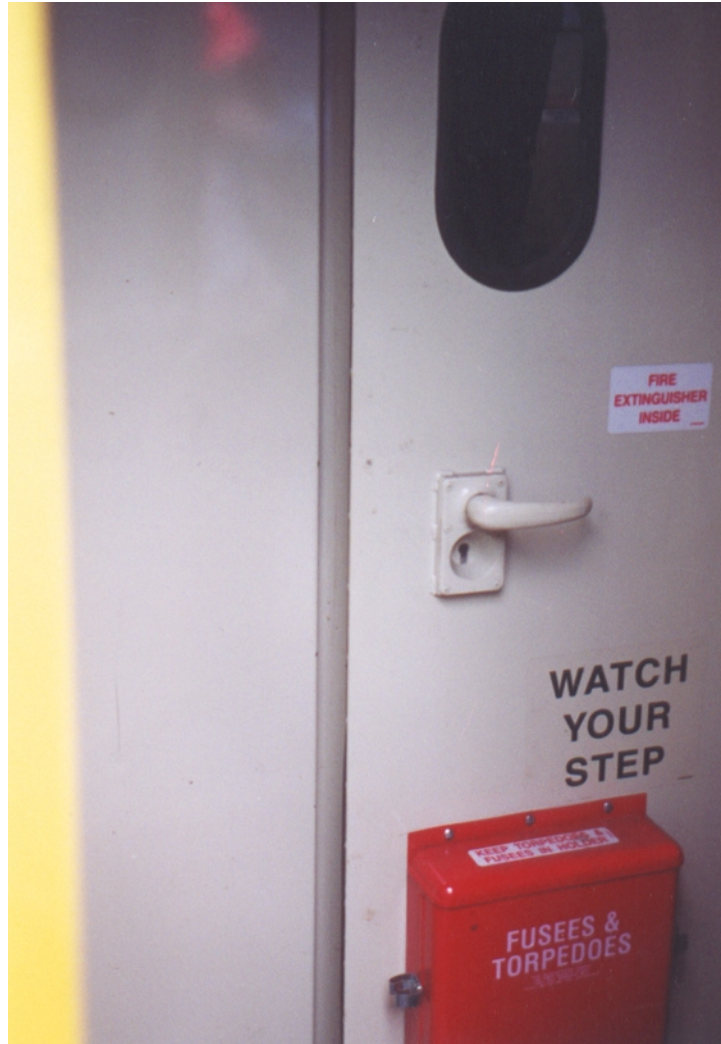
Figure 105. SD-70 MAC fuses and torpedoes box mounted on the nose side of the vestibule door

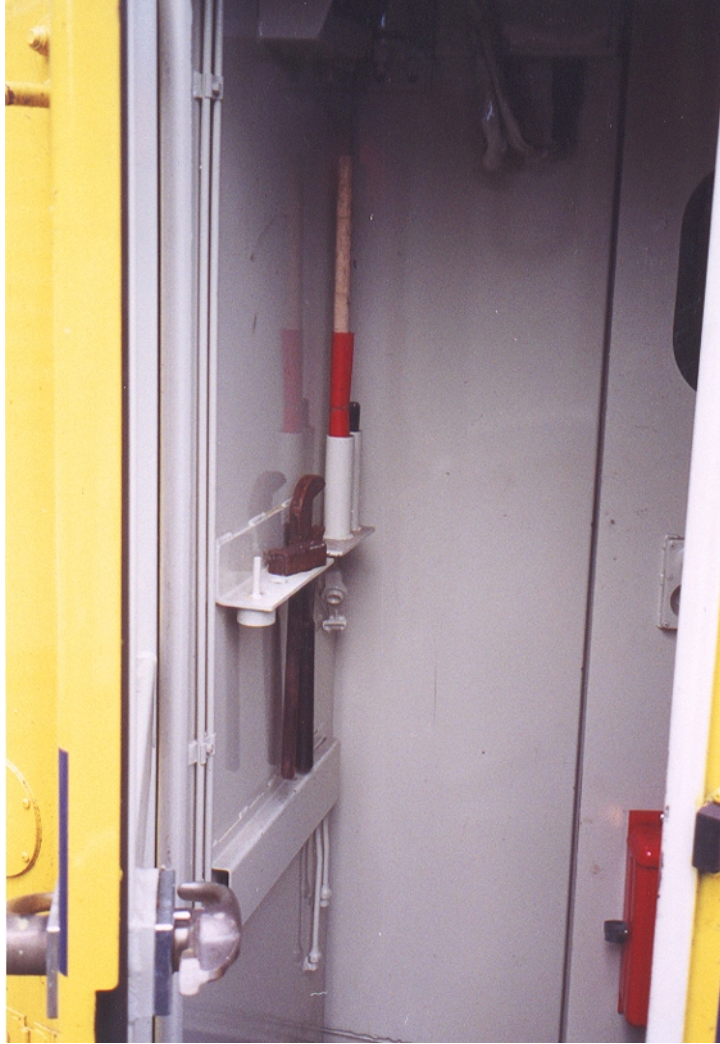
Figure 106. SD-70 MAC emergency tools located in the nose side of the vestibule

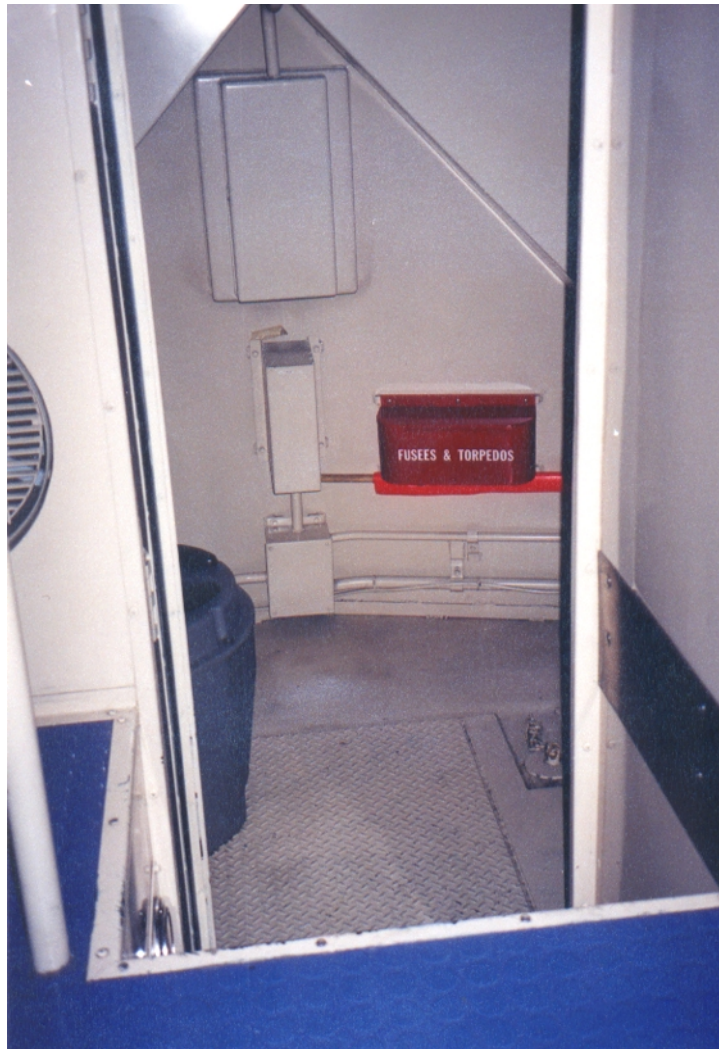
Figure 107. F40-PH3 fusees and torpedos located in nose compartment

Figure 107 shows the location of some of the cab-mounted equipment for the F40-PH passenger locomotive. For the same rationale as above, the fire extinguisher is mounted on the front bulkhead near the conductor's station, while other equipment, such as the fuses and torpedoes are located in the nose compartment. Figures 108 and 109 are for the more modern P32-AC passenger locomotive. These figures show the bulkhead immediately located behind the engineer's seat. Both the first aid kit and fire extinguisher are anchored to the bulkhead with a fastening mechanism. Figure 110 shows the location for some of the emergency tools. These are located on the rear wall near the door to the engine room.

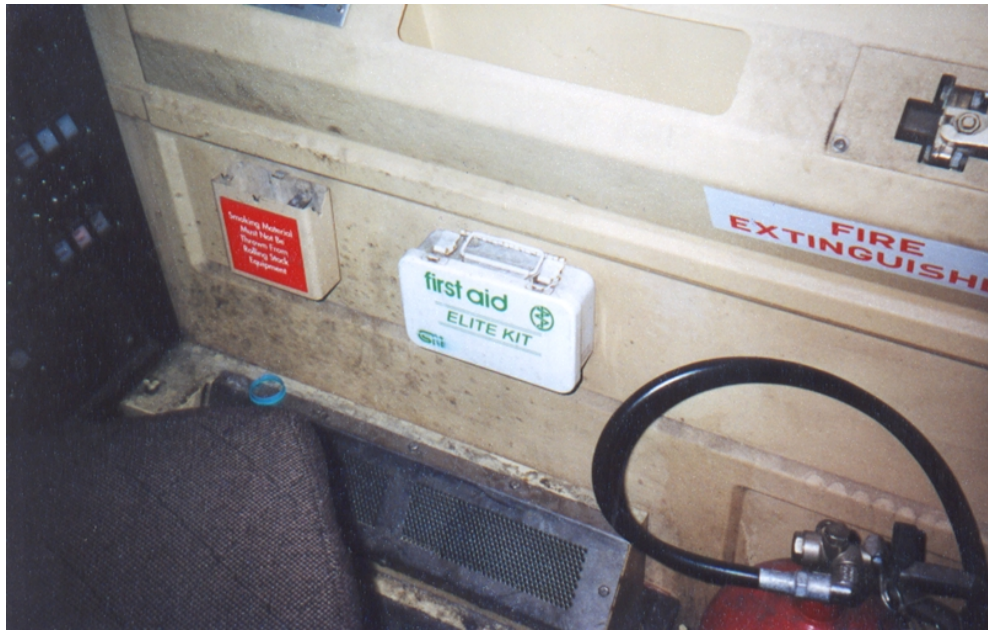
Figure 108. *First aid kit located on right side of cab below engineer's side window*

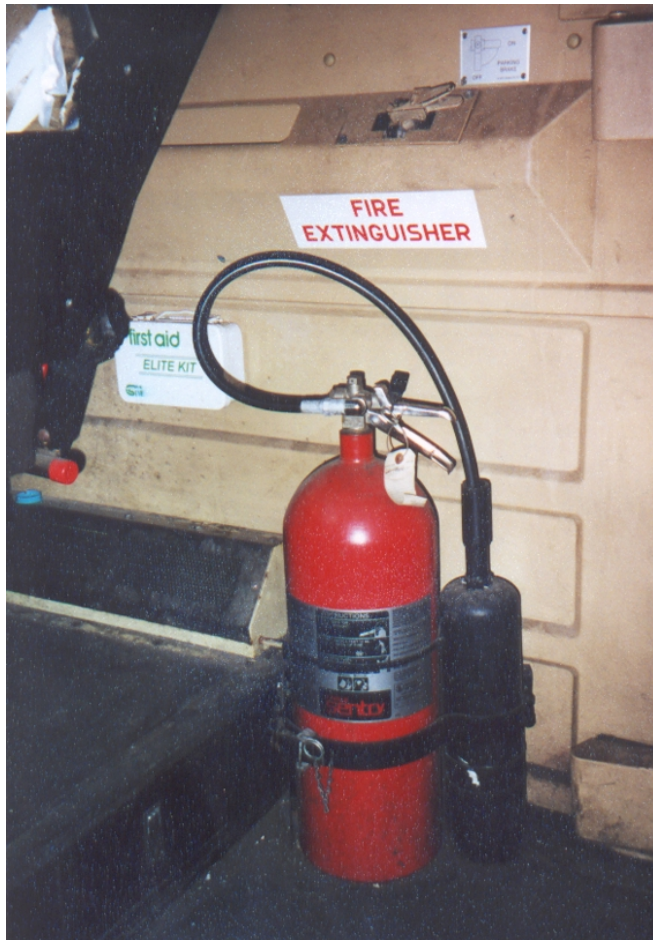
Figure 109. P32-AC fire extinguisher located immediately behind engineer's seat

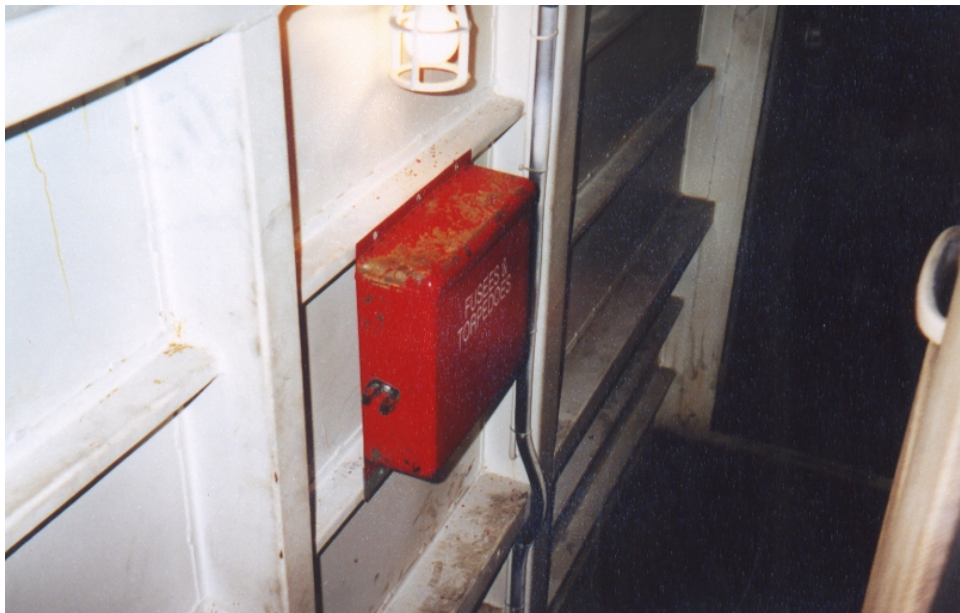
Figure 110. P32-AC emergency tools located on wall behind cab near door to engine room
