Railroad Infrastructure Trespassing Detection Systems Research in Pittsford, New York

Office of Research and Development Washington, DC 20590

Highway-Railroad Grade Crossing Safety Research

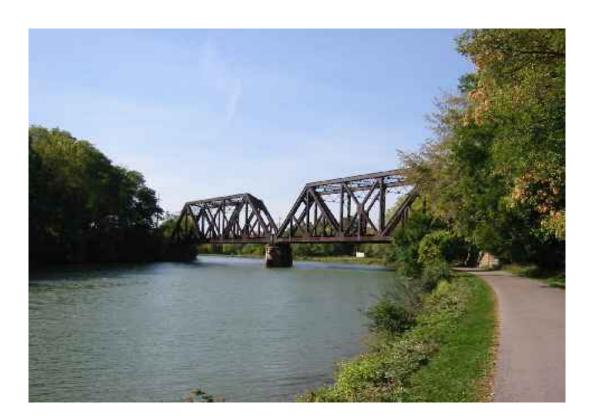
Figure 2. Railroad Bridge Chosen for Demonstration Project

A through-truss railroad bridge built in 1918 and owned by CSX Transportation was chosen for this demonstration project and is shown in Figure 2. The selection of this bridge, located in Pittsford, New York, was based both on the 1997 incident resulting in two trespass fatalities, as well as the bridge's prior trespassing history. Although not documented, teenagers have been historically known to use this railroad bridge as a meeting place, and locals were using it as a shortcut. A pedestrian walkway that passes under the bridge on the eastern approach provides easy access to the bridge. The bridge is also often used as a fishing spot. The bridge itself lies about 800 feet east of the Monroe Avenue railroad crossing and spans the Erie Canal (see Figure 3). It is situated at CSX Milepost 353.4, and the nearest crossing is designated identification number 521097M. The bridge was originally double-tracked, but only one track remains in place. The route serves as a mainline bypass around the city of Rochester and has centralized traffic control. An average of approximately nine freight trains travel over the bridge per day at speeds up to 60 mph. No regular passenger service exists on this line. The canal carries light boat traffic from May through November.

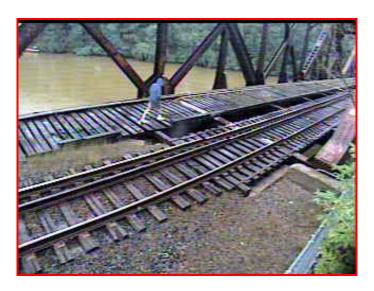
Figure 15. Trespasser Detected at 6:28 a.m.

Event 3: At 6:28 a.m. on September 8, 2004, one person was detected on the east end of the bridge and proceeded to walk across the bridge. The Doyle Security attendant subsequently warned the trespasser. He/she left the scene and the Doyle Security attendant noted the presence of a train immediately after.
