DEPARTMENT OF TRANSPORTATION

Federal Aviation Administration

[Docket No. FAA-2007-28828; Directorate Identifier 2007-NM-010-AD]

Airworthiness Directives; Boeing Model 707 Airplanes and Model 720 and 720B Series Airplanes

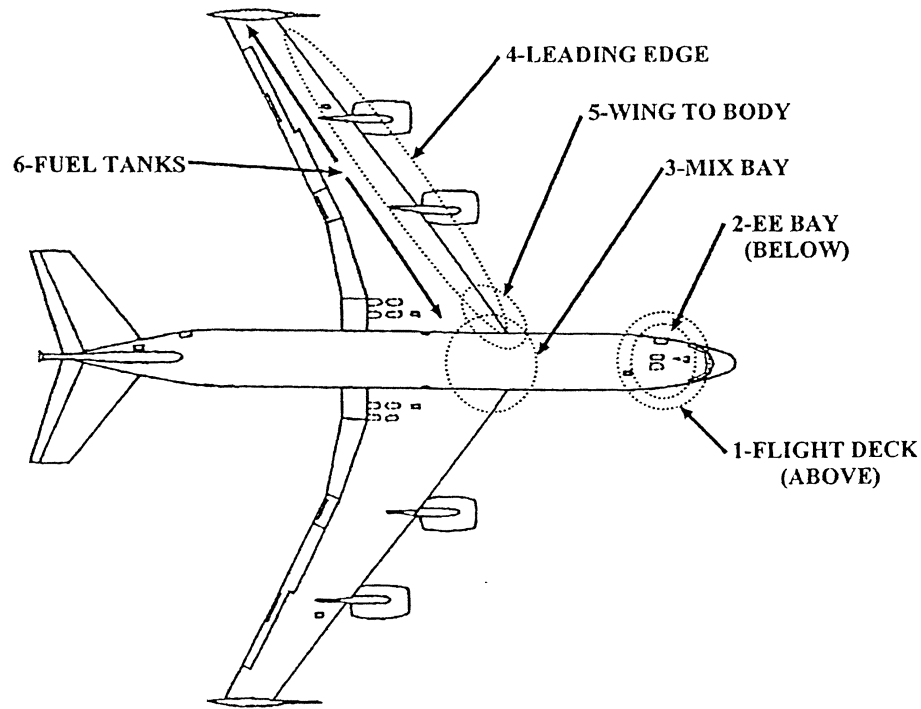
707 SFAR 88 SURVEY
AREAS

To support the development of these Service Bulletins, Boeing requires a photographic survey of the airplane. Because these airplanes are now rare,

Boeing needs operator assistance with the required SFAR-88 design changes. Boeing needs digital videos or digital photographs of the following areas of the aircraft:

1) Flight Deck

(f) Within 12 months after the effective date of this AD: Conduct an airplane survey that defines the configuration of system installations for the wing leading edges, wing-to-body area, electrical equipment bay, flight deck, and FQIS using a method approved in accordance with the procedures specified in paragraph (h)(1) of this AD. If any discrepancy is detected, repair before further flight using a method approved in accordance with the procedures specified in paragraph (h)(1) of this AD. Submit the survey results to the Manager, Seattle Aircraft Certification Office (ACO), FAA, 1601 Lind Avenue SW., Renton, Washington 98057-3356, at the applicable time specified in paragraph (f)(1) or (f)(2) of this AD. The report must include the survey results (e.g., photographs and sketches, part numbers of FQIS components and fuel pumps, and the actual configuration of FQIS and the fuel pump control systems), a description of any discrepancy found, the airplane serial number, and the number of landings and flight hours on the airplane. Under the provisions of the Paperwork Reduction Act (44 U.S.C. 3501 *et seq.*), the Office of Management and Budget (OMB) has approved the information collection requirements contained in this AD and has assigned OMB Control Number 2120-0056.
