MAP AND DESCRIPTION OF THE ACTIVE PART OF THE SLUMGULLION LANDSLIDE, HINSDALE COUNTY, COLORADO

By
Robert W. Fleming and Rex L. Baum, U.S. Geological Survey, and
Marco Giardino, Consiglio Nazionale Delle Ricerche—Centro Studi
1999

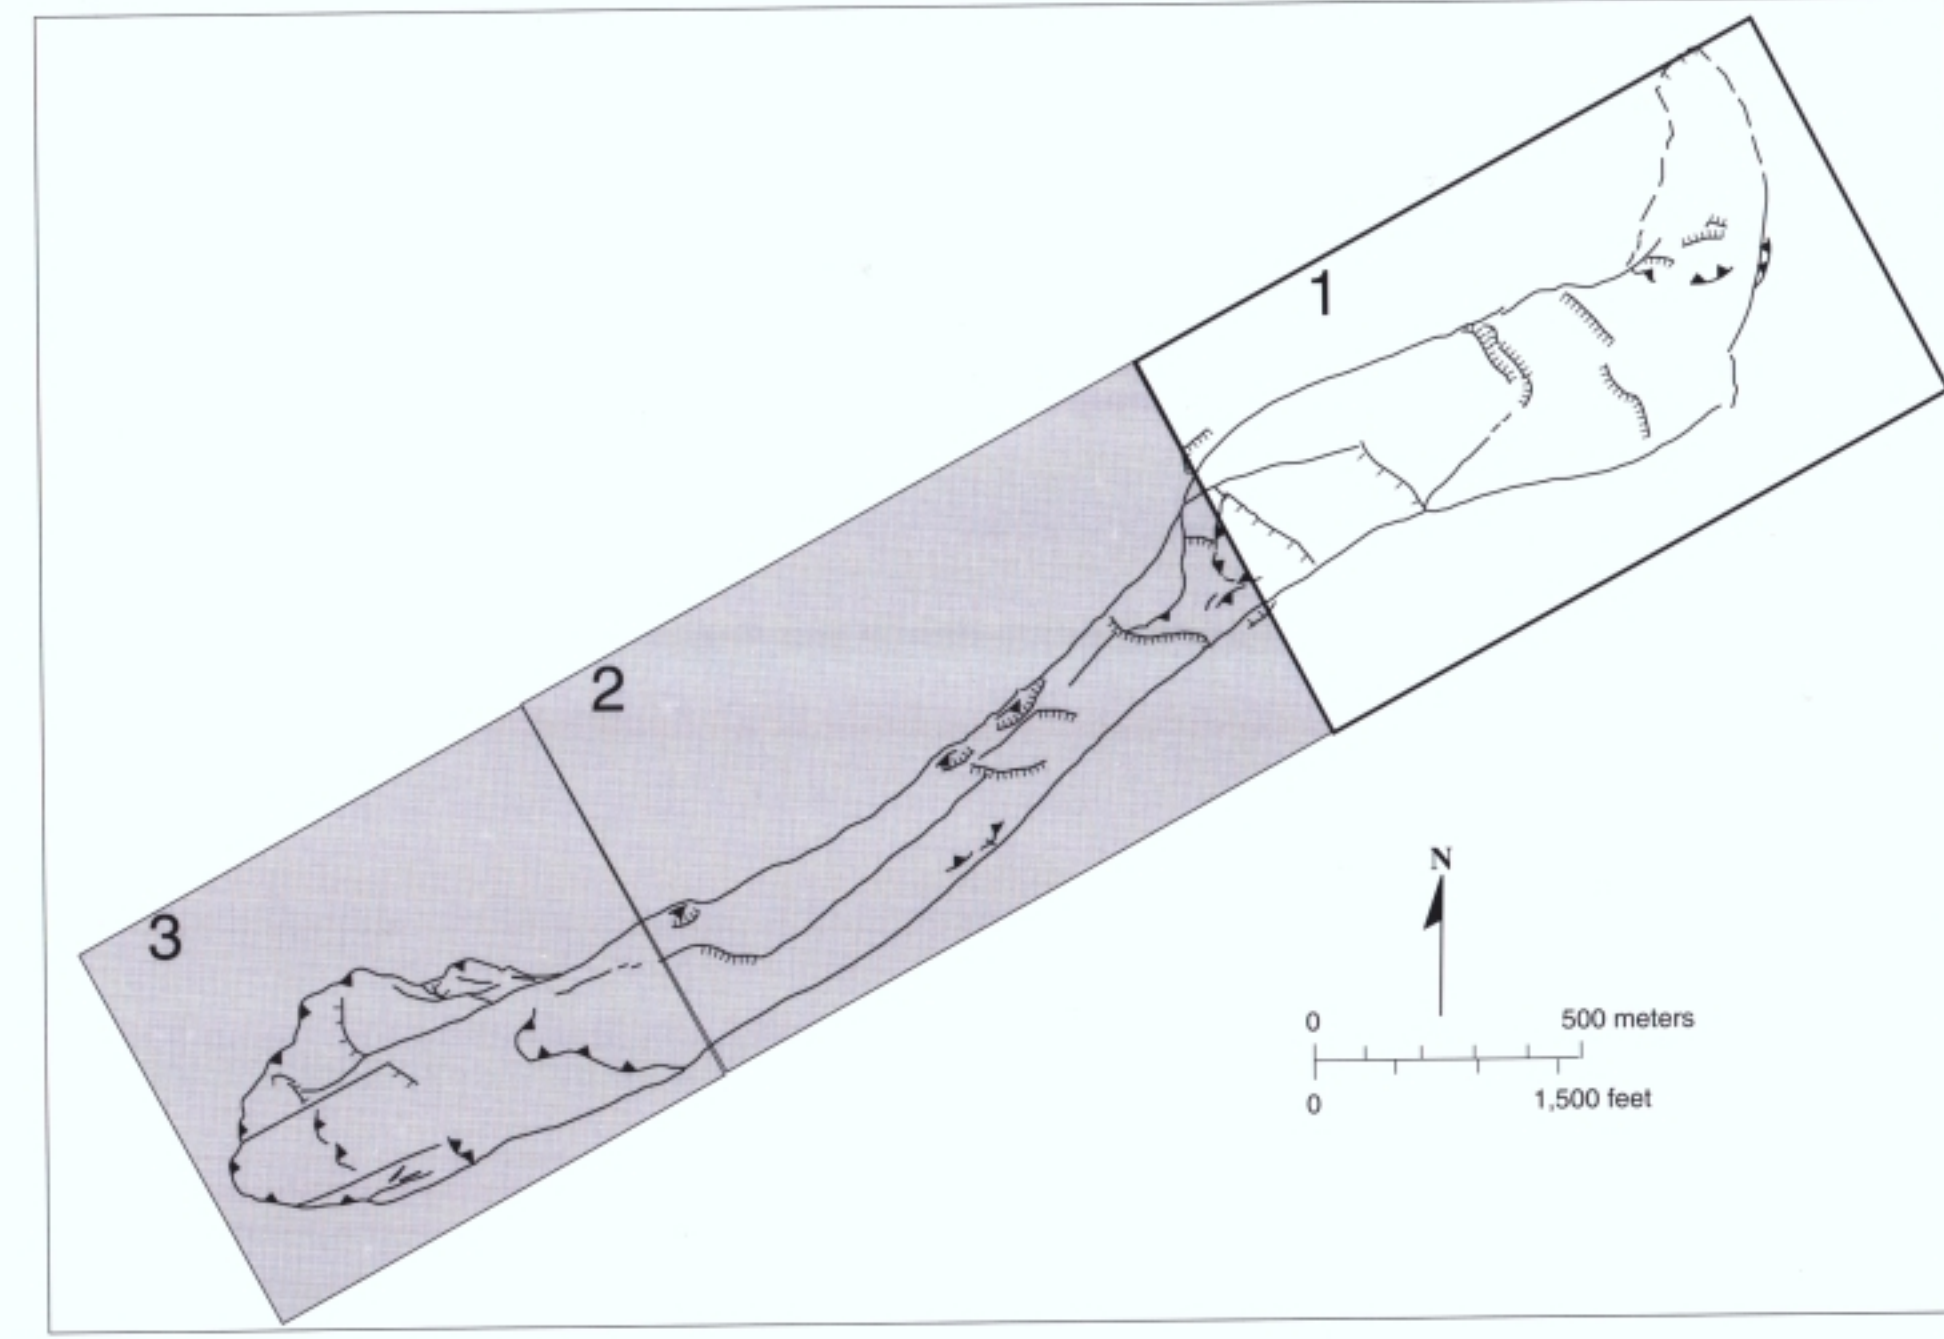
- EXPLANATION**
- Direct indicators of deformation**—Solid line indicates that feature is active and accurately located; dashed line indicates that feature is apparently inactive but accurately located; dotted line indicates feature is inferred both as to location and type of movement.

- Thrust fault**—Steepening feature in which one block of material overrides another. Sawtooth on overriding block.
 - Fault scarp**—Steepening and/or shear feature. Features face down slope. Represents a normal or oblique-slip fault. Height in meters given for a few of the scarps. Arrow indicates sense of lateral movement for oblique-slip faults.

- Displacement**
 - Displacement vector**—Horizontal component of annual displacement shown in meters per year obtained from measurements on aerial photographs taken in 1985 and 1990.

- Displacement on boundary**—Annual displacement between September 1992 and September 1993 in meters per year measured in offset of wooden stakes around landslide perimeter. Letter and number combinations identify station.

- Displacement of transverse strike line**—Position of rebar stakes in a line crossing narrowest part of landslide. Number indicates average rate of movement in meters per year.
