Fort McHenry National Monument and Historic Shrine Baltimore, Maryland

Fort McHenry *Alternative Transportation Study*

Appendix E

Ft. McHenry Accessible Docking Alternatives

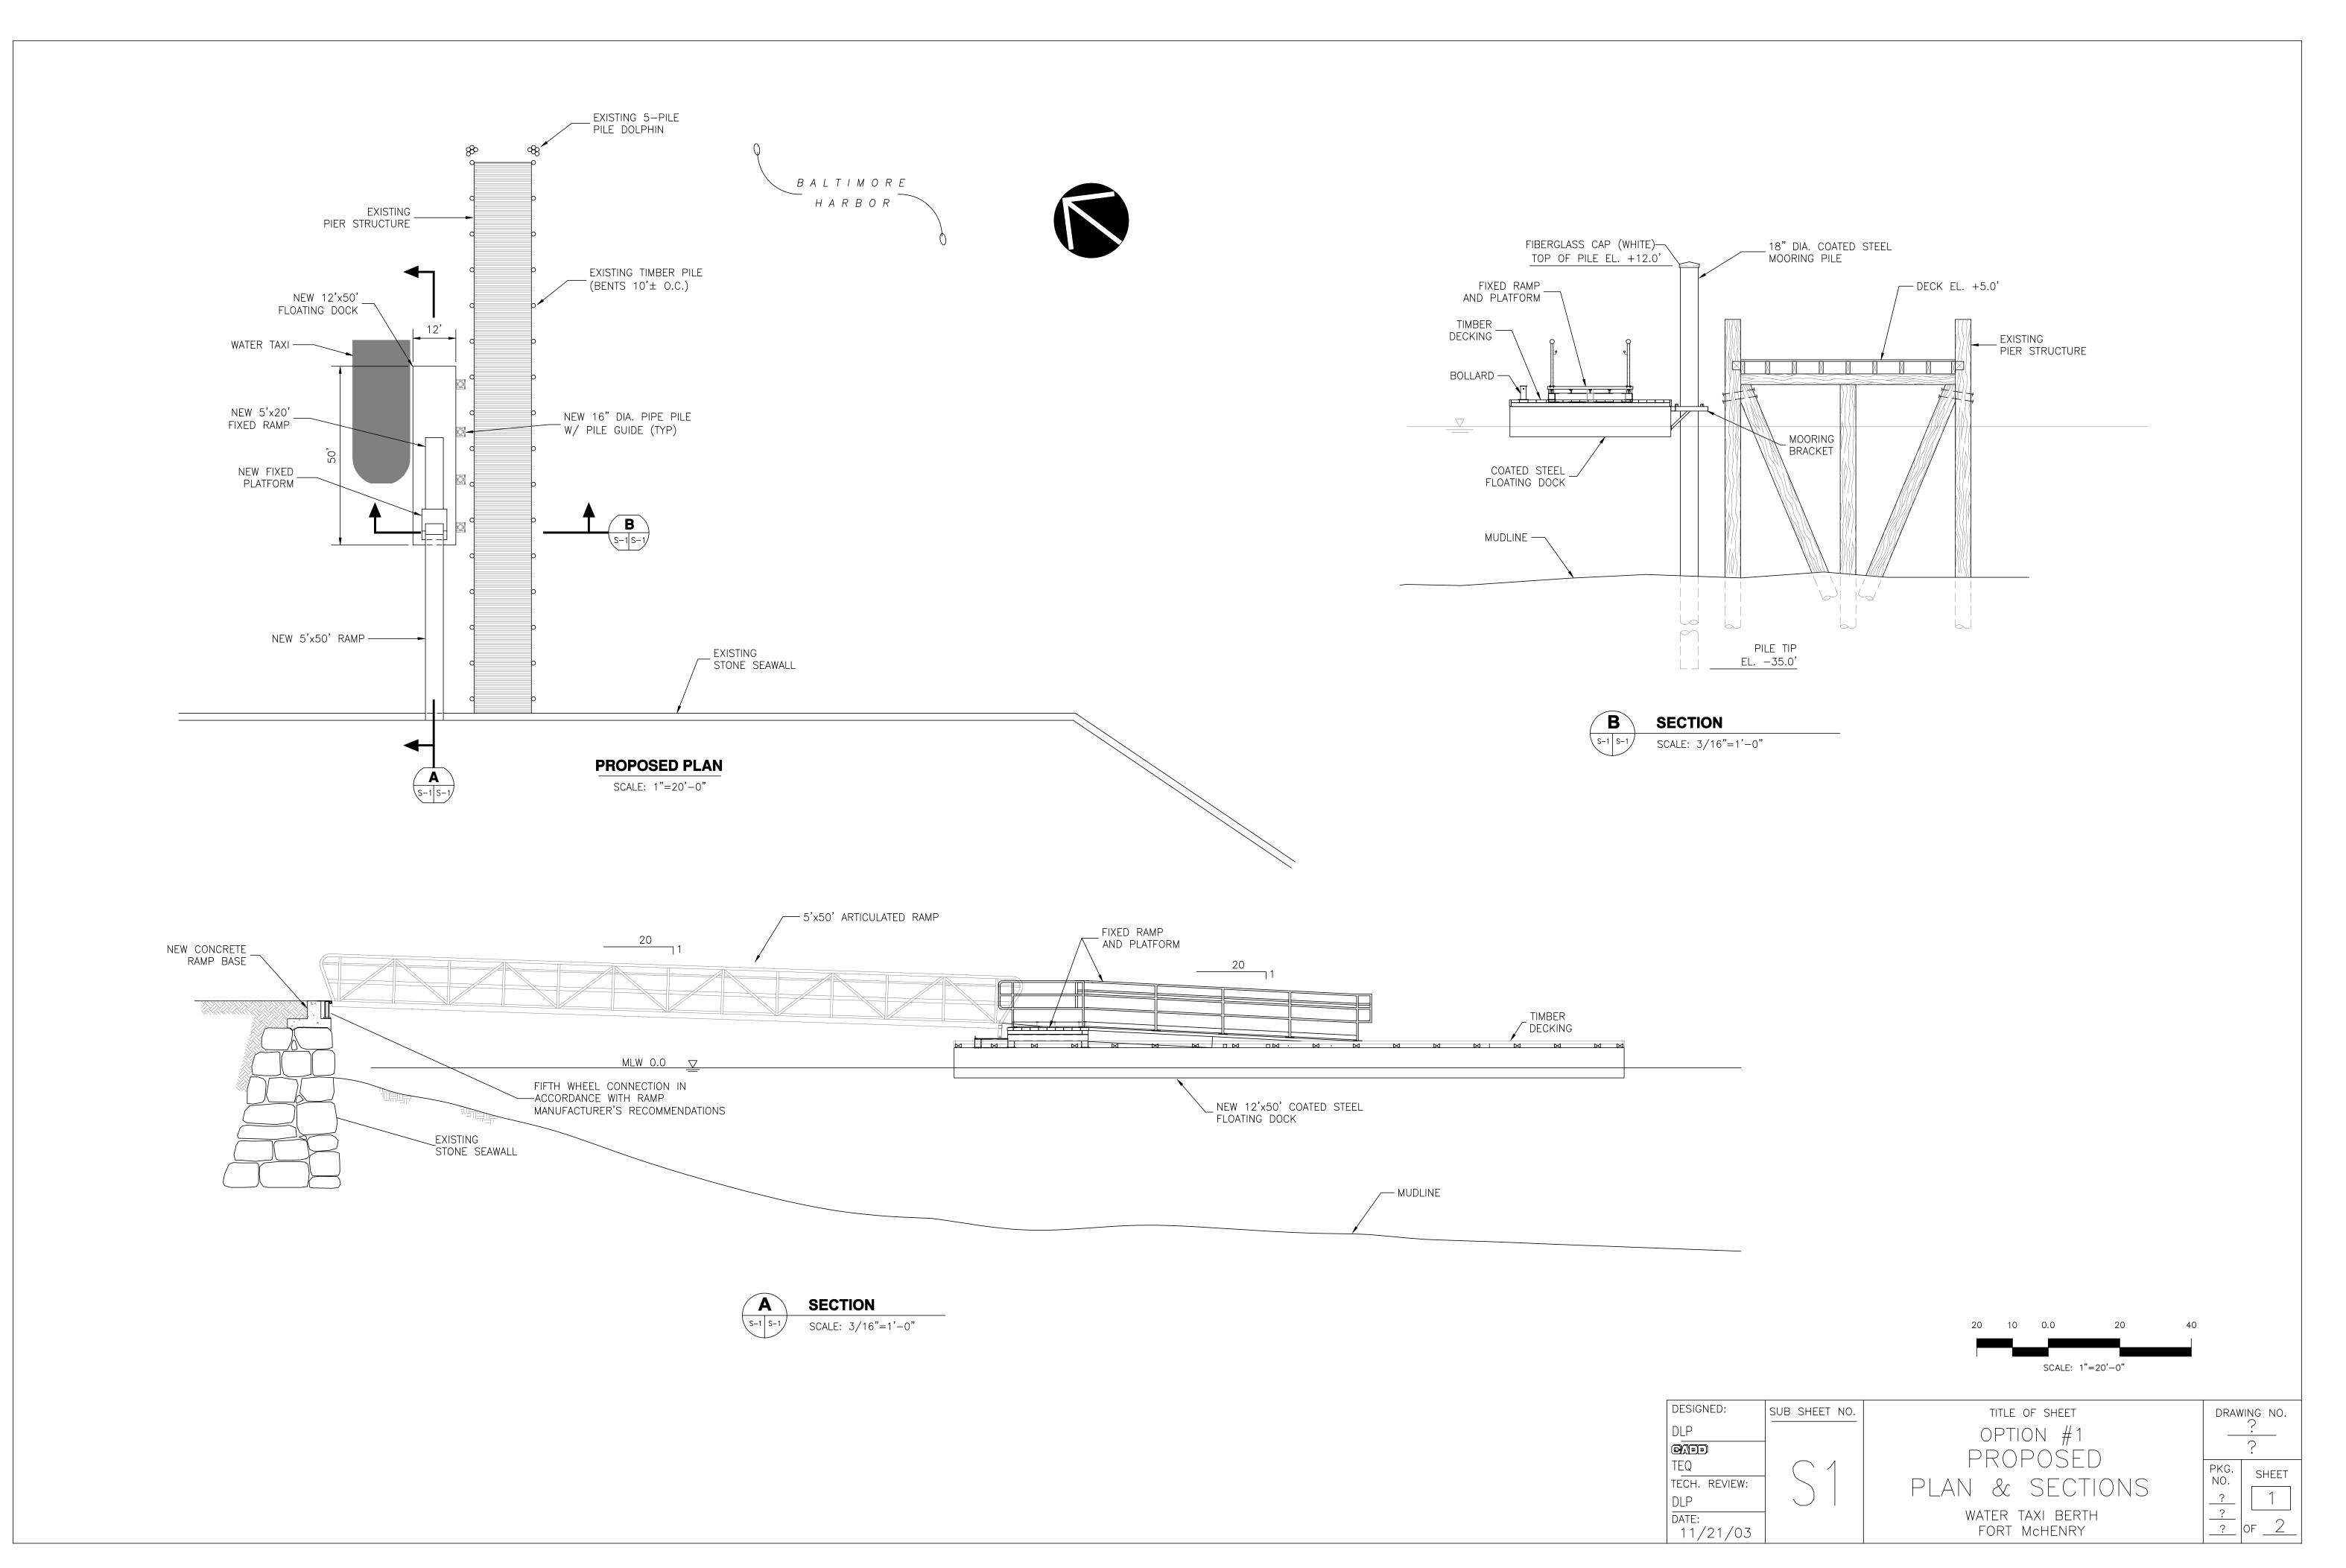
There are several options for locating the landside of the main articulating ramp on the proposed system. Option 1 as illustrated, connects to the seawall at Ft. McHenry and is not dependent upon the existence of the fixed pier. Option 2 provides access via the fixed pier through an extension to the pier where the articulating ramp is connected. Conceptual level cost estimate for Option 1 is approximately \$230,000 and Option 2 is approximately \$270,000. There is a variety of designs between the two options for connecting the landside seawall to the floating dock via the main articulating ramp. Options 1 and 2 are illustrated on the attached sketches.

The two alternatives for the rehabilitation of the Ft. McHenry harbor taxi berth utilize a floating dock for the principle berthing element. The floating dock would have a designed freeboard of 24 inches which closely simulates the existing vessels in service in the harbor and provides for a fixed ramp on the floating dock and a 50-foot long articulating ramp from land or the pier to the floating dock. This configuration allows a maximum ramp slope of 1 on 20 from the deck of the floating dock to land under normal tidal conditions. This is a gradual slope by ADA definition and is not a ramp, but a sloping walk such as a sidewalk. With these gentle slopes, accessibility for those in wheelchairs and other disabilities would meet ADAAG specifications and would be a significant improvement over the current need to climb steps or receive assistance to move from the deck of the vessel to the fixed pier elevations.
