# ANDREW JOHNSON NATIONAL CEMETERY

## CULTURAL LANDSCAPE REPORT

## ANDREW JOHNSON NATIONAL CEMETERY ANDREW JOHNSON NATIONAL HISTORIC SITE

April 1993

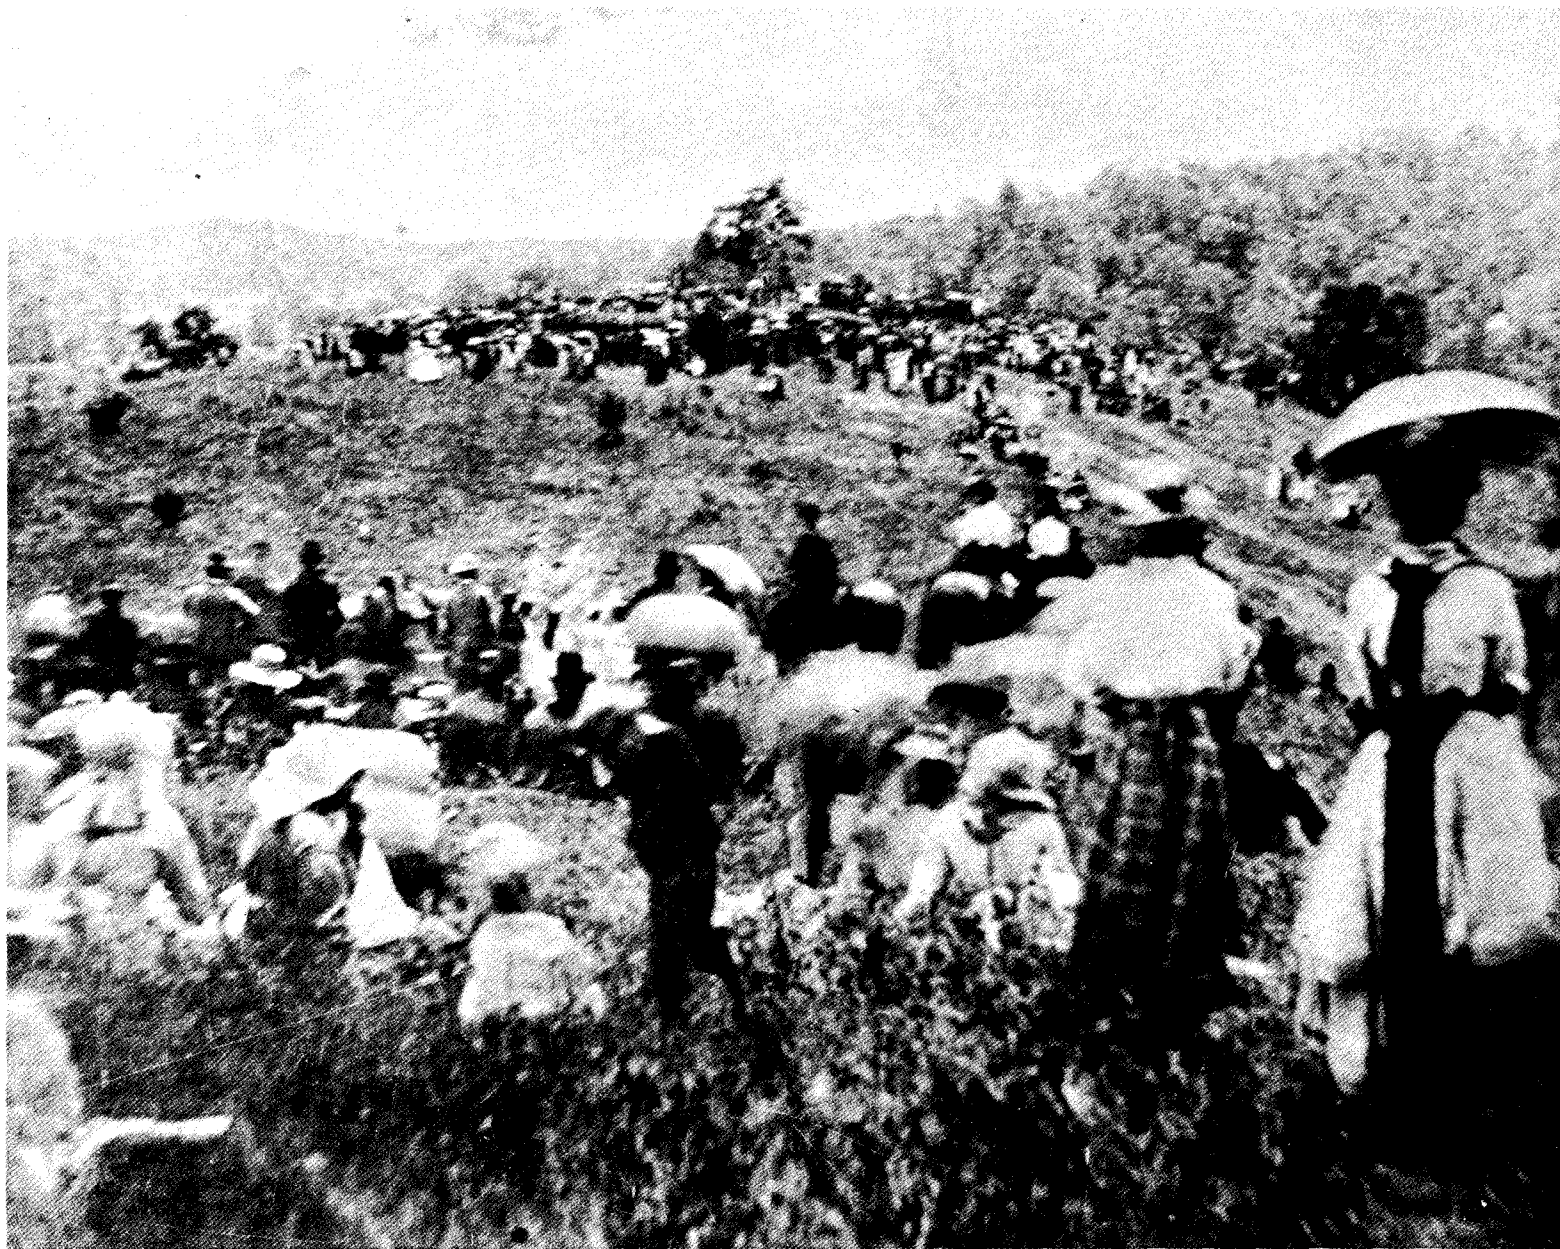
Figure 1. View of the Funeral Party on "Signal Hill," 1878.

A photograph taken at Andrew Johnson's burial in 1875 depicts a site of overgrown grasses, random scrub trees (most likely cedars), and an unpaved wagon trace climbing the hill (see fig. 1). In contrast, the distant views (outside of the cemetery) show densely wooded slopes. Site improvements by the family from 1875 until its acceptance by an act of Congress in 1906 included the addition of the monument over Andrew Johnson's grave (1878) and the cast iron fence that encircled the monument plot (c. 1880). With the erection of the monument, a marble obelisk topped by an eagle facing east, the site became known locally as "Monument Hill."

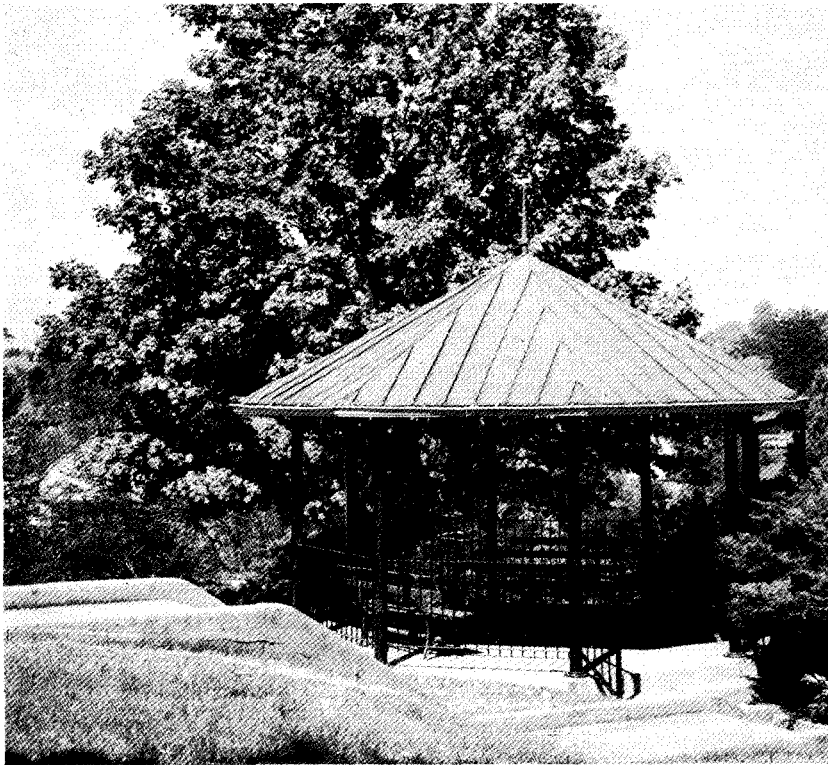
Figure 4. View of the Rostrum, 1976.

The other landscape feature that was installed during the War Department administration was the rostrum (1931). It was shown on the original plan as rectangularly shaped but was installed as an octagonal gazebo-like structure (see fig. 4).

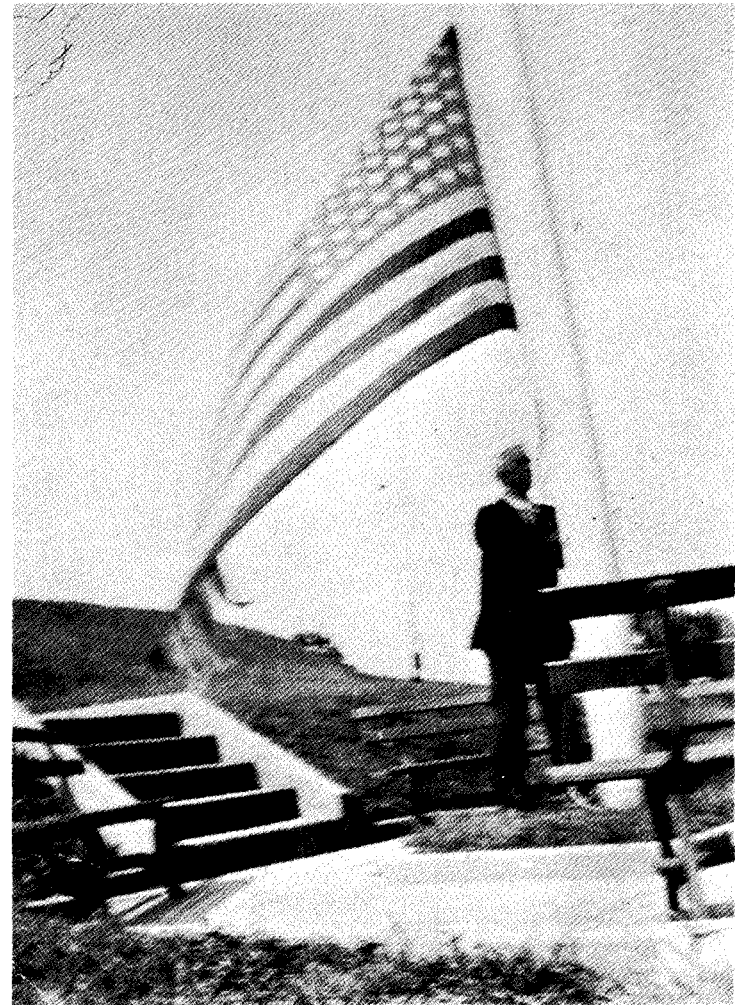
Figure 5. Period photograph illustrating settees, c. 1915.

flights of steps east and west of the monument. Although they are documented in photographs from the 1950s and showed as extant on the first NPS drawings, no date of their installation has been established. It is assumed, however, that they were in place by the time of transfer to NPS in 1942. Items never illustrated on any plans but ordered and installed as early as 1908 are "twenty-four iron settees of the usual pattern for national cemeteries."<sup>3</sup> These were requested by visitors and subsequently requisitioned by the superintendent. Although their placement does not turn up on drawings, a few locations are known from period photographs (see fig. 5).

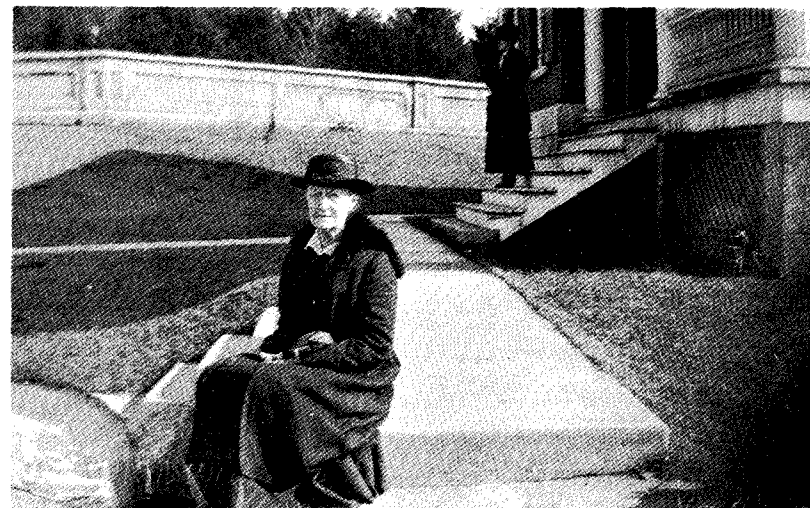
Figure 8. Historic photograph of Lodge, c. 1945.

scattered small trees, and a clump of mature cedars. No tree inventory or tree planting program was discussed in any of the War Department documents reviewed for this study. It would seem that volunteer trees existing on site were left to mature without much maintenance. The fact that not a single plant was installed around the foundation of the lodge is proof that landscaping was not a part of the War Department program (see fig. 8).

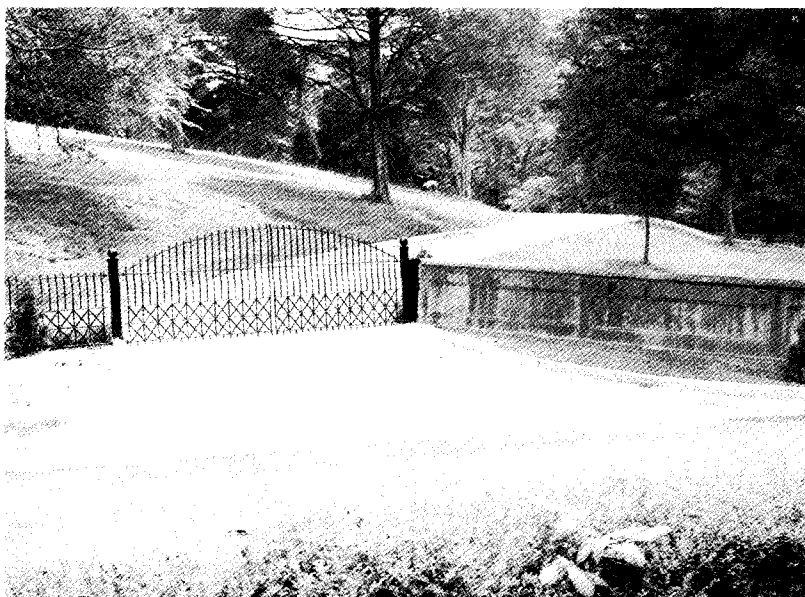
Figure 12. Photograph of Vann Road Entrance, c. 1973.

Vann Road Entrance -- A second entrance and cul-de-sac drive was completed by opening and turning back the concrete wall along a section of Vann Road (1973--see Fig. 12). Many new grave sections were laid out and a

ings. Another example is the Vann Road Entrance. The historic concrete wall was broken and two sections were awkwardly turned back to make the opening for the drive. An attempt was made to imitate the original entrance gates, but the metal is a much lighter material and does not reflect the quality of design or detail of the original gates.

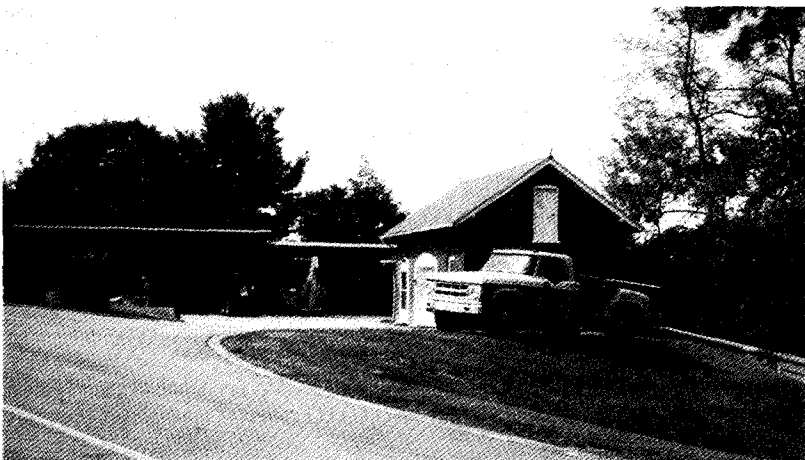
Figure 10. Maintenance additions to Stable/Utilityarea, 1991.

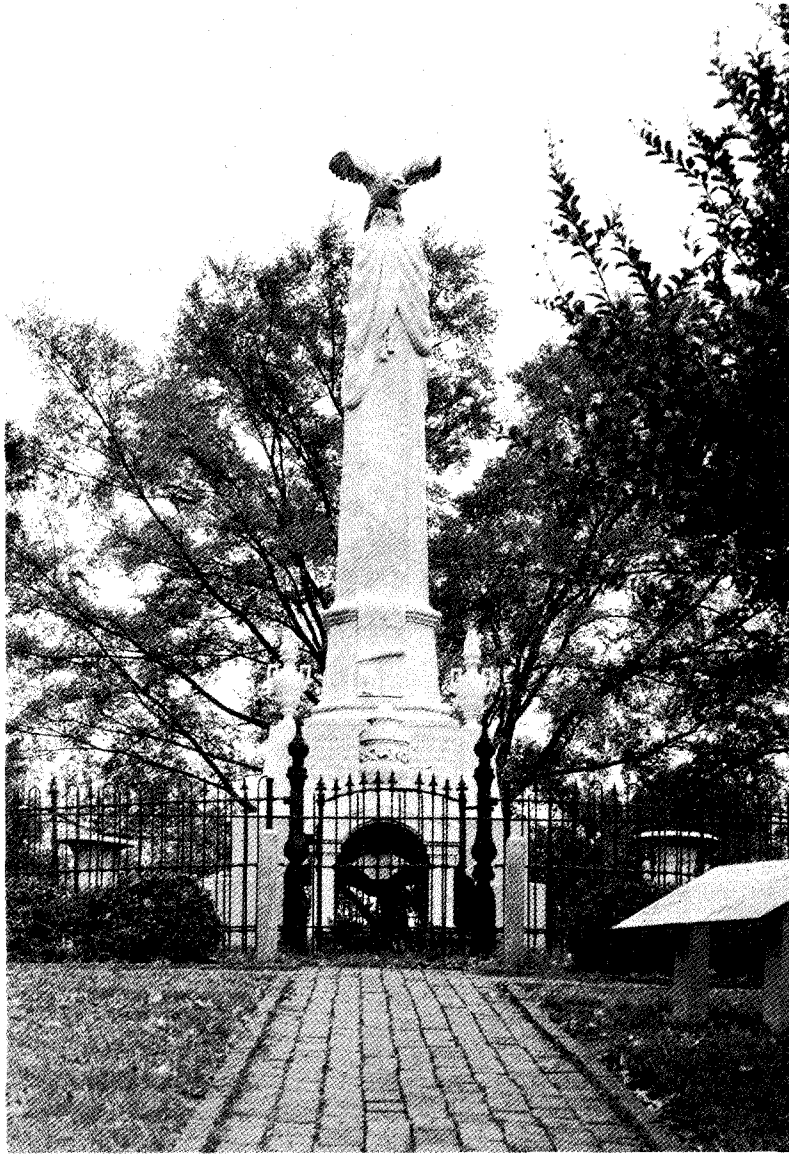
Figure 11. Monument Area, c. 1970.

Monument Area -- Brick walks installed (1960), hedge installed and removed (1960, c. 1970), second fence installed around the Johnson family graves (with, or instead of hedge not established, c. 1970--see fig. 11).

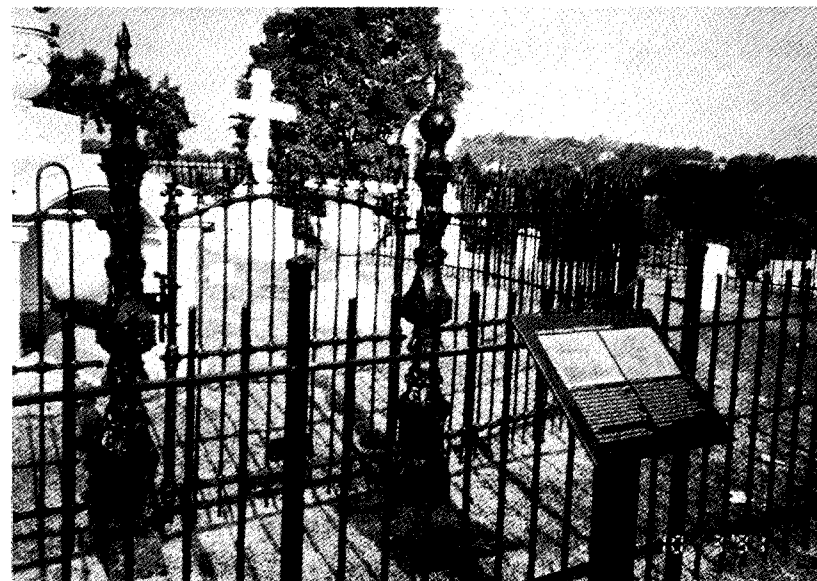
Figure 19. Existing fencing around the monument, 1991.

area. This report, however, acknowledges the importance attached to the second fence by the family members who, wanting additional security for the family gravesite, requested the fence. In order to increase the integrity of the historic scene, the recommendation is to lower the outer fence twelve inches so that a visitor can distinguish the more ornate, circular fence around the Johnson Monument (See Figure 19).
