National Park Service
U.S. Department of the Interior

Submerged Resources Center

Beached Shipwreck Archeology: Case Studies from Channel Islands National Park

Matthew A. Russell

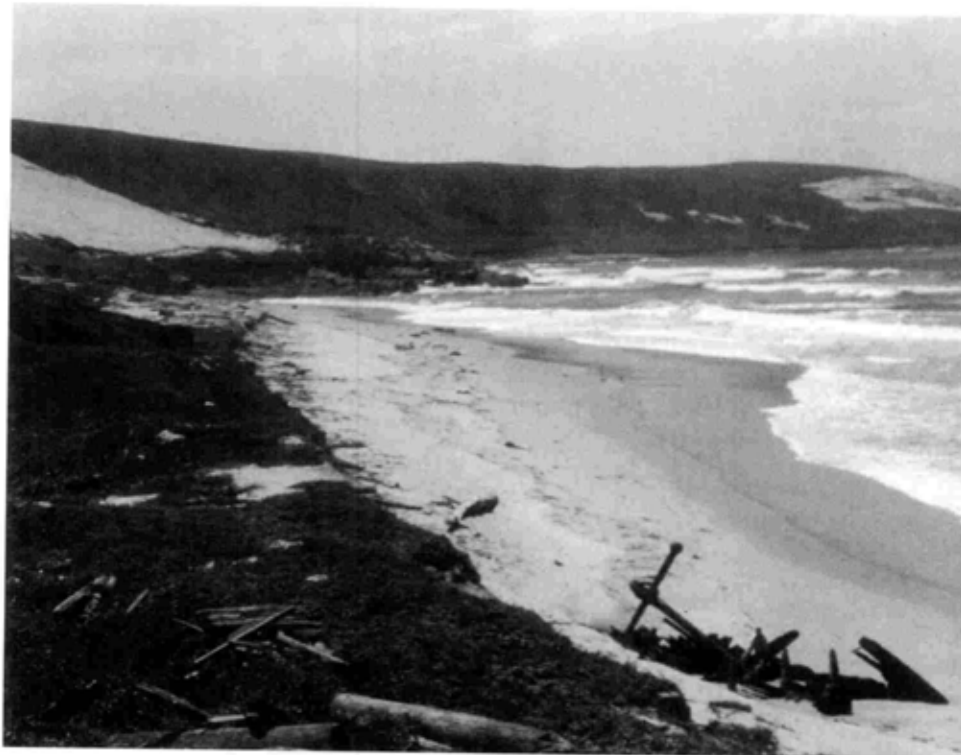
Figure 1.2. *Comet* site exposed in Simonton Cove in 1984. NPS photo by Reed McClusky.

National Park Service (NPS) personnel have known about the *Comet* site, located in Simonton Cove, San Miguel Island, since at least 1977 when the first documented site exposure occurred. The next recorded exposure was in 1984, when an NPS ranger took several photographs of *Comet's* exposed remains (Figures 1.2, 1.3 and 1.4). Although an anchor and capstan are clearly visible in the photographs, insufficient hull structure was exposed then to allow identification of specific features. Between 1984 and 1999, the site

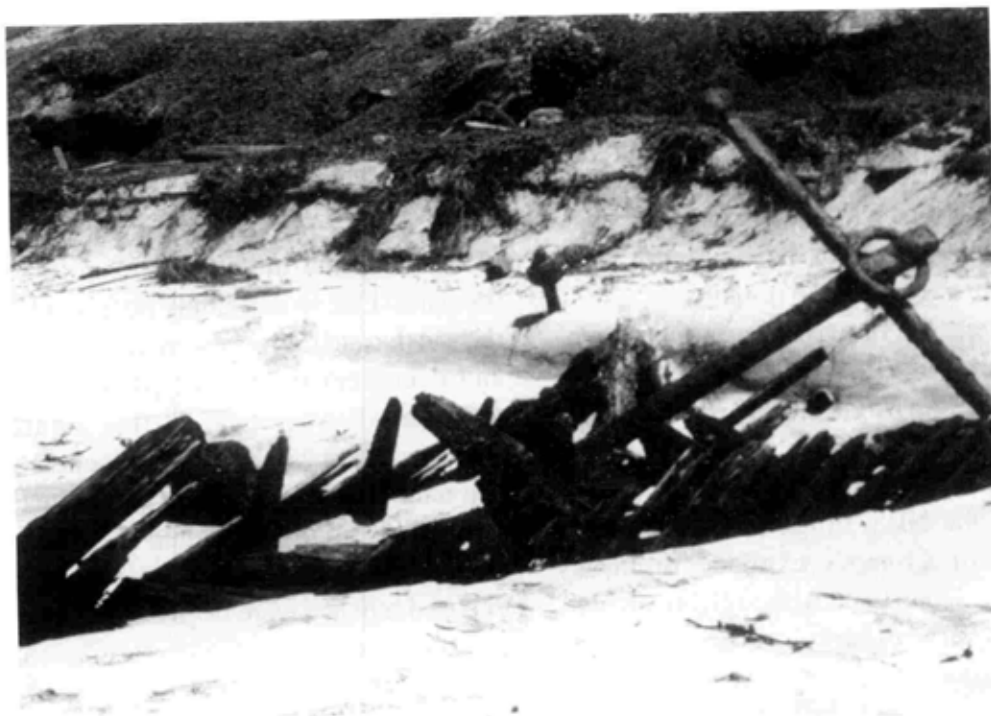
Figure 1.3. *Comet's* timbers and anchor exposed in 1984. NPS photo by Reed McClusky.

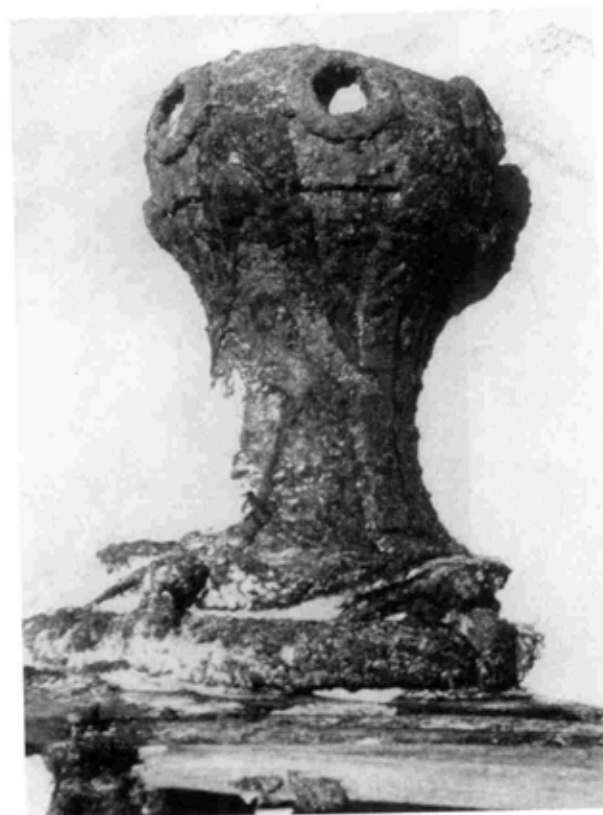
Figure 1.4. *Comet's* capstan in 1984. NPS photo by Reed McClusky.

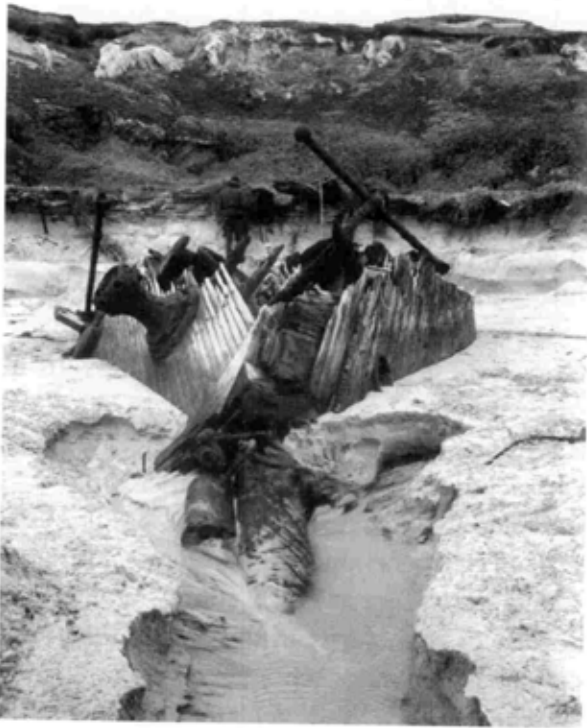
Figure 1.5. *Comet* site in April 1999, looking straight towards the bow, which is canted to the left in this photo. The forecastle deck is to the left, port side outer hull planking to the right and the bowsprit is in the bottom of the photo. NPS photo by Matt Russell.

intact bow from the break of the forecastle deck forward (Figure 1.5). The bow section is heeled to starboard; consequently, much of the port side has been exposed and is now deteriorated. But the starboard side, including the starboard half of the forecastle and main decks, is largely intact with machinery still mounted in its original location. Although only the bow section was observed during this project, this section of *Comet's* hull is the most intact and well-preserved Pacific Coast lumber schooner documented in the archeological record. Only one other intact section of lumber schooner hull has been recorded on the West Coast, which was a small section of the side of

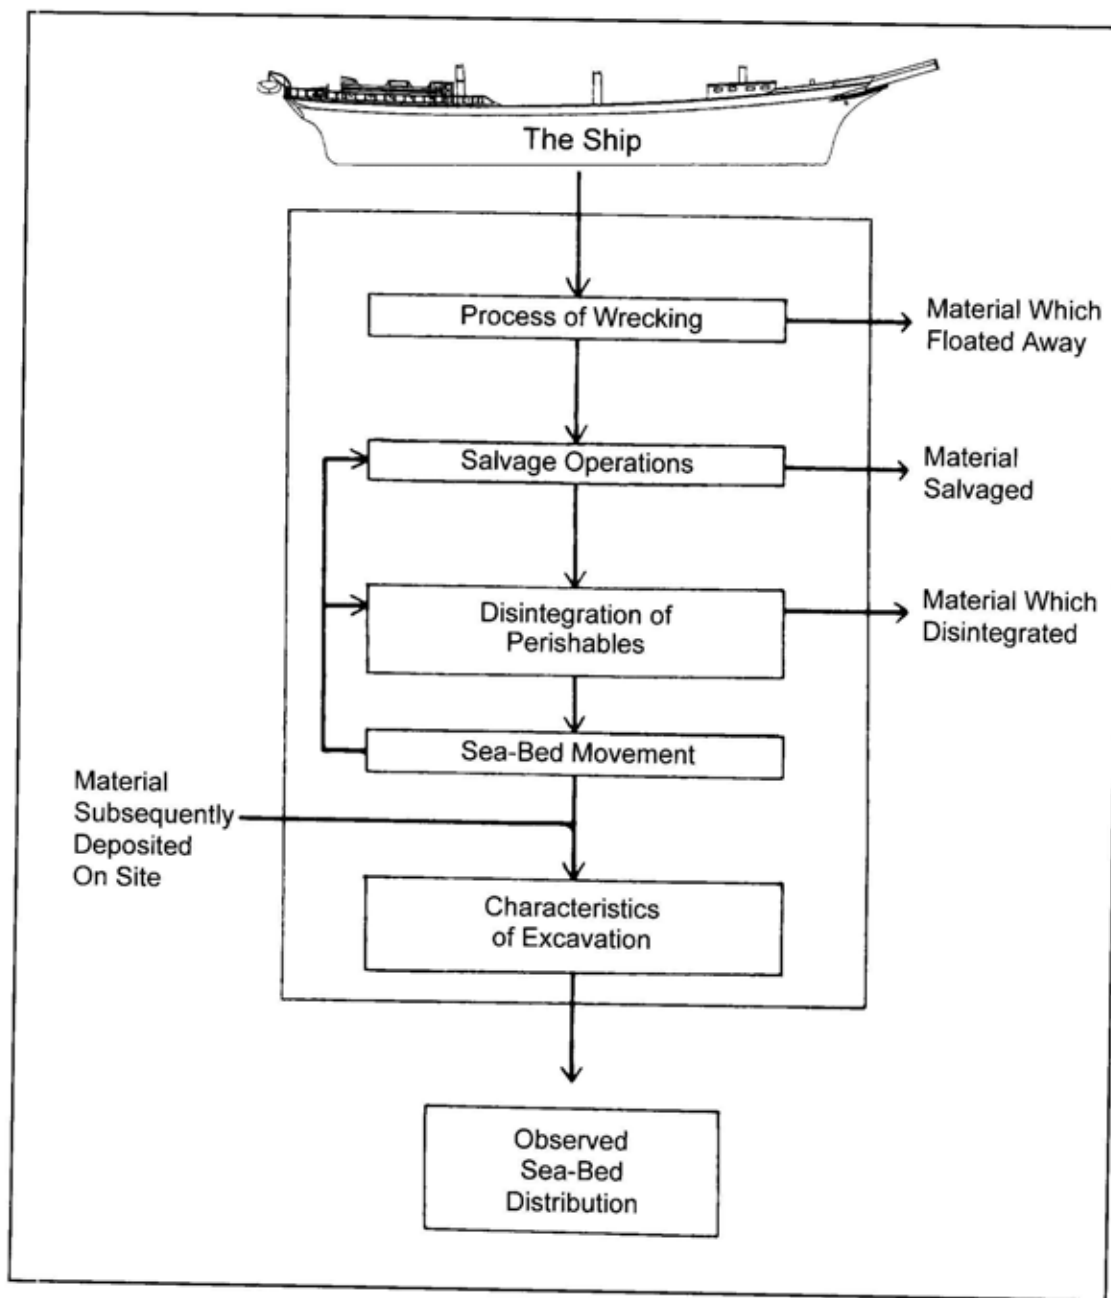
Figure 1.6. Shipwreck site formation processes based on Muckelroy (1978:158).

disintegration of perishables, sea-bed movement, and deposition of intrusive materials (Figure 1.6). A close examination of site formation processes at work on these three shipwrecks has contributed a more complete understanding of the archeological record.

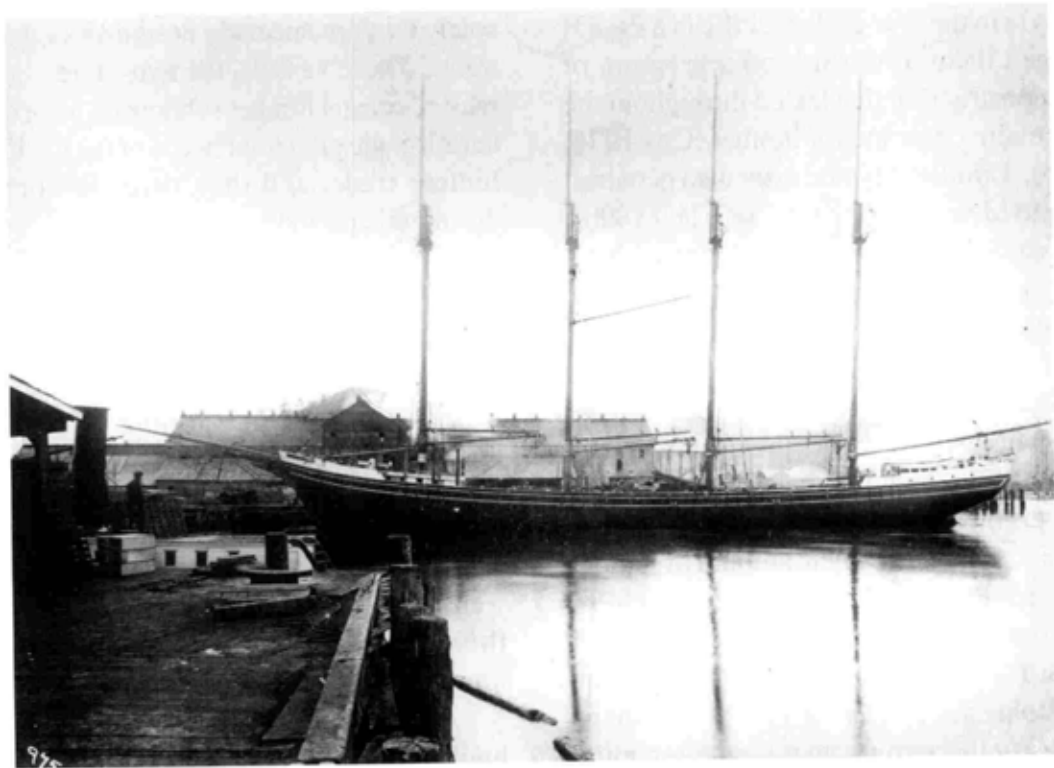
Figure 2.1. Schooner *Watson A. West* at an unknown port. *Watson A. West* was also built by the Hall Brothers. Photo courtesy of San Francisco Maritime NHP.

A distinctive vessel-type emerged for lumber transportation: the Pacific Coast lumber schooner, whose design was influenced by Pacific Coast environmental conditions and the requirement to carry an all-lumber cargo (Figure 2.1). The lumber schooner carried the raw material of California development. It delivered the basic construction material, which laid the foundation for nearly all California's metropolitan centers, making the vessel regionally significant as the primary cargo carrier.

Along with a distinct hull design, West Coast lumber schooners also had a unique schooner rig. Known as "baldheaded" schooners, they often carried only their gaff sails, preferring to run without topsails because "in the long beat to windward of the return trip there were no gafftopsails to shift when tacking" (Weinstein 1978:20). Many lumber schooners were "terns," or vessels with masts of equal height (Bauer 1988:271) (Figure 2.1). Some schooners were

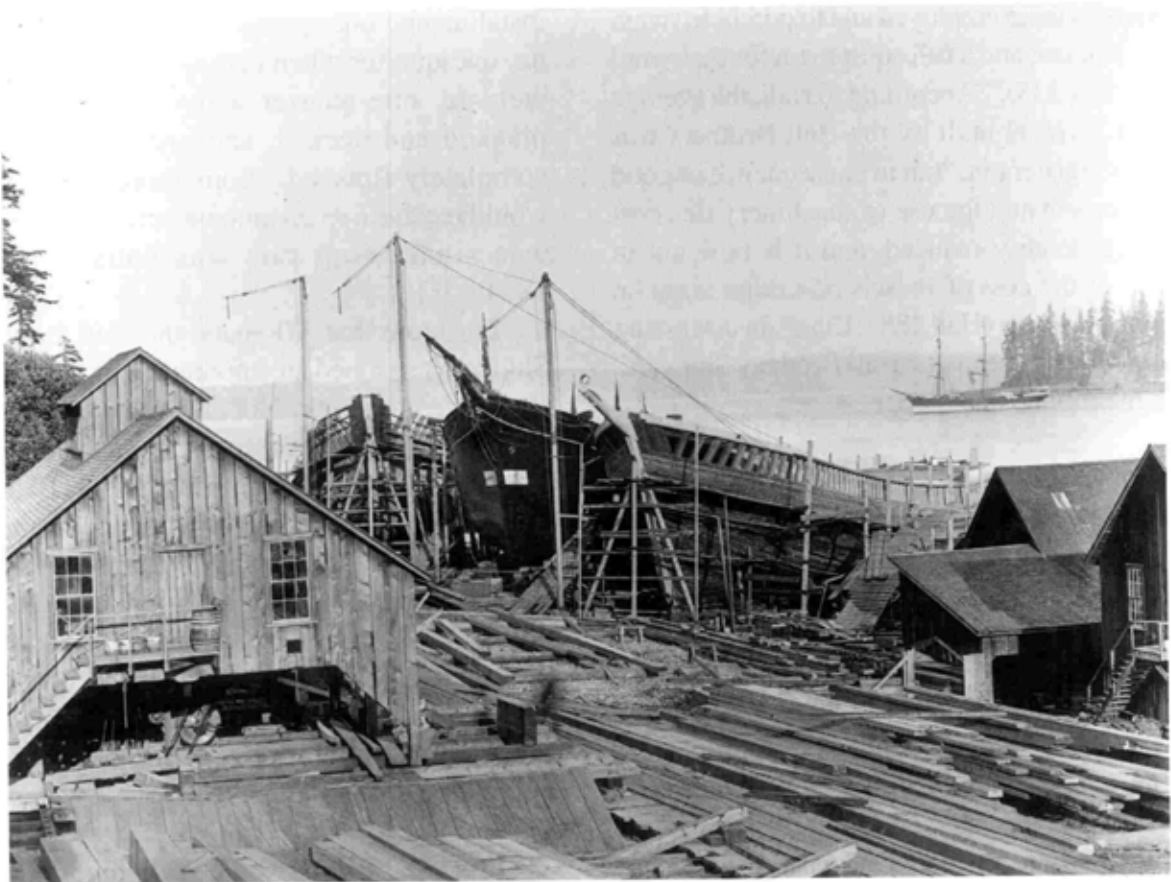
Figure 3.2. Hall Brothers Shipyard, Port Blakely, Washington, 1899. Courtesy of San Francisco Maritime NHP, Wilhelm Hester Collection, F17.20,149nl.

Mill Company, owned by Renton, Holmes and Company (Lyman 1951:99) (Figures 3.1 and 3.2). Renton promised to supply the Hall Brothers with lumber at a reasonable price, and even built a "set of wooden tracks shod with strap iron" at his (Renton's) expense to carry the lumber one-quarter mile to the shipyard (Weinstein 1978:43). On his visit to Port Blakely in December 1881, Henry Hall (the author) noted that the shipyard and the lumber mill were the only industries in Port Blakely (Lyman 1945:85).

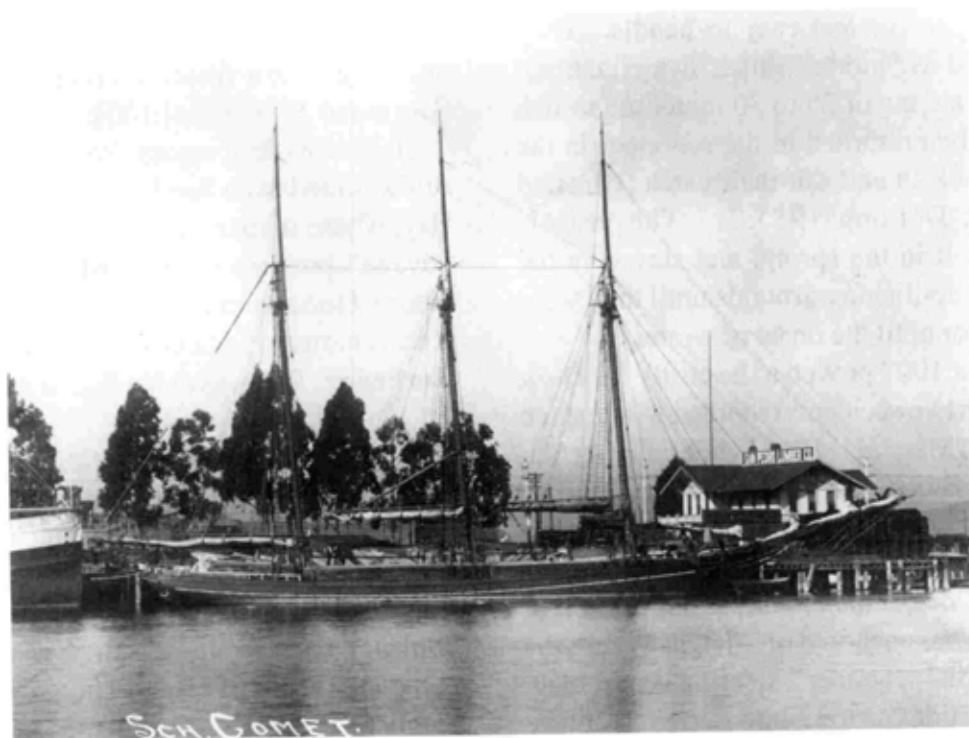
Figure 3.3. Schooner *Comet* docked at San Pedro, California. Photo by William Phelps, courtesy of San Francisco Maritime NHP.

The schooner *Comet* was launched from the Hall Brothers' Port Blakely yard in October 1886 (Figures 3.3 and 3.4). Once again, the original contract for the vessel survives, giving a complete record of construction. *Comet* had a length of 136.0 ft. on the keel, 144.6 ft. overall, with a breadth of 35.2 ft., a depth of 11.4 ft., and registered 429.74 gross and 408.26 net tons (JPSL:Hall Brothers Shipyard Contract Number 49, 1886; NA 1886:RG 41:Registry 18). Like *Dora Bluhm*, it had one deck, three masts, a billet head and an elliptic stern (NA 1886:RG 41:Registry 18). It was constructed entirely of Douglas fir, again with the exception of the stempost and sternpost, which were "hardwood (JPSL 1886)." *Comet* was entirely iron fastened, with the addition of 1¼-in. locust treenails on the outer hull planking. The vessel was also equipped with a centerboard, and, like *Dora Bluhm*, had bow and stern ports for loading and unloading lumber. During construction, *Comet* was "salted from lower edge of wales to deck." The rest of the fitting out and furniture was exactly the same as *Dora Bluhm*, down to the 24 in. windlass purchase and Number 3 capstan. For this vessel, the Hooper Brothers of San Francisco and C. F. S. Lass of Oakland agreed to pay \$30,000 in US Gold Coin, over four installments (JPSL 1886).

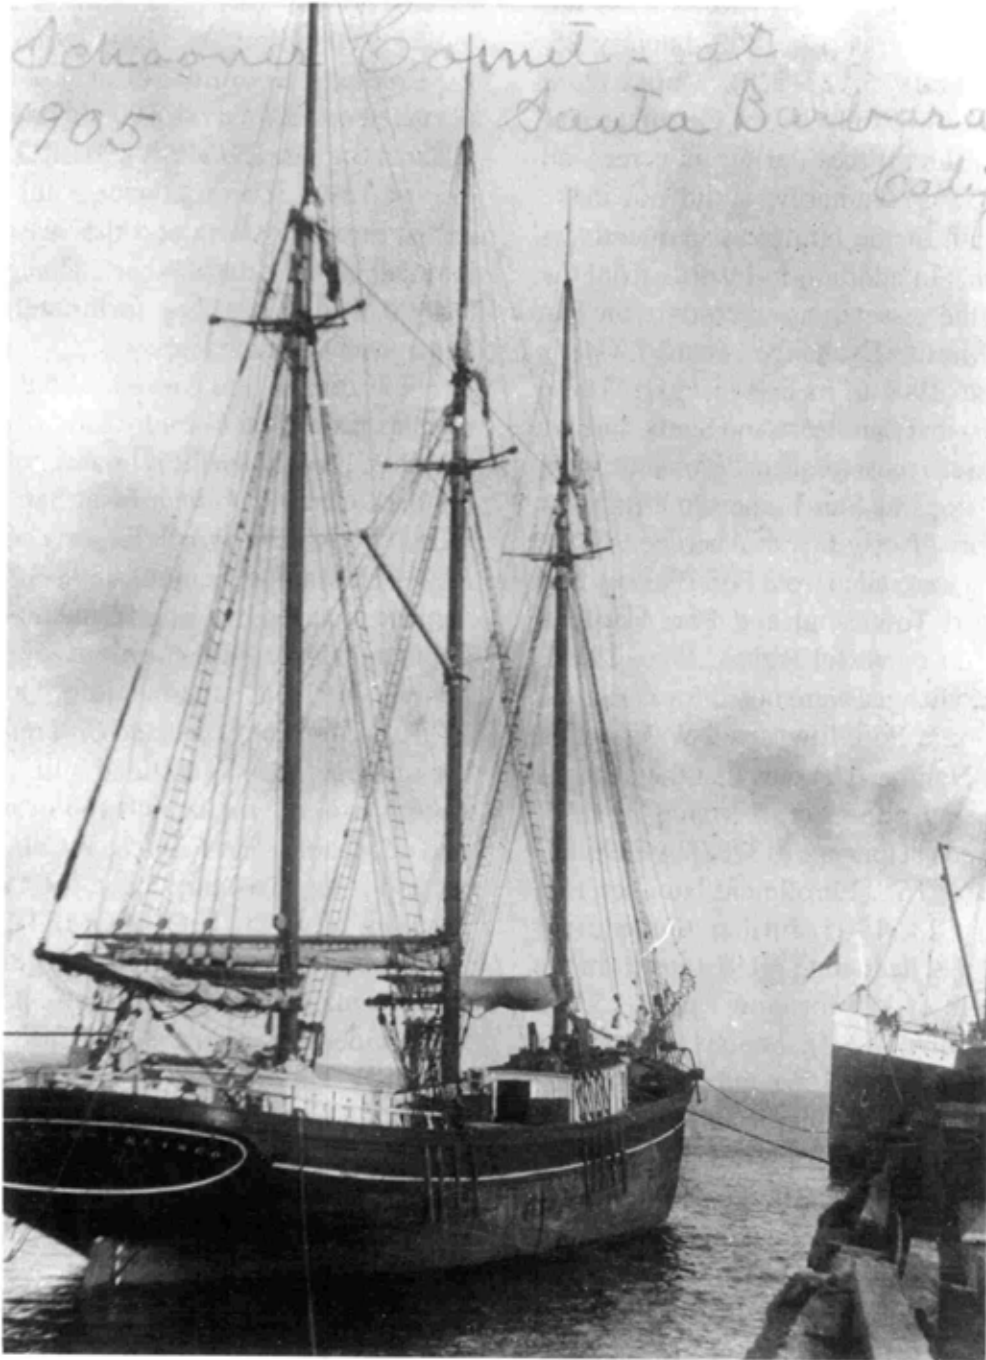
Figure 3.4. *Comet* at Santa Barbara, California, 1904. Photo courtesy of San Francisco Maritime NHP.

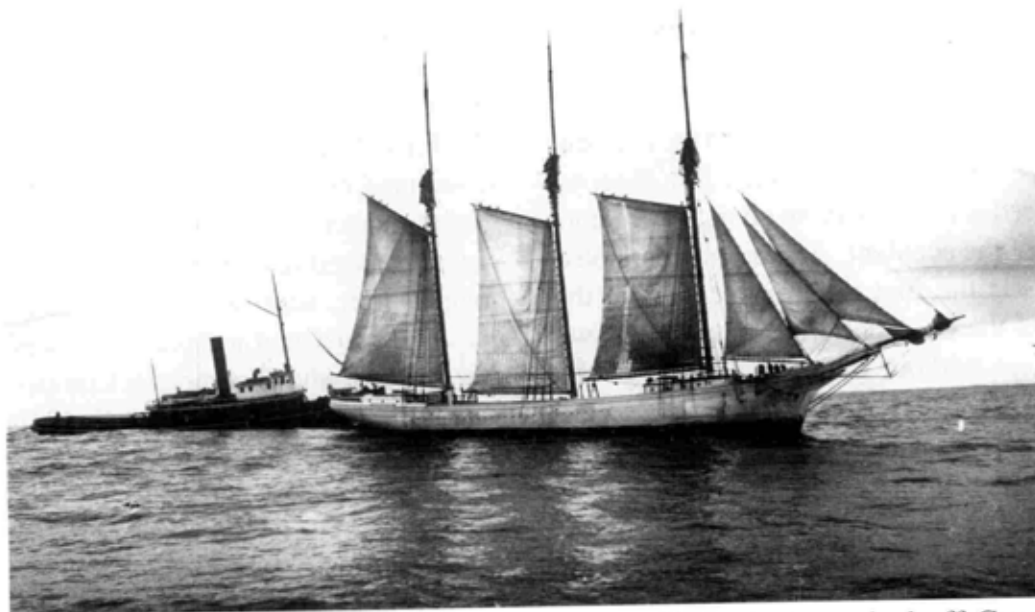
Figure 3.5. The schooner *J. M. Colman* about 1900, photographed off Cape Flattery or in the Straits of Juan de Fuca. *J. M. Colman* was built by the Hall Brothers Shipyard, who also built *Comet*. Photo by Hiram Hudson Morrison, courtesy of San Francisco Maritime NHP.

The Hall Brothers launched the schooner *J. M. Colman* in April 1888 (Figures 3.5 and 3.6). The vessel measured 157.0 ft. long, 37.0 ft. in breadth, 11.3 ft. deep, 471.95 gross tons, and 448.36 net tons. Like the other two schooners, it had one deck, three masts, a billet head and an elliptic stern (NA 1888:RG 41:Enrollment 43). It was built for J. J. McKinnon of San Francisco, who was the sole owner. Unfortunately, *J. M. Colman*'s original contract has not been located, but a hand-written ledger sheet indicates the vessel was originally known as Hull Number 56, and was built for \$33,286.84 (JPSL, Hall Brothers Shipyard Ledger Sheet Number 56, 1888). *J. M. Colman* was one of the largest three-masted schooners built on the coast, registering only 13 gross tons less than the largest, *W. F. Jewett* (Haller and Kelly 1990:22). The first master of *J. M. Colman* was C. H. Atwood (NA 1888:RG 41:Enrollment 43).

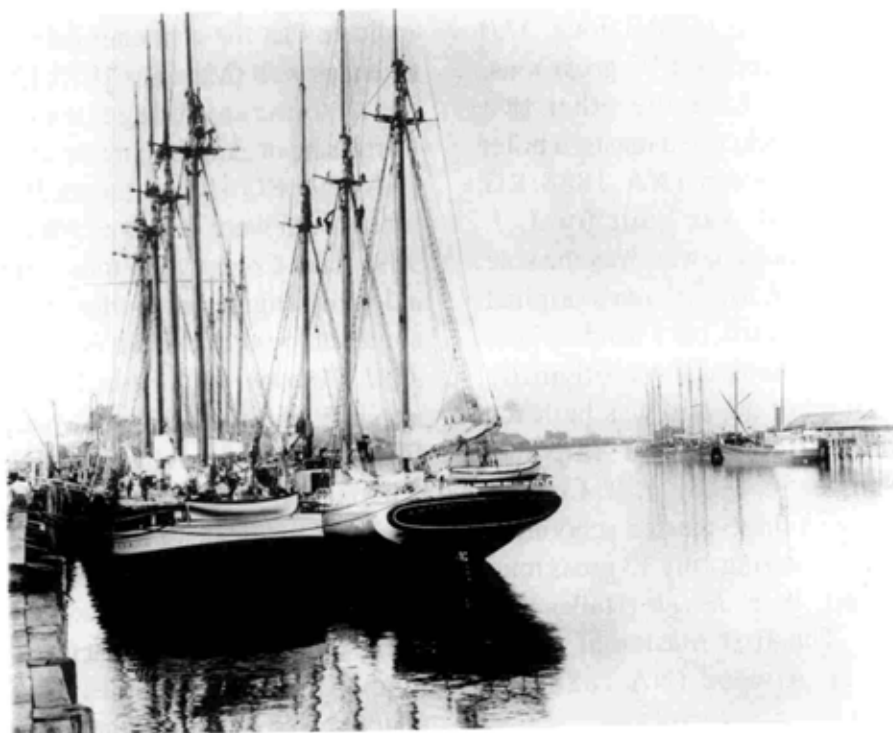
Figure 3.6. *J. M. Colman* in port at San Pedro, California. Photo courtesy of San Francisco Maritime NHP.

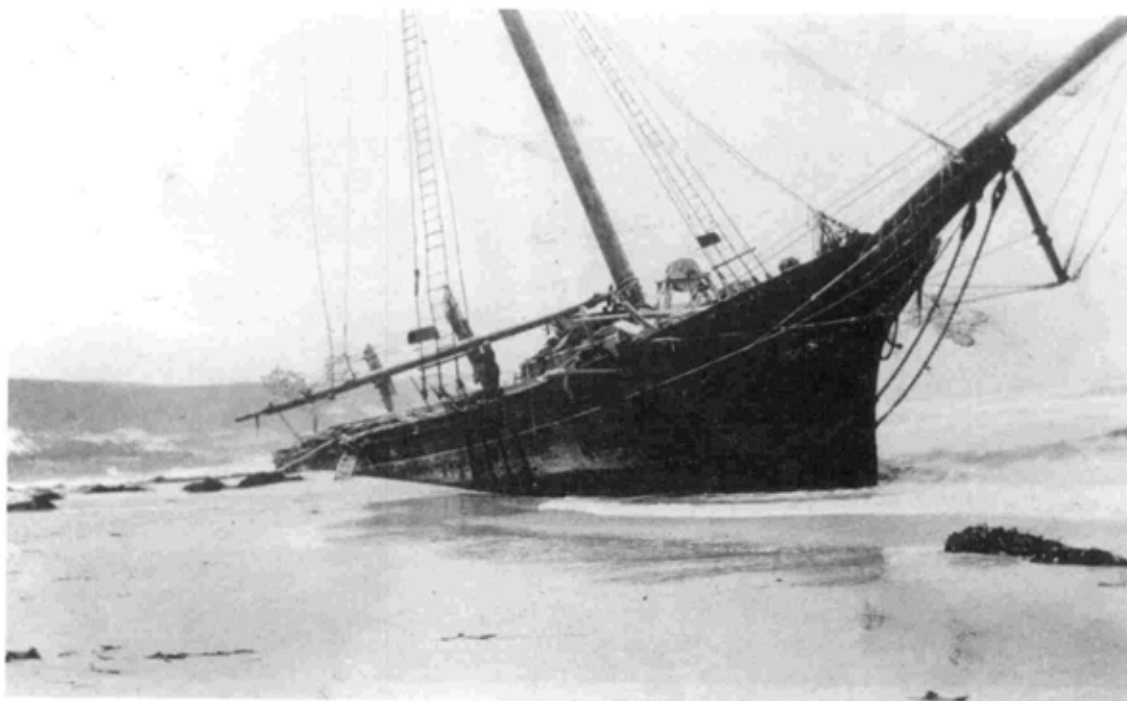
Figure 3.9. *Comet* aground in Simonton Cove, San Miguel Island. Photo courtesy of Santa Barbara Museum of Natural History.

As discussed above, a series of photographs were taken of *Comet* sometime after the wreck and before the vessel broke up. These undated photos, from the Santa Barbara Museum of Natural History's collection, show the schooner lying broadside to the surf with its port side to sea (Figures 3.9–3.11). The vessel is firmly embedded in the sand, probably between the

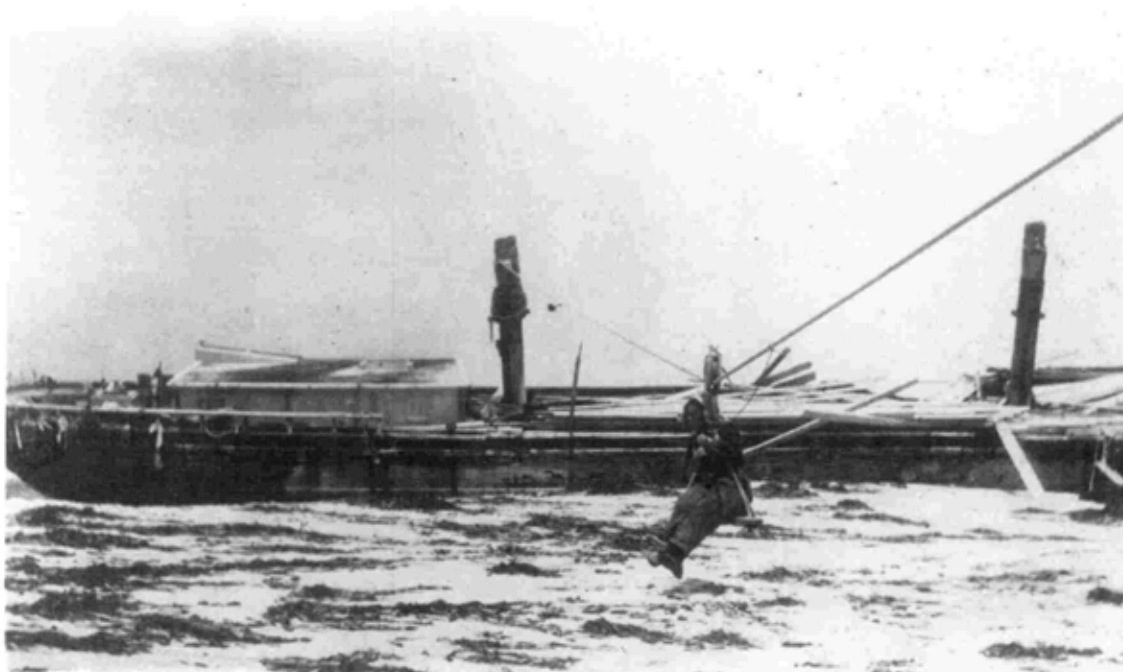
Figure 3.10. *Comet* aground in Simonton Cove, San Miguel Island, with unidentified woman. Photo courtesy of Santa Barbara Museum of Natural History.

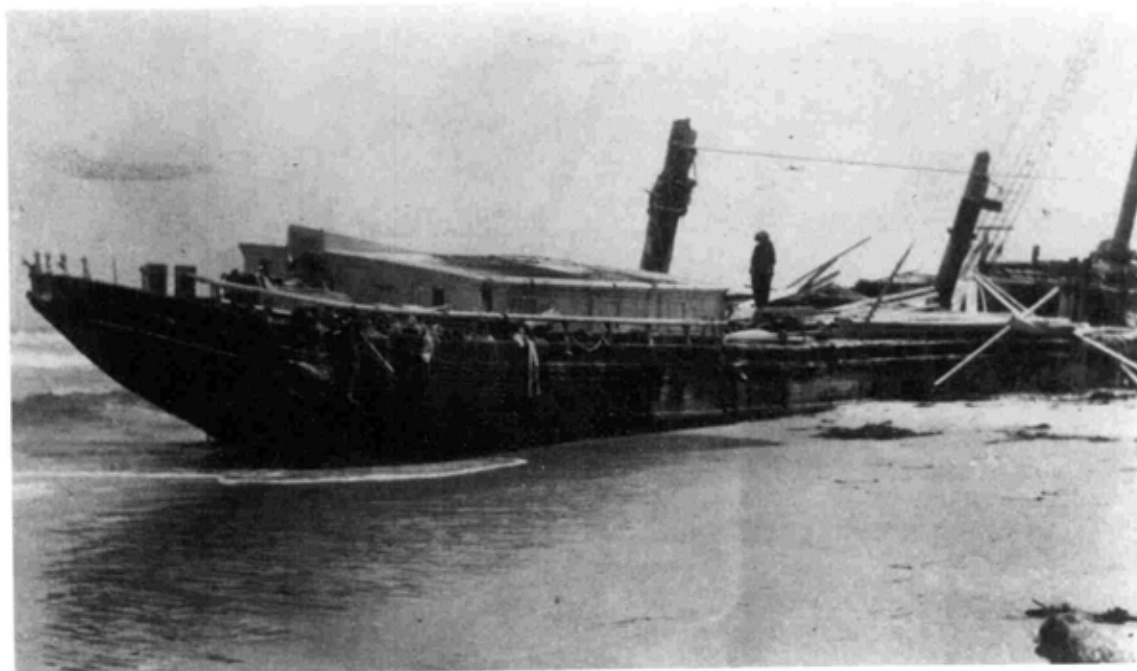
Figure 3.11. *Comet's* stern, aground in Simonton Cove, San Miguel Island. Photo courtesy of Santa Barbara Museum of Natural History.

uses. Salvage alone cannot explain, however, why only the bow is present today. Observation of site layout suggests a series of events that led to the wreck's present condition. The last known historical photographs of *Comet* (see Figures 3.9–3.11) show the vessel laying broadside to the shoreline, somewhere between high and low tide. Subsequently, *Comet*'s bow broke away from the rest of the hull at a point just aft of the forecastle deck and forward of the forward deckhouse (Figure 4.105). It is possible the stempost/keel joint broke, but the pointers kept the bow structure to aft of the forecastle deck together. The pointers crossed and were fastened into multiple frame pairs, including all the cant frames, and would have provided reinforcement to help bind them together (Figures 4.85 and 4.86).

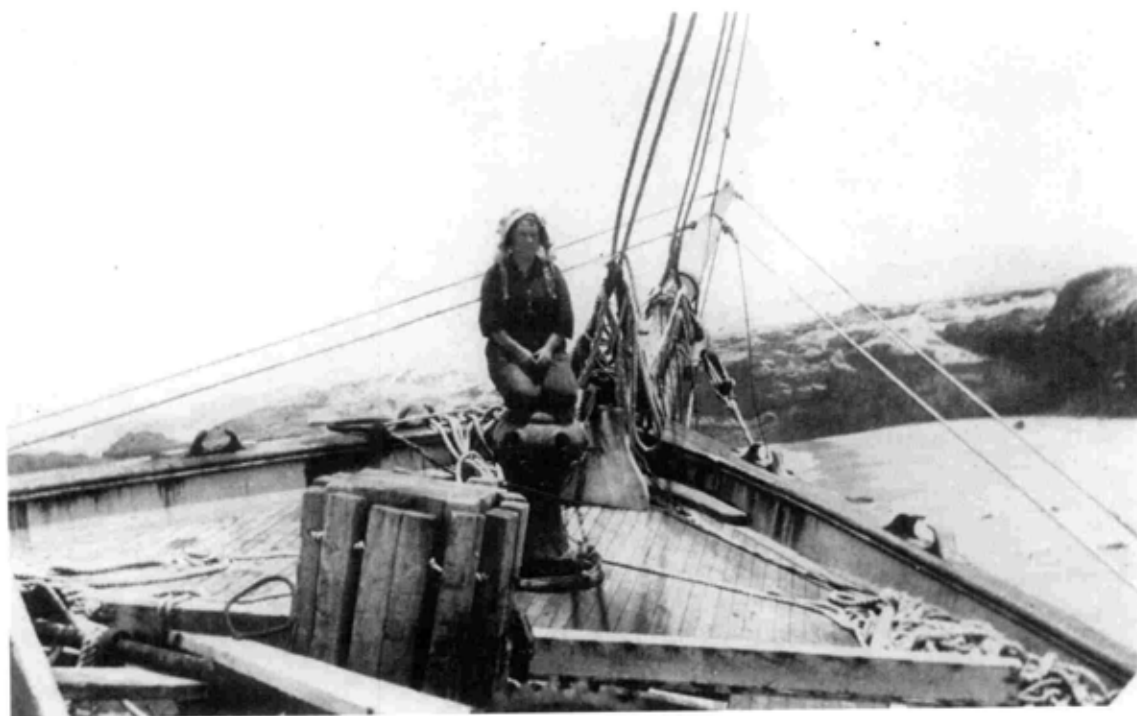
Figure 3.12. Unidentified woman on *Comet's* fore-castle deck. Photo courtesy of Santa Barbara Museum of Natural History.

mean high- and low-tide lines. The foremast is still standing, but the main- and mizzenmasts are gone. Two photographs, taken from just forward of the foremast looking forward, show a man and woman standing on *Comet's* bow (Figures 3.12 and 3.13). These photographs are the key evidence in identifying wreckage in Simonton Cove as *Comet*. In the background of the photographs is an easily identifiable rock formation that is east of the wreckage in Simonton Cove today (Figure 3.14). Therefore, with the help of these historical photographs, a positive identification of the *Comet* wreck site can be made.

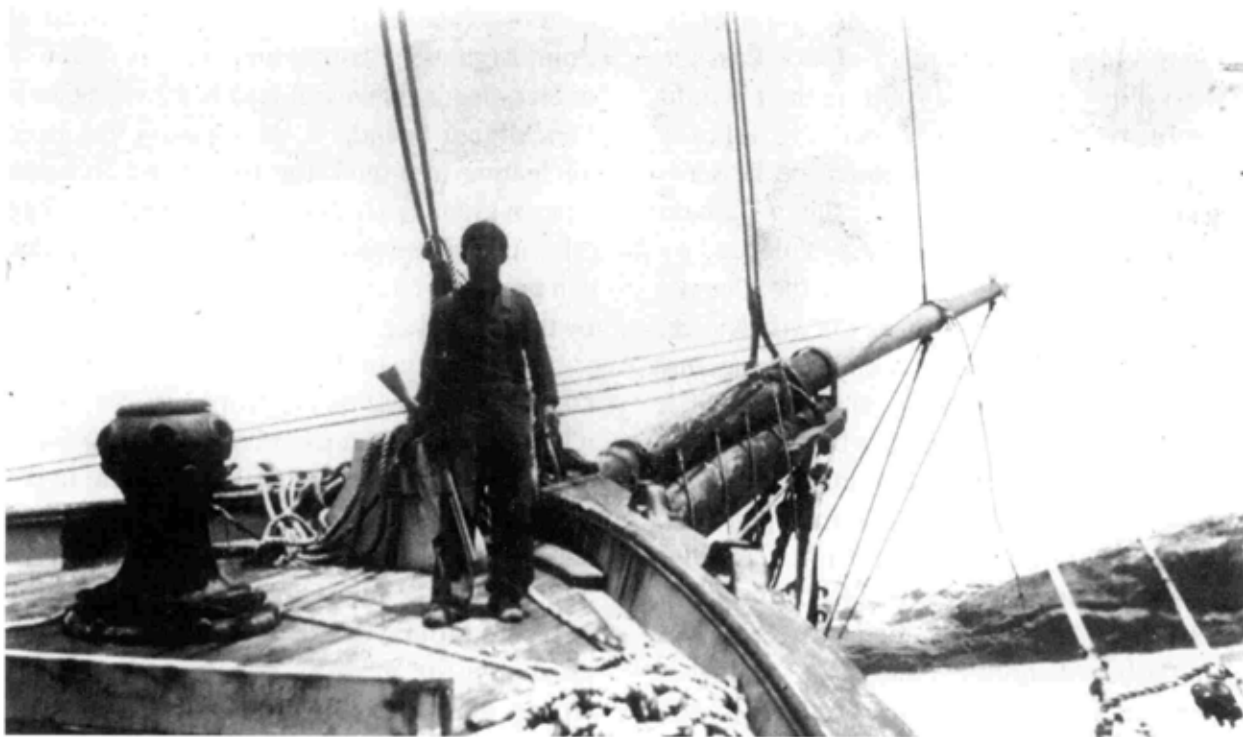
Figure 3.13. Unidentified man on *Comet's* forecastle deck. Note the capstan which is still mounted in the same location today. Also, note the rock ledge in the background which can be compared to Figure 3.14. Photo courtesy of Santa Barbara Museum of Natural History.

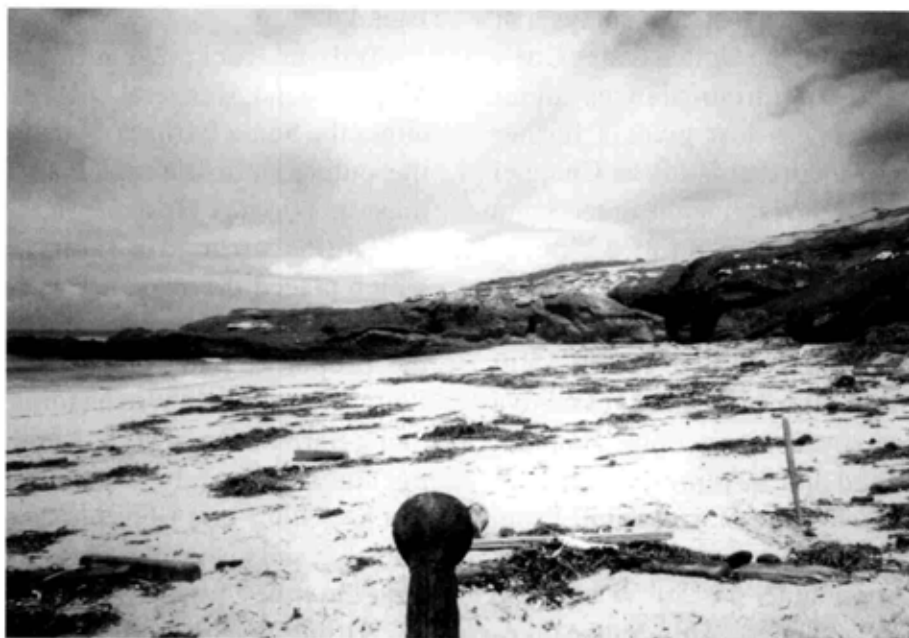
Figure 3.14. Anchor stock sticking out of the sand in Simonton Cove in the 1980s. Compare the rock ledge in the background to Figure 3.13. NPS photo by Don Morris.

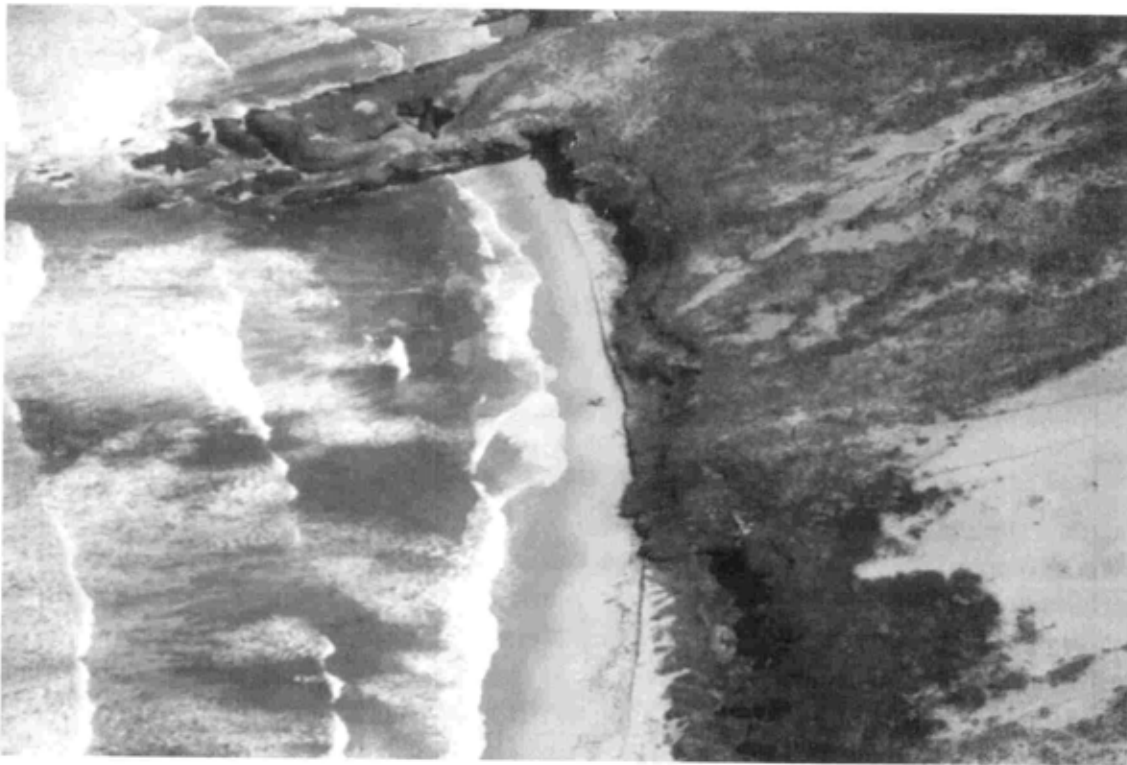
Figure 4.3. Aerial view of *Comet* site in Simonton Cove. *Comet* bow wreckage is on the beach in the center of the photograph. Photo courtesy of Robert Schwemmer.

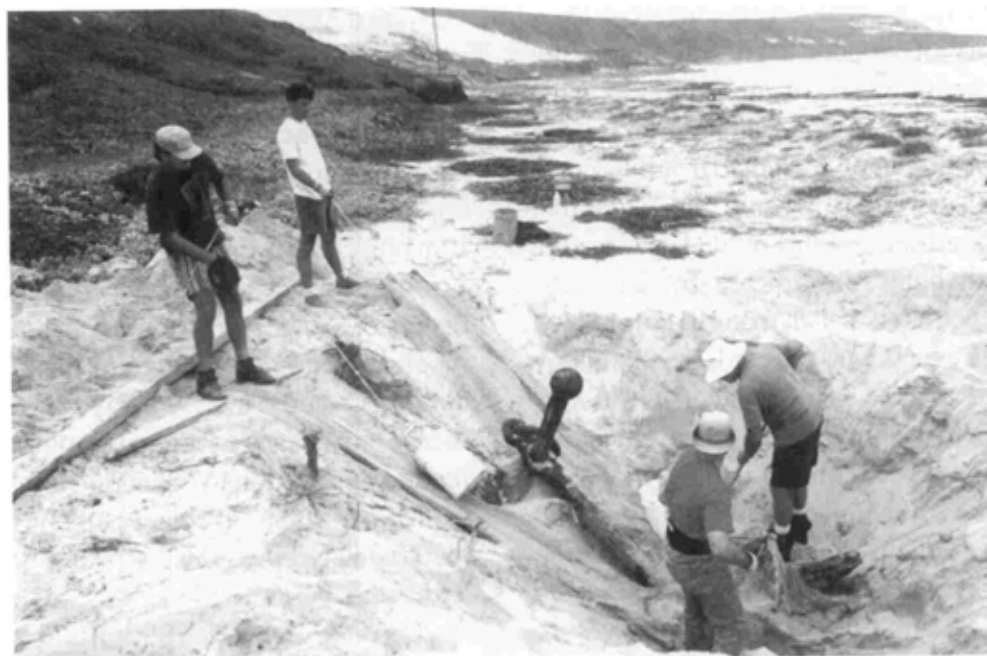
Figure 4.6. Volunteers working to expose *Comet* wreckage in October 1993. Just the tip of the anchor stock was exposed before digging began. NPS photo by Matt Russell.

Four volunteers arrived on October 19, 1993, and work began that afternoon. The tip of the anchor stock was used as a starting point for sand overburden removal. Project personnel and volunteers spent October 20–21, 1993, excavating (Figure 4.6). The anchor was

uncovered, along with a few timber ends, and nothing more. Although the timbers located are certainly from *Comet*, no details could be recorded because the unstable walls of the hole kept collapsing as the timbers were exposed. In total, about 21 cu. yds. of sand were removed from a hole 21 ft. in diameter at the top and 7 ft. deep. The few remains uncovered indicated this site could not be exposed without mechanical excavation and shoring. Barring landing a backhoe, *Comet* would have to wait for detailed recording until naturally uncovered.

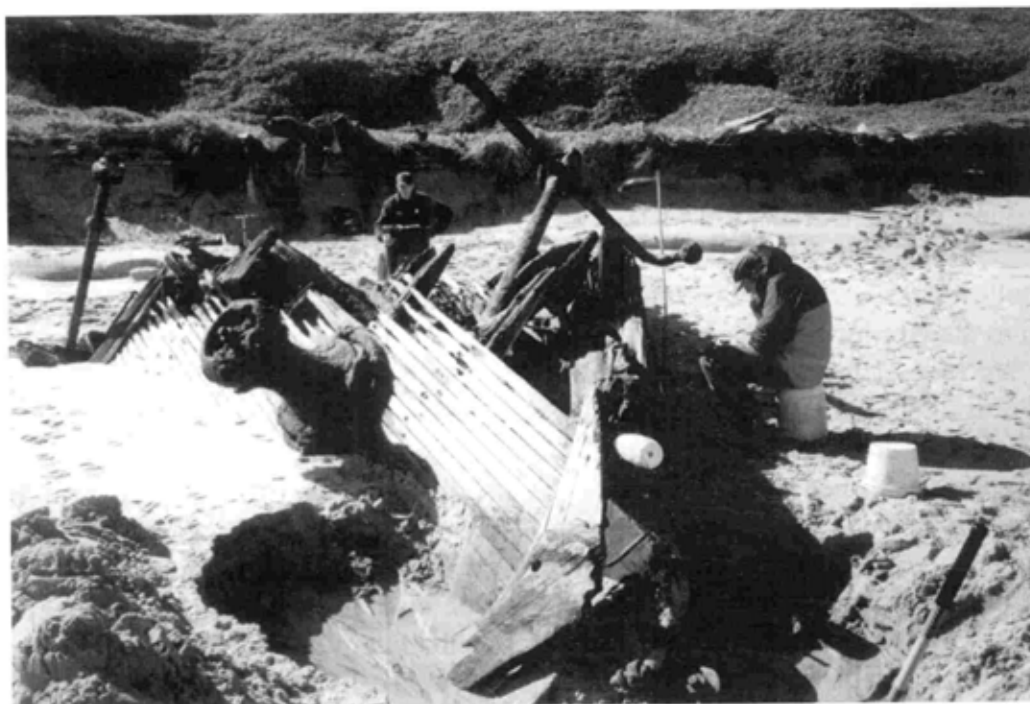
Figure 4.7. Archeologists mapping *Comet's* bow section. NPS photo by Don Morris.

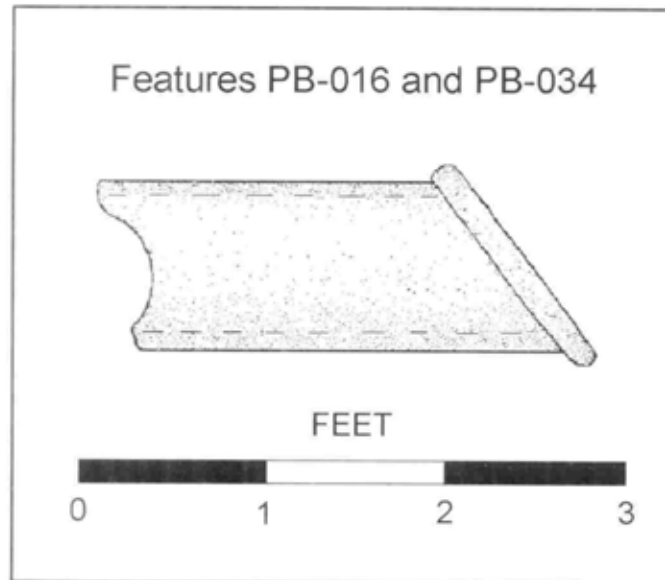
Figure 4.8. Features PB-016 and PB-034 are two identical hawse pipes. Drawing by Matt Russell.

The most diagnostic objects in the intertidal zone are two hawse pipes, features PB-016 and PB-034, of identical dimensions (Figures 4.8 and 4.9). Hawse pipes were located on each side of a vessel's bow and allowed the chain cable to pass through the hull. Hawse pipes are distinguishable from mooring pipes (which allowed mooring lines to pass through the main deck bulwarks on the main deck) and chain pipes (which allowed the chain cable to pass through the main deck into the chain locker) by their

length and their sloping outer faces, which must conform to a bow's compound curves. PB-034 is located 50 ft. 6 in. northwest of PB-016. The two hawse pipes have the same dimensions, which, combined with proximity, indicate they came from the same vessel. The pipes have an overall length of 2 ft. 11 in., an outside diameter of 11 in. and an inside diameter of 9 in.

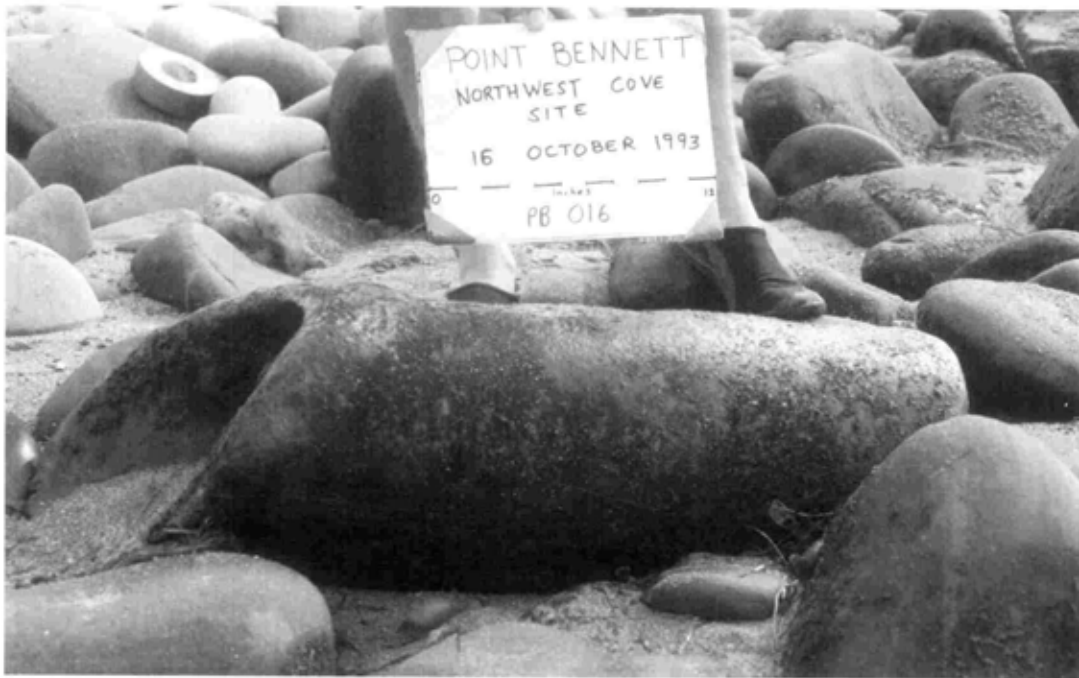
Figure 4.9. Hawse pipe (feature PB-016). NPS photo by Adriane Neidinger.

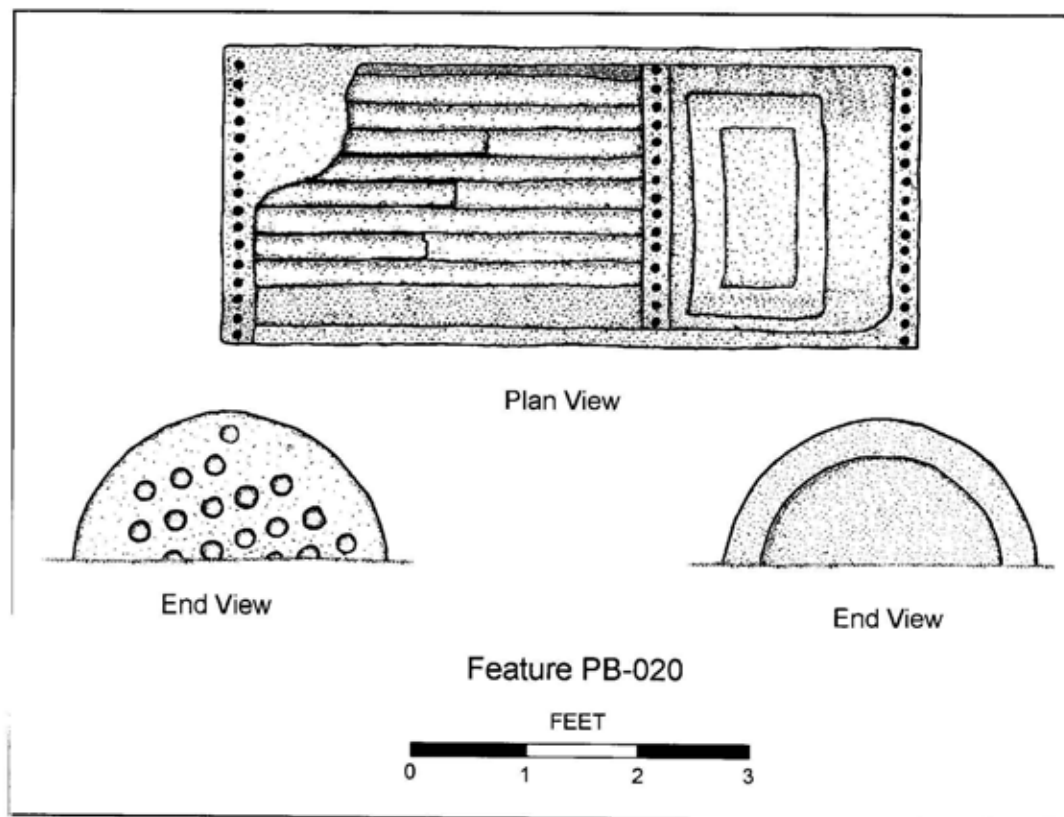
Figure 4.10. Donkey boiler (feature PB-020). Drawing by Matt Russell.

Feature PB-020 is another readily identifiable object, a steam donkey engine boiler (Figures 4.10–4.12). It is a cylinder

approximately 6 ft. 6 in. long and 3 ft. in diameter, its interior filled with 2¾-in. diameter tubes for about two-thirds of its length. Donkey engines, or “steam donkeys” as they were known, were found aboard coastal lumber schooners after the early 1880s (Cox 1974:231) and were used for a variety of purposes, including loading and unloading cargo, hoisting the sails and running the ship’s pumps. The donkey engine was usually located in the forward deckhouse, as in the coastal lumber schooner *C. A. Thayer*, built in 1895 by Hans D. Bendixsen and now on display at San Francisco Maritime National Historical Park. Like *J. M. Colman*, *Comet* and *Dora Bluhm*, *C. A. Thayer* is a three-masted lumber schooner and very similar in size and configuration to the Hall-built schooners.

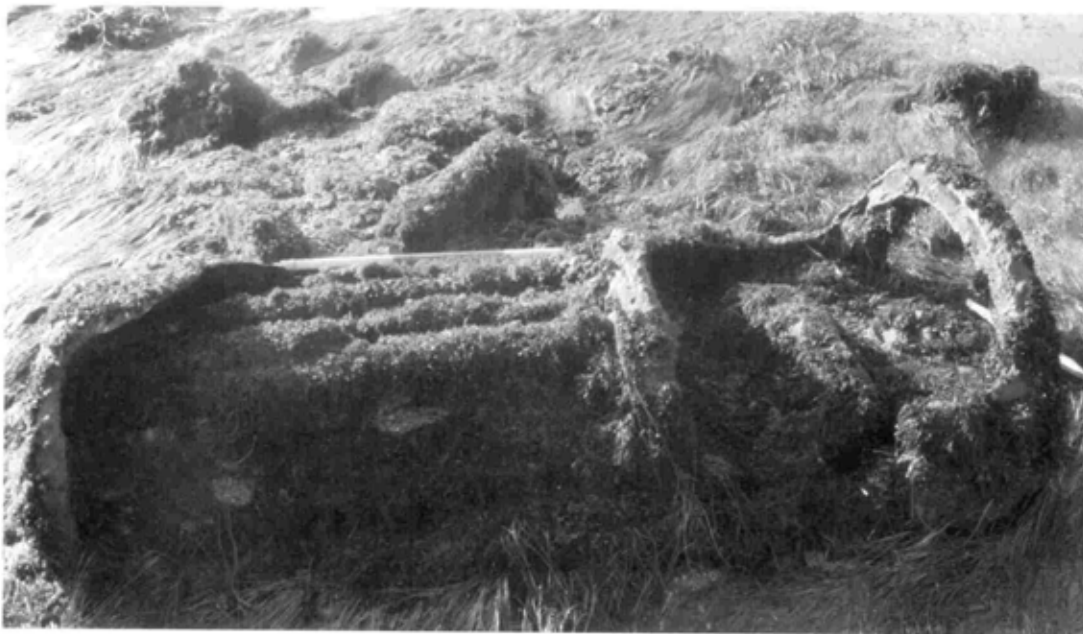
Figure 4.11. Donkey boiler (feature PB-020). NPS photo by Adriane Neidinger.
