National Park Service
U.S. Department of the Interior

Submerged Resources Center

Beached Shipwreck Archeology: Case Studies from Channel Islands National Park

Matthew A. Russell

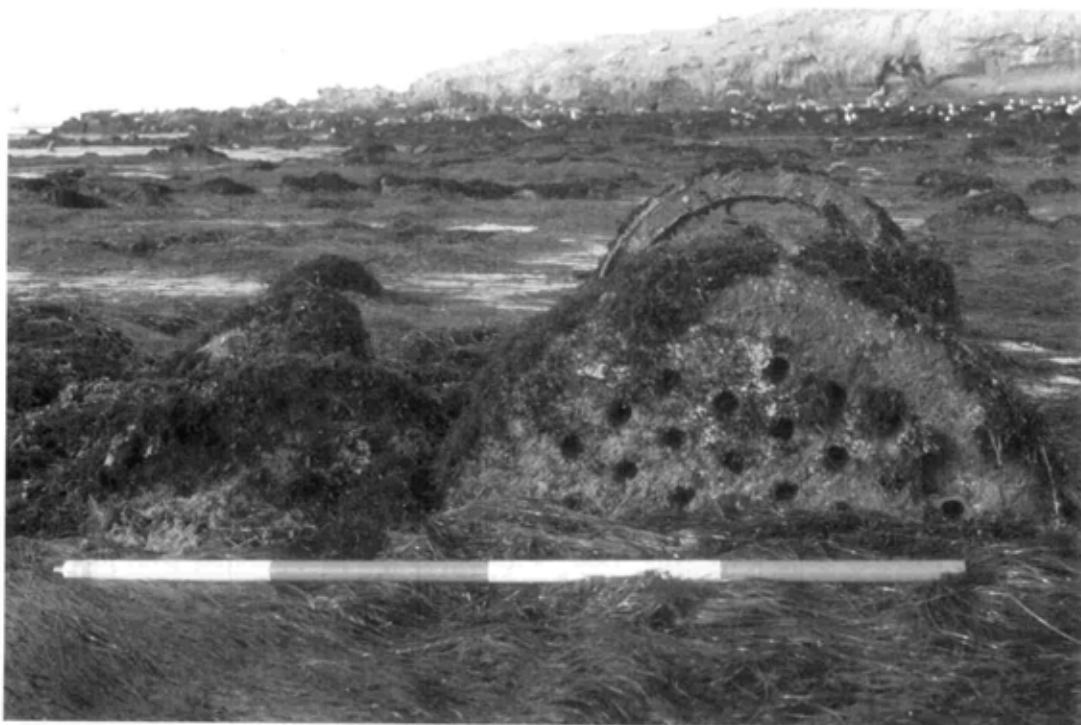
Figure 4.12. End view of the donkey boiler. NPS photo by Adriane Neidinger.

Feature PB-020 is another readily identifiable object, a steam donkey engine boiler (Figures 4.10–4.12). It is a cylinder

approximately 6 ft. 6 in. long and 3 ft. in diameter, its interior filled with 2¾-in. diameter tubes for about two-thirds of its length. Donkey engines, or “steam donkeys” as they were known, were found aboard coastal lumber schooners after the early 1880s (Cox 1974:231) and were used for a variety of purposes, including loading and unloading cargo, hoisting the sails and running the ship’s pumps. The donkey engine was usually located in the forward deckhouse, as in the coastal lumber schooner *C. A. Thayer*, built in 1895 by Hans D. Bendixsen and now on display at San Francisco Maritime National Historical Park. Like *J. M. Colman*, *Comet* and *Dora Bluhm*, *C. A. Thayer* is a three-masted lumber schooner and very similar in size and configuration to the Hall-built schooners.

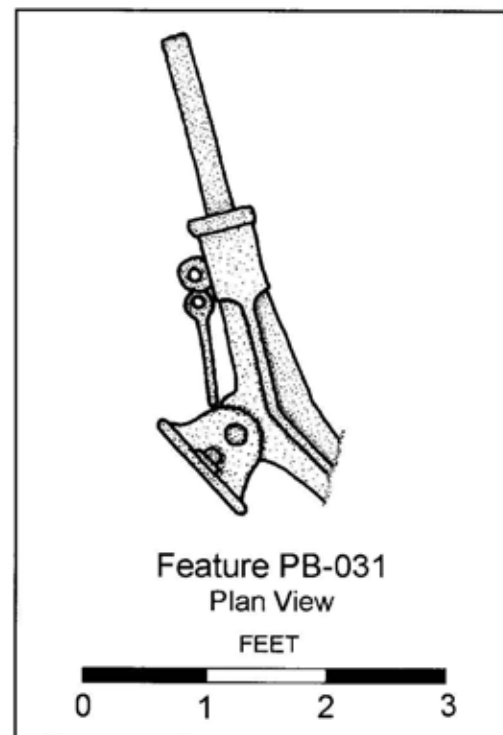
Figure 4.13. Crosshead mechanism from a pump-brake windlass (feature PB-031). Drawing by Matt Russell.

Another intertidal-zone object identified is PB-031, which is the crosshead mechanism of a hand-operated, pump-brake windlass (Figures 4.13 and 4.14). An example of this mechanism can also be seen on board *C. A. Thayer*, where it is mounted on the forecastle deck, directly forward the sampson post above the windlass. The crosshead was attached to the windlass by connecting rods that passed through the forecastle deck and were connected to the windlass purchase rims (de Kerchove 1961:614). Removable handles were inserted into the crosshead and the up-and-down motion supplied by two seamen rotated the purchase rims, which turned the windlass. This is the same type of windlass and mechanism recorded on *Comet* (see below). Feature PB-031 is partially obscured by encrustation and marine growth, but a portion of one of the removable handles is present. The overall length of the piece is 4 ft. The base of the crosshead mechanism was secured to the forecastle deck with two 1-in. diameter iron fasteners. The base is about 10 in. square and 6½ in. tall, which is similar to the crosshead mechanism found on *C. A. Thayer*.

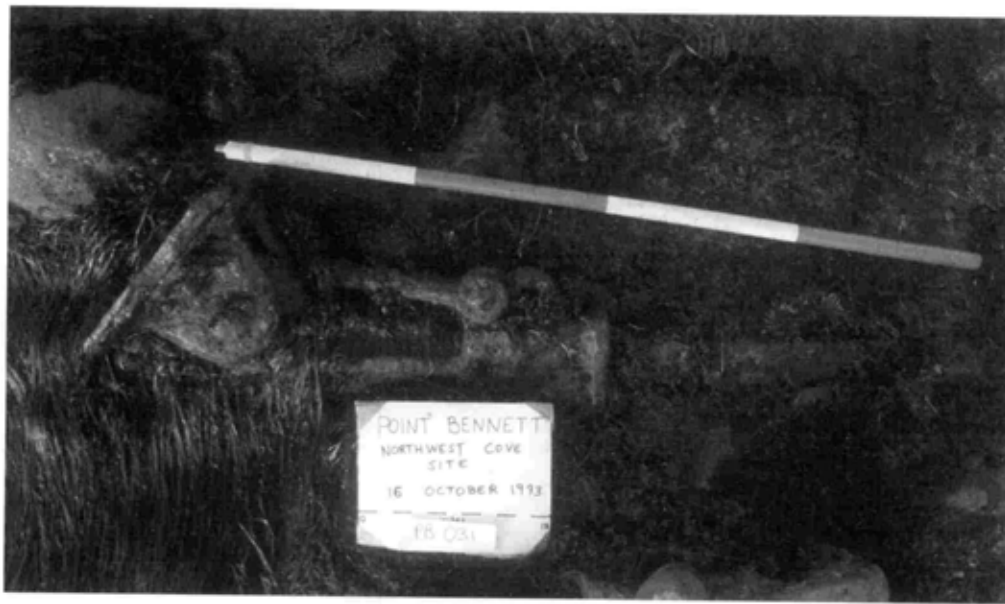
Figure 4.14. Crosshead mechanism from a pump-brake windlass. See Figure 4.96 for a similar mechanism. NPS photo by Adriane Neidinger.

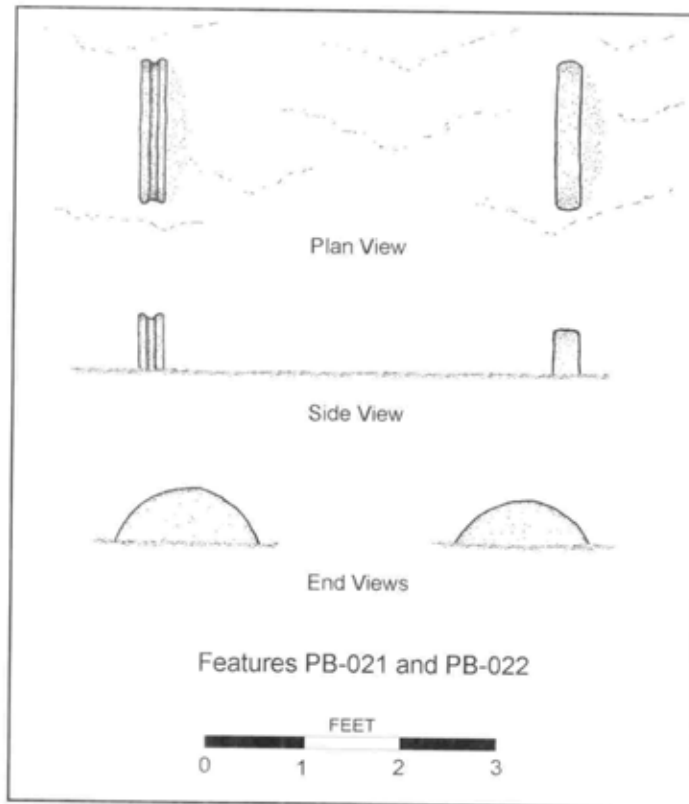
Figure 4.15. Part of the drive mechanism from a donkey engine (features PB-021 and PB-022). Drawing by Matt Russell.

At least seven of the remaining intertidal zone features are either from a windlass, a donkey engine, or a messenger chain system that linked the two. A messenger chain used a series of chains, gears and shafts to connect a steam donkey engine to the windlass, pumps, auxiliary warping heads and other hoisting gear. *Comet* was equipped with a messenger chain system to drive its windlass (see below). Feature PB-021/022 (actually a single object) is likely part of a donkey engine (Figures 4.15 and 4.16). PB-021/022 are two circular iron pieces sticking upright out of the bottom, 4 ft. apart, and connected by a shaft that could not be exposed (which is why they were given separate feature numbers). The circular iron pieces are 1 ft. 6 in. in diameter. One of them (PB-021) is featureless, while the other (PB-022) is grooved

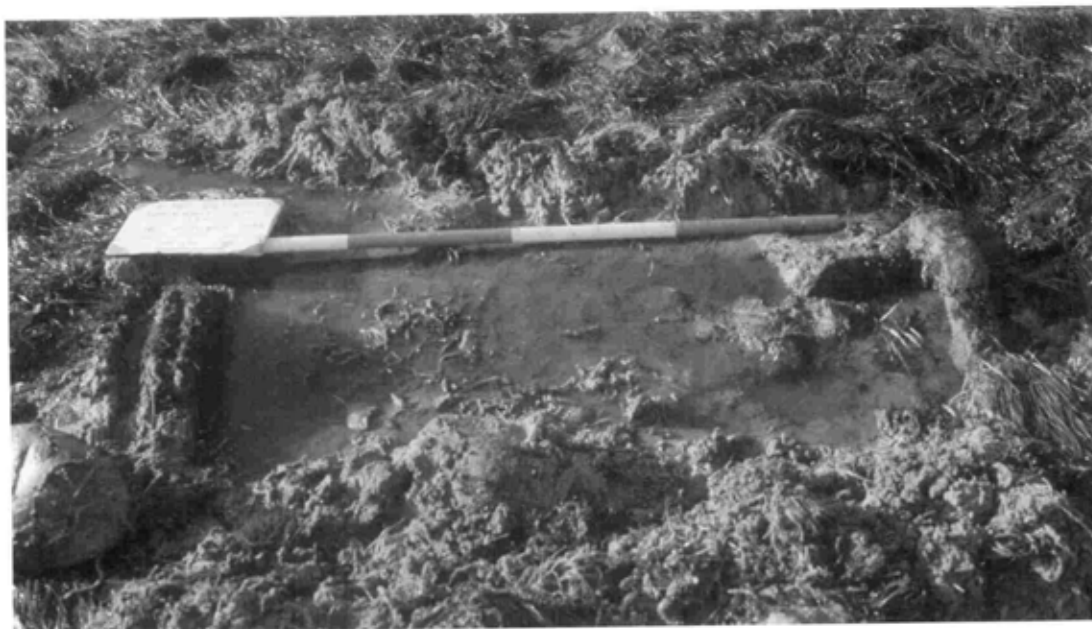
Figure 4.16. The two upright circular features are connected by a buried drive shaft. NPS photo by Adriane Neidinger.

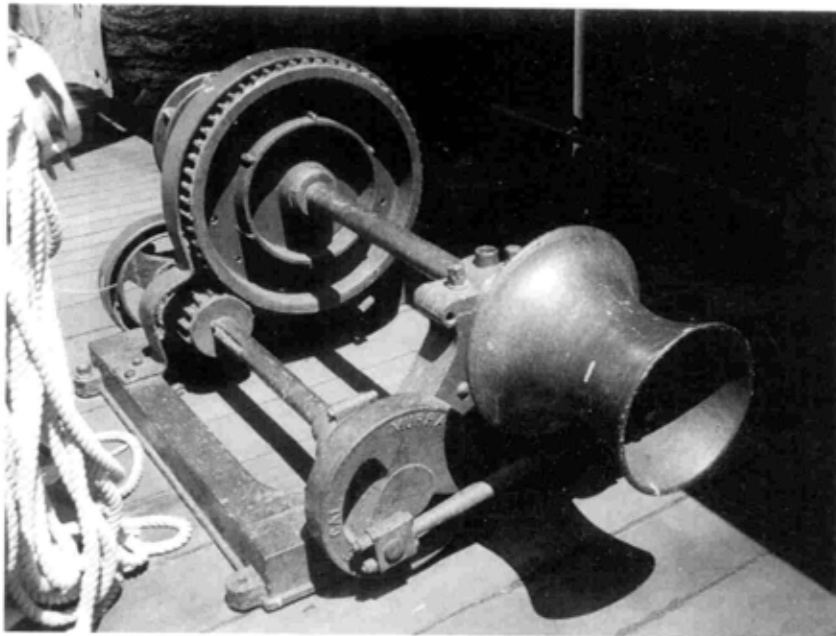
Figure 4.17. Windlass from *Falls of Clyde* in Honolulu, Hawaii. The smaller mechanism to the left is similar to features PB-021 and PB-022. NPS photo by Matt Russell.

along the edge. Although positive identification is difficult, this feature is probably the drive spindle of a steam donkey engine (Figure 4.17).

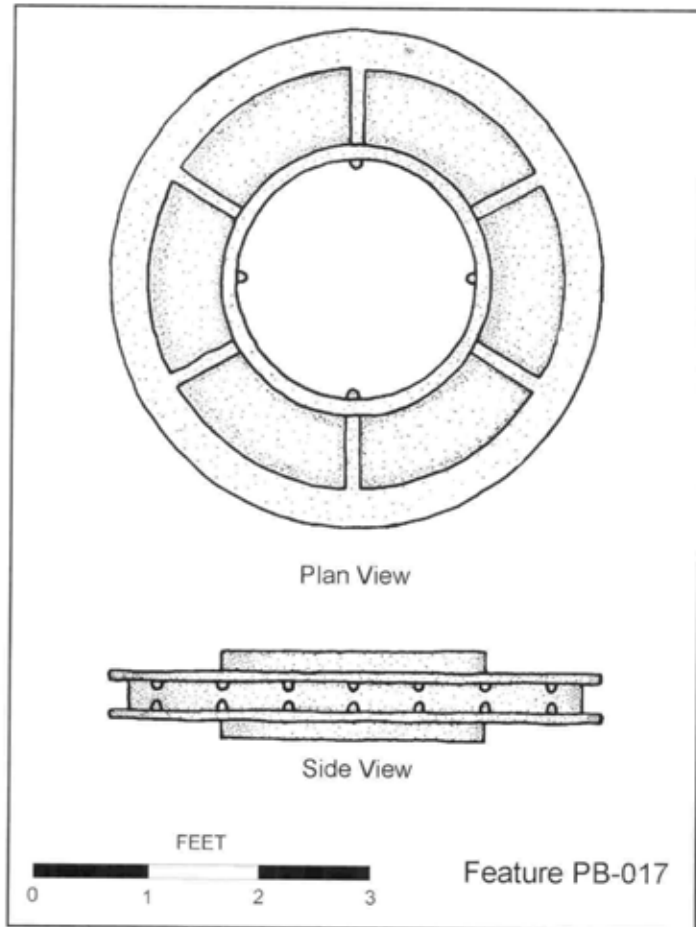
Figure 4.18. The widely-spaced teeth on this feature's outer edge indicate it is part of a messenger chain system that ran the windlass from a donkey engine. Drawing by Matt Russell.

Features PB-017, 018 and 023 are all similar objects and part of a vessel's windlass or messenger chain system. PB-017 is an iron ring with an outside diameter of 4 ft. 4 in., an inside diameter of 2 ft. 1 in., with a thickness of the main part of the ring 5 in. An inner flange adds 2 in. in thickness to either side (Figures 4.18 and 4.19). PB-018, also an iron ring, has an outside diameter of 3 ft., an inside diameter of 2 ft. 2 in., and is 4 in. thick (Figures 4.20 and 4.21). PB-023 is a solid circular iron object 2 ft. 1½ in. in diameter and 4 in. thick (Figure 4.22). All three features have edges notched for gears. Edges of PB-018 and PB-023 have closely spaced gears, while the edge of PB-017 has teeth spaced about every 7 in. Feature PB-018 is likely the purchase rim of a windlass (Figure 4.23). The 7-in.-spaced teeth of PB-017 are from the messenger chain system that ran this machinery.

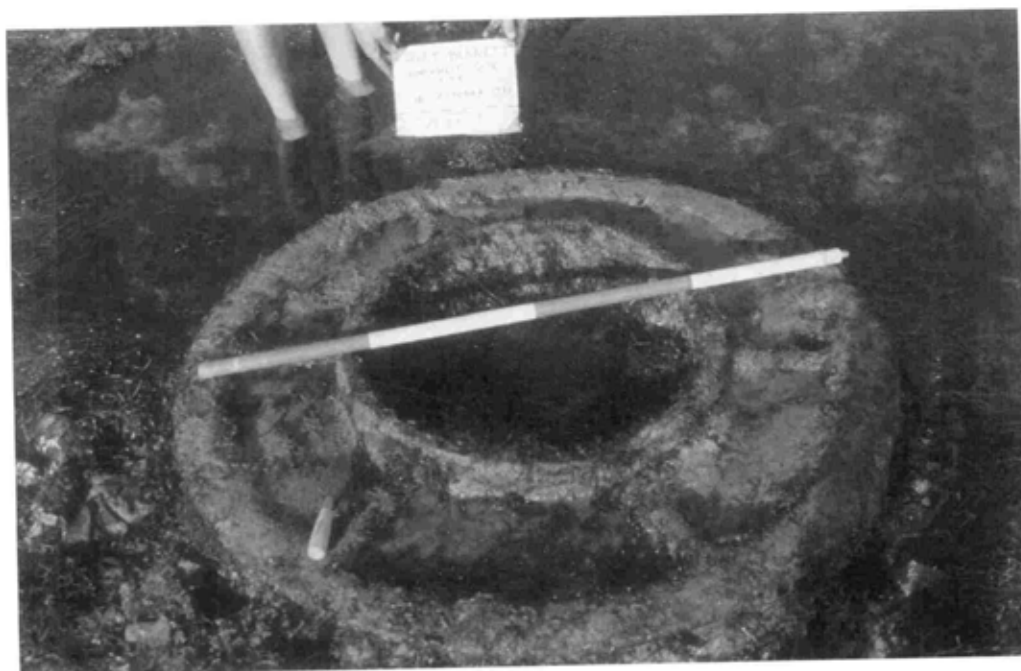
Figure 4.19. Iron ring from a windlass messenger chain system (feature PB-017). NPS photo by Adriane Neidinger.

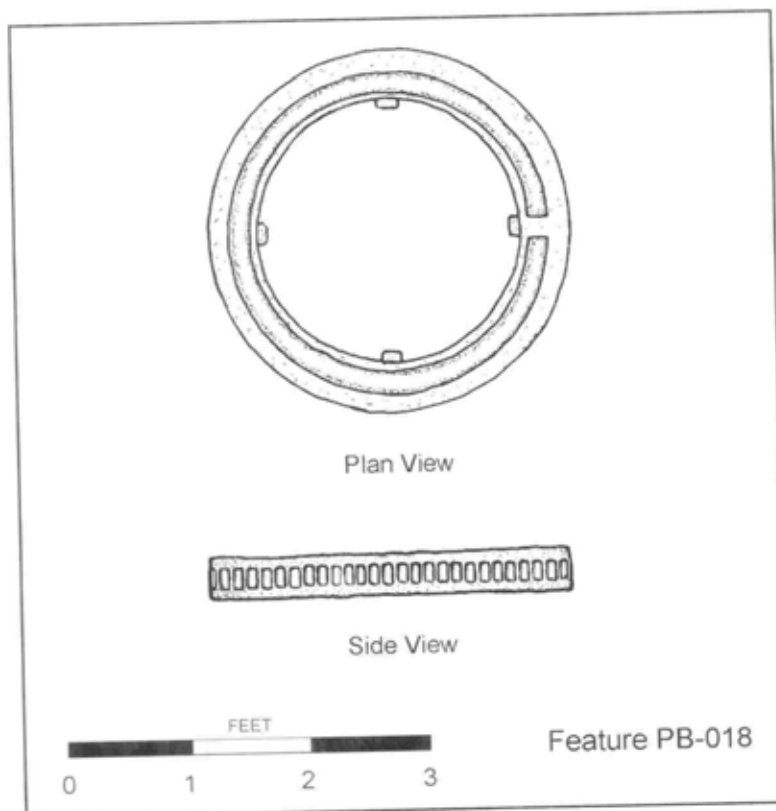
Figure 4.20. Purchase rim from a pump-brake windlass. Drawing by Matt Russell.

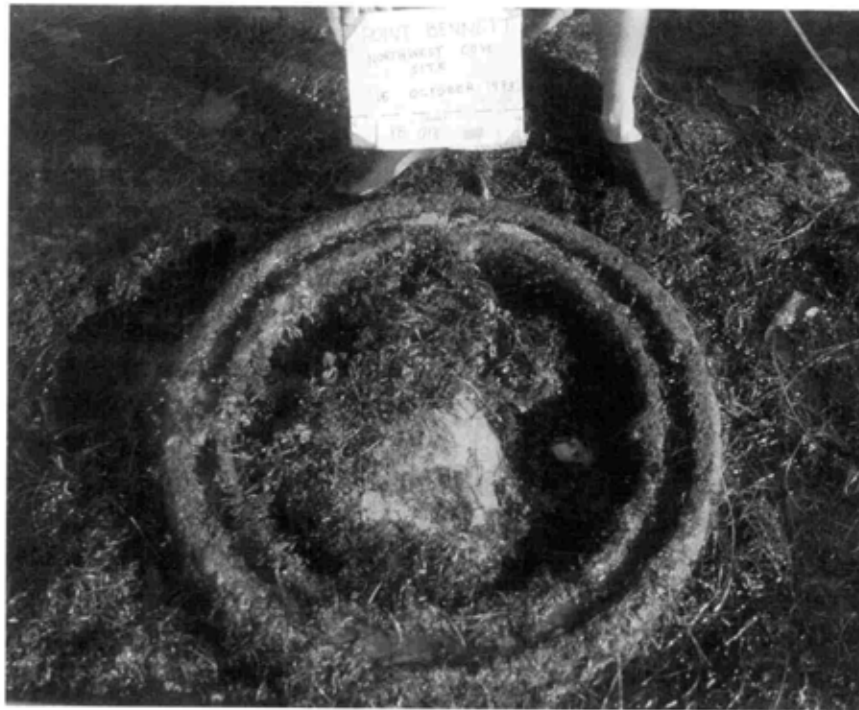
Figure 4.21. Purchase rim (feature PB-018). NPS photo by Adriane Neidinger.

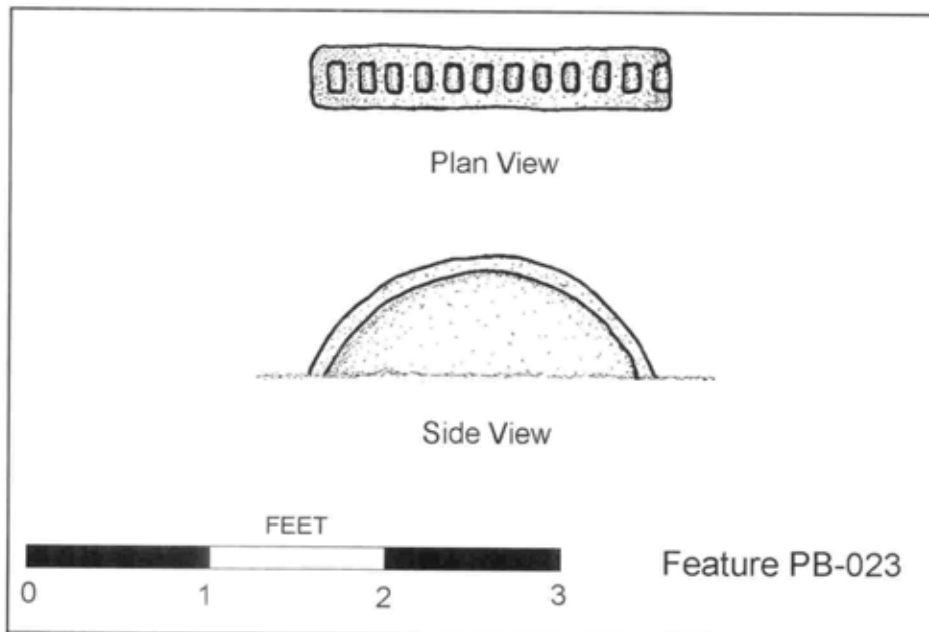
Figure 4.22. Unidentified windlass element (feature PB-023). Drawing by Matt Russell.

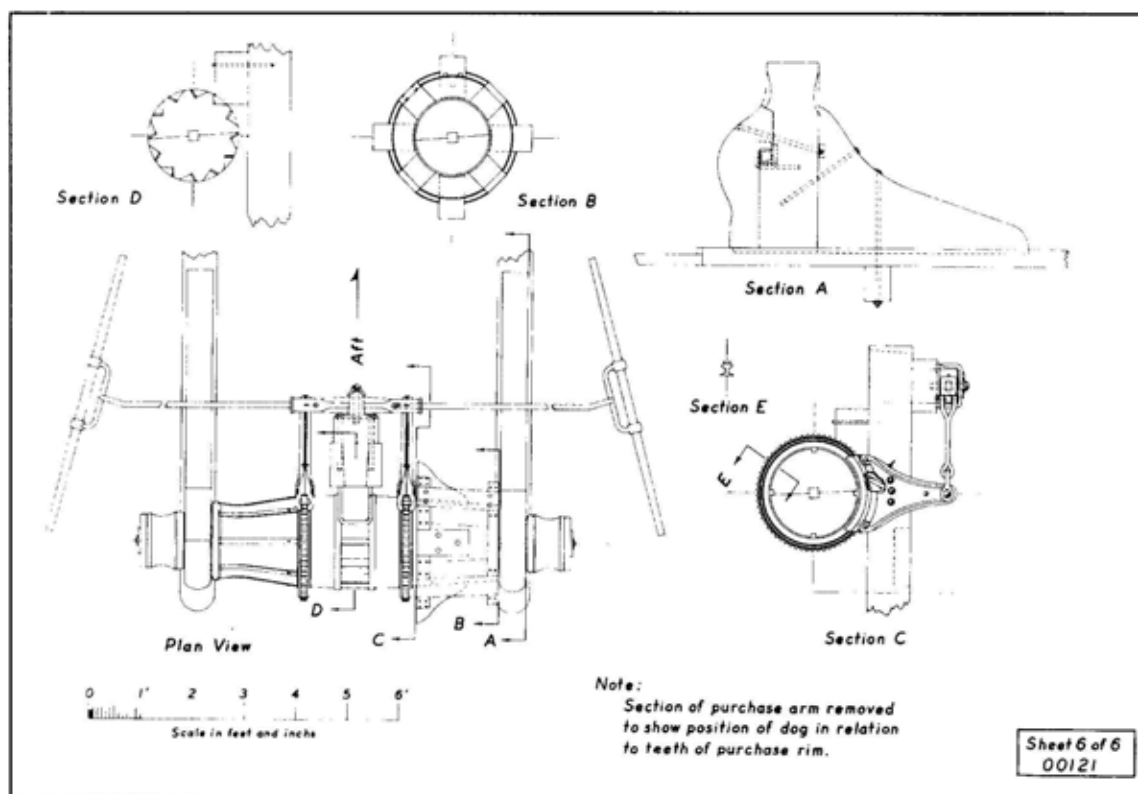
Figure 4.23. Feature PB-018 is a purchase rim, pictured here in Section C with the purchase arm attached. Note the four teeth on the inside of the rim that match those on feature PB-018. Drawing from the Smithsonian Institution.

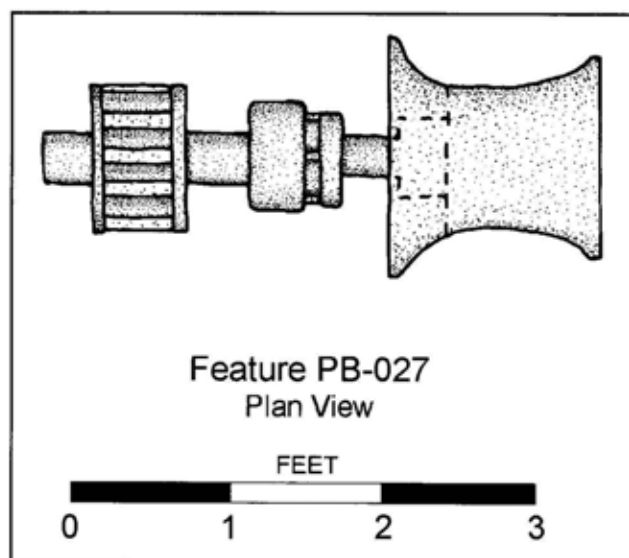
Figure 4.24. Unidentified windlass element with the warping hub (feature PB-027). Drawing by Matt Russell.

Features PB-026, 027 and 029 are also likely parts to either a windlass or a donkey engine. Both PB-027 and PB-029 contain warping hubs and geared mechanisms on shafts, likely parts from the windlass, a deck winch or the donkey engine (Figures 4.24–4.27). PB-027 is 3 ft. 9 in. long, and PB-029 is 2 ft. long. The warping hubs on each are identical, 1 ft. 4 in. long and 1 ft. in diameter at their narrowest point. Feature PB-026 has a large, circular geared mechanism 1 ft. 10 in. in diameter, and a smaller circular object 1 ft. 5 in. in diameter (Figures 4.28 and 4.29). The teeth on the latter's edge are spaced on 7-in. centers, same as PB-017, which is also from the messenger chain system (Figure 4.30).

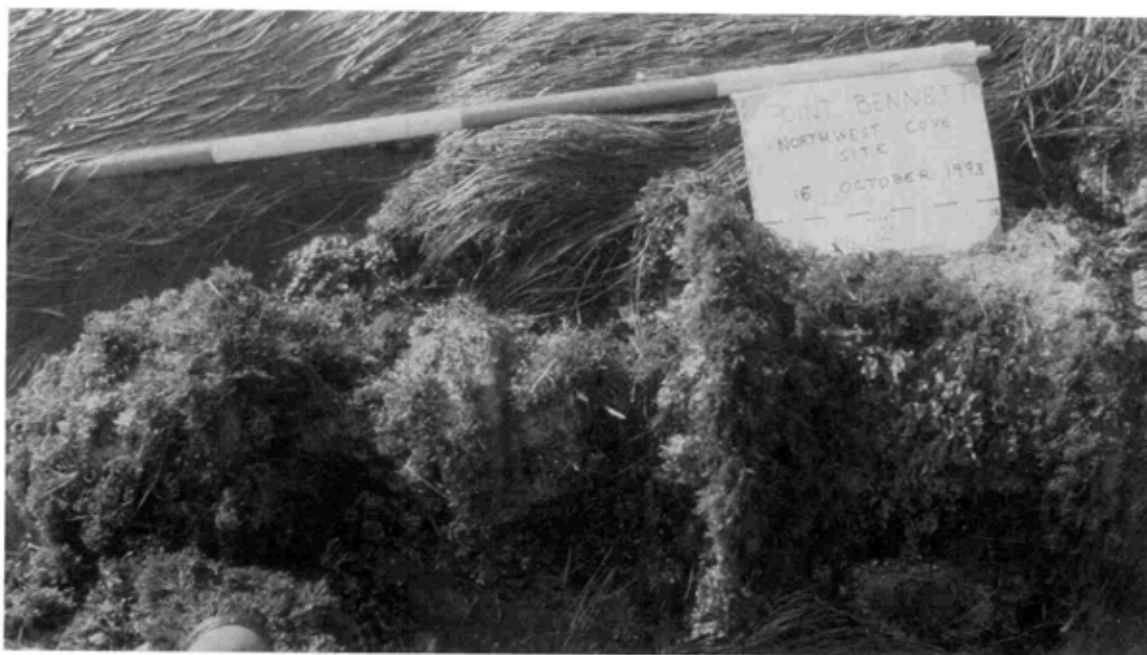
Figure 4.25. Feature PB-027. NPS photo by Adriane Neidinger.

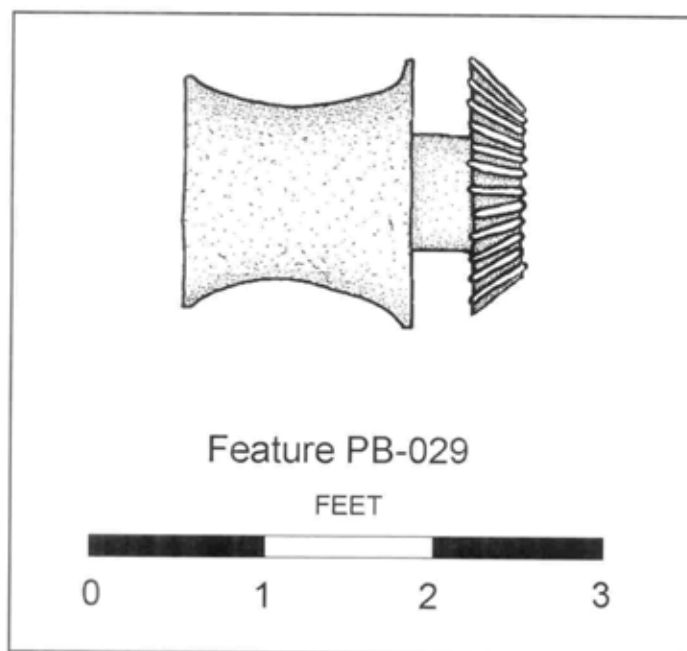
Figure 4.26. Another unidentified windlass element (feature PB-029). Drawing by Matt Russell.

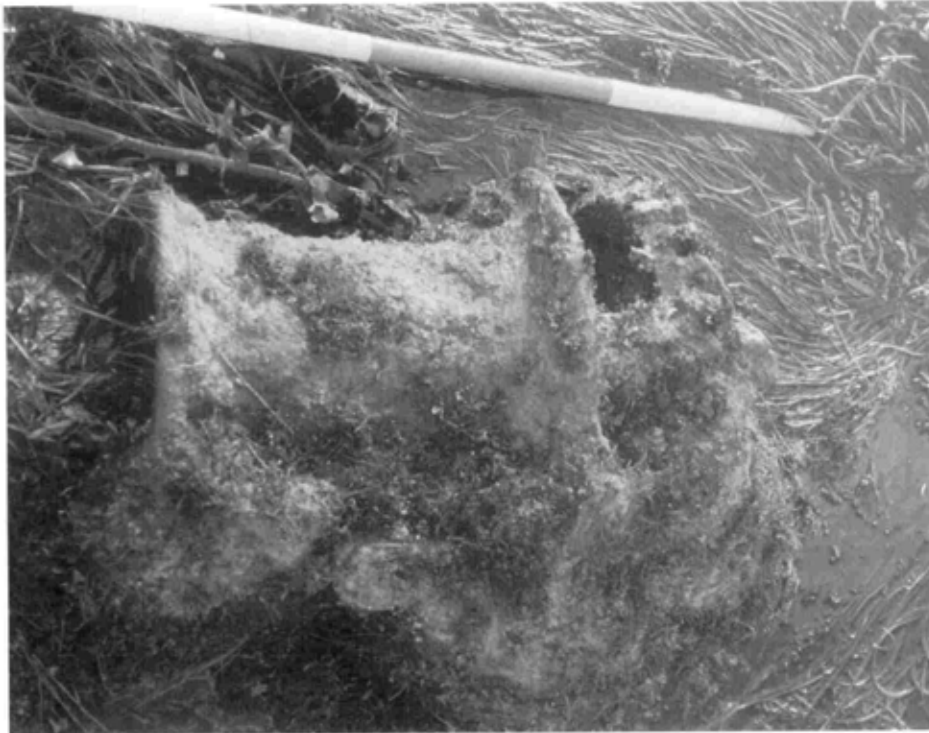
Figure 4.27. Feature PB-029. NPS photo by Adriane Neidinger.

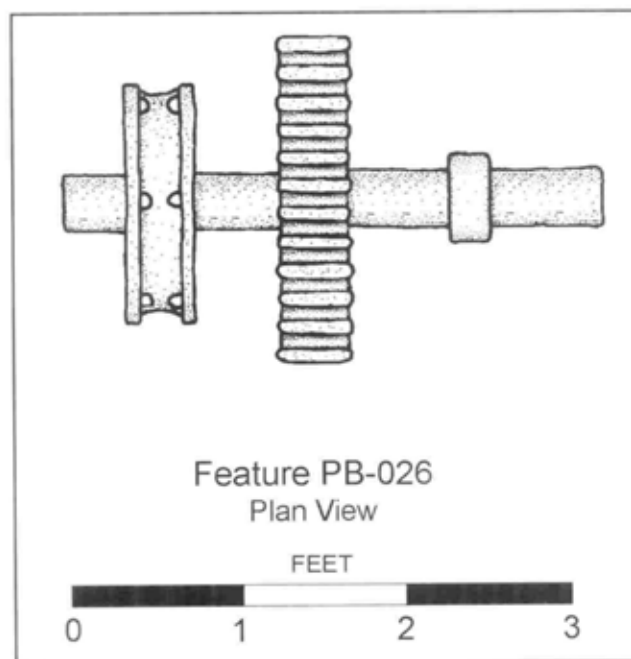
Figure 4.28. Unidentified windlass element with widely-spaced teeth for the messenger chain on the left. Drawing by Matt Russell.

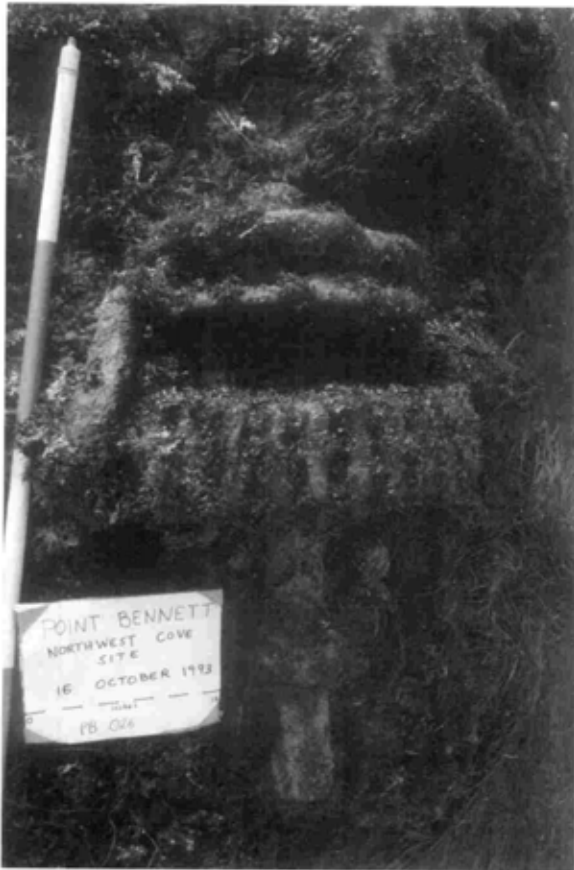
Figure 4.29. Feature PB-026 with the messenger chain gear at top. NPS photo by Adriane Neidinger.

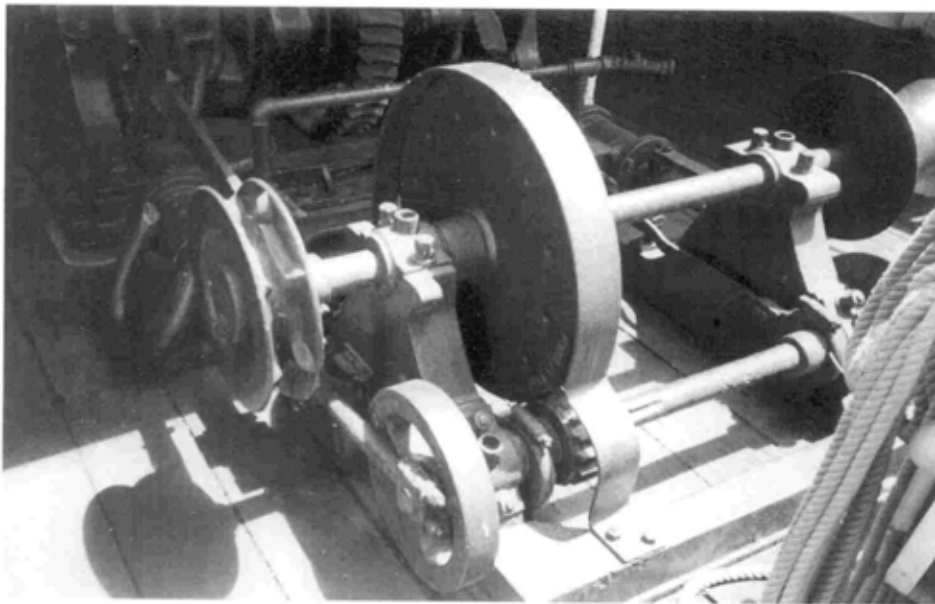
Figure 4.30. Windlass from *Falls of Clyde* in Honolulu, Hawaii. Note the gear to the left in the photograph that is from the messenger chain system. NPS photo by Matt Russell.

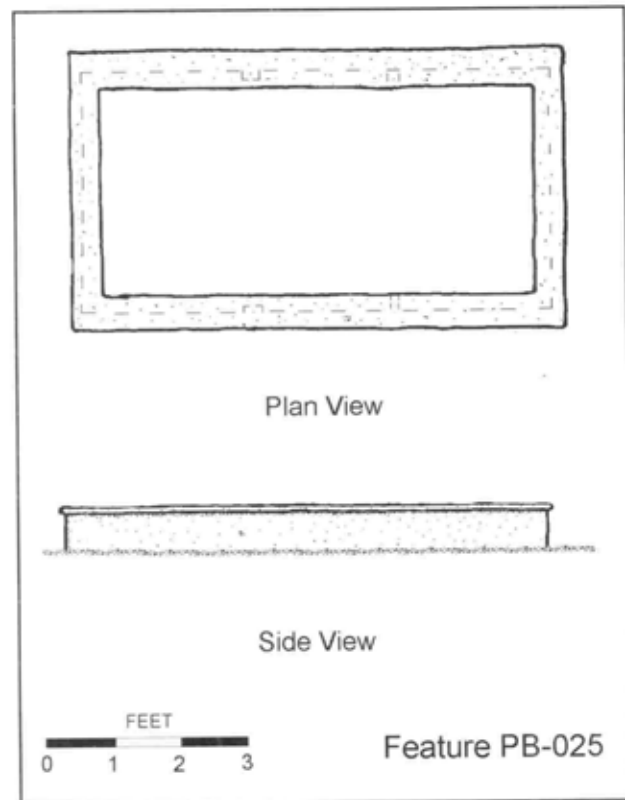
Figure 4.31. Machinery mount for the donkey engine (feature PB-025). Drawing by Matt Russell.

PB-025 is a large, rectangular-shaped iron feature encrusted to the seabed. It has an outside length of 7 ft. 2 in. and an outside width of 4 ft. 1 in. The inside length is 6 ft. 4 in., while the inside width is 3 ft. 1 in. The object is 8 in. high (Figures 4.31 and 4.32). At first glance, the object appears to be some sort of hatch coaming, which is unlikely because cargo hatches on

ocean-going vessels would have been much larger and constructed of wood. Feature PB-025 is probably the machinery mount for the donkey engine.

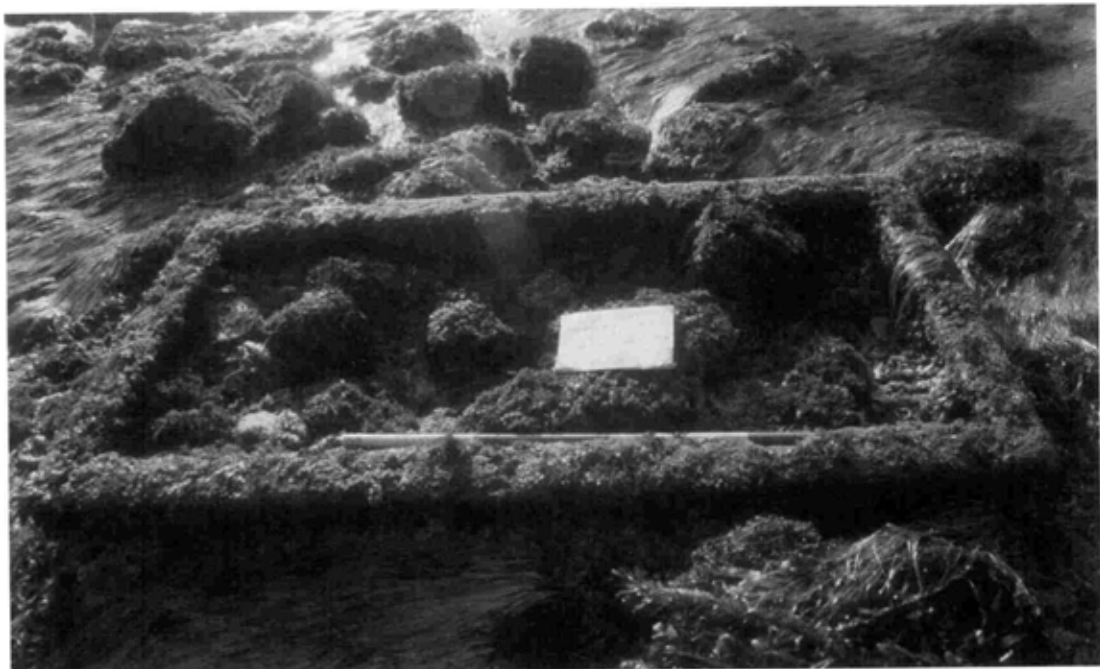
Figure 4.32. Feature PB-025. NPS photo by Adriane Neidinger.

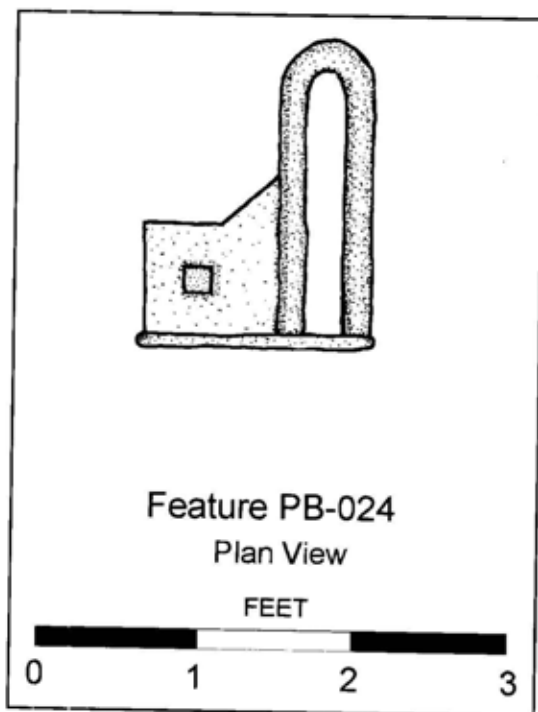
Figure 4.33. Unidentified object (feature PB-024). Drawing by Matt Russell.

The remaining six intertidal features could not be conclusively identified. Feature PB-019 is a deteriorated piece of wood firmly embedded in the bottom, probably attached through the encrustation of various iron fasteners or fittings. Feature PB-024 is an oddly shaped iron object with rough dimensions of 1 ft. 11 in. x 1 ft. 6 in. The main attribute is a U-shaped piece of iron attached to a base (Figure 4.33). The object was only drawn in two dimensions because it is encrusted into the bottom and surrounded by thick marine growth. Heavily encrusted, feature PB-028 appeared only as a small ferrous lump covered with marine growth and no details could be observed. A scale drawing was not produced. Feature PB-030 is an iron block 2 ft. 4½ in. long,

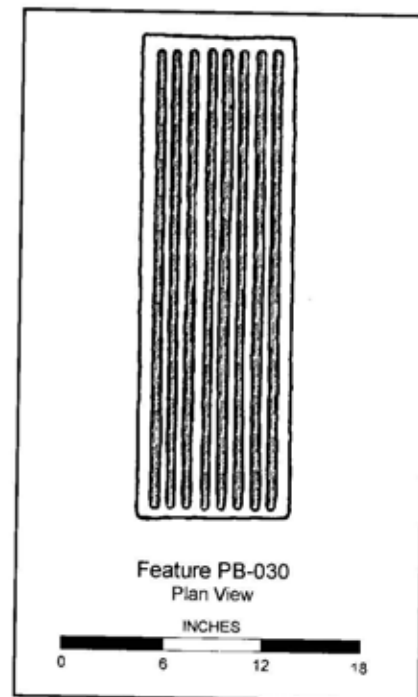
Figure 4.34. Unidentified object (PB-030). Drawing by Matt Russell.

9 in. wide and 4½ in. thick (Figure 4.34). The top (exposed) surface has shallow grooves ½ in. wide and ½ in. apart running lengthwise for the whole width of the piece. A group of three iron fasteners concreted onto the rocks make up feature PB-032. Their lengths are 9 in., 1 ft. and 1 ft. 3 in.; the two shorter ones are approximately 1-in. diameter; the longer is about 1½ in. in diameter. Feature PB-033 is a small, half-moon-shaped iron object 2 ft. 1 in. long across its base, just over 9 in. wide at the broadest point, and 1½ in. thick (Figure 4.35). The top surface has six shallow grooves running lengthwise that are ½ in. wide with ¾-in. spaces between them. The bottom surface of the object is smooth.

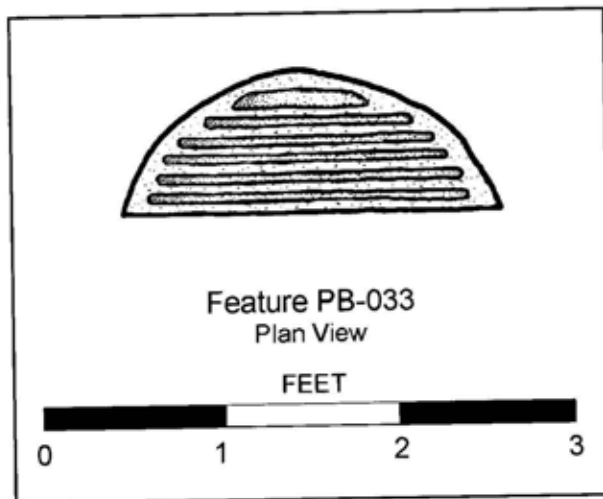
Figure 4.35. Unidentified object (feature PB-033). Drawing by Matt Russell.

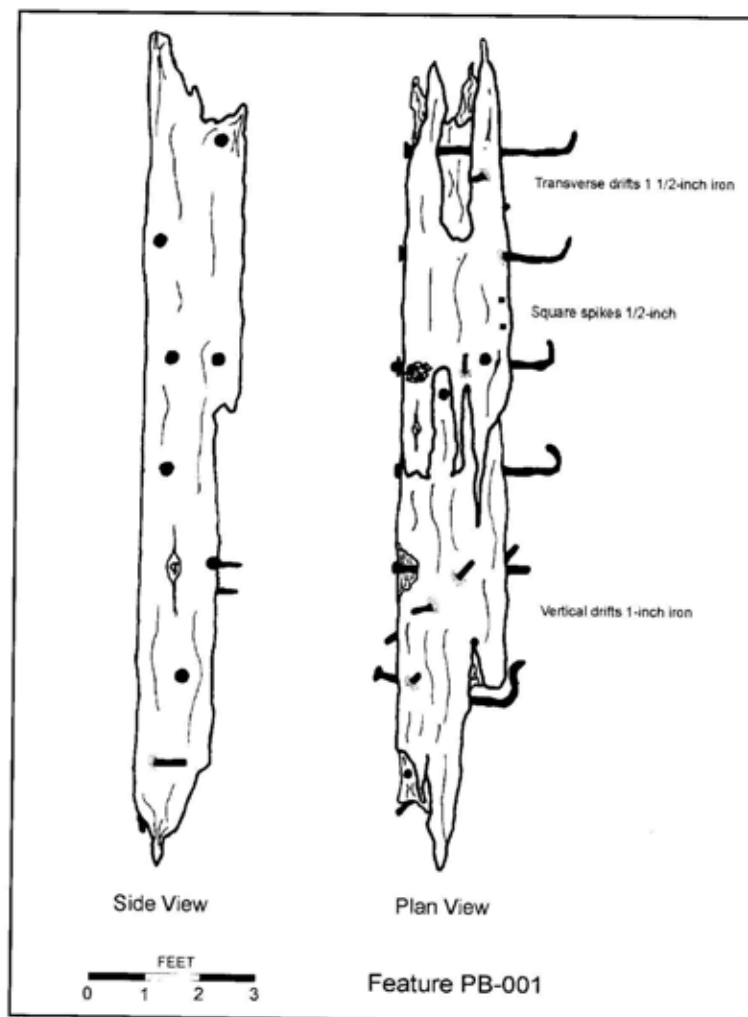
in. (Figures 4.36 and 4.37). Both ends are broken off, so it is impossible to determine the element's original length. All extant surfaces are badly worn and deteriorated, so sided and moulded dimensions are approximate. The element's most conspicuous characteristics are size and number of iron fasteners. There are six large, iron drift pins driven through and protruding from the side. These drifts are approximately 1½ in. in diameter (though exfoliating badly) and range in length from 2 ft. 2 in. (broken) to 4 ft. 2 in. long spaced an average of 2 ft. apart. There are also nine 1-in. diameter

iron drifts and five spikes ½ in. square protruding from the timber's top surface. All are broken off close to the surface.

The element's size and fasteners make it likely this feature is part of a structural member from an ocean-going vessel. Furthermore, because of the element's large size and configuration of iron fasteners, it is most likely PB-001 is a portion of a vessel's centerline structure. The lack of rabbet, fasteners driven through both axis of the piece, and the observation that the large drifts were first driven through this piece and then, probably, into

Figure 4.36. Keelson element with iron fasteners (feature PB-001). Drawing by Matt Russell.

another makes it impossible for this piece to be a portion of a keel. On the other hand, these same characteristics are consistent with a piece of a main, sister, rider or assistant keelson, which now rests on its moulded face. The element's western face, from which the large iron drifts were driven, is likely the top, or sided, surface. If PB-001 is a piece of the main keelson, then the six 1½-in. diameter drifts were probably driven through this piece, through the floors and into the vessel's keel. If it is from a sister keelson, then the large drifts were probably driven through this timber into the floors or first futtock of the vessel. If this timber is from a rider or assistant keelson, then the large iron fasteners were probably driven through the piece into the main or sister keelson. In all cases, the 1-in. diameter fasteners driven through the opposite axis of the timber edge-bolted this timber to its adjacent keelson component, indicating multiple keelson elements.

Comet's contract specifies that iron fastenings $1\frac{1}{4}$ or $1\frac{1}{8}$ in. in diameter be used to fasten the keelson. Because *J. M. Colman* was larger than *Comet*, $1\frac{1}{2}$ -in. iron drifts to fasten the keelson would be consistent. Another possibility is that the expansion caused by the corrosion process of the iron fasteners made the $1\frac{1}{2}$ -in. measurement larger than the original diameter. In either case, these fasteners reflect probable association with *J. M. Colman*.

During this analysis, I observed that the wood around the large fasteners on the east face of the timber is considerably more worn than the rest of the surface. There is no obvious explanation for this disparity. It is possible that this differential weathering is a function of the natural deterioration process of the Douglas fir, such as differential preservation of heartwood versus sapwood, caused by exposure over 80 to 90 years and not significant archeologically. On the other hand, it is also possible that this deterioration took place while the vessel was still in use. If the latter is the case, this wear might be an archeological signature of extended use and age of the vessel from which this timber came. Differential weathering of Douglas fir around iron fasteners is not historically documented. As discussed in Chapter 2, Hopkins (1874:9–10) noted that Douglas fir held iron fasteners with tenacity, that the iron would break before it could be withdrawn from the timber, and that iron did not deteriorate in fir as it did in oak. There is no mention of a problem

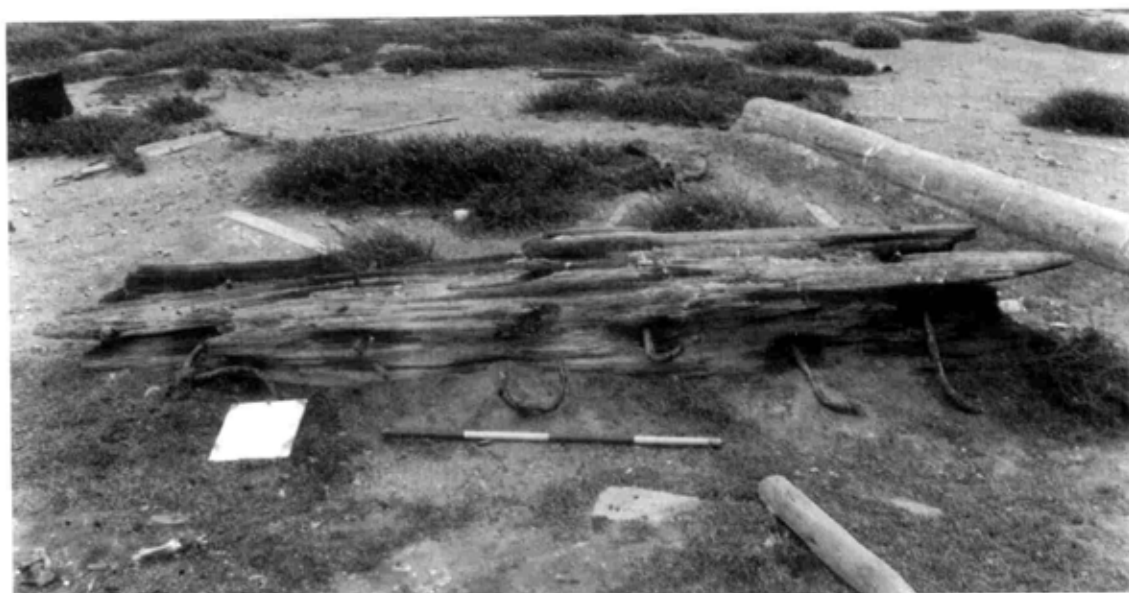
Figure 4.37. Feature PB-001. NPS photo by Matt Russell.

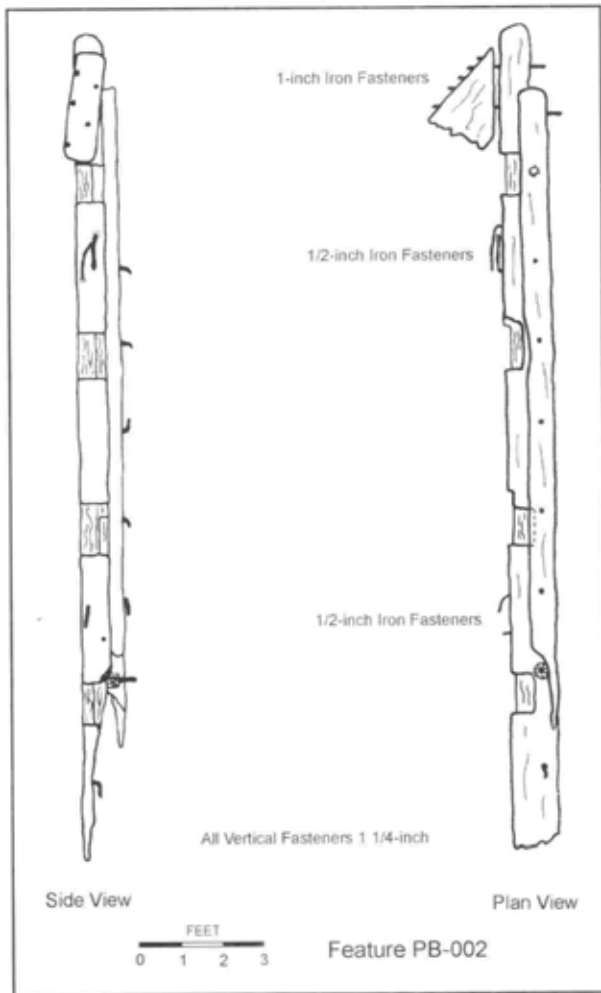
Another feature that is likely a scantling piece from a large, ocean-going vessel is PB-002 (Figures 4.38 and 4.39). This fragment consists of three wooden components: two long, rectangular pieces, one on top of the other, and a small trapezoidal piece fastened to the bottom timber. Also present are numerous iron fasteners. The bottom timber's total length is 19 ft. 8 in., it is 1 ft. 2 in. wide and 8 in. thick. This piece contains four mortises cut into its west side, which measure between 10 in. and 1 ft. 1 in. long, $3\frac{1}{2}$ in. high, and $5\frac{1}{2}$ in. deep. The mortises are indented about $1\frac{1}{2}$ in. from the side. The top timber, which was originally fastened to the bottom piece with eight $1\frac{1}{4}$ in. in diameter iron drift pins spaced 2 ft. on center, is 15 ft. 6 in. long, 8 in. wide, and 4 in. thick. On the feature's north end, a trapezoidal piece 2 ft. 2 in. long, 1 ft. $7\frac{3}{4}$ in. wide, and 8 in. thick is fastened to the lower timber with five iron, 1-in. diameter drift pins. In addition to these fasteners, the fragment also has two pairs of additional $\frac{1}{2}$ -in. diameter drifts in its west face.

Attributes of this feature suggest identification as a deck clamp or shelf. The mortises, spaced on 4-ft. centers, would have received the deck-beam ends. Deck beam spacing corresponded to frame spacing, so that the end of each deck beam rested against a frame (Desmond 1919[1984]:105). Generally, a vessel framed on 2-ft. centers would have a deck beam for every other frame, with deck beam spacing not exceeding 5 ft. (American Shipmasters'

Figure 4.38. Feature PB-002. This fragment is possibly part of a deck clamp or shelf. Drawing by Matt Russell.

Association 1879:23). The trapezoidal piece was a reinforcing chock, butted between the clamp and the deck beam.

There are several problems with this interpretation, however, and several questions to be answered before it can be wholly accepted. First, the mortises extend only about half the width of the bottom timber. Normally, the deck beam rests on the full width of the clamp, not just half. Second, a main-deck clamp would have been firmly fastened to the vessel's frames with large through-bolts driven from the outside and clinched (Desmond 1919[1984]:104). There is no evidence of any large fasteners or holes coming through the bottom timber transversely. Third, between the mortises, evidence of more reinforcing pieces like that found on the end of the feature would be expected. However, there are only two pairs of ½-in. fasteners, nothing like the five 1-in. drifts

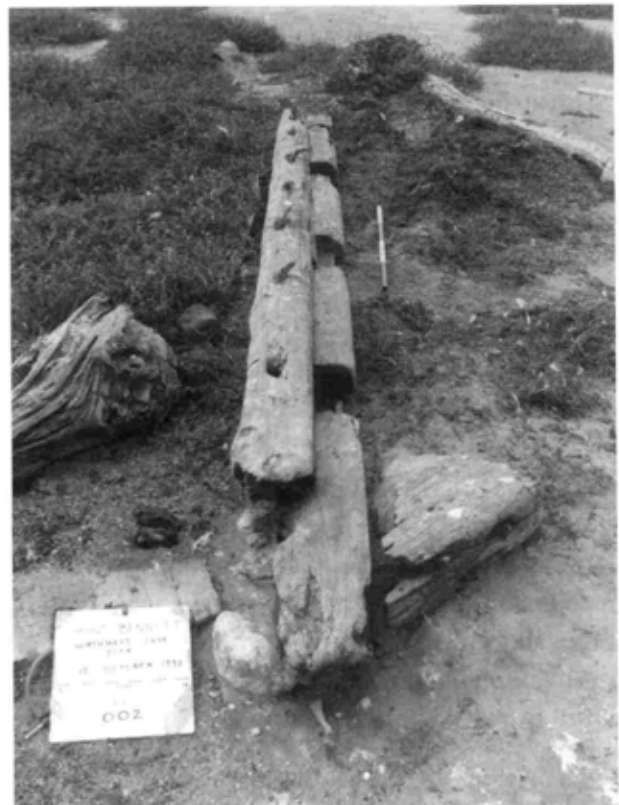
Figure 4.39. Feature PB-002. NPS photo by Matt Russell.

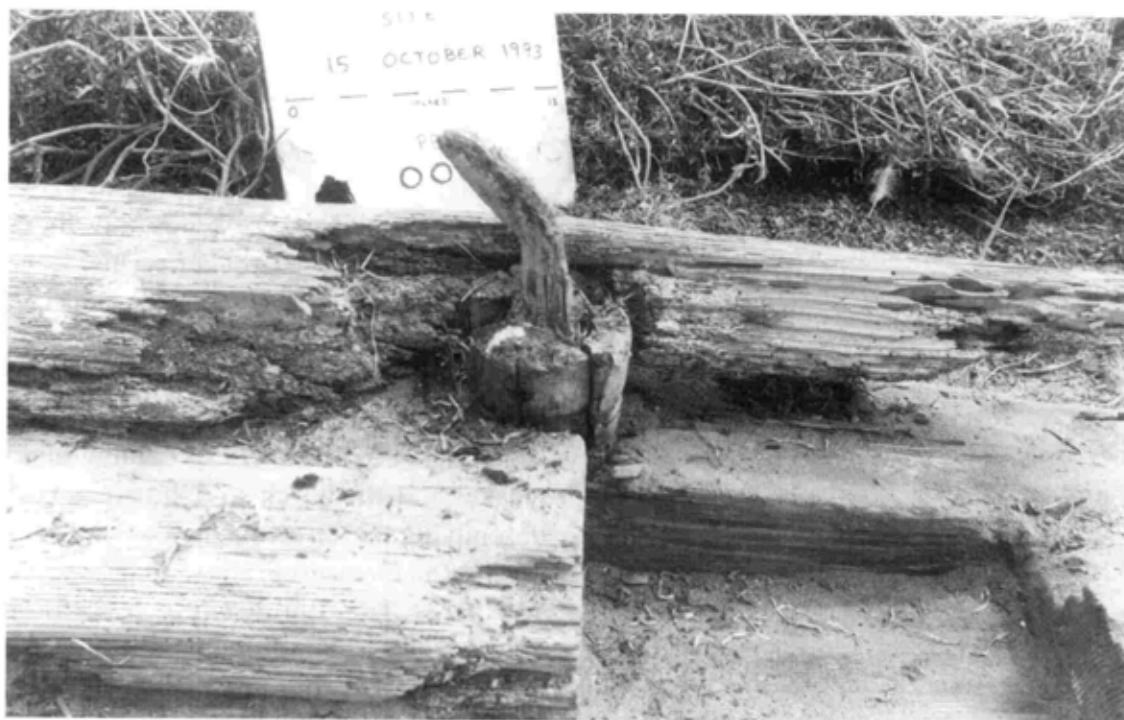
Finally, one of the most puzzling aspects of this fragment is that at least two of the vertical 1¼-in. fasteners joining the top timber to the bottom timber are driven through oak plugs (Figure 4.40). Only two could be examined, so it is possible that the remaining fasteners were also driven through plugs. Research into this practice has been inconclusive. It is unknown if this represents an effort to strengthen the bonding of these two timbers, or if this is evidence of a repair meant to replace a corroded fastener or possibly to augment wood that had deteriorated around the fastener. This may represent a peculiar and undocumented practice of the Hall Brothers. Identification as a portion of a deck clamp or shelf should be viewed as tenuous, especially when considering association with *J. M. Colman*.

Figure 4.40. Iron fastener driven through an oak plug on feature PB-002. NPS photo by Matt Russell.
