National Park Service
U.S. Department of the Interior

Submerged Resources Center

Beached Shipwreck Archeology: Case Studies from Channel Islands National Park

Matthew A. Russell

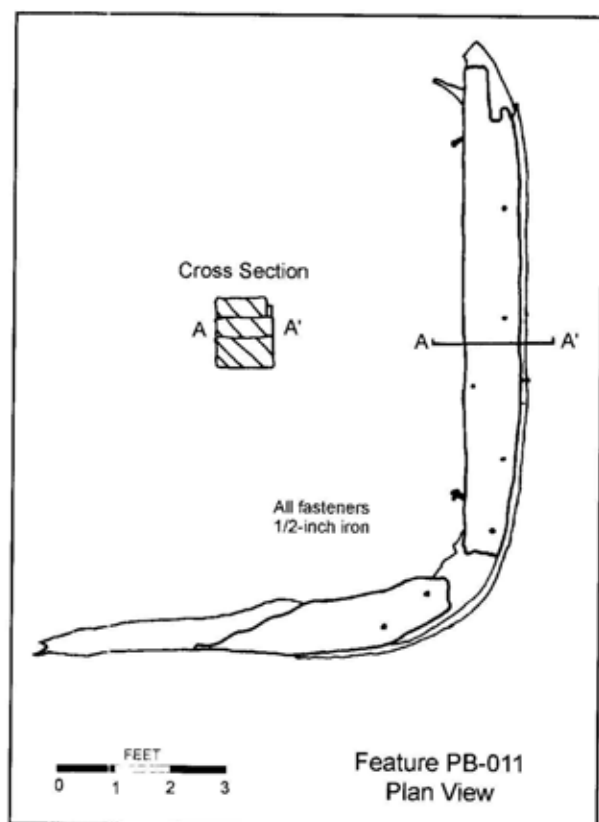
Features PB-011 and PB-014, constructed in the same manner, likely represent pieces of a wooden hatch coaming (Figures 4.41–4.44). The two fragments each have three layers of timbers, fastened together with ½-in. diameter, round iron fasteners. Originally, the structure was either U-shaped or, more likely, rectangular with rounded corners. PB-011 is sitting upright, with the three layers stacked, while PB-014 is laying face-down with the three layers side by side.

Feature PB-011's bottom timber is 6½ in. thick, the middle timber is 5 in. thick, and the top timber is 7 in. thick, giving PB-011 a total height of 18½ in. Each of the timbers is 1 ft. wide. Feature PB-011 is roughly L-shaped, with the longest side 11 ft. long, and the shorter 8 ft.

Figure 4.41. Plan view of feature PB-011, possibly part of a hatch coaming. Drawing by Matt Russell.

long; both ends are broken. The end of the longer side exhibits the beginning of a curve before the fracture. Feature PB-014 shows the beginning of a curve on one end before it is broken off, as well. In the one intact curve on PB-011, the two timbers forming the bottom layer meet in the middle of the curve. The timbers of the two top layers are joined in the curve by a chock. Feature PB-014 has shallow mortises along what would be the inside edge of the top timber, if it were standing upright. These mortises are 6 in. long, 3 in. wide with a maximum depth of 1½ in. The shorter length of PB-011 exhibits identical mortises on its inside face, suggesting that PB-014 was originally connected to PB-011 opposite their shorter length.

Each layer of wood on feature PB-011 is faced on the outside edge with thin, horizontal planks 1¼ in. thick. These are nailed to the main timbers with ¼-in. round nails. Wood species analysis identified these planks as *Quercus virginiana* or live oak. The main timbers were Douglas fir. It could not be determined if PB-014 included similar planks because the side they would have been attached to was face-down. The plank nailed to the top layer of PB-011 is only 4¼ in. wide, so it extends only about half the thickness of that timber. This, in effect, leaves a 2¾-in. deep, 1¼-in. wide rabbet around the outside of the structure's top face.

Positive identification of these fragments is difficult, but attributes are consistent with a hatch coaming, or deck structure coaming of a large vessel. Both hatch and house coamings resembling this structure are depicted in W. H. Curtis *The Elements of Wood Ship Construction* (1919:131, 152, 199, 201)(Figure 4.45). There is evidence to support this speculation and problems with this possibility, as well. In addition to the similarity to the structures depicted in Curtis, mortises cut into the top, inside edge of PB-014 and the shorter length of

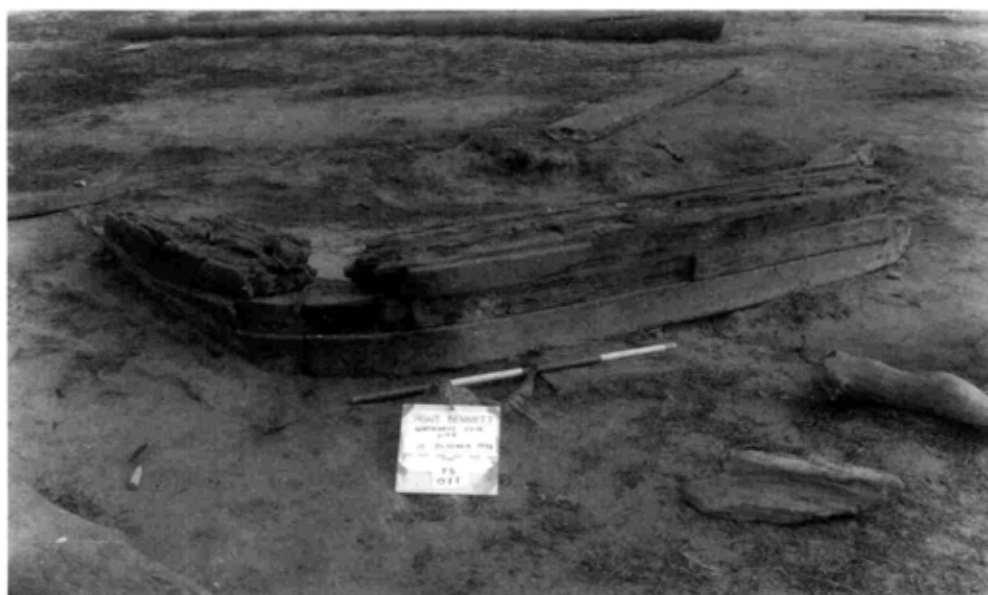
Figure 4.42. Oblique view of feature PB-011. NPS photo by Matt Russell.

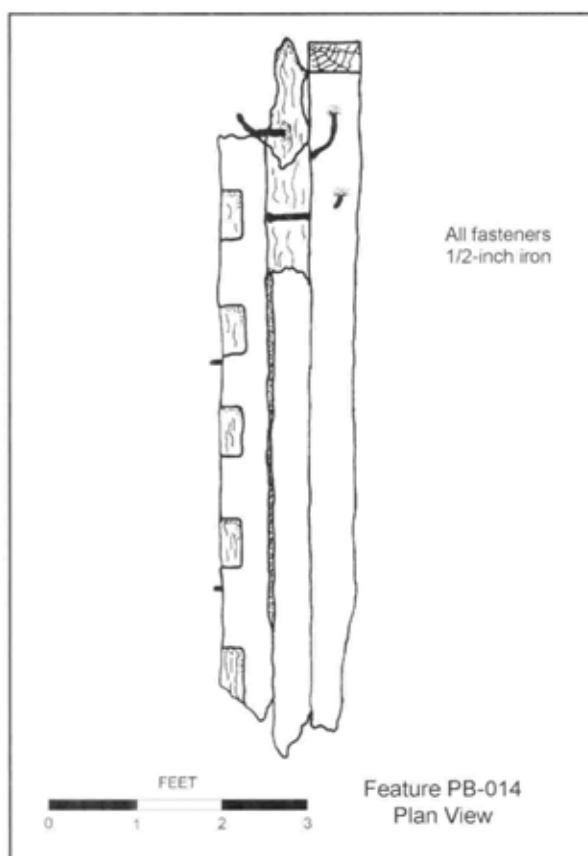
Figure 4.43. Plan view of feature PB-014, likely part of the same coaming as feature PB-011. Drawing by Matt Russell.

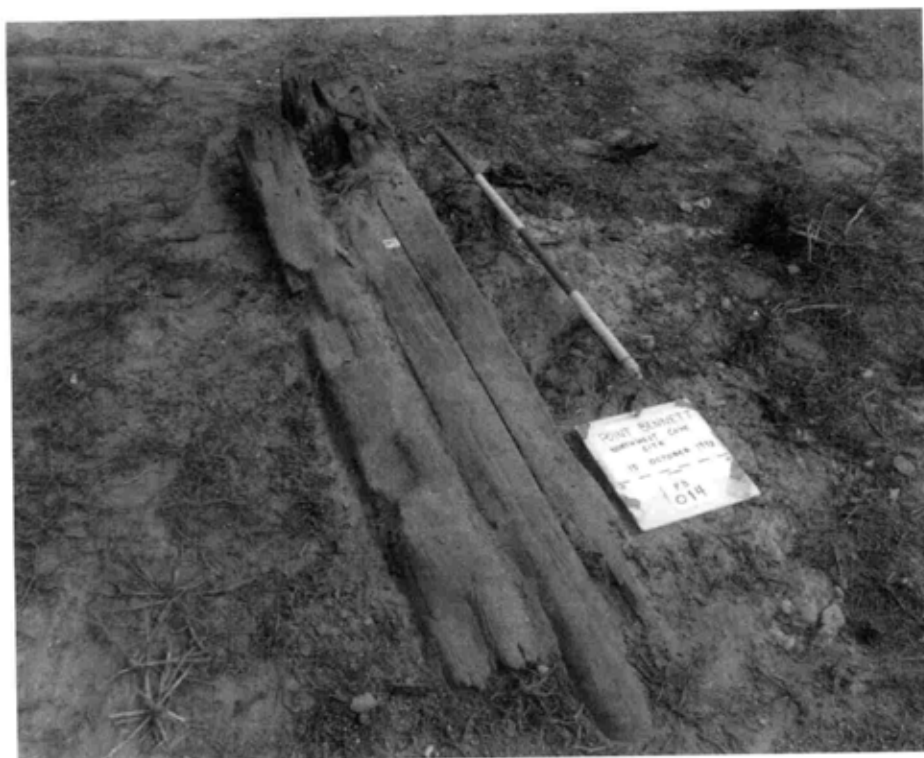
Figure 4.44. Feature PB-014. NPS photo by Matt Russell.

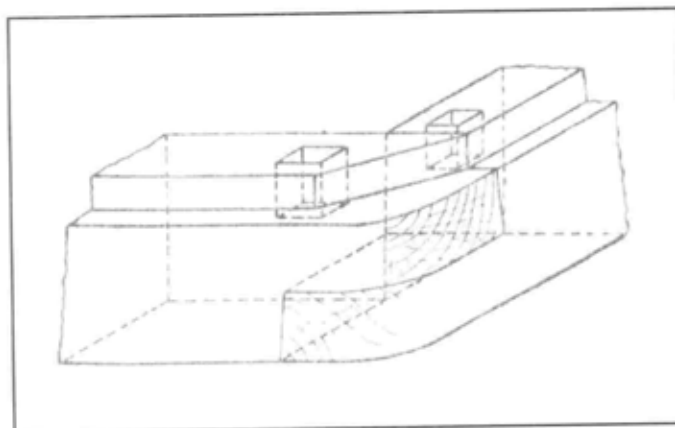
Figure 4.45. Hatch coaming depicted in Curtis 1919:200.

PB-011 support the possibility of the structure being a hatch coaming. Hatch coamings contained a number of removable beams that criss-crossed the opening of the coaming. These beams, the transverse ones called strongbacks and the longitudinal ones called, simply, fore-and-aft beams, supported the hatch cover. These supports were necessary because the hatch cover had to support a great weight of deck cargo, particularly on lumber schooners where much of the cargo was carried on deck. These beams were supported on their ends by mortises cut into the coaming. One problem with this identification is that the hatch coaming would be securely fastened to the hatch framing with closely spaced, large, iron through-bolts (Curtis 1919:133). PB-011 has only five ½-in. diameter vertical fasteners along its entire 11-ft. length. It is possible, however, that either the lowest or the lower two layers were securely fastened to the hatch framing, and then the top layer fastened to them, thereby hiding the large through-bolts.

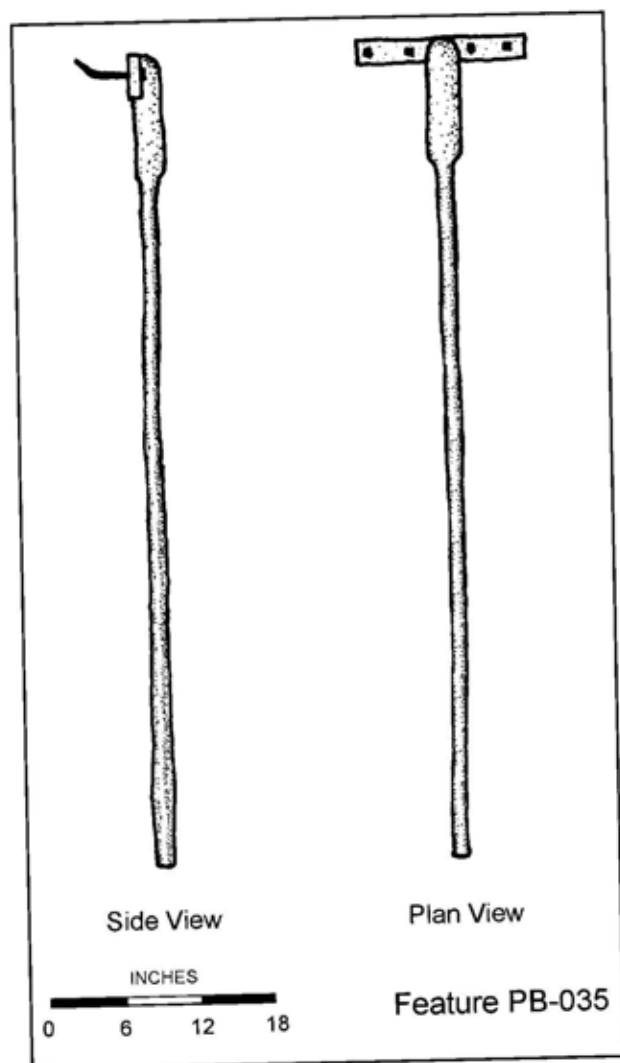
As mentioned earlier, a single, unidentified iron piece, feature PB-035, was recorded above the high-tide line at Northwest Cove (Figure 4.46). This feature is a 4 ft. 8 in. long, 1¾-in. square iron bar, which ends in a 2-in. diameter, 10-in. long round portion. Connected to the bottom of the round end is a 1 ft. 3 in. x 3½-in.

Figure 4.46. Unidentified object (feature PB-035). Drawing by Matt Russell.

rectangular piece, so that the whole object forms a "T." This rectangular piece has four ½-in. square spikes through it. This object has not been identified.

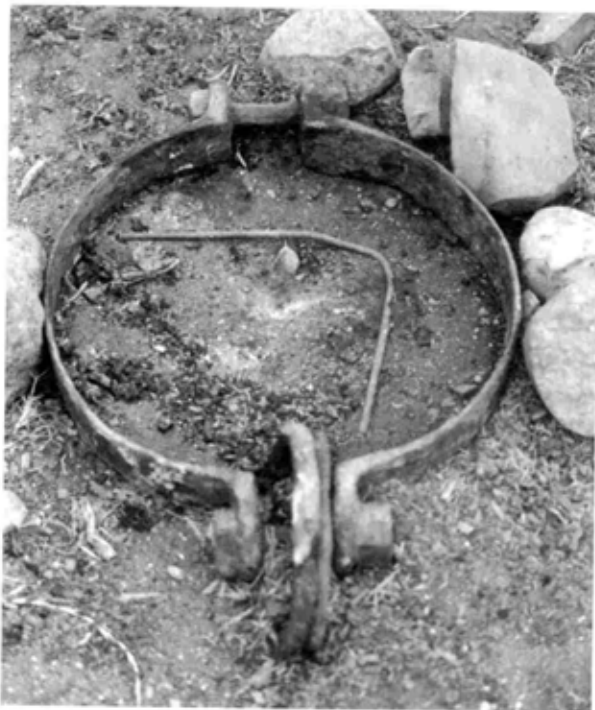
Figure 4.47. Iron mast-band used as a fire ring at Cluster Point. This object has since disappeared. NPS photo by Don Morris.

just south of Cluster Point. At that time it was being used as a fire ring, and it has since disappeared (Figure 4.47).

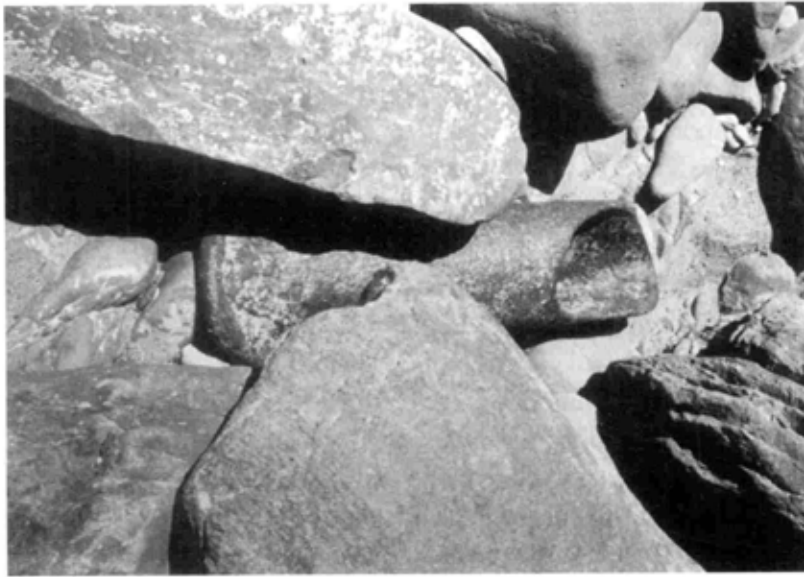
The second feature reported by Morris is an iron hawse pipe measuring 3 ft. 5 in. long, with an external diameter of 9½ in. Originally located in the rocks to the south of Cluster Point, it could not be relocated during the present study (Figure 4.48). According to the tables found in Desmond (1919[1984]), a vessel of 300 tons (*Dora Bluhm* registered 330 gross and 315 net tons) required a hawse pipe measuring 11½ in. in diameter. This hawse pipe appears to be more appropriate for a vessel of approximately 150 tons (Desmond 1919[1984]:157), but this does not discount association with *Dora Bluhm*. It has already been demonstrated that dimensions were sometimes altered from published rules, as long as overall strength was not compromised.

Figure 4.48. Hawse pipe located near Cluster Point. NPS photo by Don Morris.

Unfortunately, there is no way to be certain whether this hawse pipe is from *Dora Bluhm* or not.

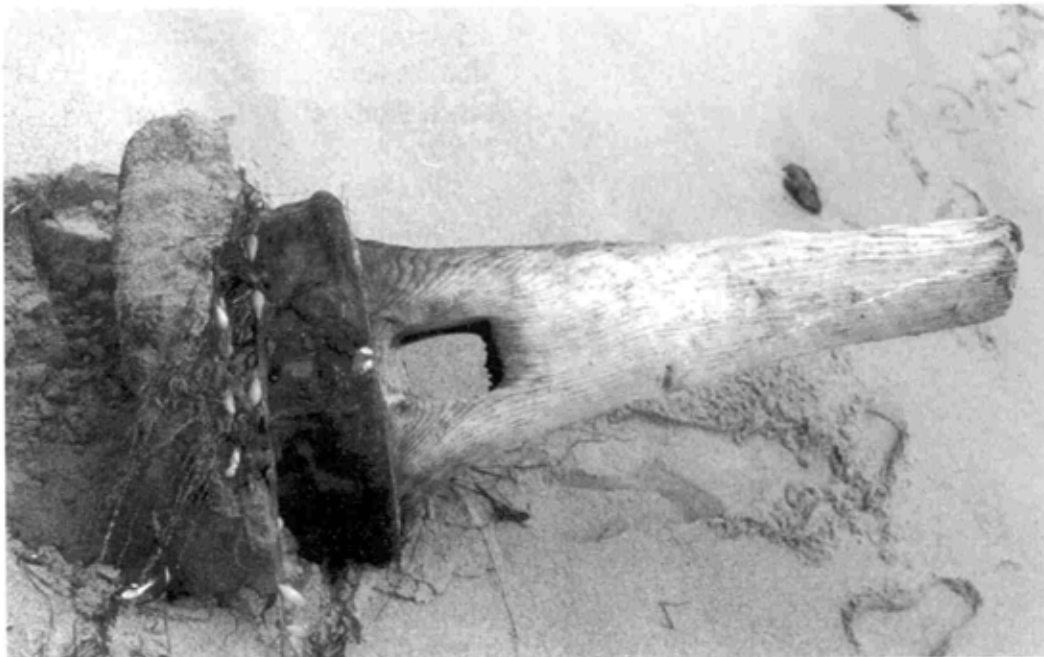
The third feature has been identified as the top of a rudder stock, which bears the yoke that attached it to a diamond-cut-screw steering gear (Don Morris, personal communication 1993; Figures 4.49–4.51). It consists of a worn wooden piece 12 in. in diameter clamped into an iron yoke, which is 10 in. wide. The iron yoke is composed of halves, connected by two iron fasteners on each side. Although there is no size comparison available, there are two pieces of evidence that support a *Dora Bluhm* association. First, the original contract for this schooner states that it was equipped with a diamond-cut-screw steering gear (JPSL 1883). Second, although not sampled for species identification, field observations by Morris indicate that the wooden portion of the feature, the top of the rudder stock, was hardwood, possibly oak. These two clues make this feature's association with *Dora Bluhm* likely. Unfortunately, this feature disappeared from the beach shortly after Morris recorded it in October 1988.

Figure 4.49. Portion of a rudder stock with the iron yoke that attached it to diamond-cut screw steering gear. NPS photo by Don Morris.

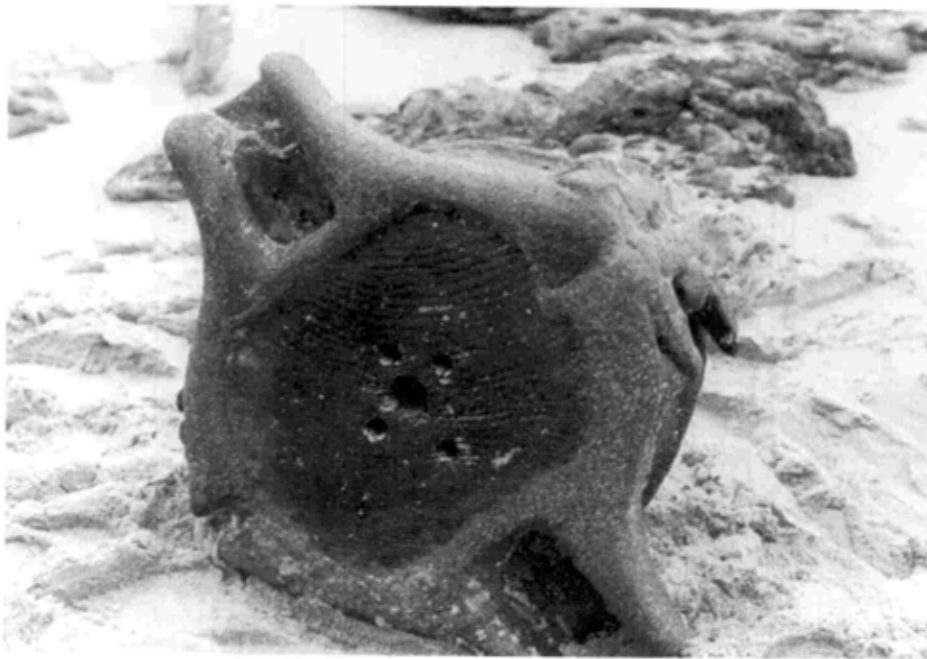
Figure 4.50. End view of the yoke attached to the end of a rudder stock. NPS photo by Don Morris.

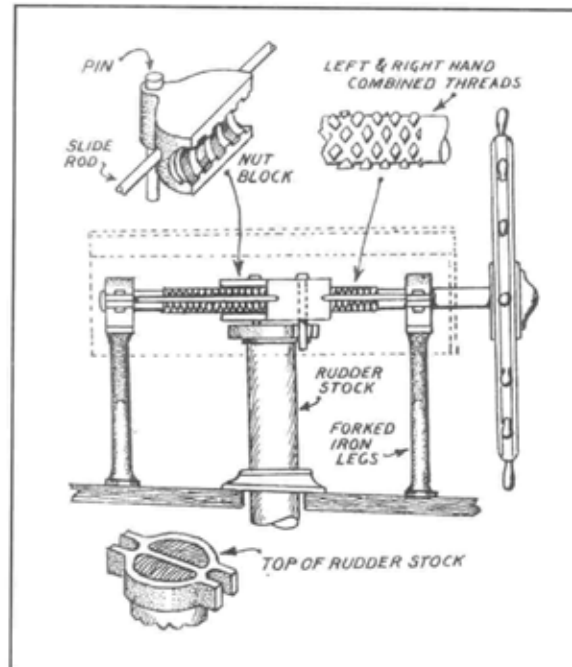
Figure 4.51. Top of rudder stock depicted with yoke that attached it to a steering gear (from Campbell 1974:127).

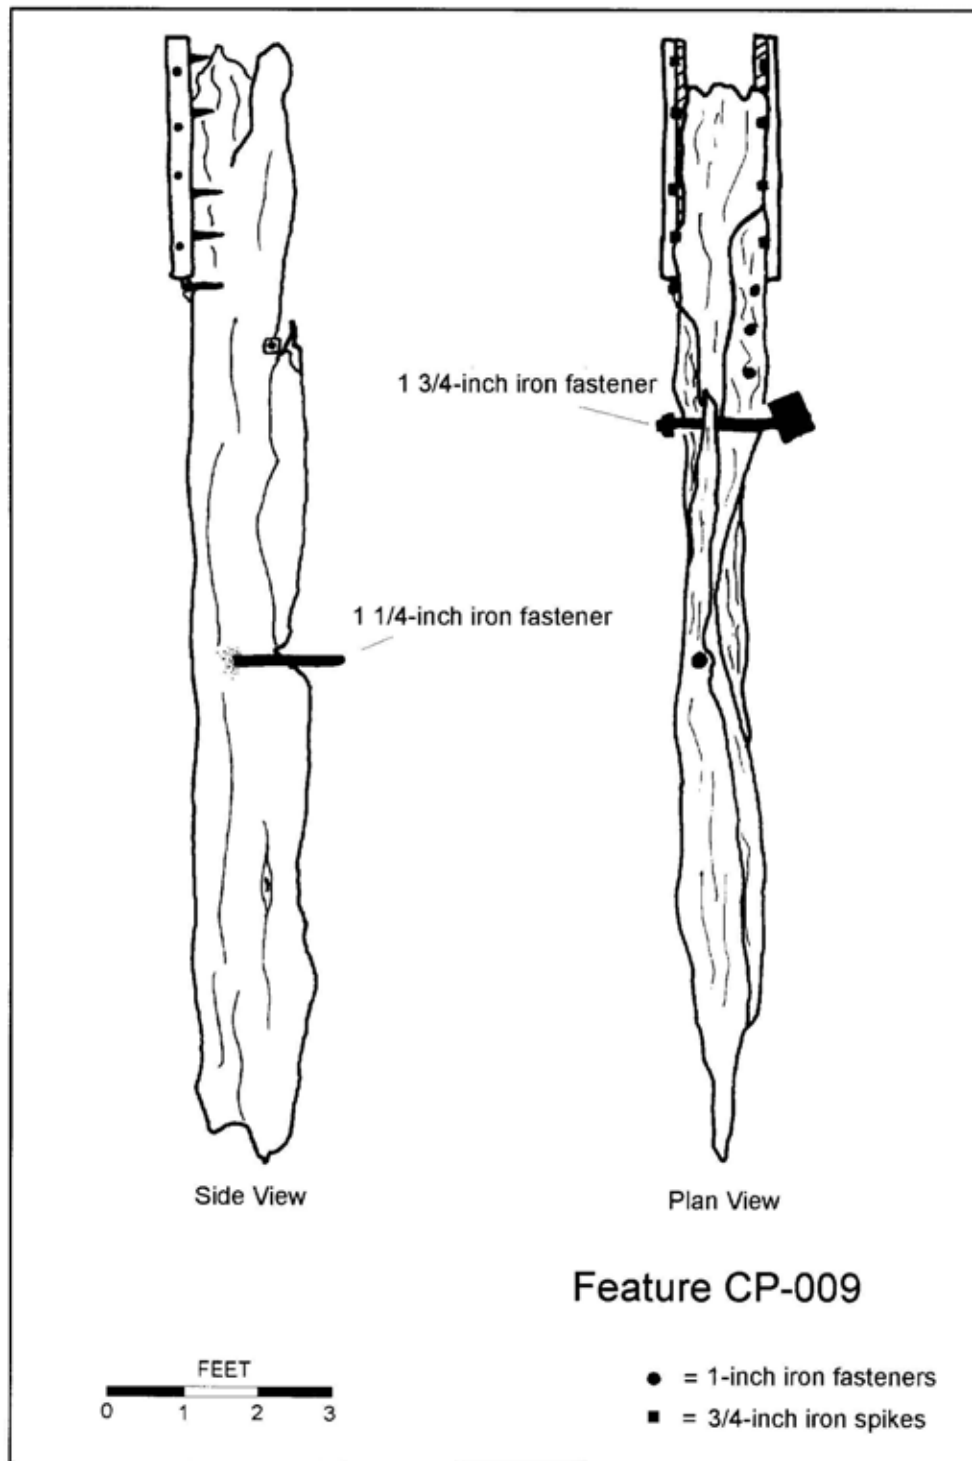
The remaining discussion focuses on features recorded during 1993 fieldwork. All 22 elements and fragments analyzed and sampled were Douglas fir, so none could be discounted immediately, as with the Northwest Cove site (Puseman 1994:6–7). One timber, however, feature CP-009 (Figure 4.52), has a wooden component identified as a member of the Fabaceae family, probably ironwood (Puseman 1994:6–7). This is not a wood usually used in ship construction. The ironwood pieces are two narrow planks 3 ft. 2 in. long, 3½ in. wide and 3½ in. thick, which are fastened to either side of a large, extremely deteriorated Douglas fir timber measuring 14 ft. 8 in. x 17 in. x 16 in. As found, the ironwood planks are fastened along the timber's bottom edge, on the western end.

Figure 4.52. Feature CP-009, likely not part of *Dora Bluhm*. Drawing by Matt Russell.

Four horizontal spikes, driven from the outside face and four vertical spikes, driven from the bottom, fasten each piece. Each iron spike is countersunk into the ironwood, and plugged with an ironwood plug. The main Douglas fir timber contains four vertical 1-in. diameter drift pins grouped near the ironwood planks; one 7/8-in. square spike; one 1¼-in. diameter vertical drift pin; and one horizontal 1¾-in. diameter bolt with a 1¾-in. square nut on one end, and a 6-in. square spacer on the other. The latter fastener's function is unknown, but it is not consistent with common late-nineteenth-century ship construction. This fastener arrangement, coupled with the relatively few fasteners in a timber this size and the unusual ironwood pieces, make this fragment's association with *Dora Bluhm* unlikely.

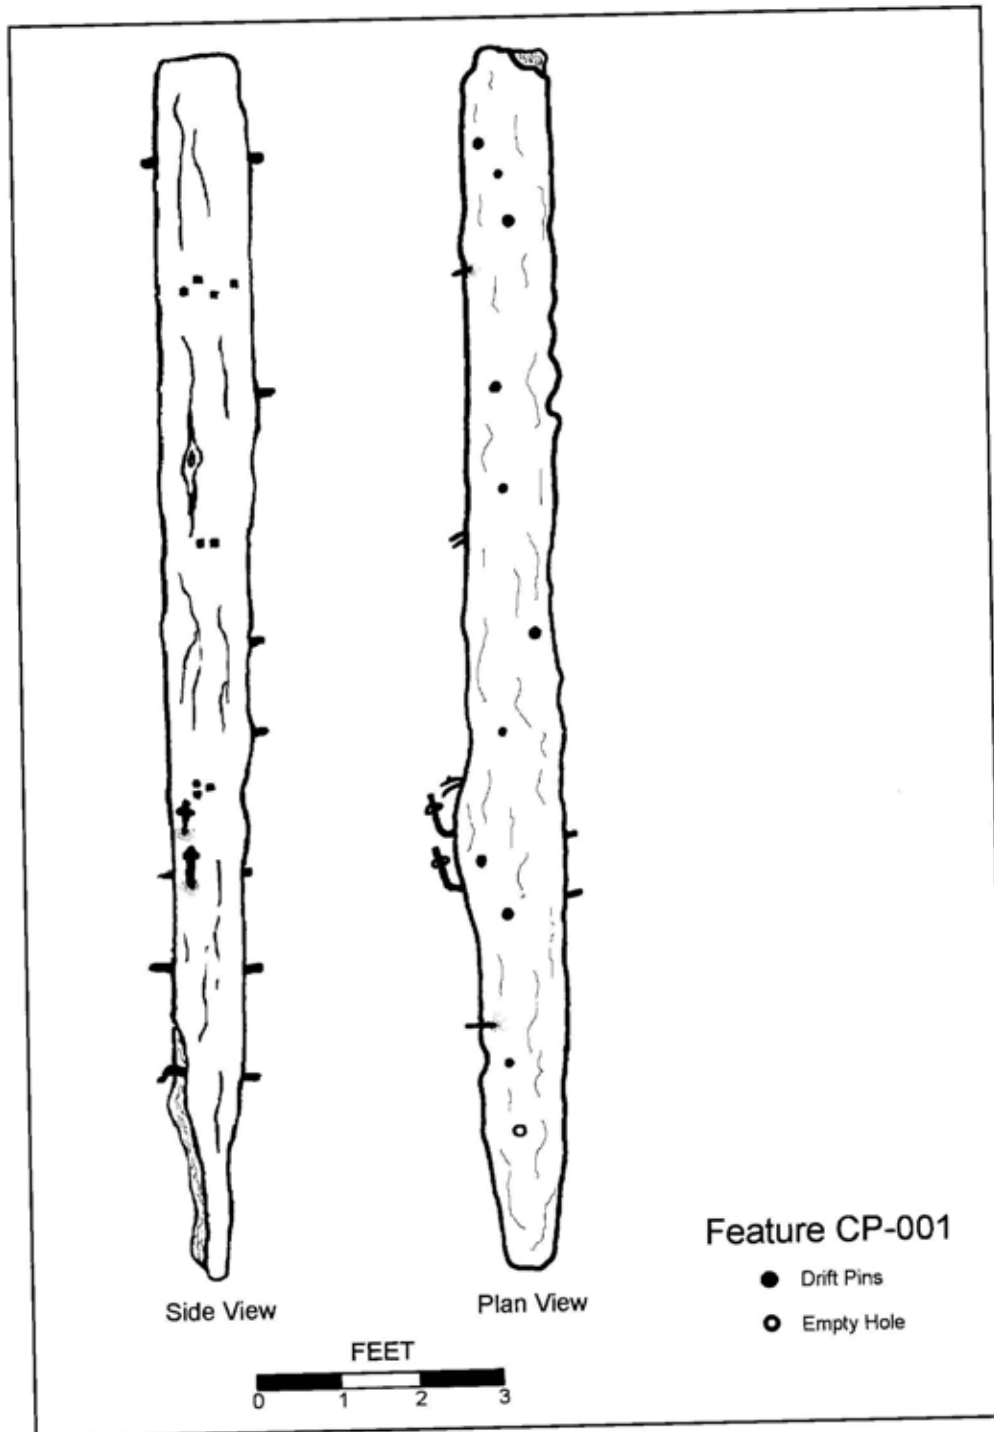
Of the nine structural members, features CP-001, 010 and 012 are all similar Douglas fir elements with large, iron fasteners (Figures 4.53–4.55). The first (CP-001), heavily abraded and worn, is 14 ft. 10 in. long, with maximum dimensions of about 15 in. x 13 in. Both ends of the element are broken; original length is indeterminate. There are ten vertical, iron drift pins along its length, and there is an empty hole for an eleventh. Six drift pins are 1¼ in. in diameter (though slightly expanded by

corrosion), four measure 1 in. diameter, and the empty hole is 1 1/8 in. diameter. These fasteners are grouped roughly in pairs (including the empty hole): the paired pins are approximately 1 ft. apart, and the pairs are about 2 ft. apart. One pair has an additional 1-in. diameter drift between them. These vertical fasteners are broken close to the timber on both sides. In addition to the vertical fasteners, there are several transverse drift pins and spikes including four ½-in. square spikes and two ¾-in. diameter drift pins with 2-in. diameter (possible) clinch rings on one end. The two drifts are paired and 9 in. apart. The drifts protrude from the timber 7 in. on the ends with the clinch rings. There is no other evidence of fasteners on the timber's side faces.

Figure 4.53. Keelson element with iron fasteners (feature CP-001). Drawing by Matt Russell.

The original contract for *Dora Bluhm* aids interpretation of these timbers. The contract specifies the main keelson was to be sided 16 in. and moulded 16 in., while the sister keelson was to be sided 12 in. and moulded 18 in. (JPSL 1883). If features CP-001, 010 and 012 are keelson elements, then, based on sided and moulded dimensions, CP-010 could be either part of the main or sister keelson, while CP-001 and 012 could only be part of the main keelson (taking into account some deterioration). Assistant and rider keelsons are not mentioned in the contract.

In addition to specifying timber dimensions, the contract required the keelson to be fastened with 1 1/8-in. iron fasteners. In all likelihood, all 1¼-in. measurements for the fasteners in CP-001, 010 and 012 are greater than the original measurement because of expansion caused by iron deterioration. This observation is supported by the single 1 1/8-in. diameter hole found on CP-001, which is assumed to be unaltered. Therefore, it is likely that the 1¼-in. diameter fasteners recorded on all three timbers were originally 1 1/8-in. iron fasteners. This does not,

however, account for the additional smaller fasteners found in these three timbers. It is conceivable that smaller iron was used in the transverse fasteners to edge-bolt the main and sister keelsons together. There is no mention in the contract of smaller iron in the vertical through-fasteners that fastened the keelson through the floor into the keel, or the sister keelson into the floor or futtock. These smaller fasteners remain unexplained. It is, nonetheless, probable that features CP-001, 010 and 012 represent portions of the keelson structure of *Dora Bluhm*.

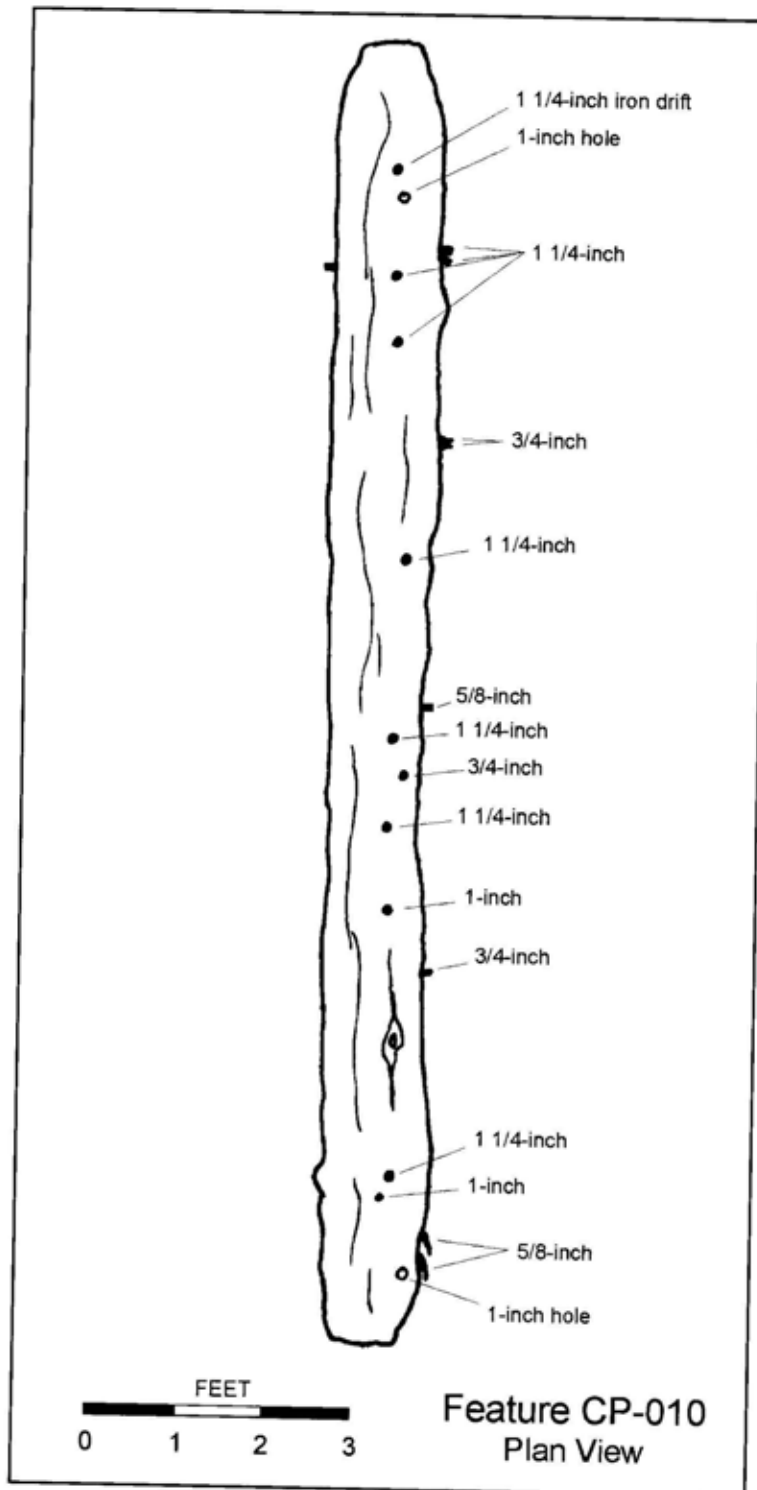
Feature CP-010 is 14 ft. 9 in. long (broken at both ends), with maximum dimensions of 15 in. x 11 in., though somewhat deteriorated, and contains ten vertical iron drift pins along its length, and holes for two more. These fasteners (and holes) include seven 1¼-in. diameter pins, four 1-in. diameter pins, and a single ¾-in. diameter pin. The element also contains transverse fasteners: a pair of 1¼-in. diameter drift pins; a pair of ¾-in. diameter drifts; a single 5/8-in. diameter drift; another, single ¾-in. diameter drift; and a pair of 5/8-in. diameter drifts. There is no discernible pattern to fastener spacing.

Figure 4.54. Keelson element with iron fasteners (feature CP-010). Drawing by Matt Russell

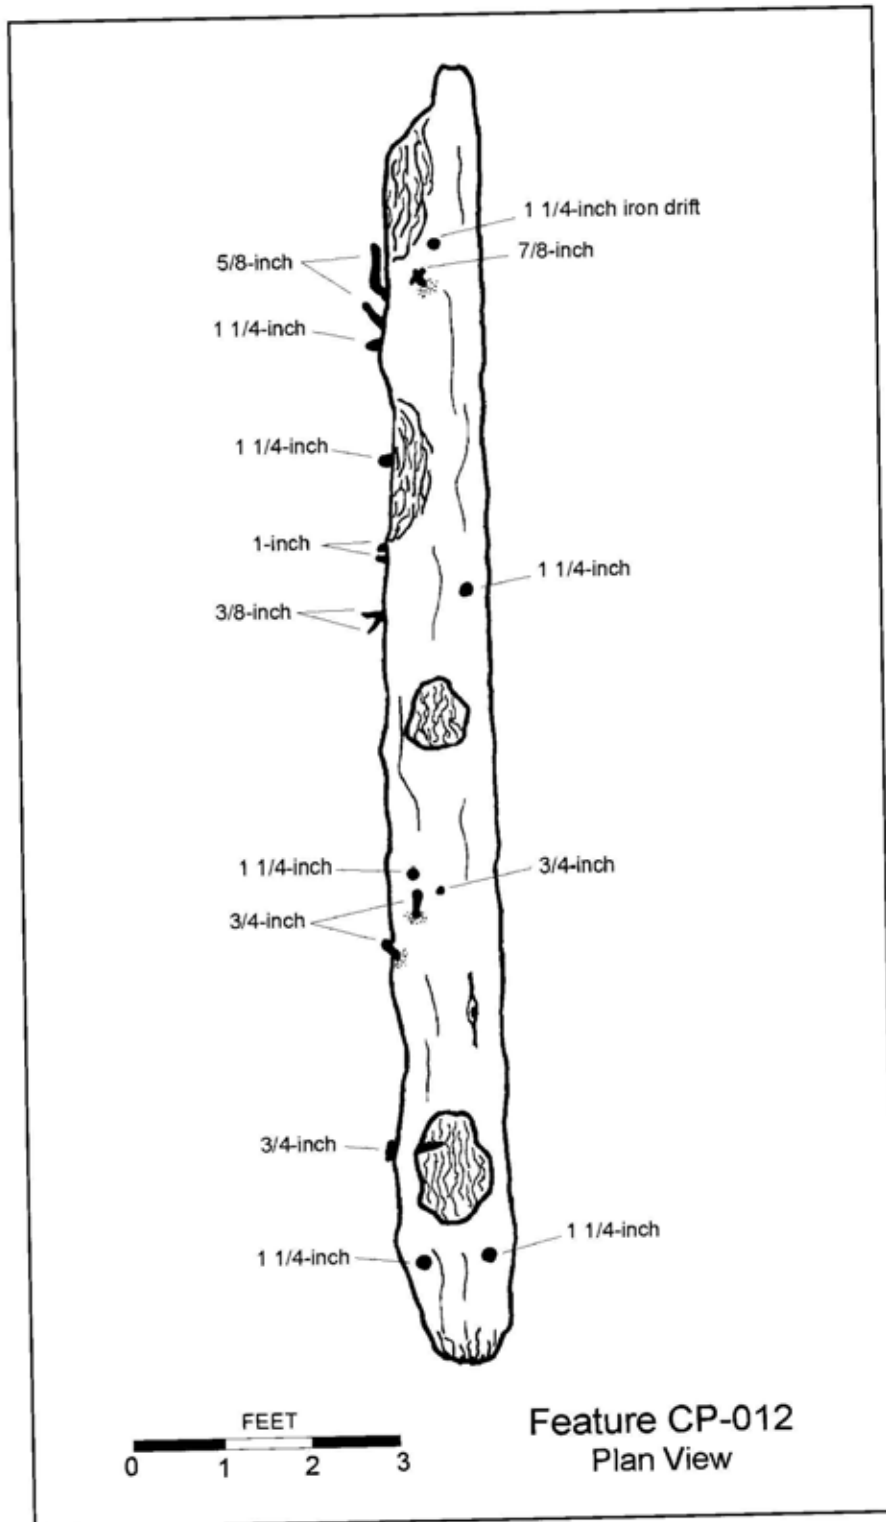
Feature CP-012 is a similar element, measuring 14 ft. 3 in. long (broken at both ends), with maximum dimensions of 14 in. x 13 in., again with some deterioration. The most conspicuous features of this element, besides the fasteners, are two large holes penetrating all the way through the timber, apparently caused by some kind of differential deterioration. There are no large fasteners in or around these holes, so it is unknown if the deterioration was centered on iron drift pins, as seen in feature PB-001. Like the two previous features, CP-012 has

Figure 4.55. Keelson element with iron fasteners (feature CP-012).
Drawing by Matt Russell.

several vertical, as well as transverse, iron fasteners. The vertical fasteners include five 1¼-in. diameter drift pins, three ¾-in. diameter drifts, and a single 7/8-in. diameter bolt with a 1-in. square nut on the end. The transverse fasteners consist of two 5/8-in. diameter round drifts, two 1¼-in. diameter drifts, two 1-in. diameter drifts, two 3/8-in. diameter round spikes, and a single ¾-in. diameter round drift.

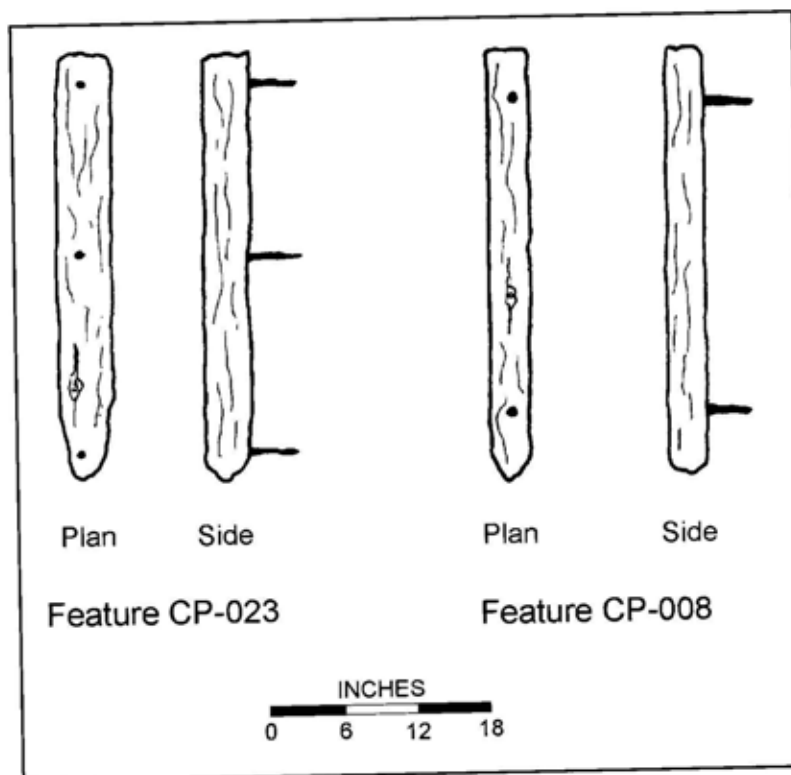
Two features that may represent small portions of structural members are features CP-008 and CP-023 (Figure 4.56). Both features are 3 ft. long and nearly square in cross-section. Feature CP-008 is 3½ in. wide and ¾ in. thick; all its faces are extremely worn. It contains two round spikes 2 ft. 2½ in. apart. One is ¾ in. diameter and the other is 7/8 in. diameter, though both are exfoliating badly. Feature CP-023 is slightly more than 4 in. wide and 3 7/8 in. thick; all its faces are also very worn. It contains three iron spikes, all ½ in. diameter. The first and second spikes are spaced 1 ft. 2 in. apart, and the second and third are 1 ft. 5 in. apart.

Figure 4.56. Deck planking elements with iron fasteners. Drawing by Matt Russell.

Dora Bluhm's contract calls for 4-in. x 4-in. main-deck planking (JPSL 1883). With deterioration taken into account, either element could be a piece of main-deck planking. Fastener spacing cannot be used as an indicator for identification of these features because it is possible that spikes were fastened into carlins or lodging knees and not only into deck beams. The fasteners may have been countersunk and plugged, which is typical practice for main-deck planks; the plugs have since disappeared and the face deteriorated enough to hide traces of countersinking. It is probable that features CP-008 and CP-023 represent portions of the main-deck planking of *Dora Bluhm*.

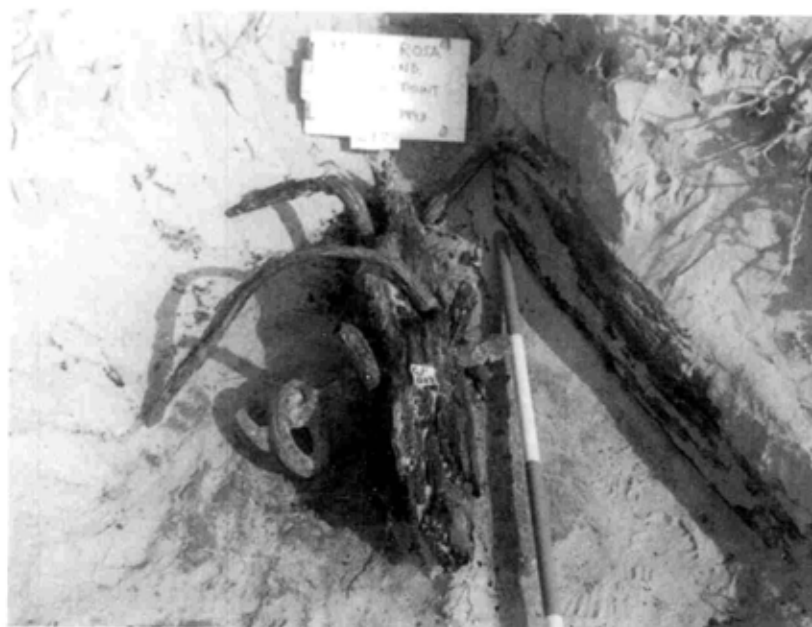
Feature CP-017 is also a structural member from a large, wooden sailing vessel (Figure 4.57). The extremely deteriorated wood element is 3 ft. 4 in. long, 7 in. wide and 10 in. thick. It contains, however, five 1½-in. diameter iron drift pins (the longest 3 ft. long), and a 2-in. diameter iron eye-bolt with a 6½-in. outside diameter ring attached. The eye-bolt and ring represents a tie-down point, which could have been placed in many locations on the vessel. The five fastener's original measurements were considerably smaller, accounting for expansion caused by iron corrosion. The largest fasteners required in the *Dora Bluhm* contract were 1 1/8-in. drifts for the keel, keelson, stempost and sternpost. Feature CP-017 likely represents a small portion of any of these components.

Figure 4.57. Unidentified element with large iron fasteners. NPS photo by Matt Russell.

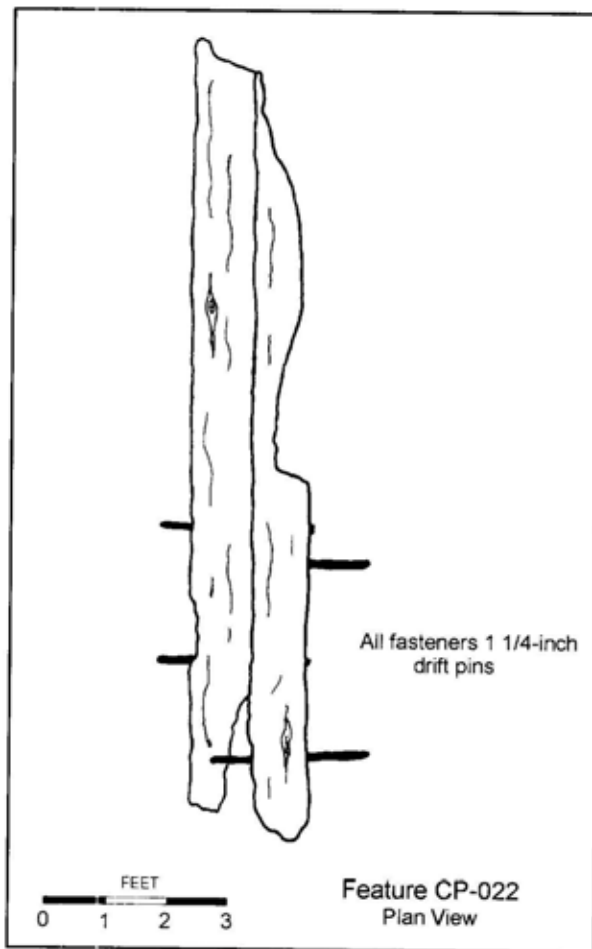
Another probable structural member of *Dora Bluhm* is CP-022 (Figure 4.58). This

fragment is composed of two timbers, each with an original width of 12 in. and surviving lengths of 12 ft. 10 in. The timbers are edge-bolted together with four 1¼-in. diameter drift bolts. The four fasteners originally edge-bolted at least two more timbers to the two surviving pieces, one on each side. The timbers have a present thickness of 5 in., but the undersides are extremely deteriorated, so they were originally thicker. The fasteners are slightly expanded, so they were probably originally 1 or 1 1/8 in. diameter.

Figure 4.58. Fragment of the centerboard trunk (feature CP-022). Drawing by Matt Russell.

At first glance, it appears this fragment may be a portion of ceiling or outer-hull planking, both of which were often edge-bolted (Desmond 1919[1984]:57–59). But this feature does not have evidence of fasteners coming through the face; both ceiling and outer hull planking would have numerous large fasteners attaching them

to every frame. Another possibility, since *Dora Bluhm* was built with a centerboard, is that feature CP-022 is a portion of the centercase. The vessel's contract specifies the centercase was to be constructed of 8-in. thick timber and fastened with 1-in. iron (JPSL 1883). With the severe deterioration on the underside of this feature, these timbers may have originally been 8 in. thick. The fasteners also may have originally been 1 in. diameter. Furthermore, the centercase would have been entirely edge-fastened, which CP-022 clearly displays (Barkhausen 1990:11–12). This feature can be distinguished from the centerboard itself, which would have been more heavily fastened. Therefore, feature CP-022 is most likely a portion of the centercase, or centerboard trunk, of *Dora Bluhm*.

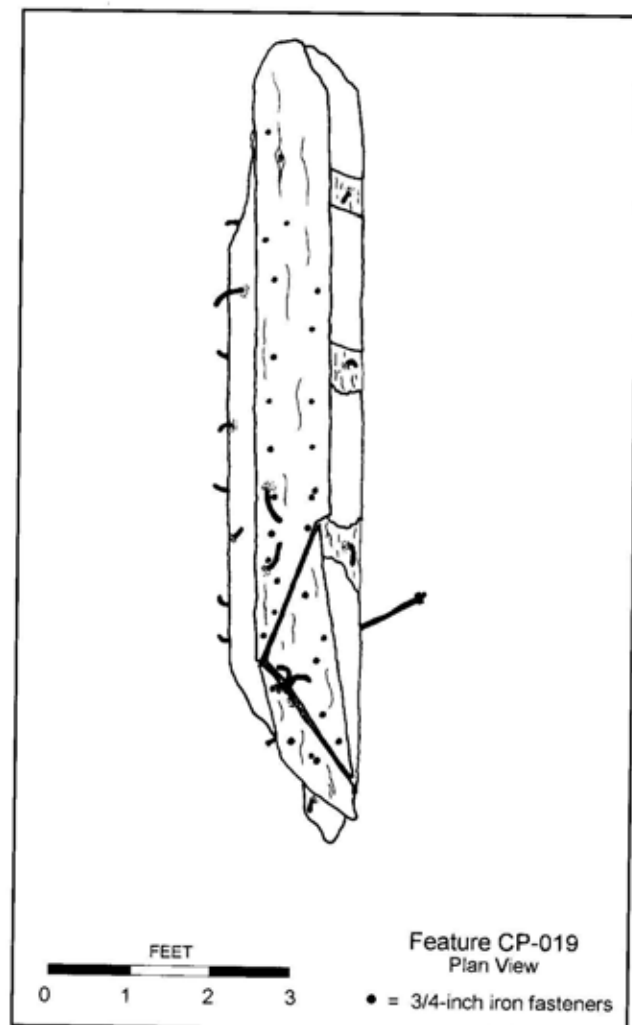
Feature CP-019 is an oddly shaped fragment that exhibits characteristics that are clearly from a large, wooden vessel (Figure 4.59–4.60). The feature is sizable and contains 47 iron fasteners,

all of which are $\frac{3}{4}$ -in. diameter round drifts. The fragment is composed of two pieces: a large, lower timber with three mortises along one edge, and a top portion made up of three different sections. These segments include a long element joined to a smaller element by a triangular chock. These three sections are fastened to the lower timber by 33 fasteners. The bottom part of the feature is 9 ft. long, 18 in. wide and 12 in. thick. The top timbers are 10½ in. wide and 3 in. thick. Like most of the other features, both ends are broken, so original length and configuration is unknown.

Figure 4.59. Feature CP-019. Drawing by Matt Russell.

Dora Bluhm's contract does not go into sufficient detail to identify this feature based on the size of fasteners alone. This is clearly a unique piece, however, and could not have been incorporated into very many places on a sailing vessel. In addition, its size and number of fasteners denote a major structural function. The mortises suggest beams were fitted into the side of the timber, making that piece a deck shelf.

The mortises are too small to have received main-deck beams, which would have been much larger. In addition, if this fragment is a main-deck shelf, then it would have been fastened to the frames using much larger fasteners than the $\frac{3}{4}$ -in. diameter fasteners present. The chock and the angle of the smaller fragment indicate this piece was at one time part of a curved portion of a vessel.

ends for the poop deck would have been laid into the mortises on the inside edge of CP-019, and the plank sheer, or cover board, would have laid over the beam ends. This fragment likely represents a portion of the vessel's port side, because of the curve exhibited by the end of CP-019. Because these pieces are not discussed in *Dora Bluhm's* contract, it is impossible to verify this interpretation using scantling or fastener sizes. It was also impossible to examine this area on *C. A. Thayer*.

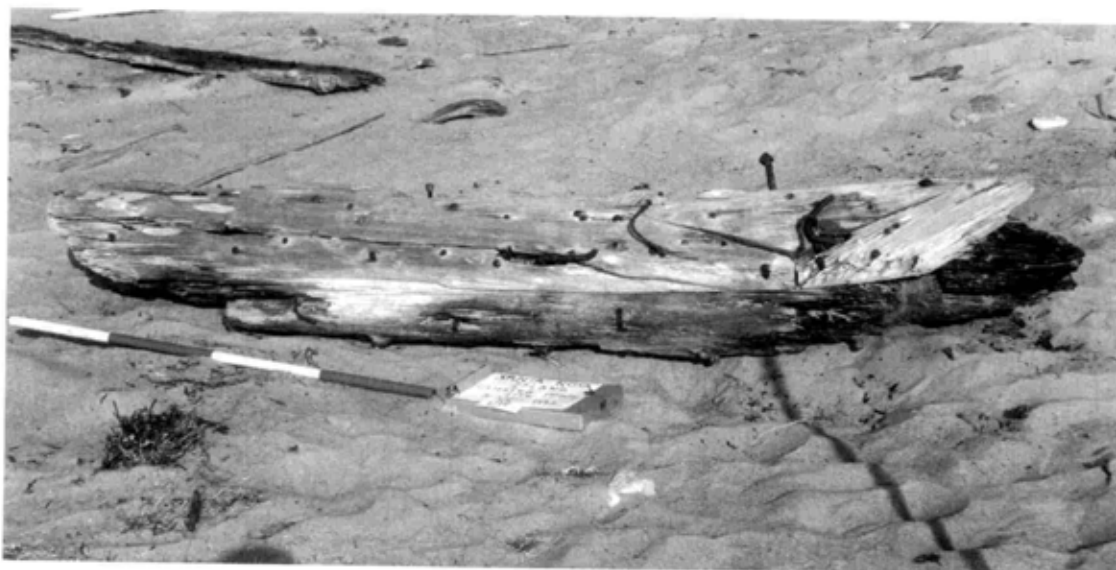
Figure 4.60. Feature CP-019. NPS photo by Matt Russell.

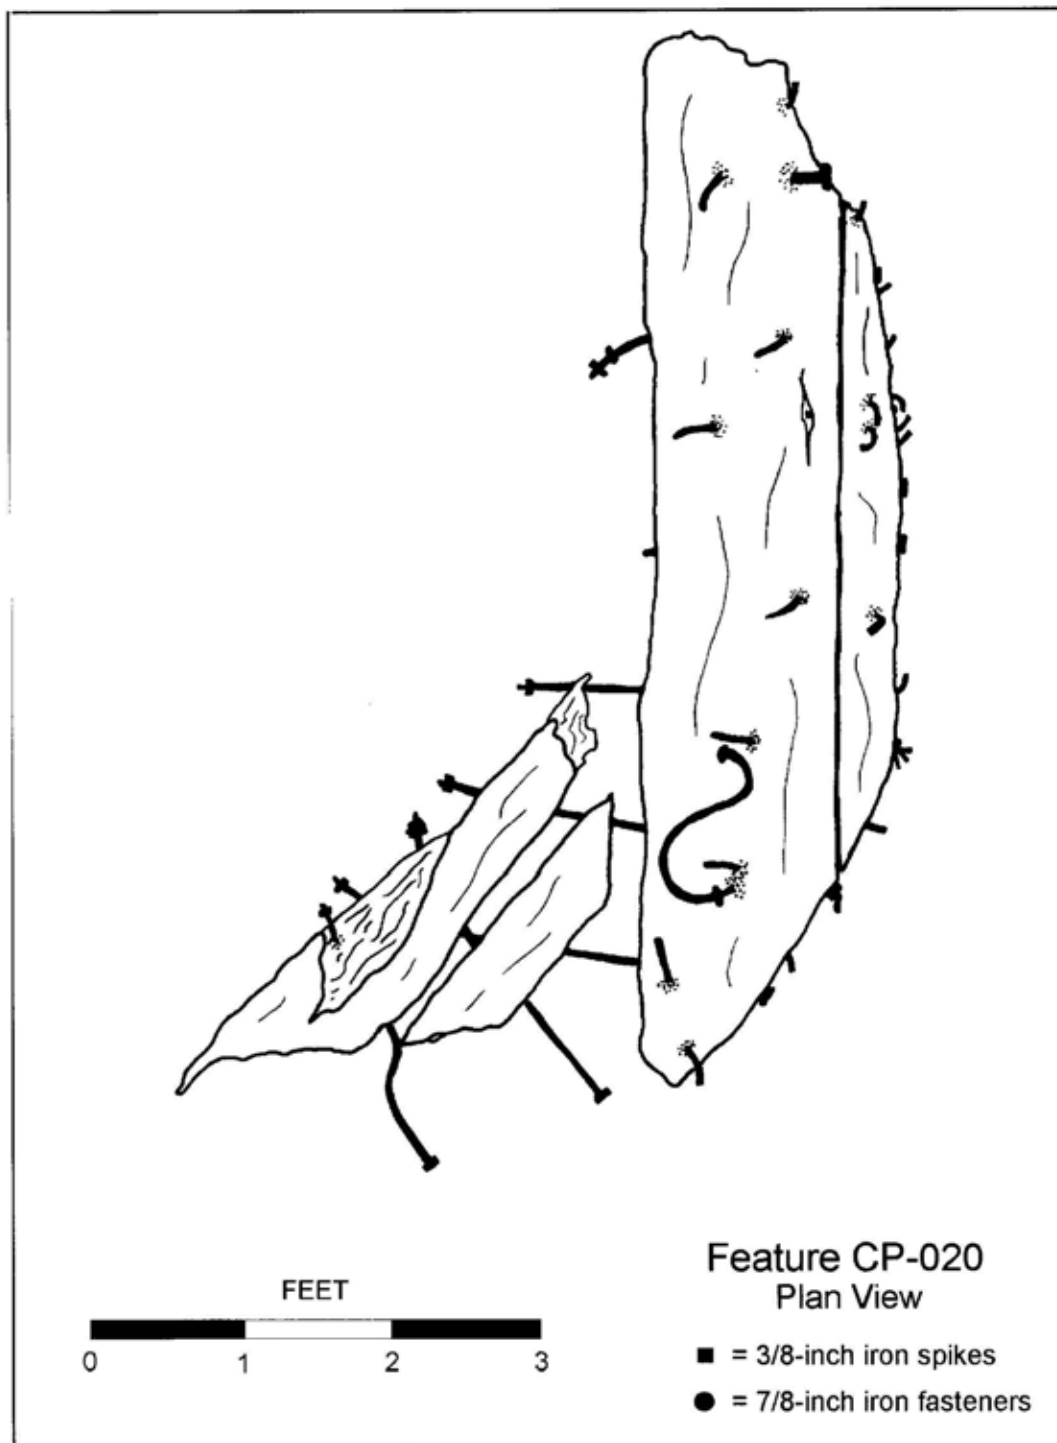
The last structural member discussed is feature CP-020 (Figure 4.61–4.62). It is a relatively flat fragment with a uniform thickness of $8\frac{1}{2}$ in. The main timber is 7 ft. 3 in. long (though broken at the ends) and 1 ft. 9 in. wide; a smaller 4-ft. x 1-ft. 4-in. fragment is fastened to it at an angle. The feature contains nineteen $\frac{3}{8}$ -in. square spikes and seventeen $\frac{7}{8}$ -in. diameter drifts. Timber and fastener configuration suggest this piece represents a portion of the "rim" of a large, wooden vessel, while the smaller fragment attached to it is a component known as the anchor stock (Curtis 1919: 66). The rim circled the stern of the vessel

Figure 4.61. Feature CP-020. Drawing by Matt Russell.

and formed the knuckle line, or main-deck line. The rim was generally composed of three sections joined by two chocks called anchor stocks. The upper ends of the stern frames ended at the bottom of the rim, and the solid work was directly above it. It was a major stern structural element.

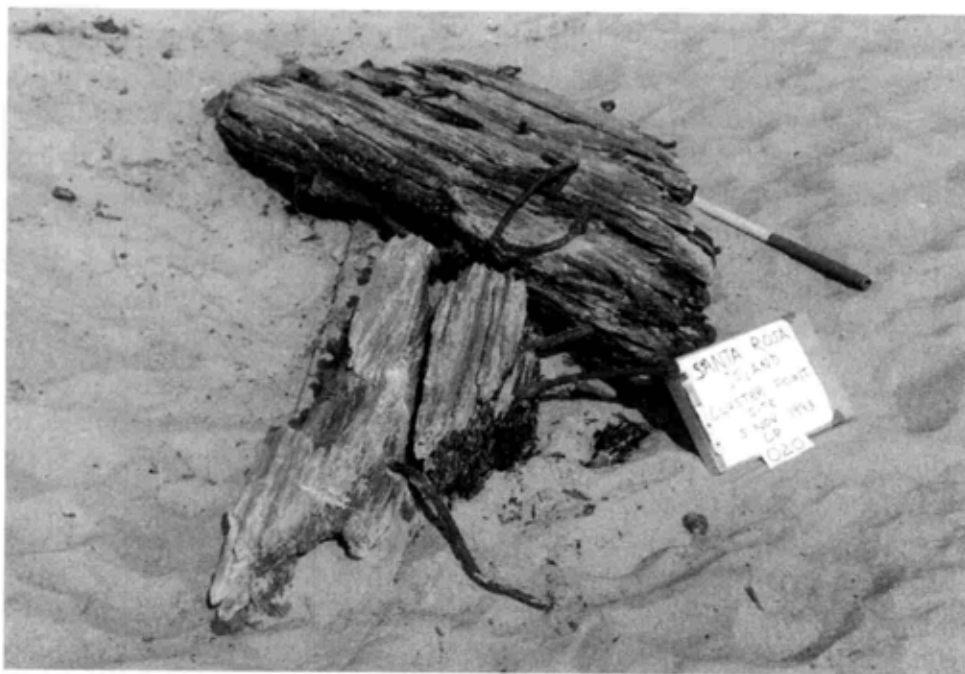
Figure 4.62. Feature CP-020. NPS photo by Matt Russell.
