National Park Service
U.S. Department of the Interior

Submerged Resources Center

Beached Shipwreck Archeology: Case Studies from Channel Islands National Park

Matthew A. Russell

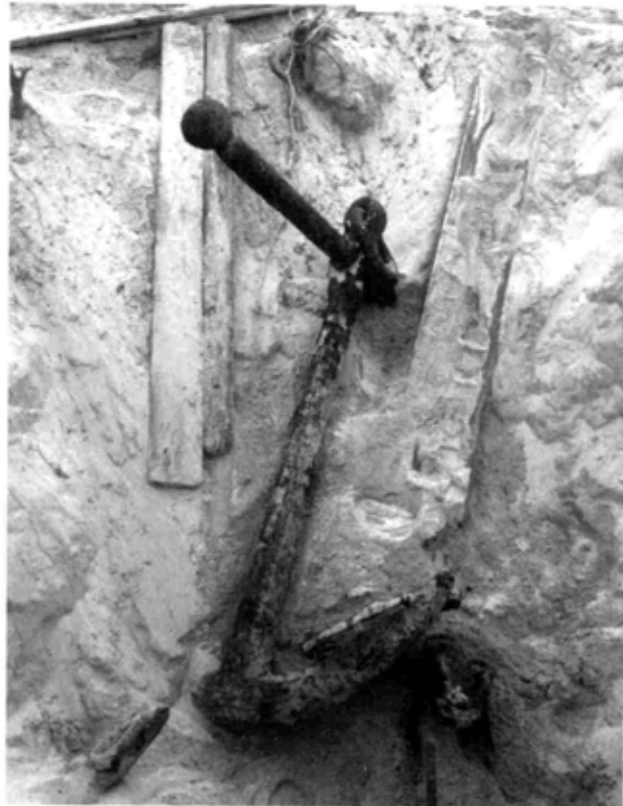
Although 1993 fieldwork exposed little of *Comet's* remains, it was possible to completely expose and record the anchor. *Comet's* anchor is iron with a collapsible iron stock (Figures 4.63–4.65). The anchor is fitted with a ring, but no cable is present. Overall length is 7 ft. 11 in.; stock length is 7 ft. 9½ in. Anchor arms are 3 ft. long, with 5 ft. 6 in. between palm tips. The palms measure 1 ft. ¾ in. wide x 1 ft. 6 in. long, and 1¼ in. thick.

Figure 4.63. *Comet's* anchor after exposure in 1993. NPS photo by Matt Russell.

tonnage (Paasch 1890:151). Calculating an anchor's weight can determine what role it played on a vessel. The *Cyclopaedia of Useful Arts* (1854) provides a formula for estimating anchor weight (in hundredweights [cwt] = 110 pounds): $cwt = \text{overall length}^3 \times .0114$ (Murphy 1993:288). Using this formula, *Comet's* anchor weighs approximately 5.6 cwt or 616 lbs. A table of minimum anchor weights for sailing vessels found in Desmond (1919[1984]) shows a 400-ton vessel (*Comet* registered 429 gross and 368 net tons) was required to carry two 1,850-lb. bower anchors, a 600-lb. stream anchor and a 300-lb. kedge anchor. The anchor found on *Comet* most likely represents its stream anchor.

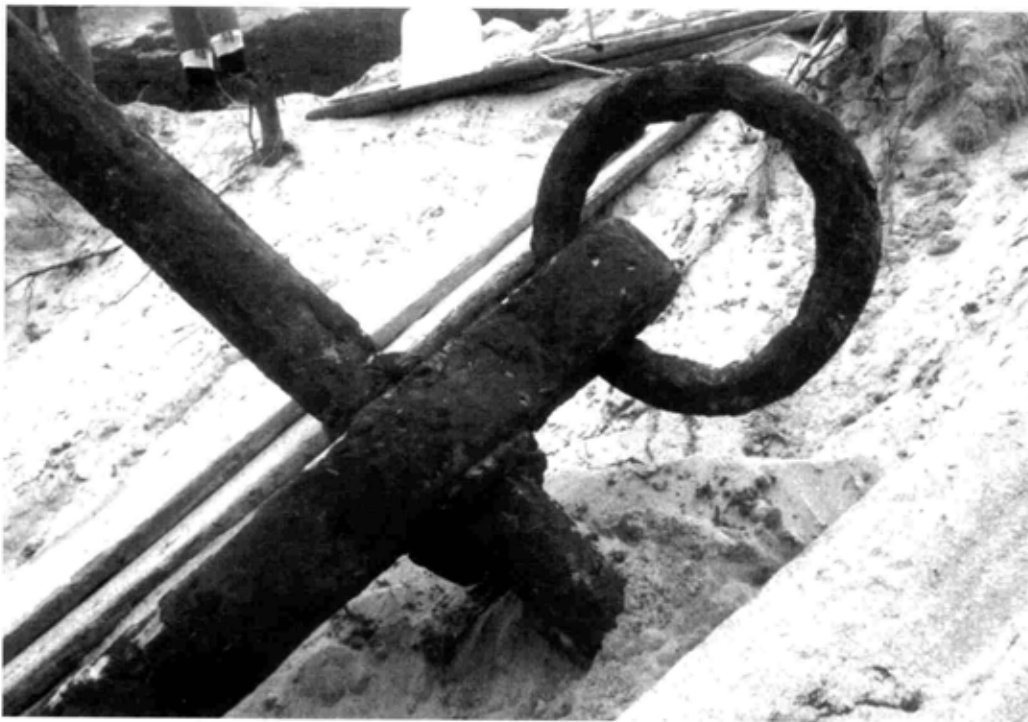
Figure 4.64. *Comet's* anchor ring. NPS photo by Matt Russell.

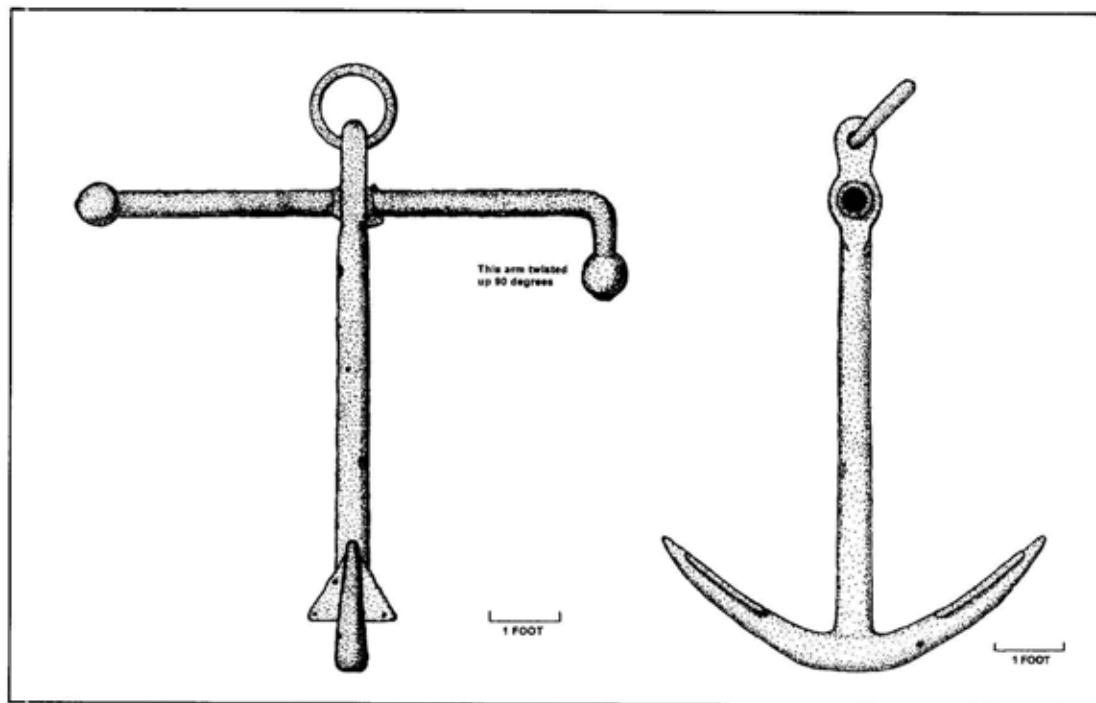
Figure 4.65. *Comet's* anchor. Drawing by Matt Russell.

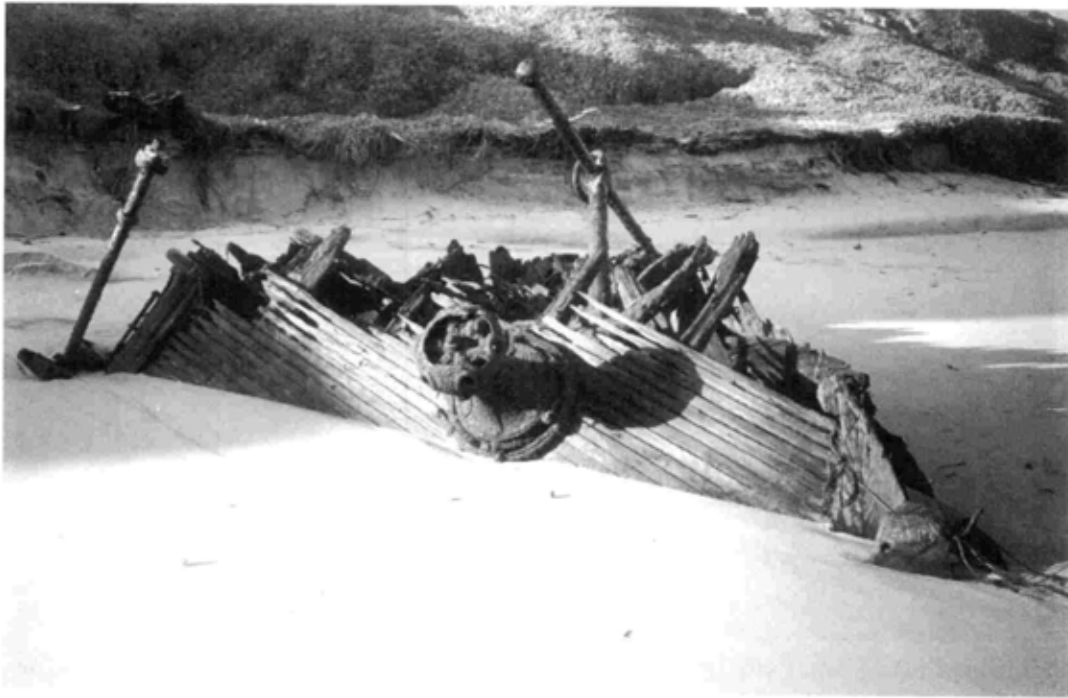
Figure 4.66. *Comet's* bow section looking down at forecastle deck. NPS photo by Matt Russell.

approximately 10 m x 8 m. The nearly intact bow section points out to sea on a heading of 317° magnetic, and the bow is heeled 55° to starboard and tilted down 20°. Much of the bow's port side has been worn away by natural deterioration (Figures 4.66–4.69).

The starboard side of the forecastle deck is intact from the bow to the deck's aft end above the windlass (Figure 4.80; also Figures 4.66 and 4.69). Forecastle deck remains are supported by five deck beams; the three forward-most beams are 5½ in. sided, and the two aft beams,

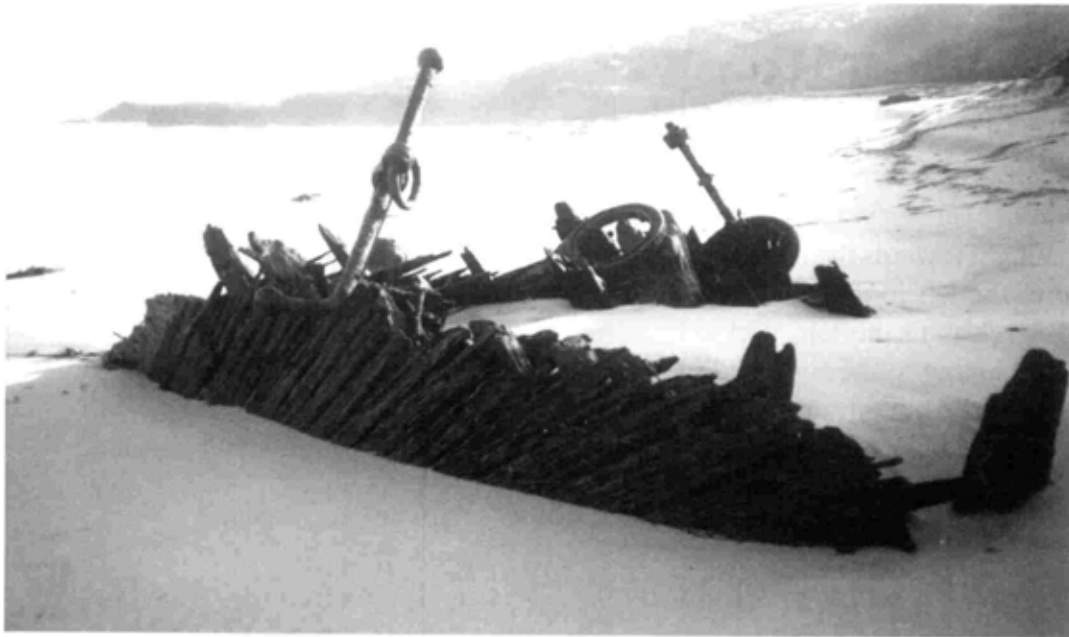
Figure 4.67. *Comet* site in April 1999, looking at the port side outer hull timbers. NPS photo by Matt Russell.

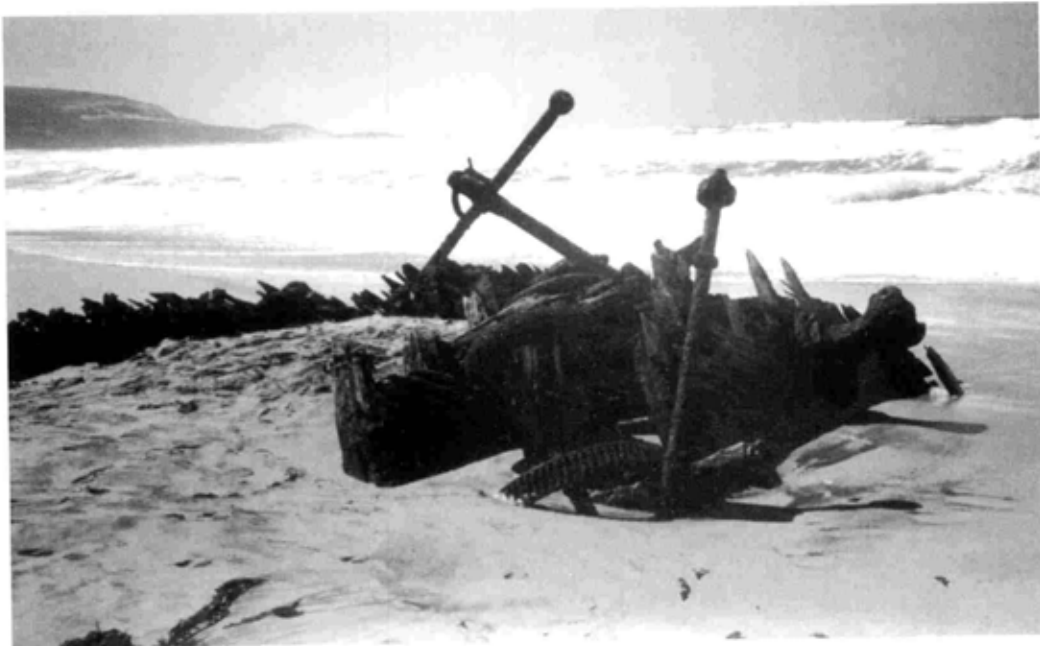
Figure 4.68. *Comet* site in 1999, looking towards the windlass (mounted on the main deck) in the center of the photo, with the capstan (mounted on the forecastle deck) to the right. NPS photo by Don Morris.

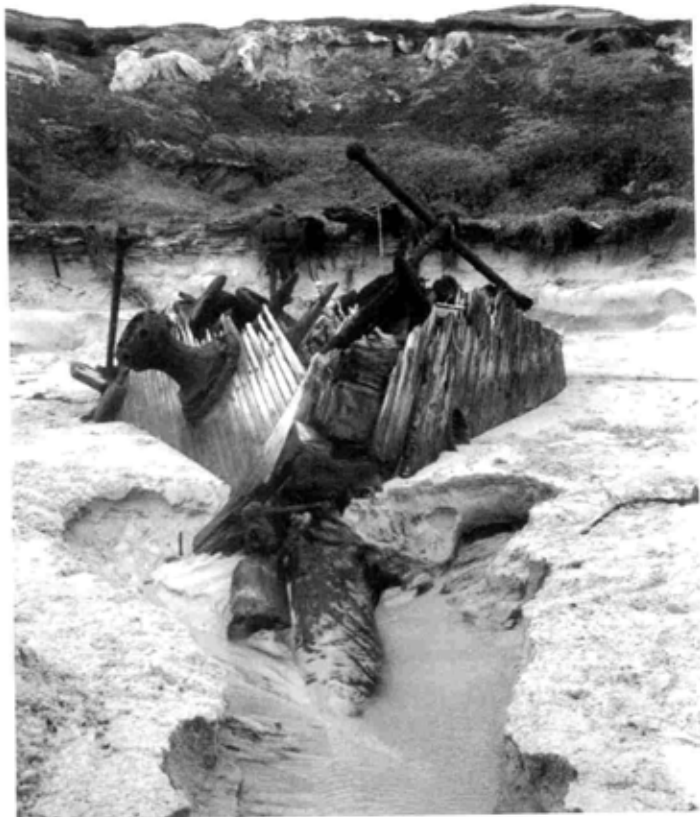
Figure 4.69. *Comet* site in April 1999, looking straight towards the bow, which is canted to the left in this photo. The forecastle deck is to the left, port side outer hull planking to the right and the bowsprit is in the bottom of the photo. NPS photo by Matt Russell.

As noted above, *Comet's* bowsprit is intact and in its original position (Figures 4.69, 4.70 and 4.75–4.77). On a wooden sailing vessel, the bowsprit, a spar that projects forward from

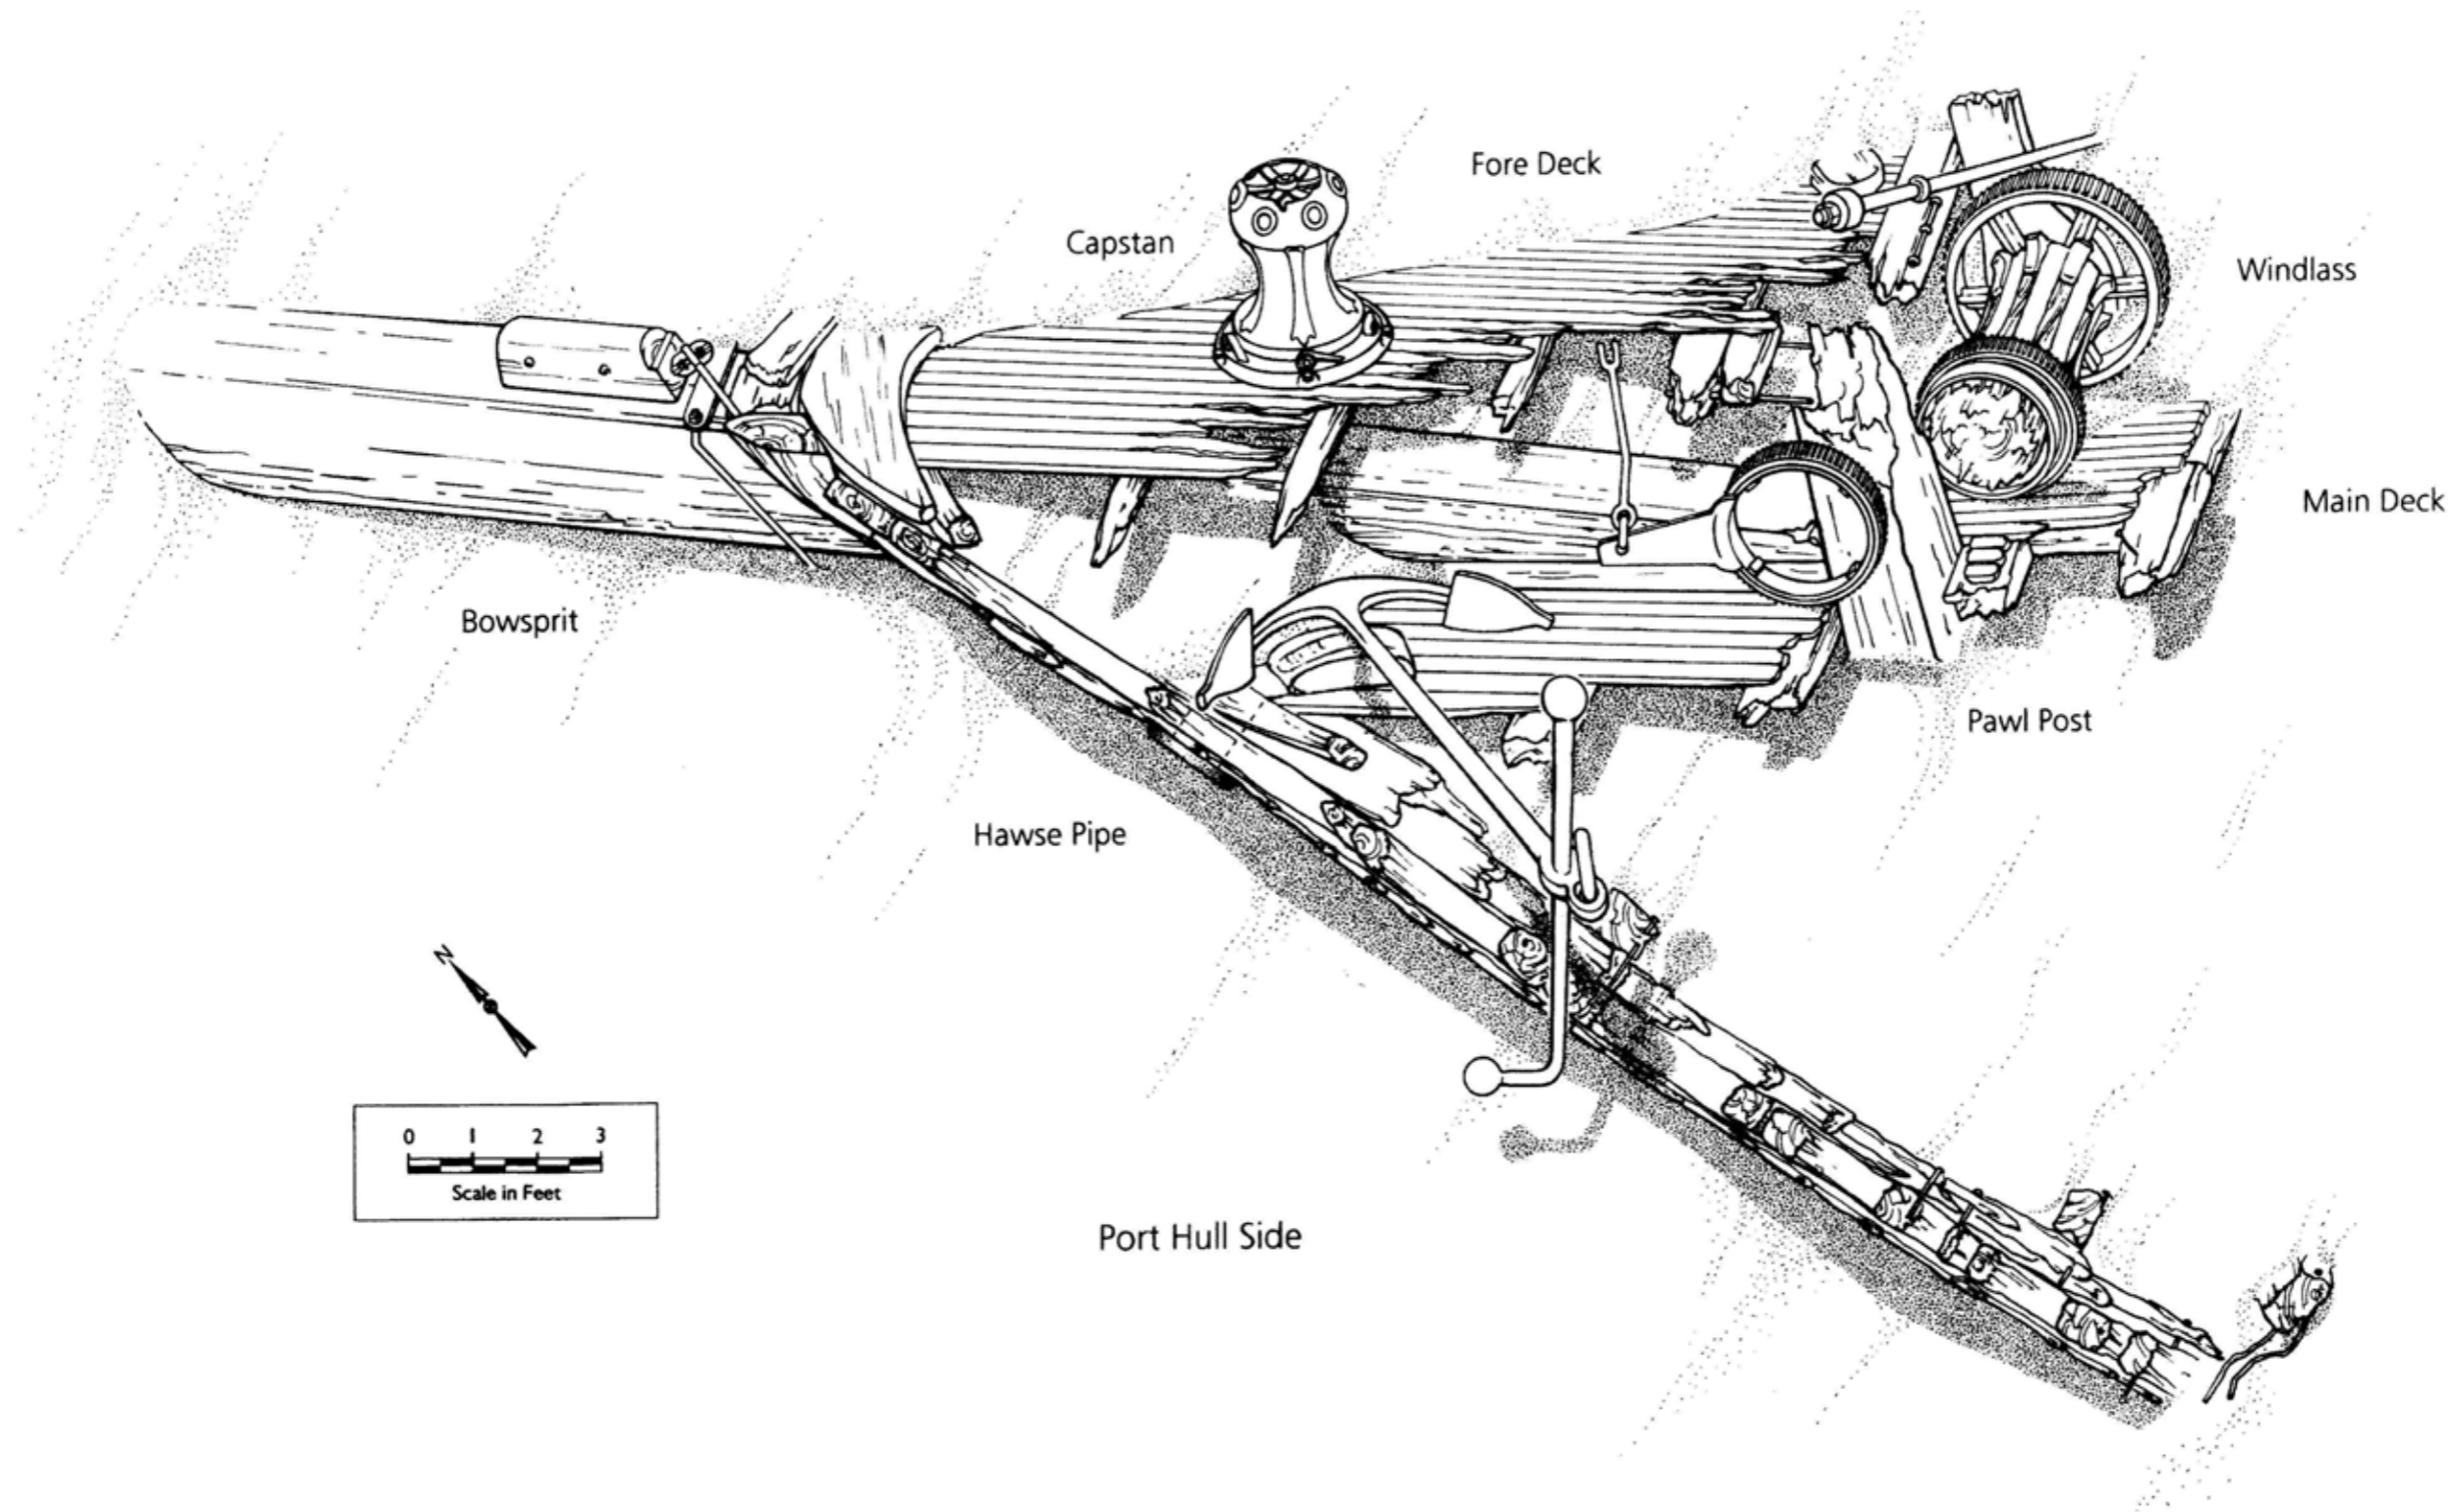
Nearly all *Comet's* original bow structure and related features are represented on the site (Figure 4.70). Exposed structural elements include port-bow framing and outer-hull planking; the partially intact forecastle deck and forecastle-deck beams; the partially intact main deck and main-deck beams below the forecastle deck; the pawl post (sometimes called a pawl bitt or Samson post) extending through the main deck and broken off at the forecastle-deck level; the bowsprit, extending from where it is stepped into the pawl post's forward face to about 19 ft. forward of the bow; the forecastle- and main-deck deck-hooks and waterway hooks; and several bow pointers. Other features present

Figure 4.70. *Comet* site plan. Field drawing by Matt Russell; final drawing by Robert Turner.

are bow rigging elements and ground tackle features including an anchor; the capstan mounted in its original location on the forecastle deck; the intact log windlass' starboard half, still mounted in its original location on the main deck, along with the iron parts of the windlass' port half; the port bow stopper or riding chock; and the port hawse pipe. Although more of the wreck is exposed than the 1984 photographs show, much of the starboard bow still lies deeply buried in the sand and was not documented.

The final structural members discussed are two timbers in the site's southwest corner, rising vertically out of the sand inside the ceiling planks (Figure 4.70). At the deepest exposure, about 2 ft. of these timbers were visible. The aft-most timber measures 1 ft. 2 in. x 9 in., and has two 7/8-in. diameter iron fasteners in it. The forward-most of these two timbers measures 11 in. x 7 in. These structural timbers are likely pointers, placed in the bow and stern angled down diagonally in their normal upright position (Figures 4.85 and 4.86). According to Curtis (1919:101), pointers are used to “. . . furnish additional stiffening to the hull at the locality where the pointer is placed, to aid in resisting panting movements and stresses, and . . . to add additional strength against torsional strains such as are experienced at the ends of a ship when rolling heavily at sea.” Pointers are fastened at a 45° angle atop the ceiling planks and into the cant frames, and they extend from the lower part of the hull upwards to the first, or in *Comet's* case, main deck (*Great Lakes Register*

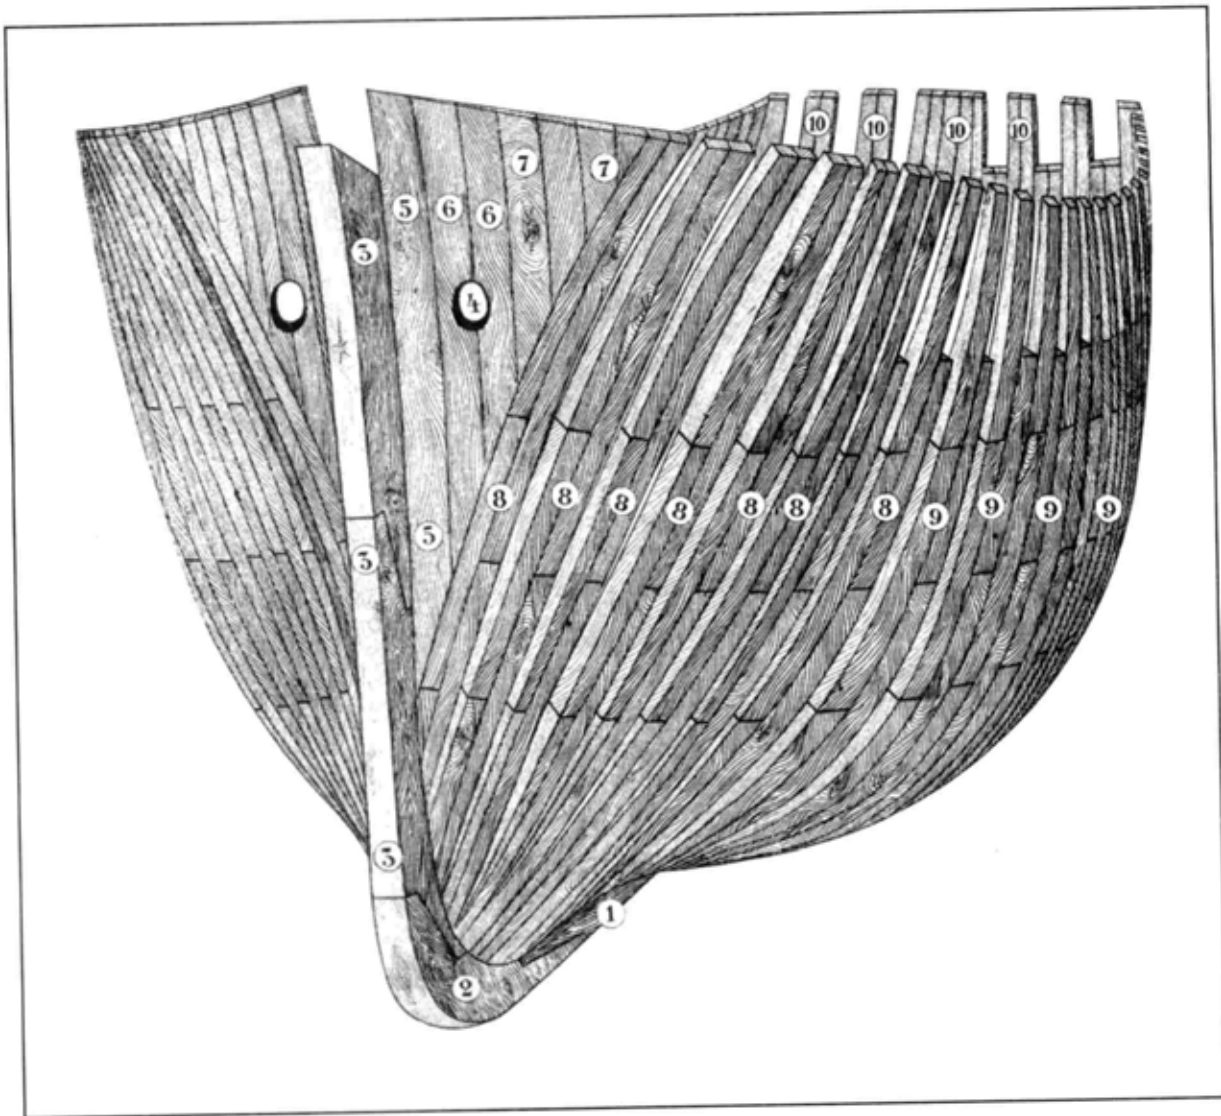
Figure 4.71. Bow framing, including stempost (3), knighthead (5), hawse timbers (6) and cant frames (8) (from Paasch 1977:plate 5).

Bow framing in a wooden vessel of this period includes cant frames, hawse timbers, knightheads, and the stempost (Figures 4.71–4.73). Cant frames are frame pairs, made up of futtocks and top timbers (futtock heels are notched into the bow deadwood, so there are no floors) that are rotated forward of perpendicular to the keel to create the vessel's bow form. Forward of the cant frames are hawse timbers, which solidly fill the space between the cant frames and knightheads. A vessel's hawse pipes pass through the hawse timbers, which provide a solid foundation for fastening the hawse pipe flanges. The knightheads are timbers located on both sides of the stempost and extend above it to support the bowsprit, which rests atop the stempost and between the knighthead timbers (Desmond 1919[1984]:50, 55).

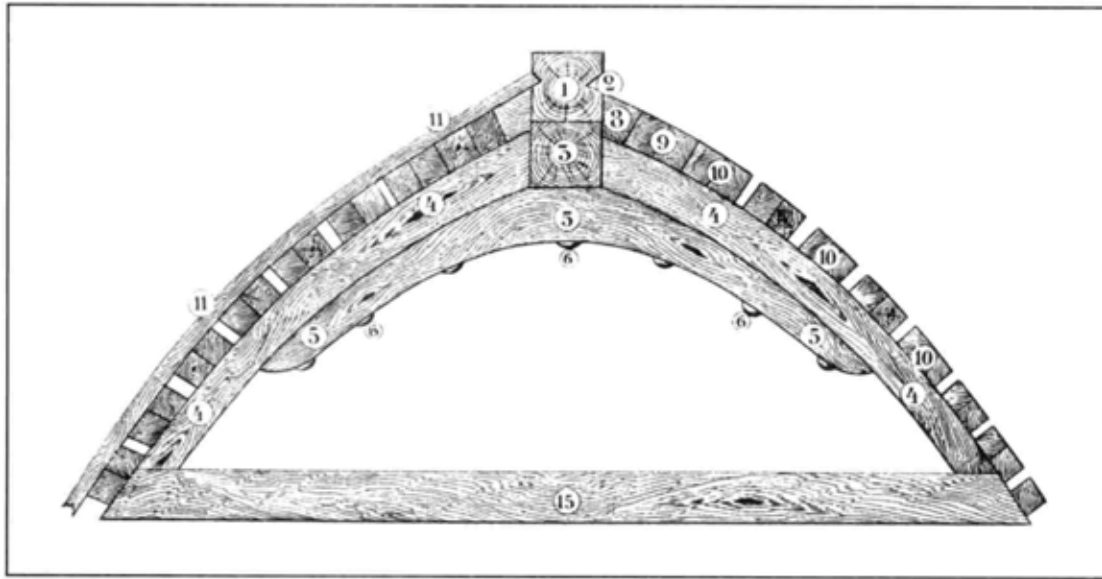
Figure 4.72. Bow framing, including stempost (1), knighthead (8), hawse timbers (9) and cant frames (10). Additional features observed on *Comet* include the deck hook (5), deck beams (15) and outer hull planking (11) (from Paasch 1997:plate 15).

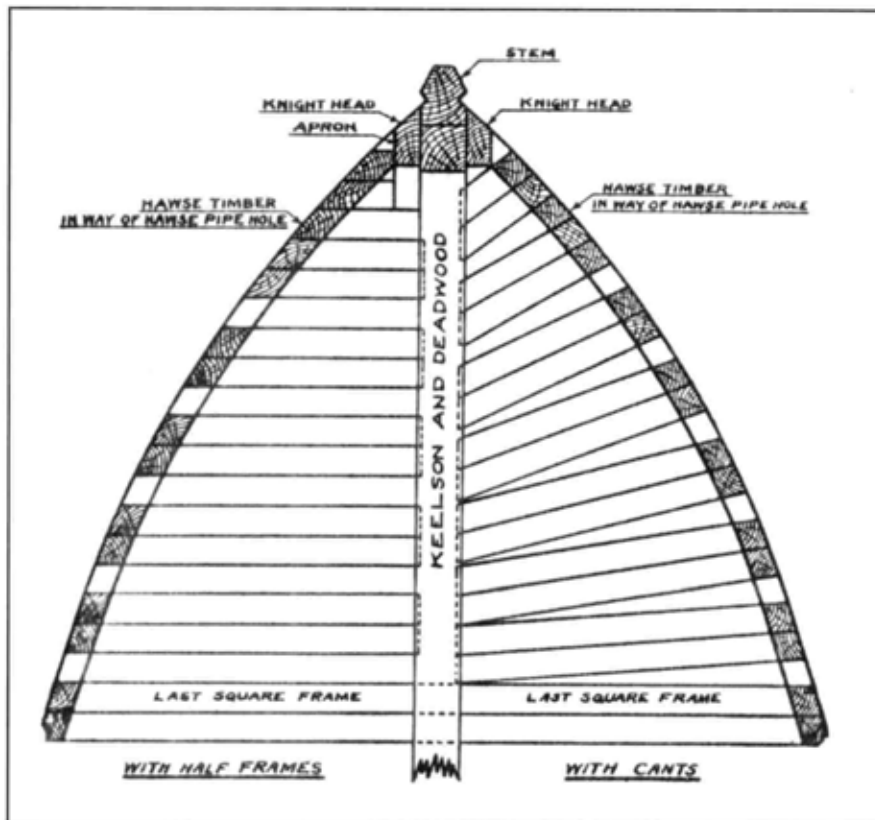
Figure 4.73. Bow framing, showing difference between cant frames and half frames (Curtis 1919:58).

Although it was difficult to verify because of limited access and complex angles involved, the five frame pairs are most likely all cant frames as opposed to half frames (Figure 4.74 and see Figure 4.73). At their greatest exposed dimension, each frame measured 9½ in. sided and 10 in. molded. Each frame's molded dimension at the top, approximate main-deck level, was 8 in. *Comet's* contract specifies frames as sided 10 in. and molded 13 in. at the keel and 6½ in. at the deck (JPSL 1886). *Rules for the Construction of Wooden Vessels* stipulates a 400-ton vessel built of "yellow fir" should have top timbers (frames at deck-level)

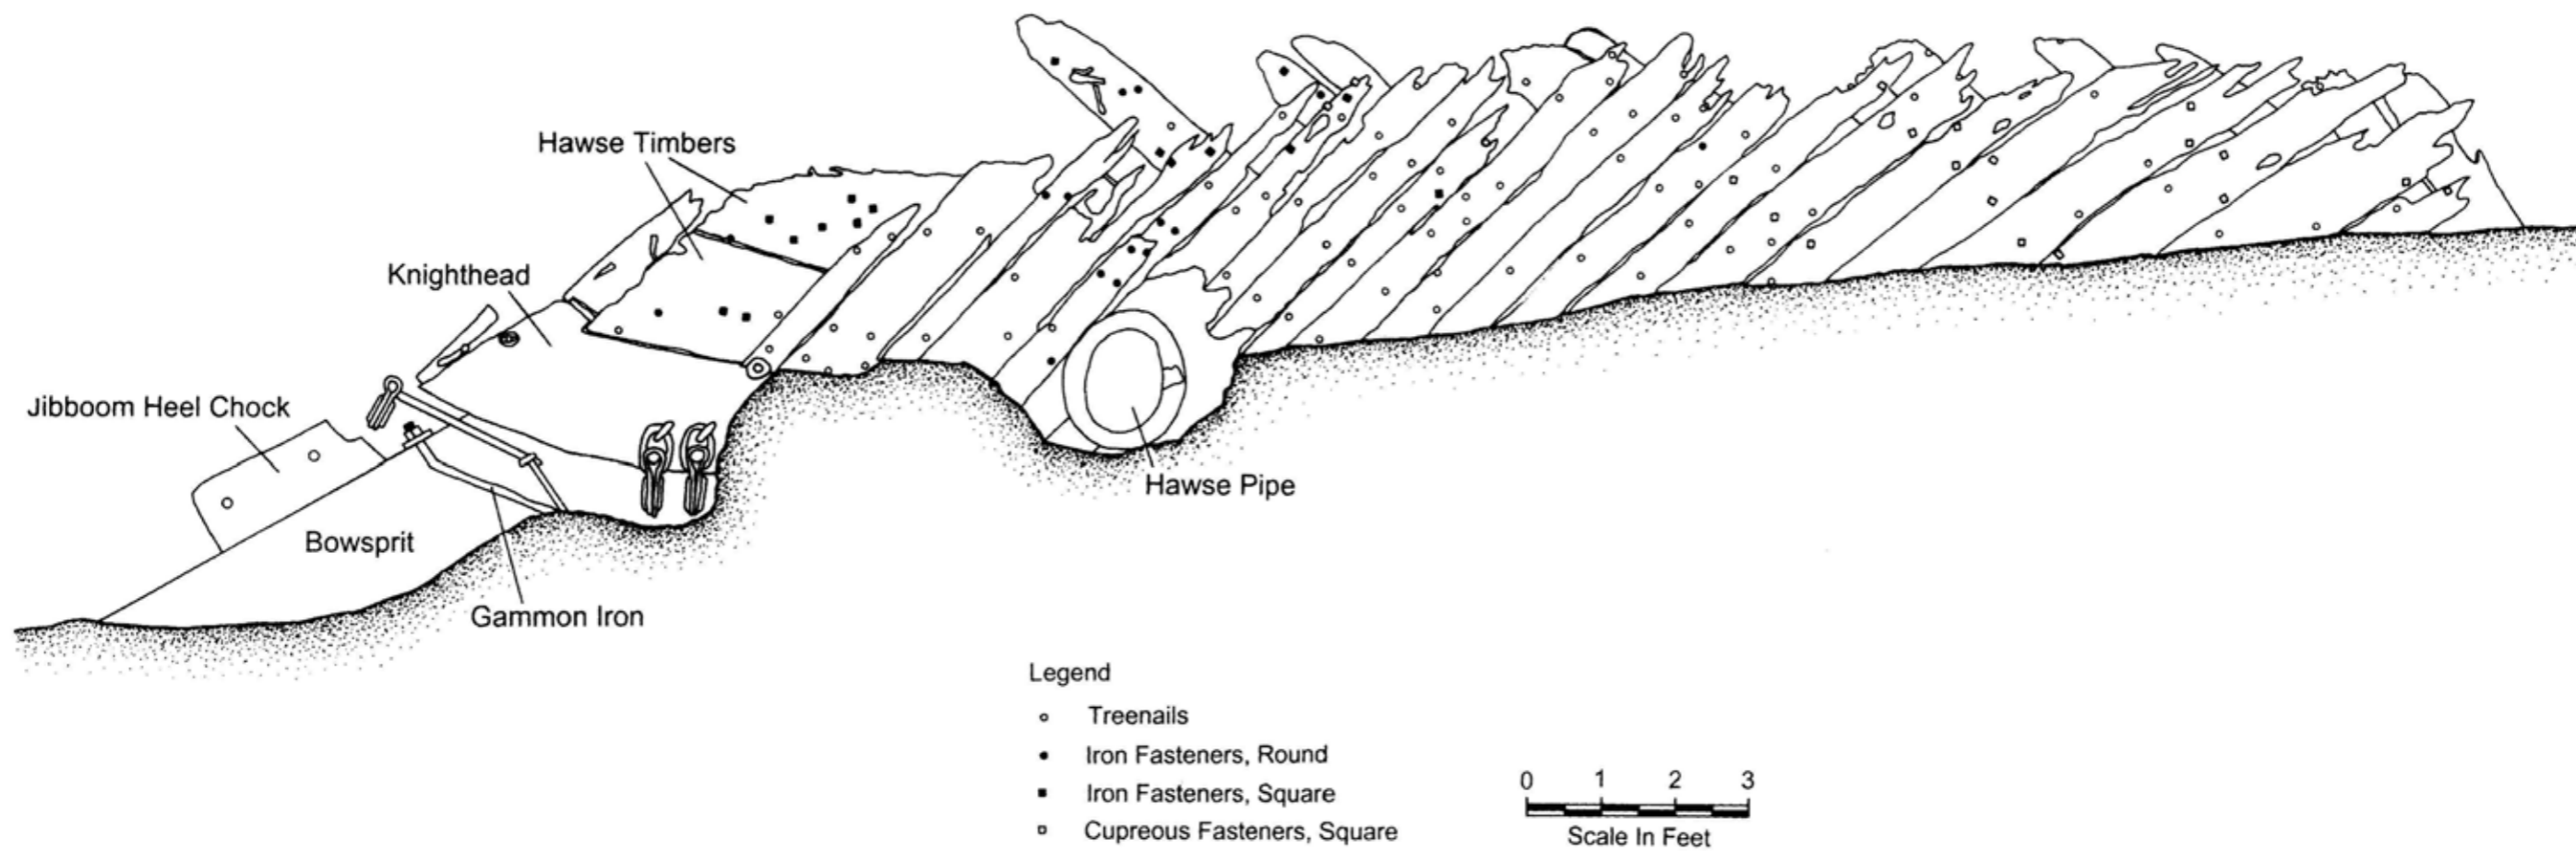
Figure 4.74. *Comet* port elevation drawing. Drawing by Jim Bradford; inked by Nancy Lamm.

sided 8 in. and molded 7½ in. (American Shipmasters' Association 1879:xxviii). Taking into account timber erosion from natural weathering, *Comet's* cant frames' sided dimension matches that specified in the contract and exceeds that given in the rules; molded dimensions exceed both the contract and rules, but this is possibly only true for the cant frames, because no square frames were present to be examined. Individual frames making up each frame pair were fastened together with treenails measuring between 1¼ and 1½ in. in diameter. A combination of treenails and iron drift pins fasten the outer hull planking, frames and ceiling planking together. Forward of the forward-most frame pair is what appears to be a single frame, but it is likely its adjacent frame member is broken below the sand line and could not be

Forward of the frame pairs are two hawse timbers, or hawse pieces (Figure 4.75; see Figure 4.74). These timbers “. . . close the openings between forward cant frames from the knightheads aft as far as necessary to give good solid fastening for hawse-pipe flanges. The lower ends of hawse timbers are bolted to the apron and the several hawse timbers are edge-bolted together . . .” (Desmond 1919[1984]:55). The hawse pieces are 6 in. molded and 2 ft. sided, though their sided dimension appears to narrow over their length, and the aft hawse piece is eroded on its aft side, making an accurate original sided dimension difficult to measure. The top edge of the hawse pipe is located 5 ft. 5 in. below the upper surface of the hawse timbers.

Forward of the hawse timbers is the port-side knighthead (Figures 4.76 and 4.77; see Figure 4.74). The knightheads strengthen the bowsprit and support the hooding ends, which are the forward ends of the outer hull planks (Desmond 1919[1984]:50). The knighthead is rhomboid in shape, with each side varying slightly between 1 ft. 2 in. and 1 ft. 3 in., and its shape narrows and curves over its length. Neither hawse timbers nor knightheads are mentioned in *Comet's* contract, but the *Rules for the Construction of Wooden Vessels* states that knightheads and hawse timbers should have double the sided dimension of the frames (American Shipmasters' Association 1879:xxi). *Comet's* hawse timbers are sided more than double the frames' sided dimensions, and the port knighthead, if measured on the diagonal, also follows this specification. The starboard knighthead and stempost were buried in the sand beneath the bowsprit and neither was observed.

A total of 21 outer hull planks were recorded, varying in width from 5 in. to 1 ft. 2 in. and from 1 to 2 in. thick (Figure 4.74). *Comet's* contract states planking should be 4 in. thick, while *Rules for the Construction of Wooden Vessels* specifies it should be 3½ in. thick (JPSL 1886; American Shipmasters' Association 1879:xxviii). Erosion likely accounts for the difference between *Comet's* outer hull planking thickness and the thickness recorded in historical documents. Outer hull planks were fastened to the frames with a combination of treenails, round iron fasteners, and square iron and cupreous spikes, which conforms to outboard fastenings specified in the contract (JPSL 1886). Two strakes overlay the outer hull planking directly above the hawse pipe, creating a double layer of planking. This feature is undocumented in contemporary historical records, and how common a construction practice this was in Pacific Coast lumber schooner shipbuilding is unknown. The ends of eight ceiling planks were

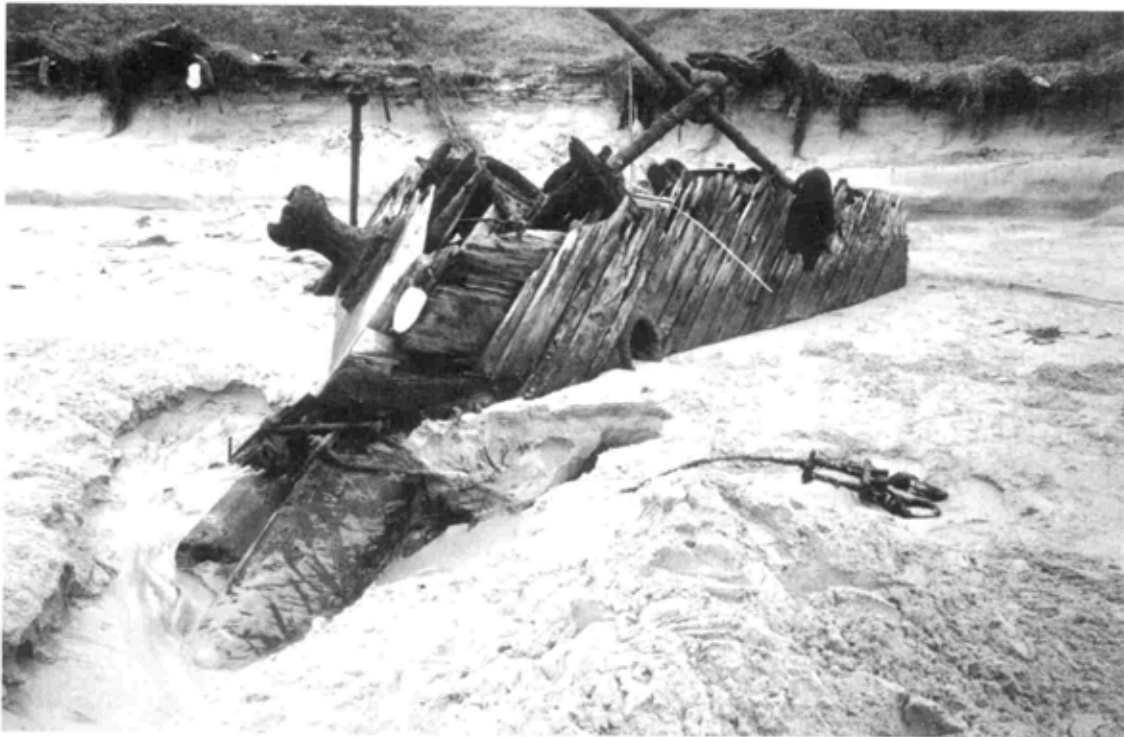
Figure 4.75. *Comet's* bow. The hawse timbers are in the center with the white float on them. The hawse pipe is visible at the sand-line, to the right of the hawse timbers. In the right foreground is an unattached rigging element. NPS photo by Matt Russell.

Comet's bowsprit is present and appears to be completely intact, though its outboard end, called the head, could not be uncovered. The bowsprit heel is stepped into a 6-in. wide x 10-in. high x 7-in. deep notch in the pawl post's forward face. At the heel, the bowsprit is 10 in. high x 1 ft. 7 in. wide (the width of the pawl post). A filler piece is fitted below the bowsprit heel between the bowsprit and the main deck. This filling timber is 9 in. thick, with an exposed length of 6 ft. 9 in. (its forward end was buried beneath the sand). The forward-most section of the bow, between decks, is buried in the sand, so the point where the bowsprit exits the hull could not be examined, however, the bowsprit presumably passes on top of the stempost and between the knightheads. Forward of the bow, the bowsprit transitions from a square cross-section to a rounded cross-section, and most likely begins to taper (Figures 4.69 and 4.75–

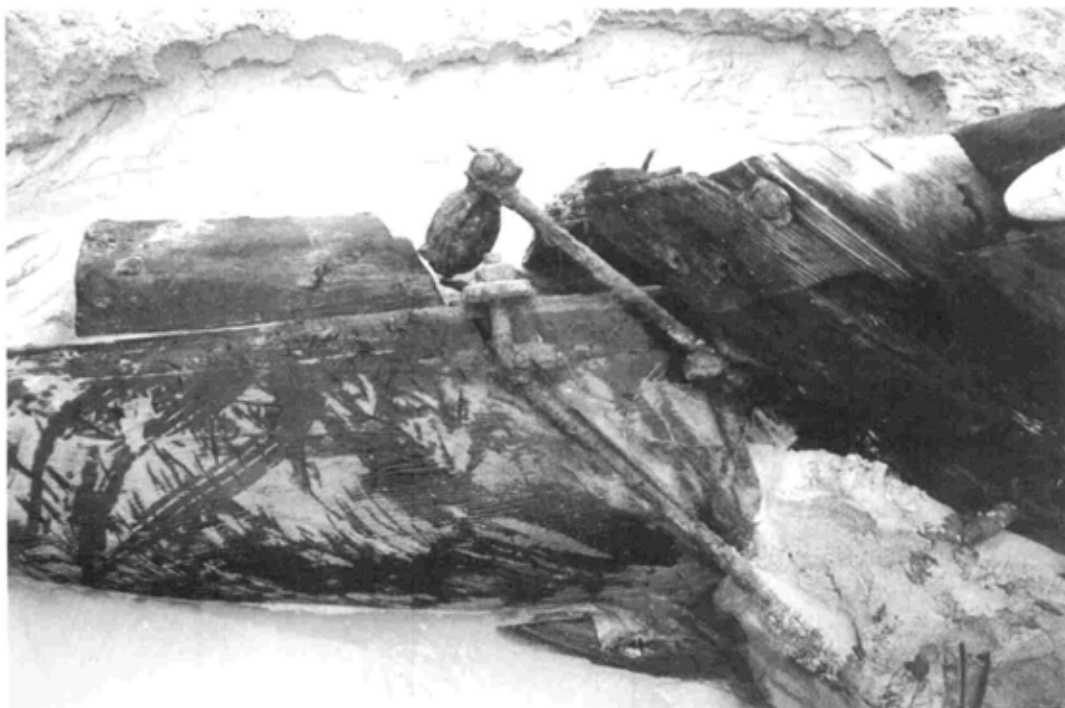
Figure 4.76. The port knighthead is the large timber on the right side of the photograph. The bowsprit extends horizontally to the left in the photo with the jibboom heel chock on top; also visible are the gammon iron and a single bull's-eye that held the foremast stay.

Just forward of the knighthead, set up around the bowsprit, is the gammoning or gammon iron (Figures 4.76 and 4.77). The gammoning secures the bowsprit to the stempost and counters the upward lift of the foremast stays. Before the late-nineteenth century, gammoning consisted of rope or chain lashed over the bowsprit; later it was replaced by an iron band, which could be tightened with nuts and bolts (de Kerchove 1961:323). Chapelle (1973:479) depicts gammon iron consisting of iron straps for both the horizontal (across the bowsprit's upper surface) and vertical (down the bowsprit's sides and bolted to the stempost) components (Figure 4.87; see Figure 4.84). *Comet* has 5-in. wide x 1-in. thick iron strap across the bowsprit's upper face secured by 1½-in. diameter, round iron bar stock on either side of the bowsprit to the stempost. The top of the bar stock is threaded and tightened to the strap with 2¾-in. hex nuts. The point where the bar stock attaches to the stempost was buried and could not be documented.

Located on the bowsprit's upper surface, just forward of the gammon iron, is the jibboom heel chock or block, also called the jibboom saddle (Figures 4.76 and 4.77) (Chapelle 1973:359, 368, 503; de Kerchove 1961:408; Underhill 1958:33). This is a small wood block that supported the jibboom heel. The jibboom is a spar located on top of and attached to the bowsprit that extends forward of it (Figures 4.84 and 4.87)(de Kerchove 1961:408).

Another single bull's eye attached to a 1½-in. diameter iron rod is bent over on top of the bowsprit (Figures 4.76 and 4.77). The bottom of the iron rod is buried in the sand below the bowsprit, so its attachment point could not be recorded. The bull's eye itself has the same dimensions as the bull's eyes described above.

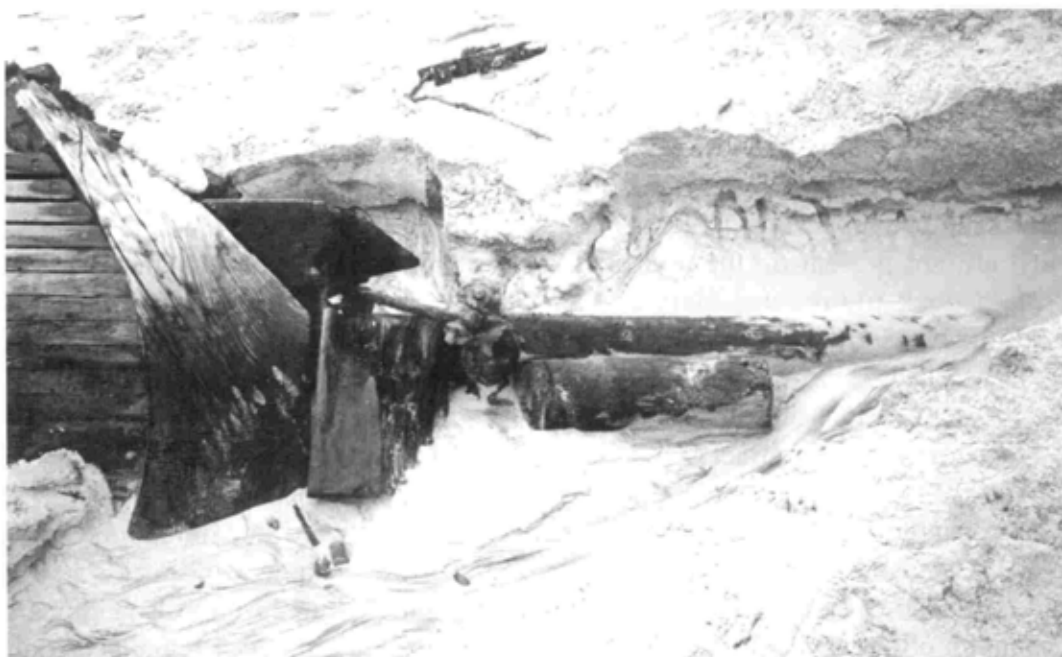
Figure 4.77. Top view of *Comet's* knighthead (to the lower right of the white float), bowsprit and jibboom heel chock. NPS photo by Matt Russell.

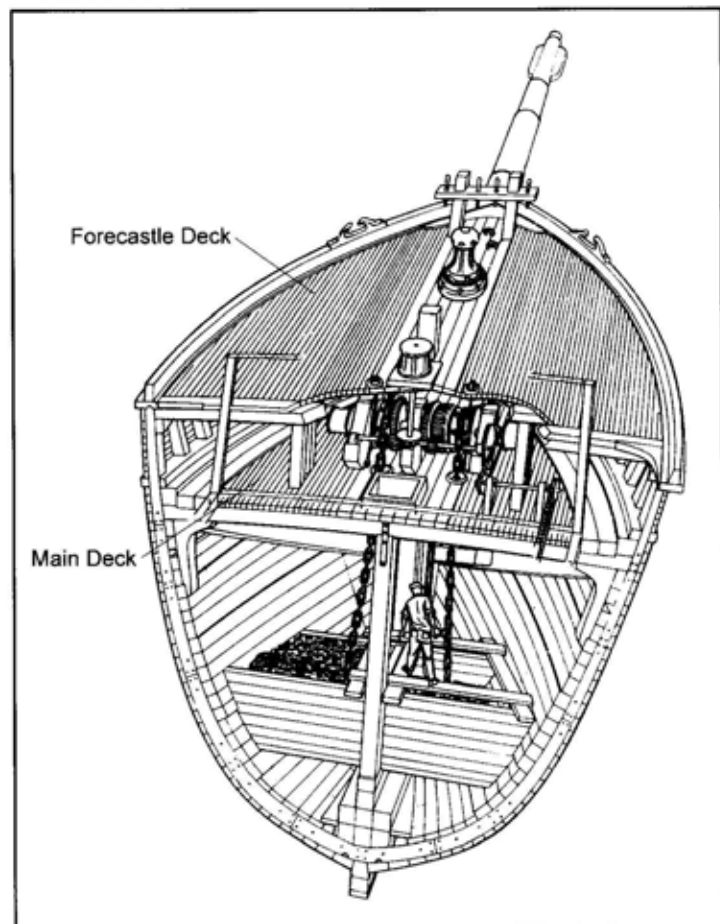
Figure 4.78. Bow section of a wooden-hulled schooner showing main deck, forecastle deck and location of windlass (from Greenhill and Manning 1995:90).

Both the main deck and forecastle deck are intact and in place from the centerline starboard, though almost the entire port half of each deck has deteriorated due to natural erosion (Figure 4.78). Four main-deck beams are visible supporting remnants of the main deck. Exposed ends of each deck beam are eroded, but dimensions vary from 10 to 13 in. wide and 7 to 9 in. thick, indicating the deck beams were originally at least 1 ft. 1 in. wide x 9 in. thick. Deck beams are specified in *Comet's* contract as being sided 14 in. and molded 11 in. (JPSL 1886), which matches reasonably, taking into account timber erosion. This again exceeds the 10½ in.-sided dimension specified in *Rules for the Construction of Wooden Vessels* (American Shipmasters' Association 1879:xxviii). Although not noted in the literature, possibly larger deck beams were used because of the large deckloads lumber schooners were required to carry. Thickening deck beams would have increased ship construction costs minimally, but returns on this small investment would have accrued throughout the vessel's operational life. Two deck beams are located directly fore and aft of the pawl post, a third is located 1 ft. 4½ in. aft of the beam butting the pawl post's aft face, and the fourth is located 2 ft. 10¾ in. forward of the

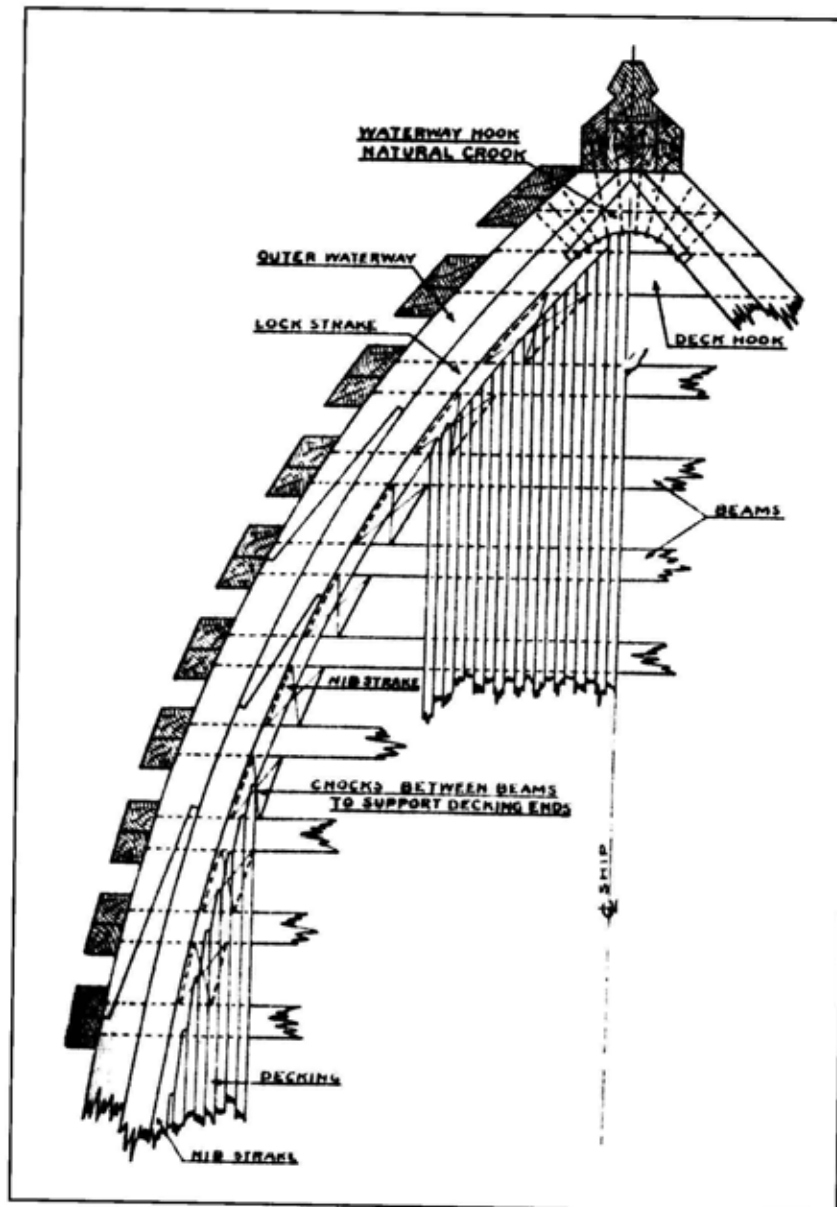
Figure 4.79. Planking details, showing deck and waterway hooks (from Curtis 1919:146).

in. long with 7/16-in. square shanks and 13/16-in., four-faceted heads, and are countersunk and plugged with 1-in. diameter wooden plugs. A main-deck hook and main-deck waterway hook are present in the bow, and the forward ends of the main-deck planks rest on and are fastened to the main-deck hook and butt against the main-deck waterway hook, which follows the typical practice (Figure 4.79)(Curtis 1919:134–135, 144–145). As with the deck clamps, waterway strakes are no longer present.

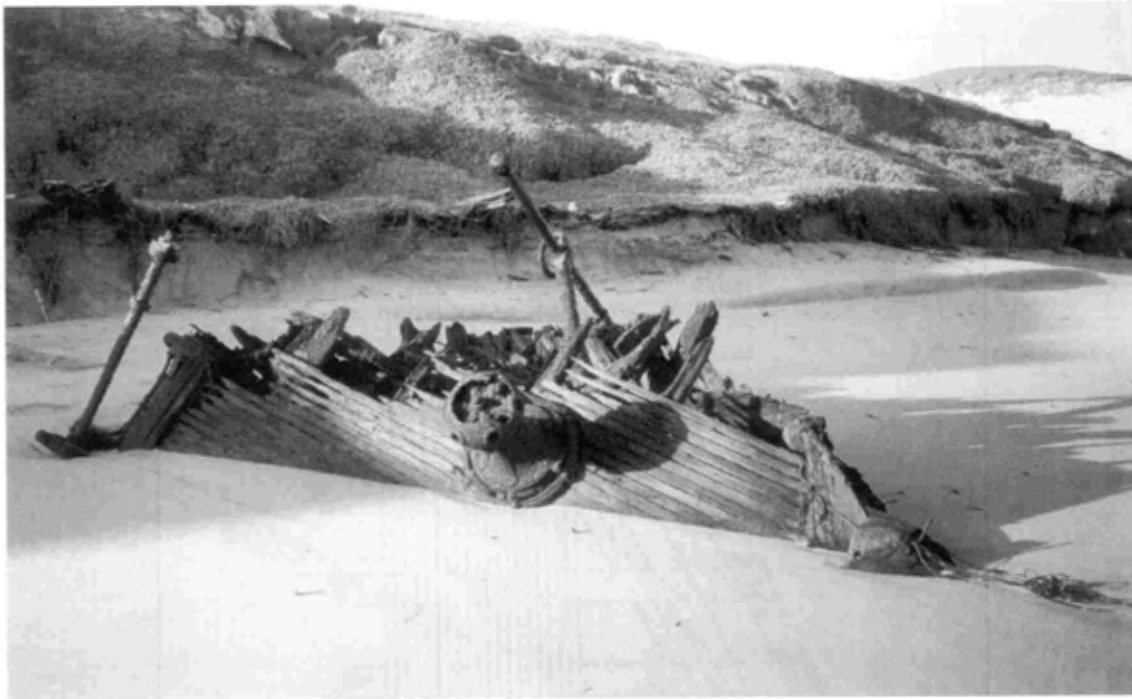
Figure 4.80. *Comet* site in April 1999, looking down on the fore-castle deck with the capstan mounted to it. The bow is to the right. NPS photo by Matt Russell.
