National Park Service
U.S. Department of the Interior

Submerged Resources Center

Beached Shipwreck Archeology: Case Studies from Channel Islands National Park

Matthew A. Russell

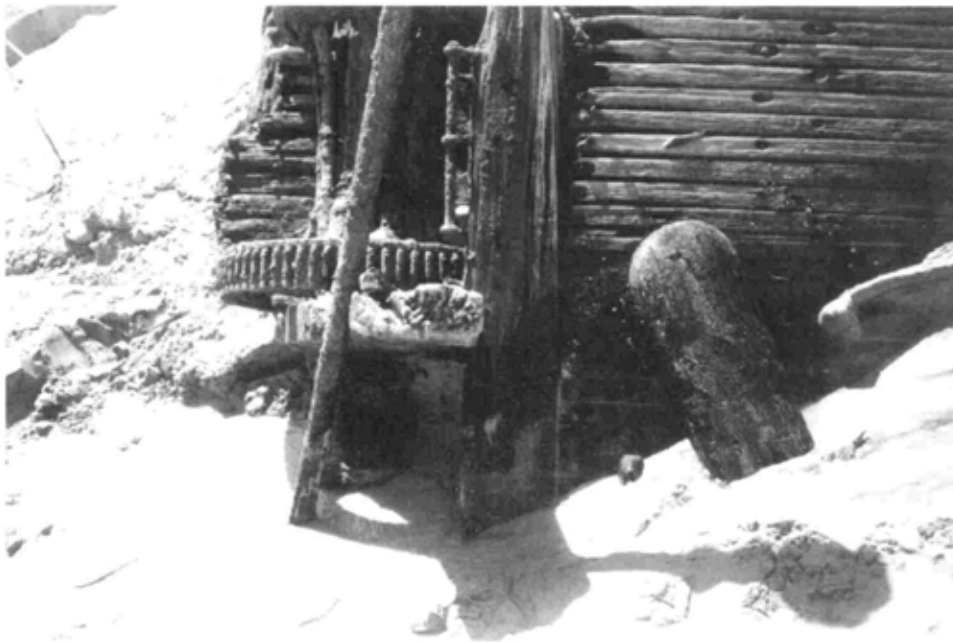
Figure 4.81. Top view of the aft end of the forecastle deck. The aft-most forecastle deck beam is the vertical timber in the center of the photo. The windlass is to the left, mounted on the main deck below; the starboard cathead is the angled timber to the right. NPS photo by Matt Russell.

fore- and aft- the pawl post, are sided between $9\frac{1}{2}$ and $10\frac{1}{2}$ in. Like on the main deck, port clamps are absent. Thirty fore-castle-deck planks are exposed; all 3 in. sided x $2\frac{1}{2}$ in. molded. Each plank is fastened with a single boat spike at its forward end, a single boat spike at its aft end (for complete planks), and a single boat spike in each deck beam. Fore-castle-deck spikes are $5\frac{1}{4}$ in. long with $5/16$ -in. square shanks and $1\frac{1}{16}$ in., four-faceted heads and are countersunk and plugged with 1-in. diameter wooden plugs. Deck plank forward ends are resting on and fastened to the fore-castle-deck hook and are butted against the fore-castle-deck waterway hook (Figure 4.77). Again, like the main deck, waterway strakes are gone. Complete deck plank aft ends are resting on and fastened to a recessed shelf notched into the forward edge of the aft-most fore-castle-deck beam (Figure 4.81). Fore-castle deck beam and

The aft end of the starboard cathead was visible attached to the forecastle deck (Figures 4.80 and 4.81). A cathead is a wood beam that projects out over port and starboard bow to support the anchor before releasing or while retrieving or stowing (Figure 4.89) (de Kerchove 1961:132)—when the anchor ring has been hoisted up to the cathead, it has been “catted.” *Comet's* cathead is a solid timber, 11 1/4 in. wide x 5 in. thick with an exposed length of 2 ft. 7 in. A 3 3/4-in. diameter, 1-in. thick iron ring is fastened to its upper surface at the lowest exposure, 2 ft. 7 in. from the aft end. No other details about the cathead were observed because most of its length was buried.

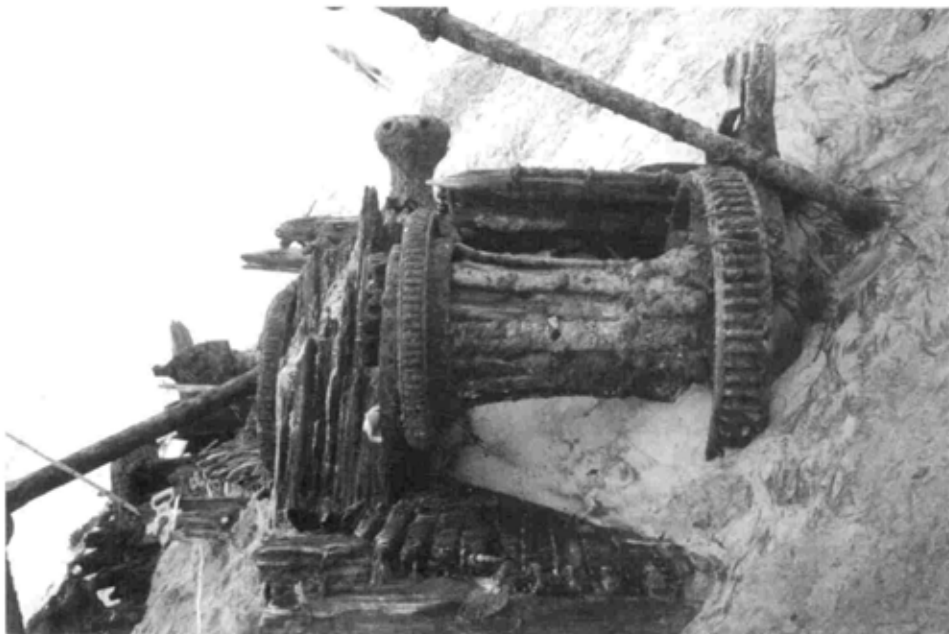
Figure 4.82. Photograph taken from the perspective as if the viewer were standing on the main deck looking forward. The pawl post is to the left of the windlass. NPS photo by Matt Russell.

The pawl post, sometimes called the pawl bitt, Samson post or heel bitt when the bowsprit is stepped into it, is present from fore-castle-deck level to the main-deck level, where it is buried in the sand (Figures 4.82–4.84). The pawl post is a solid timber, usually stepped into the keelson or bow deadwood, which extends upward and ends above fore-castle-deck level (Chapelle 1973:368–370; de Kerchove 1961:91; Underhill 1958:88). In *Comet*, the pawl post served two purposes: 1) the bowsprit's inboard end, called the heel, is stepped into the pawl post's forward face; so the pawl post serves as a major reinforcing member for the bow rigging; and 2) the windlass pawl was mounted on the pawl post's aft face, though neither the windlass pawl nor pawl rim are present on site. The pawl post

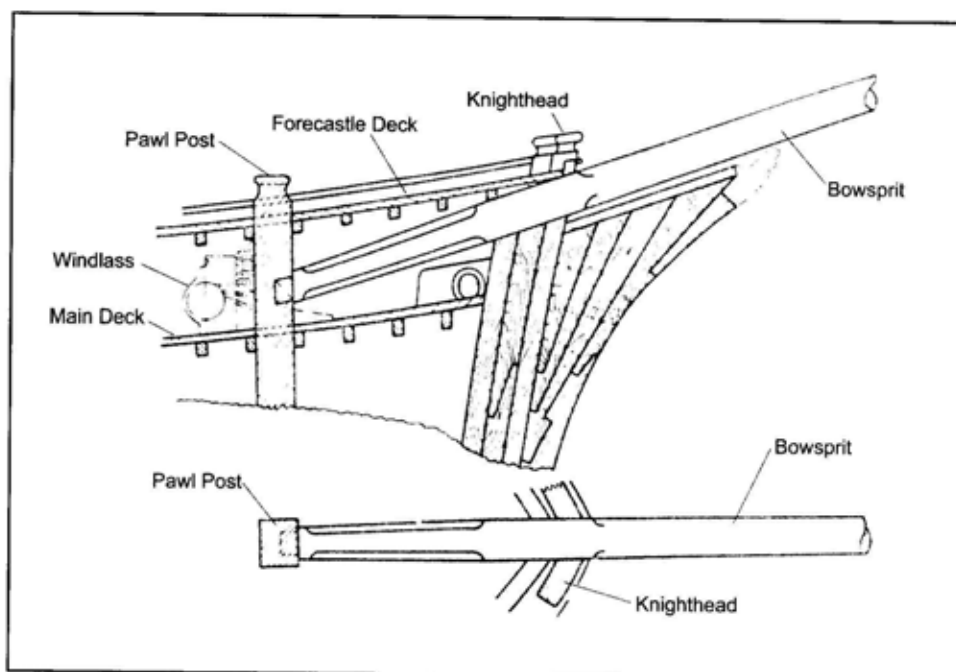
Figure 4.83. Schooner bow section showing the bowsprit stepped into the forward face of the pawl post (after Underhill 1958:88).

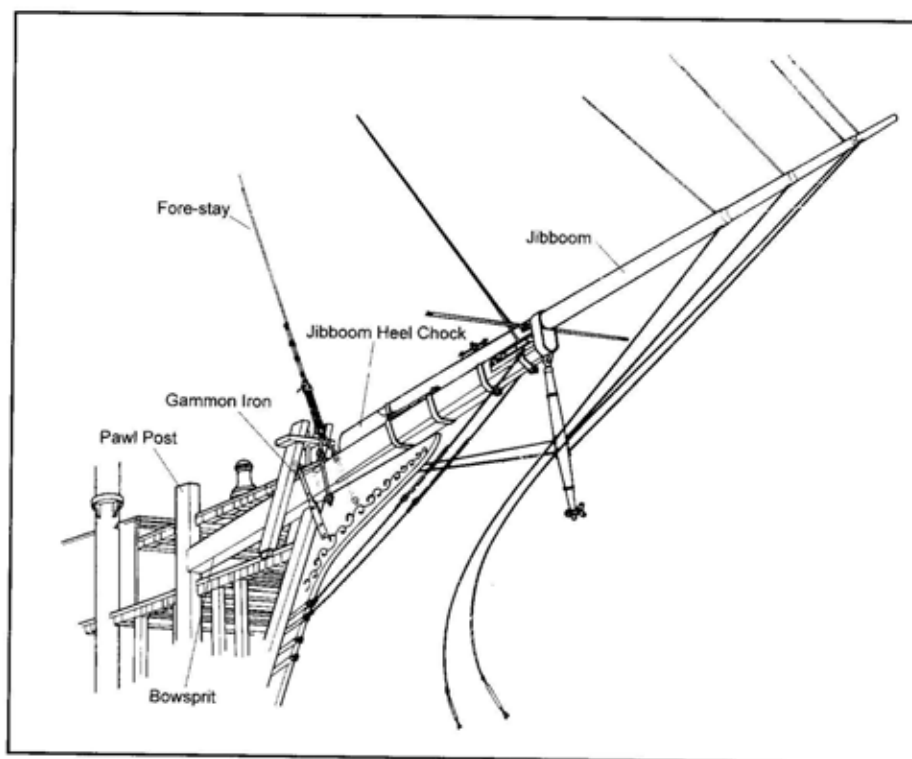
Figure 4.84. Schematic of a schooner bow-section, showing the bowsprit stepped into the pawl post, the jibboom, jibboom heel chock, gammon iron and fore-stay (after Greenhill and Manning 995:113).

the bow, serves two main purposes: 1) to extend the head sails forward, balancing the sail plan by counteracting the effect of the after sails; and 2) to support the foremast, which is fastened to it with stays (Figure 4.84) (de Kerchove 1961:90). *Comet's* bowsprit is formed from a single, large timber, most likely Douglas fir.

Located on the bowsprit's upper surface, just forward of the gammon iron, is the jibboom heel chock or block, also called the jibboom saddle (Figures 4.76 and 4.77) (Chapelle 1973:359, 368, 503; de Kerchove 1961:408; Underhill 1958:33). This is a small wood block that supported the jibboom heel. The jibboom is a spar located on top of and attached to the bowsprit that extends forward of it (Figures 4.84 and 4.87)(de Kerchove 1961:408).

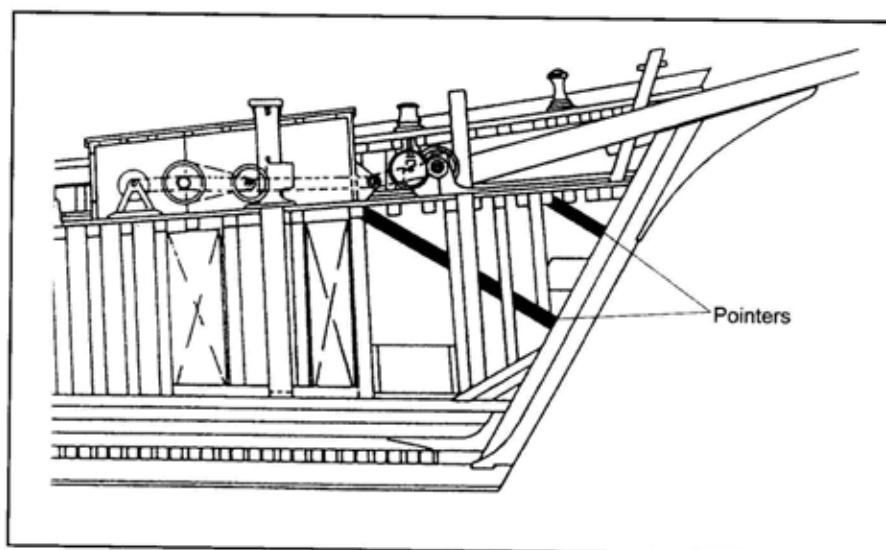
Figure 4.85. Bow pointers in a wooden-hulled schooner (after Greenhill and Manning 1995:63).

uses. Salvage alone cannot explain, however, why only the bow is present today. Observation of site layout suggests a series of events that led to the wreck's present condition. The last known historical photographs of *Comet* (see Figures 3.9–3.11) show the vessel laying broadside to the shoreline, somewhere between high and low tide. Subsequently, *Comet*'s bow broke away from the rest of the hull at a point just aft of the forecastle deck and forward of the forward deckhouse (Figure 4.105). It is possible the stempost/keel joint broke, but the pointers kept the bow structure to aft of the forecastle deck together. The pointers crossed and were fastened into multiple frame pairs, including all the cant frames, and would have provided reinforcement to help bind them together (Figures 4.85 and 4.86).

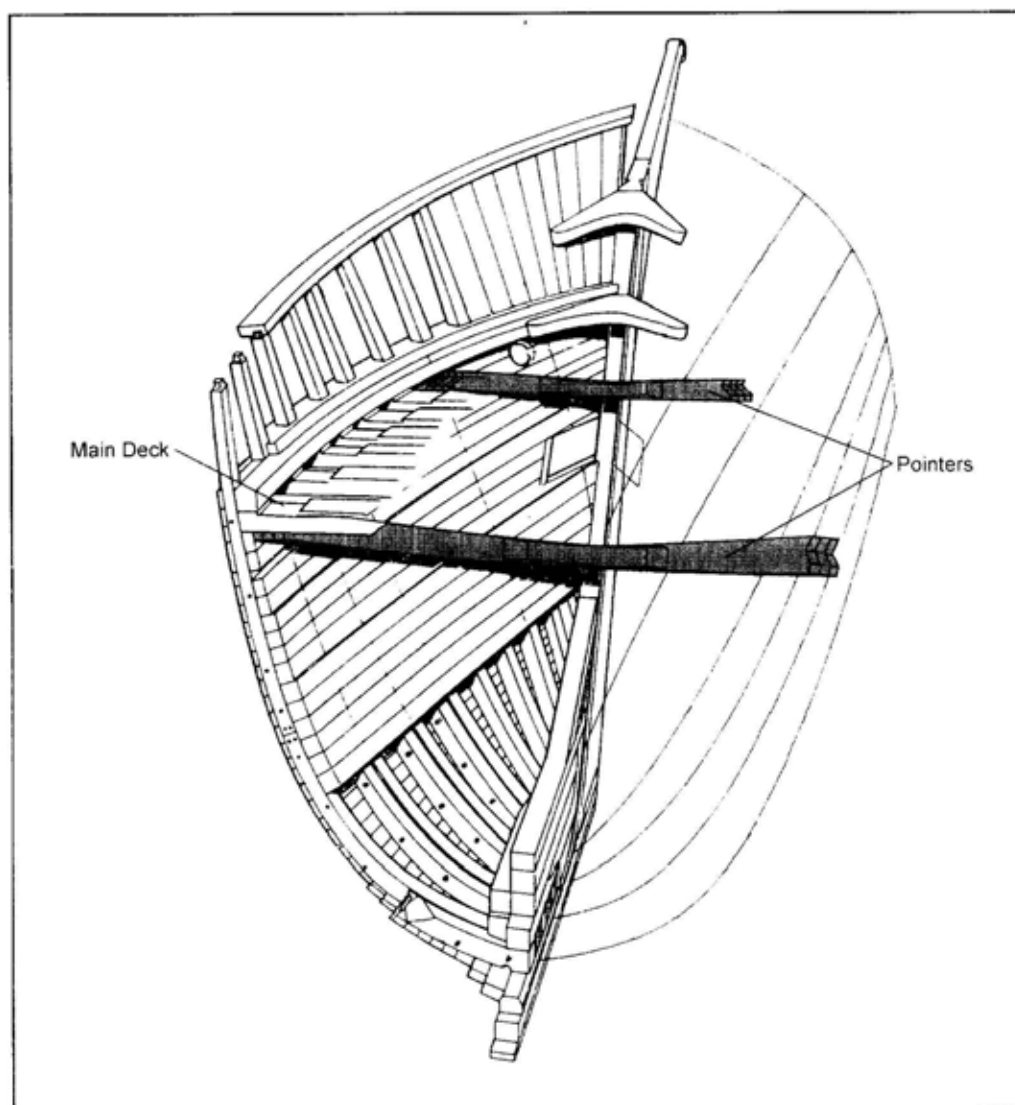
Figure 4.86. Schematic showing location of bow pointers in a wooden-hulled schooner (after Greenhill and Manning 1995:70).

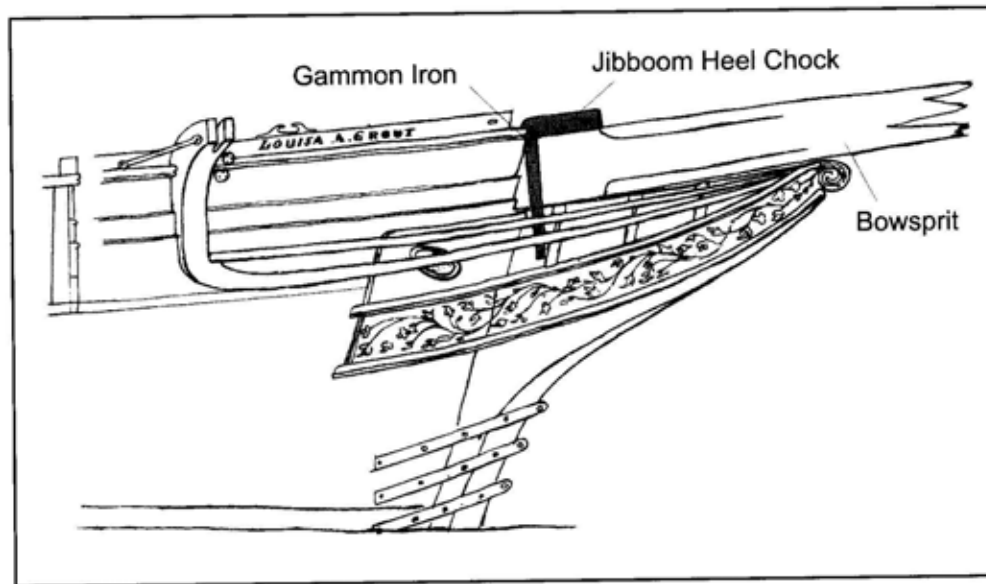
Figure 4.87. Vessel bow section showing location of the gammon iron and jibboom heel chock (after Chapelle 1973:359).

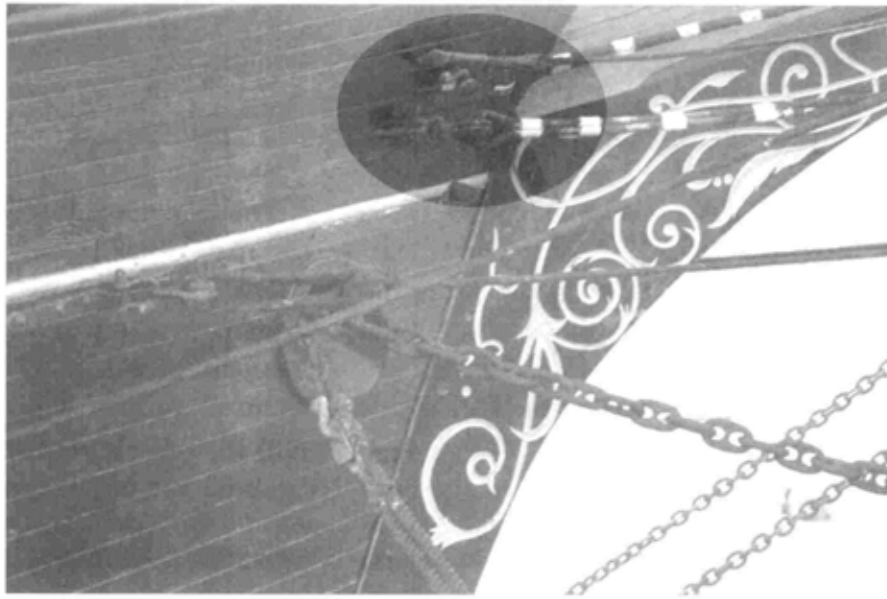
Figure 4.88. Bull's eye above and forward of the hawse pipe (at the top-center of photo) support the bowsprit guys on *C. A. Thayer* in San Francisco Maritime National Historical Park. NPS photo by Matt Russell.

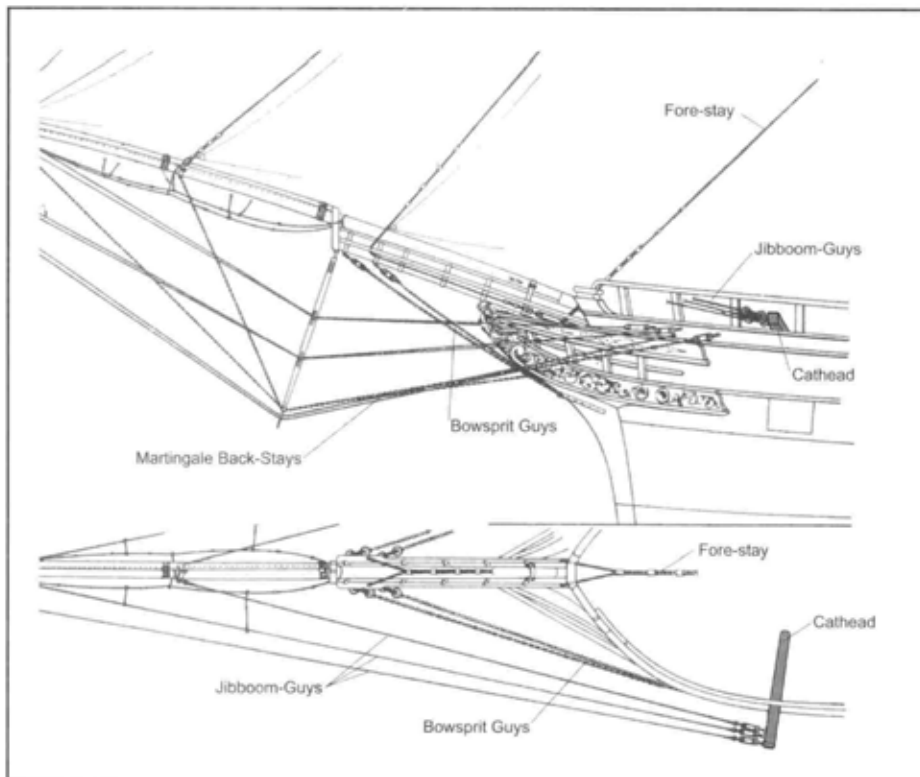
Figure 4.89. Bow rigging elements found on *Comet* site (after Underhill 1958:64).

This is most likely one of the attachment points for the fore-stay, which supported *Comet's* foremast. *C. A. Thayer* has identical bull's eyes supporting its foremast in the same location. Underhill (1958:64) also depicts a similar forestay configuration (Figure 4.89).

the attachment point for the inner- and outer-jibboom guys, or shrouds (Figure 4.89) (Underhill 1958:64). Chapelle (1973:398) notes that “as long as the schooners carried jibbooms the jibboom shrouds were set up with hearts, or small deadeyes, and lanyards on the foresides of the catheads.” *C. A. Thayer* has similar, though not identical, rigging elements on the foresides of its catheads, which support the jibboom guys (Figure 4.92). In addition, historical photos of *Comet* wrecked in Simonton Cove give indirect evidence for this identification. Although the photos do not show the cathead or this particular element, they depict the jibboom guys coming to a point that can only be on the foresides of the catheads (see Figures 3.12 and 3.13). The iron hooks are called jib stay hooks (Greenhill and Manning 1995:103), and the iron rod was a brace between the cathead and the rail (Chapelle 1973:398). The rod’s angle identifies this object coming from the port, rather than the starboard, cathead.

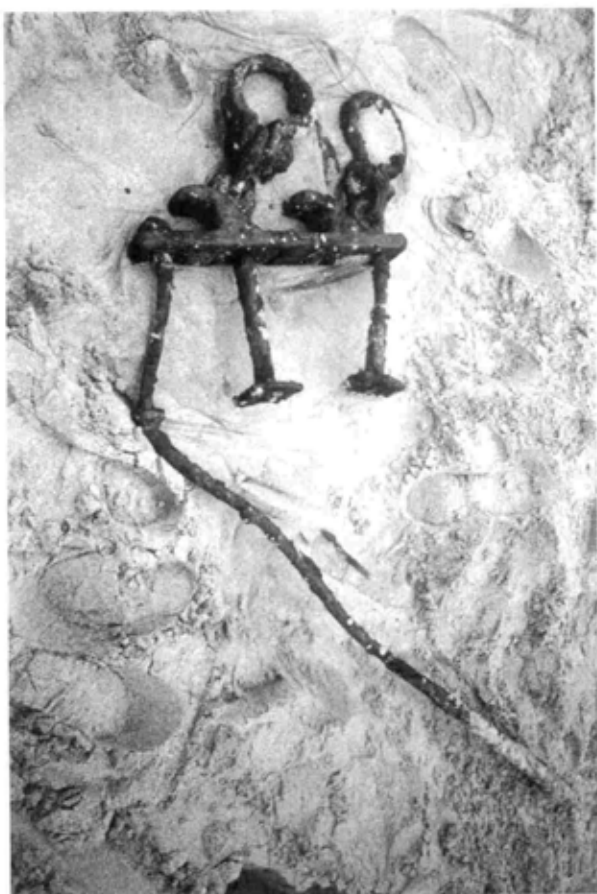
Figure 4.90. Rigging element off *Comet's* port bow. NPS photo by Matt Russell.

Located off *Comet's* port bow is an unattached iron rigging element (Figure 4.90 and 4.91; also Figure 4.75). It consists of a 4 ft. 3 in.-long iron rod with a 5 in. long x 2½ in. wide x ½ in. thick plate on one end, attached to an 11½-in. long x ¾ in. diameter iron fastener that is attached to a 1 ft. 6½-in. long x 1-in. thick iron plate. The plate is pierced by two 1 ft. 3-in. long x 1-in. diameter eyebolts, each of which has an iron ring attached to an iron strop from a bull's eye or deadeye (the wooden block is no longer present), similar to those described above. In addition, the iron plate has two iron hooks cast as part of its upper surface. Although documentary research could not identify the element's proper name, its function was identified. This object was originally fastened to the foreside of the port cathead and provided

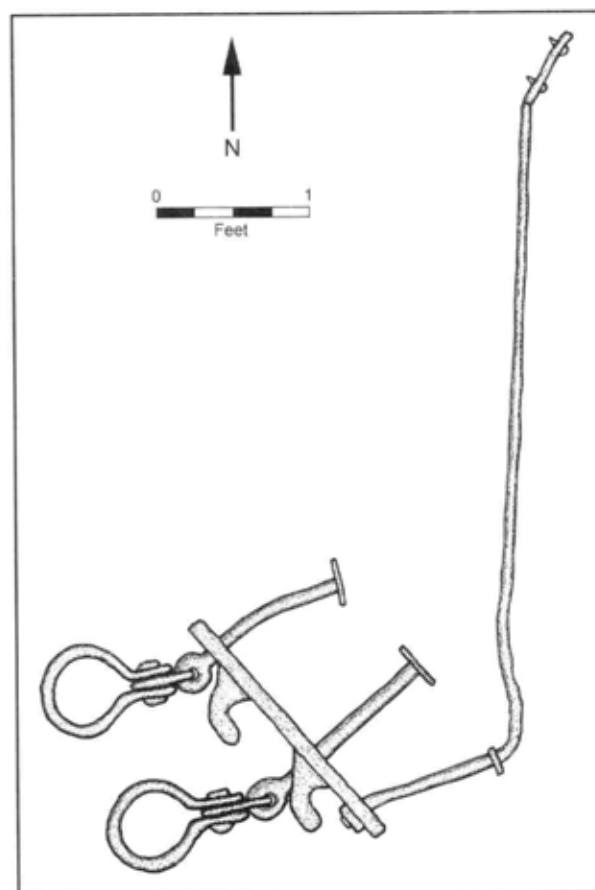
Figure 4.91. Rigging element from port cathead that secured the jibboom guys. Drawing by Matt Russell and Don Morris.

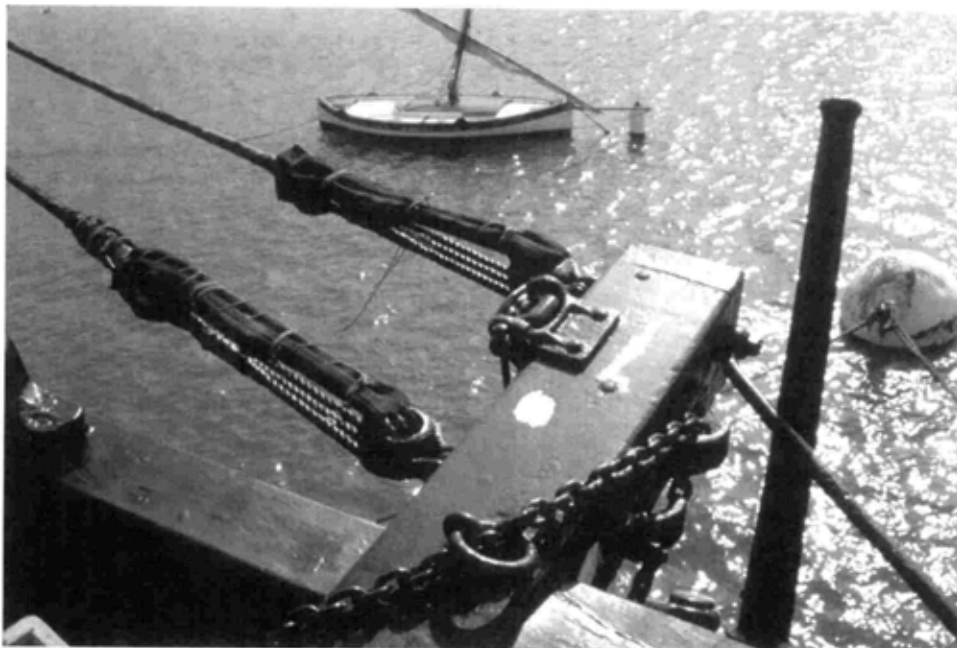
Figure 4.92. Rigging element supporting jibboom guys on forward side of *C. A. Thayer*’s cathead. NPS photo by Matt Russell.

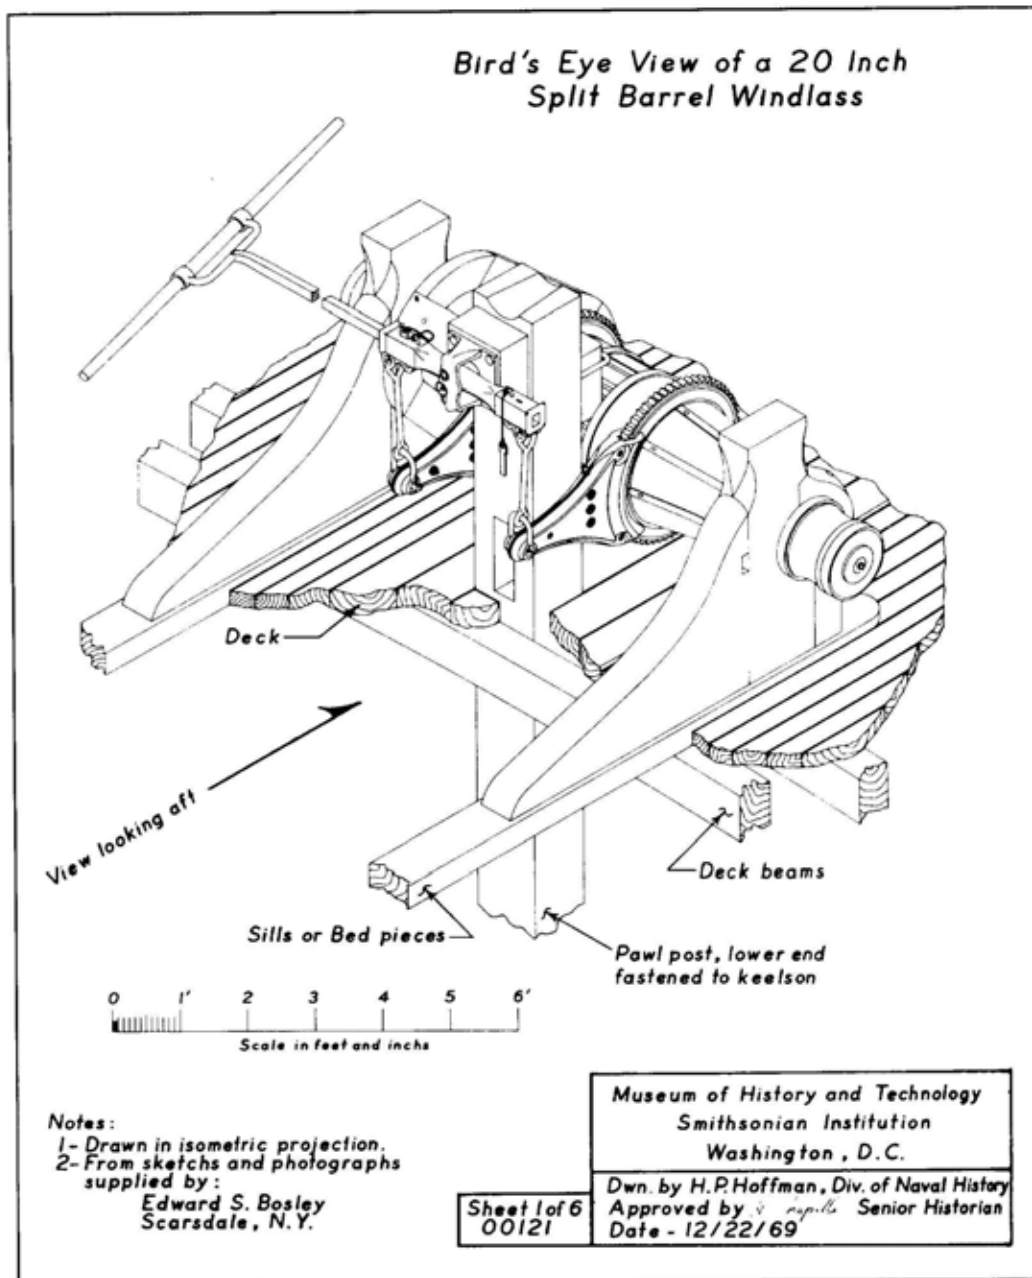
Figure 4.93. Pump-brake windlass. Drawing from the Smithsonian Institution.

Comet’s windlass is a type generically known as an “Armstrong Patent”, or pump-brake, windlass, which was introduced during the 1840s, quickly replacing older models employing handspikes. Pump-brake windlasses, which used purchase levers and pump handles, remained in use into the twentieth century (MacGregor 1984:88). Chapelle (1973:677) refers to this type of windlass as a “wooden, or log, windlass, with pump-brake ironwork” (Figures 4.93).

On this windlass type, a pawl mounted on the aft face of the pawl post engaged either teeth cut into the center of the windlass barrel or an iron pawl rim mounted on the windlass barrel, which prevented the barrel from reversing direction (Figure 4.93) (Chapelle 1973:677; Paasch 1890:Plate 70). Neither the pawl nor a pawl rim is present on the *Comet* site, possibly indicating the pawl engaged teeth cut directly into the windlass barrel rather than a pawl rim. An auxiliary warping drum, or gypsy head, was present outside each carrick bitt (Figure 4.95). Only the starboard half of the windlass barrel remains intact, including the starboard purchase rim and arm, the starboard carrick bitt supporting the windlass, and the starboard warping drum outside it. Much of the windlass's port-side ironwork is present, however, laying loose on the main deck against the bowsprit's port side, including the port purchase rim (Figure 4.97), arm and rod; four iron whelps from the port-side windlass barrel; a single large iron fastener with a diamond-shaped rove that held

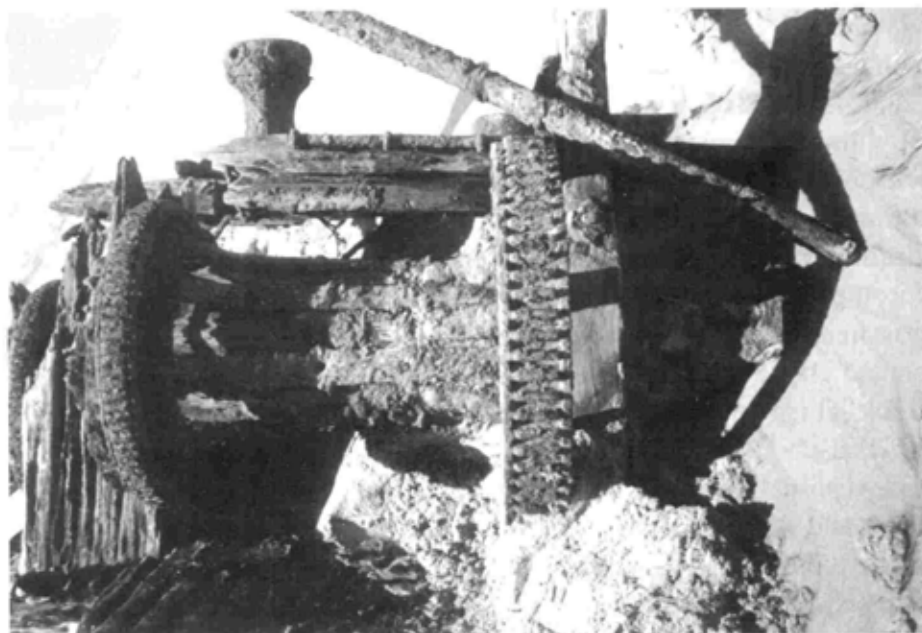
Figure 4.94. *Comet's* windlass mounted on the main deck. NPS photo by Matt Russell.

Comet's windlass is mounted on the schooner's main deck, just aft of the pawl post (Figure 4.94 and 4.95). The windlass has a wooden barrel with iron whelps supported by hardwood carrick bitts. It was worked with two iron purchase rims (with 1 ft. 11½ in., or 23½ in., inside diameter) and purchase arms connected by iron purchase rods to a pivoting rocker, or crosshead, mechanism that was originally mounted above the windlass on the forecastle deck (Figure 4.96)(Chapelle 1973:669–680; Paasch 1890:Plate 70). Just forward of the pawl post at forecastle-deck level are two fasteners and the remains of a block that supported the crosshead on the forecastle deck. On either side of the pawl post are openings in the forecastle deck where the purchase rods connected the windlass purchase arms to the rocker on the forecastle above (Figure 4.80).

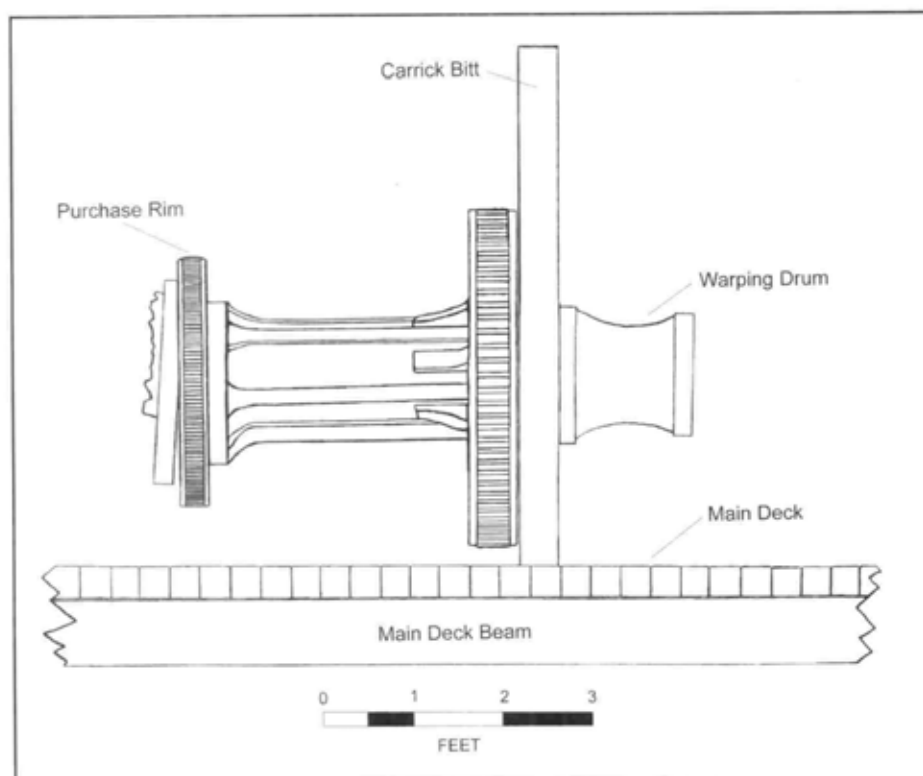
Figure 4.95. *Comet's* windlass, elevation view looking forward on main deck. Drawing by Jim Bradford and Matt Russell.

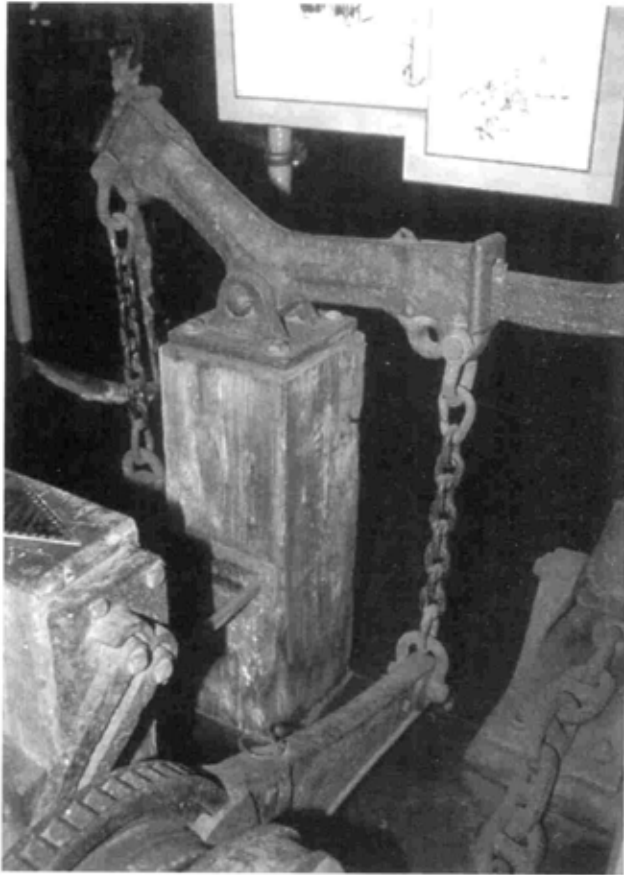
Figure 4.96. Pivoting rocker, or crosshead, mechanism connected to a windlass purchase arm with chain. *Comet* was equipped with a similar windlass type. NPS photo by Matt Russell.

Included in the iron material located on the main deck are an eyebolt fastened into the bowsprit's port face with another eyebolt attached to it, some small link chain with 2-in. long x ½-in. diameter links, 10 loose iron fasteners and an iron bar measuring 3½ to 4 in. square x 3 ft. 9½ in. long. The fasteners are probably from the windlass's port side, the link chain is possibly from the messenger chain or connected the purchase arm with the rocker (Figure 4.96) and the iron bar is possibly part of one of the pump-brake hand levers.

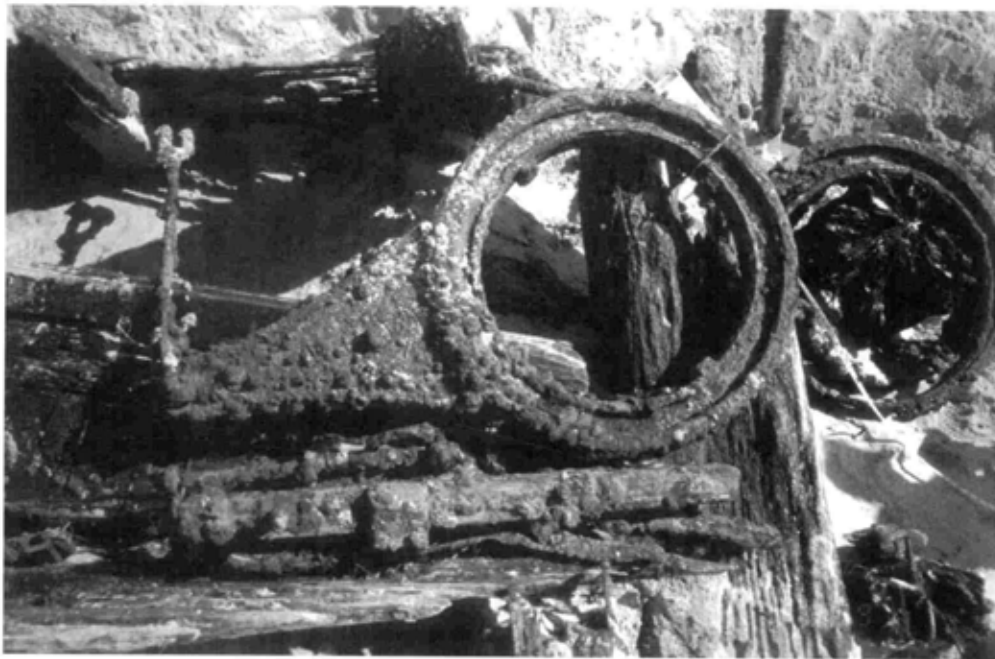
Figure 4.97. *Comet*'s port windlass purchase arm and windlass hardware on the main deck laying against the port side of the pawl post and bowsprit. NPS photo by Don Morris.

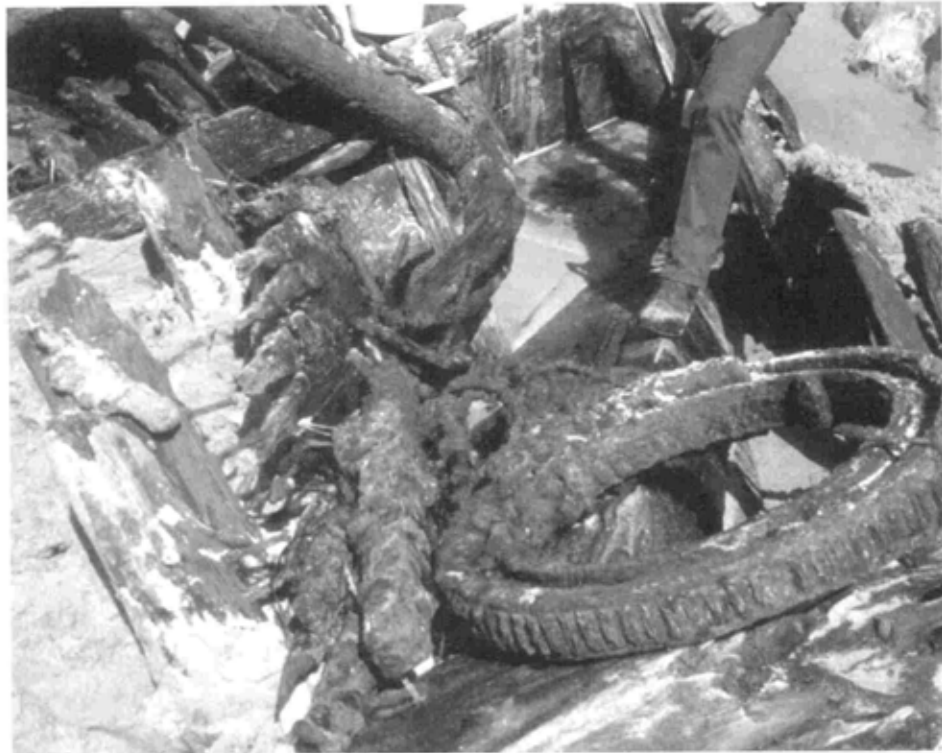
Figure 4.98. *Comet's* port windlass hardware laying on the main deck. NPS photo by Don Morris.

the port-side carrick bitt, cheek and knee together (an identical fastener is still in place on the starboard side); and the rocker base plate with two fasteners that held it to the forecastle deck (Figure 4.98).

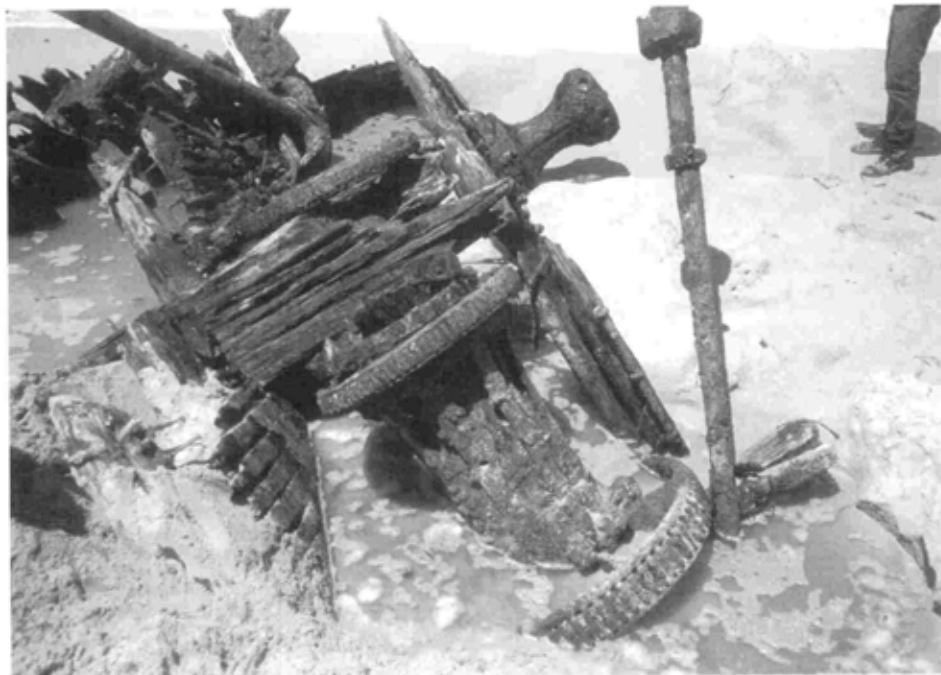
Figure 4.99. *Comet's* windlass and the iron shaft sticking out of the sand on the right side of the photograph. NPS photo by Matt Russell.

On the windlass's starboard end, just inside the carrick bitt, is a 3 ft. 6½-in. diameter gear that is not integral to the primary workings of the windlass. In addition, an upright iron shaft with some heavily encrusted bands that may have been gearing is sticking out of the sand near the windlass's starboard end (Figure 4.99; see Figure 4.95). This is part of a messenger chain system for driving the windlass by an endless chain from a donkey engine. Figure 4.100 depicts a similar arrangement, with a geared shaft mounted above the windlass articulated to a large gear on the windlass's outside end. A similar system is depicted in drawings of *Bertha L. Downs*, another late-nineteenth century schooner (Figure 4.101) (Greenhill and Manning 1995:79–81, 90). Essentially, a messenger chain system was used to run several pieces of machinery off a single donkey engine. Using a system of shafts, gears and chains, a donkey engine could power the windlass, pumps, auxiliary warping heads and other hoisting equipment. As discussed in Chapter 3, *Comet* was probably not originally equipped with a donkey engine, but one was added in the 1890s.

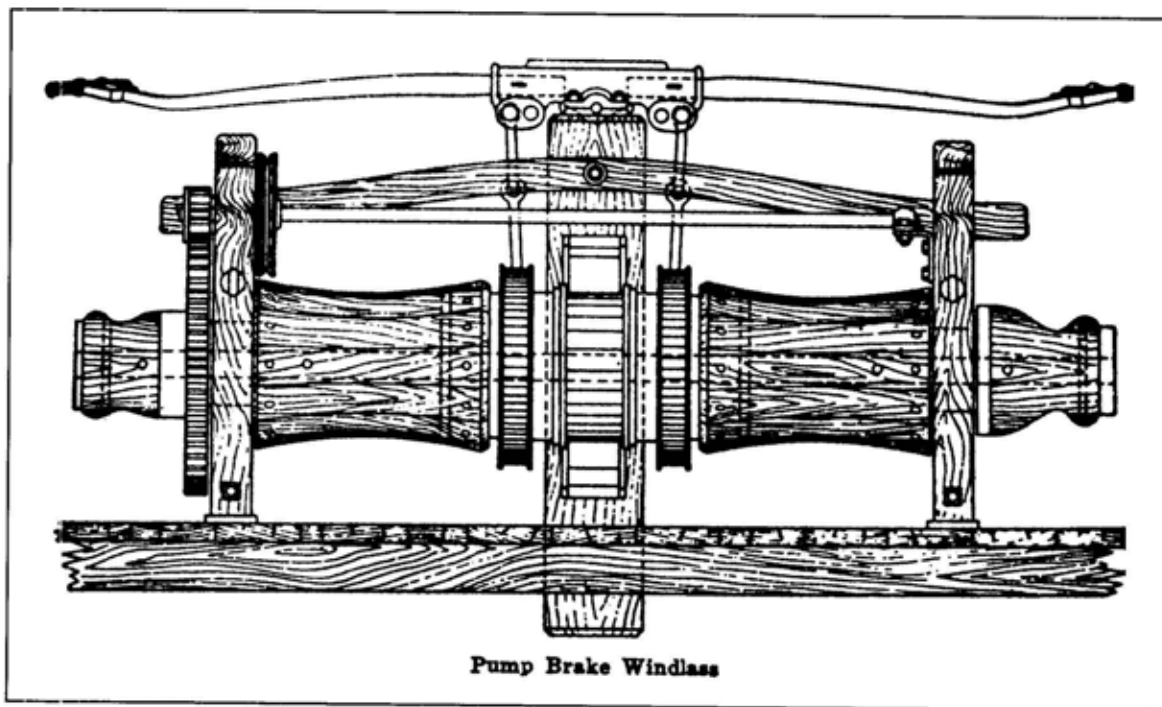
Figure 4.100. Windlass nearly identical to *Comet's* windlass, including the gearing (in this case on the port side) for the messenger chain system.

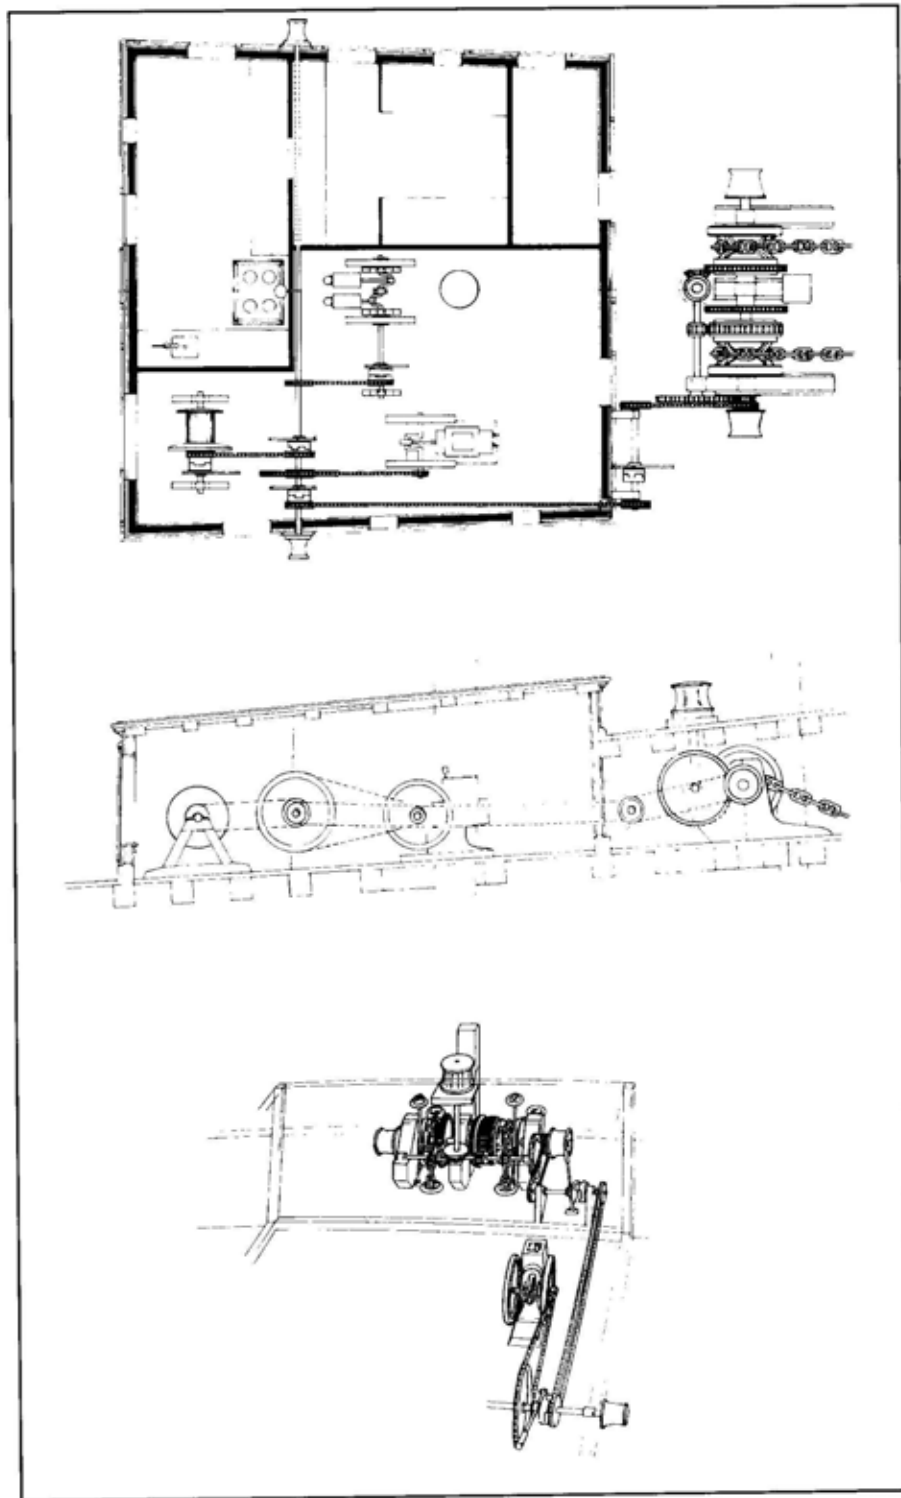
Figure 4.101. Messenger chain-driven windlass system (from Greenhill and Manning 1995:79 and 90).

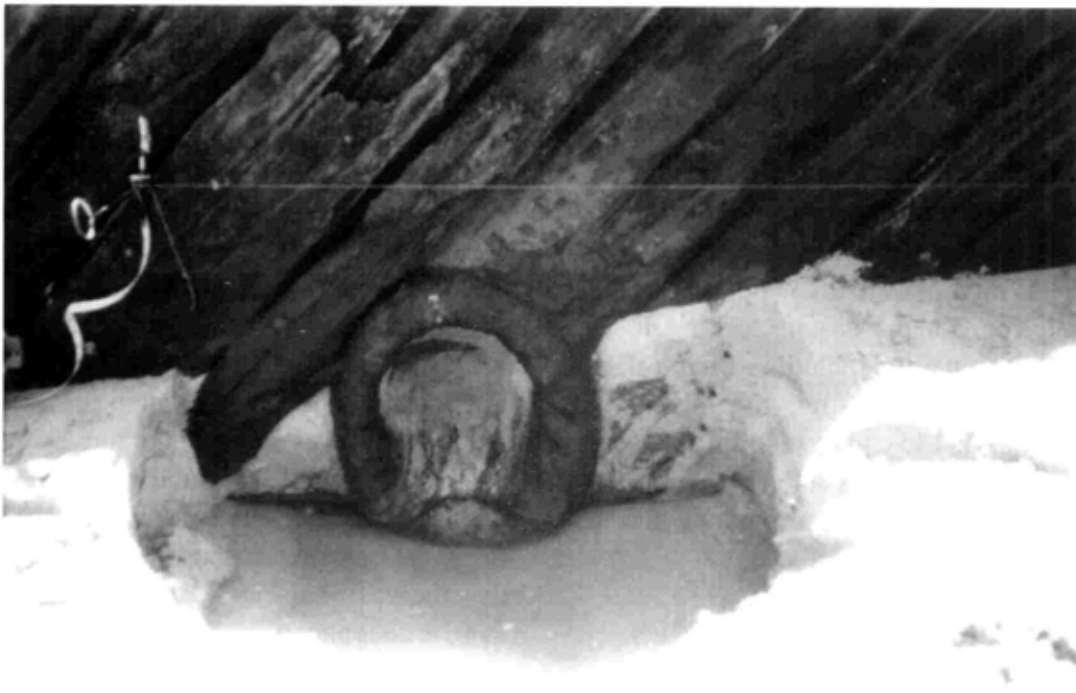
Figure 4.102. *Comet's* port-side hawse pipe. NPS photo by Don Morris.

The port hawse pipe is in place, piercing the port hull at main-deck level (Figure 4.102). The hawse pipe provided an opening for the anchor chain cable to pass through the bow to the windlass, and from the windlass into the chain locker. The hawse pipe is a flanged iron pipe with an outer face angled to fit the shape of the outer hull. The flanged opening is 1 ft. 5 in.

long x 1 ft. 6 in. wide, and the hawse pipe has an 11-in. interior diameter. Doing the same kind of analysis as above for the hawse pipes in Northwest Cove gives a different result. Using the same tables in Desmond (1919[1984]), a 400-ton vessel should carry a 1 1/8 in. diameter chain cable, which requires a 10 3/4 in. hawse pipe. This matches very well with *Comet's* 11-in. inside diameter hawse pipe. This complicates the identification of the shipwreck in Northwest Cove.

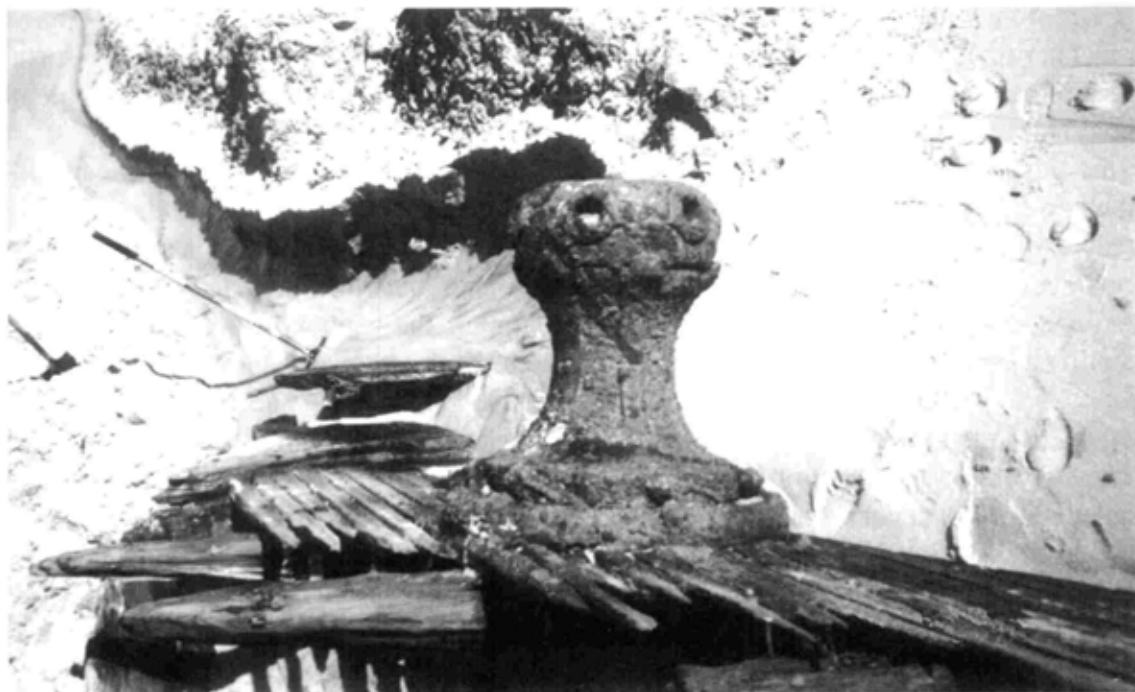
Figure 4.103. *Comet's* capstan, mounted in the center of the forecandle deck. NPS photo by Don Morris.

A hand-powered capstan is mounted in the center of the forecandle deck (Figures 4.103 and 4.104). It is not linked to the windlass, so is not technically part of the ground tackle. It was used for warping only, including such tasks as handling lines and assisting with raising sail (Campbell 1974:135). The capstan is 2 ft. 10 in. tall, with a 2-ft. 8-in. diameter base and 1 ft. 8-in. diameter head. This is presumably the "#3 capstan" specified in *Comet's* contract.

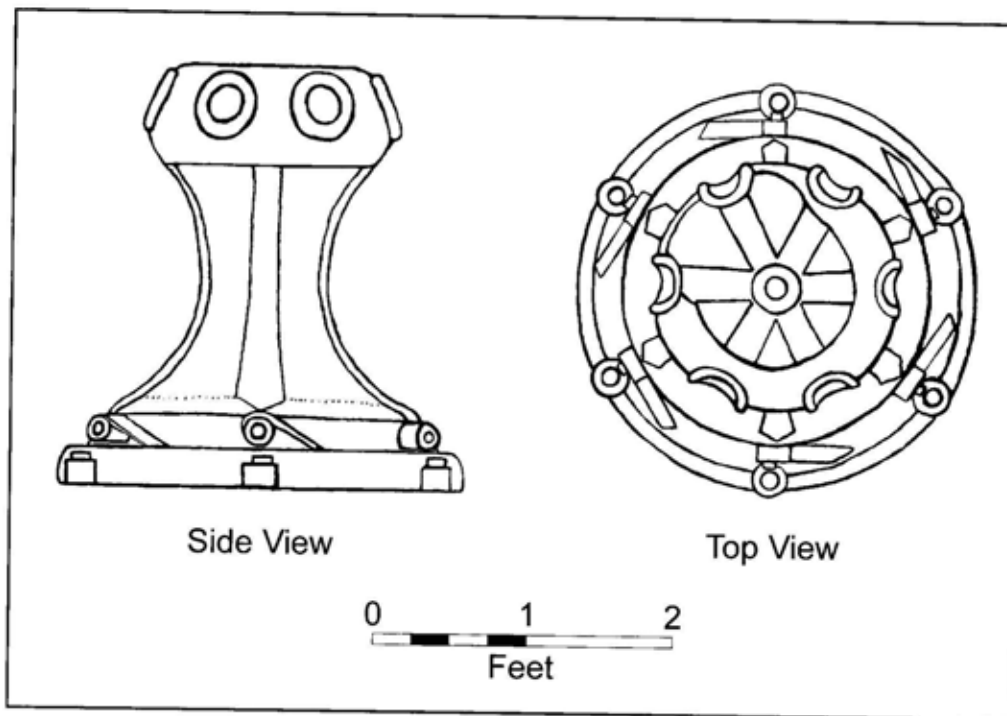
Figure 4.104. *Comet's* capstan. Drawing by Jim Bradford.

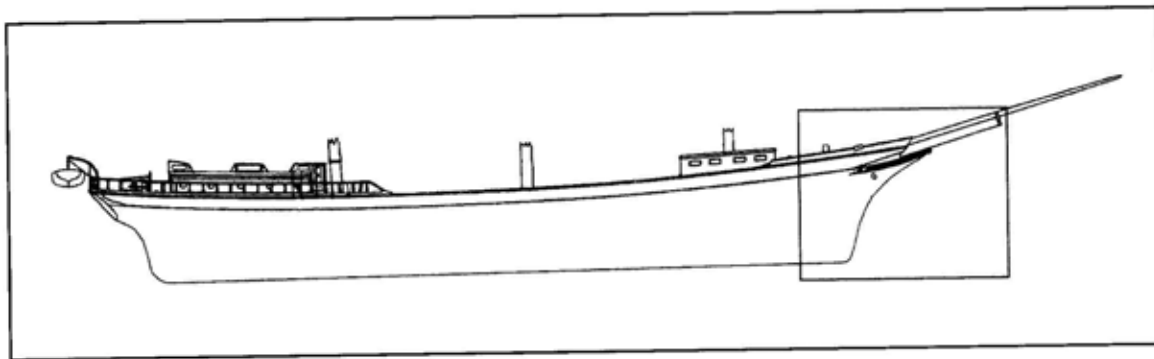
Figure 4.105. Area of *Comet's* preserved hull.

The majority of *Comet's* hull cannot be accounted for in the archeological record. Only about 10% of the hull was observed during this project. Significant natural forces worked to break the hull and separate the bow, but the location of the remainder of the hull is unknown. It is possible it is still buried elsewhere on the beach in Simonton Cove or was transported offshore and settled into the sediment. Alternatively, it could have gradually broken up and the pieces floated off into the Santa Barbara Channel. Further research, especially terrestrial
