# THE HOUSE AT GLENMONT

## HOME OF THOMAS EDISON

Edison National Historic Site

Historic Structure Report

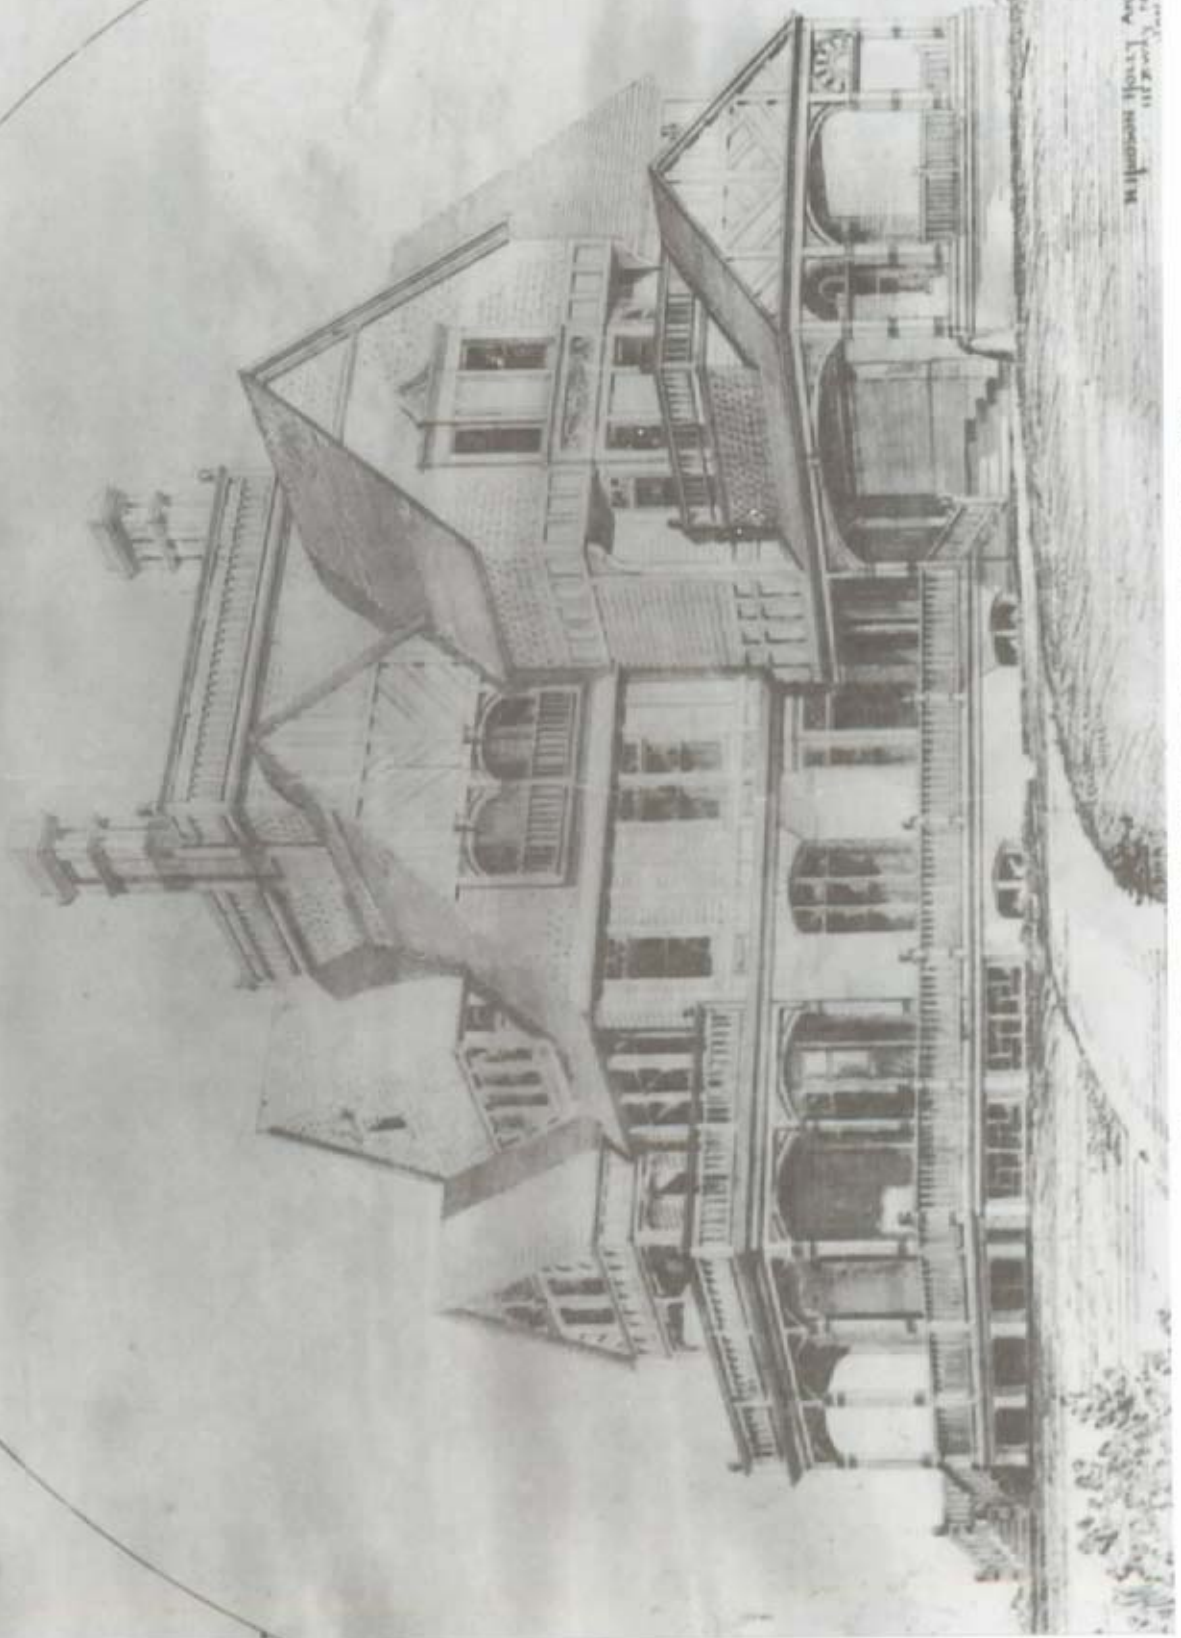
Figure 1. Early sketch of the Pedder house, January 30, 1880.

Despite this recommendation, Holly illustrated the chimneys in an early sketch of the house as being fairly plain in design (fig. 1).<sup>99</sup> The chimneys as actually constructed, however, were more in keeping with the style espoused in *Modern Dwellings*. The house was built with six chimneys of similar design. The tops of the chimneys were corbeled outward, and the two long sides of each stack were embellished with raised brickwork to look like pilasters. Each stack was capped with bluestone, and the top of every flue was fitted with a terra cotta pot.

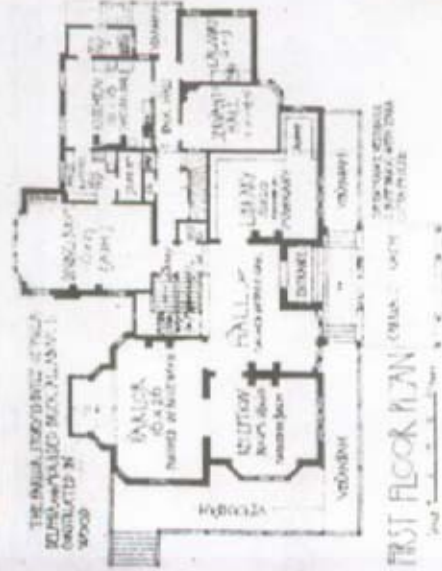
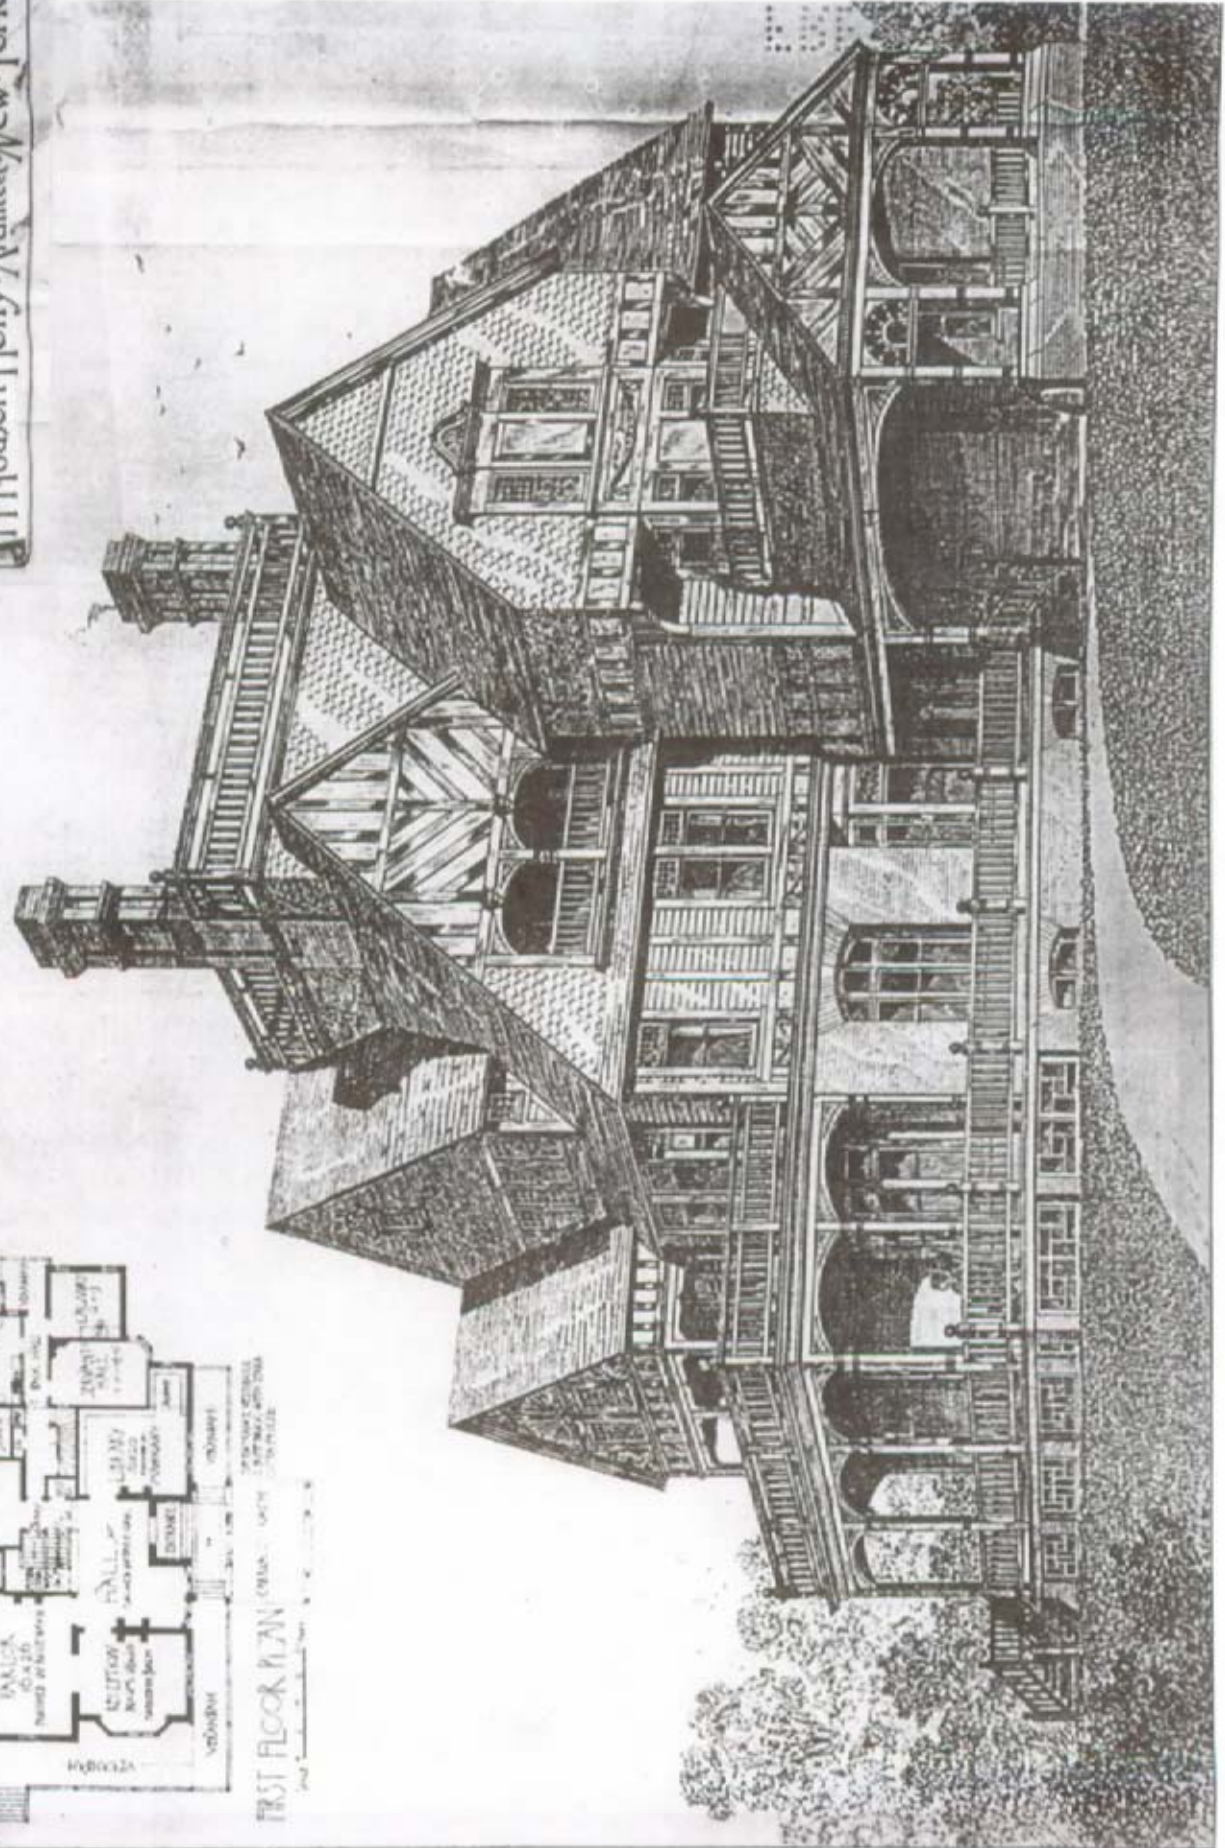
Figure 2. Exterior elevation drawing and first-floor plan, Aug. 27, 1881.

A smaller balustraded roof deck was here originally, atop the original south verandah (fig. 2). It was replaced by a larger balustraded roof deck above the Conservatory when the latter was built circa 1882 (fig. 4). Another roof deck was created just west of this deck when the Drawing Room was enlarged southward circa 1883-84. The new roof deck was incorporated into the existing Conservatory roof deck (fig. 5) to form the present-day south roof deck.

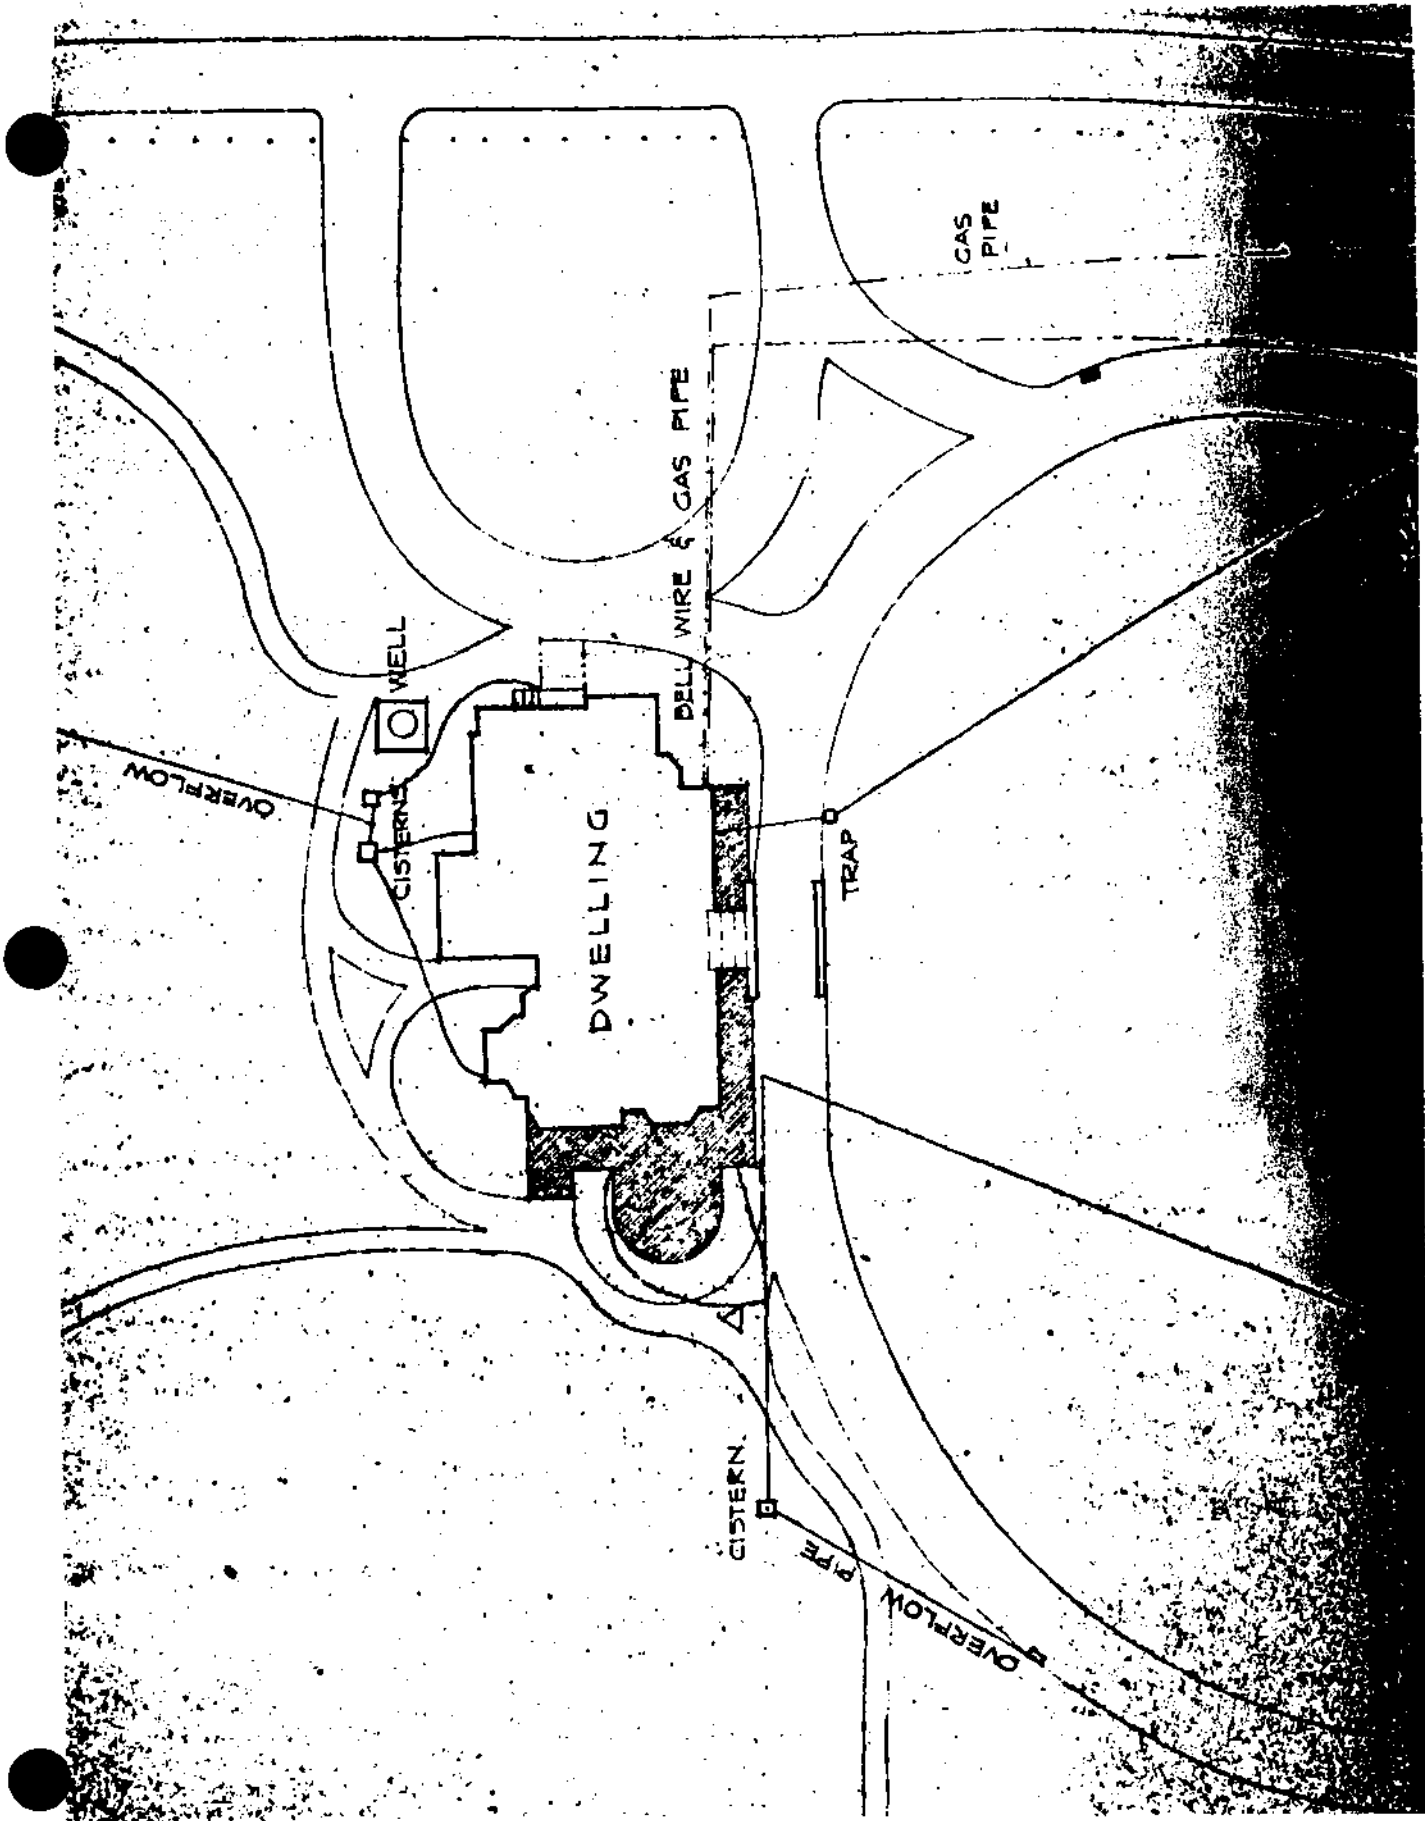
Figure 3. Detail of "Map of Residence and Grounds Belonging to H.C. Pedder Esq.," by Mead & Taylor, Engineers, 1882.

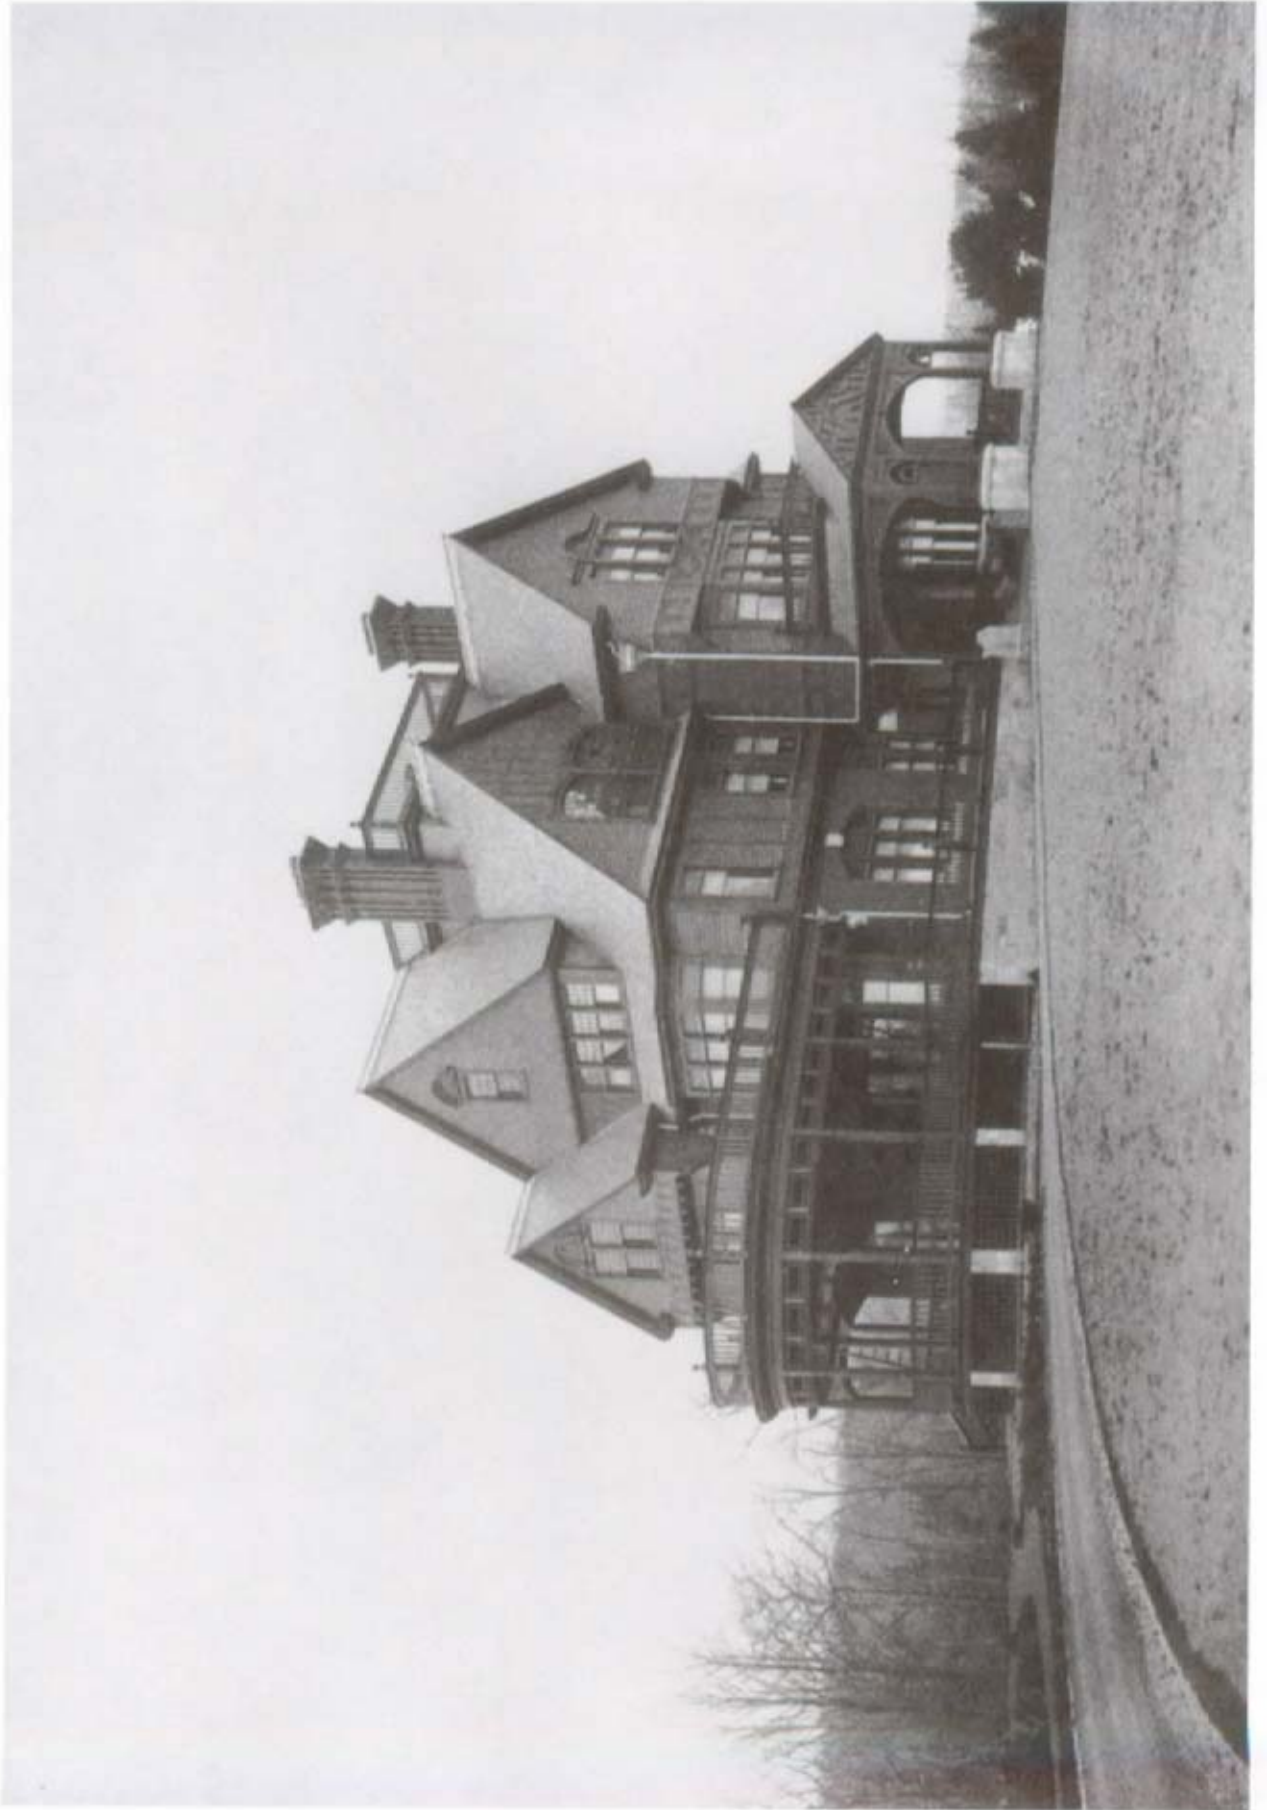
Figure 4. Earliest-known photograph of the Pedder house, circa 1882-83.

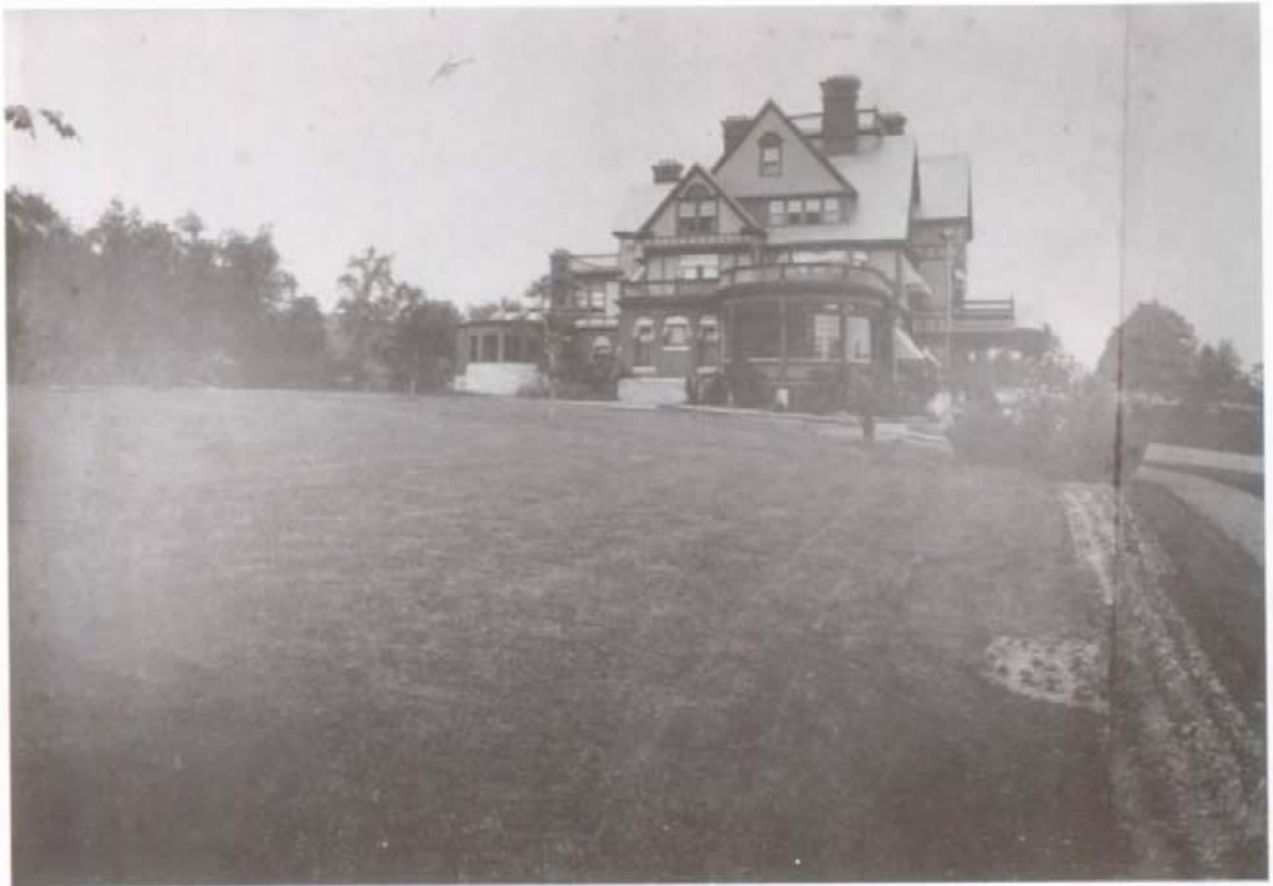
Figure 5. South elevation, circa 1884-90. Note the "billiard room" addition on the back (left) side.

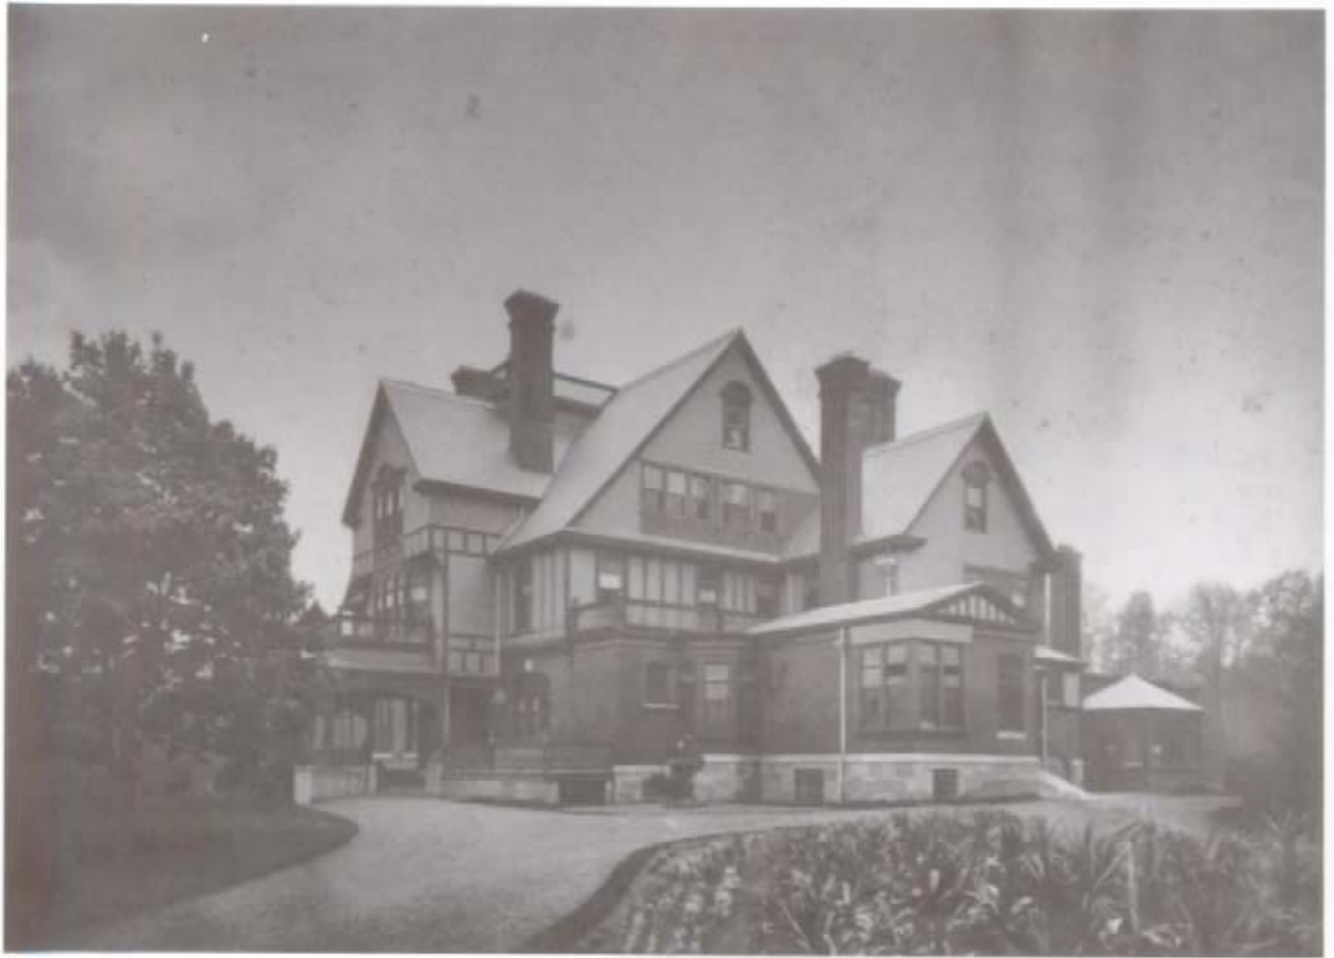
Figure 6. Northeast elevation, circa 1884-90.

The second-story roof deck off Mr. Theodore's Room (Room 206) was built in 1880-81. It functions as the roofs for the north alcove of the Library (Room 104) and the Service Dining Room (Room 105). The porch is documented by early photographs taken in the 1890's (figs. 6 and 10) as having had a wood balustrade with three posts.

The cellar entrance is probably an original feature of the 1880-81 house because it is located at one of the original foundation walls. It is certain that a bulkhead covered the entrance at an early date, based on an early exterior photograph taken sometime between circa 1884 and 1890 (fig. 6). The bulkhead was described by the residence appraisal of January 1931 as a "hinged pine cover." The wood structure that exists at the opening today is likely of later vintage, however, given its location close to the damp ground. The exact date of the existing bulkhead is not known.

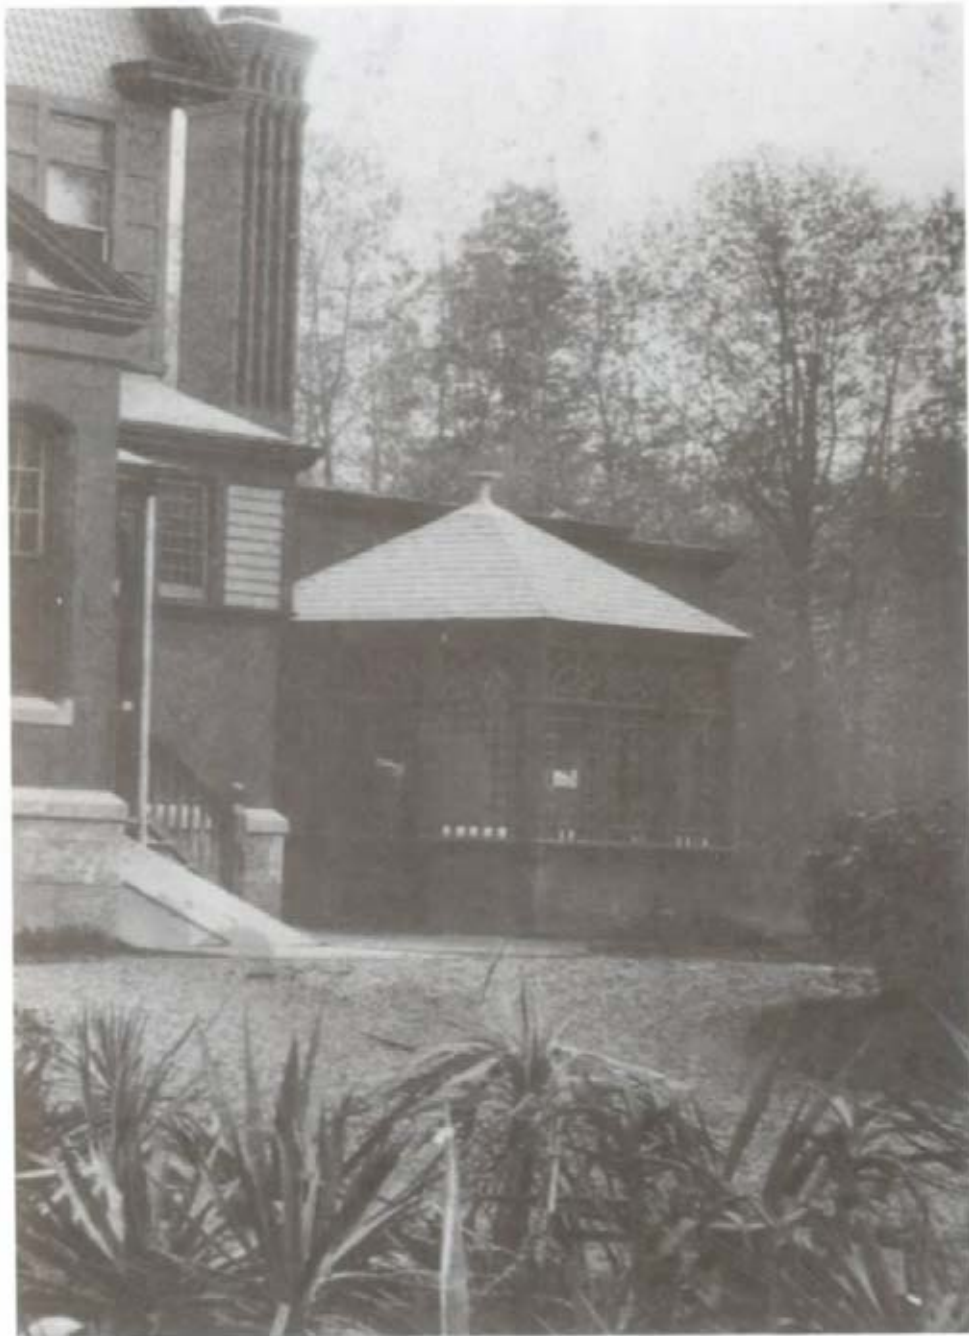
Figure 7. Detail of Figure 6, showing the "well house."

<sup>120</sup> It is believed that one of these buildings may have been the original well house that had been located on the north side of the house. The well house was moved in 1899, according to a bill from carpenter Adolph Vogel dated Dec. 15, 1899. Both buildings were wired for electricity by 1920, according to a memorandum dated Mar. 10, 1920, from the Edison Insurance Service Department.

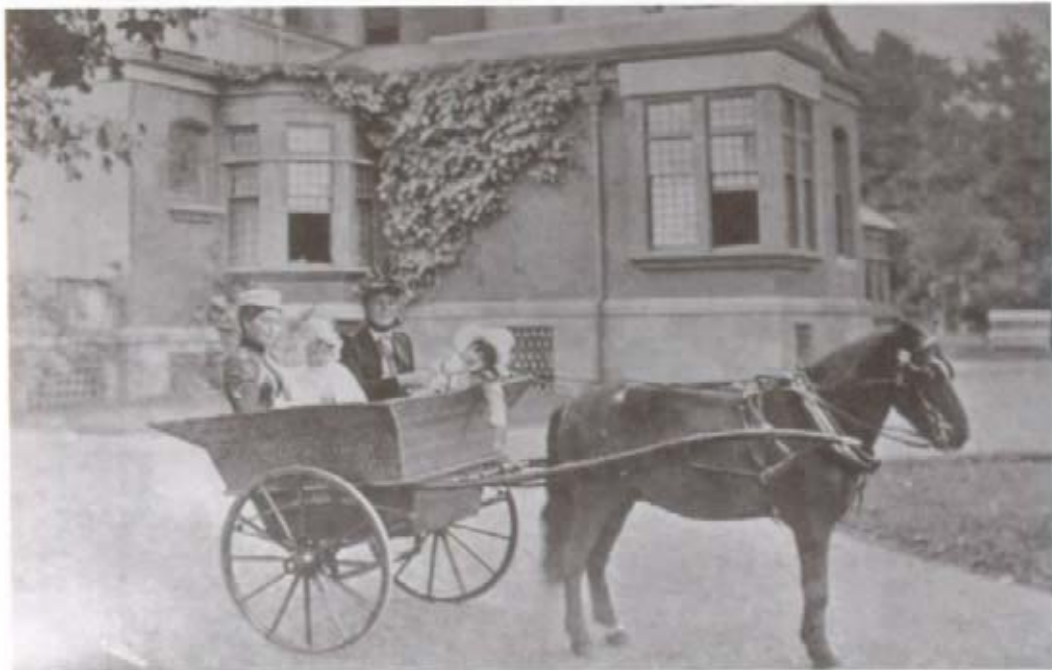
Figure 10. Close-up views of the Conservatory (above) and the Service Wing (below), circa 1890-92.

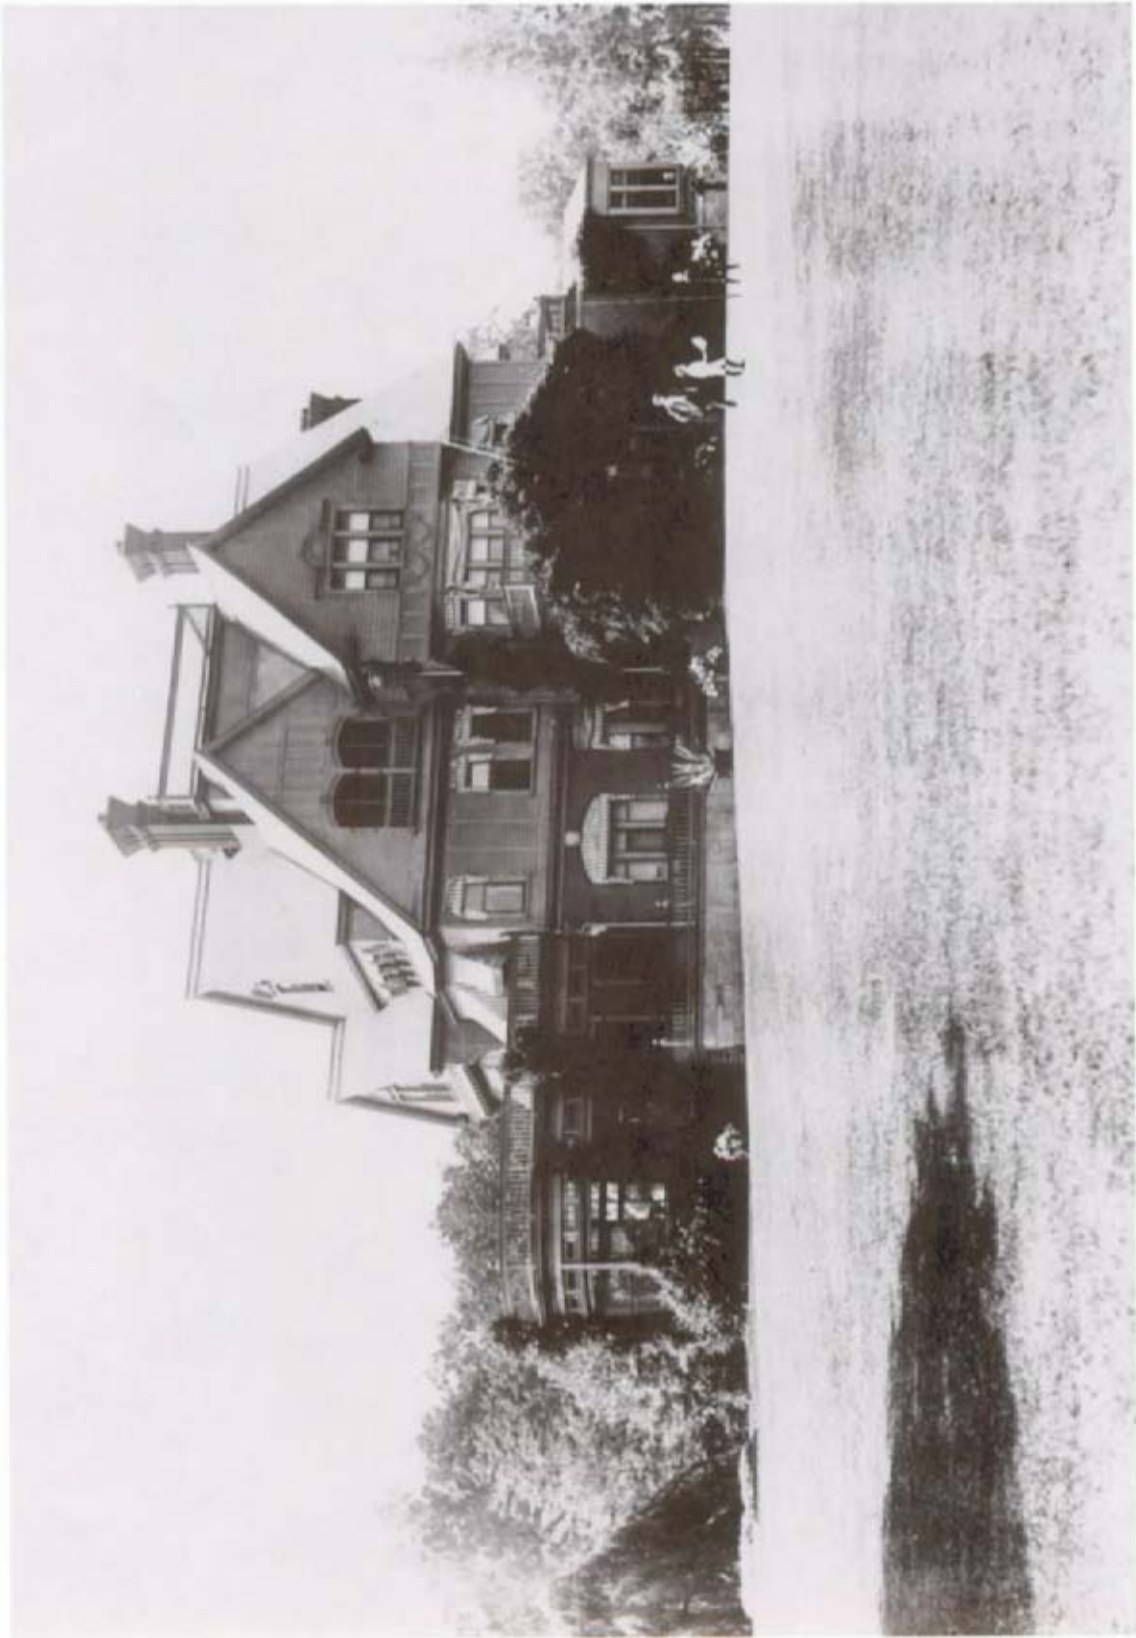
Figure 14. East elevation, circa 1897-1902.

that some of this work included making screens for the Conservatory, but this is not clearly stated. That the Conservatory may have been outfitted with screens about this time is suggested by an early photograph of the house taken sometime before 1903 that shows the screens in place (fig. 14). The Conservatory screens were divided into panels, with the large curved screens having six panels each, and the smaller flat screens having four panels each. These screens were removed during the cold months, when storm sashes were installed.

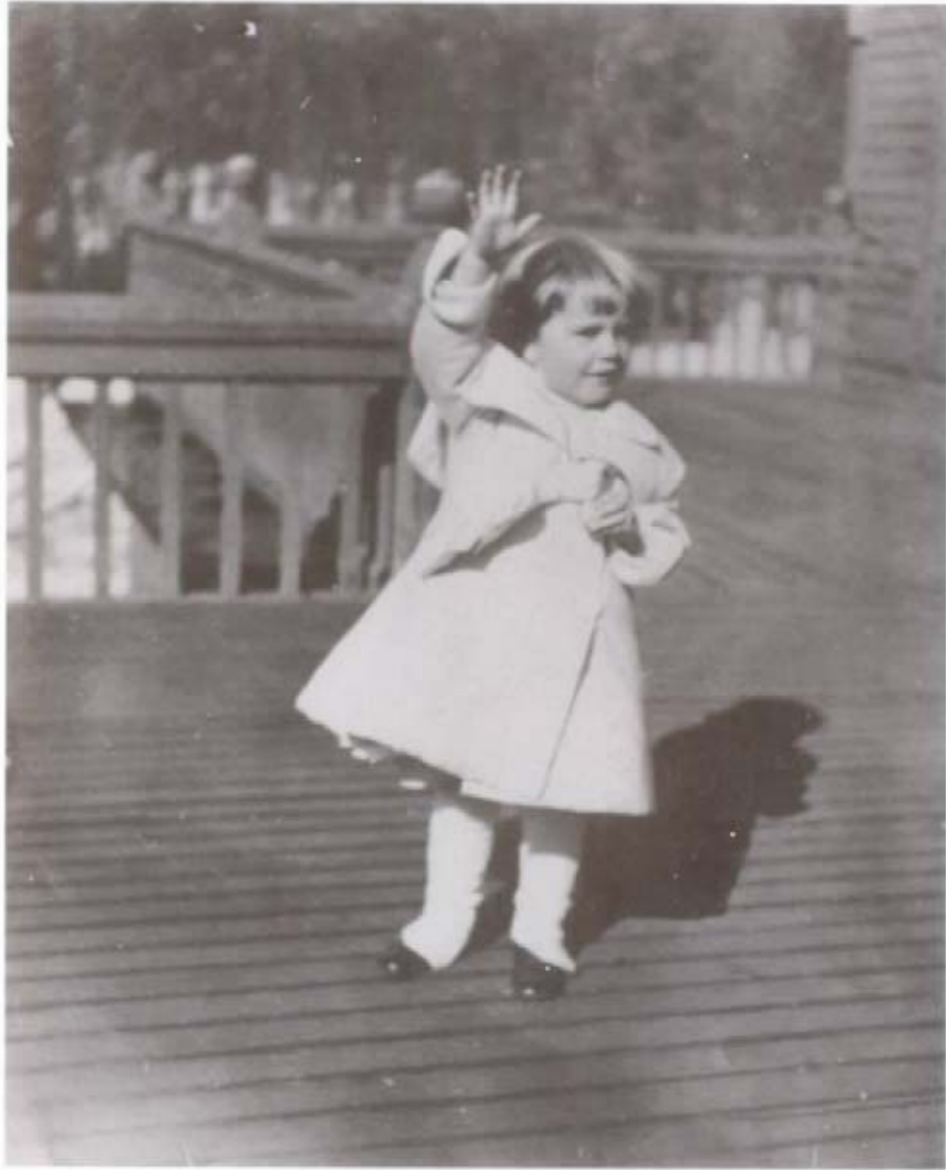
**Figure 15.** Theodore Edison on the south roof deck, above the Conservatory, circa 1902.

The second-story south roof deck was the one used most frequently by the Edison family. A large awning was installed over the Conservatory portion in May 1890.<sup>19</sup> The flooring material was wood boards that were widely spaced for drainage, according to a photograph dated circa 1902 (fig. 15).<sup>20</sup> The Drawing Room portion of the deck, and part of the Conservatory portion, were screened in 1907 and enclosed with glass in 1935. For more information on the enclosed sun porch, see the discussion of Room 202.

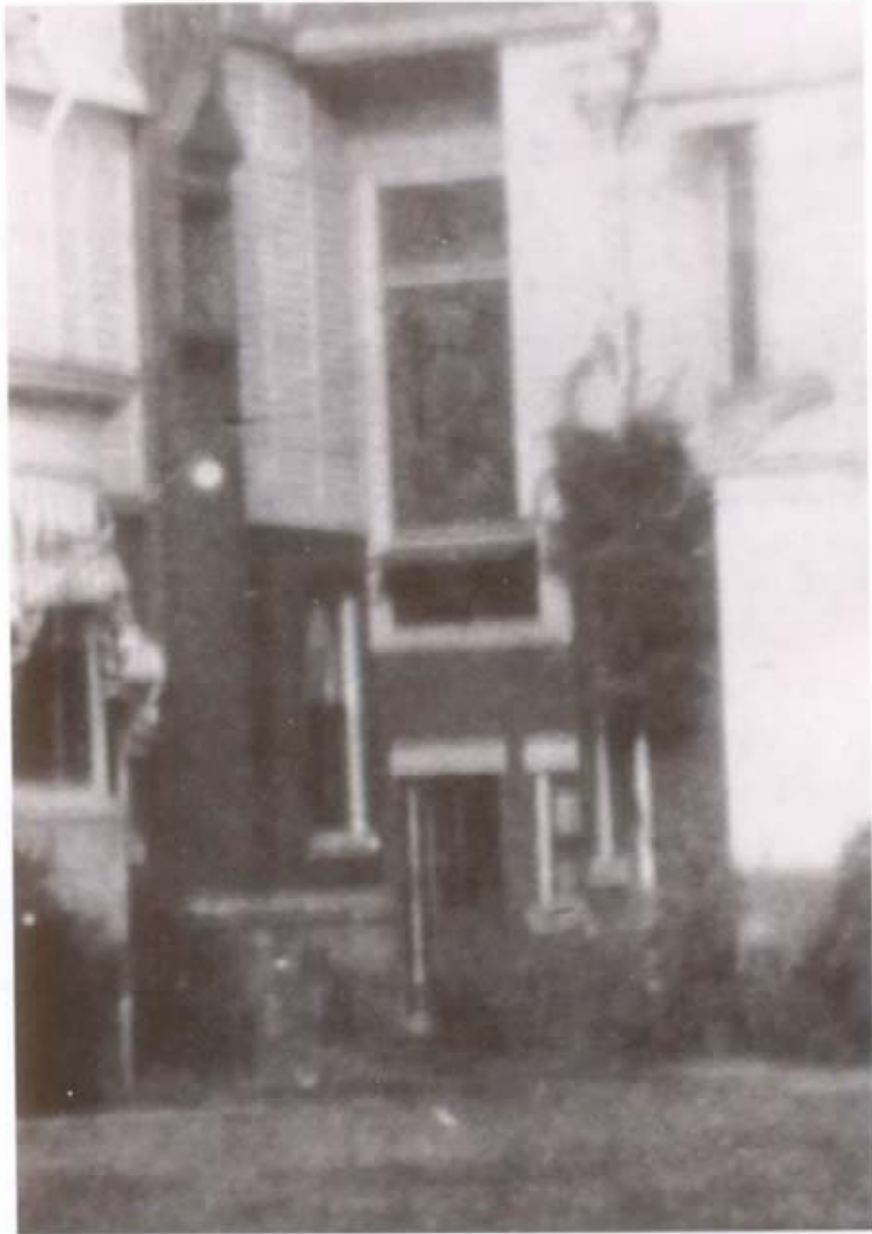
Figure 20. Detail of Figure 19, showing the original back doorway.

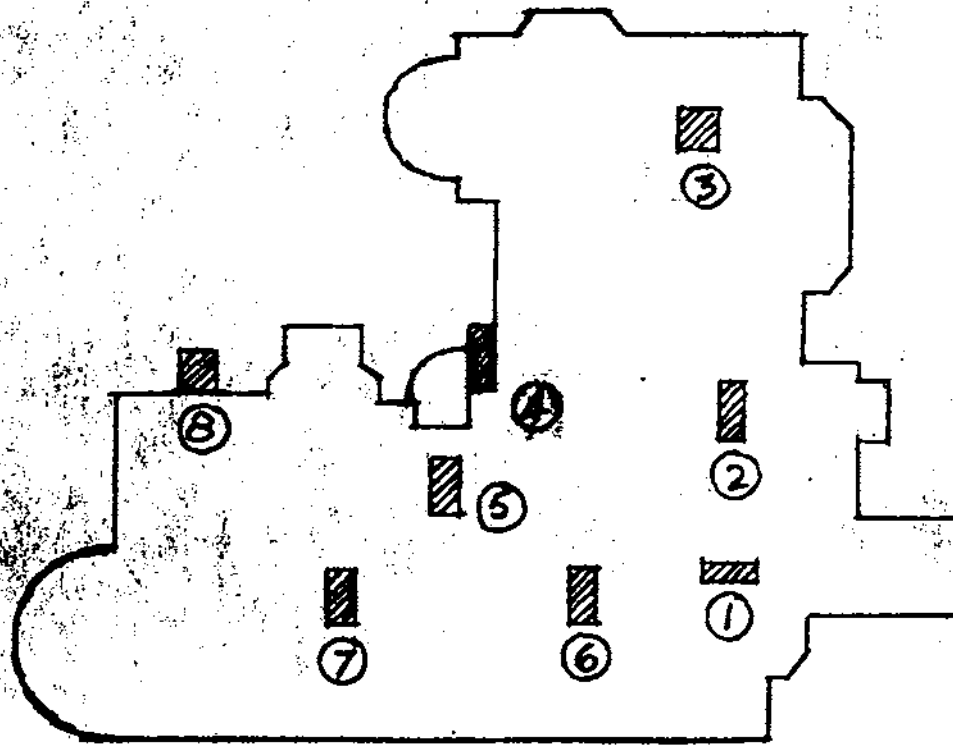
## ROUGH PLAN OF GLENMONT CHIMNEYS

(FRONT OF BUILDING)

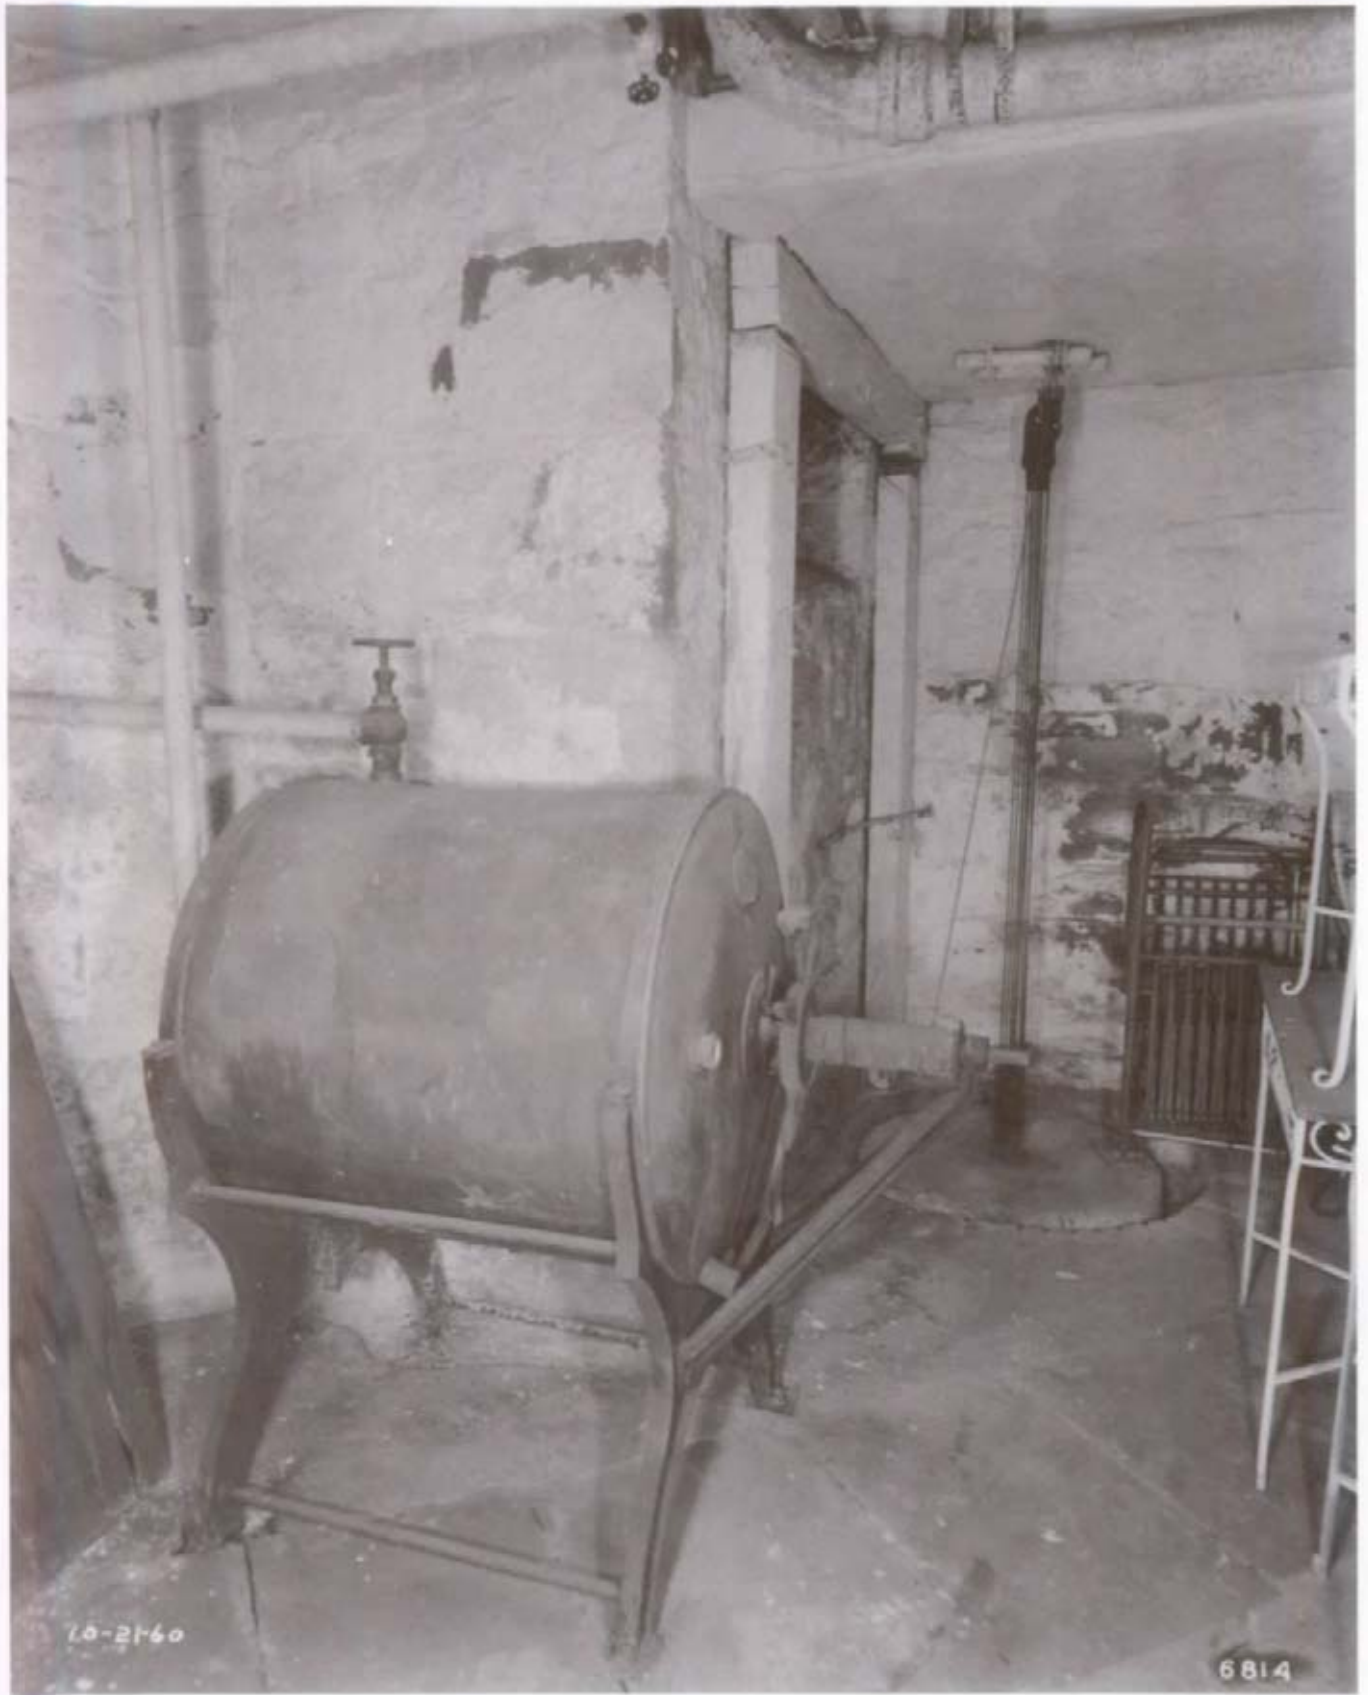
Figure 37. Room B9, northeast corner, showing the obsolete Springfield Gas Machine, 1960.

The Edison family used the gas-making equipment, including the "gas machine," until sometime before 1921. It was noted as being "obsolete" by the time of the residence appraisals of 1921, 1924, and 1931. The 1931 appraisal described the equipment in the cellar as follows:

1 Springfield gas machine, #1822, receiver 32" x 32" diameter, Gilbert and Barker Mfg. Co. (obsolete).
