# THE HOUSE AT GLENMONT

## HOME OF THOMAS EDISON

Edison National Historic Site

Historic Structure Report

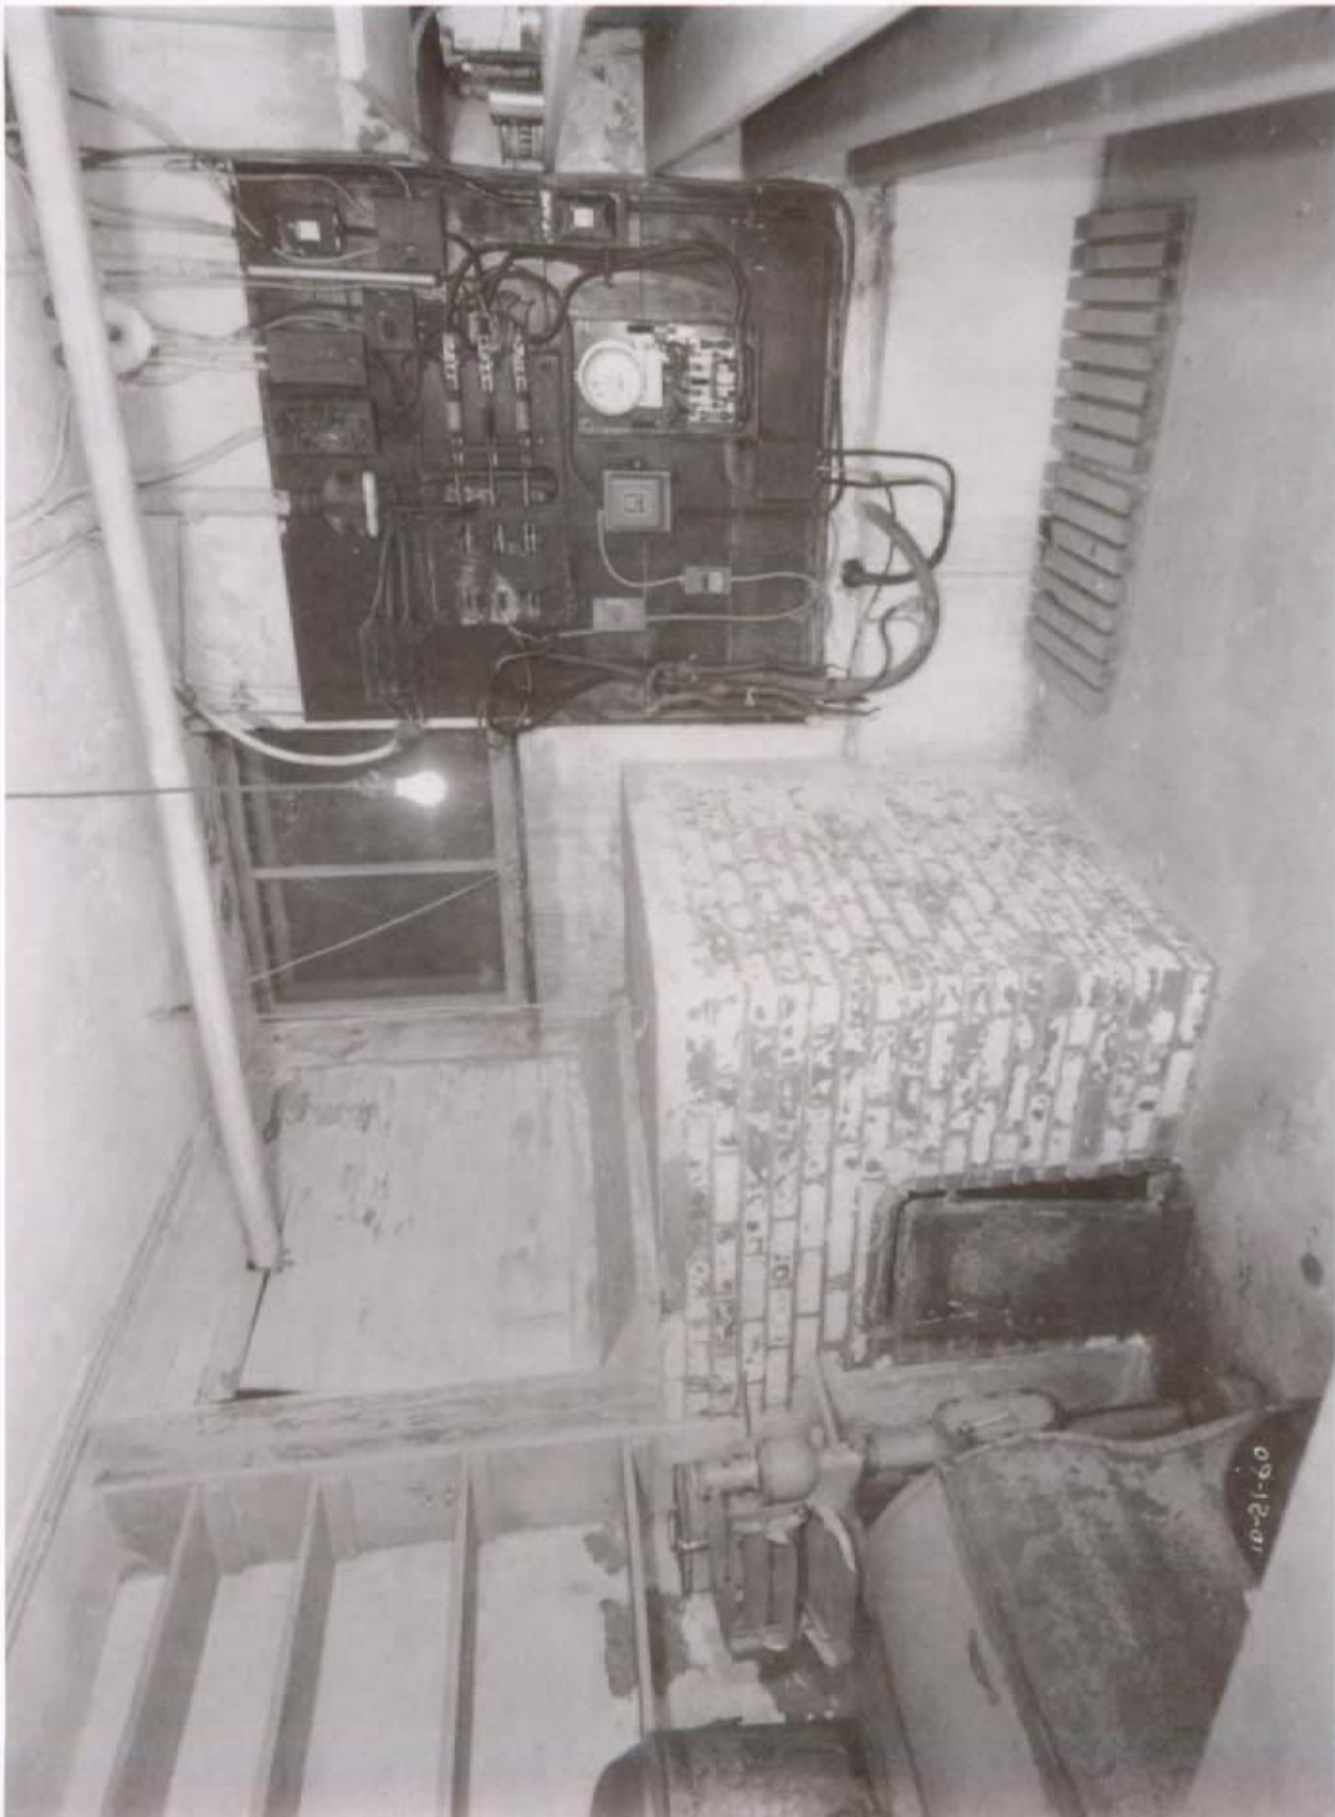
Figure 38. Store Room #2 (Room B11), northeast corner, showing the fresh-air plenum for the original heating system (left), and the electrical panel for incoming service (right), 1960.

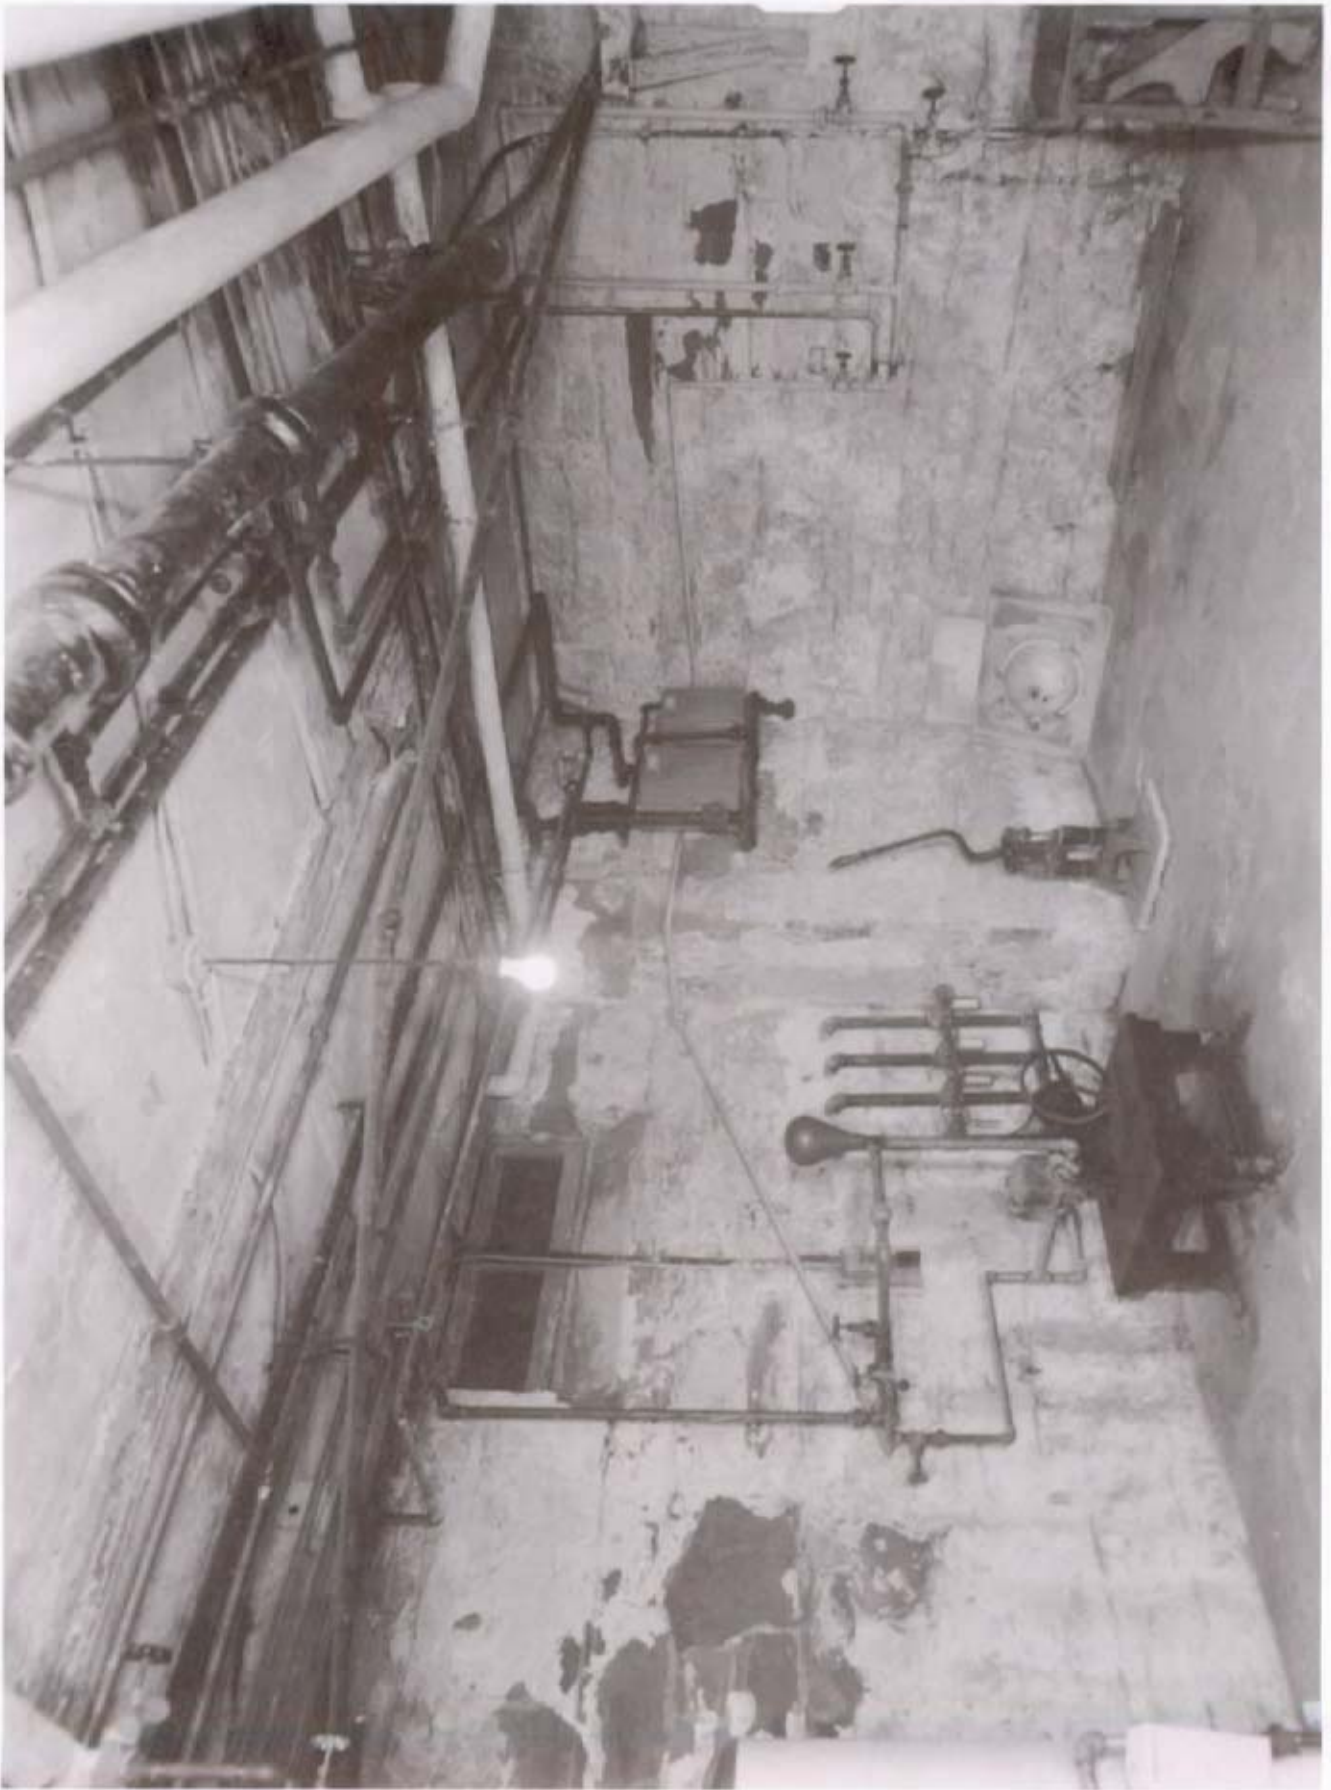
Figure 39. Pump Room (Room B14), northwest corner, showing the cistern valves and water pumps, 1960.

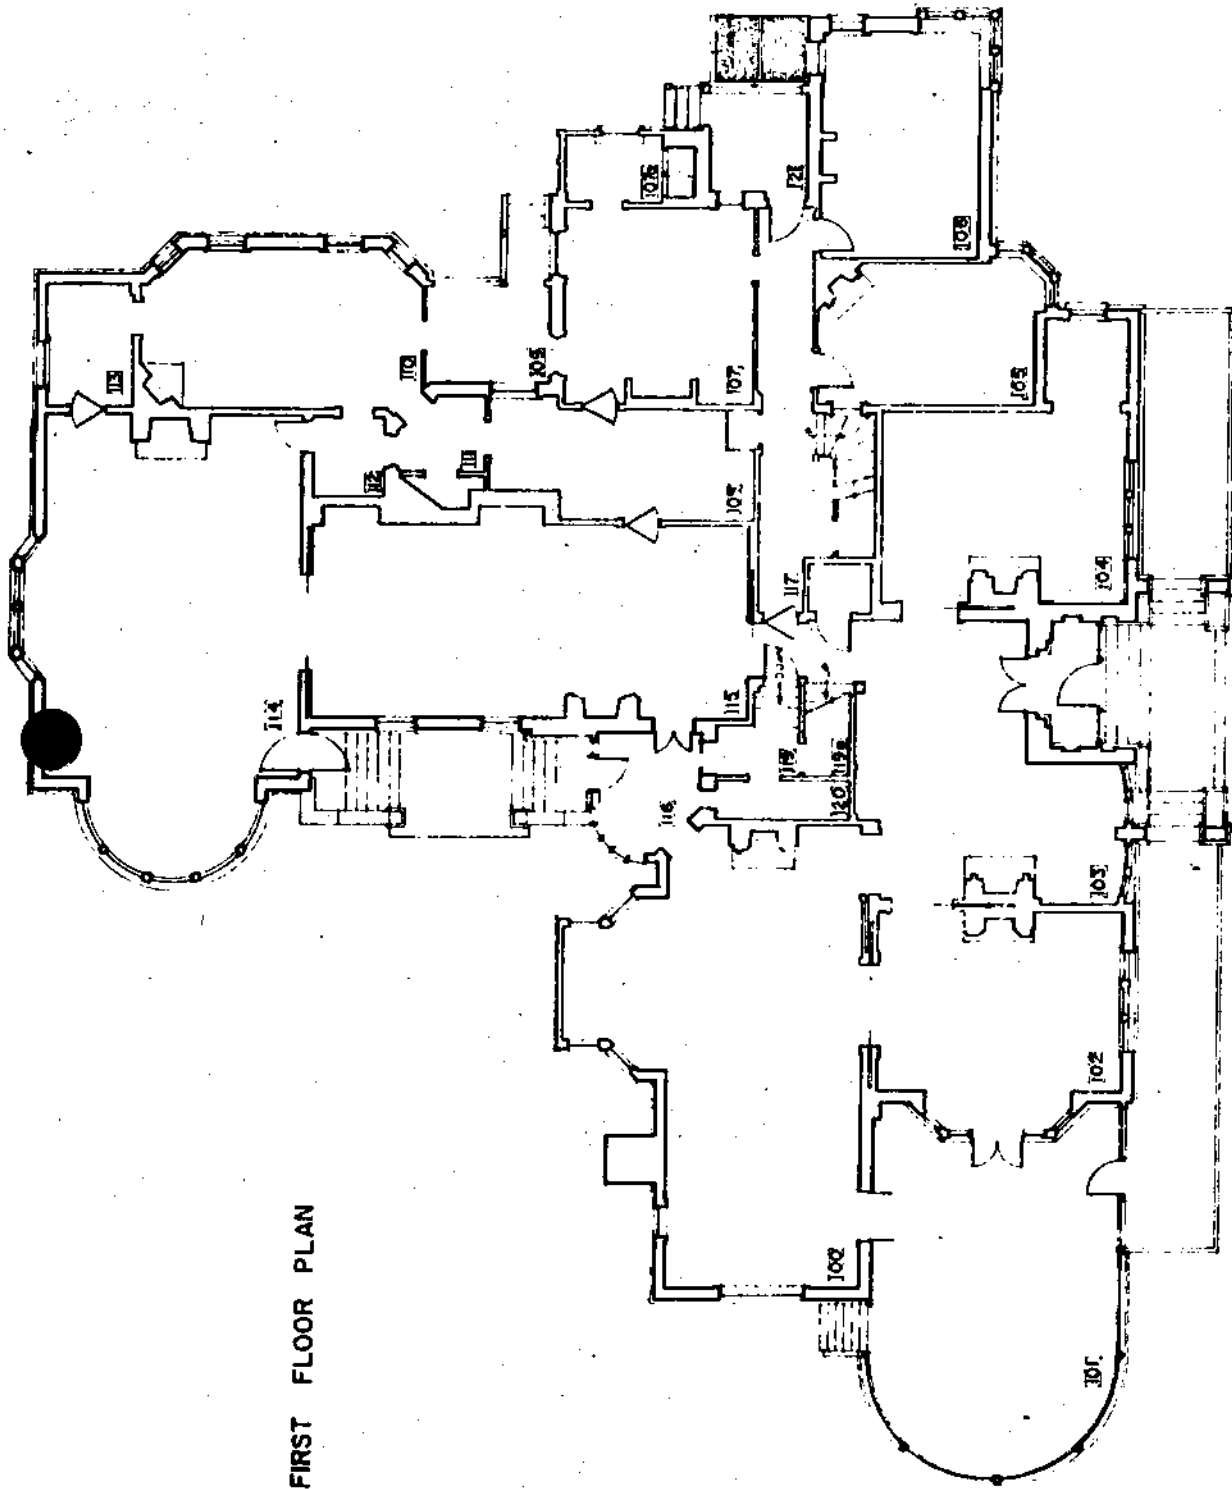
FIRST FLOOR PLAN

Figure 40. First-floor plan, 1963.

The Telephone Room is tucked beneath the Main Stairway to the second story. It occupies an interim story between the first and cellar stories, and is reached from the first story by descending a flight of five steps. The dimensions of the "Phone Room" were recorded by the residence appraisal of 1931 as being roughly 7 feet square. This does not seem to take into account an ell off the southwest corner of the room (see figure 40).

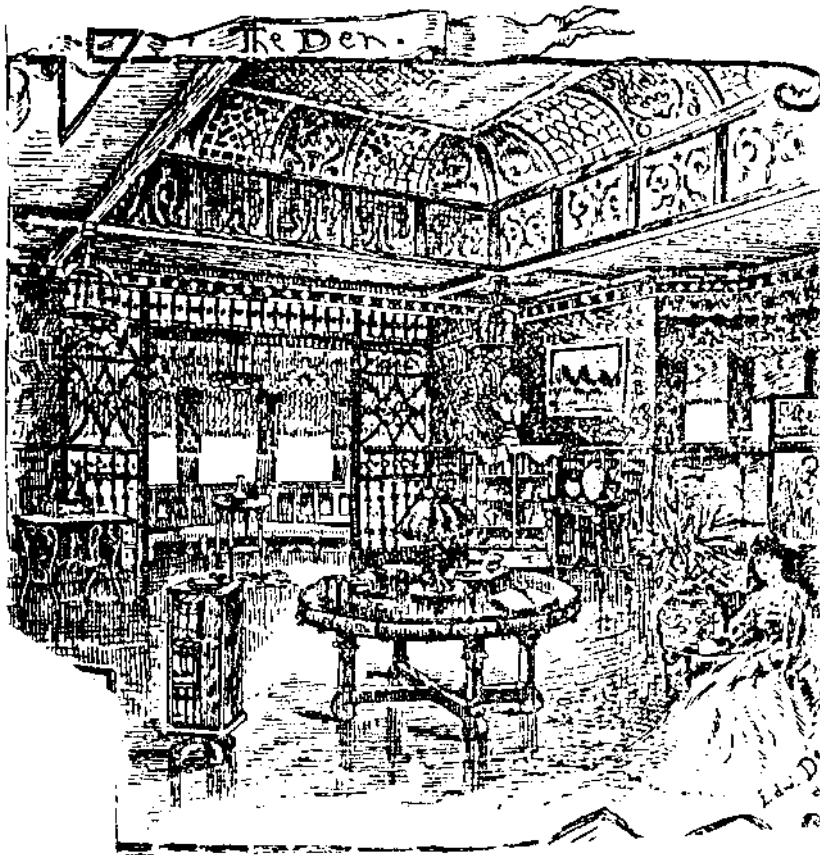
Figure 89. Sketch of the Den (Room 114), looking southwest, 1891.

Alterations were made to the woodwork when the room was remodeled in 1935. The most significant change was the removal of the original wood screen from the south-wall bay. The estimate for the work by Mrs. Renner dated July 1, 1935, described "removing existing grill partition and patching." The appearance of this screen is well-documented by several early views of the room (figs. 89 and 91-92).

The earliest visual documentation of the light fixtures is a sketch of the Den that accompanied the 1891 article (fig. 89). The earliest photograph, published in 1892, shows the two light fixtures at the north end of the room (fig. 90).<sup>209</sup>

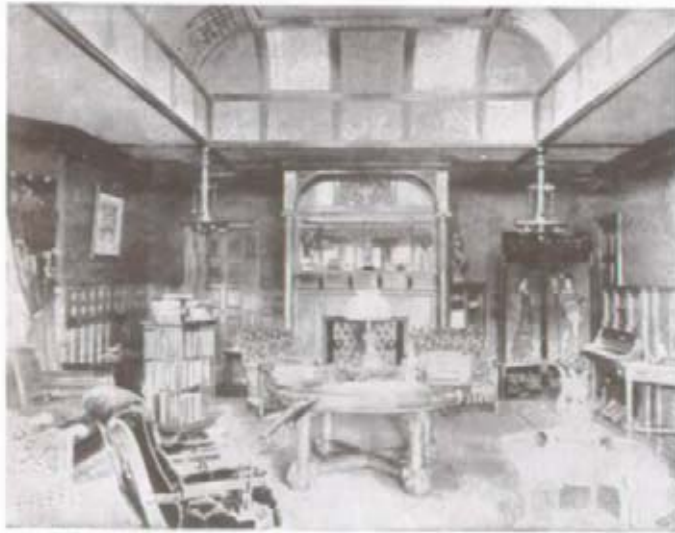
EDISON'S DEN.

Figure 90. Den (Room 114), looking north, circa 1890.

Also altered in 1935 was the wood fireplace mantel at the north end of the room. The original appearance of the mantel is seen in a photograph published in 1892 (fig. 90). The estimate of July 1, 1935, described "removing present over-mantel and pilasters [sic: columns], re-setting pilasters [sic] under present mantel shelf."

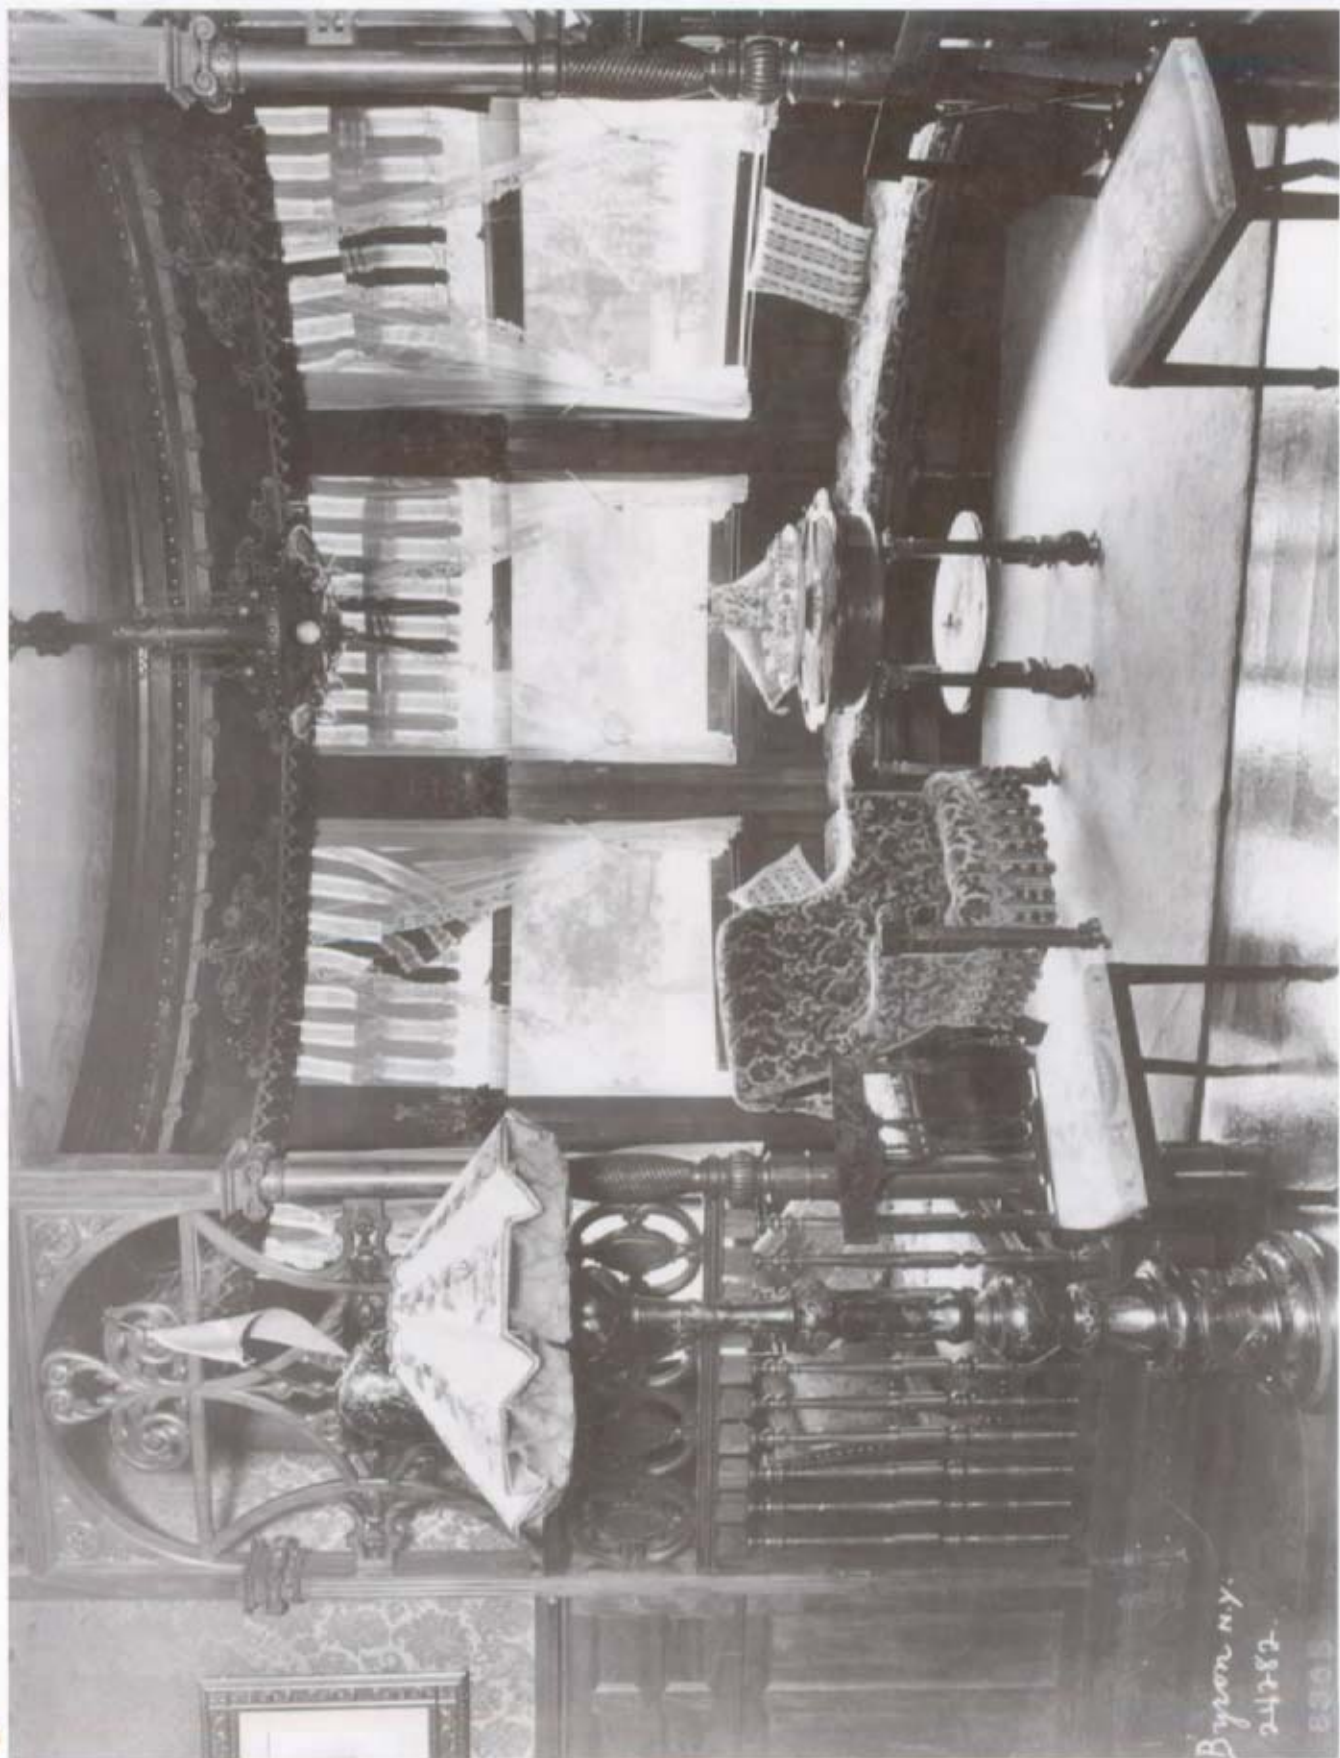
Figure 91. Den (Room 114), south bay window, 1907.

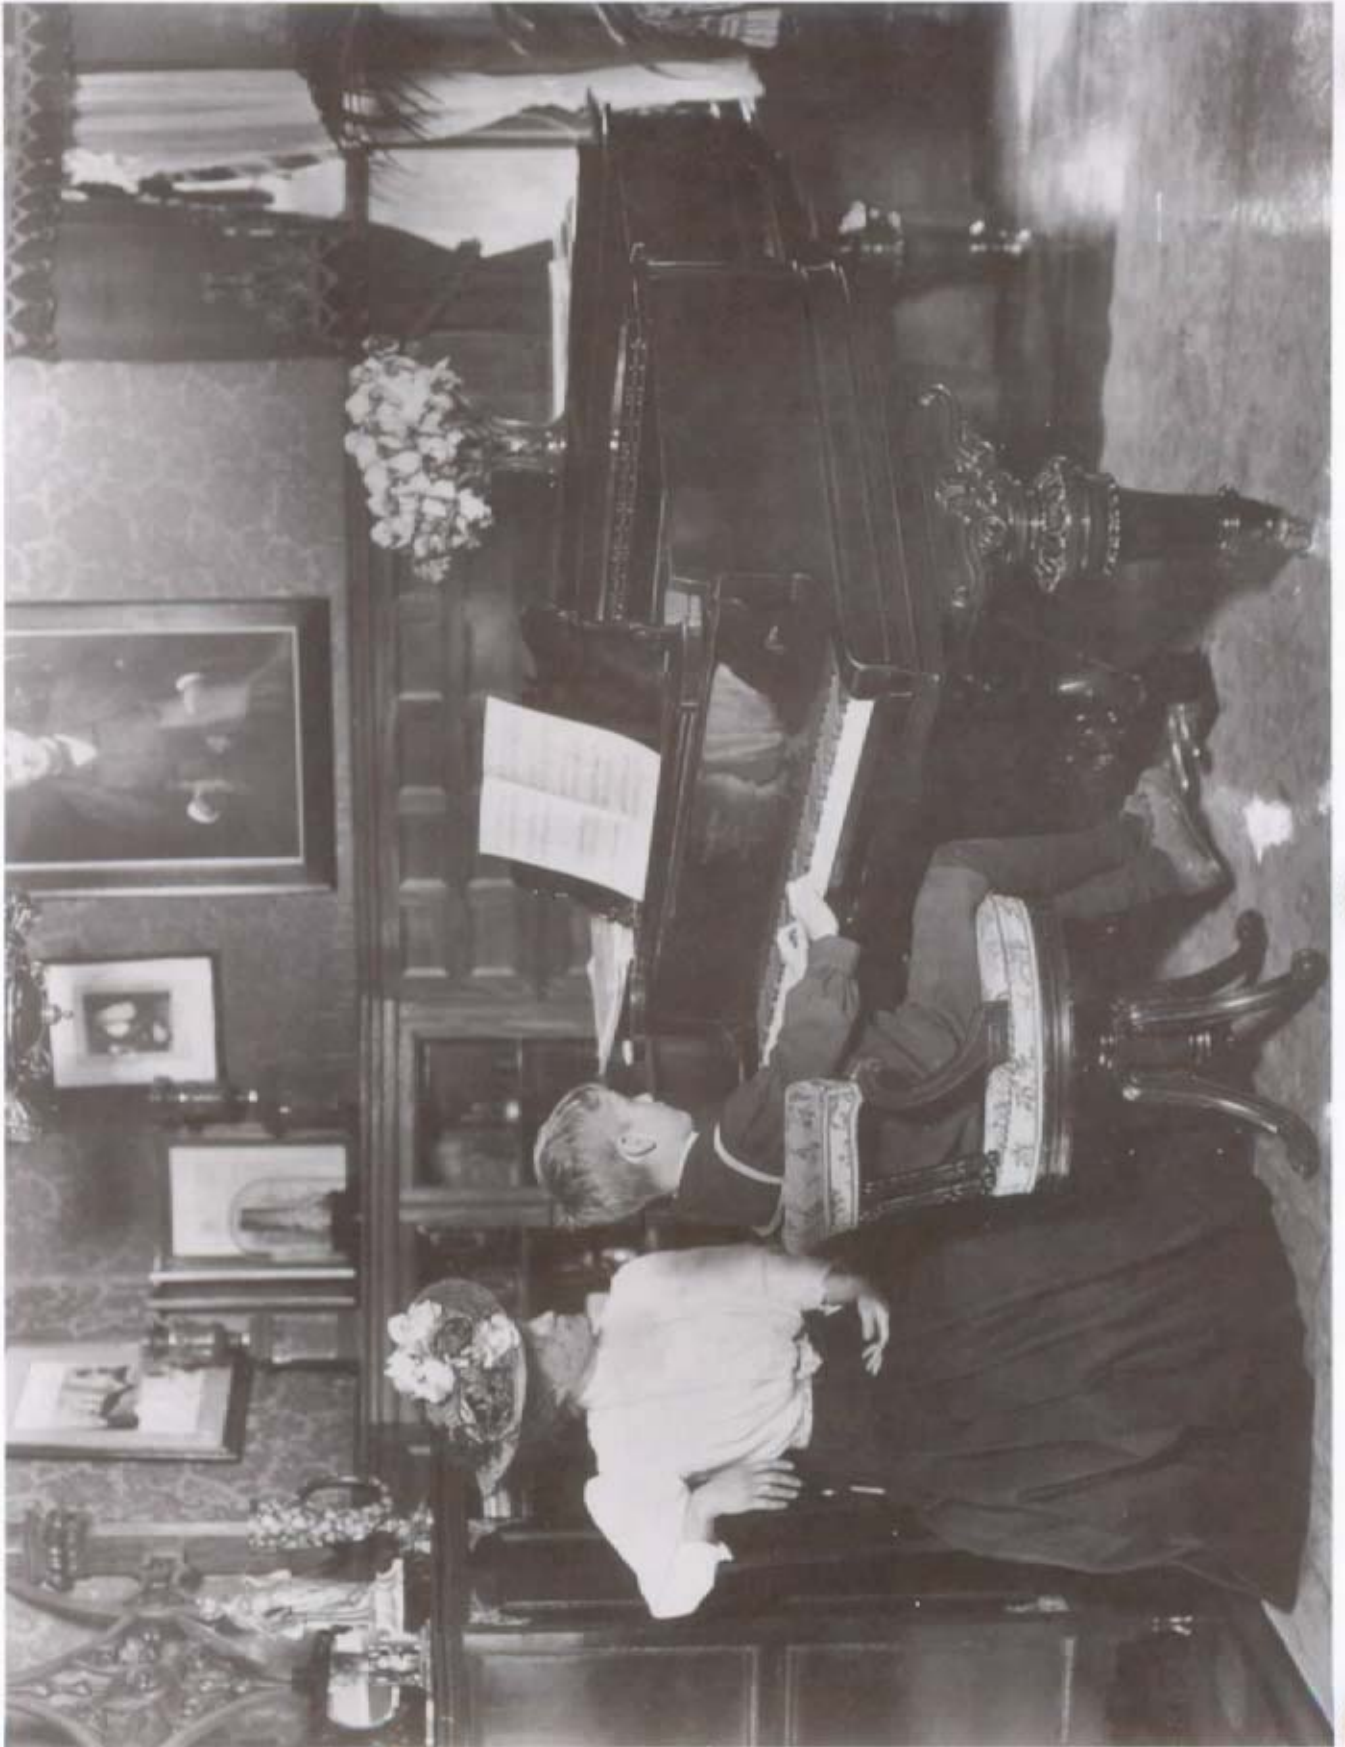
Figure 92. Den (Room 101), southwest corner, 1907.

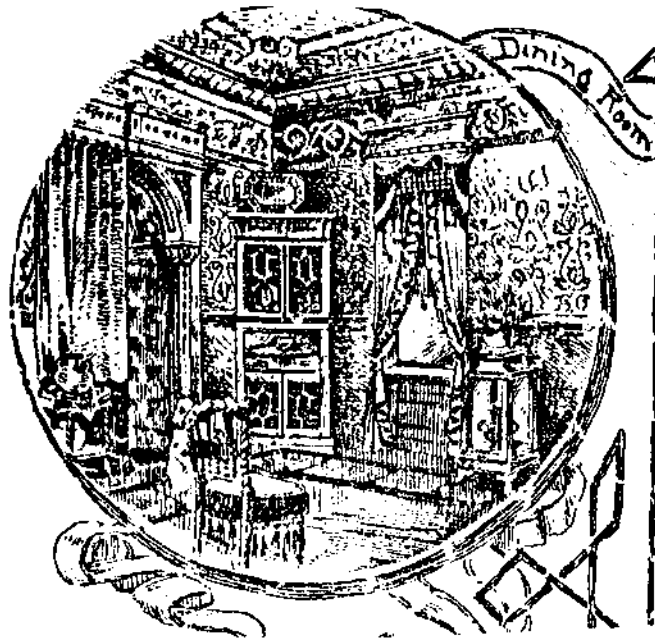
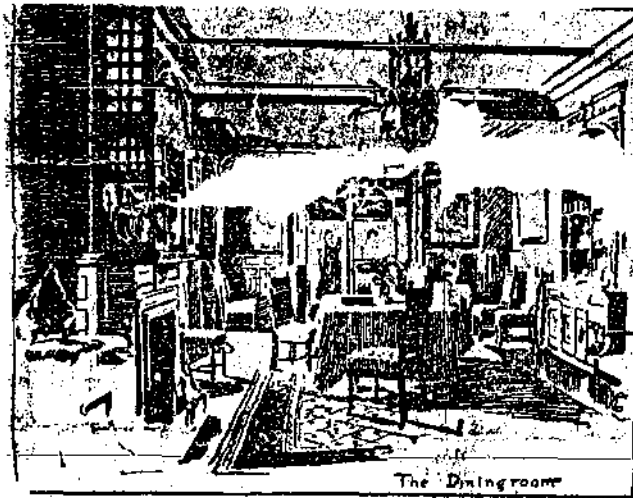
Figure 102. Two early sketches of the Dining Room: one showing the southeast corner (top, 1891); the other being a view looking west (bottom, 1894).

The article was accompanied by the earliest-known view of the room—a sketch showing the southeast corner (fig. 102).

This article was illustrated with a sketch, which was a view looking toward the west (fig. 102).

Some documentation exists on the original appearance of the fireplace as it was built in 1880-81. An inventory taken of the house in 1886 listed the Dining Room as having a "Brass and polished steel grate and fender [and] Mahogany mantel piece, with shelves and mirror." The mantel was also described in an article dated 1891 as being of "mahogany" and "reaching to the ceiling." The only known illustration of this mantel is in a sketch of the room published in 1894 (fig. 102). This shows an elaborate overmantel, with an arch on the front and open grilles on the sides.

figuring."<sup>233</sup> An accompanying sketch shows the walls as having a curvilinear design, with a wide patterned border near the ceiling. The ceiling itself also appears to have had a decorative treatment (fig. 102). No samples of the wallpaper are known to survive. Remnants of the ceiling decoration, on the other hand, may exist behind the later canvas finish.

The original chandelier is believed to have been replaced by two new chandeliers when the house was electrified in 1887. These were described by the inventory of 1891 as "2 electroliers." More detailed was an article published in 1894 that said, "There are two superb chandeliers, fitted like the others through the house with electricity." A sketch illustrating the article shows one of the two fixtures as being large and elaborate, featuring a wide spray of arms (fig. 102). No photographs of the electroliers are known.

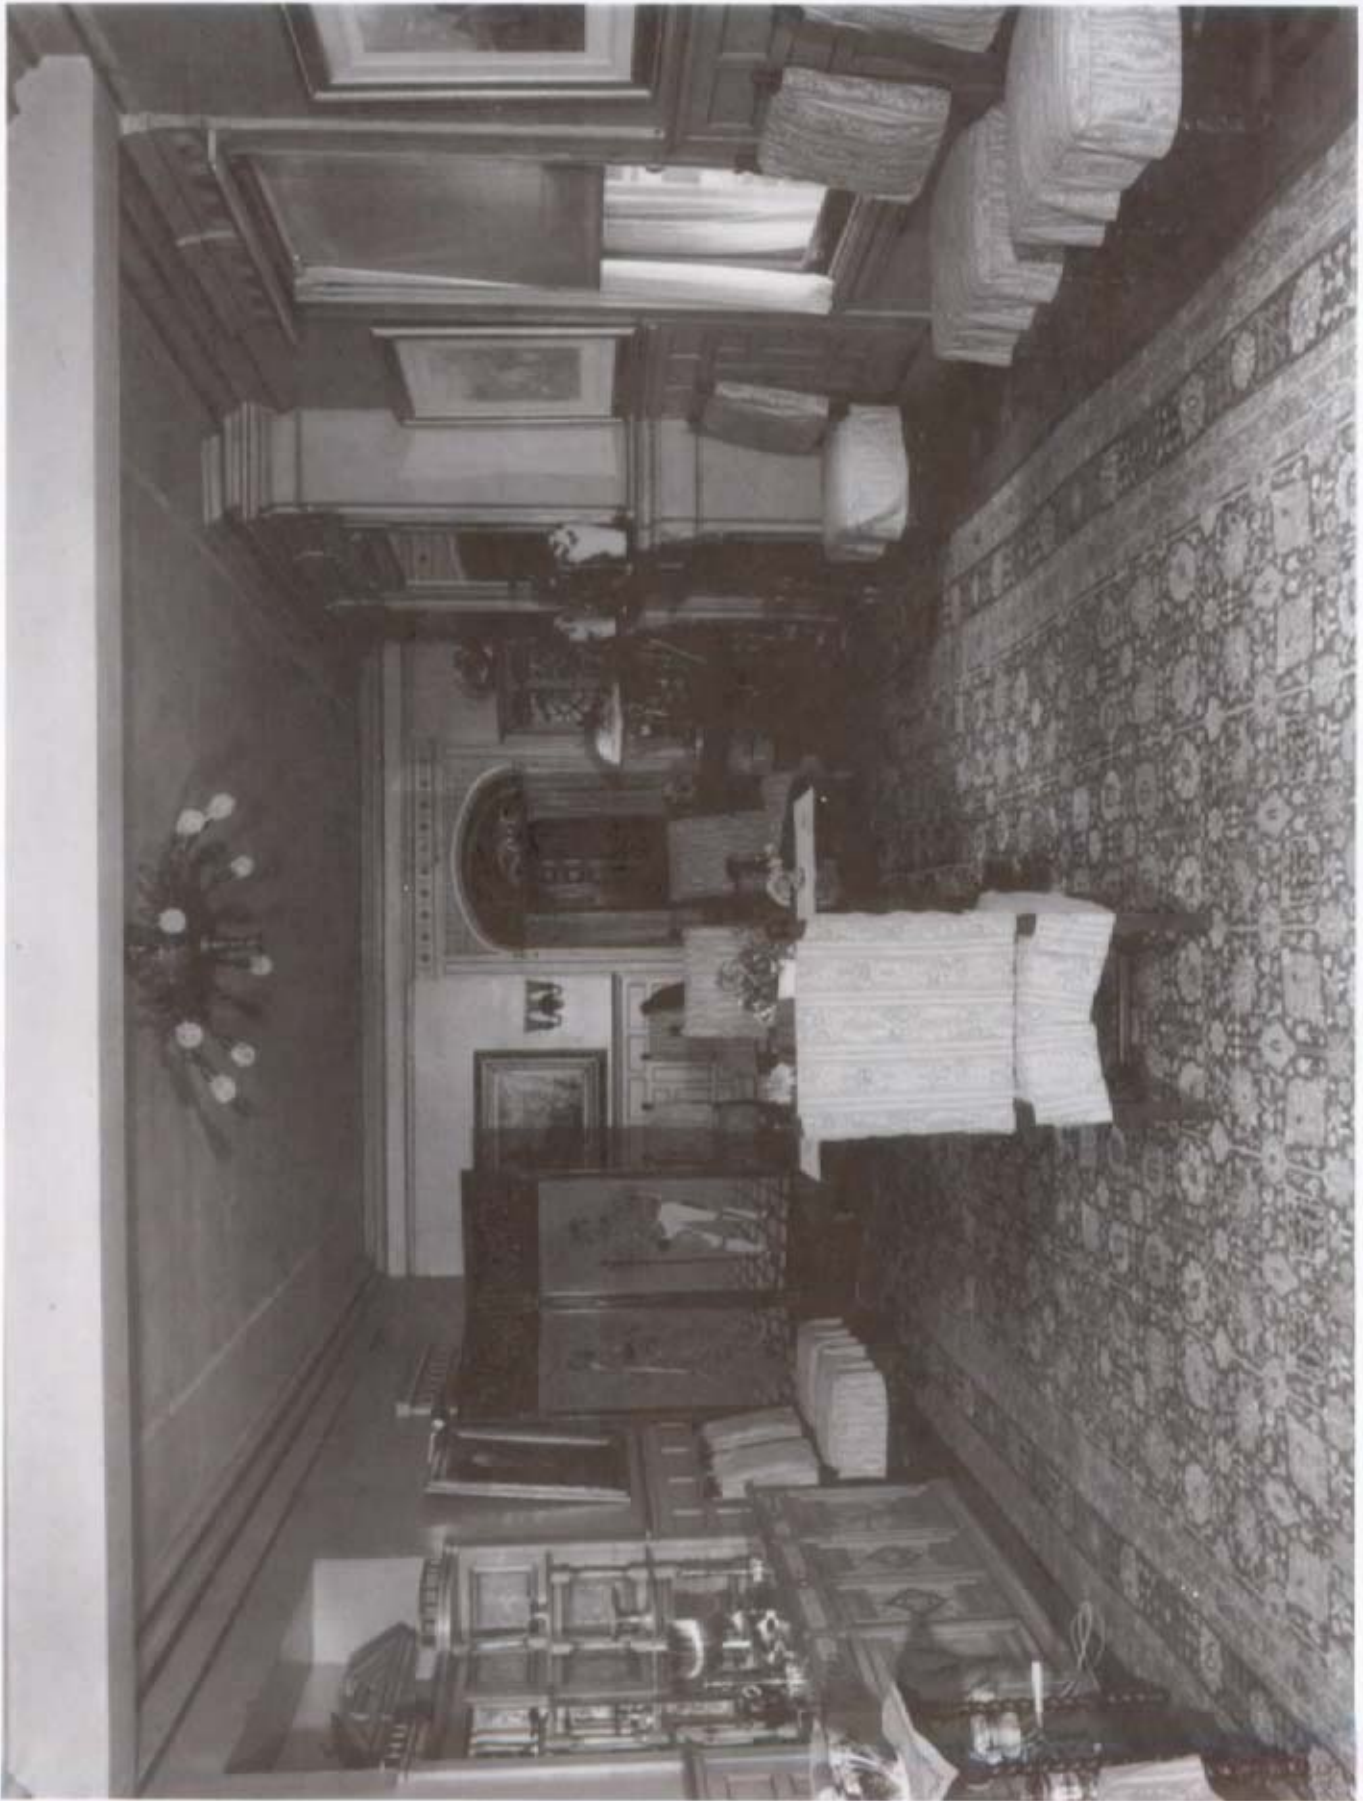
Figure 107. Dining Room (Room 115), looking east, 1947.

The earliest photograph to show the telephone is dated 1947 (fig. 107). The telephone is at the north wall, stored on a small corner shelf on the left (west) side of the built-in sideboard. The telephone cord appears to have been installed in the floor. Telephone instruments were not recorded by the residence or furnishings appraisals, most likely because they were not owned by the Edisons.
