historic structure report
and resource study
Pensacola Harbor defense project
1890 - 1947 Florida unit
march 1982

GULF ISLANDS

NATIONAL SEASHORE / FLORIDA

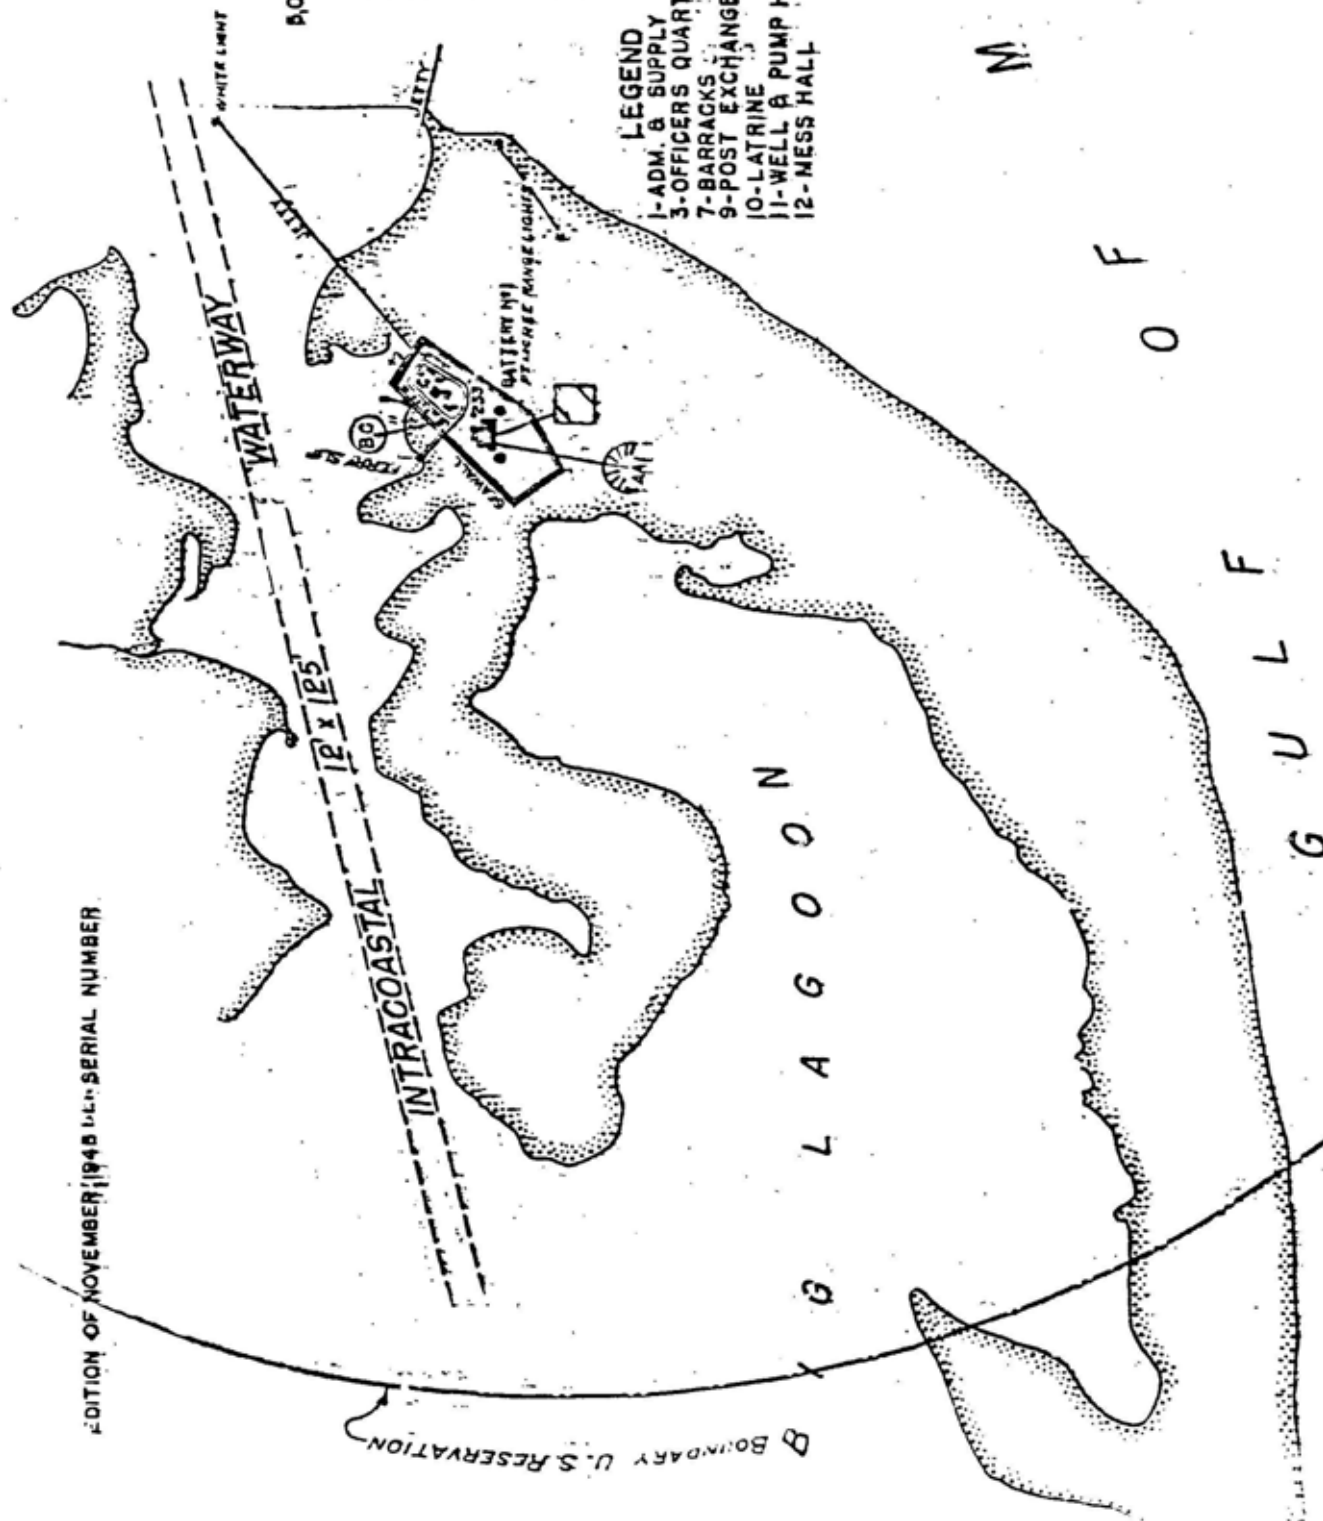
PENSACOLA HARBOR FORT MCREE

EDITION OF NOVEMBER 1945 I.L.H. SERIAL NUMBER

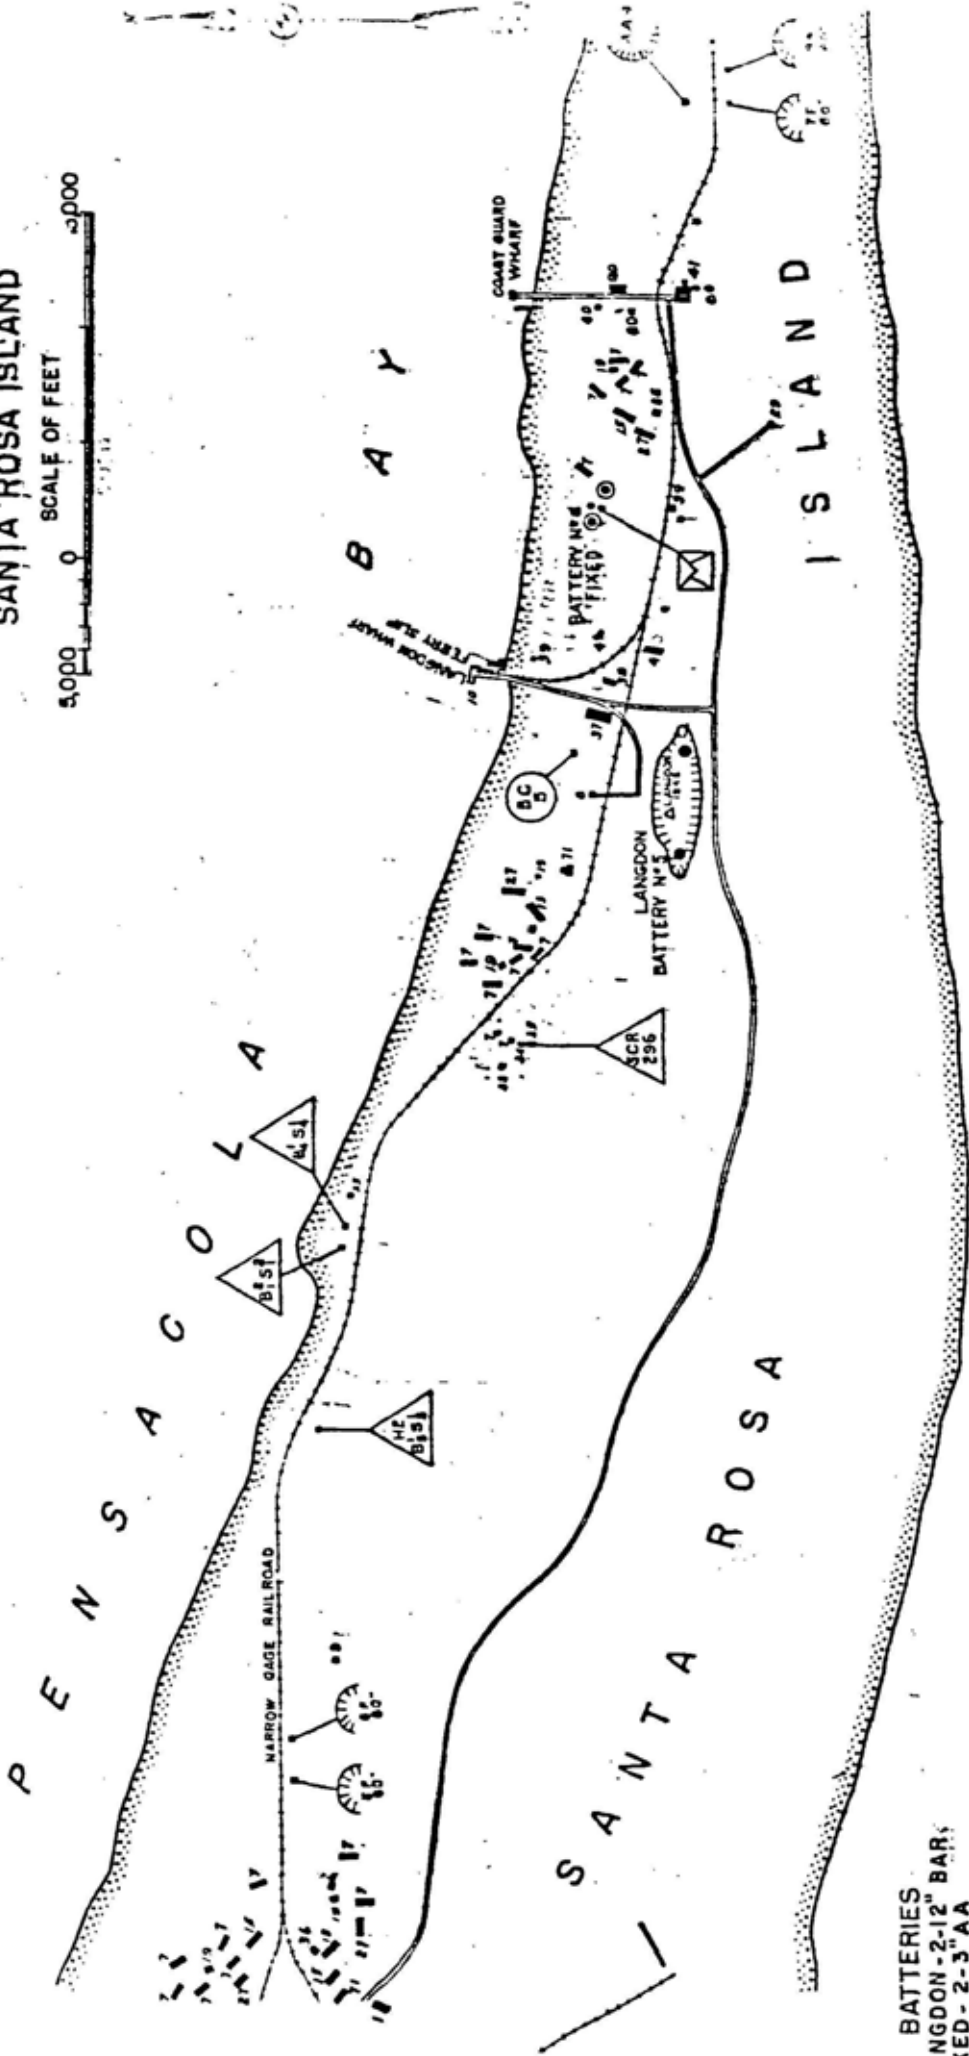
PENSACOLA HARBOR
FORT PICKENS - D2
SANTA ROSA ISLAND

BATTERIES
LANGDON - 2-12" BAR
FIXED - 2-3" AA

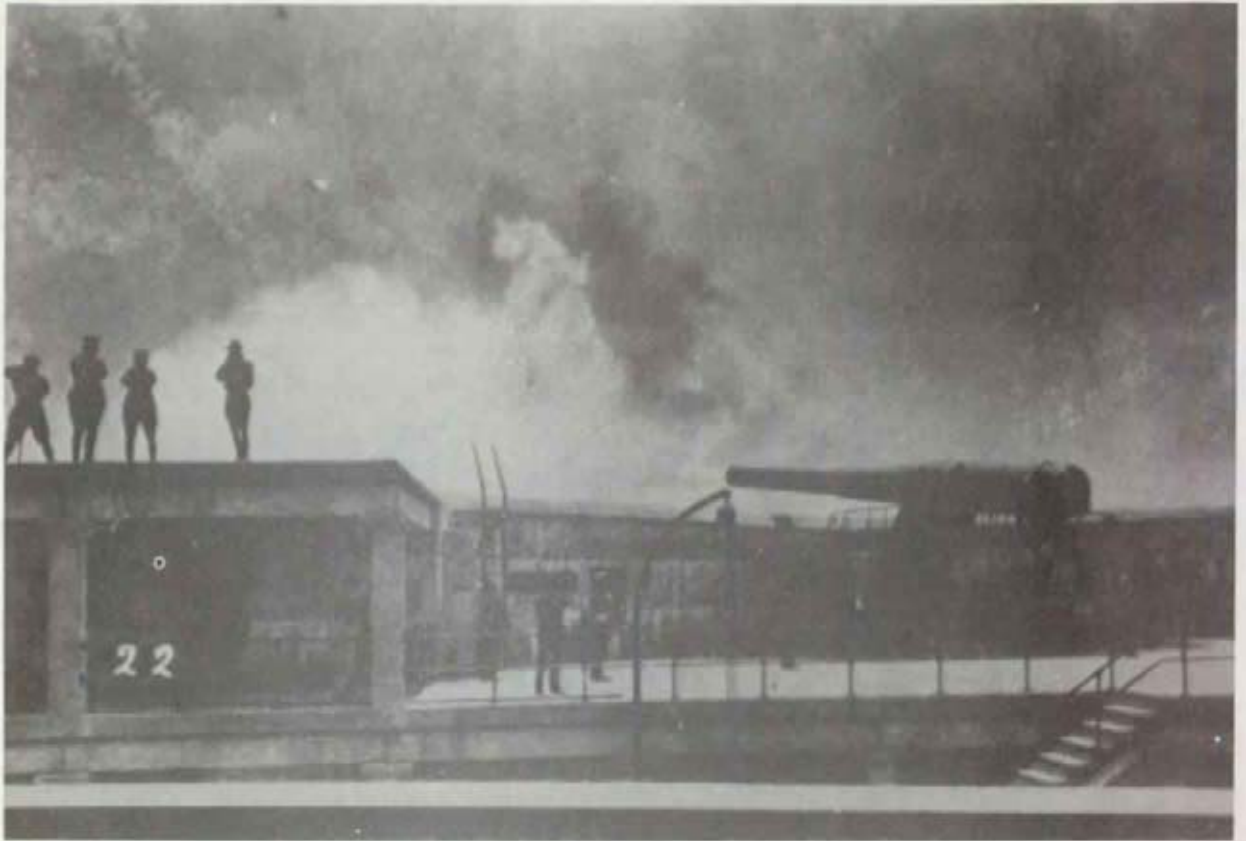
West 12-inch Disapperaing Rifle of Battery Pensacola Fires and Its Muzzle Blast Stirs up a Dust Storm, Circa 1920s.

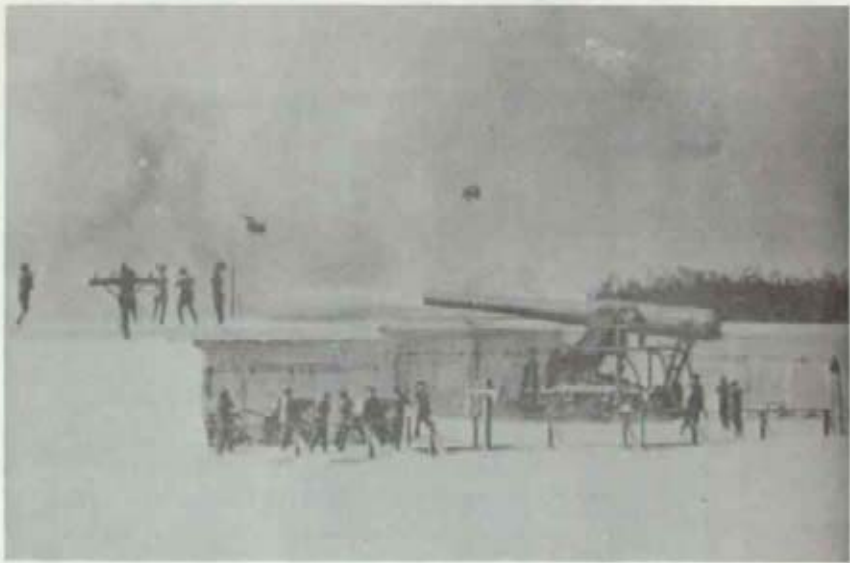
Illustration 6.

Loading West 12-inch Gun at Battery
Pensacola, Circa 1920s.

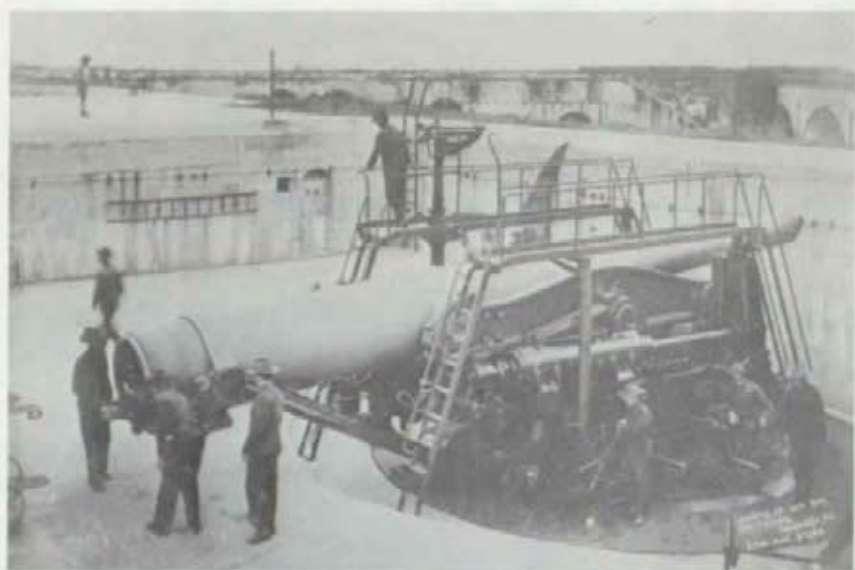
Battery Worth's Pit A Subsequent to
Removal of Two of Its 12-inch Mortars
in May 1918.

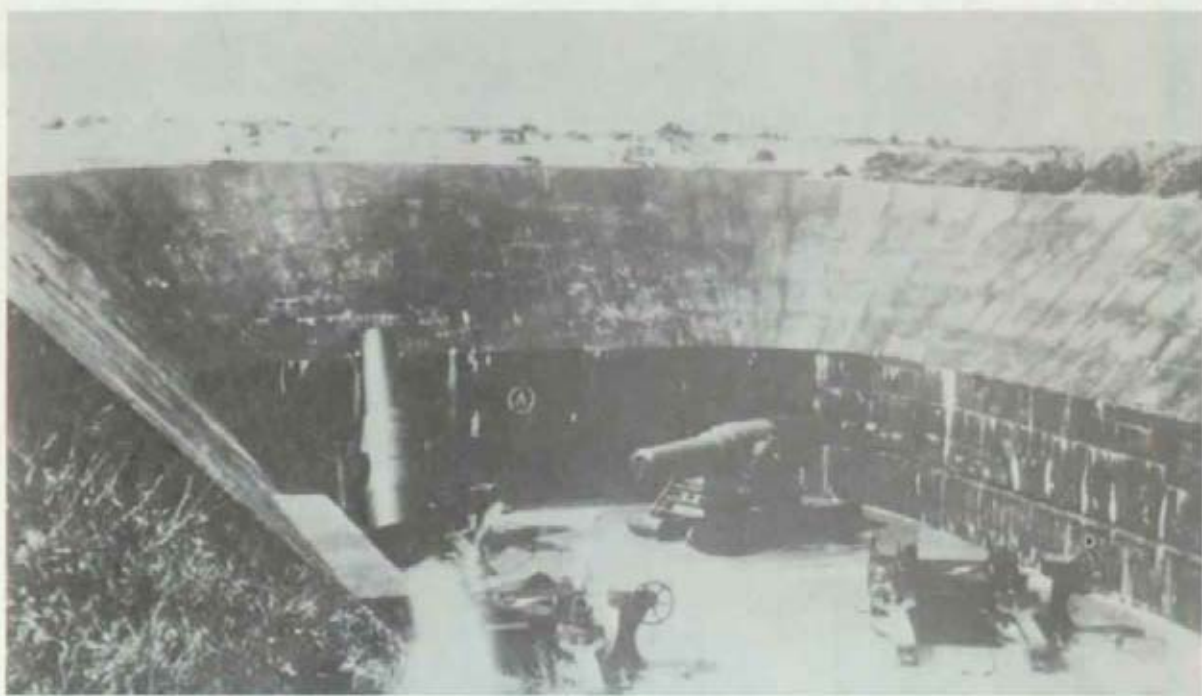
Illustration 8.

Two of Battery Worth's 12-inch
Mortars, Circa 1930s.

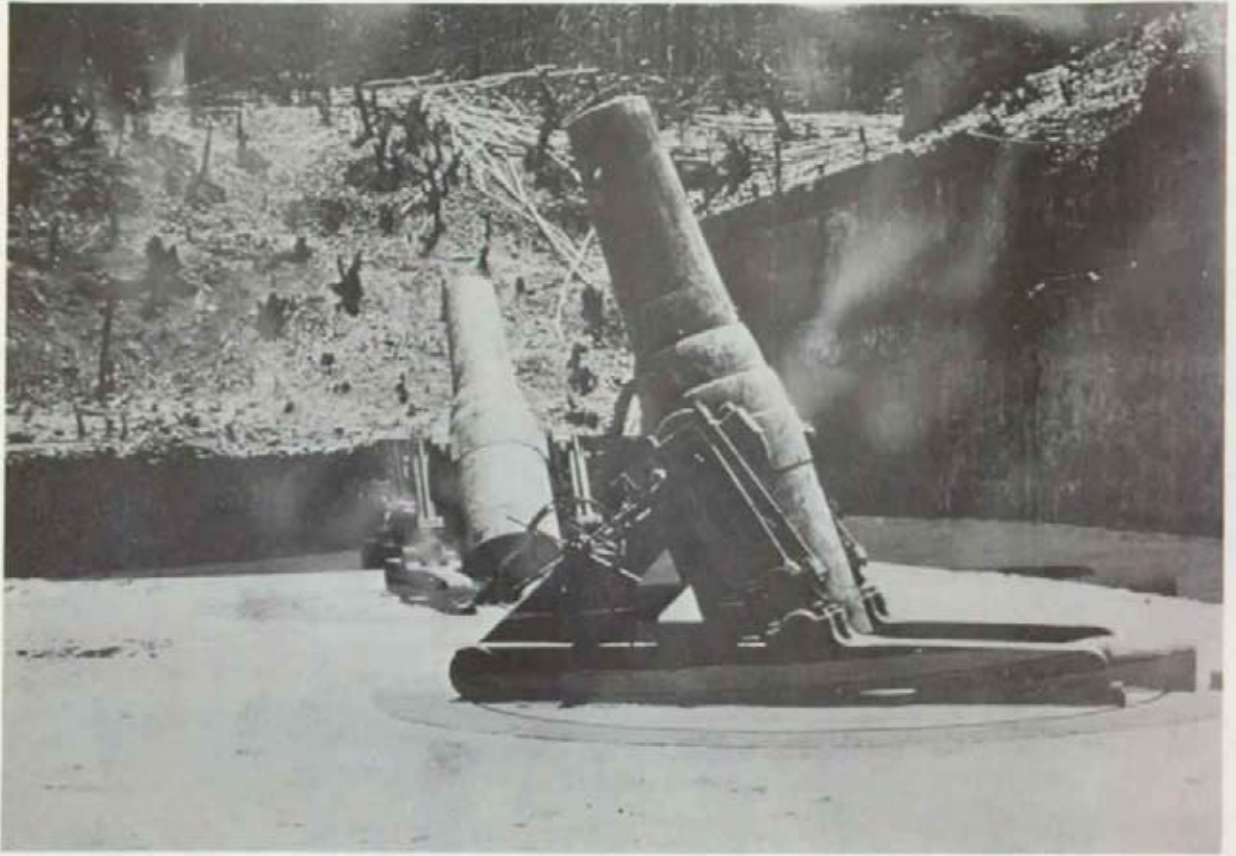
Battery Worth's Pit A. An Early 1920s
Firing Mission.

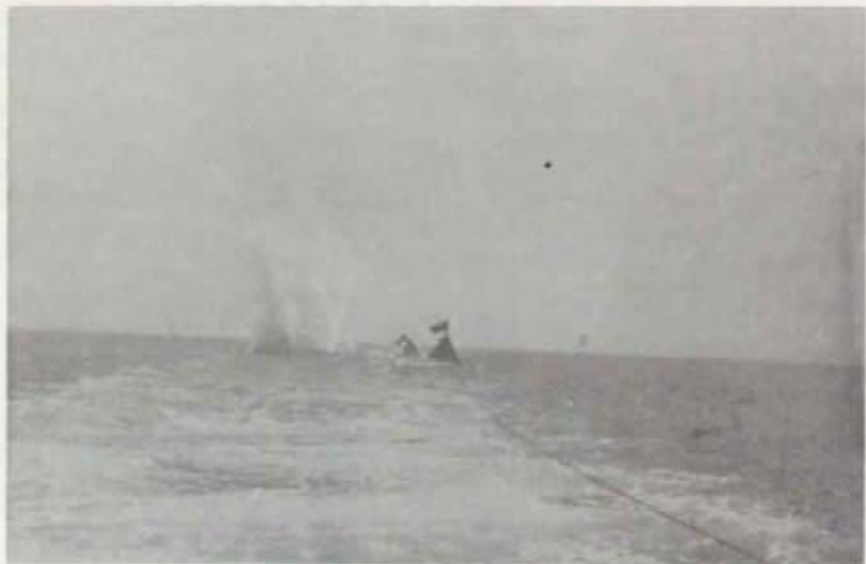
Illustration 18.

Towed Target, Showing Effect of
Hit by Big Caliber Shell, Circa
1930s.
