## MOLOKA'I LIGHT STATION HISTORIC RESOURCES REPORT

by William Chapman

Kalaupapa National Historical Park  
Moloka'i, Hawai'i  
November, 2001

REPORT NUMBER 101

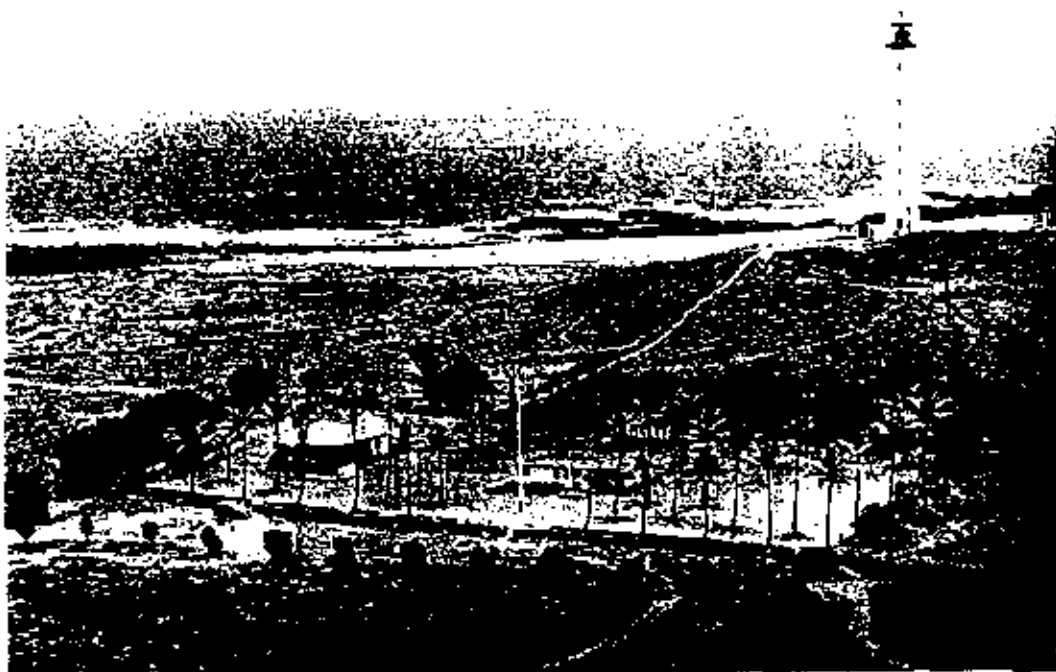
Figure 10. Aerial view, Keeper's compound and light station, 1956. U.S. Coast Guard Archives, Honolulu, Hawai'i.

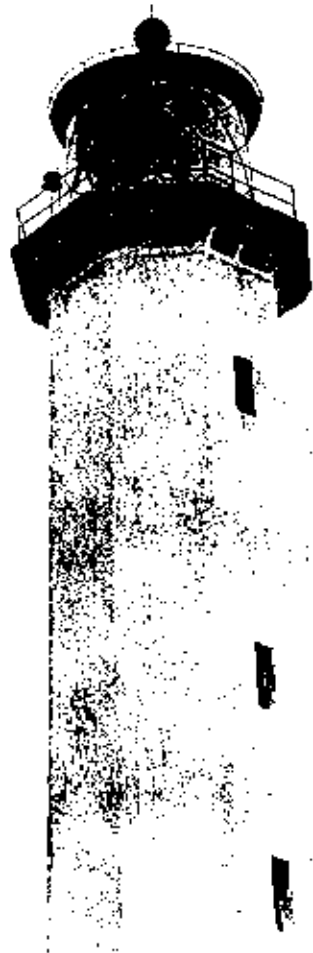
**Figure 17. Detail of tower and lantern, from northwest,  
1985, U.S. Coast Guard Archives, Honolulu, Hawai'i.**

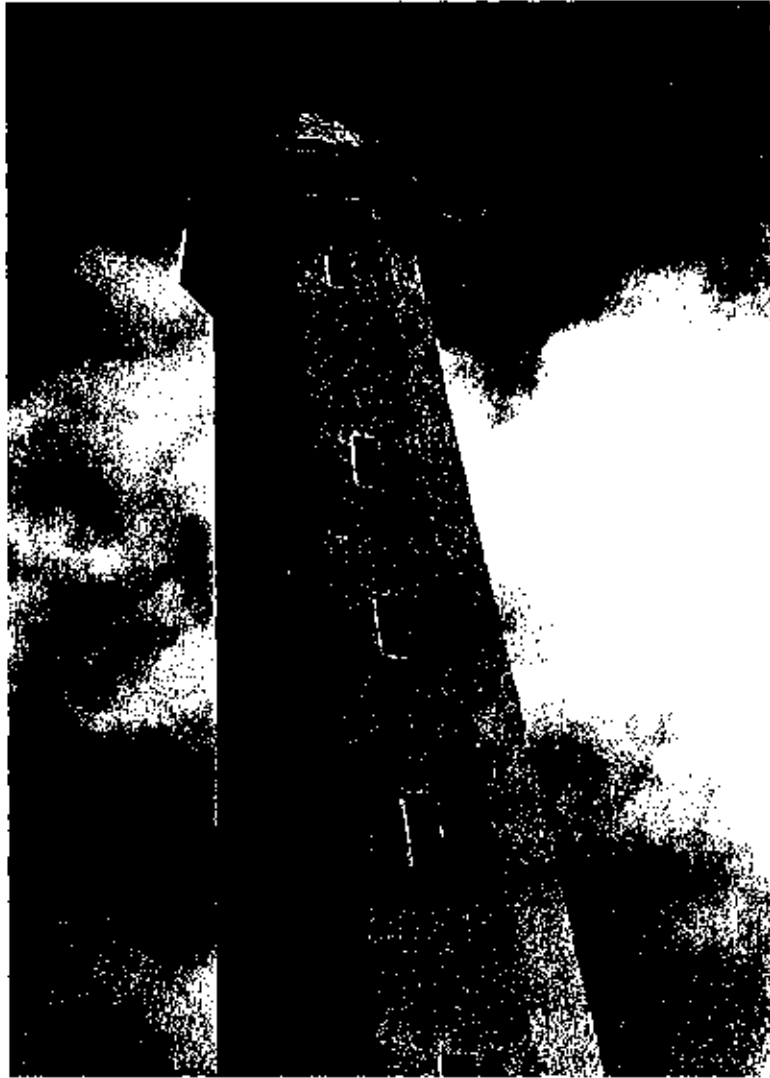
**Figure 27. Lighthouse tower (Feature 1), view from west, September, 1999. Photograph: William Chapman.**

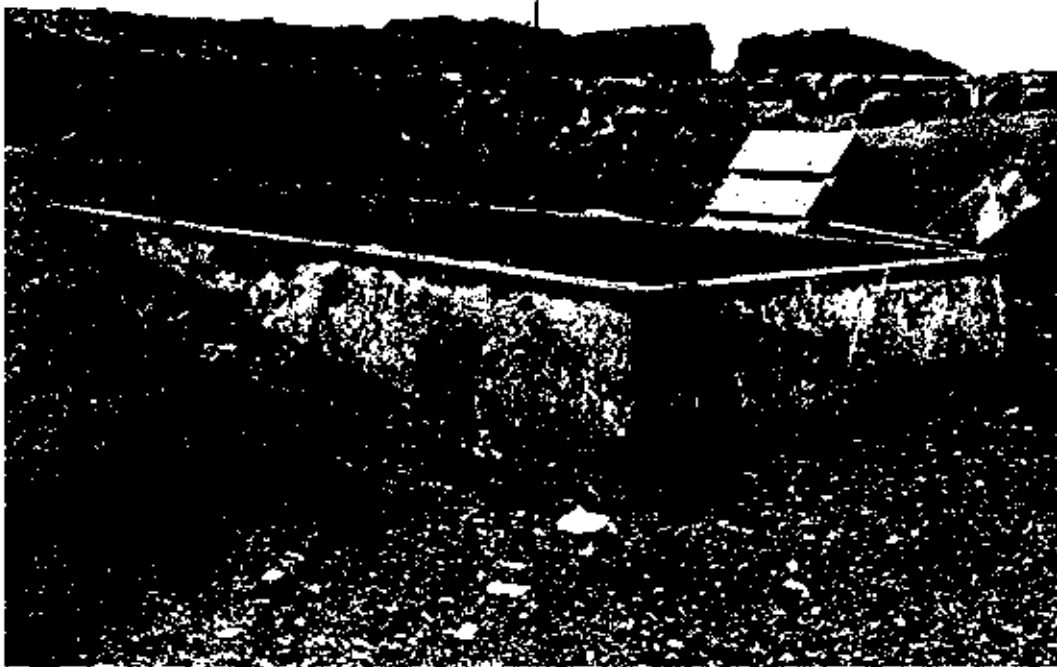
**Figure 29. Reinforced-concrete base of former oil-storage tank (Feature 2), from east, September, 1999. Photograph: William Chapman.**

Located about 15 ft south-southwest of the lighthouse tower base, this modest, reinforced concrete structure consists of a rectangular walled enclosure, containing four concrete cribs (or carriages or caissons), which historically carried a cylindrical, metal storage tank of a capacity of 1,954 gallons. Used to store fuel oil (kerosene) for the oil-fired lighting apparatus at the top of the lighthouse tower (and pumped by a hand-pump located on the ground floor of the tower to a second 25-gallon reservoir, or "receiving tank" in the tower's service room), the storage structure was a

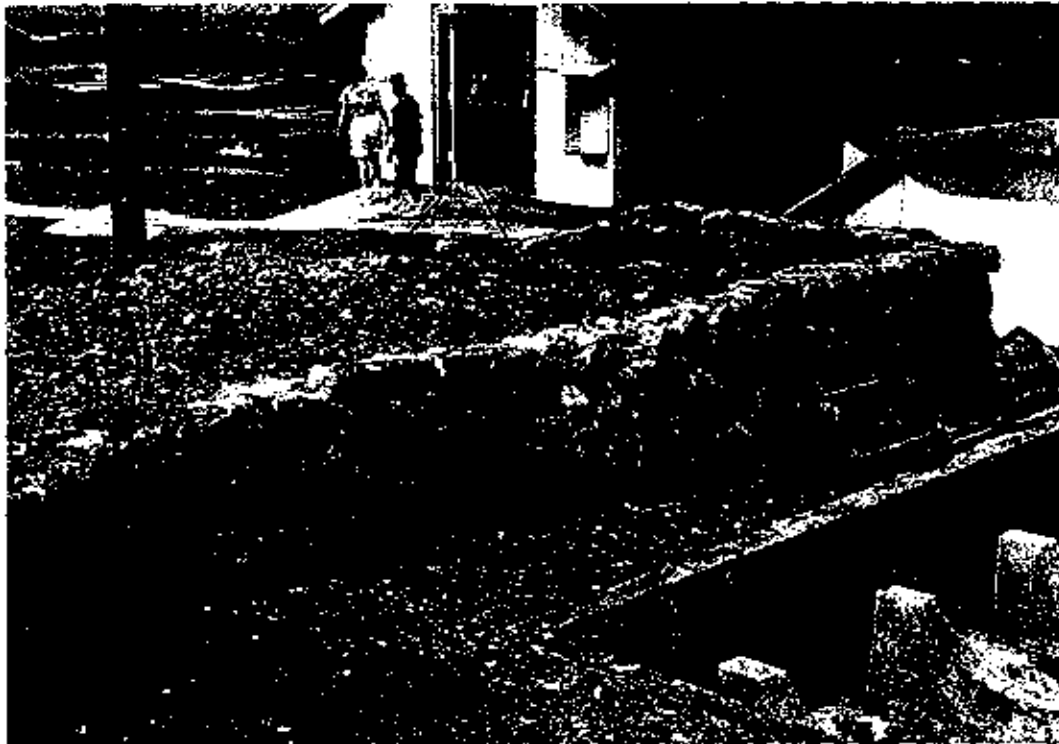
Figure 31. Retaining wall, vicinity of reinforced-concrete base of former oil-storage tank (Feature 2), from southeast, September, 1999. Photograph: William Chapman.

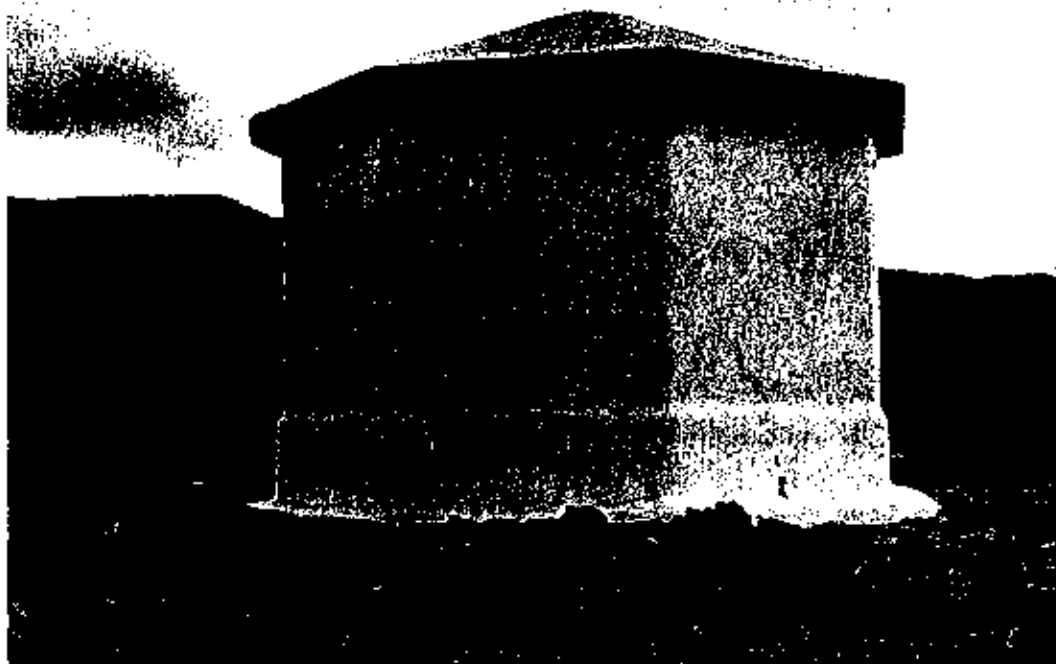
**Figure 33. Octagonal, reinforced-concrete water-storage tank (Feature 3), view from north, September, 1999. Photograph: William Chapman.**

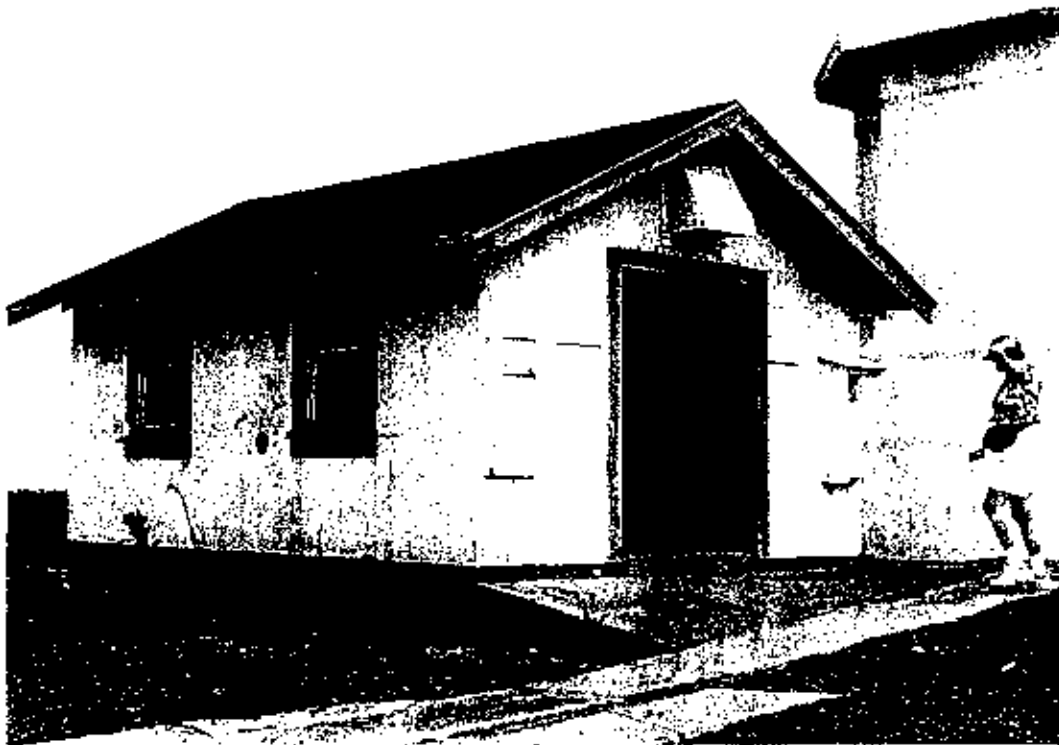
Figure 34. Wood-frame powerhouse (Feature 4), view from west, September, 1999.  
Photograph: William Chapman.

The exterior of the building is clad with 6 in (actually 5 ½ in) vertical siding. The cladding is exposed on the interior. The boards are tongue-and-groove Douglas fir, of the type common in Hawai'i during this period.

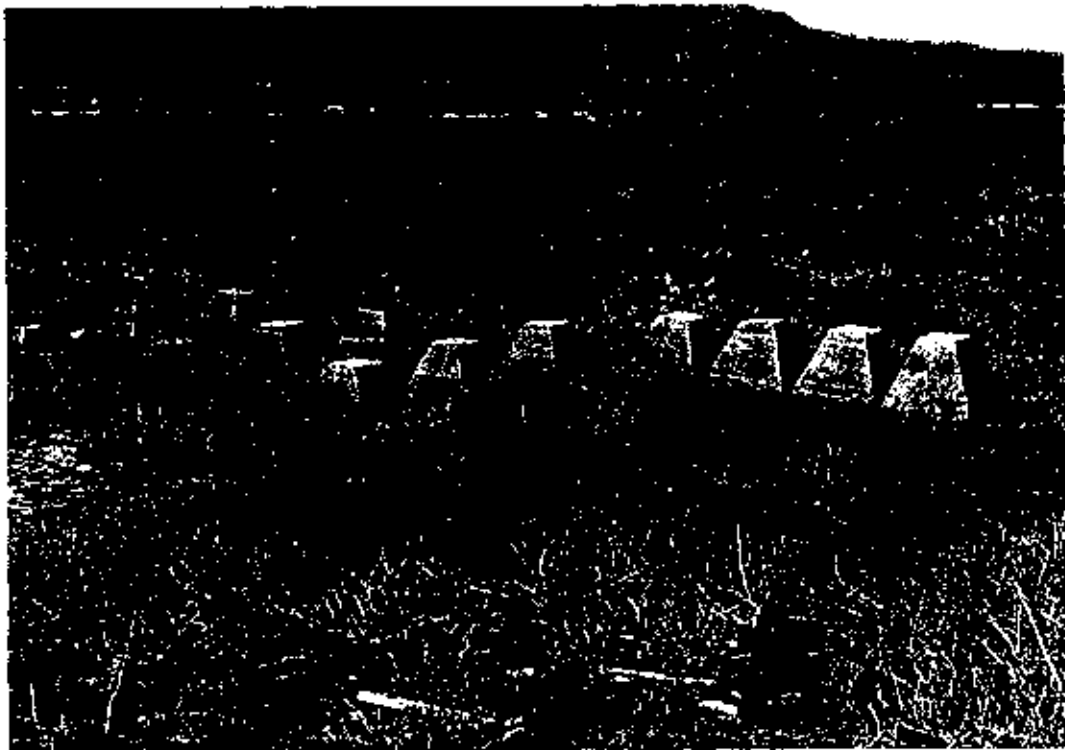
**Figure 37. Concrete pier supports for former oil-drum loading ramp (Feature 6), from northeast, September, 1999. Photograph: William Chapman.**

A plan of ca. 1950 indicates a broad "I"-shaped structure, with the stem pointing to the southeast. This plan and the present configuration of the piers and other remaining elements suggest that the ramp was inclined on the south side, and that the ramp led to a wood platform on the north.

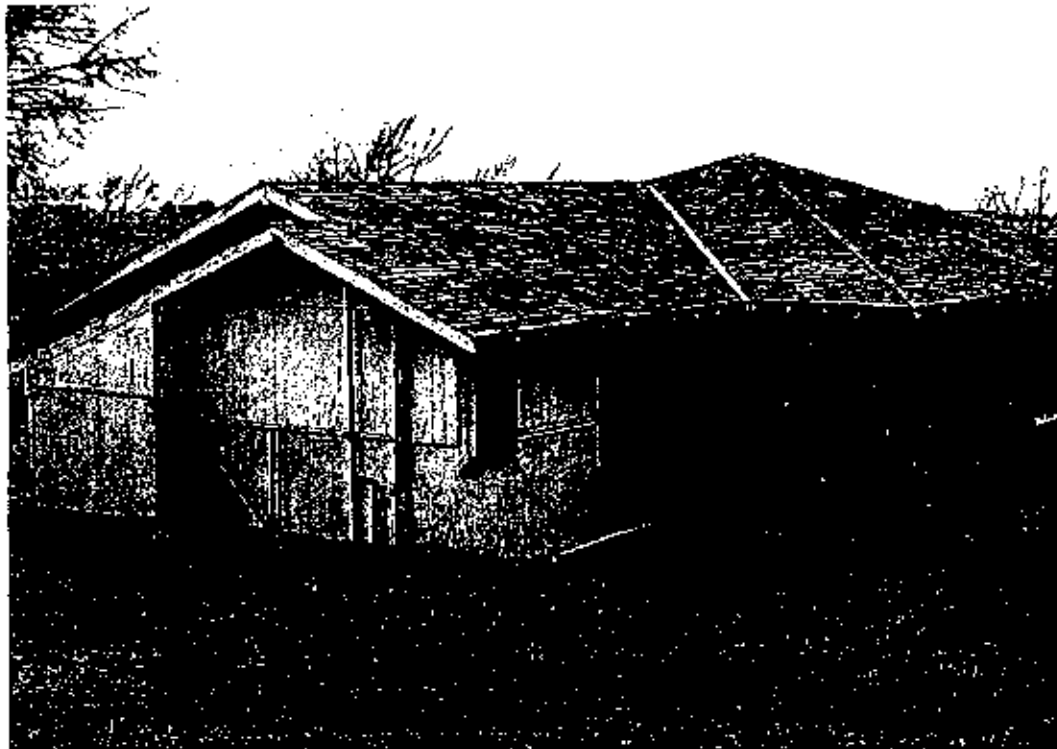
Figure 39. Stone, Principal Keeper's Residence (Feature 7), from west, September, 1999. Photograph: William Chapman.

**Figure 40. Stone, Principal Keeper's Residence (Feature 7), from east/northeast, September, 1999. Photograph: William Chapman.**

a recessed porch, on the west, and a smaller, wood-frame ell across the rear of the building, on the east. Overall dimensions for the hipped roof, one-story house are 30 ft by 30 ft for the stone section and 20 ft 5 in by 22 ft for the wood-frame ell. A small shed addition, measuring about 8 by 3 ft, projects from the southeast corner of the ell.

"U" -shaped in plan, the residence consists of a rectangular, masonry-walled main body, with

The entry porch floor is concrete and measures 14 by 8 ft 8 in area. The interior walls are rubble stone, matching the exterior. A single entry door is located in the middle of the rear porch wall. The opening measures 39 by 90 in and is fitted with a 35 by 84 in wood, three-panel door, the top panel of which is glazed. A concrete lintel, measuring 48 by 6 in spans the head of the entry door. The ceiling is beaded matchboard, with 1 ½ in wide strips. A later (ca. 1960) light fixture is placed in the middle of the ceiling, presumably a replacement of an earlier fixture.

The roof form is hipped for the main body of the building, with a cross-gable covering the rear ell. The rear of ell roof is also broken into two sections, creating a slightly different elevation on the south side from the north, where the eave is continuous with the north wall. The small shed addition, constructed of plywood, is also located at this end; this is either a modification of an earlier

The roofing material is modern, composition (asphalt) roofing. Earlier records and photographs suggest that the building was originally covered with light-colored asbestos shingles, since removed. The roof covering was replaced again in 2000 by a wood roof, substituting for the asphalt roof installed in the 1970s.

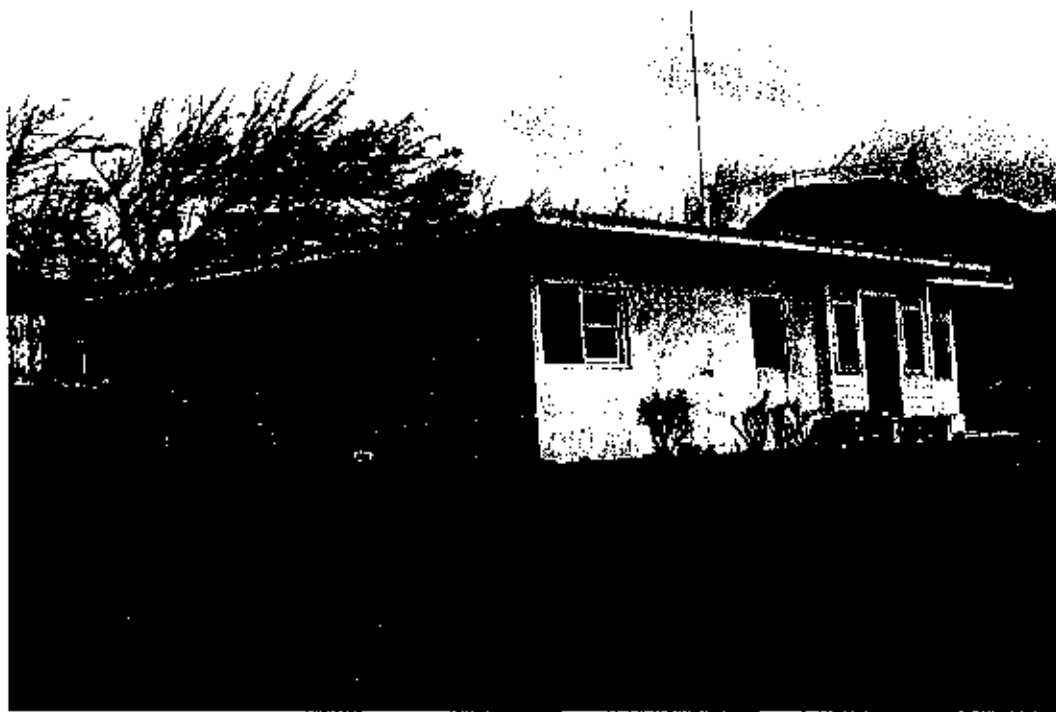
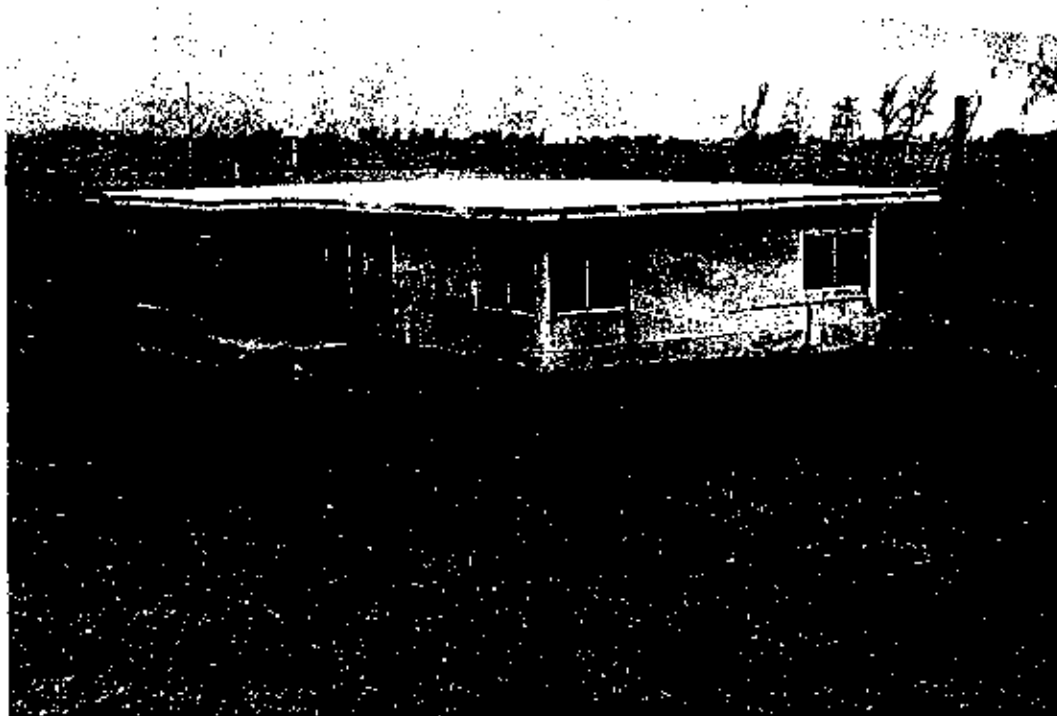
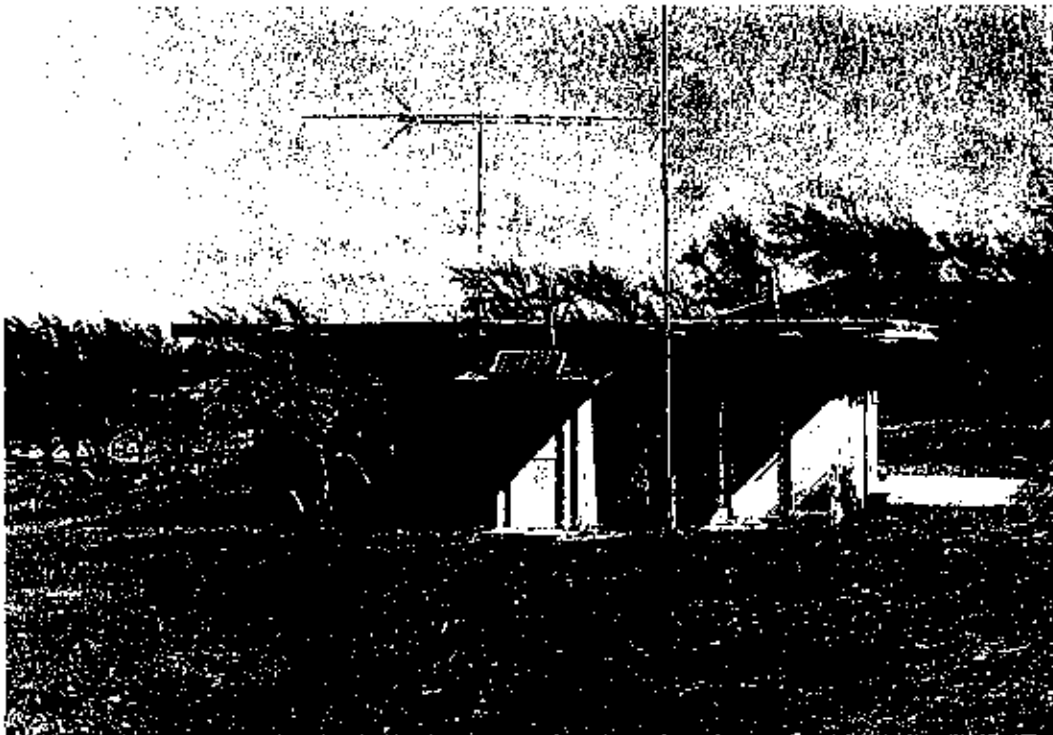
The First Assistant Keeper's Residence is a one-story, concrete-block, flat-roofed building located in the near middle of the historic keepers' compound. Measuring about 30 by 46 ft overall, the house sits on slightly sloping land, which rises toward the rear of the building. Extremely

**Figure 41. First Assistant Keeper's Residence, later Keeper's Residence (Feature 8), view from northwest, September, 1999. Photograph: William Chapman.**

**Figure 42. First Assistant Keeper's Residence, later Keeper's Residence (Feature 8), view from northeast, September, 1999. Photograph: William Chapman.**

Figure 43. First Assistant Keeper's Residence, later Keeper's Residence (Feature 8), view from south, September, 1999, Photograph: William Chapman.

utilitarian in style, the walls consist of white-painted, and unembellished concrete blocks sitting on a poured concrete foundation. The roof, which is constructed with wood rafters, is cantilevered about 3 ft from the surface of the wall. The eaves are boxed, with a fascia of about 6 in in width running around the building on all sides. The ends of the 2 x 6-in rafters are visible in the soffits. The edges of the roof have 3-in metal flashing; the roof covering is rolled roofing (asphalt), colored a bright white.

The interior of the building consists of a single, large and open living and dining area, encompassing the sun porch on the south; a kitchen and service area in the southeast corner; two bedrooms on the north side and a single bathroom. The floors are vinyl over concrete; the walls and ceilings are "celotex," wood or cane-fiber wall board, with 3/4 in wood moldings. The light fixtures and appliances are relatively modern, possibly dating to the construction period, but also possibly replacements of the 1960s or 1970s.

The exterior of the building includes concrete pads or landings on the east, near the entry, at the south outside the service door, and along the rear. That on the front measures about 10 by 1 ft; that on the south 4 by 4 ft; that on the rear, outside the rear door, also 4 by 4 ft. The rear of the building also includes a larger concrete pad, measuring about 16 by 8 ft and incorporating the older landing outside the rear service area. A few foundation plants still remain on the west side of the building, to the left of the entrance.

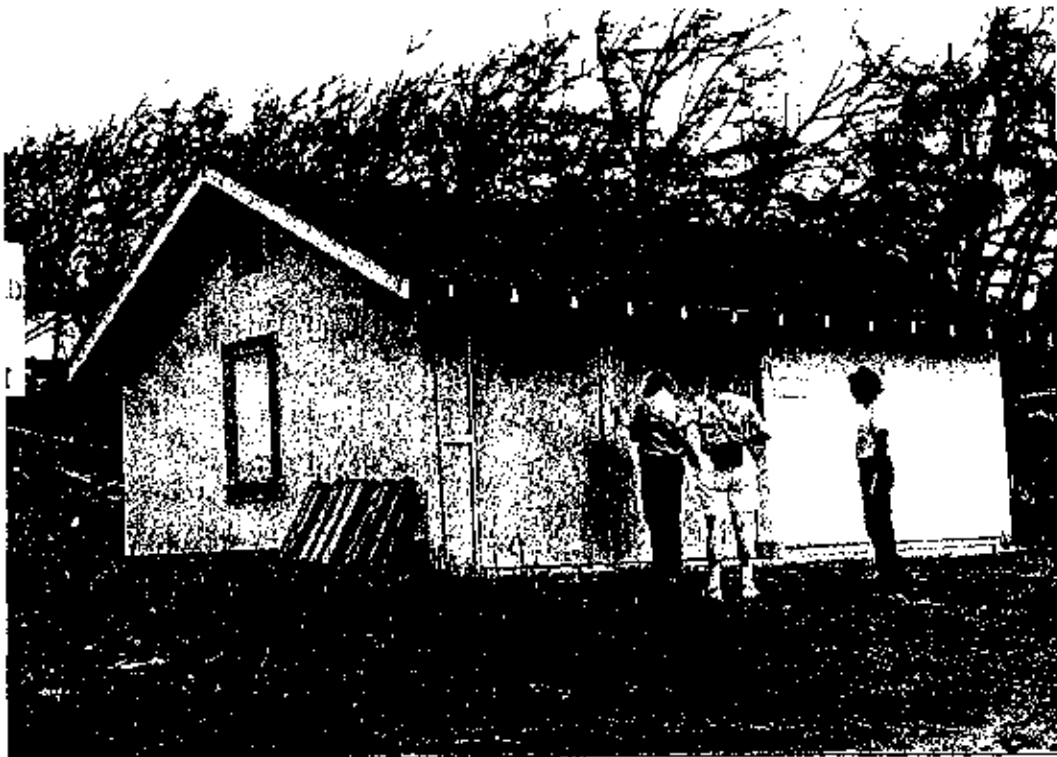
Figure 46. Wood-frame garage (Feature 10), from northwest, September, 1999.  
Photograph: William Chapman.

The simple, rectangular structure measures 17 ft 3 in by 25 ft 2 in. It is oriented roughly north and south, following the longitudinal ridge of the gabled-roof. Placed on a concrete foundation and slab, which extends 14 in above grade on the west and 6 in above grade on the east, the building has a simple 2 x 4-in frame construction and is sheathed in 5-in wide tongue-and-groove vertical boards.

The wood-frame garage is a historic and contributing feature of the Moloka'i Light Station, added around 1920 to house the station's half-ton Ford truck. No specific records of the construction of the building have been found, although it was clearly on the site as of 1927 when a detailed inventory of the station was completed. Similarly, no record could be found of when the first motorized vehicle was brought to the station. While the first motorized trucks came into being in 1896, Ford's popular model became available only after World War I. It is likely that the station acquired a truck around this time, after 1918.

The site is relatively free of overgrowth or debris. A small rubble retaining wall is visible along the rear of the building, about 4 ft from the foundation. This holds back the hill rising to the rear and was probably added at the time of the building's construction.

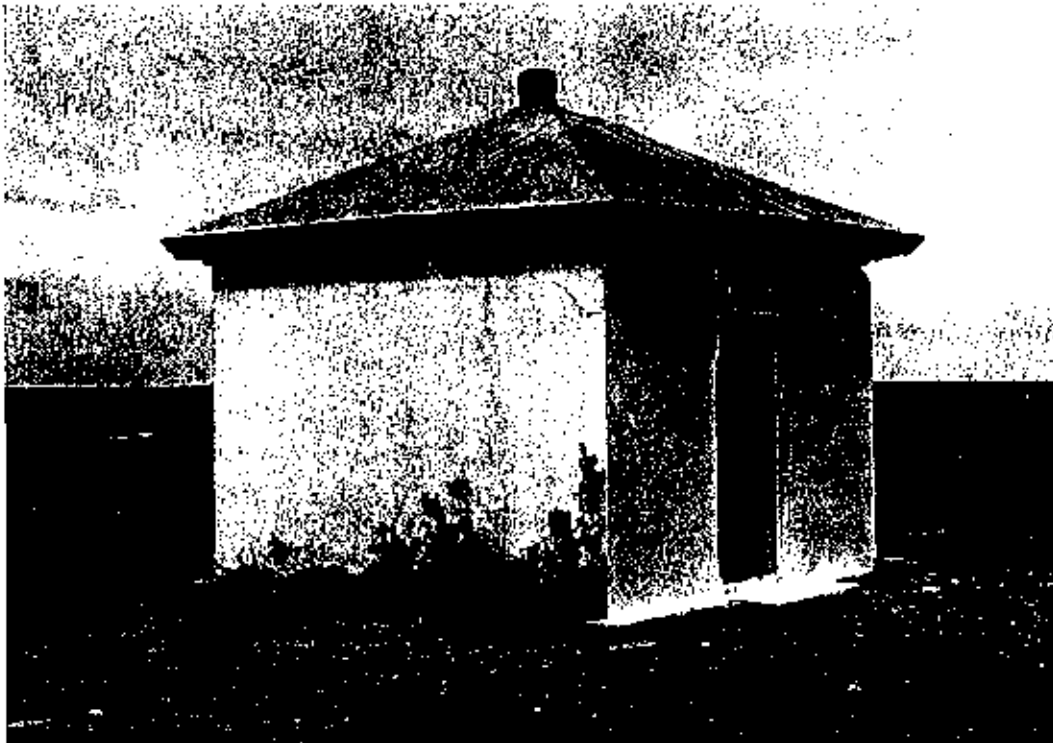
Figure 47. Oil-storage building (Feature 11), view from tower looking north, September, 1999. Photograph: William Chapman.

Figure 48. Oil-storage building (Feature 11), view from south, September, 1999.  
Photograph: William Chapman.

The oil storage building was constructed as part of the original lighthouse station as a place to store the oil (kerosene) used to fuel the lamp of the light signal. Because the material was combustible, the decision was made to store the oil away from the keepers' quarters and the light

itself. However, almost as soon as the light was completed, or even before it was completed, a second oil storage facility was constructed next to the light house, where it could be pumped directly to the lamp by the keepers. Historical records suggest this oil house became a secondary storage building and at a later date became a storage building for other hazardous materials as well.

The roof of the building is about 6 in thick and made up of red-painted, reinforced concrete. The outer edge of the roof projects about 8 in from the wall and includes a decorative, square molding and drip mold. The roof has several cracks, showing evidence of rusted reinforcing bars.

The interior of the building is stark and empty. The floor is concrete, now covered with debris, including spalled concrete from the interior walls and roof. The walls are fitted with a pattern of 2 x 3 in wood blocks set in the wall surface in a grid pattern, nine per side. These appear to be nailing

blocks, possibly intended to aid in the installation of shelving or an interior wall of some kind. The walls and ceiling show much evidence of cracking, due largely to the rusting of iron reinforcing bars. A noticeable horizontal crack cuts across both the interior and exterior about 1 ft below the level of the wall plate.

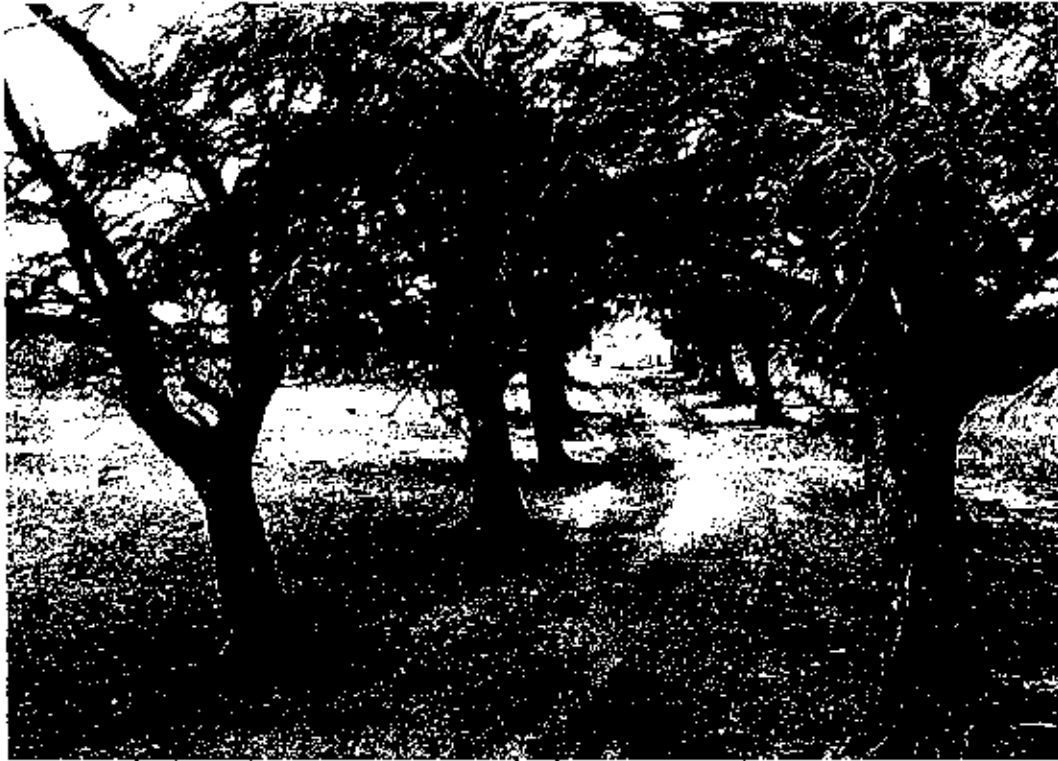
**Figure 51. Principal access road and Ironwood trees (Features 13 and 19), view looking west/northwest, September, 1999. Photograph: William Chapman.**

The road as nominated to the National Register extends from the northwest edge of the plot in a southeasterly direction, then curves toward the south in a wide arc ending at a point in front of and parallel to the west wall of the keepers' compound for a distance of about 700 ft. Just to the north and west of the keepers' compound the road splits, with one branch going eastward toward the lighthouse tower, then southward to the rear of the keepers' compound.

The road is gravel surfaced and graded. It appears to follow its historic route.
