**MELROSE ESTATE
NATCHEZ NATIONAL HISTORICAL PARK**

NATCHEZ, MISSISSIPPI

**HISTORIC STRUCTURES REPORT
VOLUME III
APPENDIX**

ANN BEHA ASSOCIATES

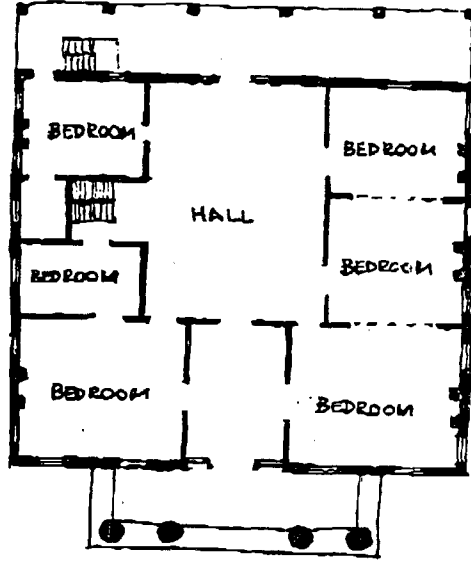
Second floor

Plans of Melrose
Natchez, Mississippi

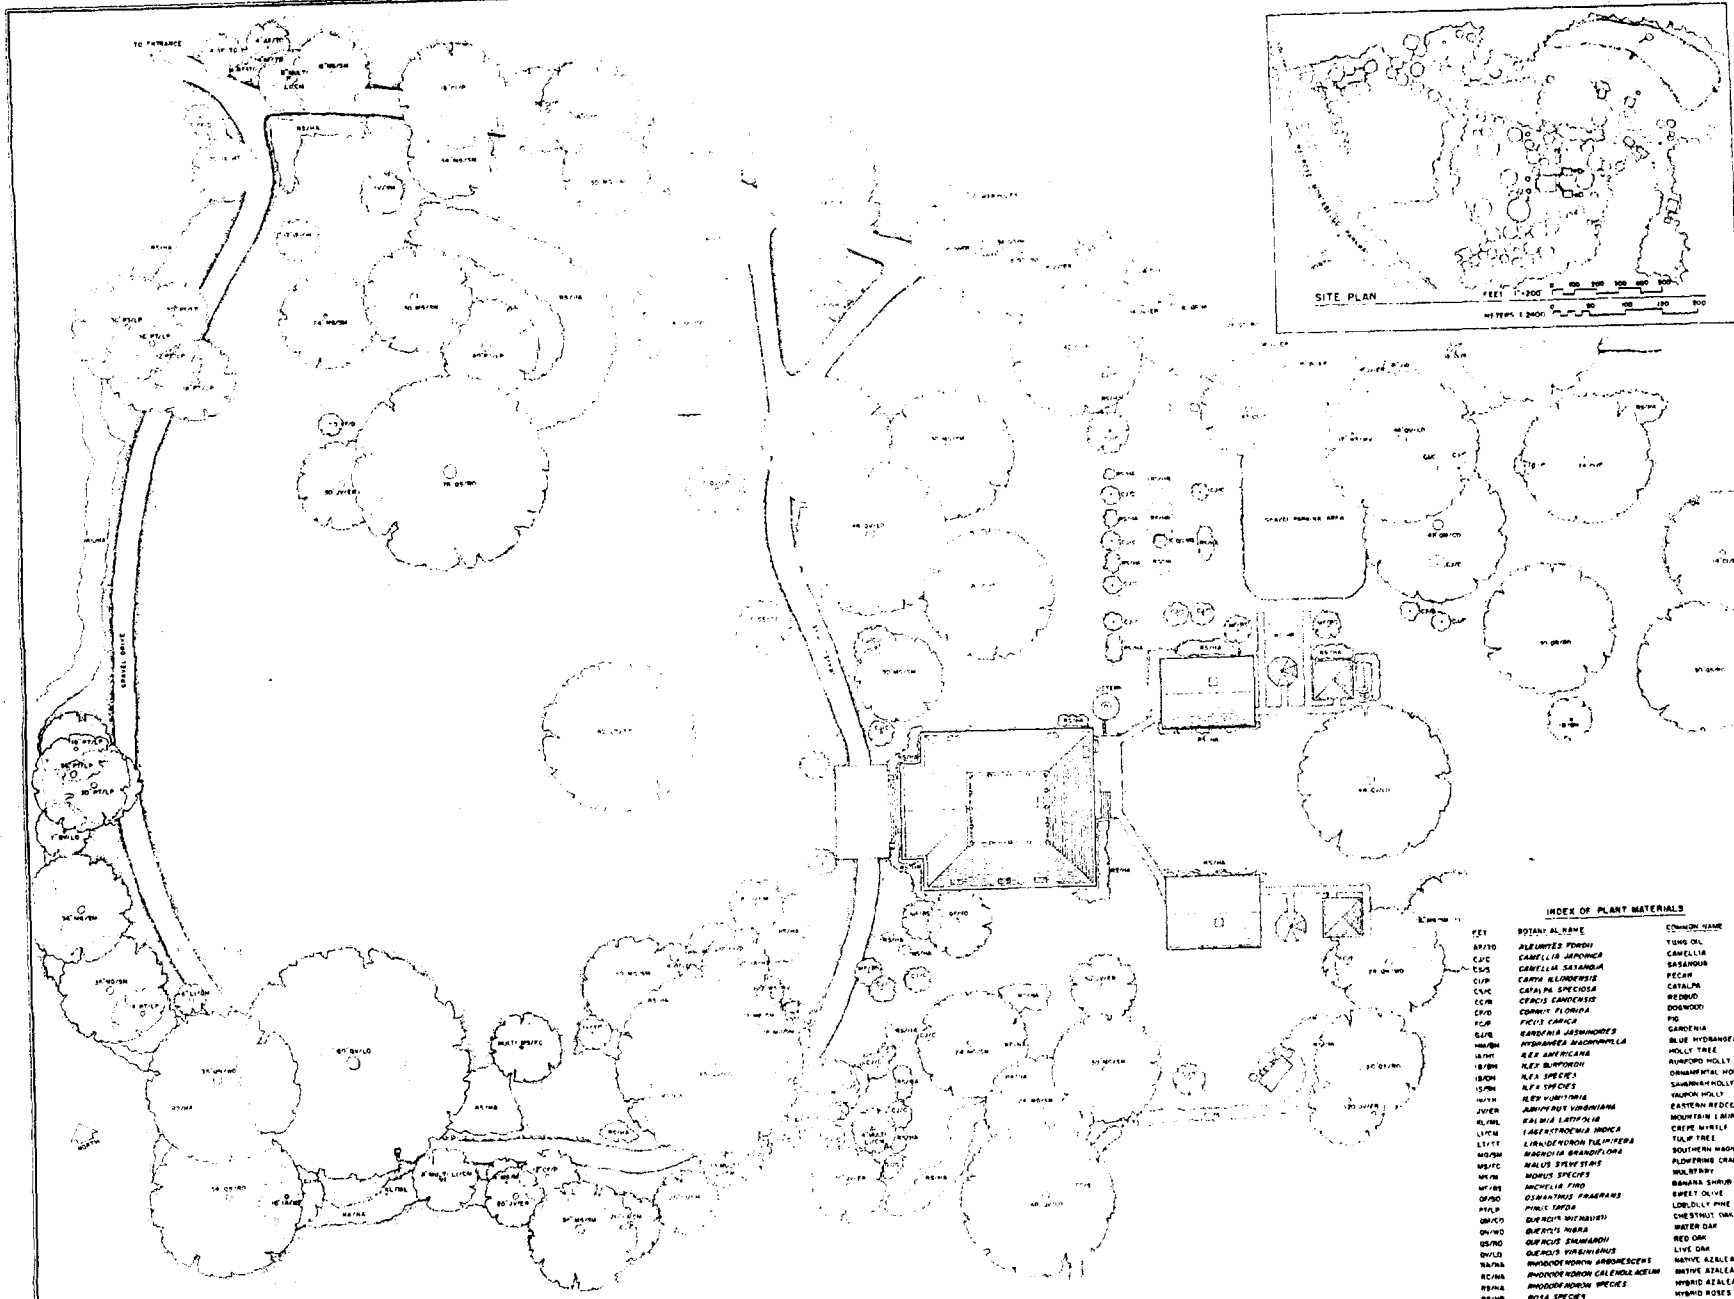
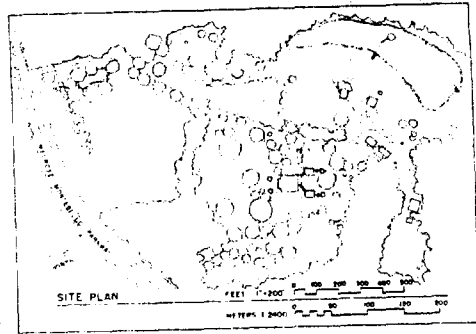
SITE PLAN
 FEET 1" = 20'
 METERS 1:200

SITE PLANS ADAPTED FROM TOPOGRAPHIC MAPS 1076 AND 1077 BY JORDAN, WATER AND SEXTONS, CIVIL ENGINEERS.
 SITE PLANS BY WILLIAM GARDNER & BONDAREFF ARCHITECT AND FIELD PHOTO DATA

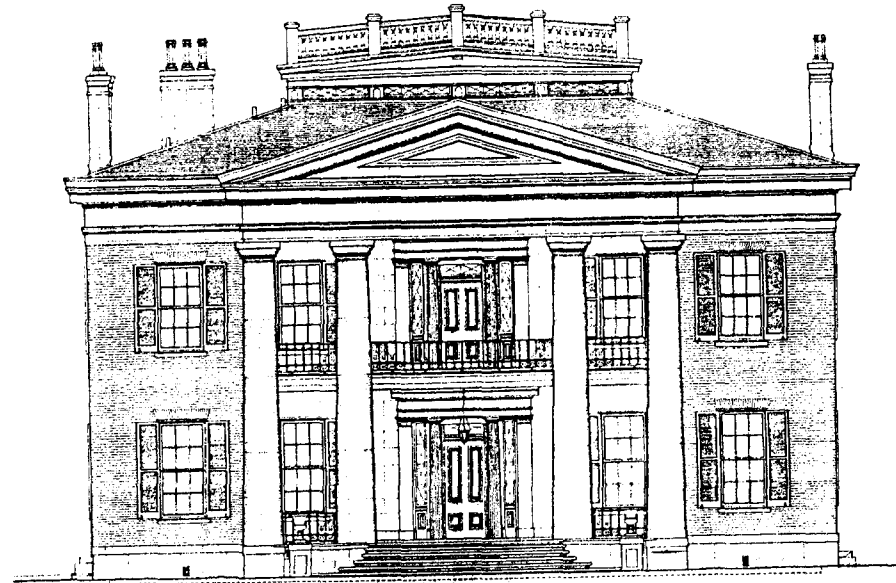
NORTHWEST ELEVATION

MATERIALS
 FOUNDATION BRICK
 WALLS STUCCO ON BRICK AND BRICK
 COLUMNS STUCCO ON BRICK
 ROOFING SLATE SHINGLES

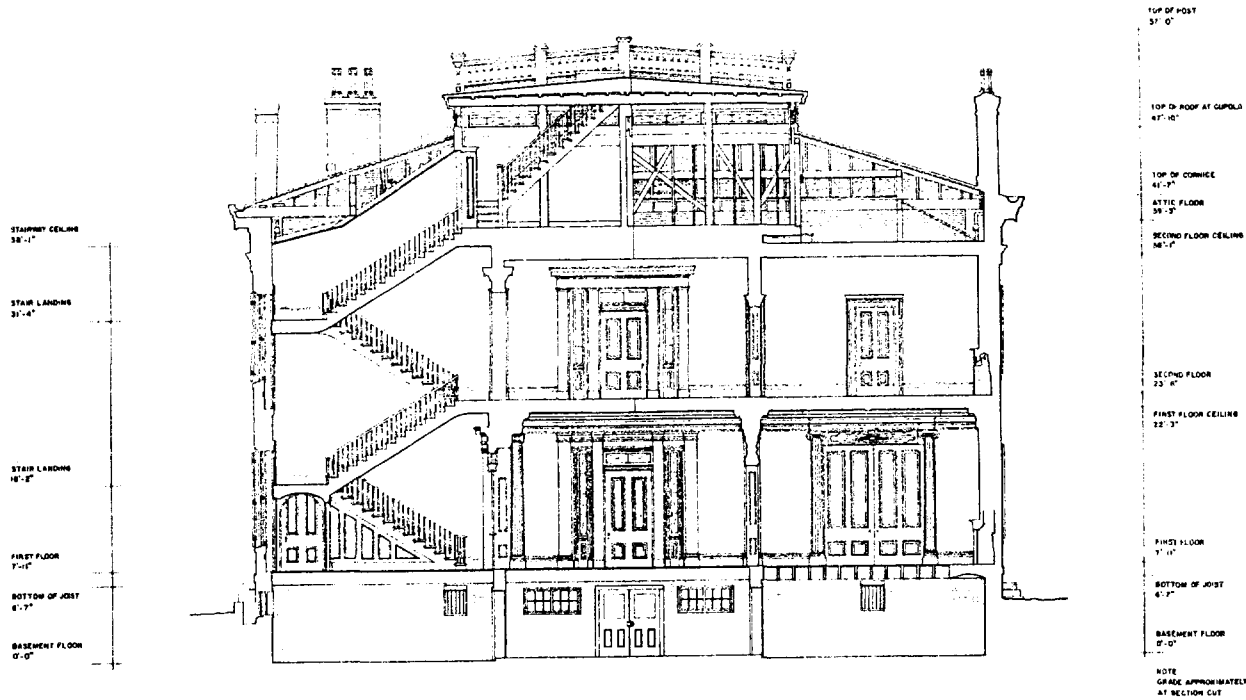
STAIRWAY CEILING
38'-4"

STAIR LANDING
31'-4"

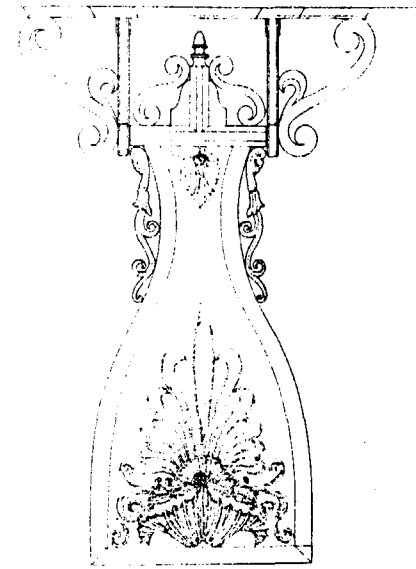
CAST-IRON MANTLEPIECE

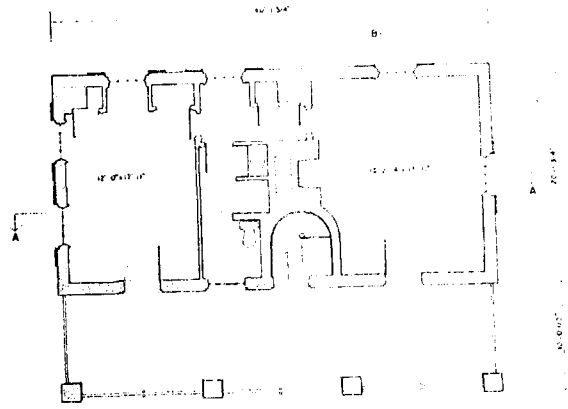
SECOND FLOOR PLAN

MATERIALS
FLOORS RANDOM WIDTH WOODEN BOARDS
WALLS PLASTER
CEILING PLASTER

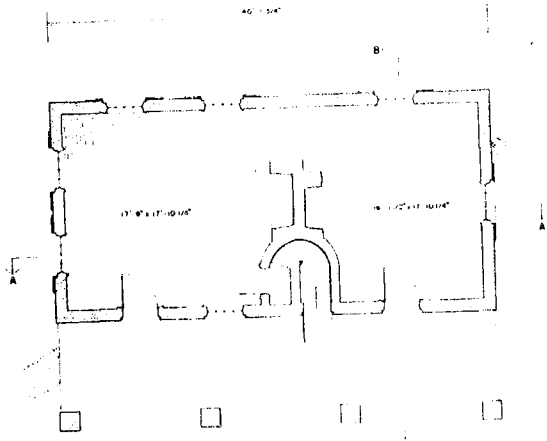
FIRST FLOOR PLAN

MATERIALS
FLOORS CURVED AND WOODEN BOARDS
WALLS LADDER
CEILING PLASTER

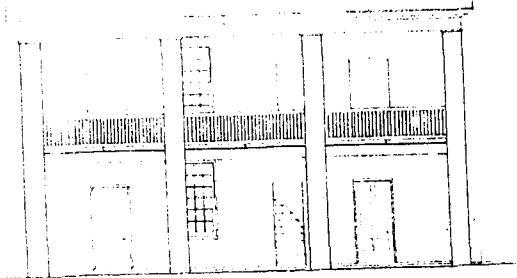
SOUTHEAST ELEVATION

MATERIALS
FOUNDATION BRICK
WALLS STUCCO OVER BRICK
ROOFING METAL

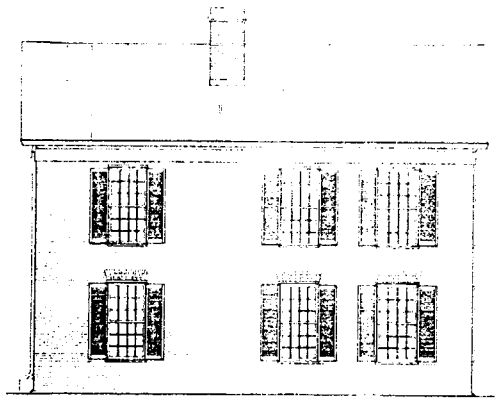
NORTHEAST ELEVATION

MATERIALS
FOUNDATION
WALLS
ROOFING

BRICK
METAL

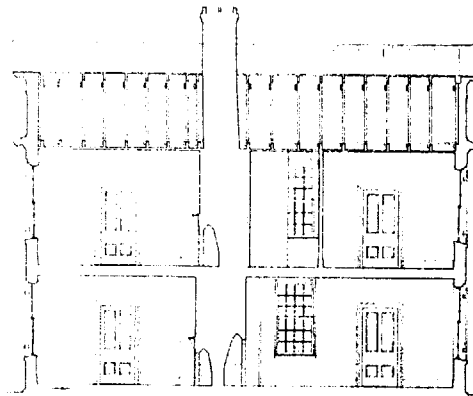
SECTION A-A

MATERIALS
FLOORS
WALLS
CEILING

FIRST FLOOR CEILING
8'-10 3/4"

FIRST FLOOR
0'-0"

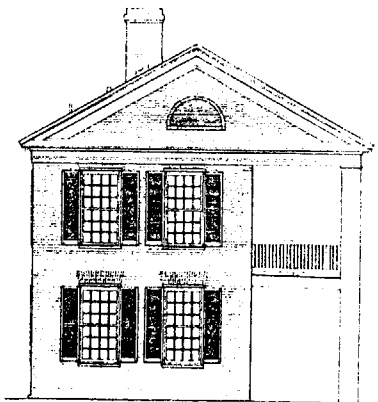
NORTHWEST ELEVATION

MATERIALS
FOUNDATION
WALLS
COLUMNS
ROOFING

BRICK
STONE AND BRICK
METAL

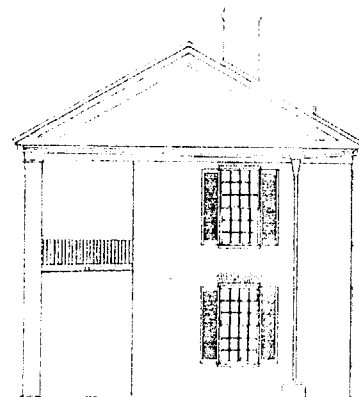
SOUTHEAST ELEVATION

MATERIALS
FOUNDATION
WALLS
COLUMNS
ROOFING

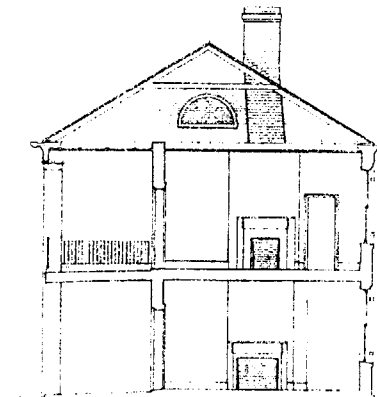
SECTION B-B

MATERIALS
FLOORS
WALLS
CEILING

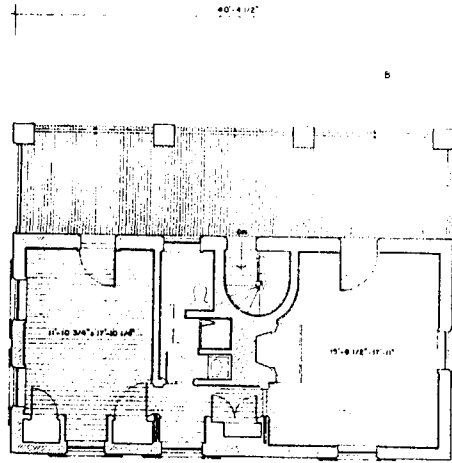
SECOND FLOOR PLAN

MATERIALS
FLOORING RANDOM WIDTH WOOD PARQUET
WALLS PLASTER
CEILING PLASTER

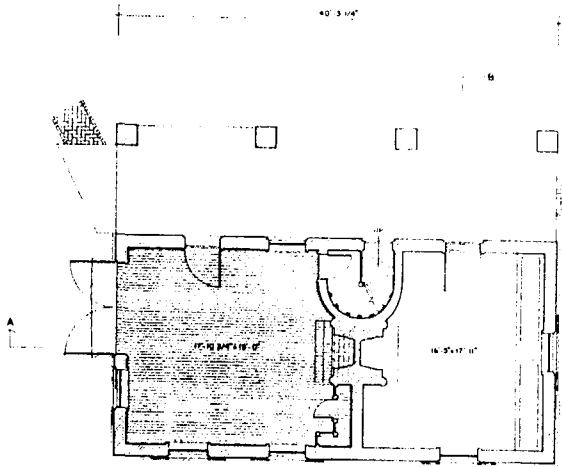
FIRST FLOOR PLAN

MATERIALS
FLOORING CONCRETE AND WOODEN BOARD
WALLS PLASTER
CEILING PLASTER

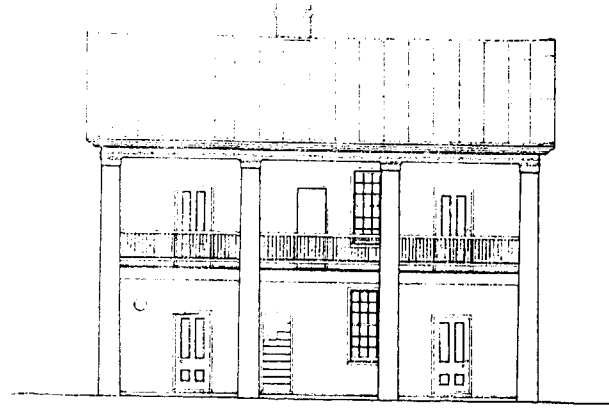
NORTHEAST ELEVATION

MATERIALS
FOUNDATION BRICK
WALLS STUCCO OVER BRICK
ROOFING METAL

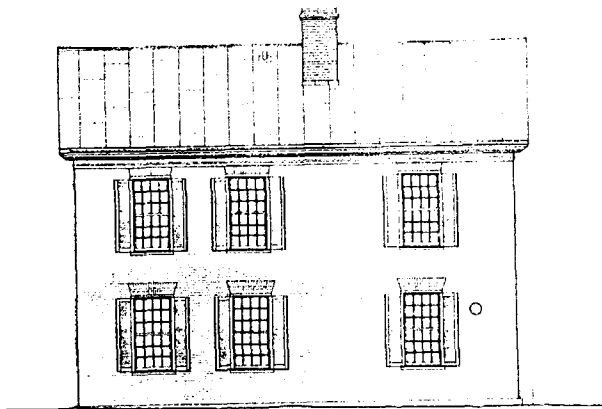
SOUTHWEST ELEVATION

MATERIALS
FOUNDATION BRICK
WALLS BRICK
ROOFING METAL

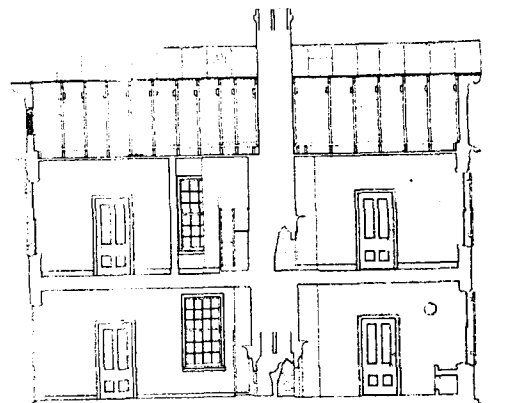
SECTION A-A

MATERIALS
FLOORS LAMINATE AND WOODEN BOARD
WALLS PLASTER
CEILING PLASTER

ROOF 22' 0"
SECOND FLOOR CEILING 22' 0"
SECOND FLOOR 11' 0"
FIRST FLOOR CEILING 10' 3 1/4"
FIRST FLOOR 0' 0"

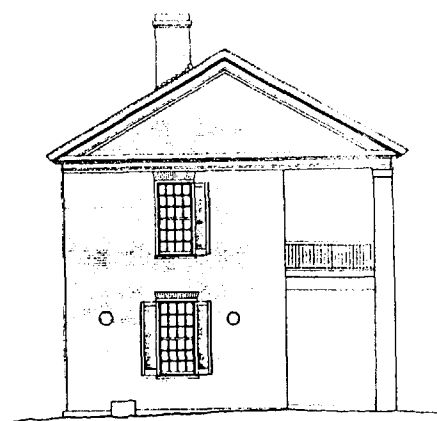
SOUTHEAST ELEVATION

MATERIALS
FOUNDATION BRICK
WALLS BRICK
COLUMNS BRICK
ROOFING METAL

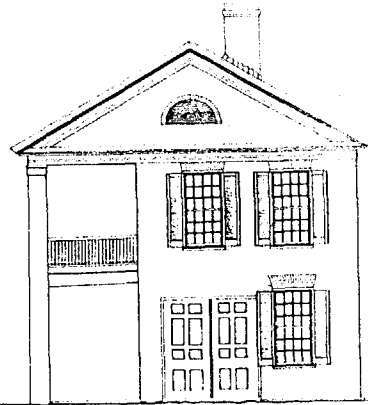
NORTHWEST ELEVATION

MATERIALS
FOUNDATION BRICK
WALLS BRICK
COLUMNS BRICK
ROOFING METAL

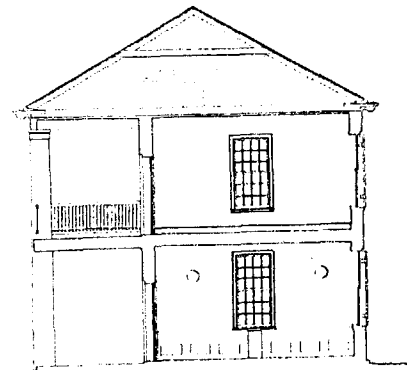
SECTION B-B

MATERIALS
FLOORS CONCRETE AND WOODEN BOARD
WALLS PLASTER
CEILING PLASTER

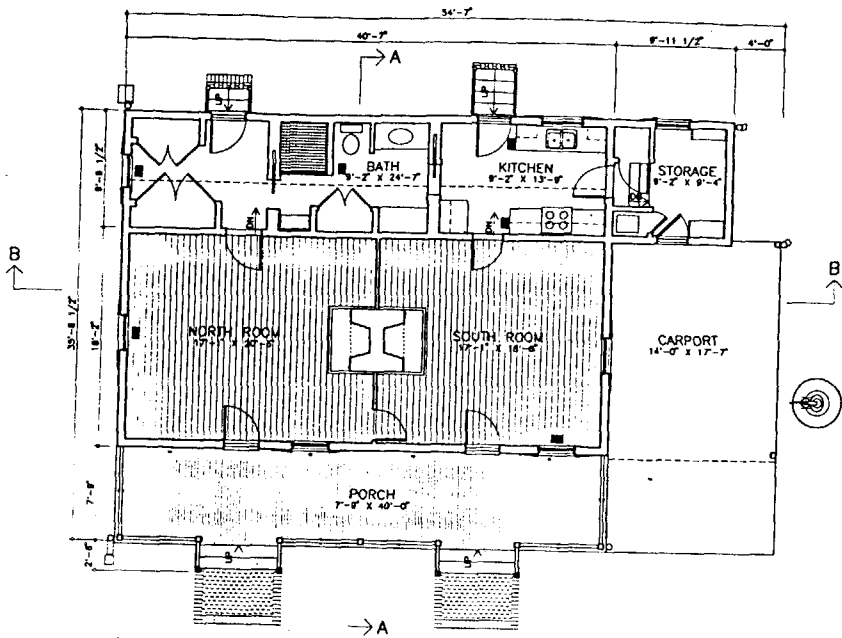
FIRST FLOOR PLAN

MATERIALS
 FLOOR: WOOD, CARPET, LINOLEUM, TILE
 WALLS: PLASTER
 CEILING: PLASTER

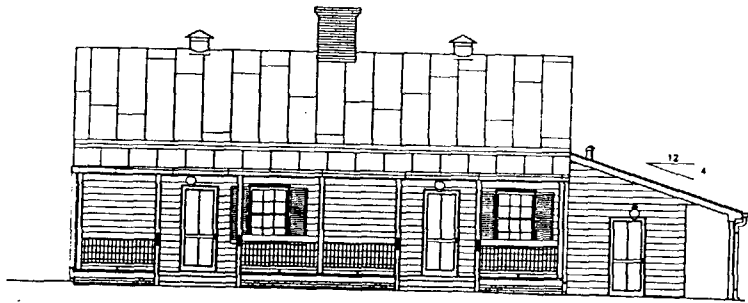
WEST ELEVATION

MATERIALS
 FOUNDATION: BRICK, CONCRETE & CONCRETE BLOCK
 WALLS: WOOD SIDING
 ROOFING: TIN

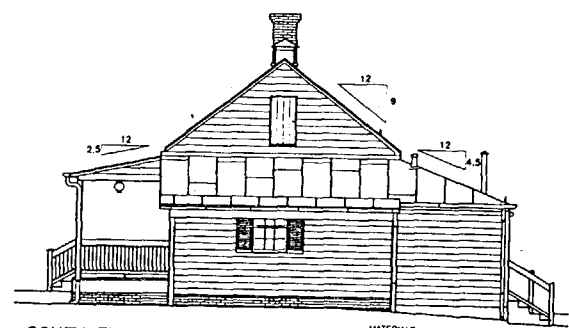
SOUTH ELEVATION

MATERIALS
 FOUNDATION: BRICK, CONCRETE & CONCRETE BLOCK
 WALLS: WOOD SIDING
 ROOFING: TIN

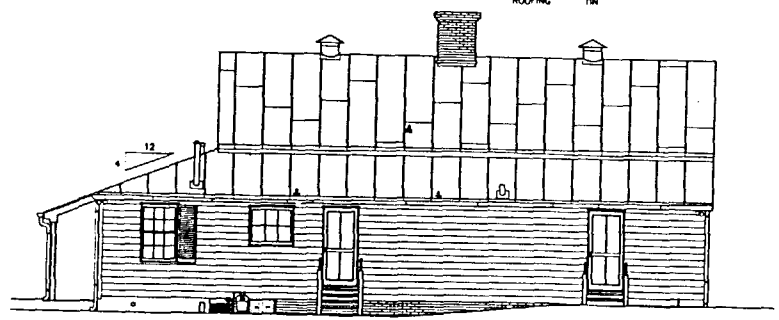
EAST ELEVATION

MATERIALS
 FOUNDATION: BRICK, CONCRETE & CONCRETE BLOCK
 WALLS: WOOD SIDING
 ROOFING: TIN

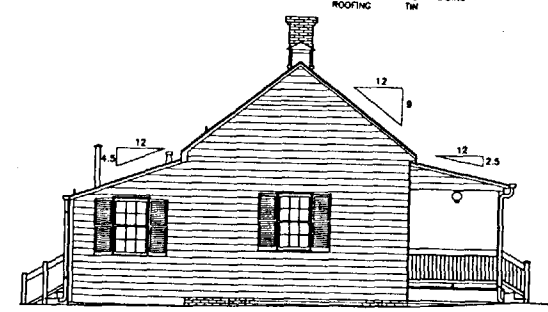
NORTH ELEVATION

MATERIALS
 FOUNDATION: BRICK, CONCRETE & CONCRETE BLOCK
 WALLS: WOOD SIDING
 ROOFING: TIN

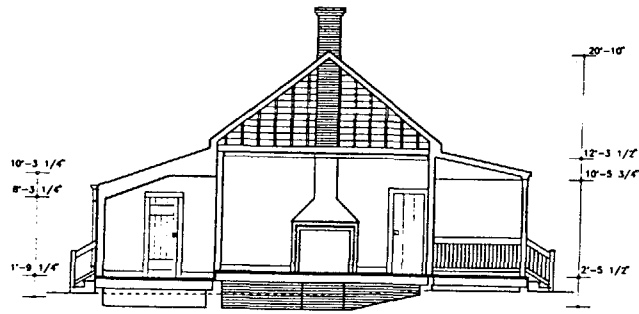
SECTION A-A

MATERIALS
FLOOR WOOD, CARPET, LINOLEUM, TILE
WALLS GYPSUM BOARD
CEILING GYPSUM BOARD

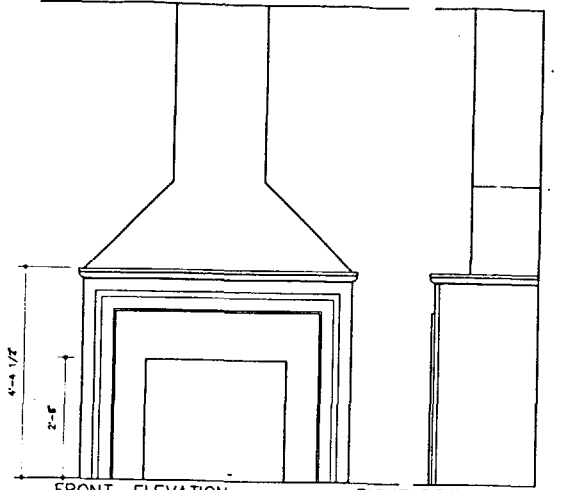
FRONT ELEVATION RIGHT SIDE ELEVATION
FIREPLACE

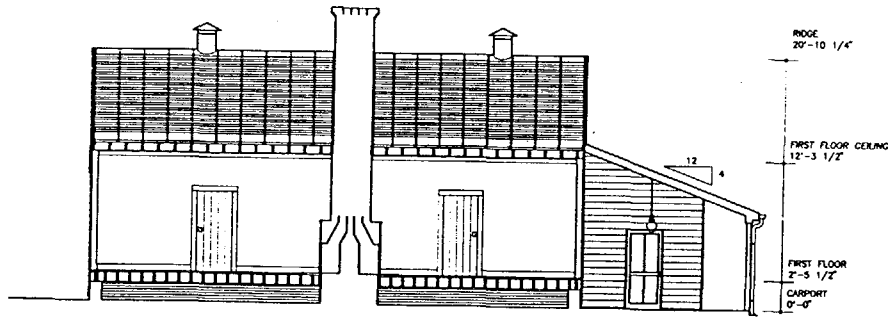
SECTION B-B

MATERIALS
FLOOR WOOD, CARPET, LINOLEUM, TILE
WALLS GYPSUM BOARD
CEILING GYPSUM BOARD

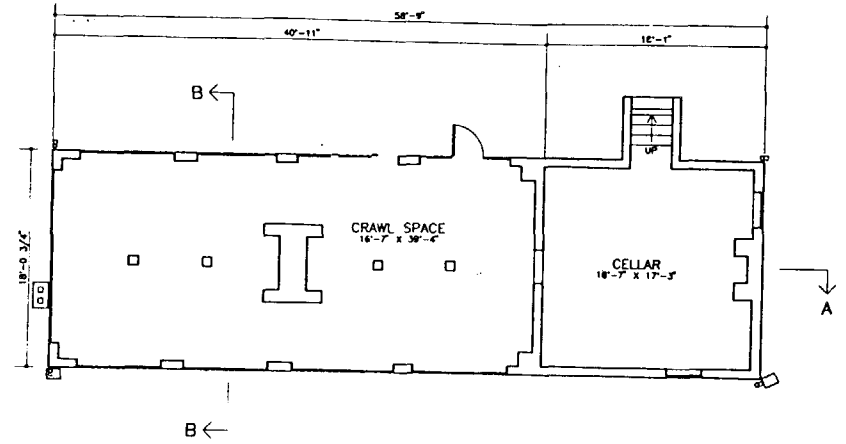
CRAWL SPACE / CELLAR FLOOR PLAN

MATERIALS
FLOOR: DIRT
WALLS: BRICK
CEILING: EXPOSED WOOD STRUCTURE

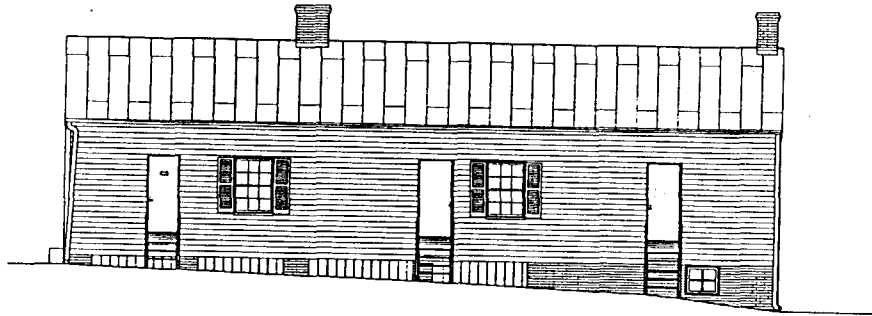
WEST ELEVATION

MATERIALS
FOUNDATION: BRICK
WALLS: WOOD SIDING
ROOFING: TIN

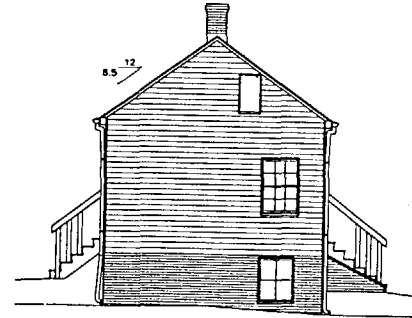
SOUTH ELEVATION

MATERIALS
FOUNDATION: BRICK
WALLS: WOOD SIDING
ROOFING: TIN

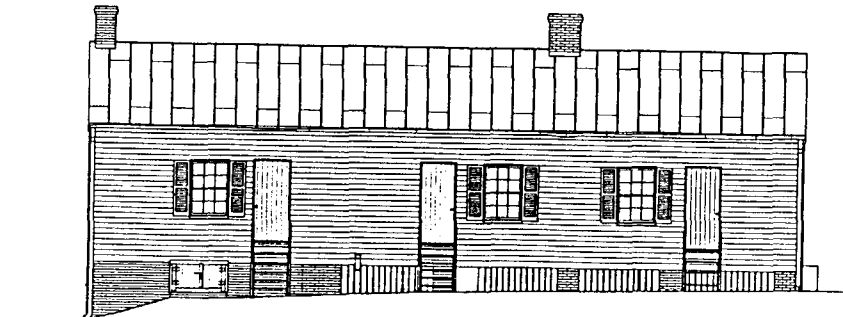
EAST ELEVATION

MATERIALS
FOUNDATION: BRICK
WALLS: WOOD SIDING
ROOFING: TIN

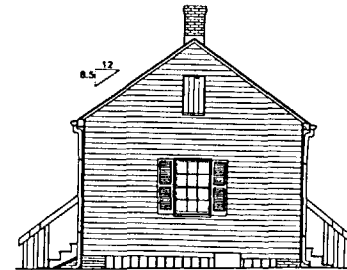
NORTH ELEVATION

MATERIALS
FOUNDATION: BRICK
WALLS: WOOD SIDING
ROOFING: TIN

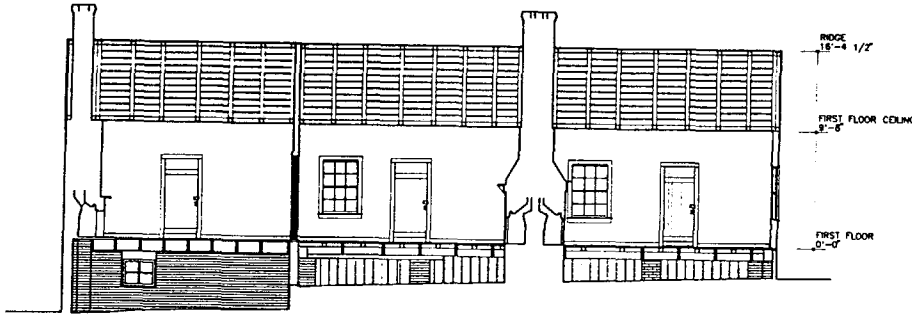
SECTION A-A

MATERIALS
FLOOR WOOD
WALLS PLASTER
CEILING PLASTER

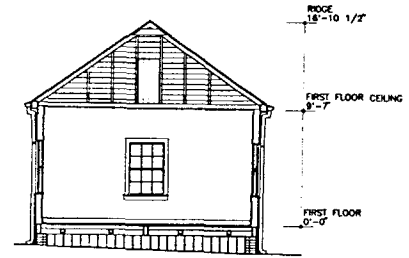
SECTION B-B

MATERIALS
FLOOR WOOD
WALLS PLASTER
CEILING PLASTER

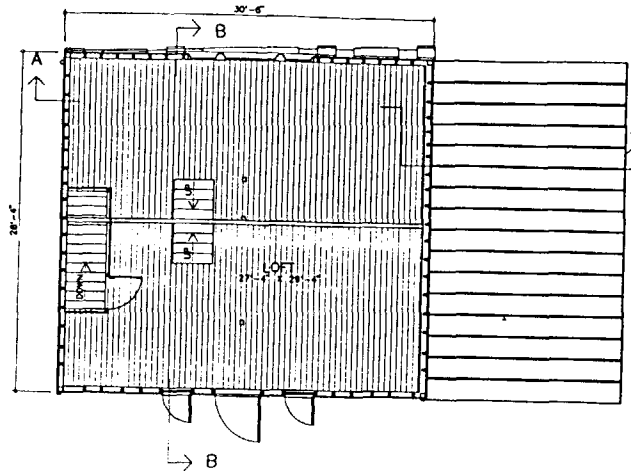
SECOND FLOOR PLAN

MATERIALS
FLOORS WOOD
WALLS EXPOSED WOOD STRUCTURE
CEILING EXPOSED WOOD STRUCTURE

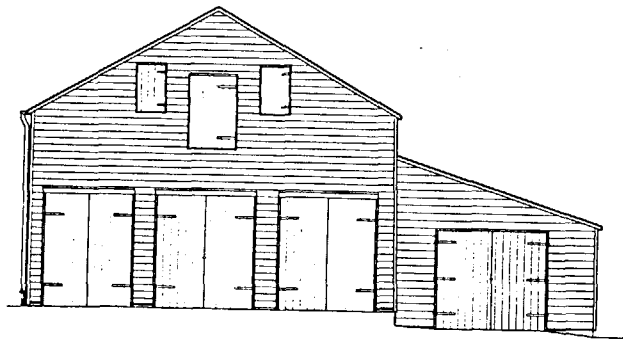
WEST ELEVATION

MATERIALS
FOUNDATION CONCRETE
WALLS WOOD SIDING
ROOFING TIN

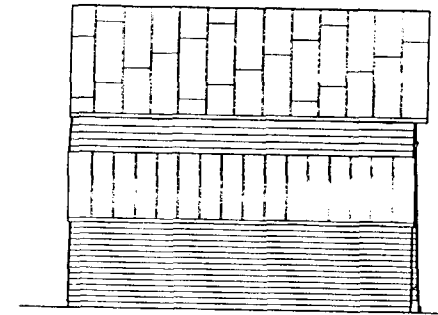
SOUTH ELEVATION

MATERIALS
FOUNDATION CONCRETE
WALLS WOOD SIDING
ROOFING TIN

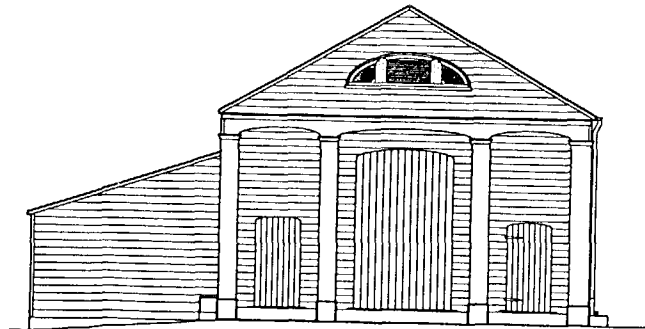
EAST ELEVATION

MATERIALS
FOUNDATION CONCRETE
WALLS WOOD SIDING
ROOFING TIN

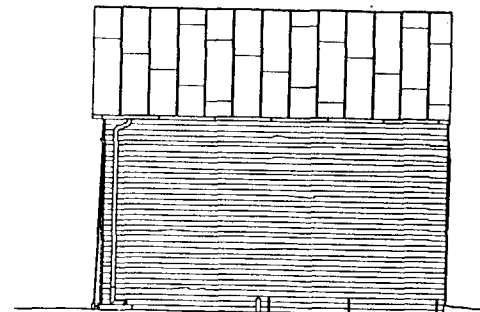
NORTH ELEVATION

MATERIALS
FOUNDATION CONCRETE
WALLS WOOD SIDING
ROOFING TIN

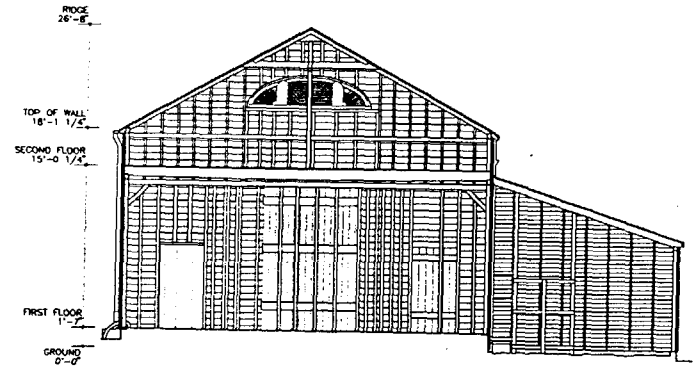
BUILDING SECTION

MATERIALS
FLOORS CONCRETE, WOOD
WALLS EXPOSED WOOD STRUCTURE
CEILING EXPOSED WOOD STRUCTURE

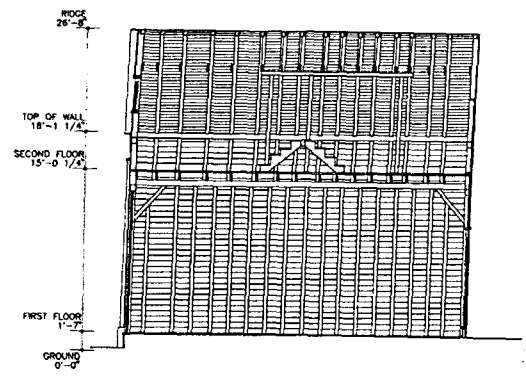
BUILDING SECTION

MATERIALS
FLOORS CONCRETE, WOOD
WALLS EXPOSED WOOD STRUCTURE
CEILING EXPOSED WOOD STRUCTURE

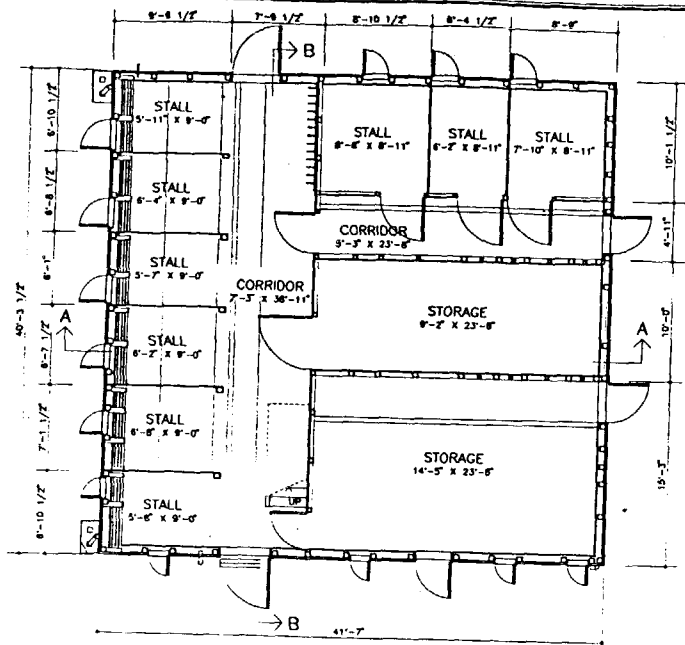
PLAN

MATERIALS
FLOORS CONCRETE
WALLS EXPOSED WOOD STRUCTURE
CEILING EXPOSED WOOD STRUCTURE

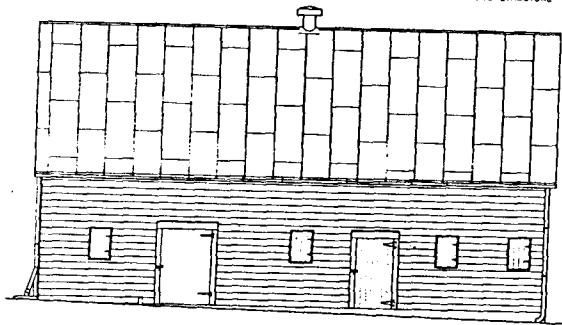
WEST ELEVATION

MATERIALS
FOUNDATION CONCRETE
WALLS WOOD SIDING
ROOFING TIN

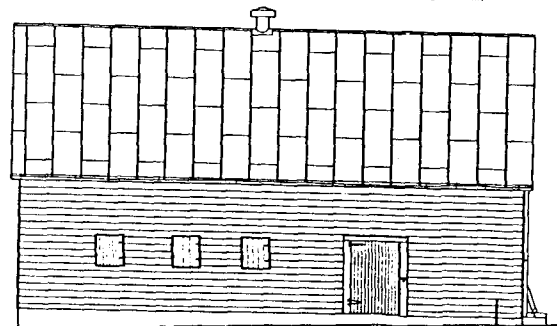
EAST ELEVATION

MATERIALS
FOUNDATION CONCRETE
WALLS WOOD SIDING
ROOFING TIN

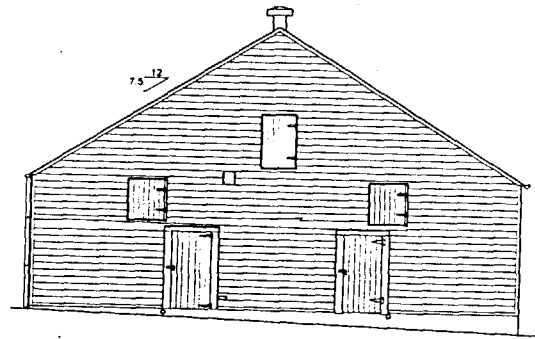
SOUTH ELEVATION

MATERIALS
FOUNDATION CONCRETE
WALLS WOOD SIDING
ROOFING TIN

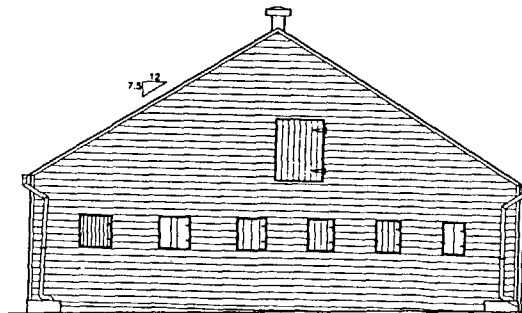
NORTH ELEVATION

MATERIALS
FOUNDATION CONCRETE
WALLS WOOD SIDING
ROOFING TIN

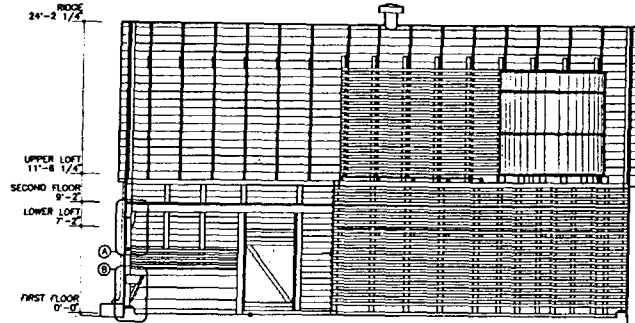
SECTION A-A
FEET 1/4"=1'-0" 0 1 2 3 4 5 10
METERS 1:48 0 1 2 3

MATERIALS
FLOORS CONCRETE
WALLS EXPOSED WOOD STRUCTURE
CEILING EXPOSED WOOD STRUCTURE

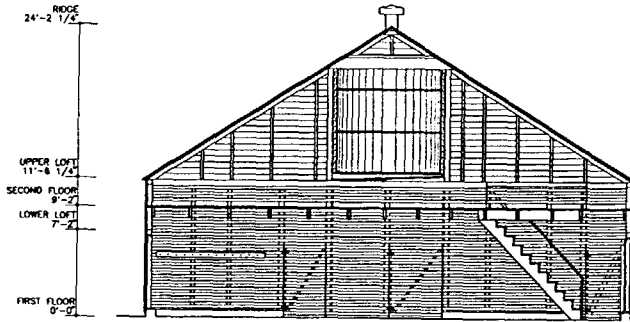
SECTION B-B
FEET 1/4"=1'-0" 0 1 2 3 4 5 10
METERS 1:48 0 1 2 3

MATERIALS
FLOORS CONCRETE
WALLS EXPOSED WOOD STRUCTURE
CEILING EXPOSED WOOD STRUCTURE

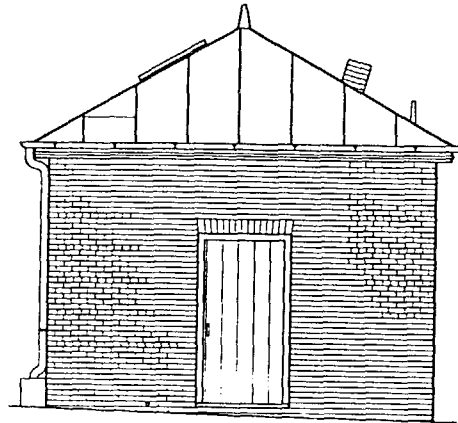
SOUTH ELEVATION

MATERIALS
FOUNDATION BRICK
WALLS BRICK
ROOFING TIN

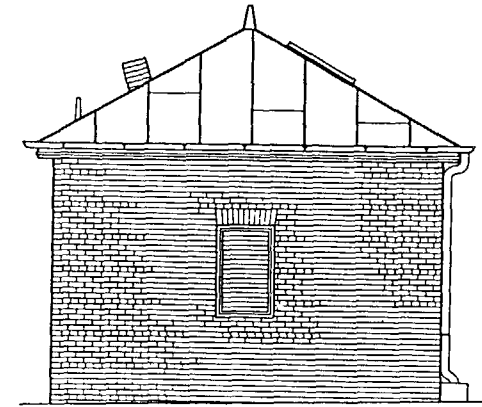
NORTH ELEVATION

MATERIALS
FOUNDATION BRICK
WALLS BRICK
ROOFING TIN

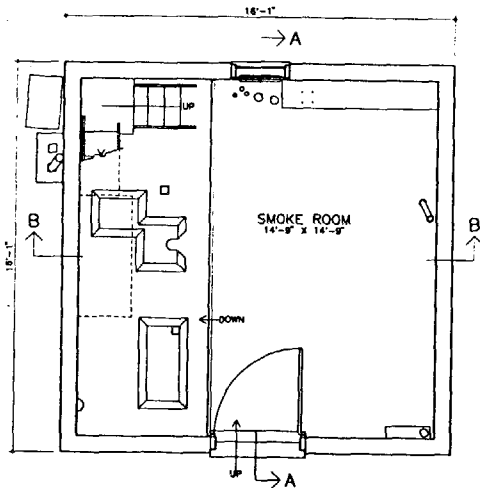
PLAN

MATERIALS
FLOOR CONCRETE
WALLS BRICK
ROOFING BRICK
EXPOSED WOOD STRUCTURE

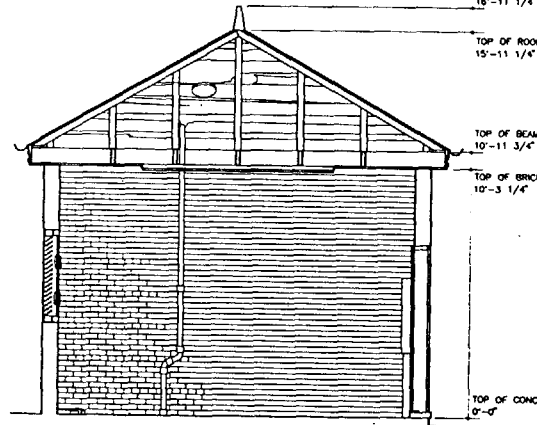
SECTION A-A

MATERIALS
FLOOR CONCRETE
WALLS BRICK
ROOFING BRICK
EXPOSED WOOD STRUCTURE

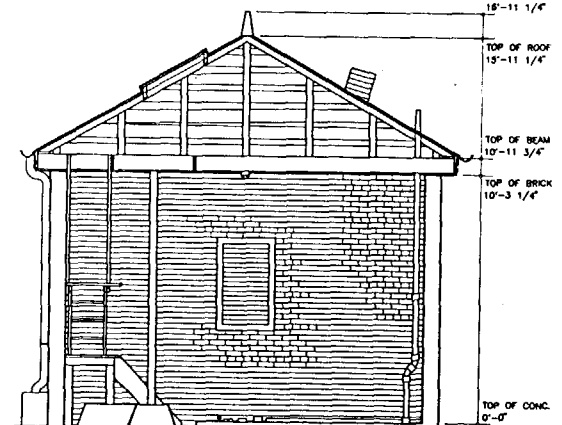
SECTION B-B

MATERIALS
FLOOR CONCRETE
WALLS BRICK
ROOFING BRICK
EXPOSED WOOD STRUCTURE

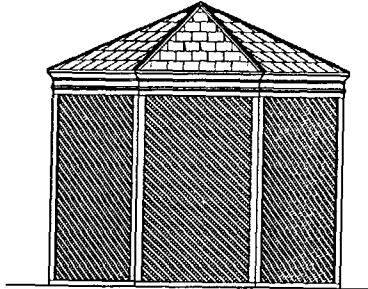
TYPICAL CISTERN ELEVATION

MATERIALS
FOUNDATION BRICK
WALLS WOOD LATTICE
ROOFING STAMPED TIN

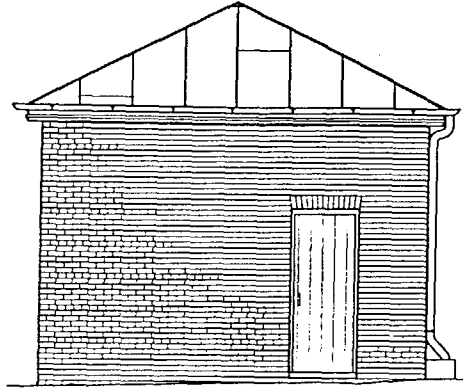
NORTH PRIVY ELEVATION

MATERIALS
FOUNDATION BRICK
WALLS BRICK
ROOFING TIN

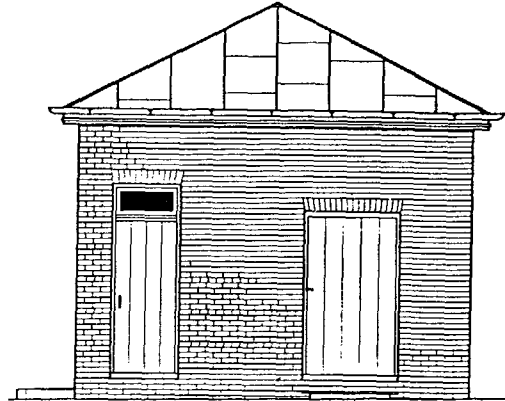
EAST PRIVY ELEVATION

MATERIALS
FOUNDATION BRICK
WALLS BRICK
ROOFING TIN

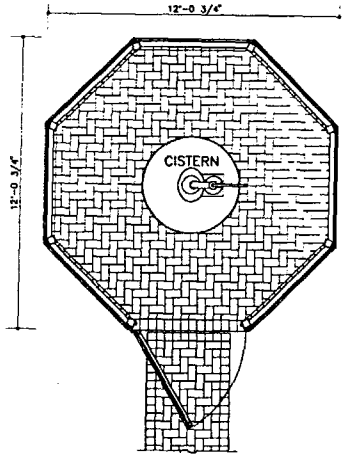
PLAN OF CISTERN

MATERIALS
FLOOR BRICK
WALLS WOOD LATTICE
CEILING EXPOSED WOOD STRUCTURE
