**MELROSE ESTATE
NATCHEZ NATIONAL HISTORICAL PARK**

NATCHEZ, MISSISSIPPI

**HISTORIC STRUCTURES REPORT
VOLUME III
APPENDIX**

ANN BEHA ASSOCIATES

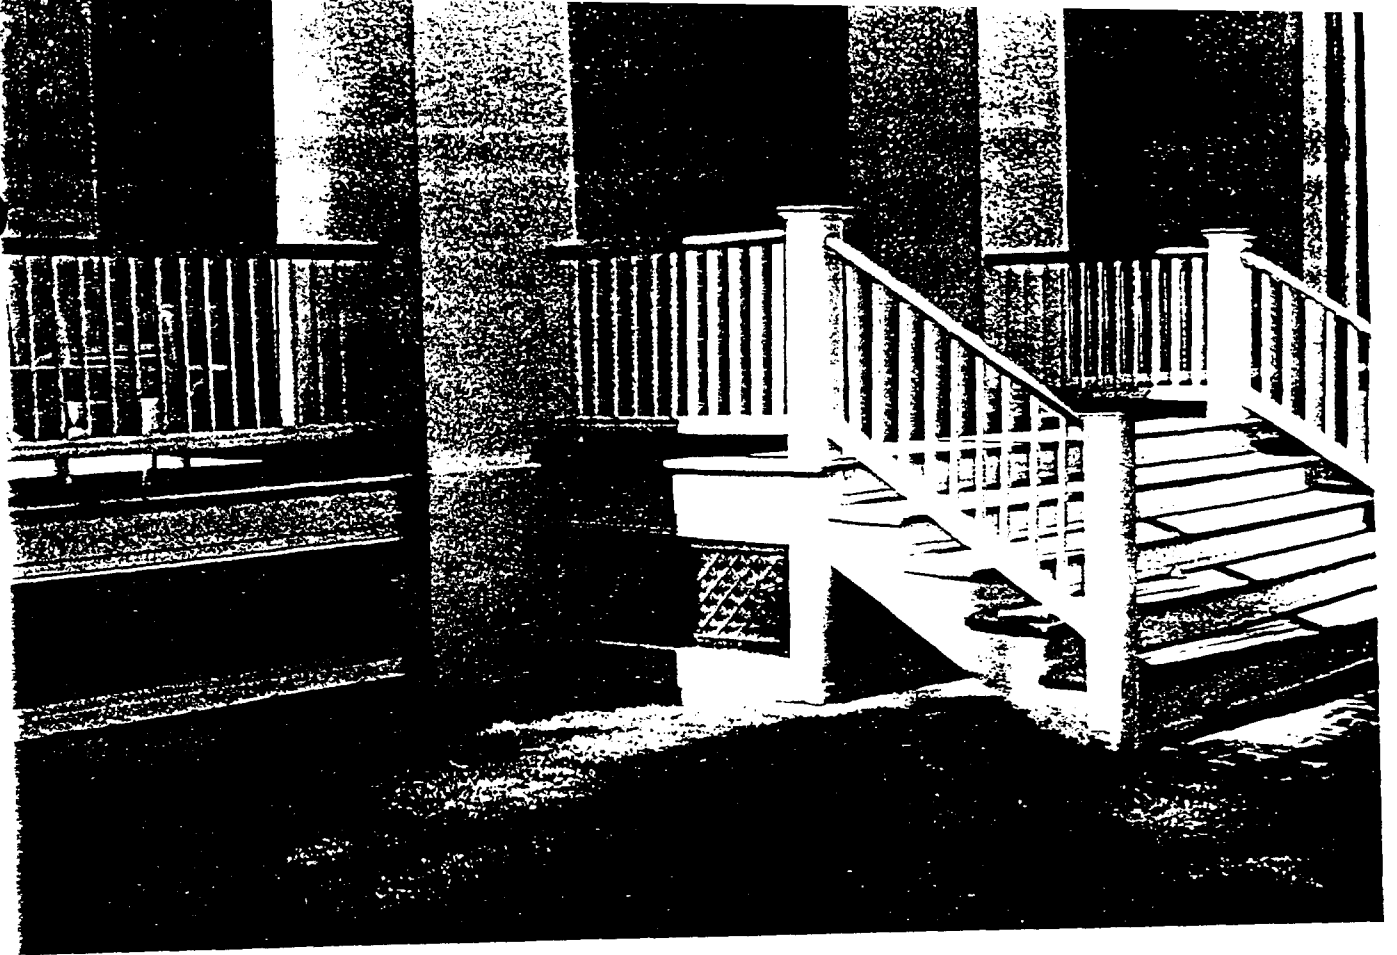
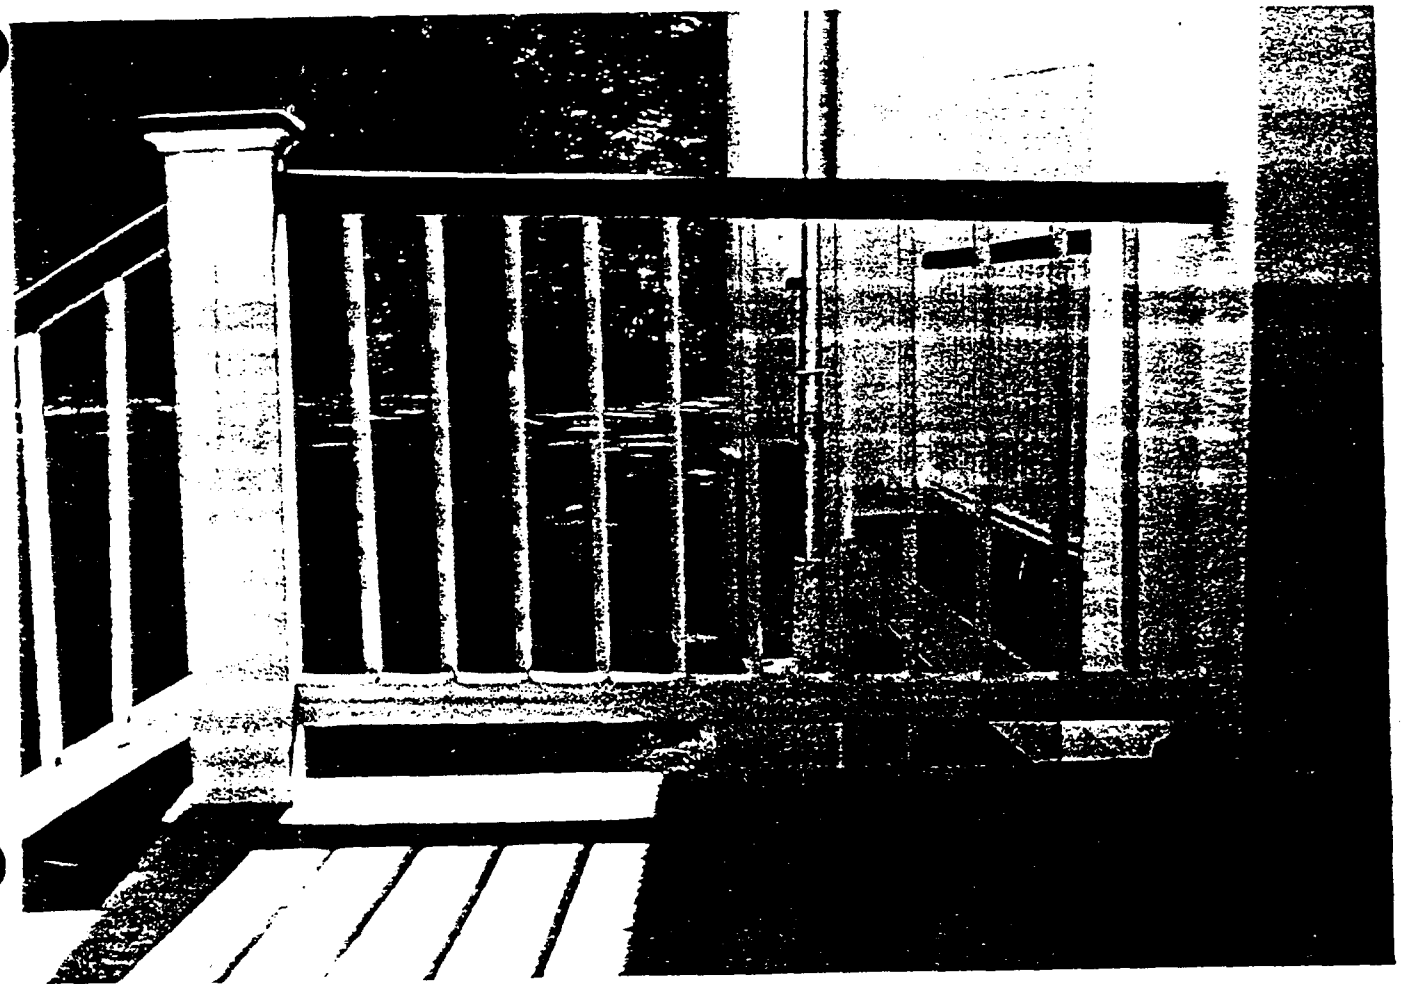
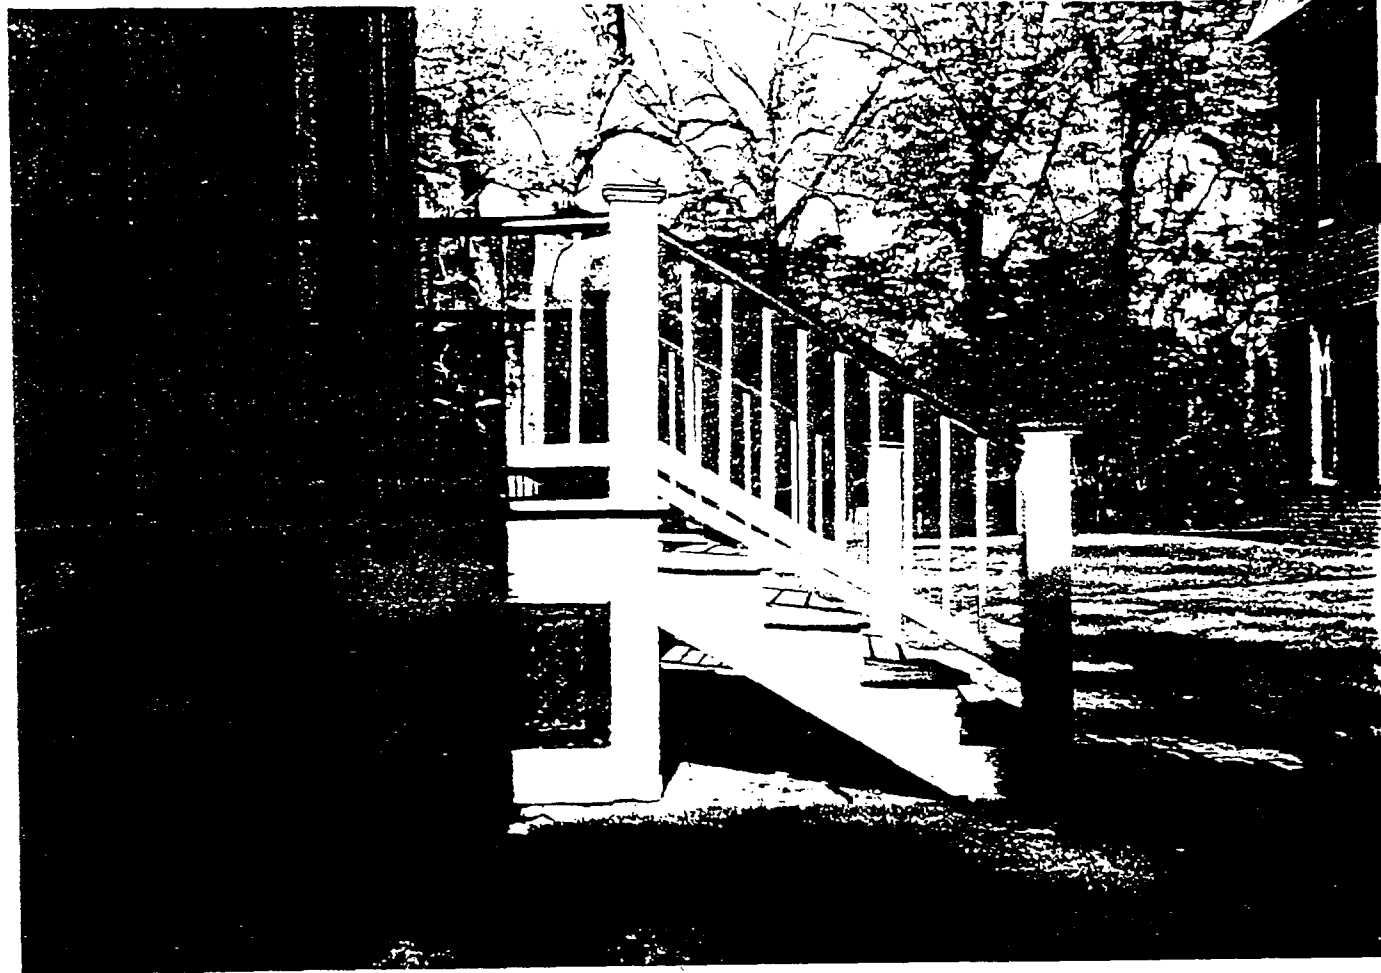
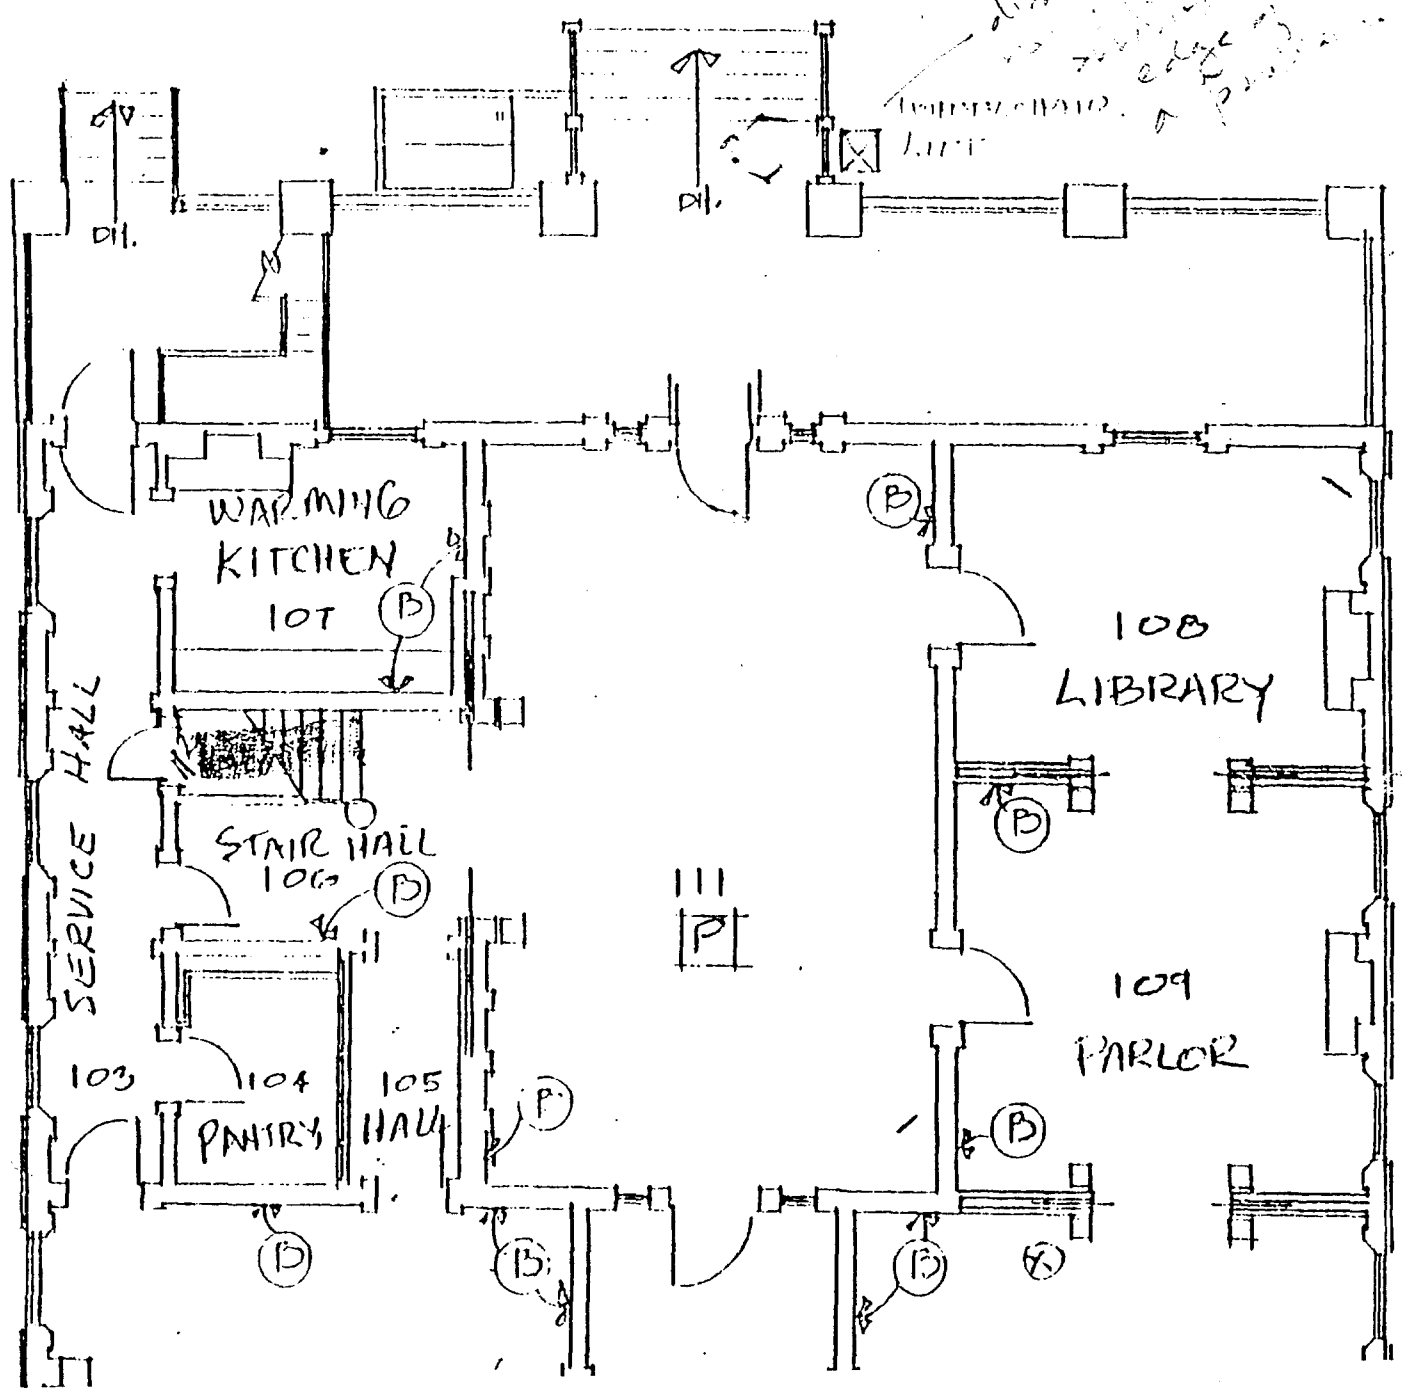
disposition of the edge of the plan
LIFT

The project will require excavation of a pit of approximately ten feet to accommodate the lift apparatus. Drainage will be accomplished by either a sump pump or gravity feed into an existing cistern drain. Conduit will be routed from the basement through the basement wall to the apparatus. The balustrade will be removed, and anchors affixed to the porch column and staircase post which will be used to resecure the balustrade. The balustrade could then be easily removed when the lift is in operation and replaced and secured afterwards. To provide space to maneuver a wheelchair at grade level the area around the lift will be surfaced with brick. The pan of the lift platform will also be surfaced with brick to provide minimal visual intrusion when the lift is not in operation.

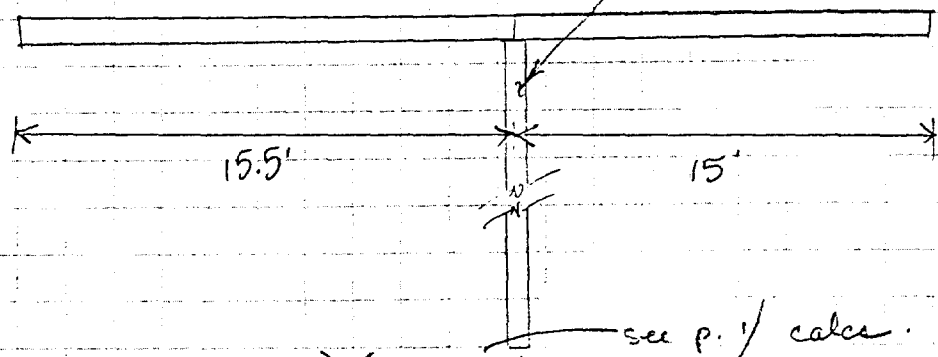
WALL IS TAKING ROOF LOADS
 ↳ wall is $2\frac{3}{4}'' \times 4'' @ 16'' \text{ o/c studs}$

Tributary loads taken by this wall:

$$W = \frac{1}{2}(15.5' + 15')(35 \text{ PSF})$$

$$= 534 \text{ plf}$$

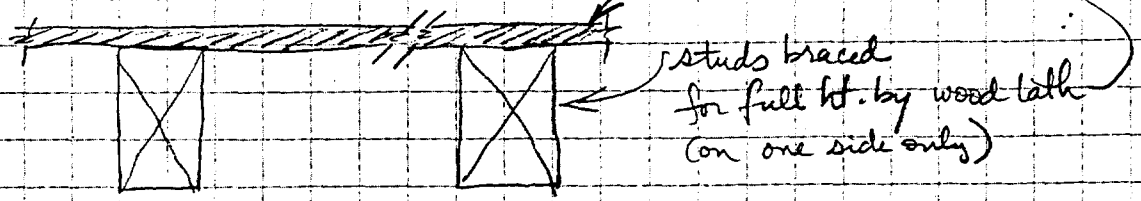
PARTIAL PLAN
 N.T.S.

$$f_a = \frac{712}{(2.75)(4)} = 65 \text{ psi}$$

Ht. of stud wall = 10.5'
