historic structure report
historical data
november 1978

PICTURED ROCKS
AU SABLE LIGHT STATION

HISTORIC STRUCTURE REPORT
HISTORICAL DATA
AU SABLE LIGHT STATION
PICTURED ROCKS NATIONAL LAKESHORE
MICHIGAN

Prepared by
Louis Torres

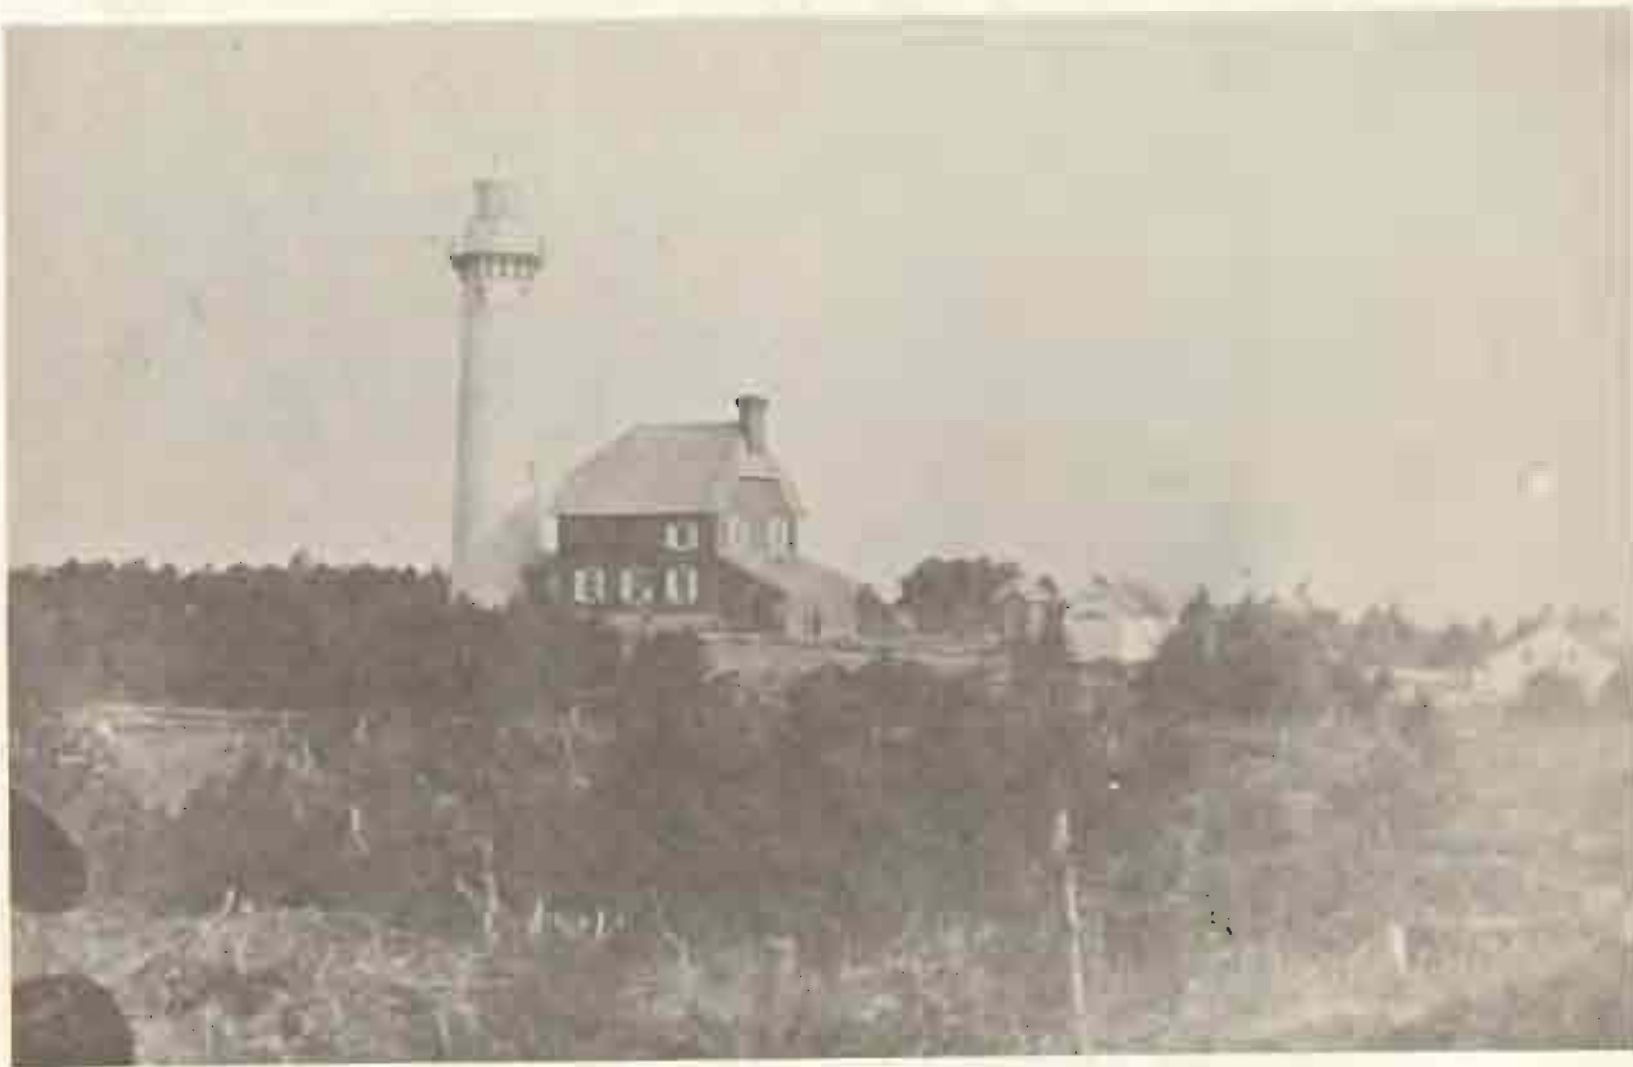
Illustration 1
Big Sable (Au Sable) Light Station, 1884.
(Photograph No. 26-LG-49-5, Record Group 26, National Archives)

10. Photograph No. 26-LG-49-5, 1884, RG 26, NA; a similar photograph is numbered 26-LG-49-7, 1884, RG 26, NA.

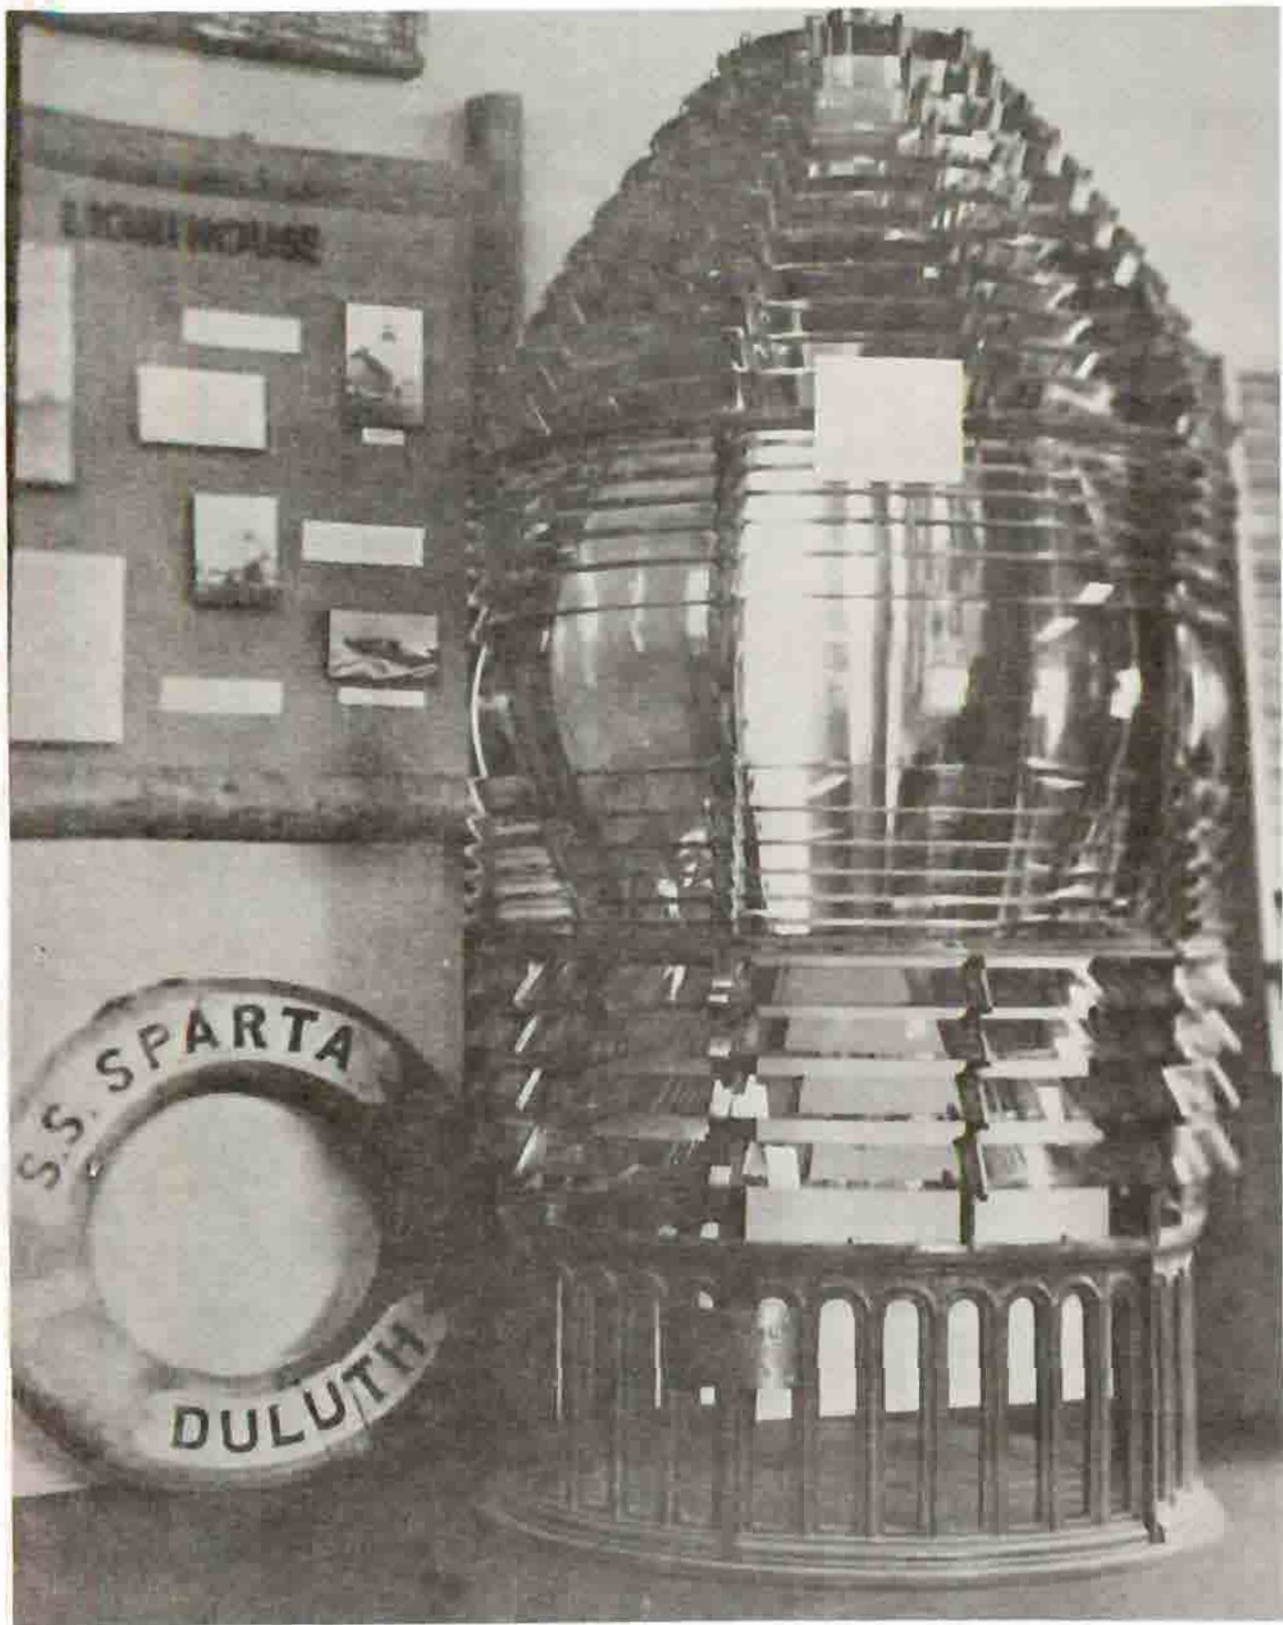
Illustration 3
Third Order Lens on Exhibit at Headquarters of
Pictured Rocks National Lakeshore

The third order lens was finally removed from the lantern in 1972 and replaced by a much smaller 300 mm acrylic lens.⁹ This lens was fastened to the upper gallery of the tower. Meanwhile, the old lantern was boarded up to preserve it from the weather and the old lens was transferred to the National Park Service, where it is now exhibited in the headquarters of Pictured Rocks National Lakeshore (see Illustration 3).

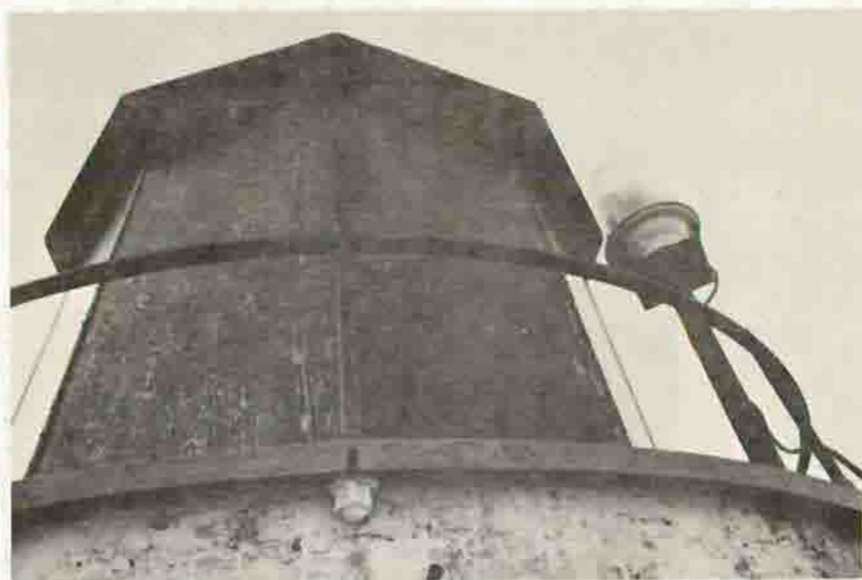
Illustration 8
Lantern Section and 1972 Automatic Light on Lighthouse Tower
1977

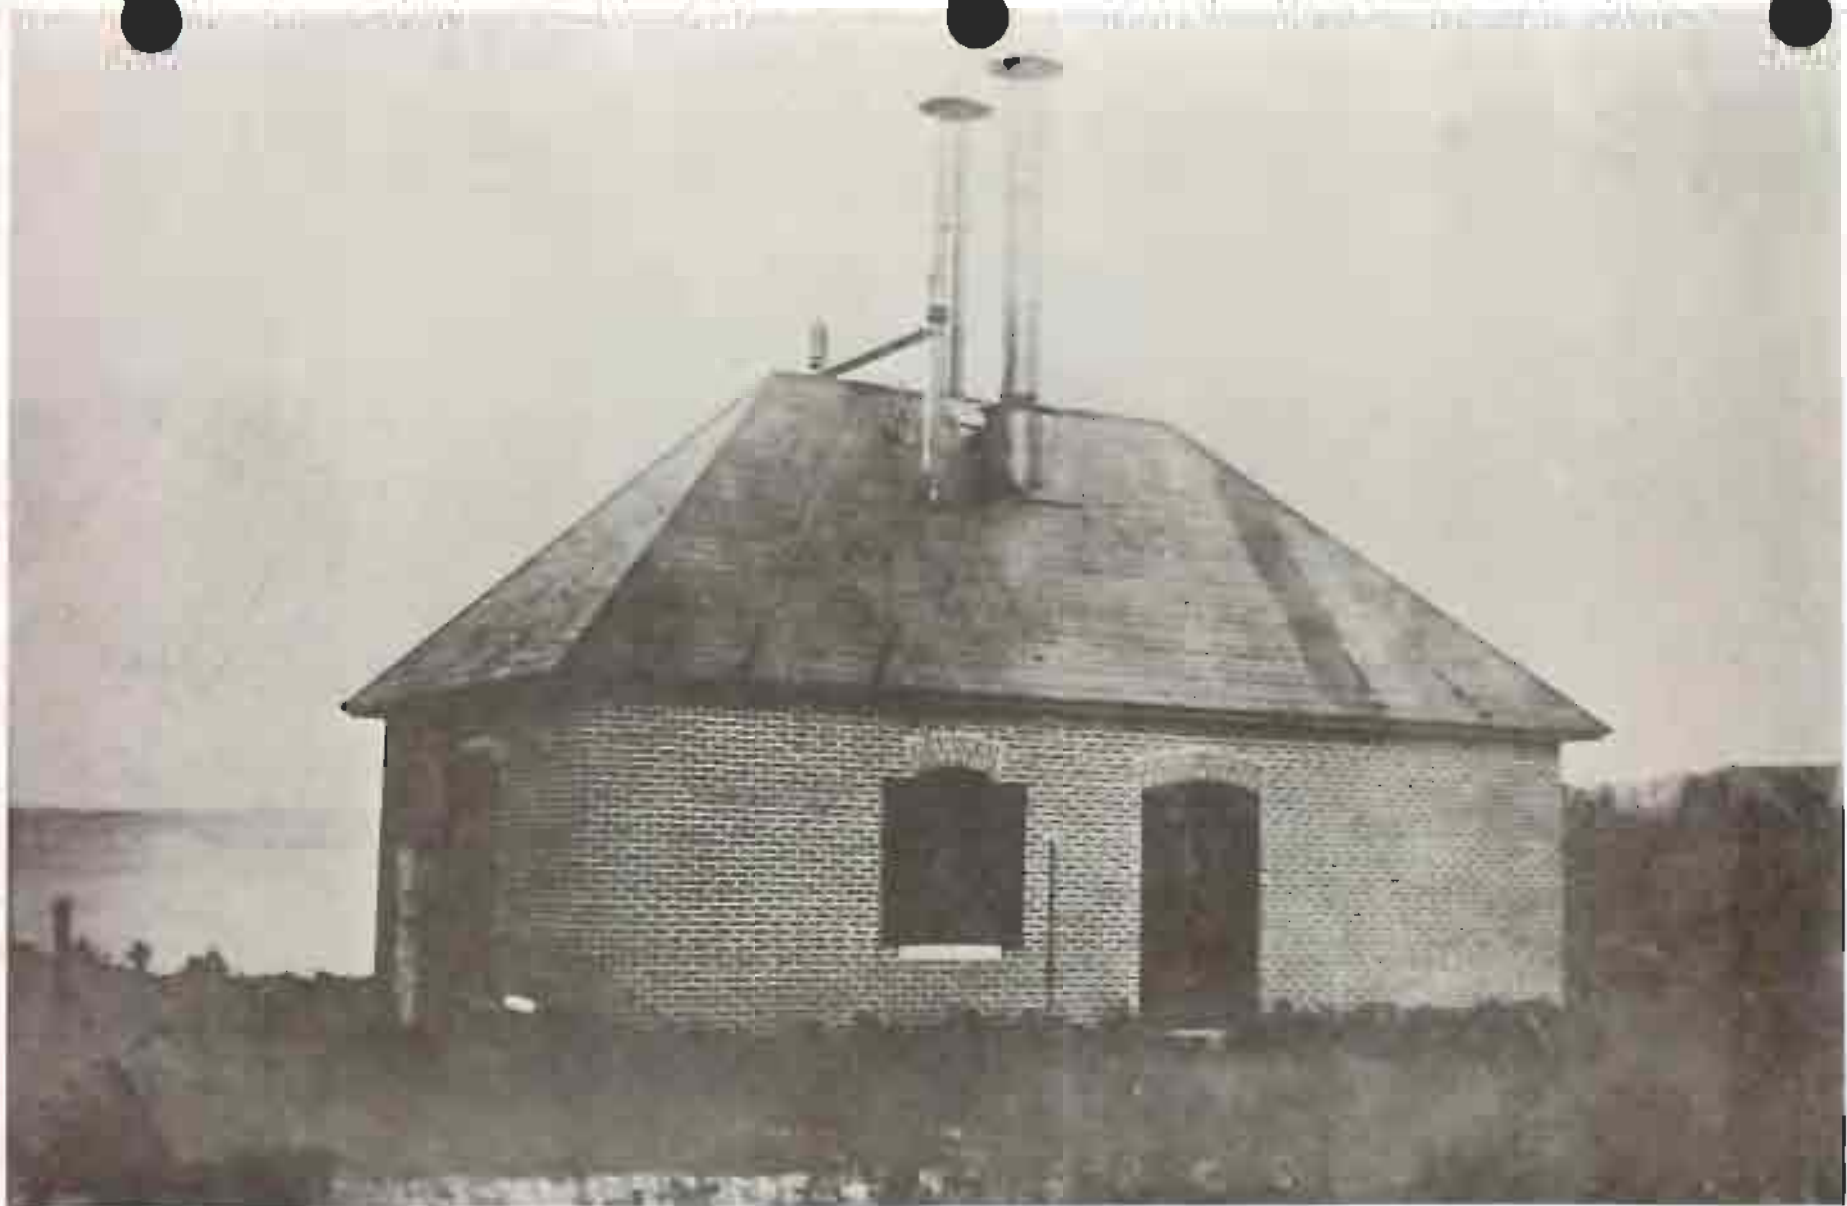
Illustration 11
Fog Signal House
Big Sable (Au Sable) Light Station, 1904
(Photograph No. 26-LG-49-6A, Record Group 26, National Archives)

The building housing the fog signal equipment was a one-story red brick structure with a red metal shingle roof. Its dimensions were 22 feet by 40 feet. Originally the roof had two long metal smokestacks, but in 1904 these were removed and replaced by a 40-foot brick chimney.¹⁷ A photograph taken in 1904, just before the brick chimney was added, provides an excellent description of this building only seven years after it was completed (Illustration II).¹⁸

18. Photograph 26-LG-49-6A, 1904, RG 26, NA. See also Illustration 12, photograph taken in 1920, showing the brick chimney.

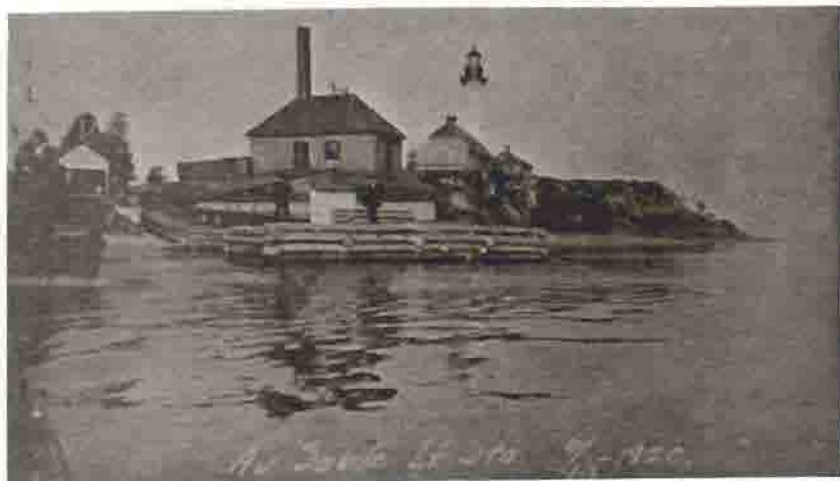
Illustration 12
Fog Signal House with Brick Chimney
June 1920

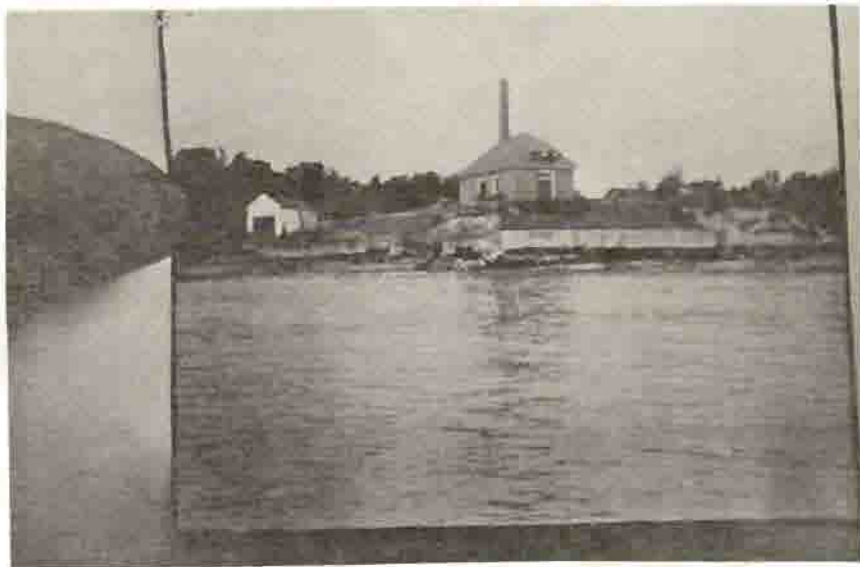
Illustration 13
Fog Signal House
Photograph shows change in roof
after new equipment was installed.
Park Files--1950s

This equipment consisted of a water pump, air compressor, and air hoist.²⁰ The changes made at this time altered the roof to some extent in order to fit in the new equipment (Illustration 13).²¹ In later years the size of the chimney was reduced to its present dimensions (Illustrations 14, 15, and 16).

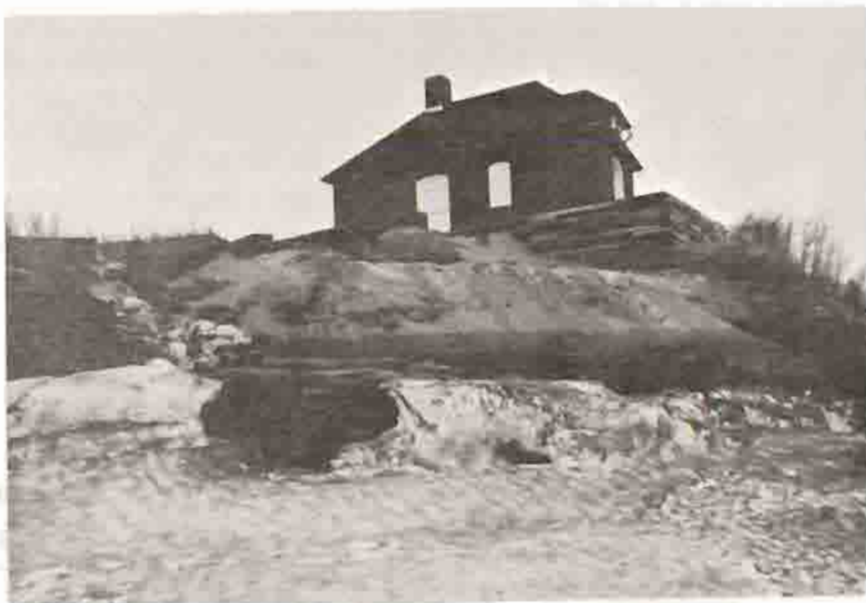
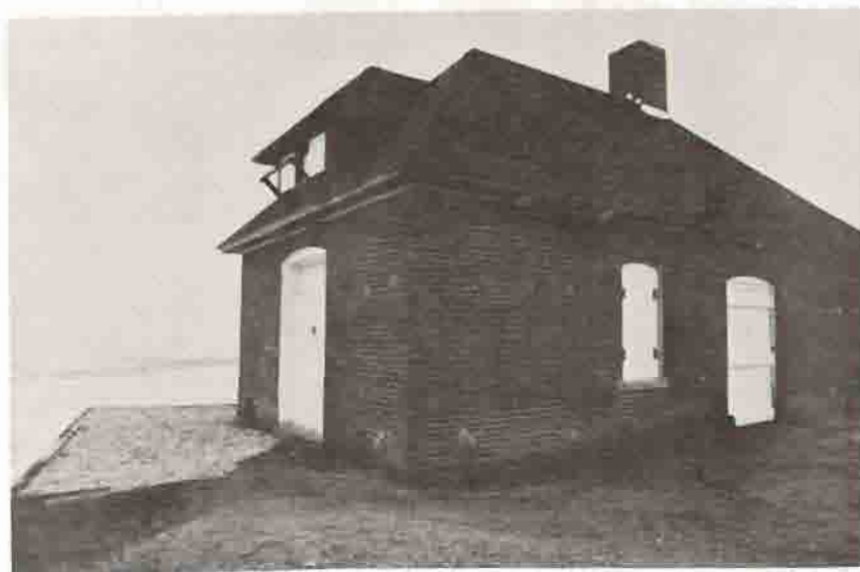
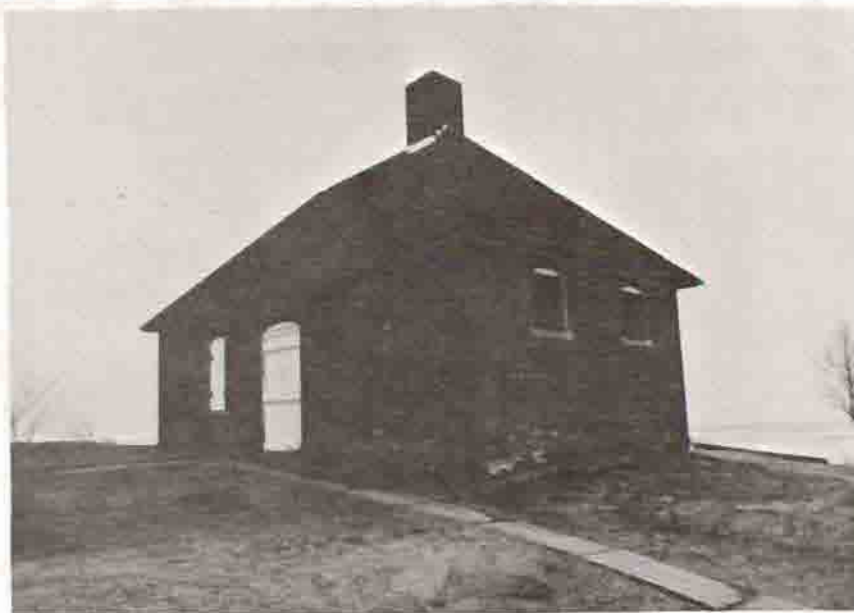
Illustration 14
Fog Signal House Looking Southwest
1977

Illustration 15
Fog Signal House Looking East
1977

Illustration 16
Fog Signal House Looking Northeast
1977

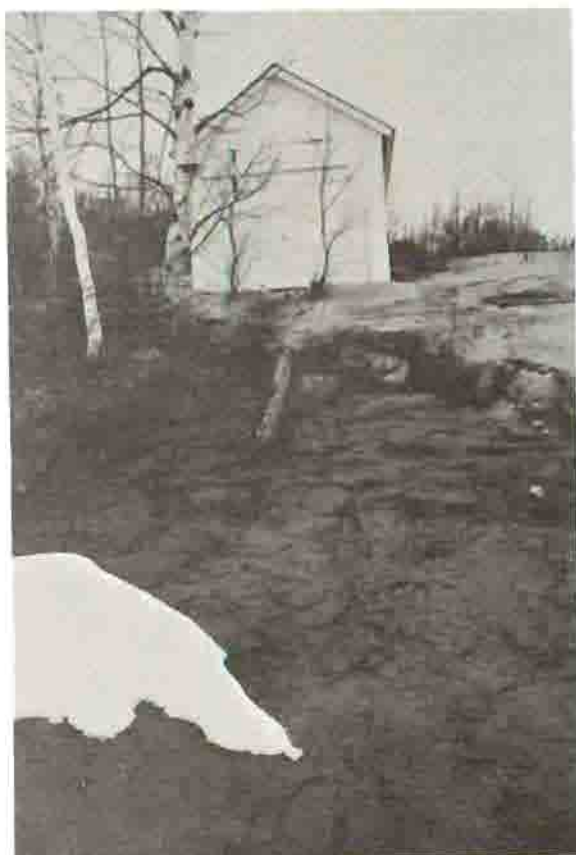
Illustration 17
Boathouse

Photograph shows side toward lake and
ruins of boatway.

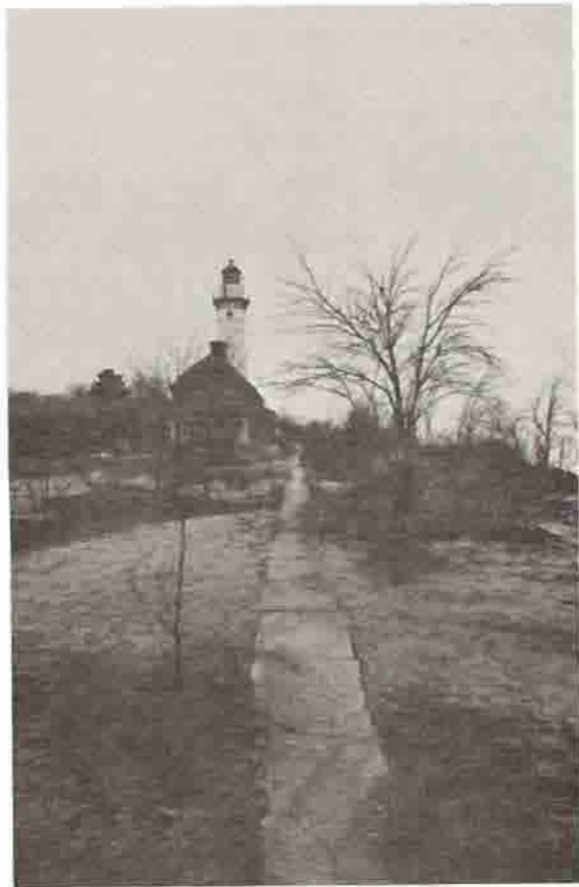
Illustration 24
Section of Concrete Walk Leading from
Fog Signal House to Dwellings and Tower
1977

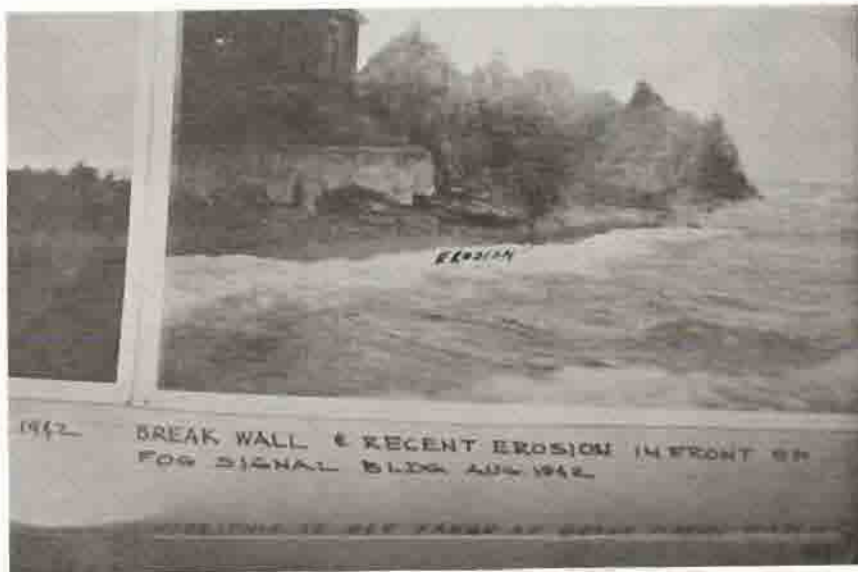
Illustration 26
Retaining Wall Photograph shows area of erosion.
Park Files--August 1942

43. Photograph, captioned: "Break Wall & Recent Erosion In Front of Fog Signal Bldg., Aug. 1942," in park files (Illustration 26).

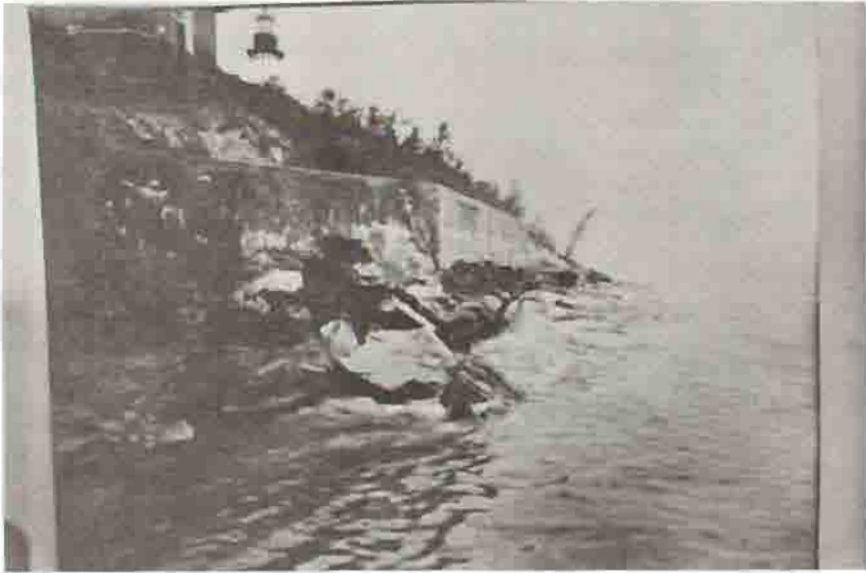
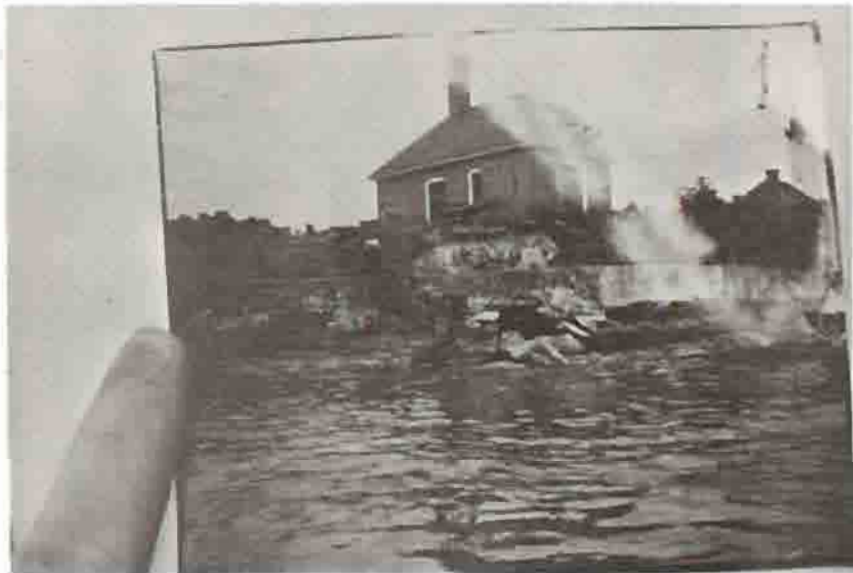
Illustration 27 and 28
Extended Sections of Retaining Wall
Park Files--ca. 1950s

44. Drawing, "Plot Plan," n.d. but ca. 1954, in park files. See photographs, ca. 1950s, in park files, showing where the new extension began and where it ended (Illustrations 27 through 28).

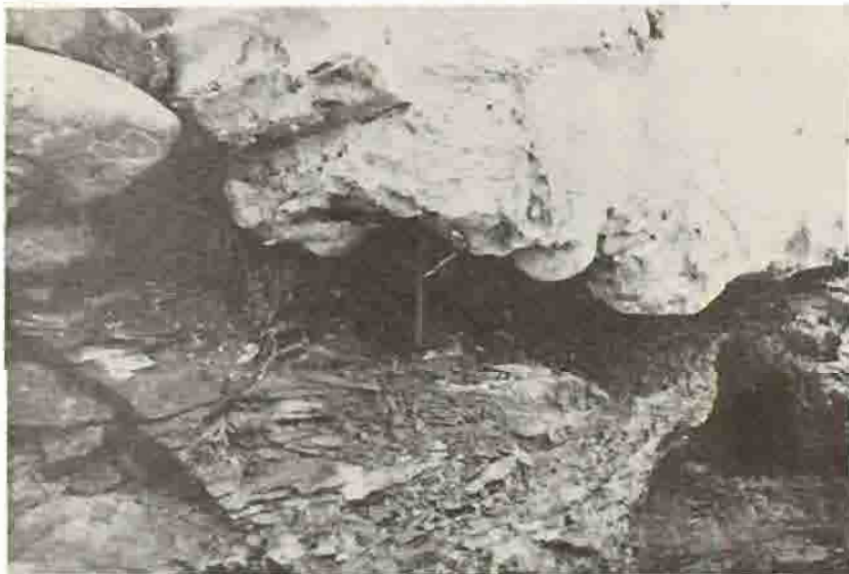
Illustration 32
Bottom of Retaining Wall, Anchored in Bedrock
1977

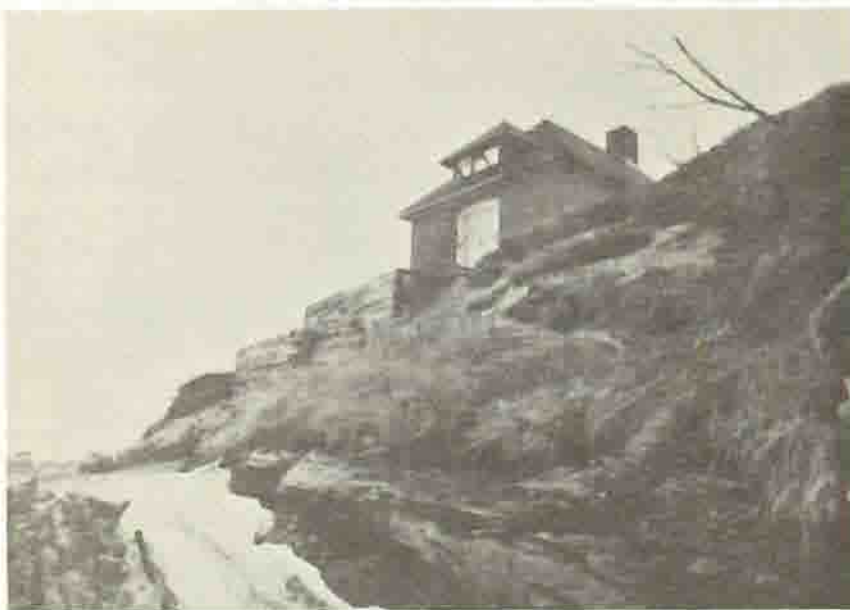
Illustration 34
Double-Tiered Wooden Retaining
Wall Under Fog Signal House
1977

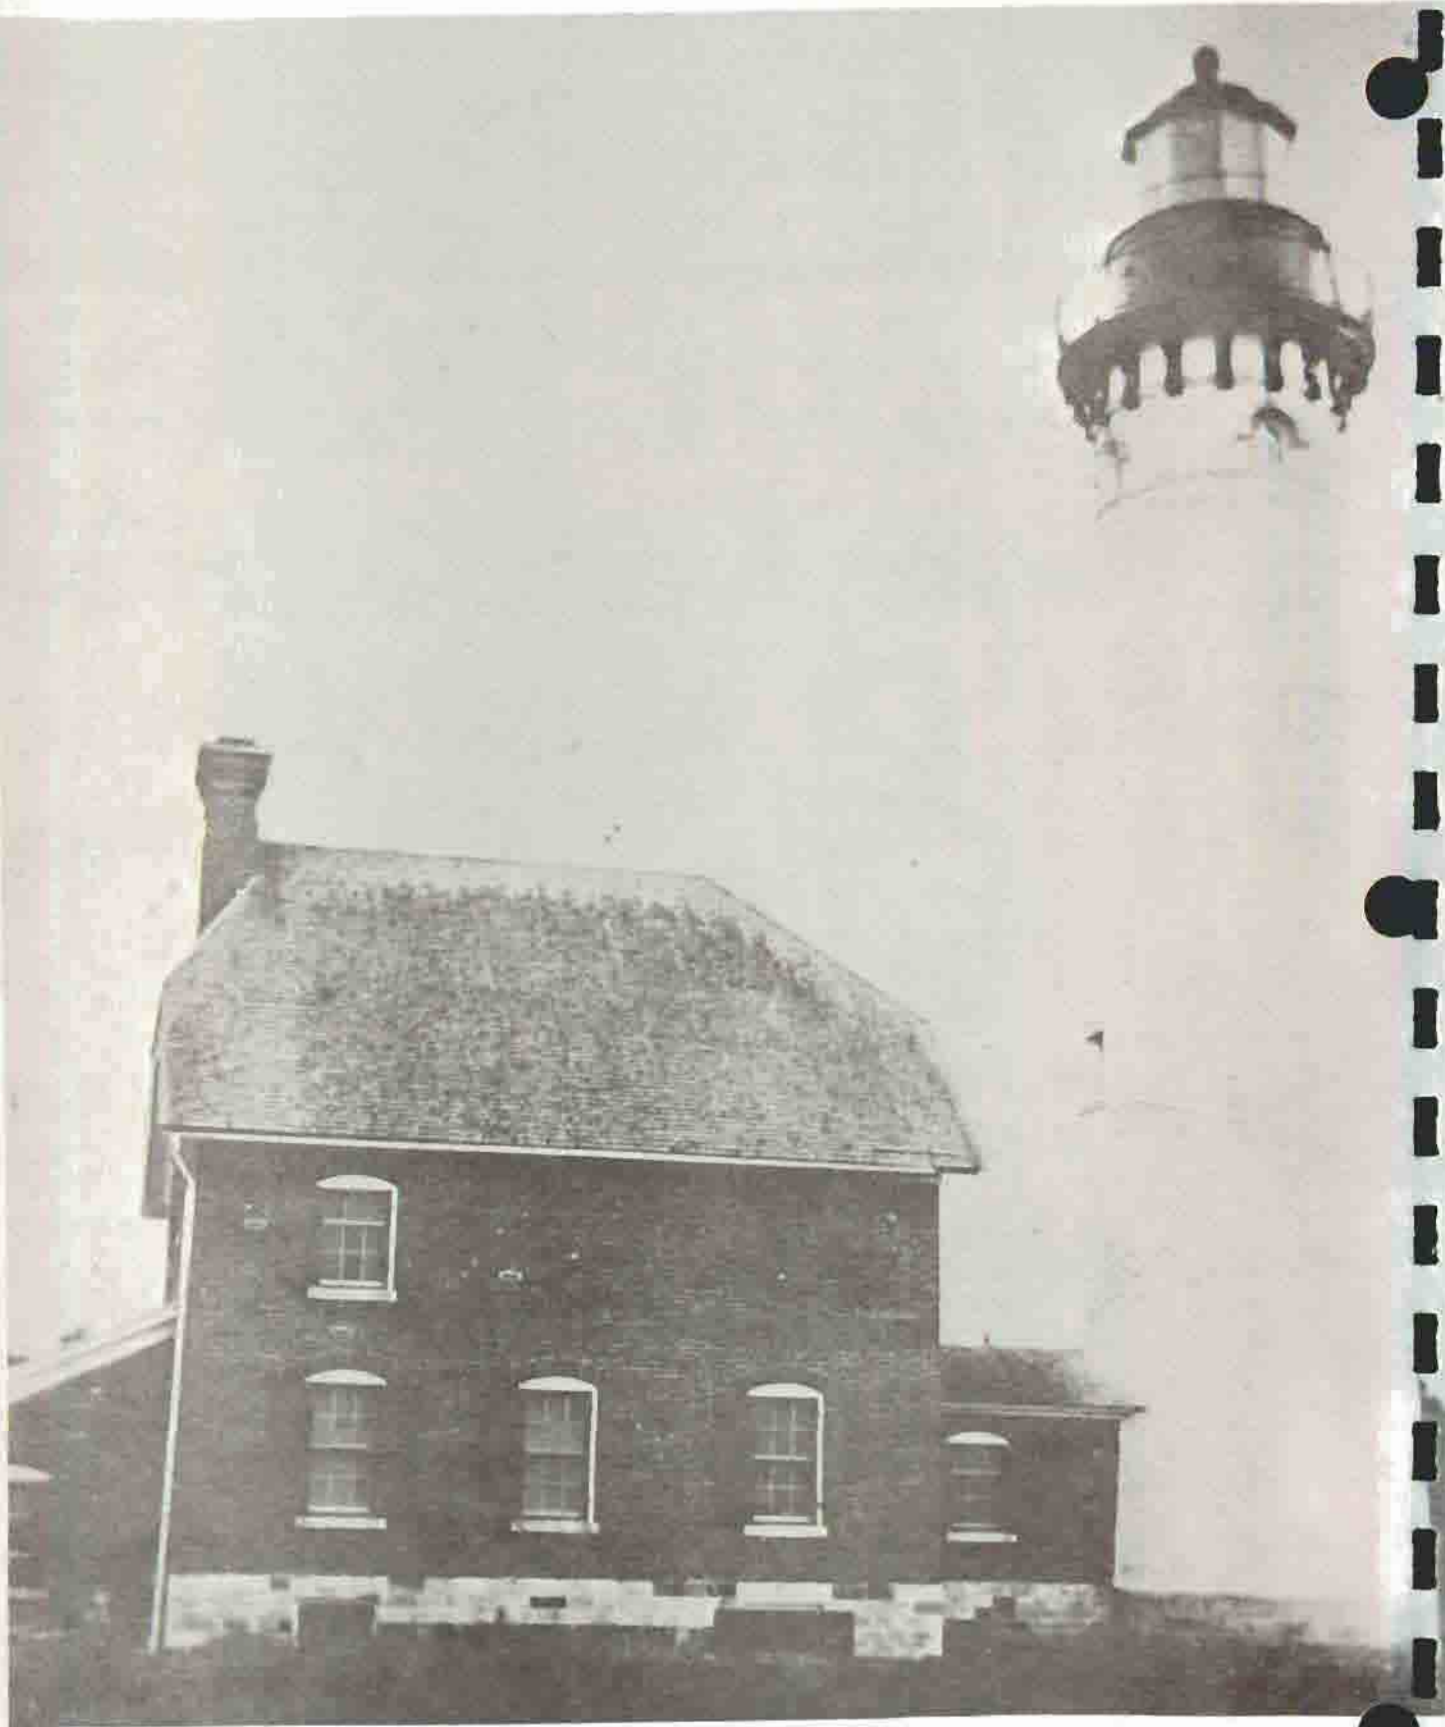
Illustration 35
Attached Dwelling
Viewed from the North, 1904
(Photograph No. 26-LG-49-6B Record Group 26, National Archives)

2. Photograph, No. 26-LG-49-6B, RG 26, NA.

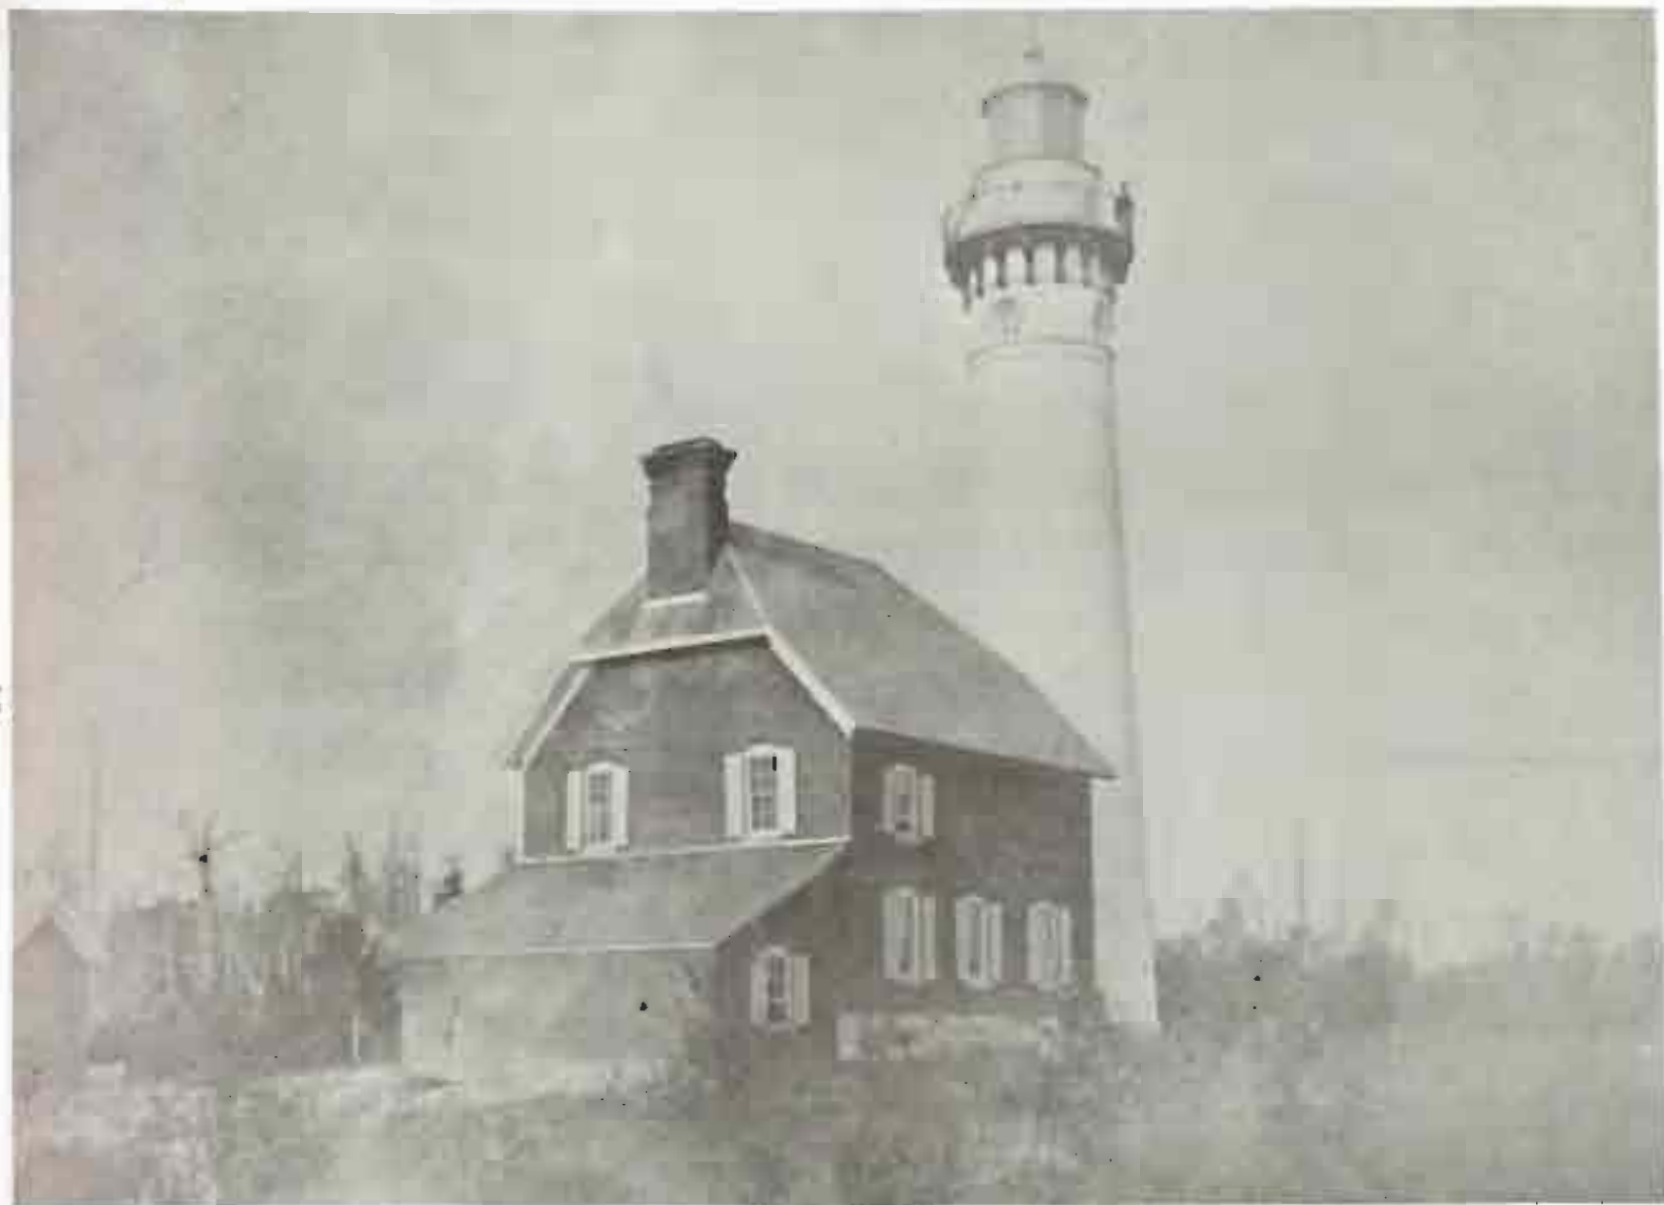
Illustration 36
Attached Dwelling
Viewed from the Northeast, 1884
(Photograph No. 26-LG-49-8, Record Group 26, National Archives)

3. Keeper's log book, November 7, 1903, RG 26, NA. In addition to the blueprint, "Keeper's Dwelling For Big Sable Lt. Sta.," ca. 1874, in park files, photographs No. 26-LG-49-8, 1884, No. 26-LG-49-5, 1884, and No. 26-LG-49-7, all in RG 26, NA, provide excellent descriptions of the dwelling only ten years after it was constructed (Illustration 36).

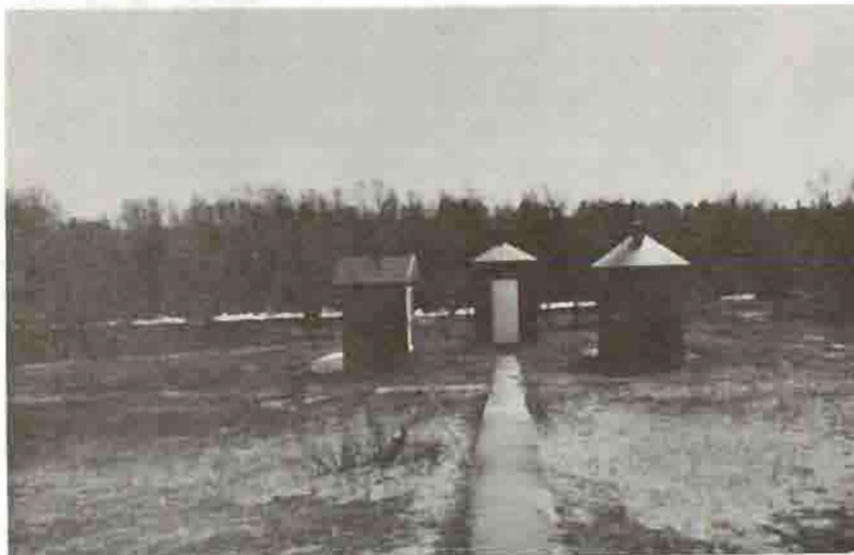
Illustration 52
Present Location of 1874 Privy
Privy is at left, brick oil house is at center, and
metal oil house is at right.
1977

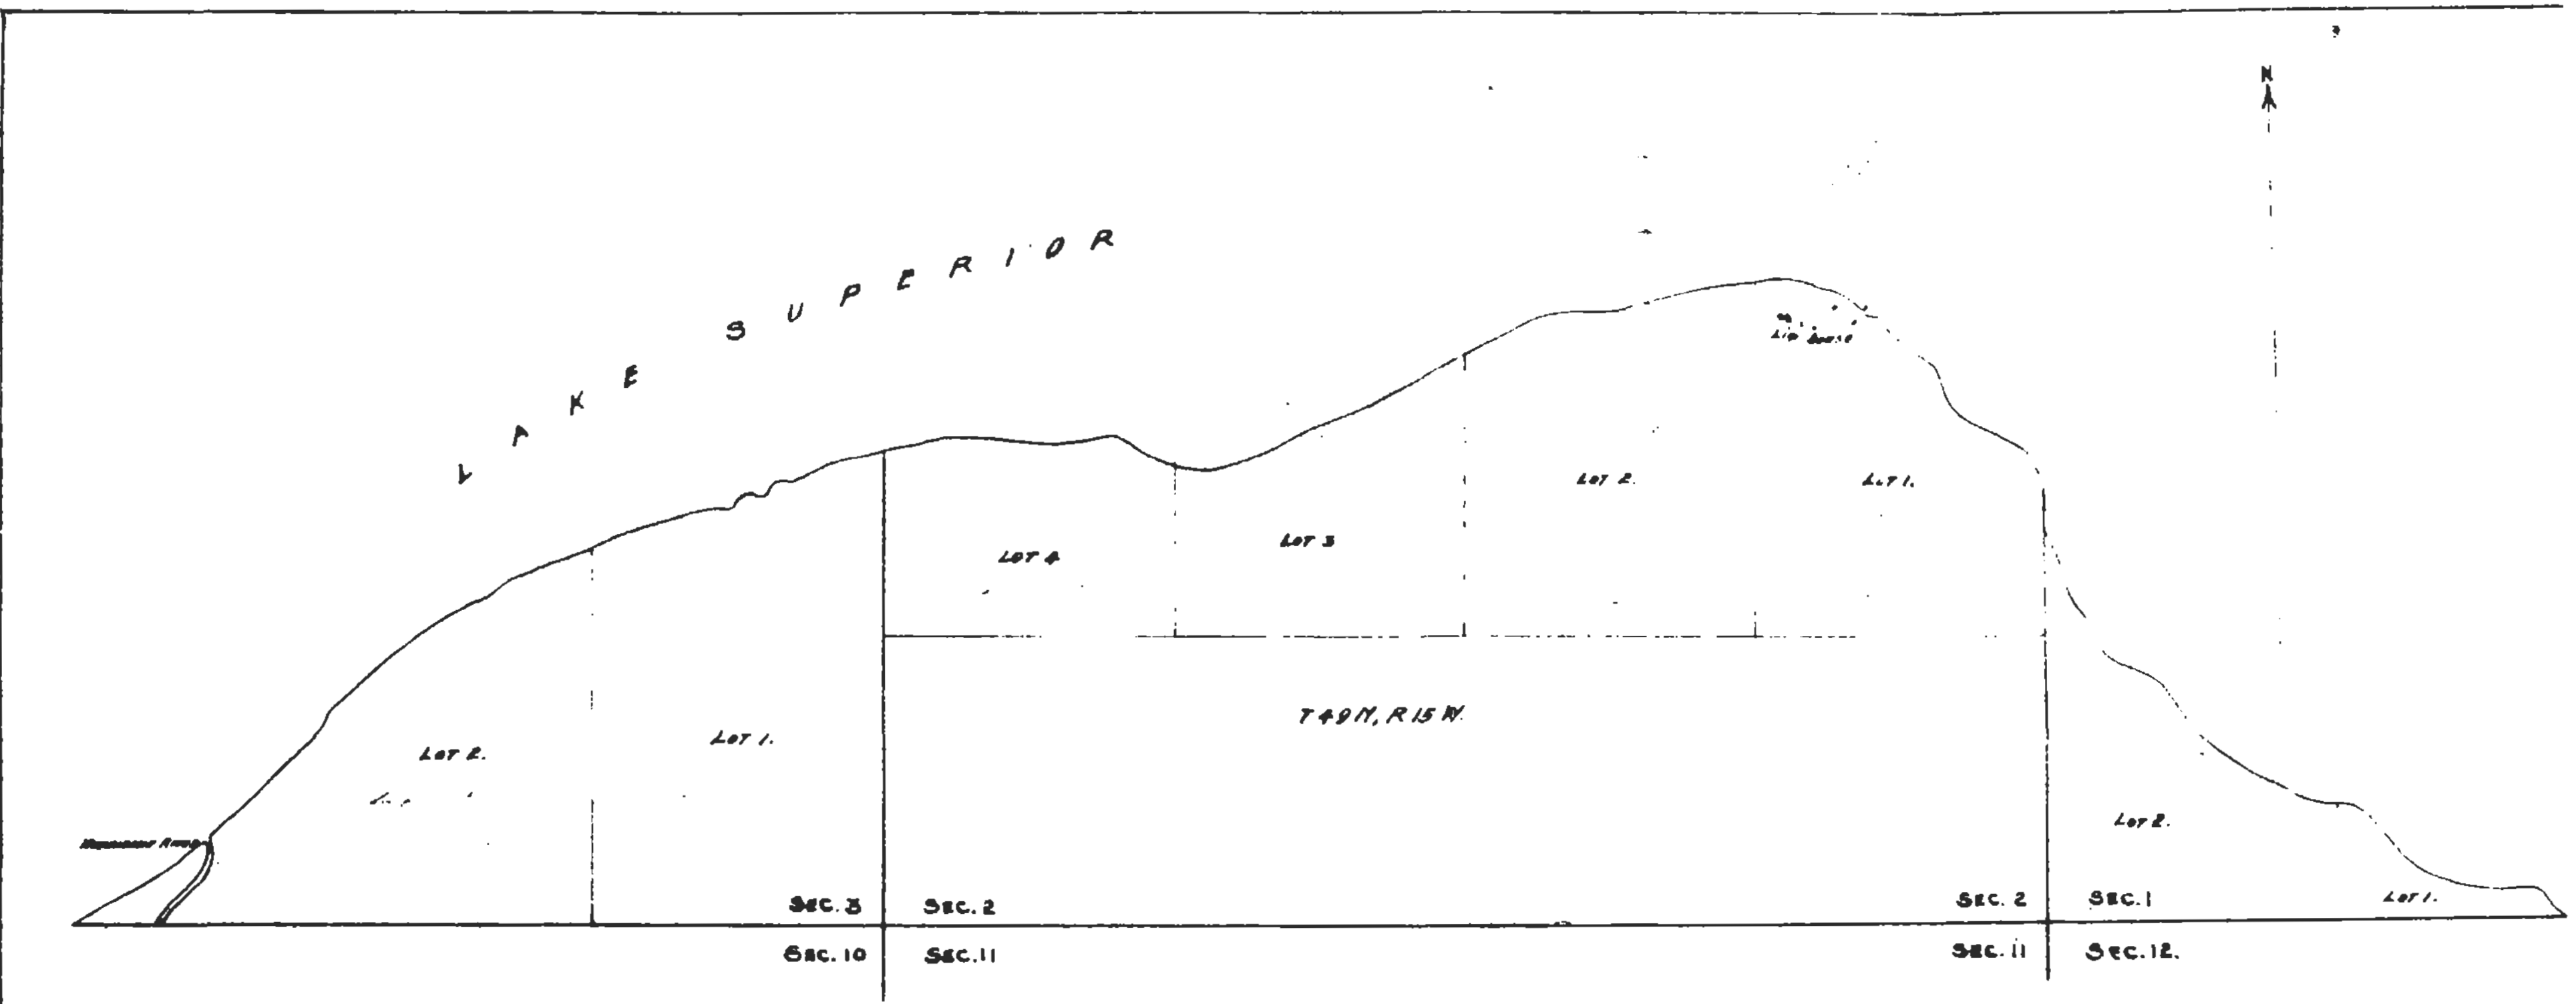
The Light-House Site consists of Lots 1 and 2, Sec. 1; Lots 1, 2, 3, and 4, Sec. 2; Lots 1 and 2, Sec. 3; Township 49 North, Range 15 West.

SKETCH OF LIGHT-HOUSE SITE
AT
BIG SABLE
MICH.
Purchased in 1872.
Surveyed in 1884.

16. Drawing, "Big Sable Light Station, Mich., Reservation Surveyed Aug. 11-13, 1884 by Geo. Y. Wisner," RG 26, NA.
